Building Inspection Report VR

Inspection Date: Mon, 2 Mar 2026

Property Address: 15 Macquarie Cct, Pakenham VIC 3810,
Australia

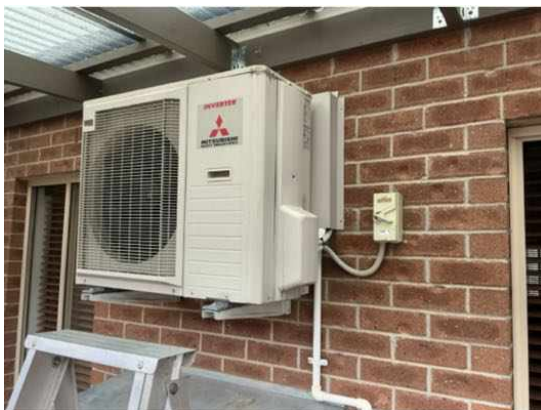
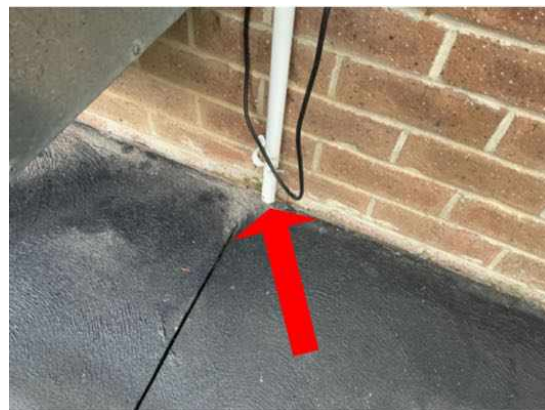
Defects 3.01

Building: Main Building
 Location: Yard - RHS
 Finding: AC Overflow - Not plumbed to suitable drainage
 Information: Upon inspection, it was found that the AC overflow is not plumbed or connected to suitable drainage. This could lead to the surrounding area becoming excessively damp, which in turn may cause secondary defects such as rot, rust, corrosion of associated building elements, and the formation of fungal decay. In addition, prolonged damp conditions could create potential slip hazards. Poor site drainage may exacerbate the issue, potentially attracting termite activity to the area.

We recommend that a licensed plumber be appointed to properly plumb the AC overflow and connect it to suitable drainage. This will help ensure that the area remains dry and free from secondary defects.

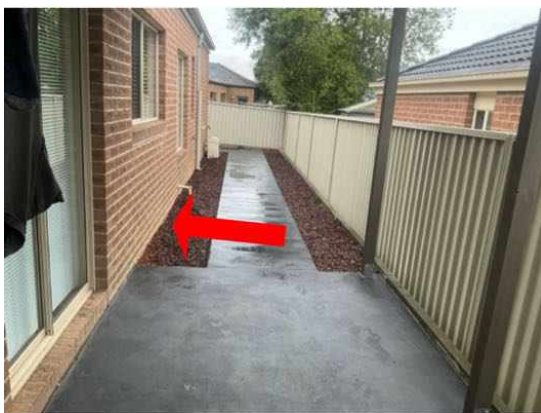
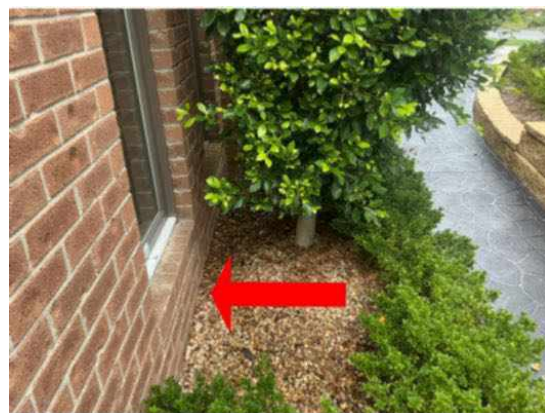
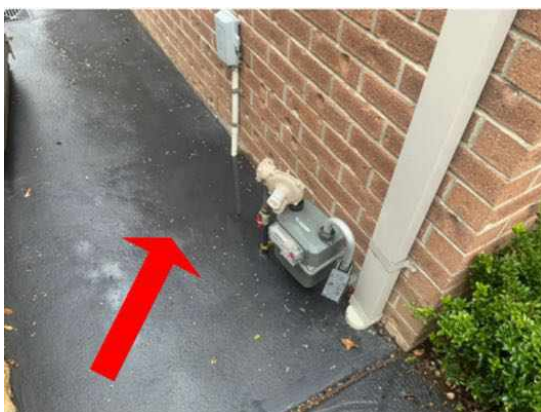
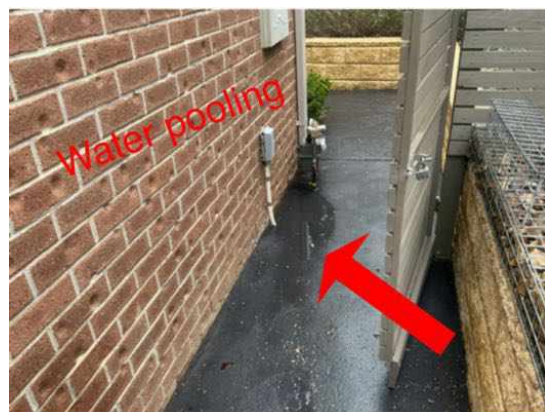
Defects 3.02

Building: Main Building
 Location: All External Areas
 Finding: Site drainage - Inadequate
 Information: The site drainage in sections of the sideyards and front yard was found to be

inadequate at the time of inspection, creating potential for subsequent water damage to associated building elements.

It is important that water does not lie against the base of walls; surrounding paths and ground levels should be sloped to drain water away from walls. Downpipes should not discharge stormwater onto lower walls or plinths. Stormwater should be carried away by large, regularly cleaned drains. Ground levels may need to be lowered to expose a buried DPC.

Where site drainage is inadequate, installation of an Agricultural (Aggie) Drain may be required. A qualified plumber should be appointed to further inspect the property and perform any remedial works as necessary. Water damage and secondary defects are likely to occur if left unmanaged.

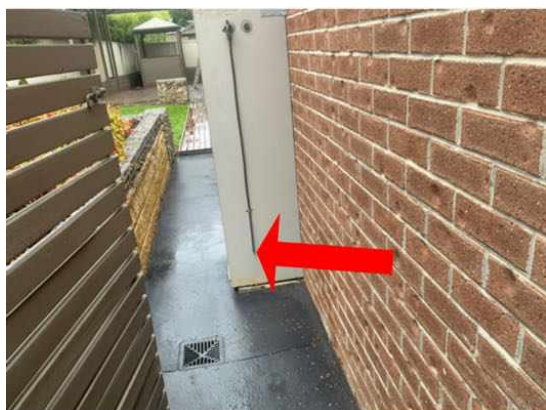
Defects 3.03

Building:	Main Building
Location:	Yard - Side
Finding:	HWS Overflow - Not Connected
Information:	The Hot Water System (HWS) overflow was found to be disconnected from storm water drainage and is creating excessive moisture in the surrounding area.

These damp conditions can lead to secondary defects such as rot, rust or corrosion

of associated building elements, the formation of fungal decay, or even the creation of potential slip hazards. When coupled with poor site drainage, pooling of water may also attract termite activity to this area.

It is highly recommended that a licensed plumber be appointed to connect the HWS overflow in order to prevent such an environment from being created. These minor works should be carried out as soon as possible.

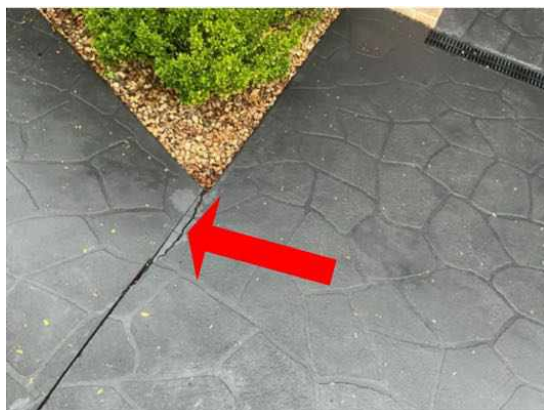
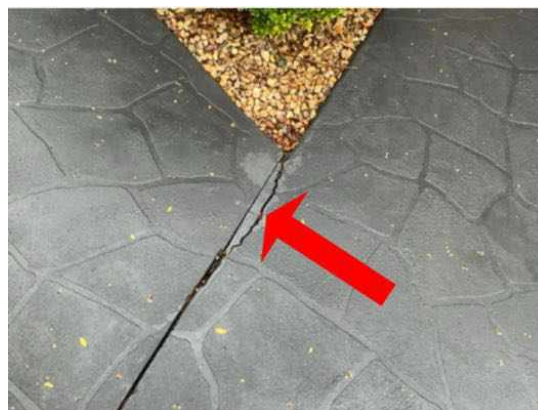
Defects 3.04

Building:	Main Building
Location:	External concrete paving
Finding:	Cracking - External Concrete Paving Damage Category 2 - Distinct (less than 3mm)
Information:	Distinct cracks were identified in external concrete paving. Distinct cracks are generally found in older concrete paving, and may also present as a trip hazard as consequence of an uneven or curved surface.

General age and expected deterioration of the paved areas is a common cause of this type of cracking. However, expansion and contraction of the slab may also have occurred due to environmental factors. Such factors include variable moisture and weather conditions, the presence of trees and their roots having a settling or lifting affect on the soil, or the effect of load bearing, e.g. heavy vehicles over a sustained period of time.

Cracking to this degree may also be due to poor original installation of the concrete. Factors such as poor compaction of the sub surface and/or inadequate reinforcing of the slab may create cracking and other secondary defects.

Repairs are likely to be required to prevent further cracking and to reduce hazards associated with cracking, such as tripping. Monitoring of all cracking should be conducted frequently. Always contact a building inspector should cracks widen, lengthen, or become more numerous.

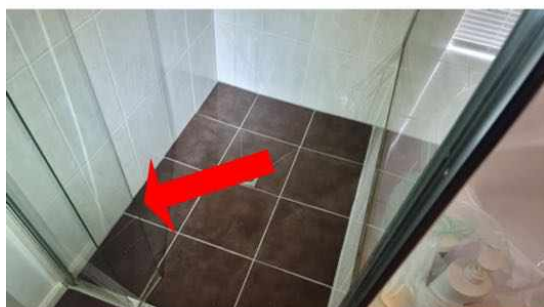
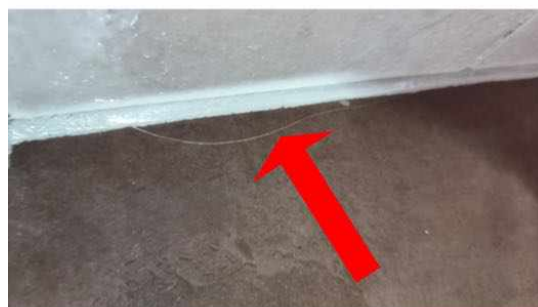
Defects 3.05

Building: Main Building
 Location: Ensuite - Master
 Finding: Cracked Floor Tile – Master Ensuite Shower
 Information:

At the time of inspection, one of the floor tiles within the shower area of the master ensuite was observed to be cracked.

Cracked tiles may allow water to penetrate beneath the tiled surface and can lead to further deterioration of the tile or underlying substrate if not rectified.

A qualified tiler should be engaged to carefully remove and replace the damaged tile and reinstate the grout to ensure the tiled surface remains watertight and serviceable.

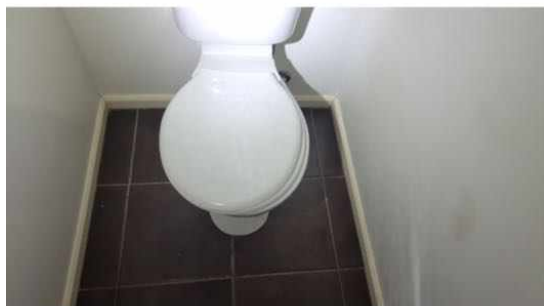
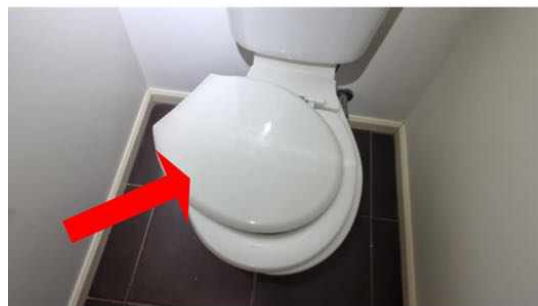
Defects 3.06

Building: Main Building
 Location: Ensuite - Master
 Finding: Toilet seat - loose
 Information: The toilet seat was found to be loose and shifting during use at the time of inspection. This defect likely developed due to wear and tear of the seat's fixing hardware. However, it may also be the result of improper installation or accidental impact.

If left unaddressed, the loose toilet seat could worsen, leading to potential damage to the mounting points or discomfort for users. In some cases, further instability may lead to minor injuries or increased wear on the toilet bowl.

It is recommended that the toilet seat be properly refastened or replaced by a licensed plumber to ensure safe and stable use.

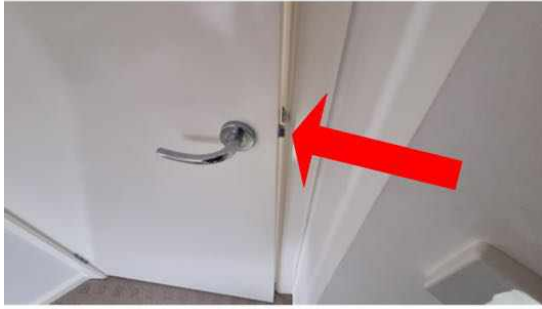
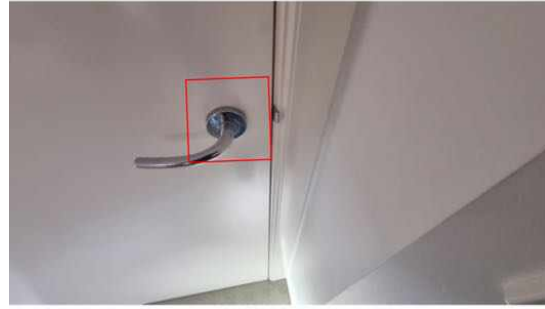
Defects 3.07

Finding: Door handle - Not latching

Information: It was noted that the door in this area was not latching during operation at the time of inspection. Whilst detracting from the functionality of this building element, this minor defect may also be a security risk, and may therefore have serious implications if left unattended.

It is suspected that this defect has occurred due to minor issues with the associated hinges. Such damage is identified as general wear and tear, which is expected for building elements of this age.

A qualified carpenter or general handyperson may be appointed to perform rectification works as necessary, at client discretion. If left unattended, further functional impairment is likely to occur.

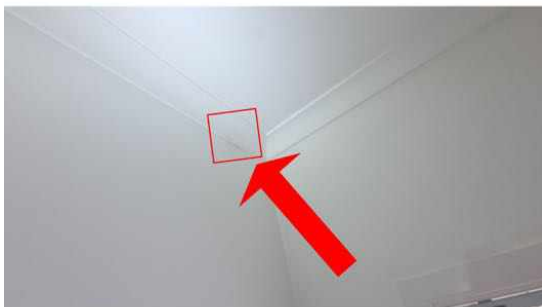
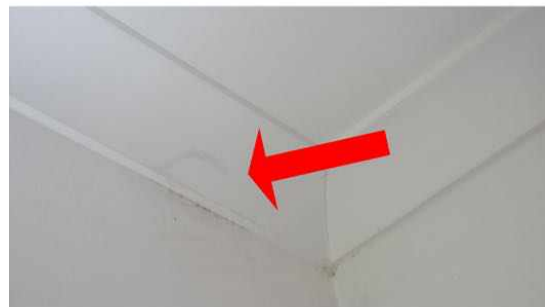
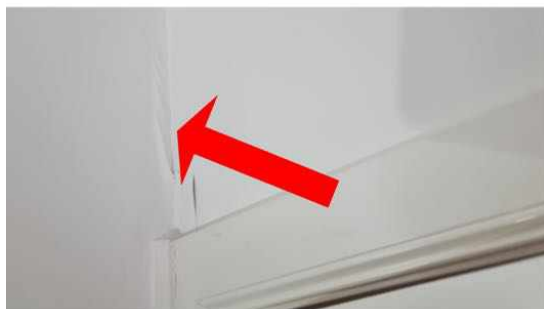
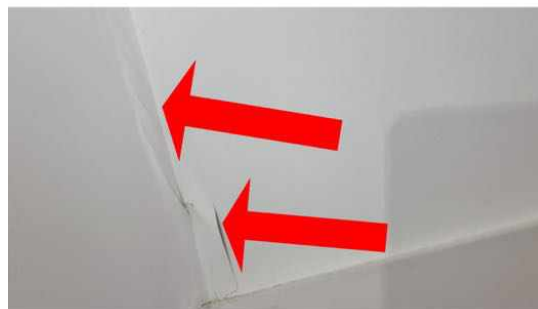
Defects 3.08

Building: Main Building
 Location: Bathroom 2
 Finding: Paint Defects and Discolouration – General Bathroom Ceiling and Door Frame
 Information:

At the time of inspection, a discoloured area resembling a water stain was observed on the ceiling of the general bathroom near the corner junction. Moisture testing of the affected area was carried out using a moisture meter, and the readings recorded were within normal ranges, indicating no elevated moisture levels at the time of inspection. The discolouration is therefore considered consistent with a paint finish defect rather than an active moisture issue.

An additional paint defect was observed above the door frame within the same bathroom, where the paint finish has begun to detach along the line of previously applied masking tape.

These items are considered cosmetic defects. It is recommended that the affected areas be lightly sanded and repainted to achieve a uniform finish consistent with the surrounding surfaces.

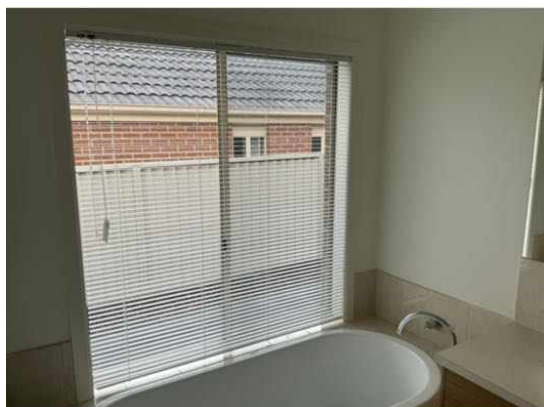
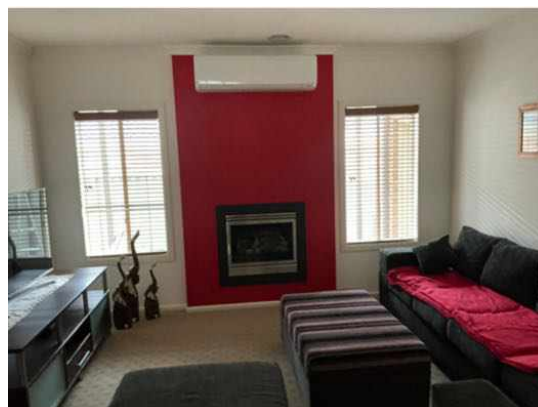
Defects 3.09

Building:	Main Building
Location:	Internal windows
Finding:	Windows - Stiff to slide
Information:	Several windows throughout the property were jammed and difficult to operate at the time of the inspection. Windows provide ventilation to the adjoining area and should be at a fully operational level to ensure user comfort. Restricted function of the window may also pose as a potential safety hazard if required for emergency egress from the building.

Generally, factors such as general age of the building element and a lack of maintenance are the usual causes for this type of defect.

Replacement of window hardware or frame may be required, as well as minor repairs and cleaning. A registered builder or general handy person will be required to repair the affected windows.

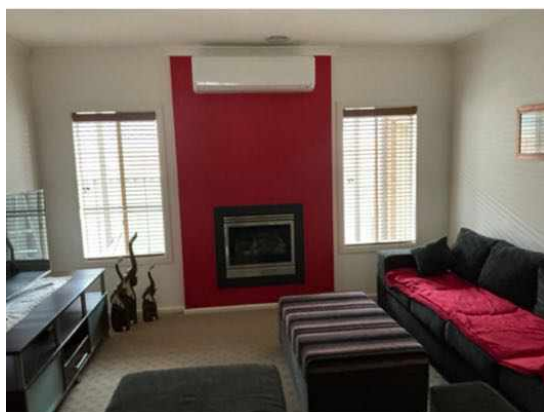
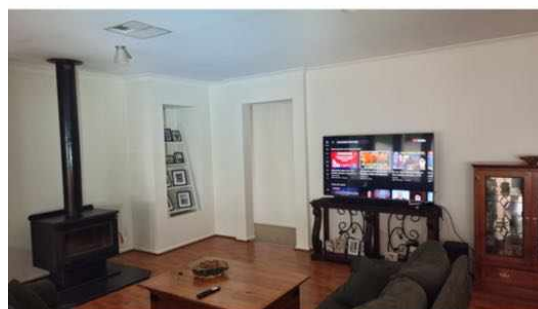
Noted Item

Building: Main Building
Location: All Areas
Finding: Obstructions and Limitations - Interior
Information: These photographs are an indication of the obstructions and limitations which impeded the inspection of the internal areas of the property at the time of inspection. These obstructions can hide an array of defects and should be removed to allow full inspection to be carried out. A re-inspection is recommended once the areas are made accessible.

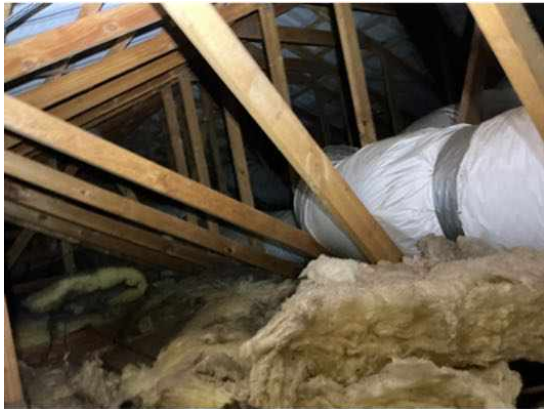
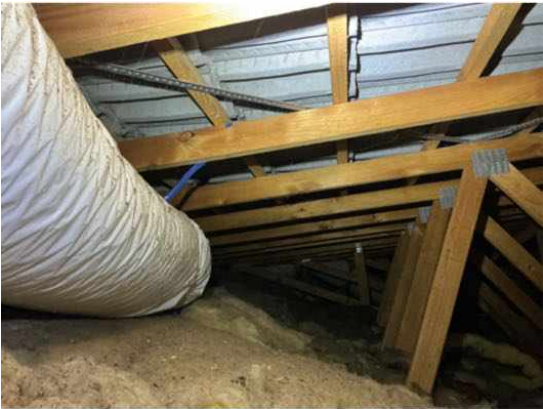
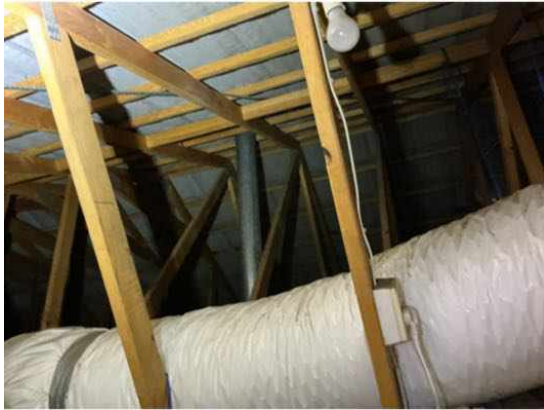
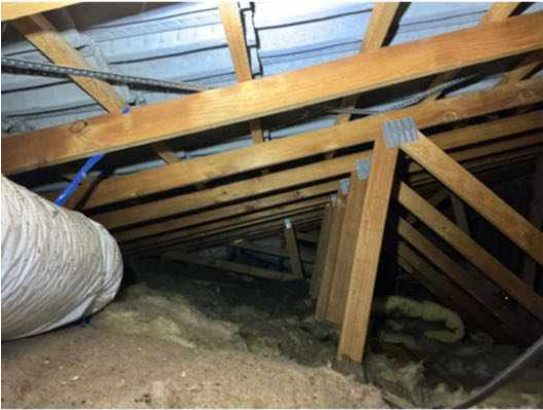
Noted Item

Building: Main Building
Location: Roof Void
Finding: Obstructions and Limitations - roof cavity
Information: These photographs are an indication of the obstructions and limitations which impeded the inspection of the roof cavity area of the property at the time of inspection. These obstructions can hide an array of defects and should be removed to allow full inspection to be carried out. A re-inspection is recommended once the areas are made accessible.

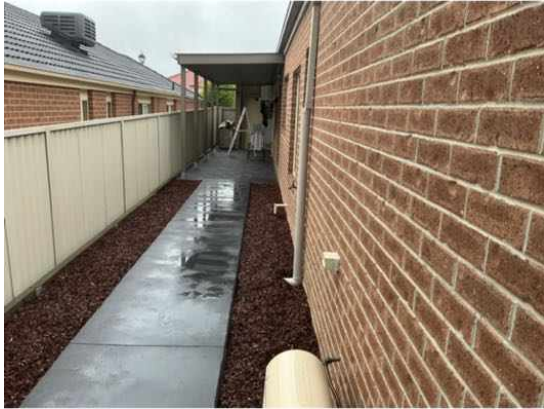
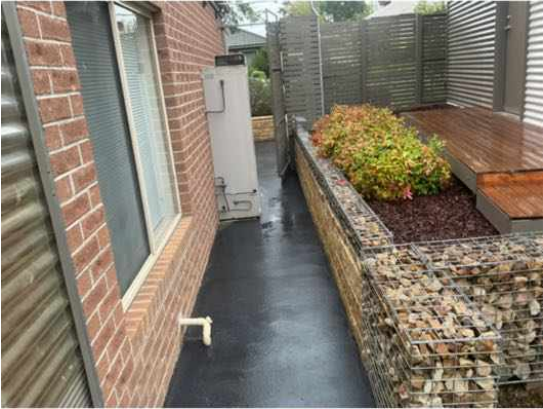
Noted Item

Building: Main Building
Location: All External Areas
Finding: Obstructions and Limitations - Exterior
Information: These photographs are an indication of the obstructions and limitations which impeded the inspection of the external areas of the property at the time of inspection. These obstructions can hide an array of defects and should be removed to allow full inspection to be carried out. A re-inspection is recommended once the areas are made accessible.
