## Building Inspection Report

Inspection Date: Wed, 28 Jan 2026

Property Address: 167B Glenwood Park  
Dr, GLENWOOD, NSW, 2768, Australia

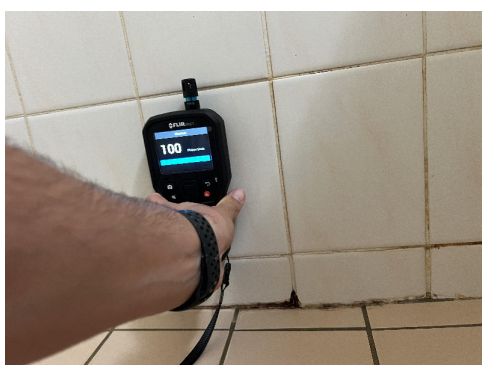
#### Defects 2.01

Finding: Elevated Moisture Readings to Shower Wall Tiles

Information: Elevated moisture readings were recorded to the lower sections of the shower wall tiles when tested using a non-invasive moisture meter, with readings reaching high levels at the time of inspection. The testing was carried out to the tiled wall surfaces within the shower area. It should be noted that the shower appeared to have been recently used prior to the inspection, which is likely to have influenced the moisture readings obtained.

While elevated readings in recently used shower areas can be expected, the presence of other defects within the shower area, including missing sealant and cracked tiles, increases the potential risk of moisture penetration beyond the tiled surface. It is recommended that the shower area be monitored and, if elevated readings persist once the area has had sufficient time to dry, further assessment by a suitably qualified bathroom or waterproofing specialist may be warranted. Rectification of associated defects is recommended to reduce the risk of ongoing moisture-related issues.

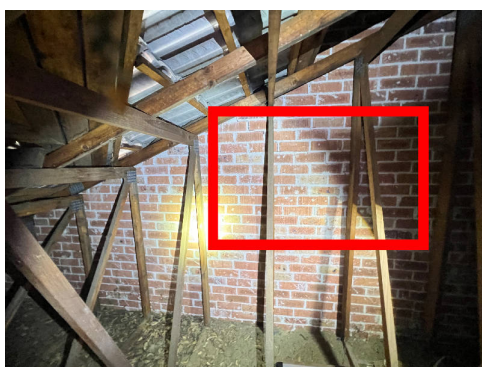
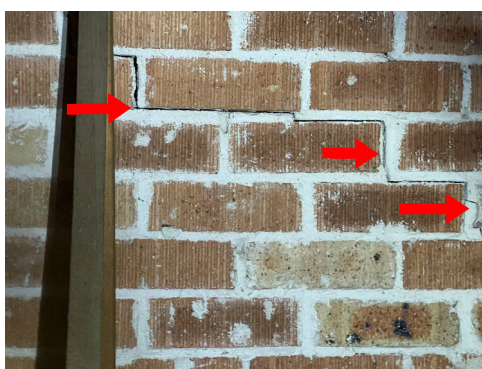
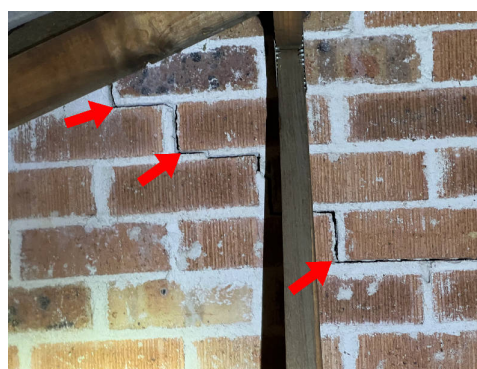
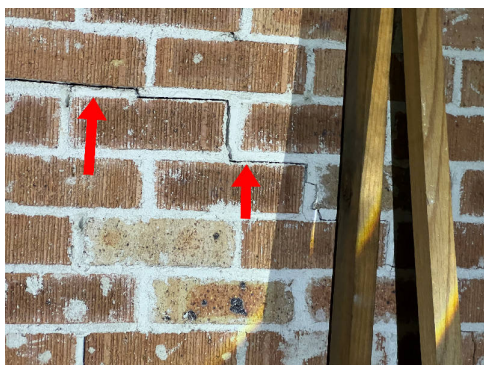
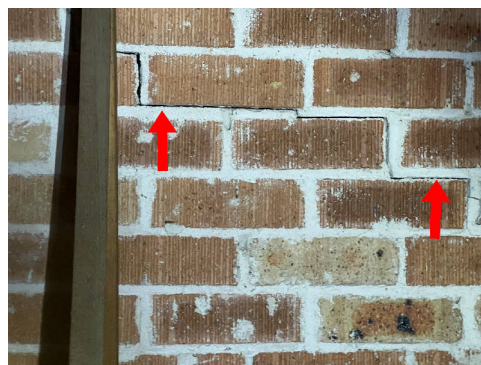
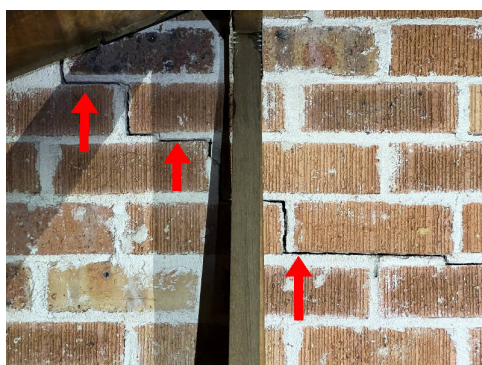
## Defects 2.02

Finding: Major Cracking to Masonry Party Wall Within Roof Space

Significant cracking was observed to the masonry party wall within the roof space at the time of inspection. The cracking follows a stepped pattern through the brickwork and mortar joints and is visible across multiple courses. This condition was observed adjacent to roof framing members and is considered more than minor or cosmetic cracking.

Cracking of this nature may be indicative of structural movement, differential settlement, thermal movement, or load-related stresses affecting the party wall. Due to the location and extent of the cracking, further investigation is warranted to determine the cause and assess the structural implications. It is recommended that a suitably qualified structural engineer or experienced builder assess the party wall and provide advice on any required repairs or monitoring. This defect is considered significant and should be addressed as a priority.

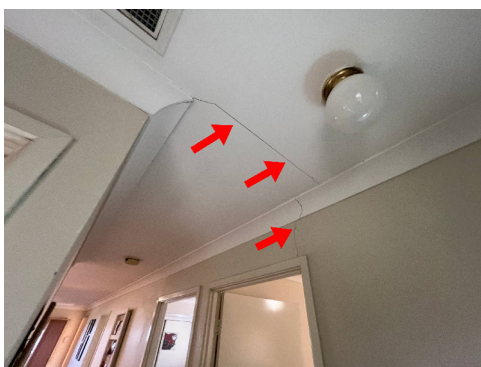
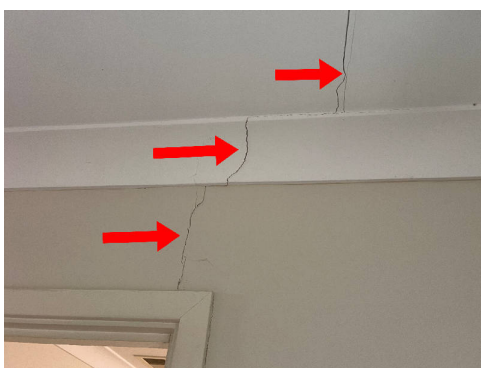
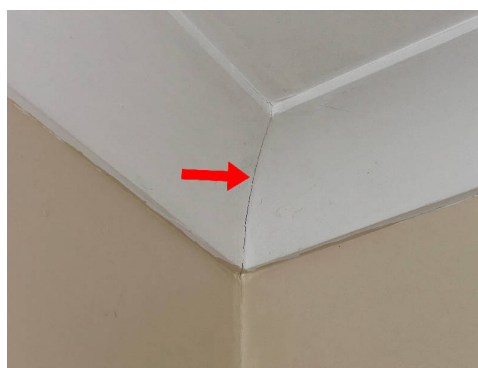
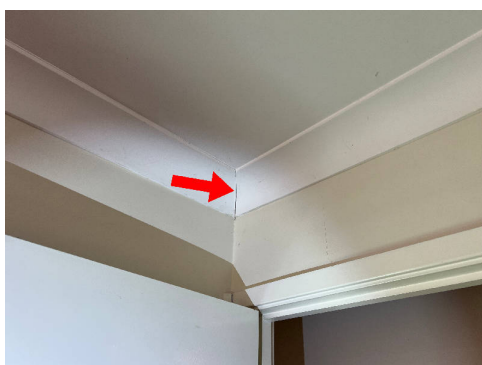
### Defects 3.01

Building:	Main Building
Location:	All Internal Areas
Finding:	Internal Cracking to Ceiling and Wall Junctions

Cracking was observed to the internal ceiling lining and extending down the adjacent wall surface at the junctions between the ceiling, cornice, and wall. The cracking follows ceiling sheet joints and continues vertically down the wall below. This condition is commonly associated with building movement, minor settlement, or thermal expansion and contraction of materials. While this type of cracking is often cosmetic in nature, it can indicate ongoing movement if it continues to worsen or reappears after repair.

It is recommended that the cracking be assessed by a licensed plasterer or suitably qualified builder to confirm whether the issue is cosmetic only or if further investigation is required. Monitoring is advised in the short term, with repairs to be undertaken if the cracking increases, reopens after patching, or if cosmetic improvement is desired.

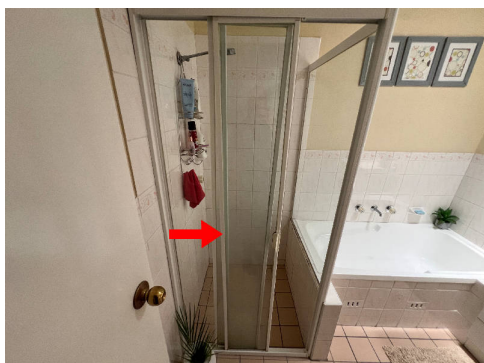
### Defects 3.02

Information: The shower screen door was observed to become stuck and does not open or close smoothly during operation. The door appears to bind within the frame and tracks, which may be due to misalignment, wear to the rollers or guides, or a build-up of debris within the track. This condition affects the normal operation of the shower screen and may lead to further wear or damage if continued to be forced during use.

It is recommended that a suitably qualified glazier or bathroom repair specialist assess the shower screen door to determine the cause of the obstruction and carry out the necessary adjustments or repairs. Rectification is recommended in the short term to restore proper operation and prevent further deterioration of the door components.

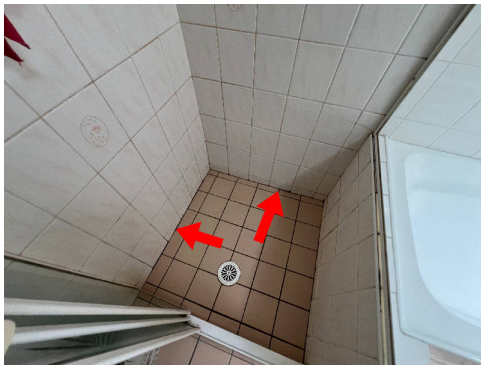
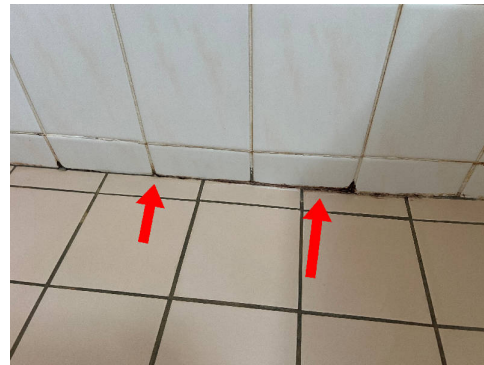
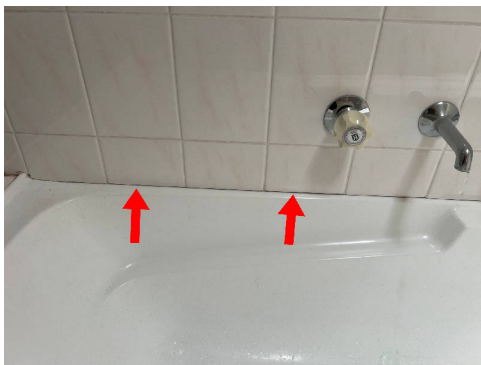
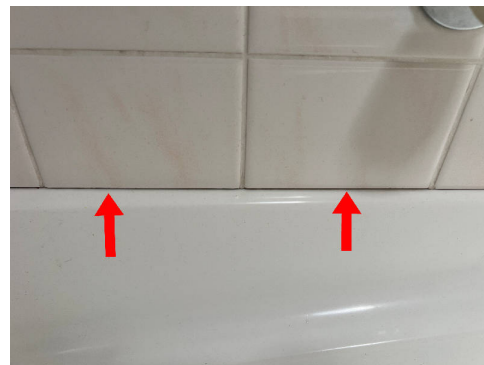
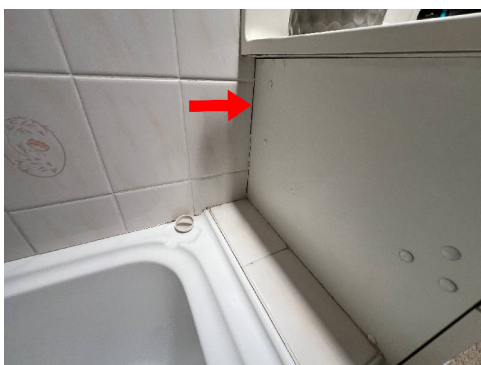
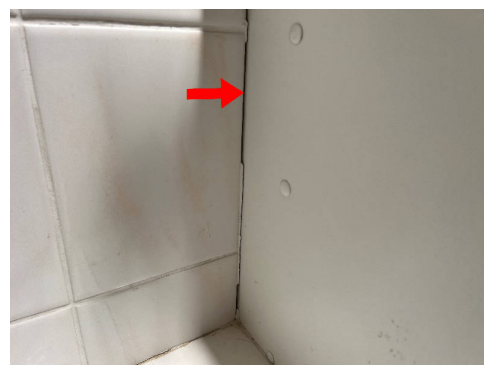
### Defects 3.03

Finding: Missing and Deteriorated Sealant to Bathroom Wet Area Junctions

Information: Missing and deteriorated sealant was observed at multiple wet area junctions within the bathroom, including the shower wall to floor junction, around the bath tub perimeter, and to the vanity splashback and adjacent junctions. Sealant in these locations is intended to provide a flexible, water-resistant barrier to prevent moisture from penetrating behind tiled finishes and fixtures. The absence or failure of sealant at these junctions compromises this barrier and allows water to migrate into concealed areas.

This condition increases the risk of moisture ingress, deterioration of waterproofing membranes, and concealed damage to wall and floor substrates over time, particularly in regularly used wet areas. It is recommended that a suitably qualified tiler or bathroom repair specialist reapply appropriate waterproof sealant to all affected junctions as a single scope of works. Rectification is recommended in the short term to reduce the risk of ongoing moisture-related issues and potential future damage.

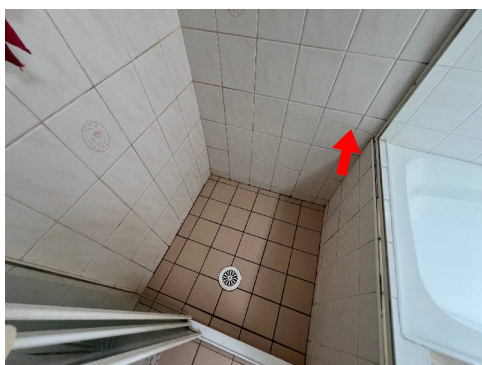
### Defects 3.04

Finding: Cracked Wall Tile Within Shower Area

Information: A cracked wall tile was observed within the shower area, located to the tiled wall adjacent to the shower screen. The cracking runs through the tile surface and compromises the integrity of the tile finish. Cracked tiles in wet areas can occur due to building movement, impact damage, or stress within the substrate behind the tile.

This condition may allow moisture to penetrate behind the tiled surface, increasing the risk of water ingress, deterioration of the waterproofing membrane, and concealed moisture damage over time. It is recommended that a suitably qualified tiler assess the affected area and replace the cracked tile in the short term to maintain the integrity of the shower waterproofing system and prevent further deterioration.

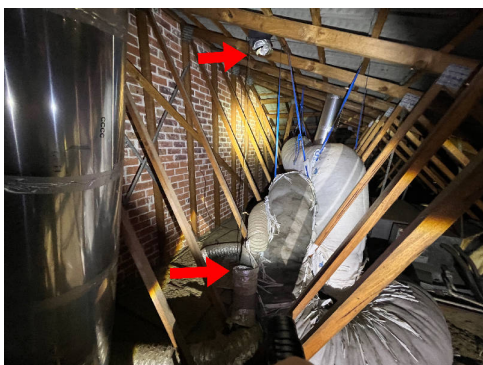
### Defects 3.05

Finding: Disconnected and Damaged Air Conditioning Ductwork Within Roof Space

Information: Disconnected ductwork and tearing to sections of the air conditioning ducts were observed within the roof space at the time of inspection. The affected ducts appear to be partially detached from the main system and show visible damage to the flexible duct material. This condition was identified adjacent to the air handling unit and associated duct runs.

Disconnected and damaged ductwork can significantly reduce the efficiency and effectiveness of the air conditioning system by allowing conditioned air to escape into the roof space rather than being delivered to internal rooms. This may result in poor system performance, increased running costs, and uneven temperature control throughout the dwelling. It is recommended that a suitably qualified air conditioning technician assess and repair or replace the affected ducting as required in the short term to restore proper system operation.

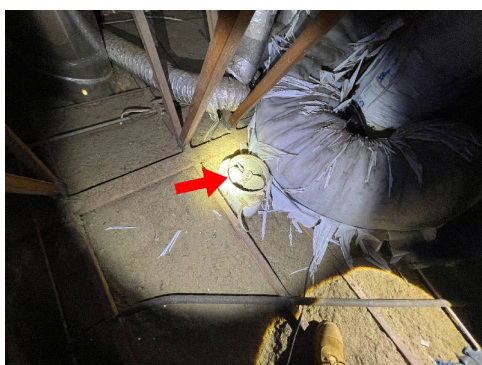
### Defects 3.07

Information: The bathroom exhaust fan was observed to discharge air directly into the roof void rather than being ducted to an external vent. The fan unit and associated ducting were located within the roof space, with no effective connection to an external outlet evident at the time of inspection.

Venting moist air into the roof space can lead to a build-up of condensation, which may contribute to moisture-related issues such as mould growth, deterioration of insulation, and potential damage to roof timbers over time. It is recommended that a suitably qualified contractor or electrician install appropriate ducting to vent the bathroom exhaust fan to the exterior of the building. Rectification is recommended in the short to medium term to reduce the risk of ongoing moisture-related issues within the roof space.

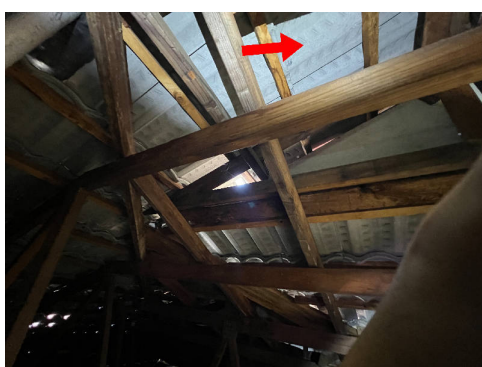
### Defects 3.08

**Information:** No sarking was observed beneath the roof covering within the roof space at the time of inspection. The underside of the roof tiles and roof battens were visible, with no reflective foil or breathable membrane installed. This condition appears consistent with the original method of construction for dwellings of this age and type.

While sarking is not always required in older homes, the absence of sarking can allow wind-driven rain, dust, and condensation to enter the roof space and may reduce thermal efficiency. It is recommended that this condition be noted for future reference, particularly if roof works or re-roofing are undertaken, at which time the installation of sarking could be considered to improve weather protection and energy performance.

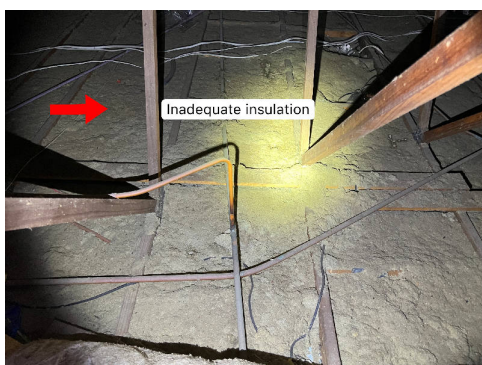
### Defects 3.09

**Building:** Main Building  
**Location:** Roof Void  
**Finding:** Inadequate Ceiling Insulation Within Roof Space

**Information:** Ceiling insulation within the roof space was observed to be limited and uneven in coverage at the time of inspection, with areas of the ceiling lining either insufficiently insulated or not insulated at all. This condition was evident across multiple sections of the roof space and appears consistent with older-style construction or insulation that has not been upgraded over time.

While this condition does not present a structural concern, inadequate insulation may reduce the thermal efficiency of the dwelling and contribute to increased heating and cooling costs. It is recommended that the insulation be upgraded or supplemented to improve energy efficiency and internal comfort. This item is considered a minor defect and is noted for client awareness and future improvement.

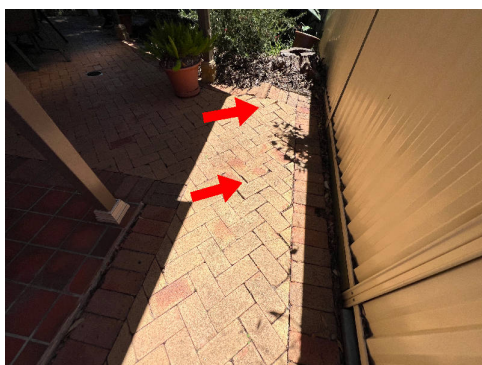
### Defects 3.11

Information: Several areas of the paved surface within the rear yard were observed to be uneven, with individual pavers having settled or become displaced over time. This condition was evident across multiple sections of the paved area, resulting in an inconsistent walking surface and visible gaps between some pavers.

Uneven pavers may present a minor trip hazard and can worsen over time due to ground movement, tree root activity, or inadequate base preparation. It is recommended that a suitably qualified landscaper or paving contractor re-level and re-bed the affected pavers to improve safety, functionality, and appearance. This item is considered a minor defect and is noted for maintenance and future rectification.

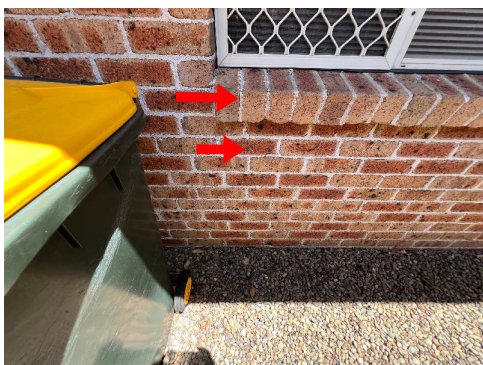
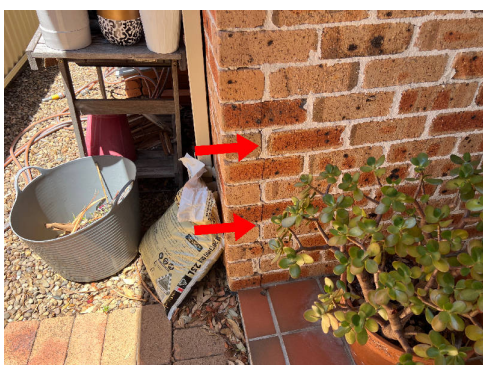
### Defects 3.12

Finding: Cracking to External Brickwork at Rear Corner and Side Elevation

Information: Cracking was observed to the external brickwork at the rear corner and along the side elevation of the dwelling at the time of inspection. The cracking appears predominantly vertical and extends through several courses of masonry, including areas beneath a window opening. The cracking was visible externally and appears consistent with movement-related stresses rather than isolated mortar shrinkage.

Cracking of this nature may be associated with footing movement, soil reactivity, thermal expansion, or long-term settlement. While no immediate signs of structural failure were evident at the time of inspection, the extent and location of the cracking warrant further assessment to determine the cause and whether repairs or monitoring are required. It is recommended that a suitably qualified builder or structural engineer inspect the affected areas and provide advice on appropriate rectification. This defect is considered moderate and should be addressed to prevent further deterioration.

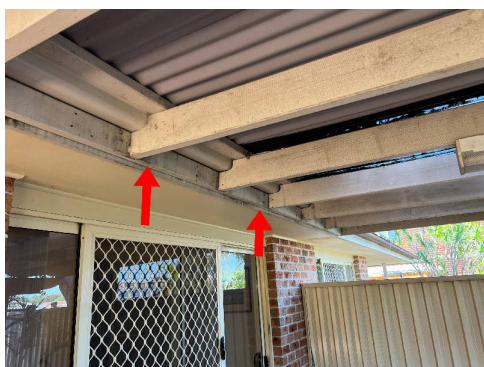
### Defects 3.13

Building: Main Building  
Location: Yard - Back  
Finding: Pergola Structure Not Adequately Secured

The pergola structure was observed to be inadequately secured at the time of inspection, with visible gaps and insufficient fixing between the pergola framing members and the adjacent structure. The connection appears loose, and movement was evident, indicating the pergola is not firmly anchored as intended.

An inadequately secured pergola may become unstable over time and could pose a safety risk, particularly during strong winds or adverse weather conditions. It is recommended that a suitably qualified carpenter or builder inspect the pergola and install appropriate fixings or bracing to ensure the structure is securely anchored and compliant with expected construction practices. This defect is considered moderate and should be rectified to reduce the risk of movement or damage.

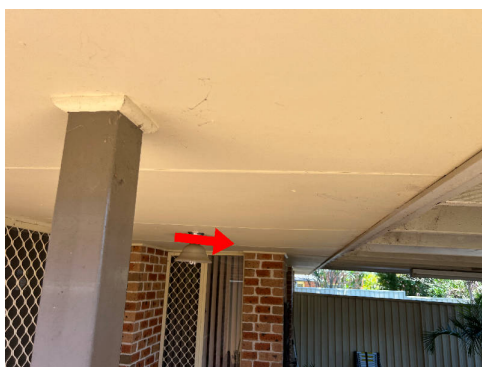
**Defects 3.14**

Information: The ceiling lining to the external covered area was observed to be sagging and uneven at the time of inspection. This condition indicates that the lining has lost rigidity and may no longer be adequately supported or fixed to the framing above. The issue was visually evident across the affected section of the ceiling.

Sagging ceiling linings can occur due to age-related deterioration, moisture exposure, or failure of fixings, and may worsen over time if not addressed. There is a risk that sections of the lining could further deform or detach. It is recommended that a suitably qualified carpenter or builder inspect the ceiling structure to determine the cause and carry out appropriate repairs or replacement as required. This defect is considered minor and should be rectified to prevent further deterioration and potential safety concerns.

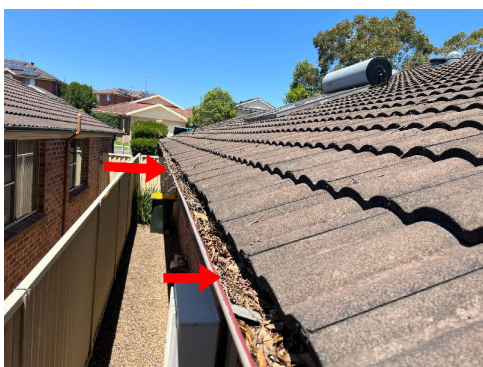
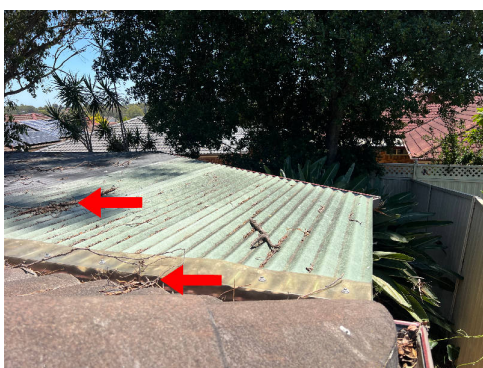
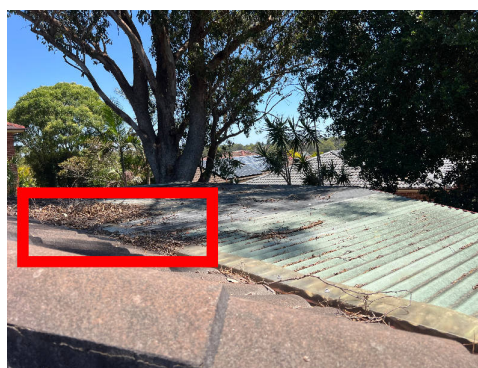
### Defects 3.15

The roof gutters were observed to be significantly blocked with accumulated leaves and organic debris along sections of the roof perimeter at the time of inspection. This condition restricts the effective flow of rainwater and prevents the guttering system from operating as intended.

Blocked gutters can lead to water overflow during rainfall, which may contribute to moisture penetration to eaves, fascia boards, external walls, and potentially internal areas over time. Ongoing blockage may also accelerate deterioration of gutter components. It is recommended that the gutters be cleaned and maintained by a suitably qualified contractor or competent person. Regular maintenance should be undertaken, particularly in areas surrounded by vegetation, to prevent recurrence. This item is considered a maintenance defect and should be addressed in the short term.

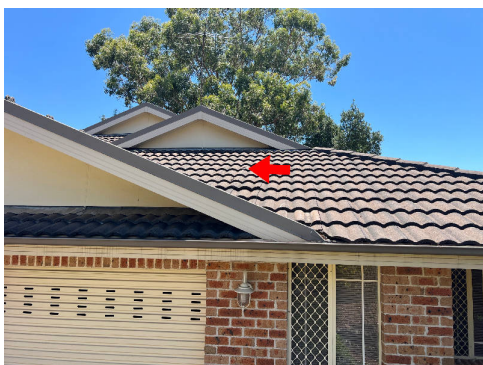
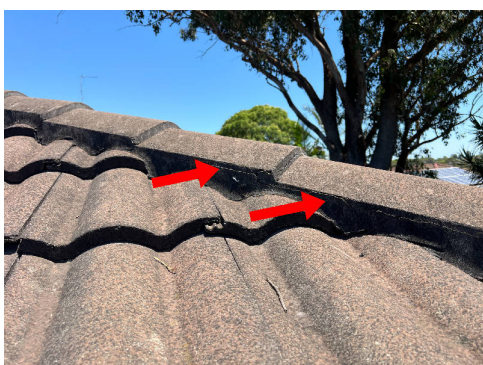
### Defects 3.16

Information: The exterior tiled roof covering was generally observed to be in fair condition for its apparent age; however, isolated deterioration was noted to the mortar bedding and pointing, particularly within valley areas. Minor cracking and areas of loose or degraded mortar were evident at the time of inspection, indicating that previous pointing materials have begun to break down due to age and weather exposure.

Deteriorated or cracked mortar within roof valleys can compromise the weatherproofing performance of the roof covering and may allow water ingress during heavy rainfall. If left unaddressed, this condition may lead to secondary defects such as minor roof leaks and moisture exposure to internal roofing components. Re-pointing and re-sealing of affected areas may be considered as an interim maintenance measure to assist in preserving and extending the service life of the existing roof tiles. It is recommended that a suitably qualified roofing contractor assess the roof and provide advice regarding appropriate remedial works required in the short to medium term.

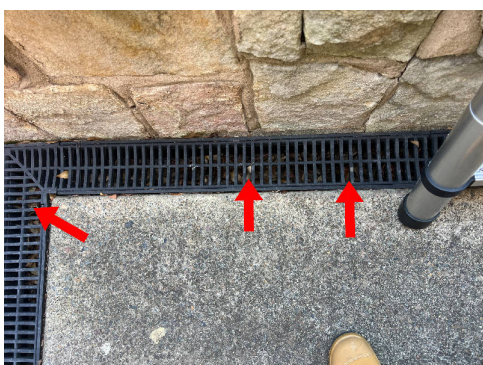
### Defects 3.17

Information: The surface drainage system adjacent to the dwelling was observed to be impeded at the time of inspection due to drainage grates being blocked with accumulated leaf debris. This was noted along the paved pathway adjoining the external wall, where water runoff is directed toward the drains.

Blocked drainage points may prevent effective removal of surface water during rainfall, which can result in water ponding against paving and external walls. Prolonged moisture exposure in these areas may contribute to deterioration of finishes and increase the risk of moisture ingress over time. It is recommended that the drains be cleared of debris and maintained on a regular basis to ensure effective surface water discharge. This item is considered a maintenance issue and should be addressed in the short term.

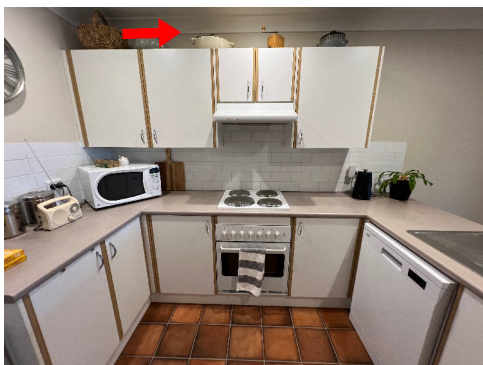
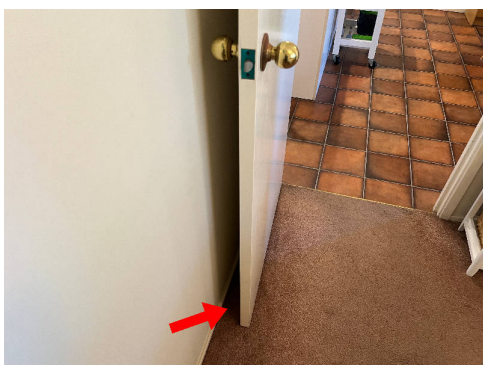
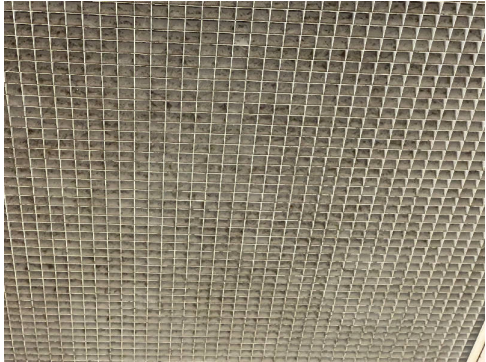
### Noted Item

Building: Main Building  
Location: All Internal Areas  
Finding: General Maintenance Items Observed

Several general maintenance-related items were observed throughout the property at the time of inspection. These included staining to the ceiling above the kitchen area consistent with a build-up of cooking vapours, the absence of a door stop to one of the bedroom doors, and air conditioning components requiring attention, including a loose ceiling vent and a dirty return air grille and visible ducting. These conditions are commonly associated with normal wear, use, and routine maintenance items rather than structural defects.

While no immediate safety or structural concerns were identified in relation to these items, addressing them would improve the overall presentation, functionality, and longevity of the building components. It is recommended that these matters be attended to as part of routine maintenance, including improving kitchen ventilation where possible, installing an appropriate door stop, securing the air conditioning vent, and cleaning or servicing the air conditioning system as required.
