Building and Timber Pest Inspection Report

Inspection Date: Wed, 18 Feb 2026

Property Address: 7/3 Prince

St,OATLANDS,NSW,2117,Australia

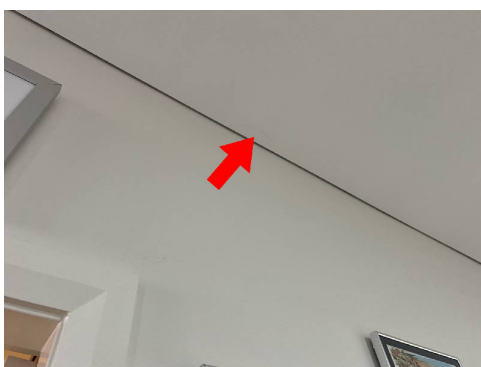
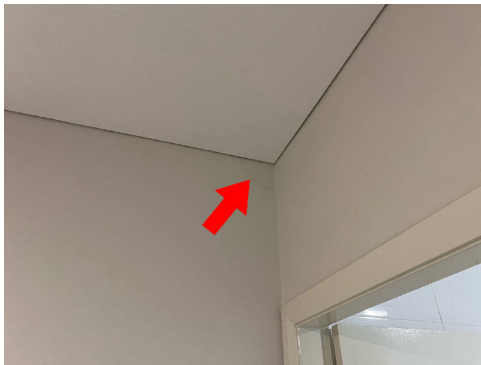
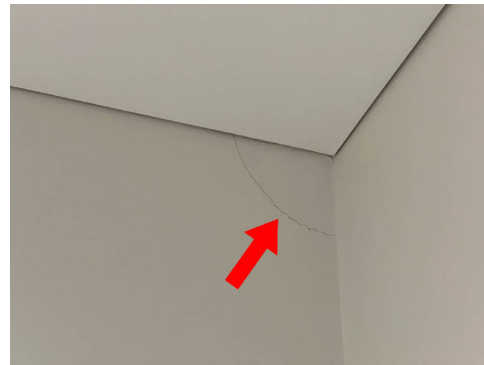
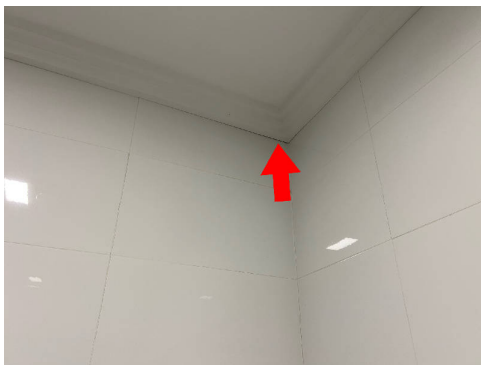
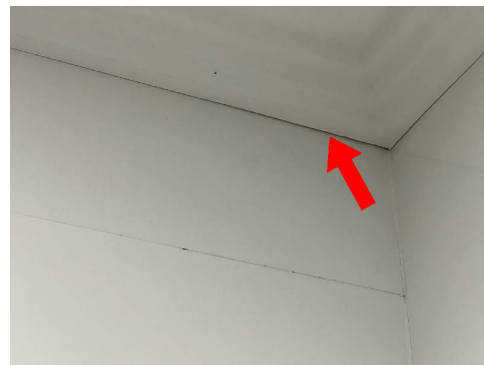
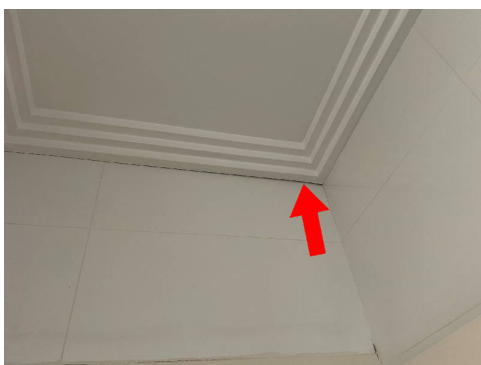
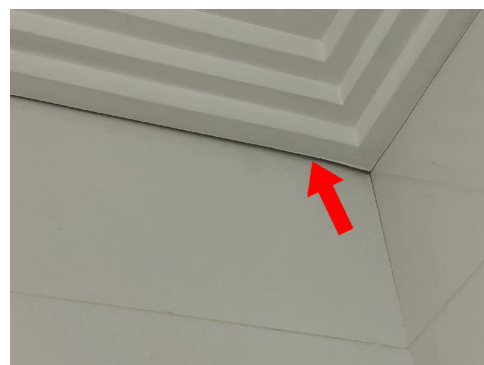
Information: Minor cracking was observed to the garage ceiling lining and to internal wall surfaces in multiple locations. The cracks appear fine and consistent with typical shrinkage or minor movement; however, they indicate some degree of building movement or material settlement.

Although the cracking currently appears cosmetic in nature, such movement-related cracking can worsen over time if underlying causes persist. No significant displacement or structural distortion was noted at the time of inspection. Monitoring is recommended, and if cracking increases in width, length, or frequency, further assessment should be undertaken. Repairs can be carried out by a qualified plasterer as required.

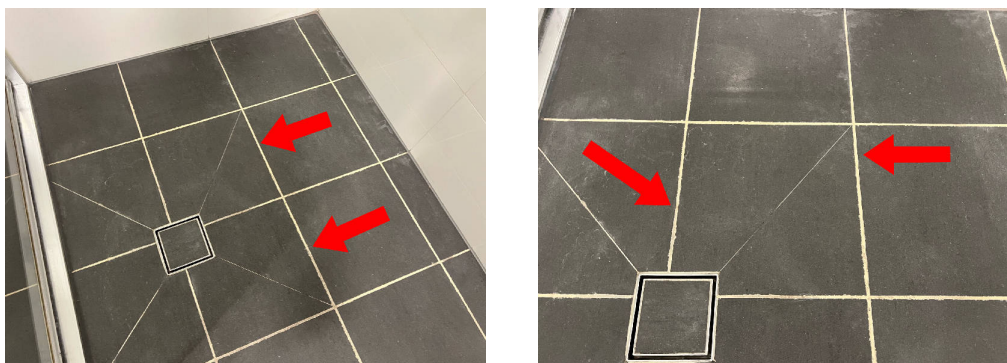
Finding 3.02

Finding: Deteriorated Grout to Shower Floor Tiles

Information: Deterioration to the grout joints was observed to the shower floor tiles in the bathroom, particularly surrounding the floor waste and along several tile joints. The grout appears patchy and worn in sections. Grout forms part of the surface water barrier within wet areas and assists in limiting moisture penetration beneath the tiled finish. Where grout has deteriorated, moisture may track below the tiles, which can contribute to loosening of tiles, water damage to the substrate, and potential waterproofing concerns over time if not rectified.

This condition is located to the shower recess floor within the bathroom. While no active leaks were evident at the time of inspection, maintaining grout integrity in wet areas is important to preserve the performance of the tiled surface. It is recommended that a licensed tiler assess the affected areas and re-grout as necessary to ensure the shower floor remains adequately sealed. Rectification should be undertaken in the short term as part of routine maintenance.

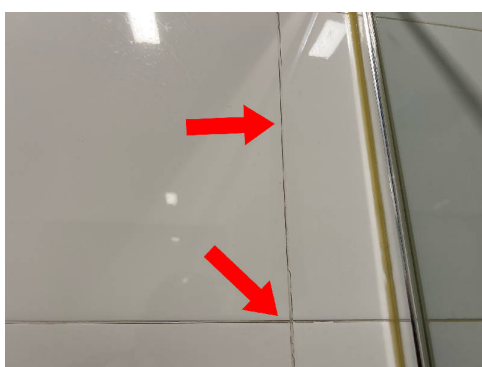
Finding 3.03

Building:	Main Building
Location:	Bathroom
Finding:	Cracked Grout to Bathroom Wall Tiles
Information:	Cracking was observed to the grout joints between wall tiles within the bathroom, primarily adjacent to the shower enclosure. The tiles themselves appear intact, however the grout lines show visible cracking and minor separation along vertical joints. This condition is generally associated with minor building movement, shrinkage, or insufficiently flexible grout at junctions.

Deteriorated or cracked grout can allow moisture penetration behind the tiled surface over time, which may contribute to substrate deterioration, loss of adhesion, and potential water damage if not addressed. While the cracking currently appears minor in nature, it should be rectified to maintain the integrity of the waterproofed wet area.

It is recommended that a licensed tiler remove and replace the affected grout and ensure appropriate flexible sealant is installed at movement joints. Repairs should be carried out in the short term to prevent moisture ingress.

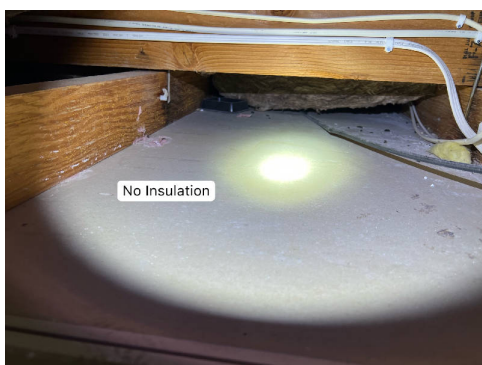
Finding 3.04

Finding: Displaced / Missing Roof Insulation

Information: Sections of ceiling insulation within the roof space were observed to be displaced and not evenly covering the ceiling area. It appears insulation batts may have been moved during previous works and not reinstated to their original position.

Gaps or displaced insulation reduce the thermal efficiency of the dwelling and may contribute to heat gain or loss. While this does not represent a structural issue, reinstatement is recommended to maintain energy efficiency and comfort. A suitable tradesperson or insulation contractor should reposition and ensure full coverage to the affected areas.

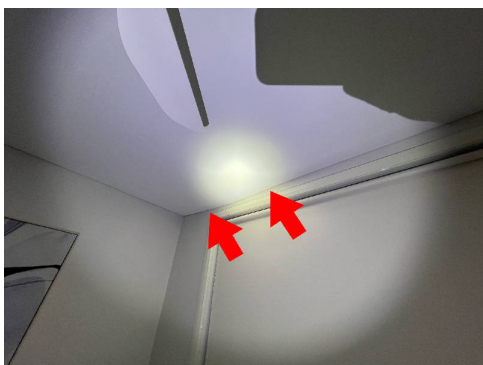
Information: Sagging to the ceiling lining was observed in Bedroom 2, with a noticeable dip to the plasterboard sheeting. The owner advised that a roof leak had previously occurred in this area and has reportedly been repaired. Sagging ceilings typically occur where plasterboard has been affected by moisture, which can cause loss of structural integrity, softening of the board and potential loosening of fixings over time.

Although the leak is reported to have been repaired, the ceiling lining remains visibly deformed and may deteriorate further if not properly rectified. Moisture-affected plasterboard can fail without warning in some circumstances. It is recommended that a licensed plasterer assess the ceiling and carry out repairs or replacement as required. Confirmation that the source of the leak has been permanently rectified should also be obtained.

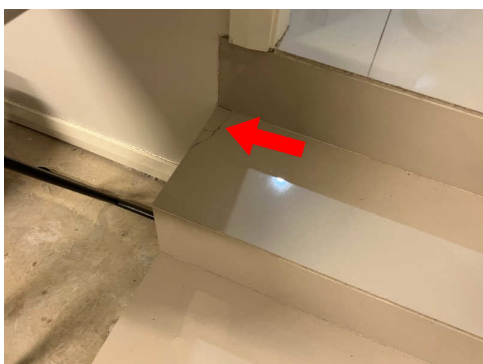
Finding 3.07

Finding: Cracked Tile to Garage Step

Information: A floor tile located to the step within the garage is observed to be cracked through its surface. The cracking appears localised to a single tile at the step junction and is visible along the tile face extending toward the corner. Cracked tiles can worsen over time due to foot traffic and minor movement, potentially leading to loose sections or sharp edges, and may allow moisture penetration into the substrate if left unaddressed.

It is recommended that a licensed tiler assess the affected tile and replace as necessary to prevent further deterioration. Repairs should be carried out in the short term to maintain serviceability and reduce the likelihood of further damage.

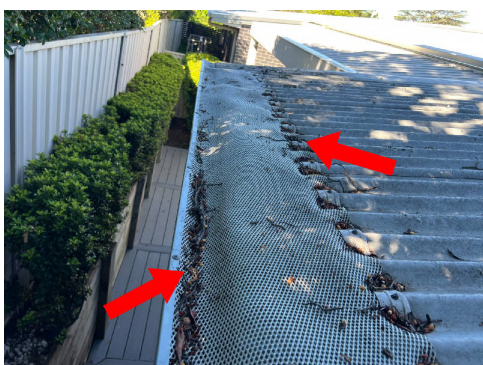
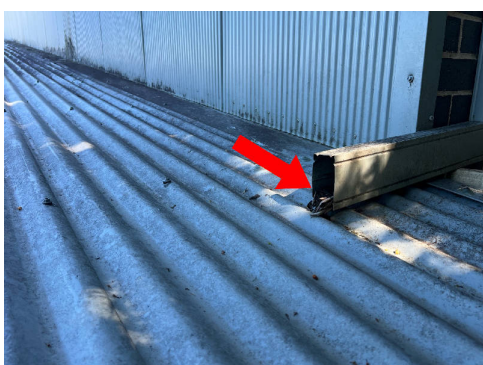
Finding 3.08

Information: Leaves and organic debris were observed accumulating along the gutter guard and at the downpipe entry points to the roof drainage system. This was noted to the external roof line as shown in the attached images. The buildup of debris can restrict the free flow of rainwater, potentially leading to water ponding, overflow into the roof cavity, and increased moisture exposure to fascia and roofing components if not maintained.

It is recommended that the gutters, gutter guard and downpipe inlets be cleaned and cleared by a licensed roof plumber or suitable contractor, and that a regular maintenance schedule be implemented to reduce the likelihood of future blockages. Maintenance should be carried out in the short term.

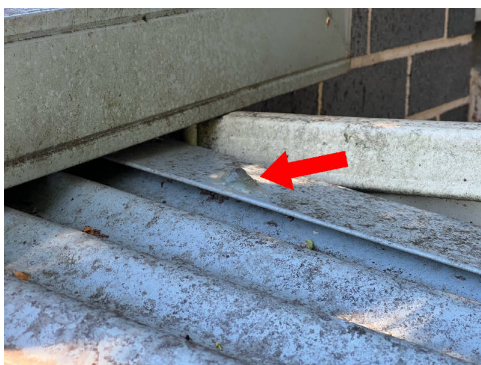
Finding 3.09

Finding: Temporary Sealant Repairs to Roof Fixings

Information: Sealant has been applied over multiple roof screw fixings to the metal roof sheeting, observed externally near the wall junction and beneath the window area. This appears to have been installed as a repair following a reported roof leak. While sealant can provide a short-term reduction in water ingress, it is generally considered a temporary measure and may deteriorate over time due to weather exposure, movement of the roof sheeting, and thermal expansion and contraction.

If the underlying cause of the leak (such as failed washers, loose fixings, or flashing deficiencies) has not been permanently rectified, water penetration may reoccur. A licensed roofing contractor should assess the affected area to confirm that the repair is adequate and durable, and carry out more permanent rectification works if required. This is considered a minor defect, however monitoring is recommended, particularly during heavy rainfall.

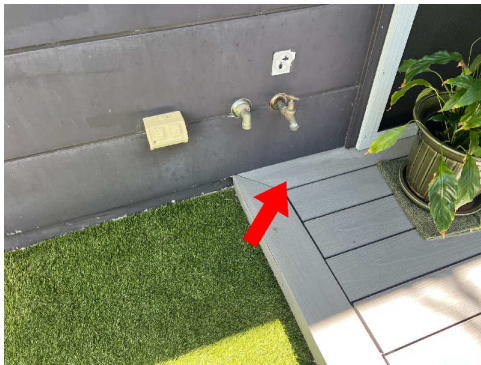
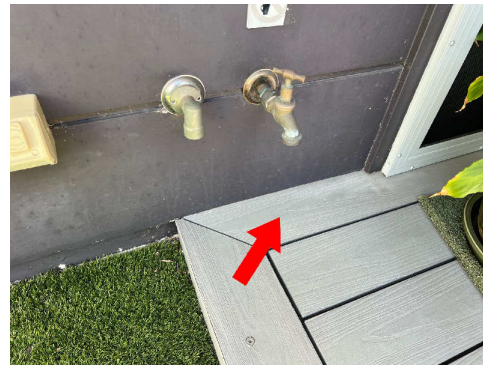
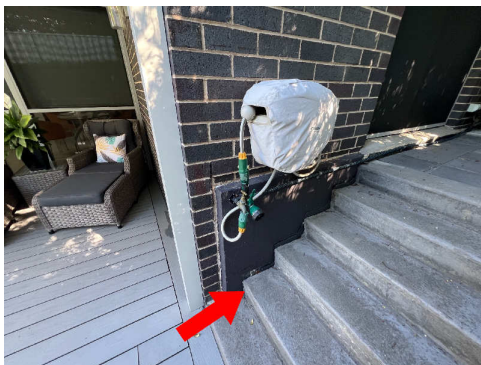
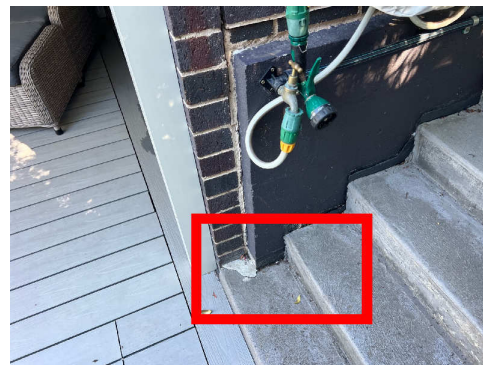
Information: External hose taps were observed installed against the dwelling walls without any visible drainage provision beneath. No grated drain, spoon drain or adequate surface fall away from the structure was noted directly below the taps in the areas inspected. This condition allows water discharged from the taps, whether from use or minor leakage, to accumulate at the base of the wall and adjacent slab/footing areas.

The absence of drainage may contribute to ongoing moisture exposure to the wall base and surrounding materials. Prolonged wetting of these areas can increase the risk of moisture ingress, rising damp issues, or create conditions conducive to termite activity. Although no active moisture damage was noted at the time of inspection, the configuration presents a preventable moisture risk.

It is recommended that a licensed plumber assess the external taps and consider installation of an appropriate drainage solution (such as a grated drain connected to stormwater or improved surface grading) to direct water away from the structure. This should be addressed in the short term to reduce the risk of moisture-related deterioration.

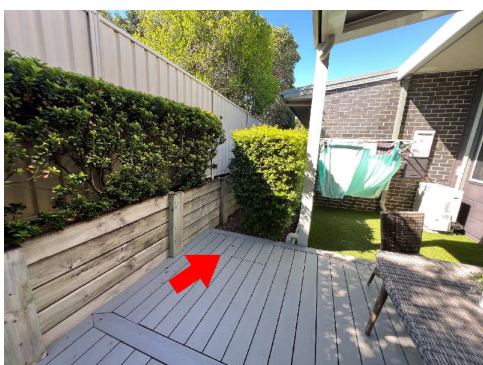
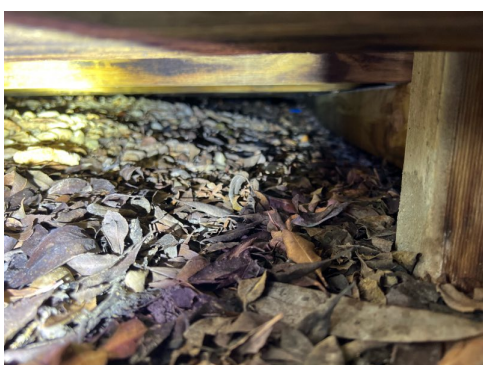
Finding 6.02

The subfloor area beneath the rear deck was observed to have restricted ventilation, with limited clearance between the ground surface and structural timbers. Accumulation of leaf litter and organic debris was noted on the ground surface, and sections of the supporting timber framing exhibited moisture staining. The limited air movement and build-up of organic material create a damp micro-environment beneath the deck structure.

Inadequate ventilation and the presence of organic debris are conducive to elevated moisture levels, which may increase the risk of timber deterioration, fungal decay and potential termite activity over time. While no active structural failure was observed at the time of inspection, the current conditions are considered unfavourable for long-term durability of the timber elements.

It is recommended that the debris be removed and that subfloor ventilation be improved where practicable to promote adequate airflow. Consideration should be given to consultation with a licensed builder or carpenter to assess options for increasing ventilation openings or modifying the deck configuration if required.

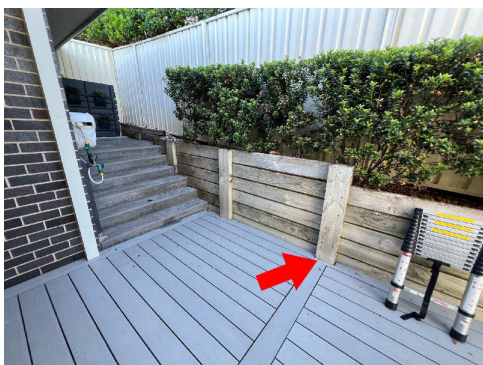
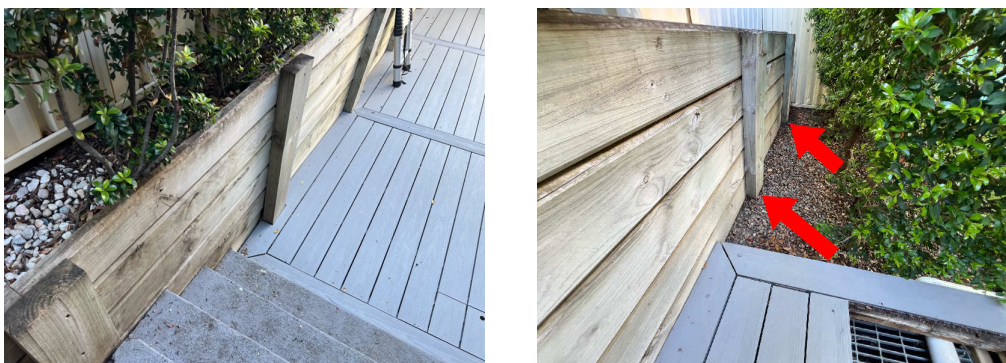
Finding 6.03

Information: Timber components of the rear retaining wall and garden bed were observed to be in direct contact with soil and garden materials. This was noted along the boundary side of the rear deck area, where treated timber sleepers and posts are retaining soil and supporting planted hedging. Timber elements in constant ground contact are exposed to ongoing moisture and may be susceptible to premature deterioration over time.

Direct soil contact can contribute to timber decay and may create conditions conducive to termite activity, particularly where moisture is retained against structural elements. Although no active timber pest attack was identified at the time of inspection, the current configuration increases long-term risk. It is recommended that a suitably qualified landscaper or builder assess the installation and implement appropriate separation or protective measures. Rectification should be carried out in the short to medium term to reduce the risk of deterioration.

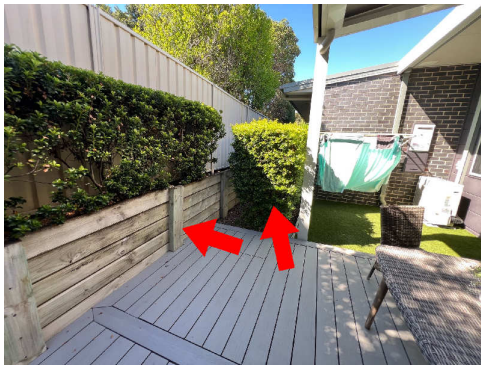
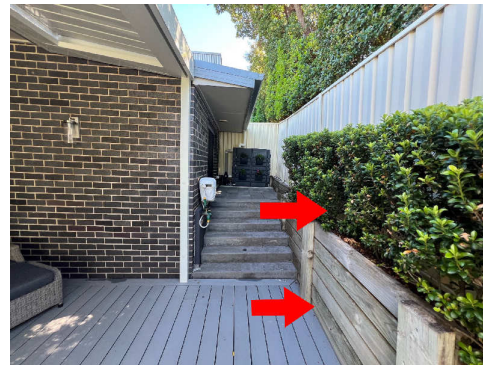
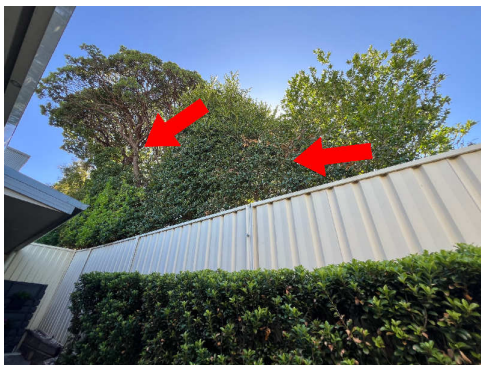
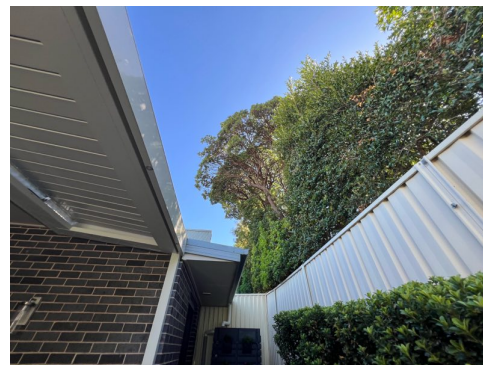
Information: A raised garden bed with timber retaining wall was observed along the rear boundary of the property, directly adjacent to the decked area. The garden bed contains soil and established vegetation, and a large mature tree is located on the neighbouring property immediately beyond the boundary fence. The timber retaining elements and soil are positioned in close proximity to structural components of the deck.

The presence of soil, garden materials and vegetation against timber elements creates a conducive condition for moisture retention and potential concealed timber deterioration over time. In addition, the large neighbouring tree may contribute to increased leaf debris, root growth and moisture within the area. While no active structural failure was noted at the time of inspection, the current configuration increases the risk of future timber decay and may also attract termite activity due to concealed and moisture-prone conditions.

It is recommended that the garden bed and retaining wall be regularly monitored and maintained to ensure adequate drainage and separation from structural timbers. Consideration should be given to reducing soil levels, improving ventilation, and ensuring no direct soil contact with structural timber elements. Advice from a licensed landscaper or builder may be beneficial if rectification works are considered.

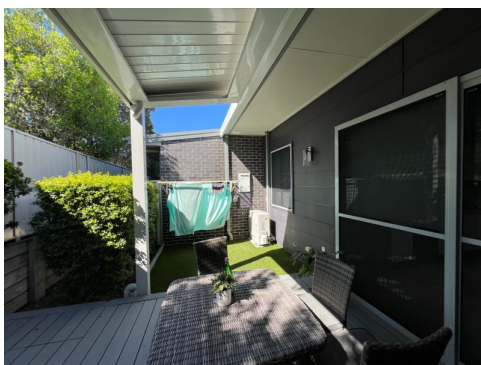
Finding 6.06

Building: Main Building
Location: Rear Elevation
Finding: Air Conditioning Condensate Discharge

Information: The external air conditioning condenser unit is installed to the rear of the dwelling. At the time of inspection, the condensate discharge point was not clearly visible and it could not be confirmed whether the unit drains to an approved stormwater connection or discharges directly onto the surrounding surface. Where condensate is not properly connected to a suitable drainage point, ongoing discharge can contribute to excess moisture accumulation, staining, deterioration of adjacent materials and potential slip hazards.

This condition was observed to the rear external area adjacent to the outdoor living space. Although no active moisture damage was noted at the time of inspection, the drainage arrangement could not be verified. It is recommended that a licensed plumber or suitably qualified air conditioning technician confirm that the condensate line is connected to an appropriate drainage point and modify if required. This should be addressed in the short term as a preventative measure.

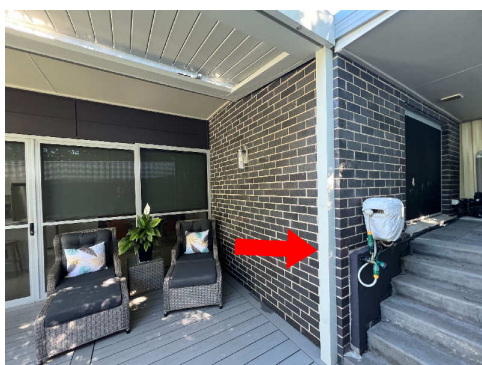
Finding 6.07

Building: Main Building
Location: Rear Elevation
Finding: Bridging to External Walls and Service Penetrations

At the external wall adjacent to the rear patio and stair area, service pipes and conduits have been installed in direct contact with the brickwork and extend from ground level upward, creating potential bridging points over the slab edge. These penetrations and fittings may allow concealed termite entry pathways by bypassing the visible inspection zone. Termite management systems rely on maintaining a clear and unobstructed inspection gap at the slab perimeter; however, the current arrangement reduces visibility and may conceal termite activity.

This condition was noted to the side wall near the hose connection and service meter location. While no active termite activity was observed at the time of inspection, the configuration presents conducive conditions for concealed entry and future infestation. It is recommended that a licensed pest control specialist assess the area and advise on appropriate rectification measures to reinstate a compliant and visible inspection zone. Any necessary modifications should be carried out in conjunction with a licensed plumber if relocation or adjustment of services is required. Rectification should be undertaken in the short term to reduce risk.

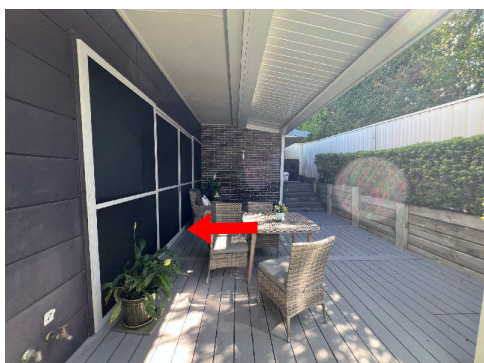
Finding 6.08

Building:	Main Building
Location:	Rear Elevation
Finding:	Bridging and Reduced Slab Edge Clearance

At the rear patio area, the external decking and artificial turf have been installed at a height that appears close to the internal finished floor level and slab edge. This configuration reduces the visible slab inspection zone and may constitute bridging over the damp-proof course/termite barrier line. Adequate clearance between external finished ground levels and the internal floor level is required to allow visual inspection for termite activity and to reduce the risk of moisture ingress.

The condition was observed along the rear elevation adjacent to the sliding doors and wall cladding. While no active moisture penetration or termite activity was identified at the time of inspection, the reduced clearance presents a potential risk by limiting inspection visibility and increasing the likelihood of concealed termite entry or moisture-related deterioration over time.

It is recommended that the external surface levels be reviewed and adjusted as necessary to reinstate appropriate slab edge exposure in accordance with current standards. A licensed builder and/or pest control specialist should be consulted to advise on suitable rectification. Works should be undertaken in the short to medium term to minimise ongoing risk.
