Building and Timber Pest Inspection Report

Inspection Date: Thu, 12 Mar 2026

Property Address: 60 Hay Street, Lawson NSW 2783

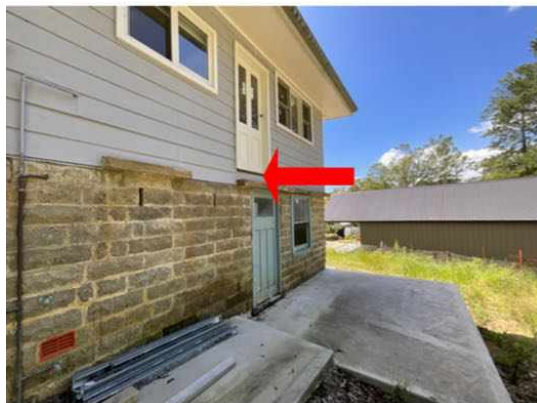
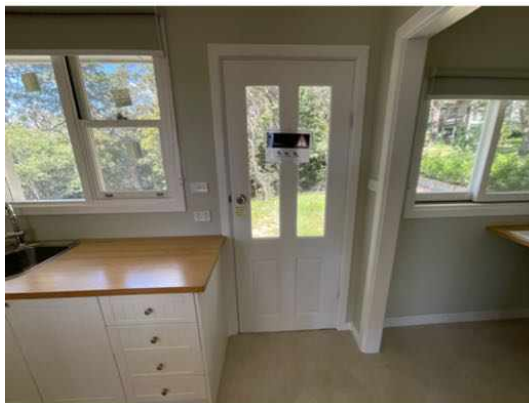
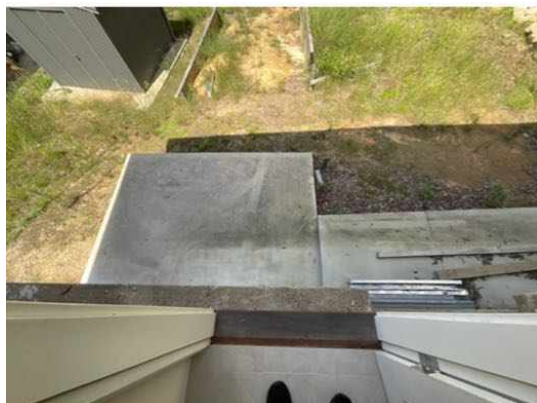
Building:	Main Building
Location:	Rear Door
Finding:	Safety Hazard – Unprotected Second Storey Door Opening
Information:	Observation

At the time of inspection, it was observed that a door located at the rear of the dwelling on the second storey opens directly to the exterior with no balcony, landing, platform, or protective barrier installed. The door is operational and can be opened from inside the dwelling. This creates an unprotected opening at height where a person could inadvertently step through the doorway.

An unprotected opening at an elevated level presents a significant safety hazard. Occupants, visitors, or tradespeople may unknowingly open and use the doorway, which could result in a fall from height. Falls from upper levels can lead to serious injury or worse. Openings of this nature would generally require a compliant balcony, landing, or protective barrier system in accordance with applicable building and safety standards to reduce the risk of accidental falls.

It is strongly recommended that this doorway not be used until appropriate safety measures are installed. Consideration should be given to securing or restricting the door to prevent access until suitable works are completed. If a balcony or external landing is intended for this location, the installation should be carried out by a suitably qualified and registered builder and designed to meet the relevant building code and safety requirements. Prompt attention to this issue is recommended to eliminate the fall risk and ensure the area is safe for occupants and visitors.

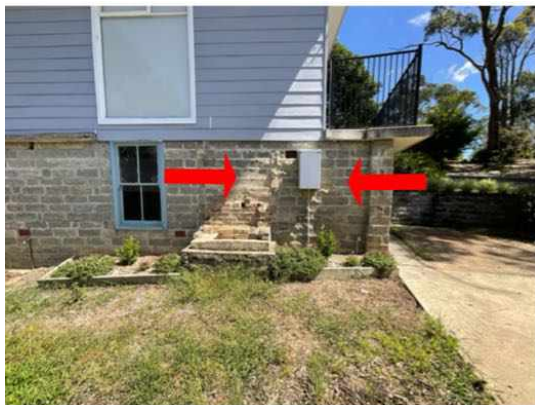
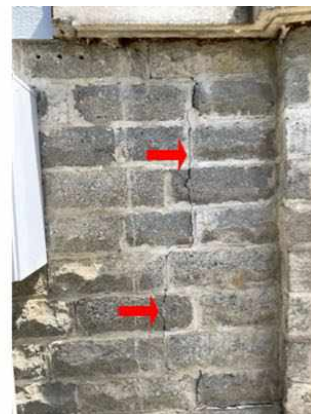
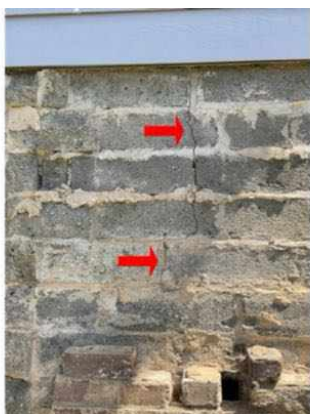
Building: Main Building
 Location: Exterior walls - left side
 Finding: Brickwork - Cracking Minor.
 Information: Observation:

Cracking was identified in sections of the external brickwork at the time of inspection. Cracking of this nature is relatively common in buildings of similar age and construction type.

While the observed cracking does not currently indicate a major structural defect, it may serve as an early indicator of underlying movement or moisture-related issues that could worsen over time if left unaddressed.

- Although cracking appears minor and non-structural at this stage, it is recommended that the area be monitored
- For a more detailed assessment, consultation with a qualified Structural Engineer is advised to determine if movement is ongoing and whether any remedial action is necessary

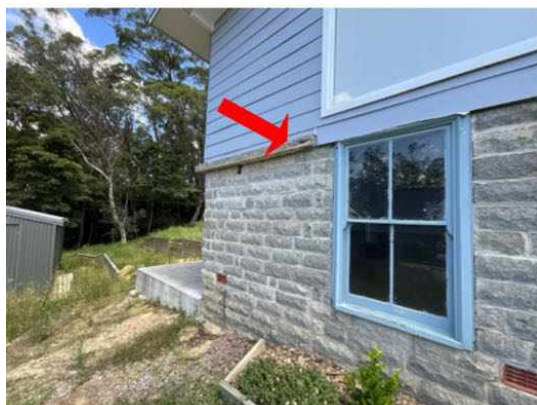
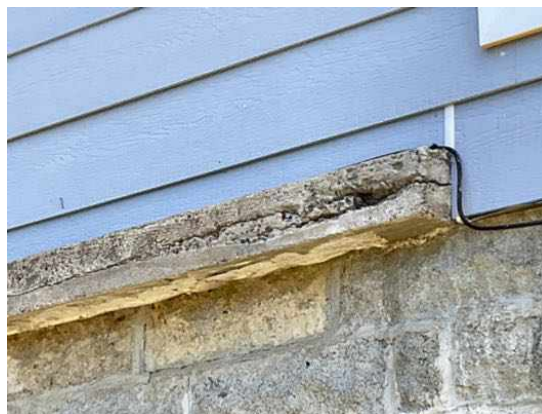
Finding 3.02

Building:	Main Building
Location:	Exterior walls - left side
Finding:	Defect – Minor Cracking and Spalling to Concrete (Indicative of Early Concrete Deterioration)
Information:	Observation

At the time of inspection, cracking and minor spalling of the concrete surface was observed in sections of the concrete structure. The condition is consistent with early stages of deterioration commonly referred to as “concrete cancer.” The extent of the visible damage appeared minor at the time of inspection and was limited to localised areas of the concrete surface. This assessment was based on a visual inspection only, and no destructive testing or specialised investigation of the internal reinforcement was undertaken.

Although the condition presently appears minor, it is recommended that the affected areas be monitored and that remedial treatment be considered to prevent further deterioration. Repair methods typically involve removal of the affected concrete,

treatment or cleaning of any exposed reinforcement, and reinstatement using suitable repair mortars or specialist products designed for structural concrete repair. In some cases, resin injection or patch repair systems may be used depending on the extent and severity of the damage.

A suitably qualified contractor experienced in concrete repair or remedial building works should be engaged to further assess the condition and carry out any necessary repairs. Early intervention is generally recommended to limit the progression of deterioration and reduce the potential for more extensive repairs in the future.

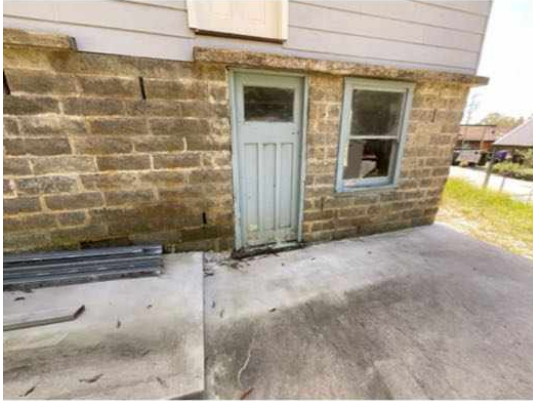
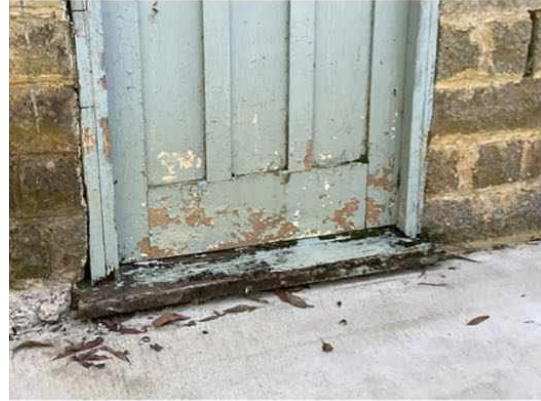
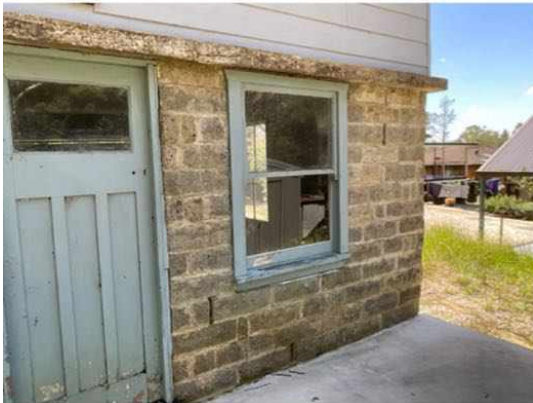
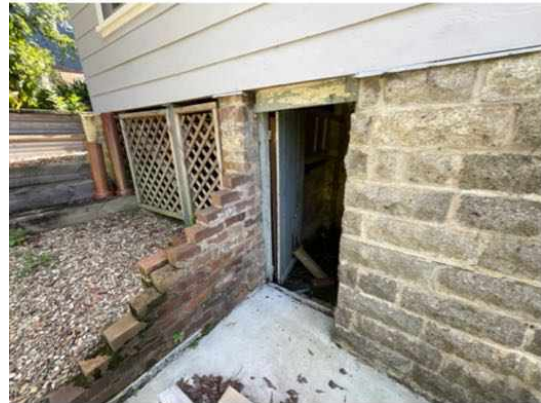
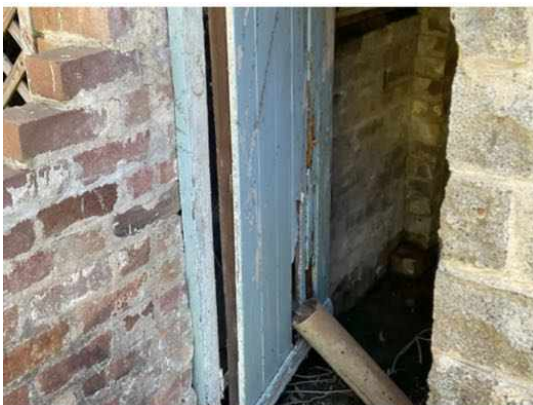
Finding 3.03

Building: Main Building
 Location: Rear Elevation
 Finding: External Timber Elements – Weather Exposure and Condition
 Information:

External timber elements were observed in various locations around the property. Some of these timbers appear to lack adequate protective treatment (e.g., paint or sealant), leaving them exposed to the effects of weathering.

Untreated or poorly protected external timbers are susceptible to accelerated deterioration due to exposure to moisture, UV radiation, and general weathering. If left unattended, ongoing deterioration may occur, potentially resulting in the need for premature replacement of affected timbers.

It is recommended that exposed and untreated timber elements be sealed or painted

by a suitably qualified painting contractor or handyman as soon as practicable to prevent further deterioration.

Where timber components have already deteriorated beyond practical repair, a licensed carpenter should be engaged to carry out necessary repairs or replacement.

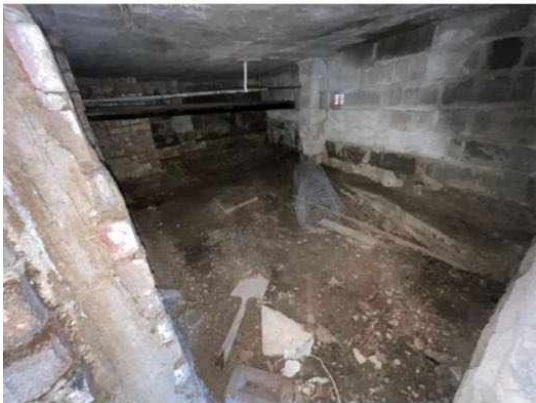
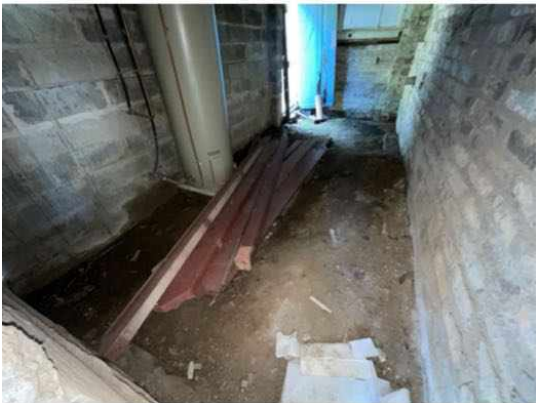
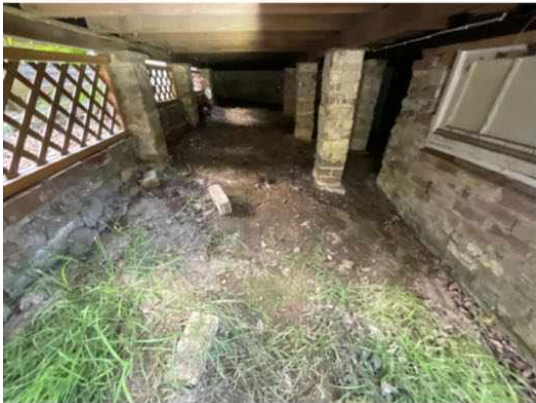
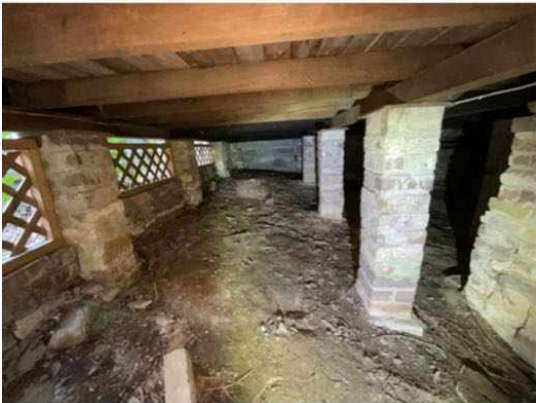
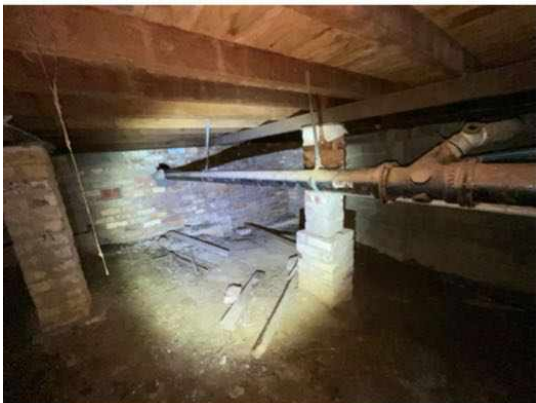
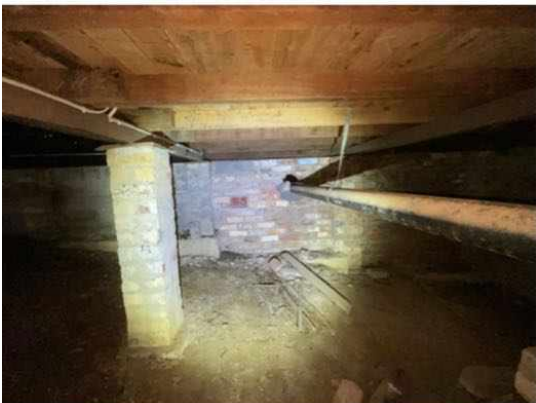
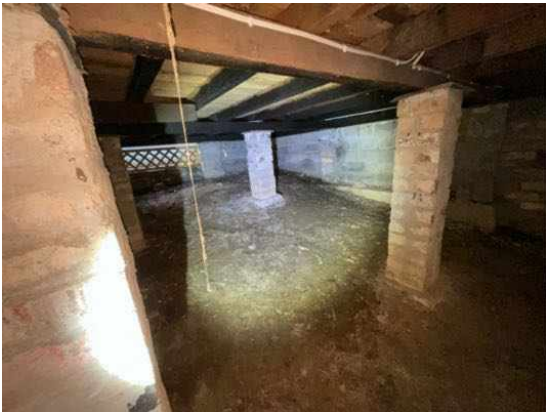
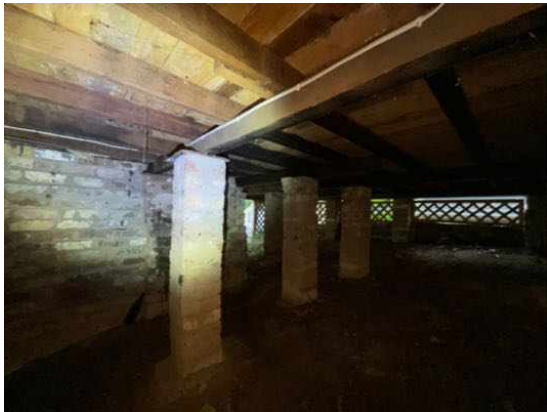
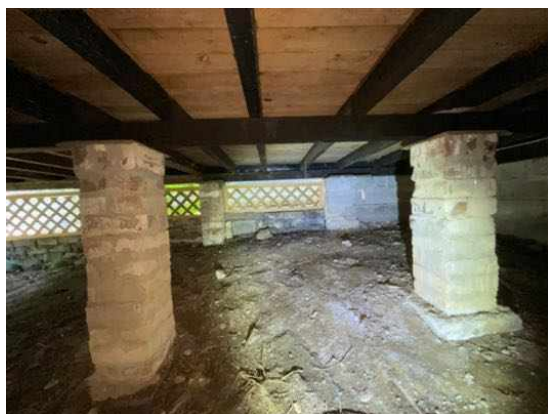
Finding 3.04

Building:	Main Building
Location:	Subfloor
Finding:	Subfloor - Inspection Summary
Information:	Subfloor

Damp conditions were observed within sections of the subfloor area at the time of inspection. Localised moisture was noted to the ground surface and surrounding subfloor environment. Subfloor dampness can occur due to a range of factors including inadequate site drainage, limited subfloor ventilation, surface water entry, or seasonal ground moisture. Moisture levels in subfloor areas may vary depending on weather conditions, recent rainfall, and seasonal changes.

Evidence of dampness and indications of previous water entry were observed within the subfloor area. Moisture beneath the structure is likely the result from surface water runoff, inadequate site drainage, or groundwater movement. Prolonged or repeated water entry may contribute to elevated humidity levels and may lead to deterioration of building materials over time if not addressed.

Localised mould or mildew was observed within parts of the subfloor environment. The presence of mould or mildew in subfloor areas is commonly associated with elevated moisture levels and limited airflow. While the observed growth appeared localised at the time of inspection, ongoing damp conditions can encourage further biological growth and may contribute to timber deterioration if left unmanaged.

Overall, the subfloor area was assessed as being in average condition for a structure of this type and age. However, moisture ingress beneath the structure was noted and should be monitored and addressed to minimise the potential for ongoing dampness or associated deterioration of building materials. Loose stored materials, timber offcuts, and general debris observed within the subfloor should be removed to improve airflow, reduce moisture retention, and minimise the potential for pest harbourage.

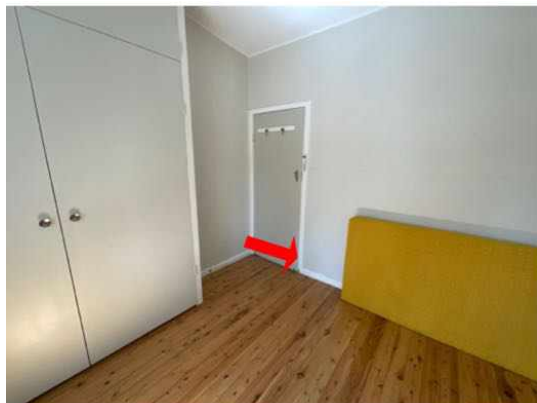
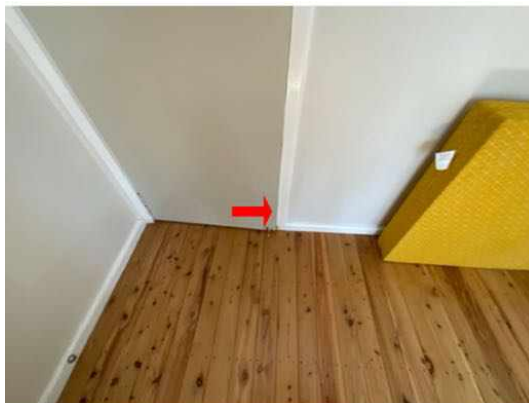
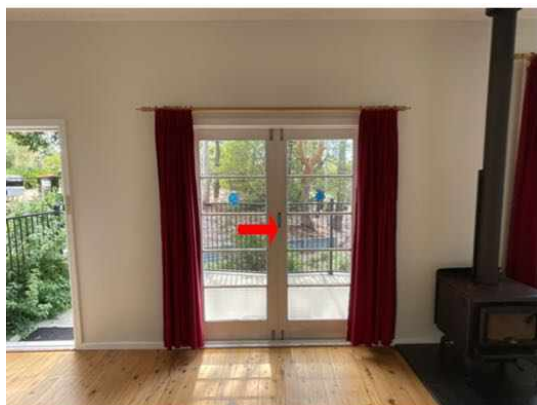
Finding 3.05

Building:	Main Building
Location:	Bedroom & Family Room
Finding:	Door - Binding and/or Jamming.
Information:	Functional Defect Identified

Binding and/or jamming of this door was observed during standard operation and appeared to be rubbing or binding. This issue impairs the normal functionality of the door and may lead to secondary damage to adjacent building elements, such as scuffing or tearing of floor coverings, or stress to door hardware and framing.

- If the issue appears to be related to major structural movement, it is recommended that a registered builder with experience in re-stumping or subfloor repairs be engaged to assess the extent of the movement and provide a quotation for necessary remedial works.
- Where the issue is minor in nature, a qualified carpenter or general handyperson may be appointed to carry out corrective works at the client's discretion.

Prompt assessment and remediation are advised to prevent further deterioration or related damage.

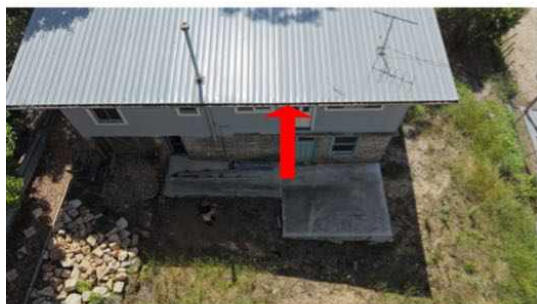
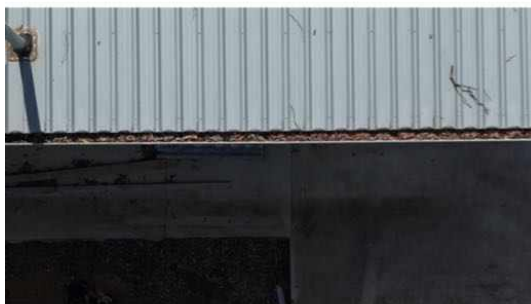
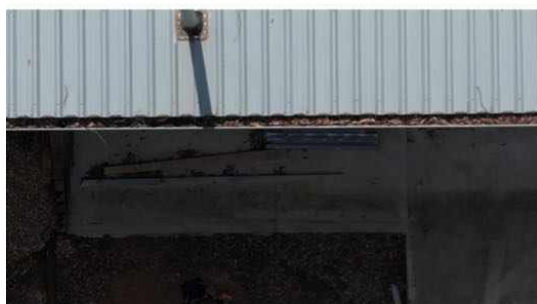
Finding 3.06

Building:	Main Building
Location:	Roof Exterior
Finding:	Minor Defect – Blocked Guttering.
Information:	Observation:

During the inspection, the guttering was found to be blocked at this location. Debris accumulation was observed, restricting the effective flow of rainwater through the gutter system.

Roof plumbing components, including gutters and downpipes, are designed to collect and discharge roof water away from the building. Where gutters become blocked, water can pool and overflow during rainfall events. This overflow may lead to wetting of eaves, fascia boards, and adjacent exterior wall surfaces. Prolonged or repeated moisture exposure can contribute to deterioration of building materials, including rusting of metal components and decay of timber elements.

This defect is considered minor; however, timely maintenance is advised. Blocked gutters should be cleared to restore effective drainage and reduce the risk of moisture-related deterioration. Cleaning may be undertaken by the homeowner or a general handyperson in the short term. For further assessment or if ongoing drainage issues are identified, consultation with a licensed plumber is recommended to determine whether additional remedial works or system improvements are required.

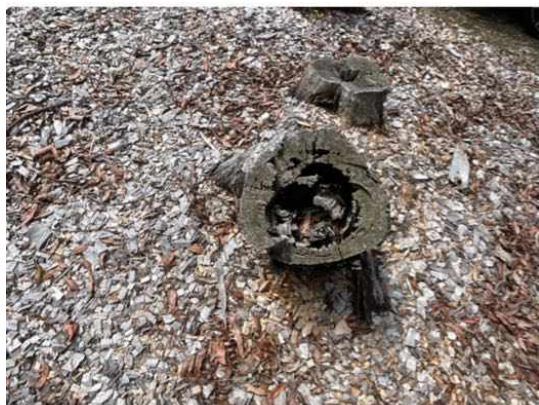
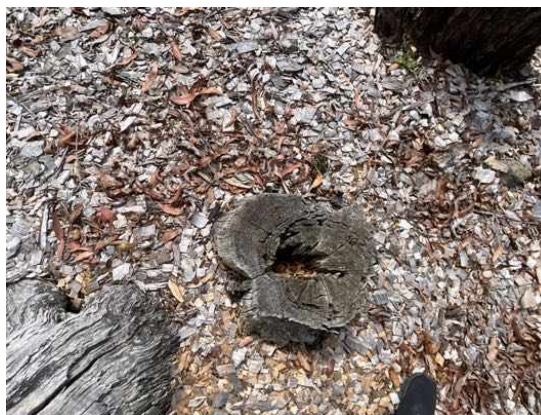
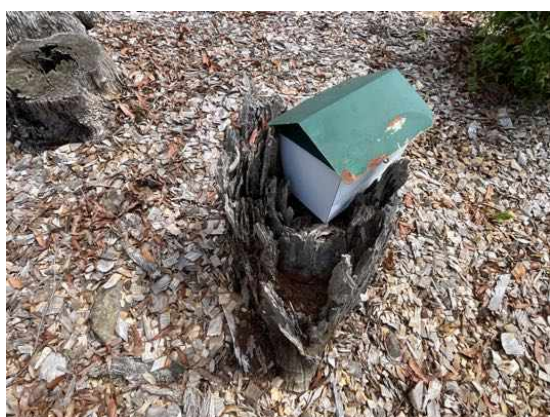
Visible evidence of termite workings (e.g., mud leads, galleries, or frass) was observed in tree stumps located to the front of the property at the time of inspection.

There was no visible evidence of live termite activity within the tree stumps at the time of inspection. The findings are therefore classified as inactive—meaning that while no live termites were detected, evidence of past activity or damage is present, including mudding or damage consistent with termite attack.

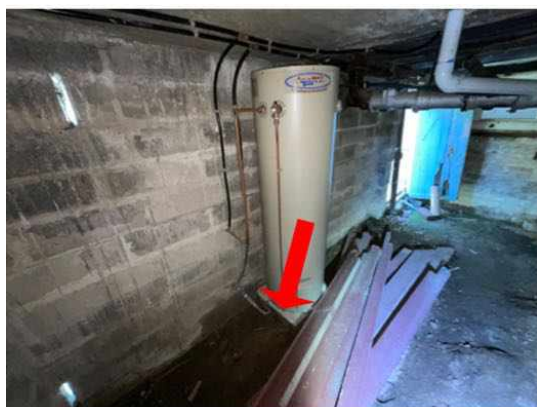
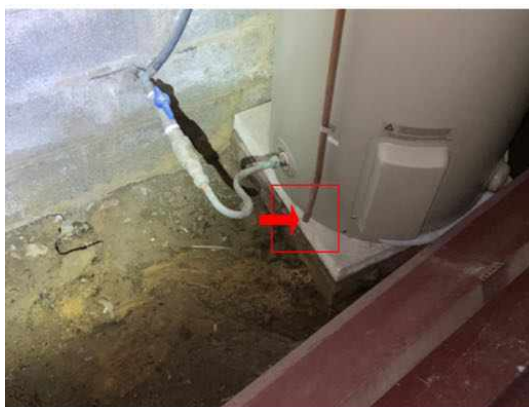
Finding 6.01

Building:	Main Building
Location:	Subfloor
Finding:	Overflow Management – Risk of Termite Activity..
Information:	Observation: Water Pooling from HWS and Air Conditioning Overflows

Water discharge from the Hot Water System (HWS) pressure relief valve and air conditioning unit overflows was observed discharging close to the base of the structure, contributing to water pooling around the building perimeter.

Persistent moisture near the foundation or subfloor area significantly increases the likelihood of termite activity. Termites are highly attracted to damp environments, and stagnant water near structural elements provides ideal conditions for foraging and infestation.

It is highly recommended that all overflows from the HWS and air conditioning units be redirected away from the building, preferably via fixed drainage or extension piping, to prevent water accumulation near the structure.

These minor corrective works should be undertaken promptly to minimise the risk of both termite ingress and potential structural damage due to ongoing moisture exposure.

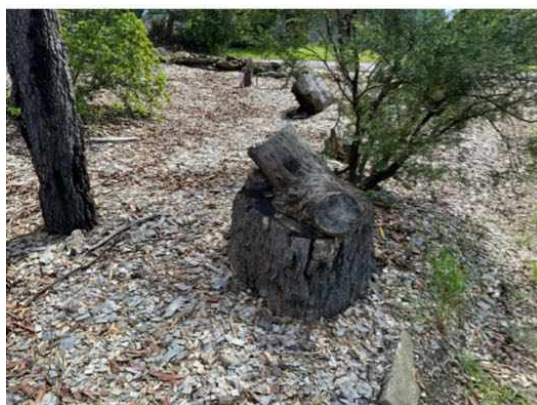
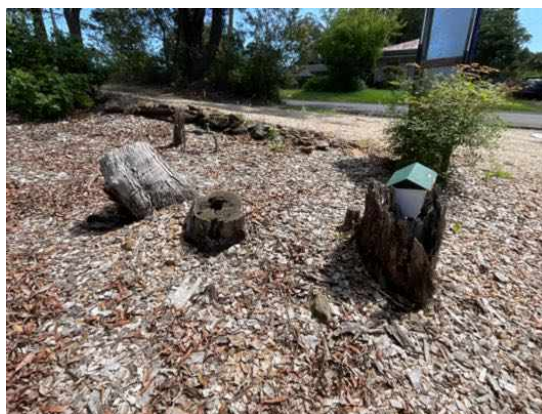
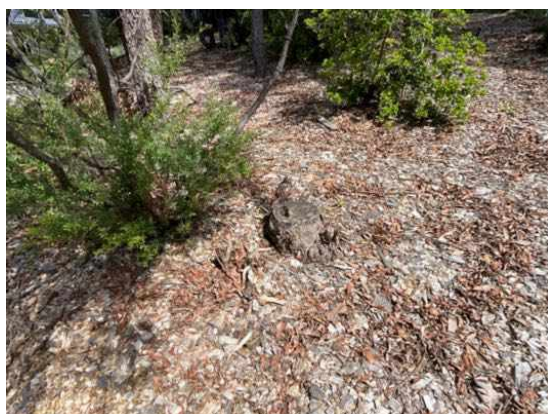
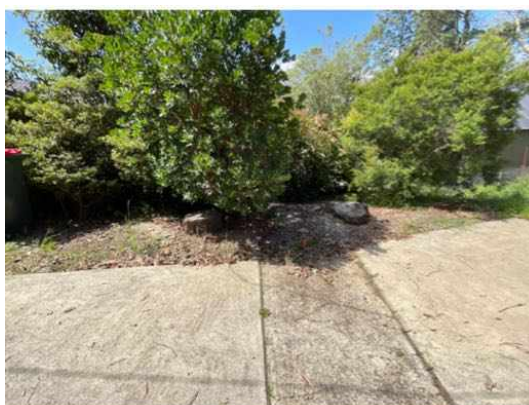
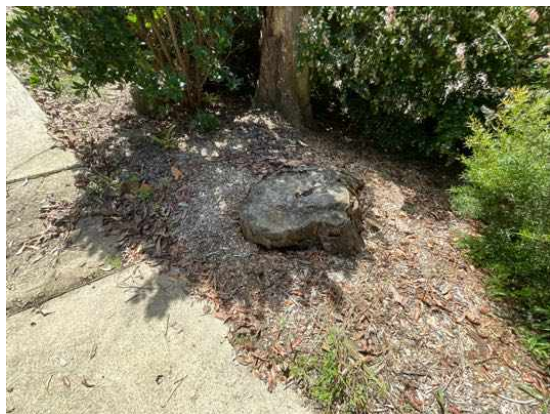
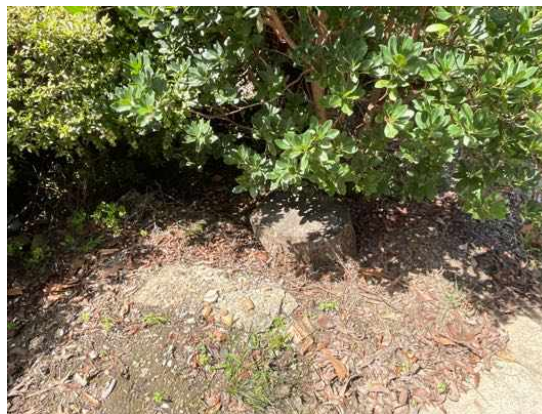
Finding 6.02

Building:	Main Building
Location:	Yard
Finding:	Tree Stumps and Termite Risk..
Information:	Tree stumps that are in direct contact with soil and exposed to moisture create conditions highly conducive to termite activity. These stumps offer both a food source and shelter, making them an ideal environment for termite infestation.

When subjected to excessive moisture, tree stumps are prone to decay and fungal

growth (wood rot), which further attracts subterranean termites. In some cases, tree stumps in ground contact can even serve as nesting sites for active termite colonies.

- It is strongly recommended that all tree stumps on the property, particularly those in contact with soil, be removed as soon as possible to reduce the risk of attracting termites to the structure.
- Where removal is not feasible, a further invasive inspection—such as drilling and internal testing—should be conducted to determine the presence of termite activity.
- If termite activity is confirmed or suspected, chemical treatment of the stump should be carried out by a licensed pest technician to prevent further infestation.

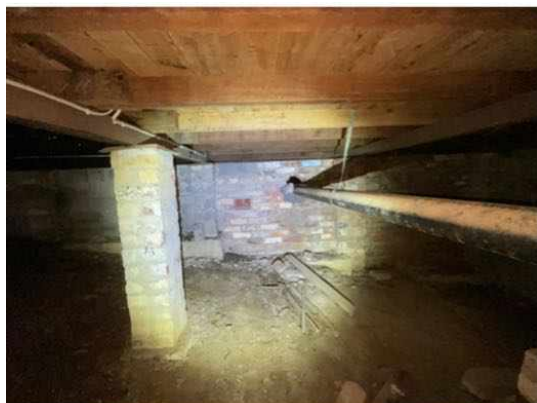
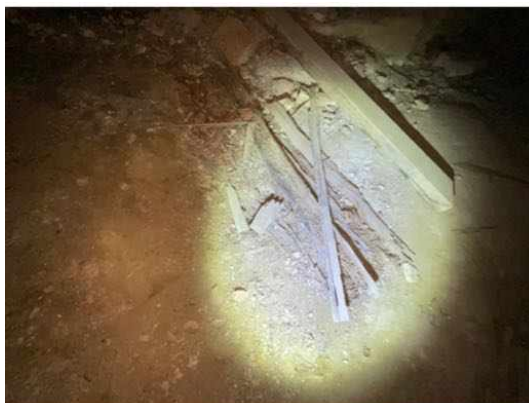
Finding 6.03

Building:	Main Building
Location:	Subfloor
Finding:	Subfloor – Timber Debris & Termite Risk..
Information:	Observation: Presence of Timber Debris in Subfloor

It is strongly recommended that all residual and loose timber debris be immediately removed from the subfloor and surrounding areas.

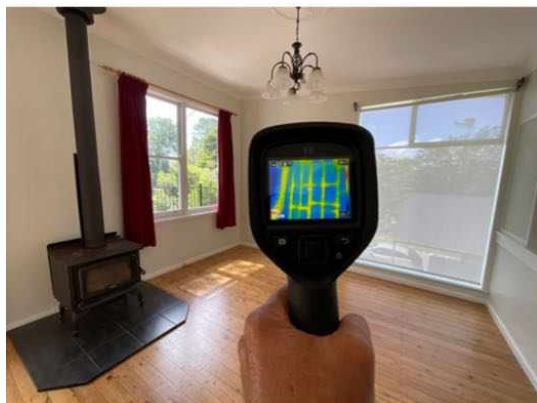
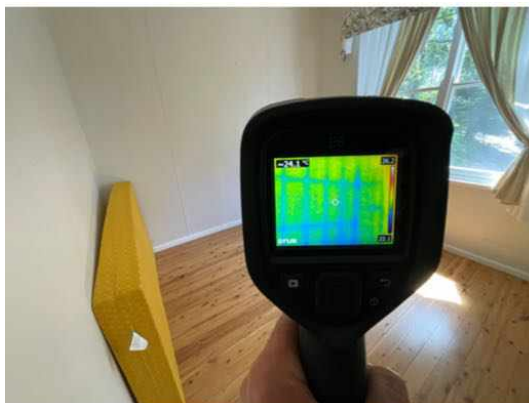
Finding 6.04

Building:	Main Building
Location:	Subfloor
Finding:	Timber Pest Report – Moisture Conditions Noted..
Information:	Excessive moisture was detected in some building elements during the inspection. High moisture levels can create conducive conditions for timber pest activity, particularly subterranean termites, and can also lead to fungal growth and timber decay.

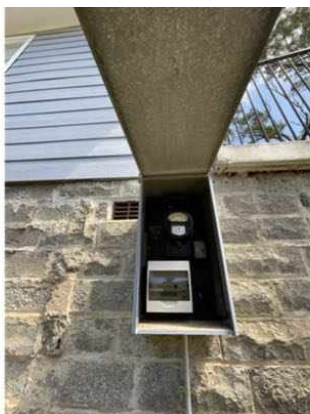
Building:	Main Building
Location:	All Areas
Finding:	Termite Management System - Missing Durable Notice..
Information:	Observation: Missing Durable Notice for Termite Management System

Proper maintenance and documentation are essential to ensure continued protection. Without a visible durable notice, there is no clear indication of what system (if any) is in place, which may limit the effectiveness of future termite inspections and hinder warranty claims.
