# Building and Timber Pest Inspection Report

Inspection Date: Thu, 12 Feb 2026

Property Address: 166 Connells Point Rd, Connells Point NSW  
2221, Australia

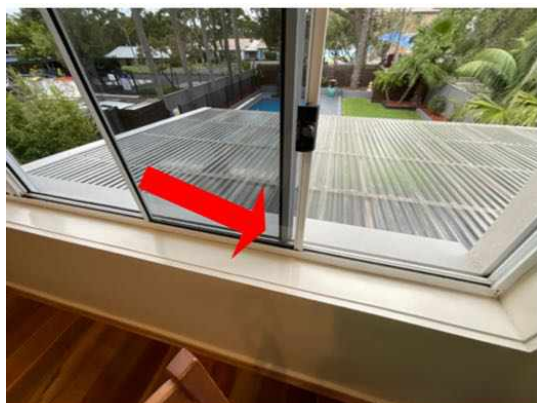
#### Finding 1.01

Building:	Main Building
Location:	Bedroom - Master
Finding:	Window restriction - missing stopper to bedroom
Information:	<p>The handle to the window was missing at the time of the inspection. Absence of the window stopper limits the operation of the window and may pose as a safety risk. Installation of the stopper should be conducted as soon as possible. A general handy person or qualified carpenter should be appointed to perform these works to improve the operational state of the affected window and improve the safety of the internal area. The NCC sets the minimum requirements for the design, construction and performance of buildings throughout Australia. To limit the risk of a child falling through an openable window, the NCC states that if the floor below the window in a bedroom is 2.0 m or more above the surface beneath and the lowest level of the window opening is less than 1.7 m above the floor, a restriction (device or screen) is required to:</p> <ul style="list-style-type: none"><li>• Restrict window openings to less than 125mm; to not permit a sphere of 125mm diameter to pass through the window opening or barrier screen; while resisting an outward horizontal force through the opening of 250 newtons (equivalent to 25.49Kg) while the window is restrained by a restriction device or barrier screen protecting the opening.</li><li>• Have a child resistant release mechanism, thus the screen or device is unable to be removed, unlocked or overridden.</li></ul>

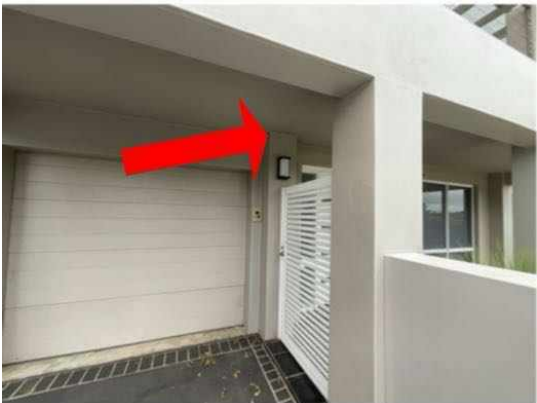
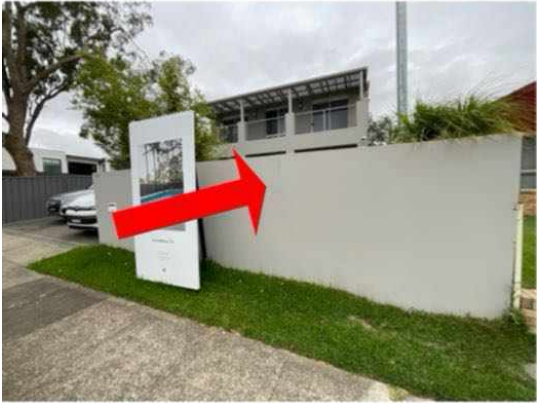
Building: Main Building  
Location: Exterior walls  
Finding: Cracks to external render - Category 1  
Information: It has been observed that cracking to external rendered surfaces has occurred. The degree of damage falls within Category 1, described as fine cracks that do not need repair and which are less than 1.0mm in width limit.

Damage of this category is not considered a defect for rectification. Always contact your building inspector should cracks widen, lengthen, or become more numerous.

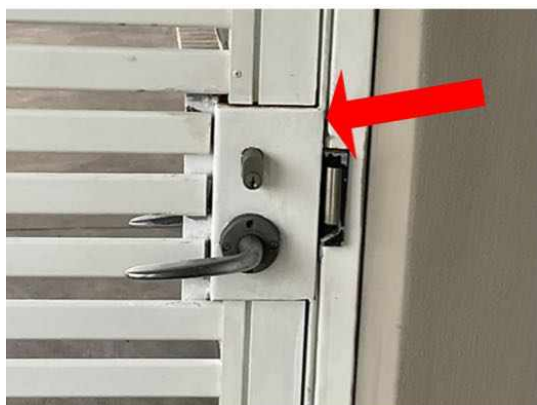
### Finding 3.03

Building:	Main Building
Location:	All External Areas
Finding:	Gate - Binding / Jamming
Information:	Binding and/or jamming of this gate is evident during standard operation. This defect inhibits the functionality of the affected gate as well as creating potential for secondary defects to associated building elements, such as damage to the walls. A gate that binds to gate frame may have several causes, ranging from minor defects, such as poor installation of the gate or deteriorated hinges, through to major structural issues, such as damage to post or wall structures. For minor causes, a qualified carpenter or general handyperson should be appointed to perform minor rectification works at client discretion.

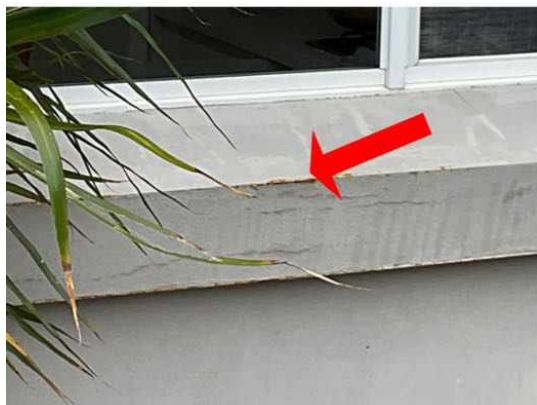
### Finding 3.04

Building:	Main Building
Location:	All External Areas
Finding:	Building element - Rusted or corroded
Information:	This building element shows evidence of rusting and corrosion, which is likely to have developed as a result of excessive exposure to moisture and or inadequate coatings.  As surface rust provides no protection to the underlying iron, the deteriorating

condition is likely to worsen if not addressed in the short-term future.

Where possible, the use of galvanized (treated) metals or aluminium coated metals aid in rust prevention, as does regular general maintenance. Rust formation can be controlled with coatings, such as paint, that isolate the iron from the environment.

Rusting and corrosion should be managed by ideally removing or limiting the affected surface from exposure to moisture. A registered builder may be appointed to replace any building elements that have been severely affected by rust or water damage.

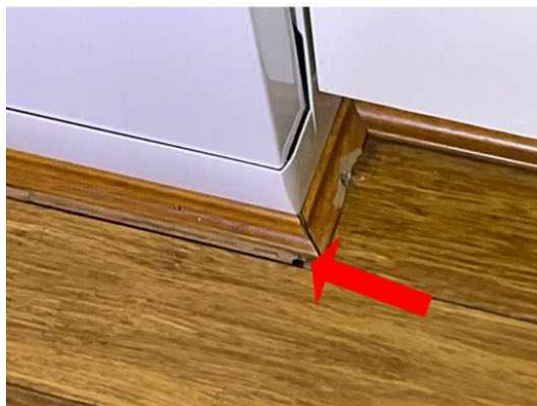
Building:	Main Building
Location:	Kitchen
Finding:	Float Timber flooring - damaged / gap
Information:	Damages / gaps to float laminate flooring were found during inspection. The laminate timber flooring is typically resistant to water damage, but standing water and large

amount of moisture that gets under the floor (as the water has no place to evaporate) can eventually destroy the floor and delaminate the product.

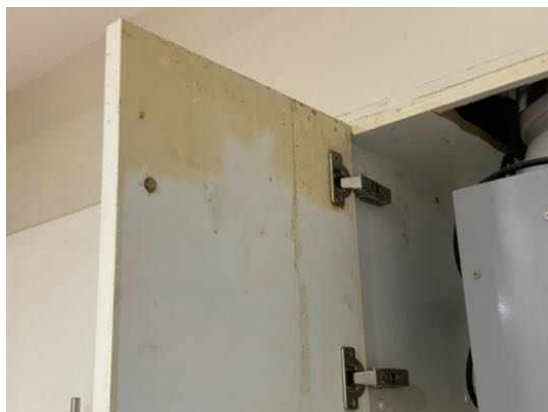
Works that have not been completed to a satisfactory level create potential for the development of building defects and may impede on the safety and integrity of the overall structure.

It is highly recommended that the relevant trades be appointed to complete these works and ensure the safety of the area and the longevity of all associated building elements.

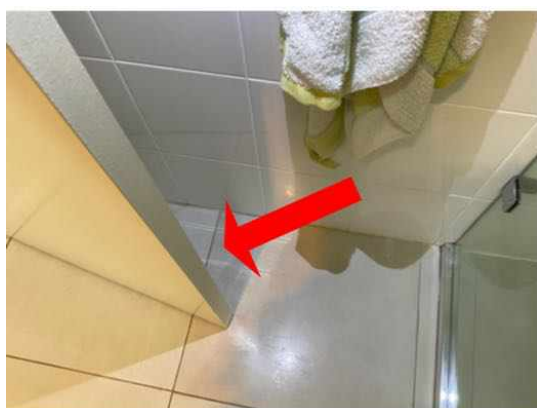
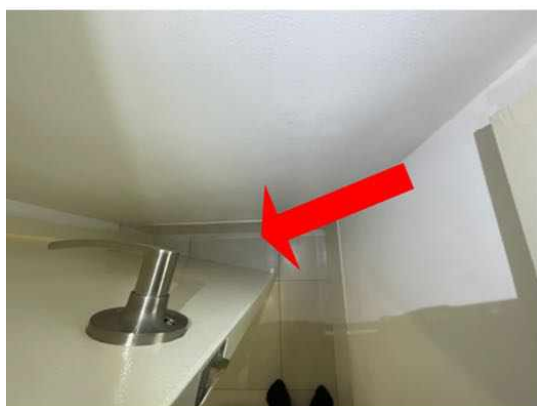
Building:	Main Building
Location:	All Internal Areas
Finding:	Door stop - Missing
Information:	The door stop is missing or is inadequate to stop the door handle from damaging the wall. Although some building elements may seem irrelevant or unnecessary, all building elements play a key role in the operation and function of the overall structure and its performance.

Re-installation or replacement of the door stop is advised as soon as possible to prevent any subsequent damage to the door or associated structures. A general handyman may be appointed to perform these works at client discretion.

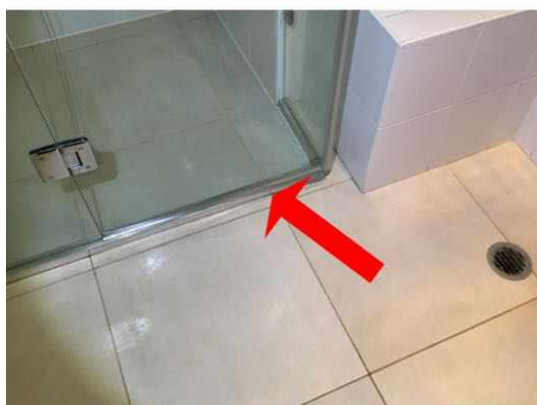
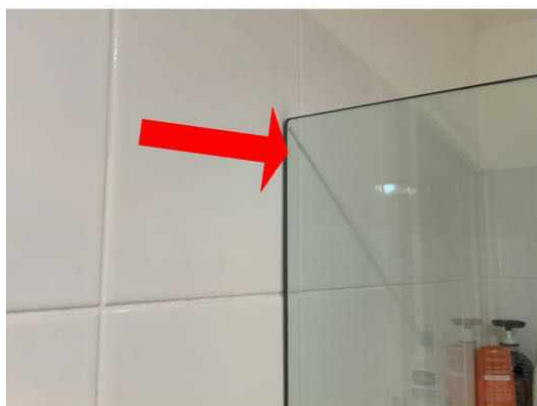
Building:	Main Building
Location:	Bathroom
Finding:	Shower Screen Door - Jamming or Binding
Information:	Binding and/or jamming of this shower screen door is evident during standard operation. This defect inhibits the functionality of the affected door as well as creating potential for secondary defects to associated building elements, such as damage to the floor or crack to glass .

For minor causes, a qualified Glazier appointed to perform minor rectification works at client discretion.

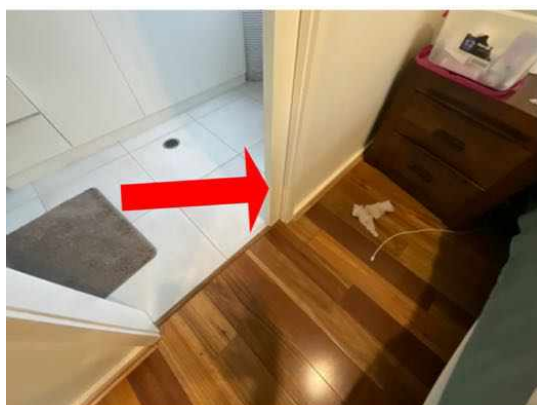
### Finding 3.17

Building: Main Building  
 Location: Bedroom - Master  
 Finding: Cavity Sliding door - defect  
 Information: Most of cavity sliding doors may have a ball bearing type system that runs along the track and this system may get the defects by installation and some other impacts.

The qualified carpenter should be nominated to repair the matter.

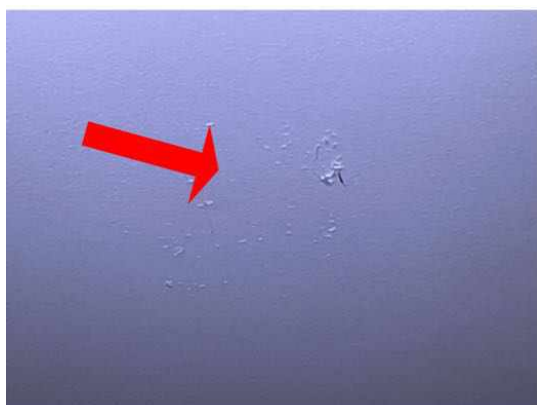
Building:	Main Building
Location:	Ensuite
Finding:	Moisture Damage and Possible Mould – Bathroom Ceiling
Information:	Visible discolouration and patchy staining were observed on the bathroom ceiling, indicative of possible mould or mildew growth. This is likely caused by poor ventilation, inadequate exhaust fan performance, or excessive humidity from regular use of the bathroom.

Prolonged moisture exposure can lead to fungal decay, damage to plasterboard, or create conditions conducive to timber pest activity above the ceiling line.

It is recommended that:

- A licensed plumber or building professional assess for hidden water leaks.
- Exhaust fan performance and airflow be reviewed and upgraded if necessary.
- The affected area be cleaned, treated, and repainted with mould-resistant paint.
- The roof void or ceiling cavity above be inspected for hidden moisture or damage if accessible.

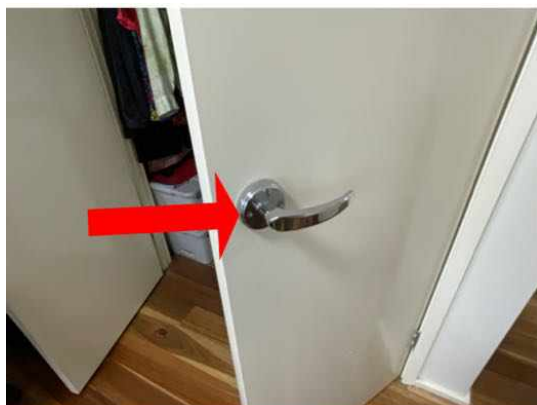
### Finding 3.21

Building:	Main Building
Location:	Bedroom
Finding:	Fitting (door handle) - Loose
Information:	The fitting in this area is loose and requires adjustment to tighten.

If left unmanaged, the fitting may further deteriorate, causing potential for the development of other minor secondary defects.

A relevant tradesperson should be appointed to perform these rectification works at discretion of the client.

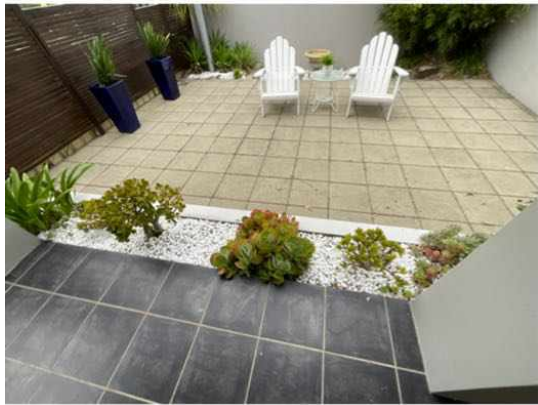
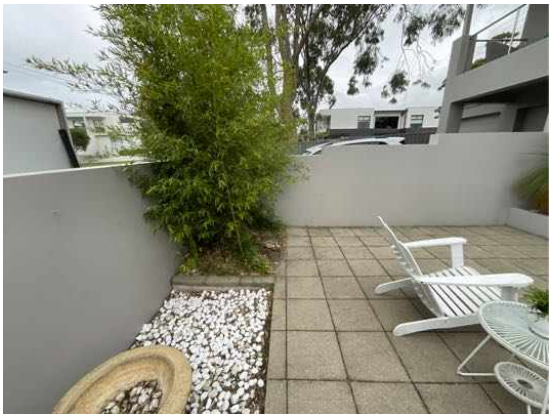
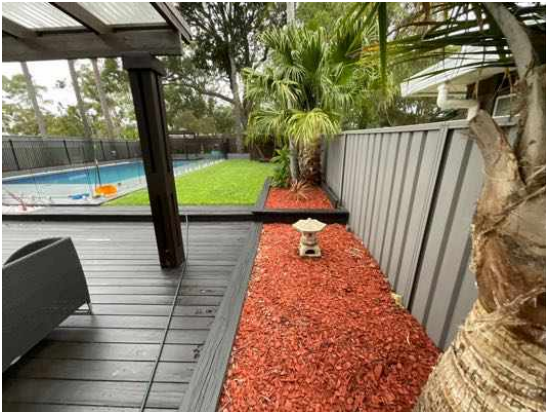
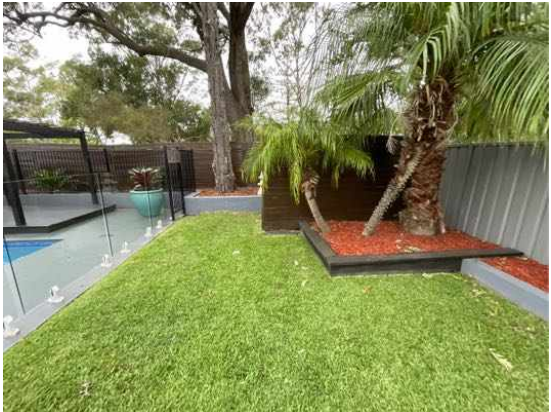
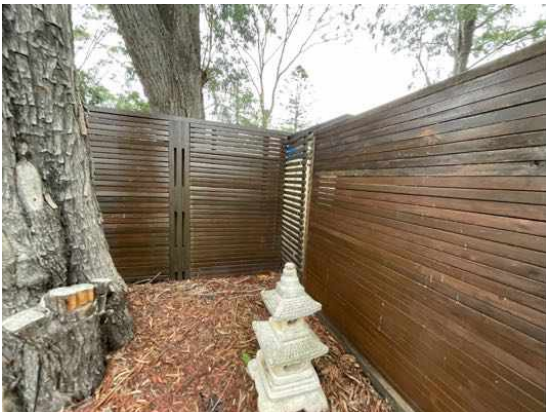
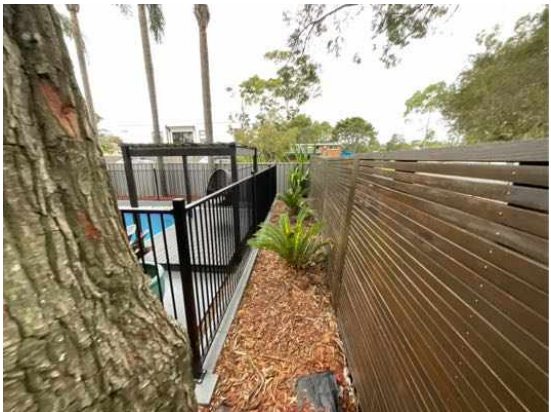
#### Finding 6.01

Building:	Main Building
Location:	All Areas
Finding:	Garden Beds - Conditions Conducive to Termites
Information:	Garden beds were found to be evident in the garden area. These garden beds can include untreated timber, and with a combination of moisture from watering hosing can make conditions conducive to termite activity and termite ingress.

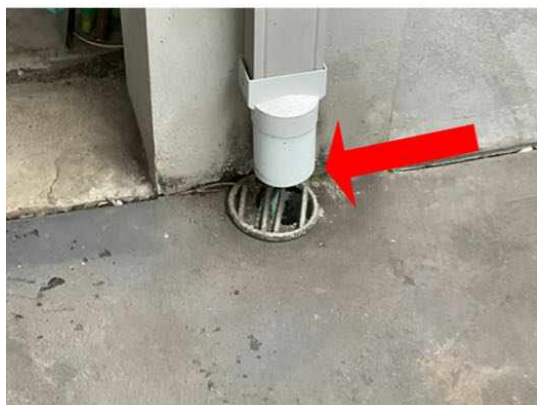
**Finding 6.02**

Building: Main Building  
 Location: All Areas  
 Finding: Overflow - Not plumbed for drainage  
 Information: The overflow is not plumbed or connected to suitable drainage, which has resulted in the surrounding area becoming excessively damp. These damp conditions can lead to secondary defects such as rot, rust or corrosion of associated building elements, the formation of fungal decay, or even the creation of potential slip hazards. When coupled with poor site drainage, pooling of water may also attract termite activity to this area. It is highly recommended that a qualified plumber be appointed to install adequate drainage to the overflow. These works will ensure that the area remains dry and free of

any secondary defects.

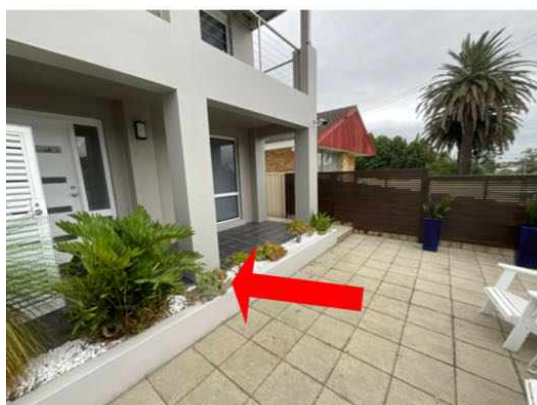
### Finding 6.03

Building:	Main Building
Location:	All Areas
Finding:	Bridging of termite barrier/inspection zones
Information:	Bridging is the spanning of a termite barrier or inspection zone so that subterranean termites are provided with passage over or around that barrier.

Where bridging has occurred, full inspection is prevented and termites may enter a property in a concealed or undetectable manner.

It is recommended that minimum 75mm clearance below the bottom of weep or ventilation holes be maintained where possible, otherwise annual inspections should be conducted by a licensed pest control company. Vegetation should also be kept clear of walls to allow regular inspection of all areas.

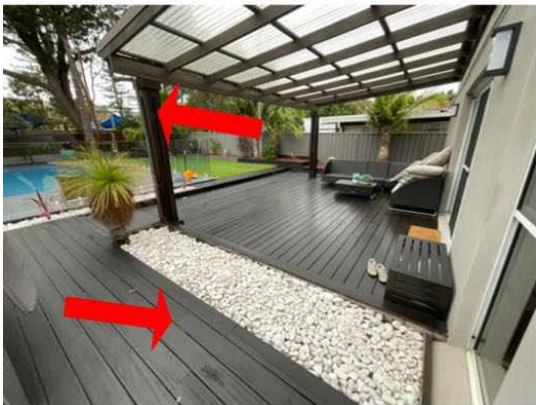
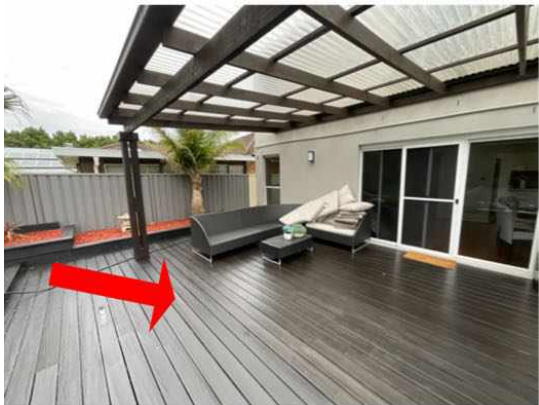
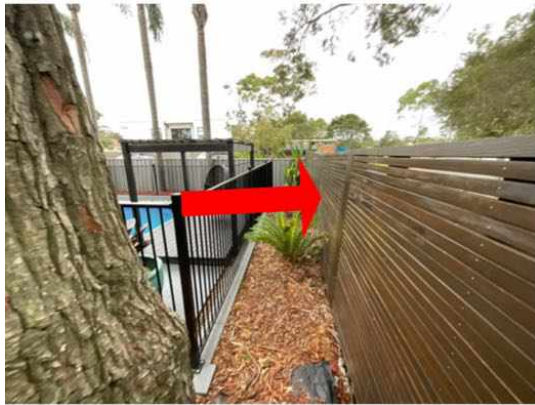
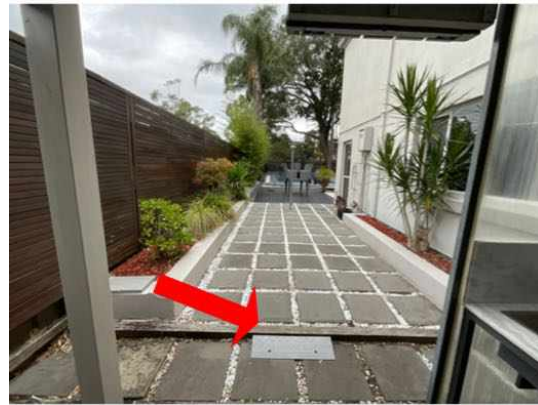
**Finding 6.04**

Building: Main Building  
Location: All Areas  
Finding: Timber - exposed to weather  
Information: External timbers that are frequently exposed to harsh weather conditions require adequate protection in order to maintain their condition. Where timbers have not been painted or treated adequately, general deterioration is likely to occur at an accelerated rate.

If left unattended, replacement of these timbers is likely to be necessary in the short-term future. Adequate treatment of these timbers is required as soon as possible by a painting contractor or general handyman.
