Building and Timber Pest Inspection Report

Inspection Date: Tue, 10 Feb 2026

Property Address: 8/138 Marlborough St, Bellbird Park QLD
4300, Australia

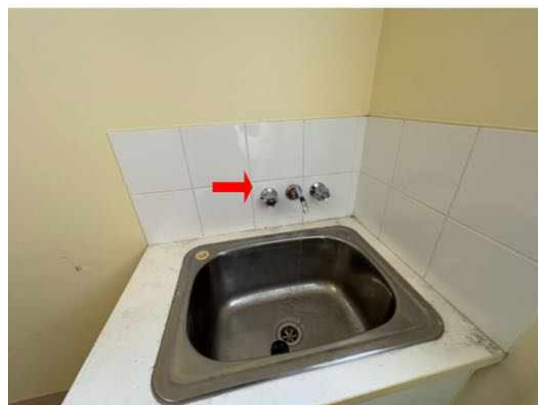
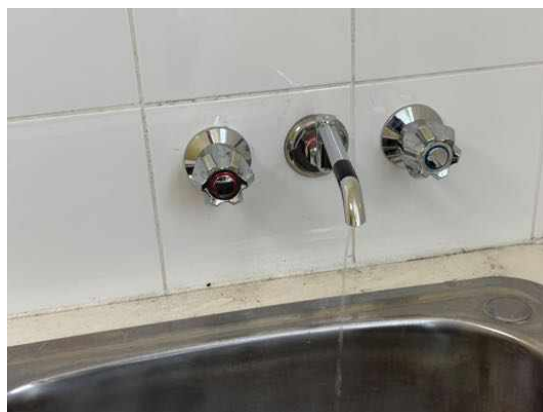
Finding 3.01

Building: Main Building
 Location: Laundry
 Finding: Laundry - no water supply to tub taps
 Information: At the time of the inspection, it was noted that no water was coming from the laundry tub taps when they were turned on. The reason for this could not be determined. Enquiries need to be made of the vendor as to the possible cause.

As a result, the tub drain and taps could not be checked for leaks.

A licensed plumber could be engaged to investigate the reason for the lack of water to the laundry tub taps. This can be done at the clients discretion.

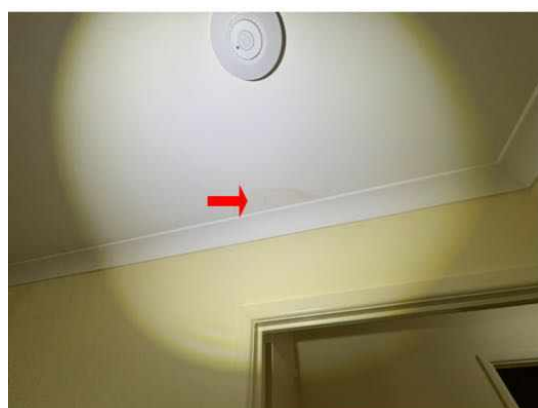
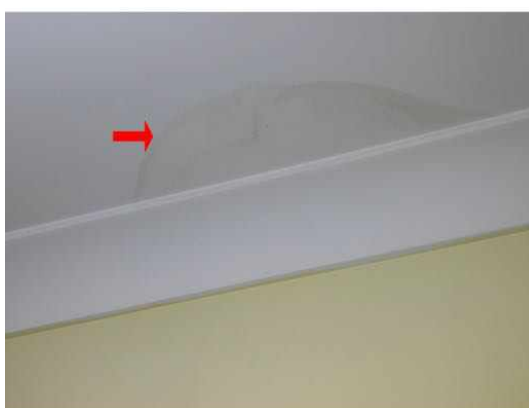
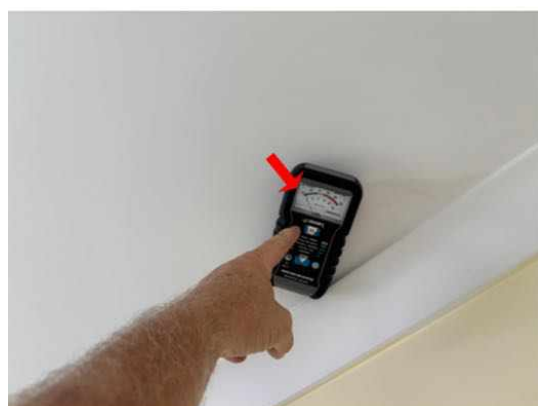
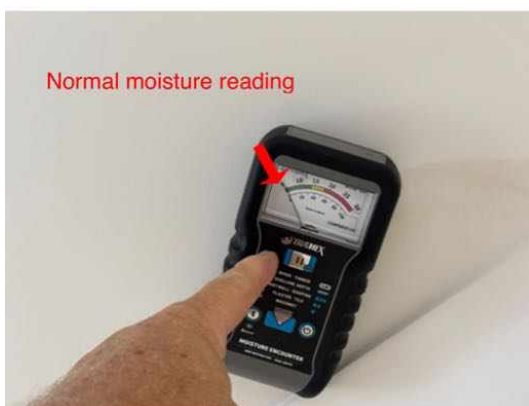
Finding 3.02

Building: Main Building
 Location: Master bedroom
 Finding: Master bedroom - water stain to ceiling
 Information: At the time of the inspection, it was noted that there was a water stain to the master bedroom ceiling. Normal moisture levels were recorded on this stain. No signs of staining were found above this area in the roof void.

Water staining indicates that surfaces have been exposed to excessive moisture over time. The minerals and other elements in the water lead to staining, which may graduate to corrosion and deterioration if left unmanaged.

While mostly an appearance defect, water staining can be indicative of more serious defects, which may be currently concealed by interior ceiling linings.

Where water staining is active, a licensed plumber must be consulted to identify the cause of the staining and to provide advice on any reparation works that may be required. Replacement of any damaged structures is advised.

Conversely, where water staining is old and inactive, affected building materials may be repaired or replaced at client discretion.

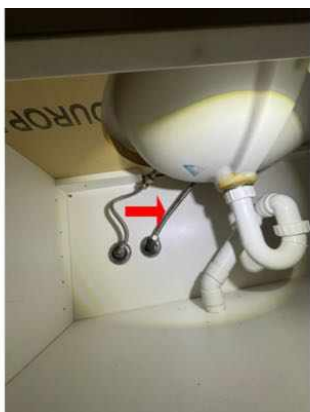
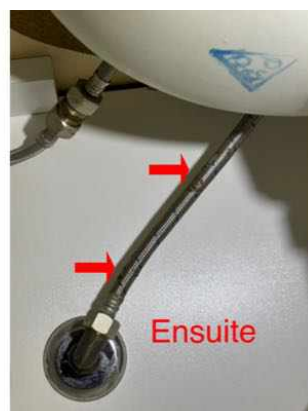
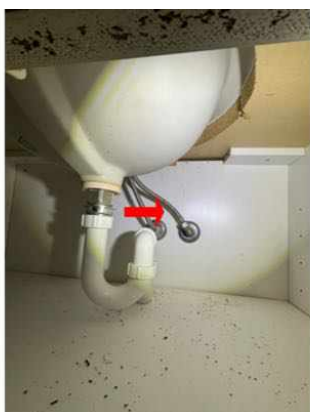
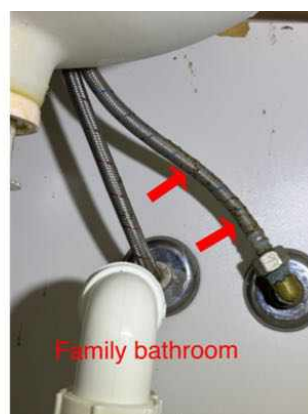
Finding 3.03

Building:	Main Building
Location:	Bathrooms
Finding:	Bathrooms - flexible hoses have signs of rust
Information:	At the time of the inspection, it was noted that a flexible hose to the vanity mixers in the ensuite and family bathroom had signs of rusting. This may be due to the age of the hose. Flexible hoses typically have a 5 - 10 year lifespan. It is recommended that they be changed if they have signs of bulging, fraying, kinking or rust.

A licensed plumber should be engaged to replace both the flexible hoses to the vanity mixers in the ensuite and family bathroom. This should be done as a matter of urgency.

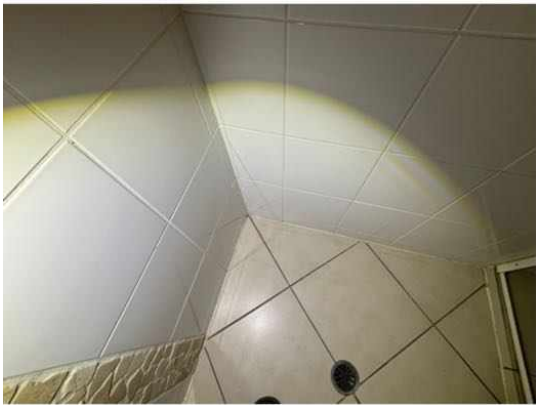
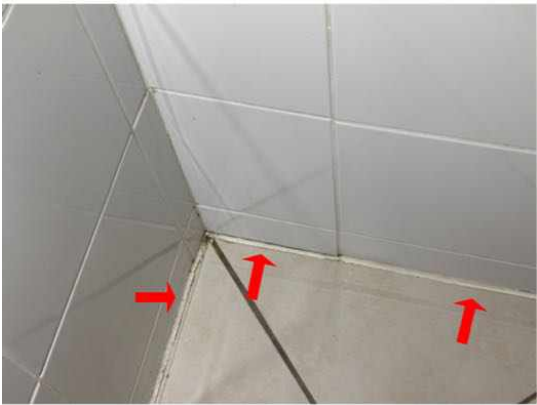
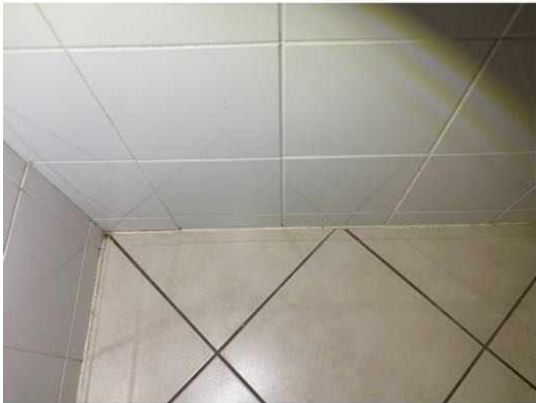
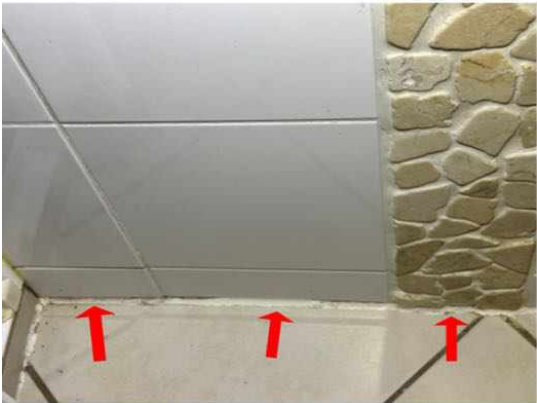
Finding 3.04

Building:	Main Building
Location:	Family bathroom
Finding:	Sealant deteriorating
Information:	At the time of the inspection it was noticed that the sealant in the shower in the family bathroom was deteriorating.

Sealant is used in tiled areas to prevent moisture from entering the wall cavity and causing damage to the building elements. A moist environment in the wall cavity may also be a conducive condition for termite activity.

If it is not addressed, damage to building elements will occur and would require invasive works to rectify any damage.

A building maintenance professional or sealant applicator should be appointed to replace all sealant as a matter of urgency.

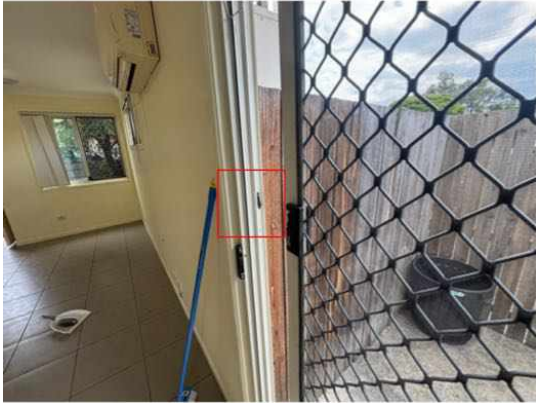
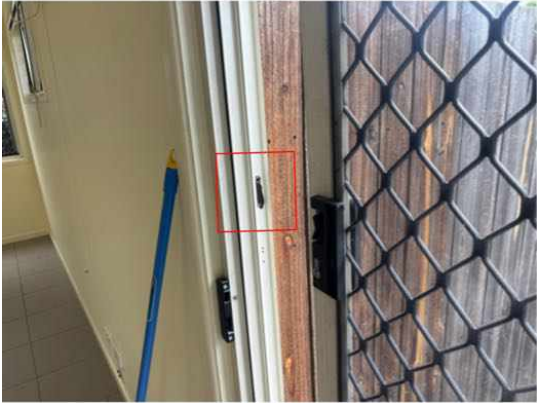
Finding 3.05

Building: Main Building
Location: Lounge
Finding: Lounge - security screen door latch missing
Information: At the time of the inspection, it was noted that the latch for the security screen door was missing. As a result the screen door cannot be locked.

A building maintenance professional or screen door specialist could be engaged to replace the missing latch. This can be done at the clients discretion.

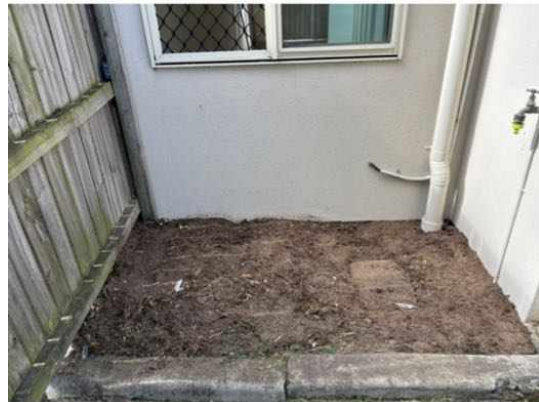
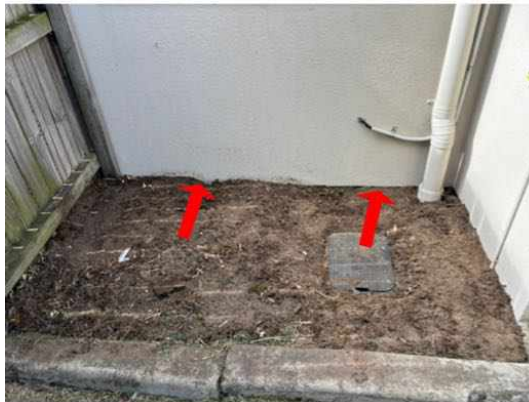
Finding 6.01

Building: Main Building
 Location: Front elevation
 Finding: Slab inspection zone - covered
 Information: At the time of the inspection, it was noted that at the front of the dwelling, soil has been built up over time to cover the 75mm inspection zone to the slab. Concealed entry of termites may occur in these areas.

The client should remove the soil to re-instate the inspection zone to the slab. This should be done as a matter of urgency. Annual termite inspections must be carried out to further protect the dwelling.

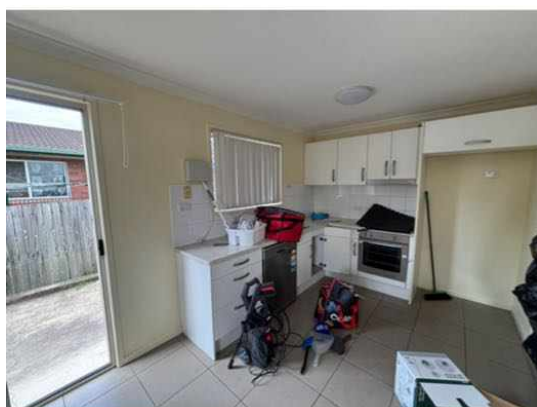
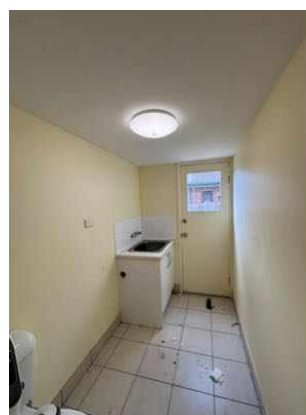
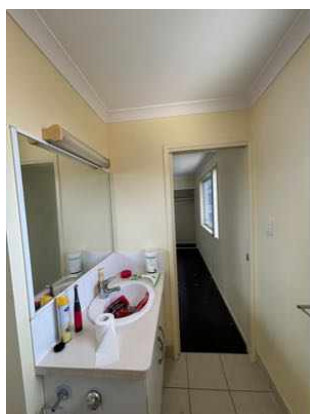
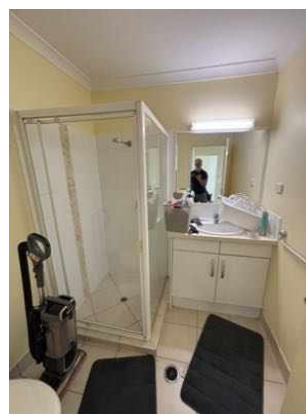
Building: Main Building
 Location: All Internal Areas
 Finding: Obstructions and Limitations - Internal areas
 Information: These photographs are an indication of the obstructions and limitations which impeded full inspection of the property of the internal areas at the time of inspection. These obstructions can hide an array of defects and should be removed to allow full inspection to be carried out. A re-inspection is recommended once the areas are made accessible.

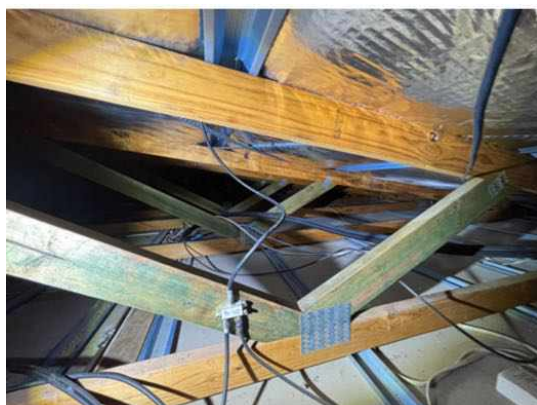
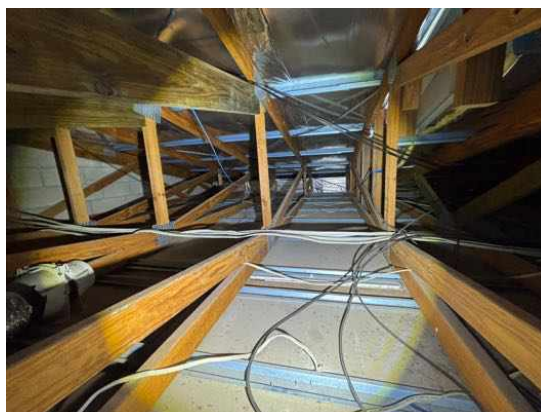
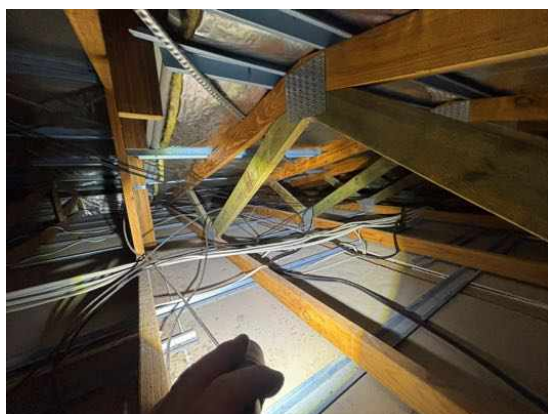
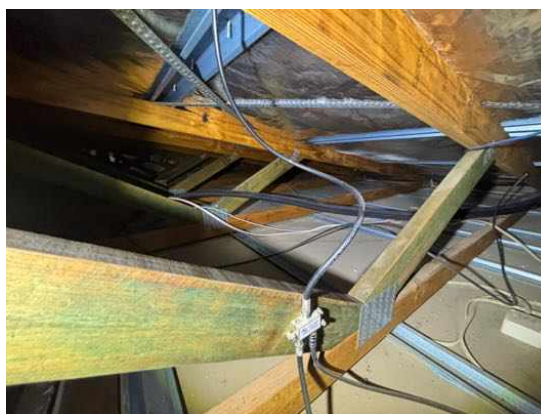
Building: Main Building
 Location: Roof Void
 Finding: Obstructions and Limitations - Roof cavity
 Information: These photographs are an indication of the obstructions and limitations which impeded full inspection of the property of the roof cavity

at the time of inspection. These obstructions can hide an array of defects and should be removed to allow full inspection to be carried out. A re-inspection is recommended once the areas are made accessible.

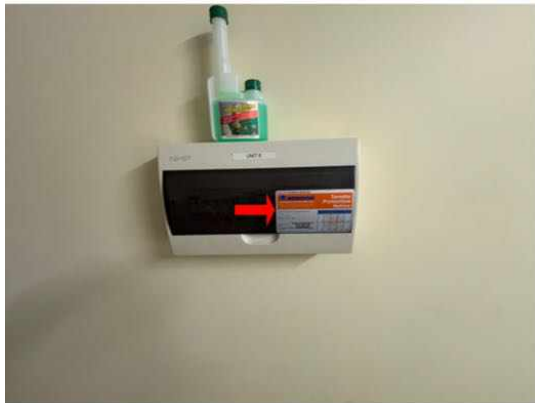
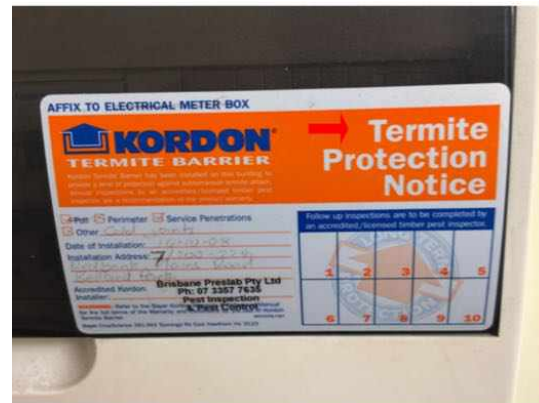
Building:	Main Building
Location:	All External Areas
Finding:	Evidence of a physical termite management system was identified.
Information:	At the time of the inspection, evidence of a physical termite management system was found by way of a durable notice in the electricity meter box.

A physical termite barrier was installed to the slab penetrations, perimeter and cold joints during construction. The durable notice is dated the 14/10/2008.

The client may wish to enquire of the body corporate as to the nature of the termite management plan for the complex and the individual townhouses. Also, are annual termite inspections being carried out and up to date.

A termite and timber pest technician should be engaged to carry out annual termite inspections as per AS 3660 in order to further protect the dwelling. Annual termite inspections must be carried out in partnership with any termite treatment system, physical or chemical, as no treatment system can be expected to be 100% effective. A physical termite barrier does not stop or eliminate termites. A physical termite barrier is designed to expose concealed termite activity.
