Building Inspection Report

Inspection Date: Fri, 13 Mar 2026

Property Address: 97 Emberwood Rd, Warragul VIC 3820,
Australia

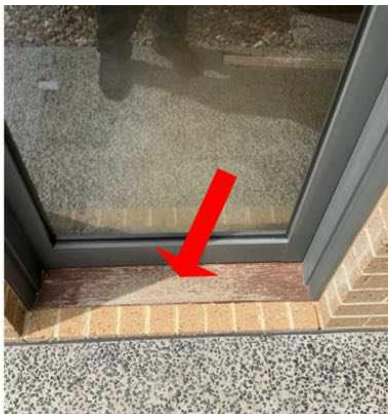
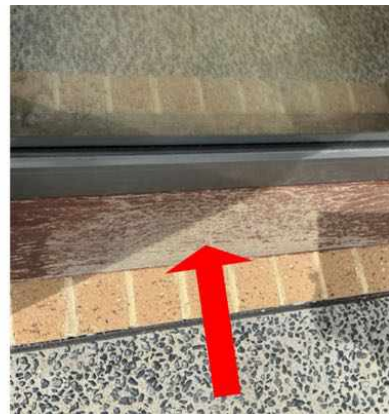
Defects 3.01

Building: Main Building
 Location: Garage
 Finding: Garage door sill - weathered
 Information: The door sill at the bottom of the garage door shows signs of weathering, indicating exposure to moisture and the elements. This deterioration may compromise the integrity of the door and affect its overall functionality.

If left unaddressed, continued weathering could lead to further damage, including warping or rotting of the timber, which may necessitate costly repairs or replacement.

It is recommended to assess the condition of the door sill and consider applying a suitable weatherproofing treatment or replacing the affected section to restore its durability and appearance.

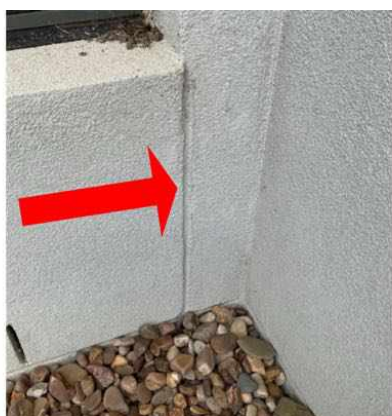
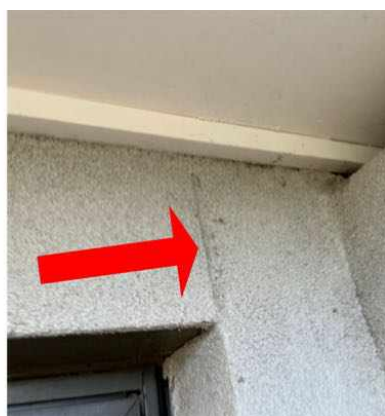
Defects 3.02

Building: Main Building
 Location: Exterior walls - front
 Finding: Rendered Over Expansion Joint
 Information: The external expansion joint at the front elevation of the dwelling has been rendered

When these joints are covered by rigid finishes such as render, the ability of the structure to move freely is reduced. This can lead to cracking in the render or adjacent building elements over time, and may also contribute to moisture ingress if movement causes gaps or fractures in the render.

It is recommended that the rendered-over section be carefully removed to expose the expansion joint, and the joint reinstated with an appropriate flexible sealant or control joint system to ensure it continues to function as intended.

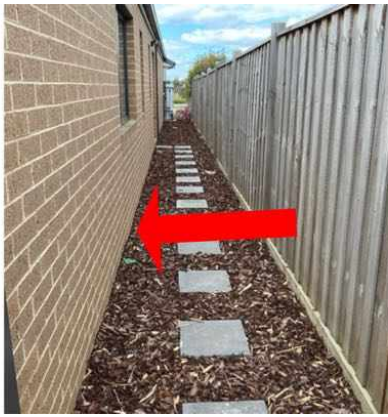
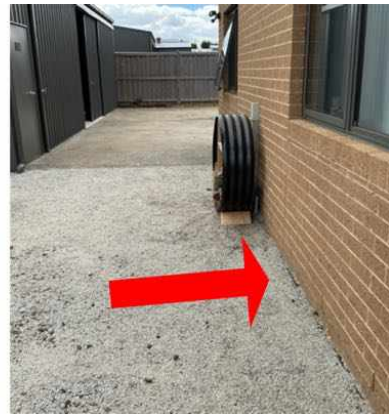
Defects 3.03

Building:	Main Building
Location:	All External Areas
Finding:	Site drainage - Inadequate
Information:	The site drainage in the backyard and sideyard was found to be inadequate at the time of inspection, creating potential for subsequent water damage to associated building elements.

It is important that water does not lie against the base of walls; surrounding paths and ground levels should be sloped to drain water away from walls. Downpipes should not discharge stormwater onto lower walls or plinths. Stormwater should be carried away by large, regularly cleaned drains. Ground levels may need to be lowered to expose a buried DPC.

Where site drainage is inadequate, installation of an Agricultural (Aggie) Drain may be required. A qualified plumber should be appointed to further inspect the property and perform any remedial works as necessary. Water damage and secondary defects are likely to occur if left unmanaged.

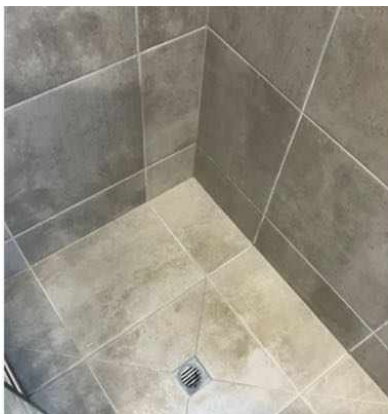
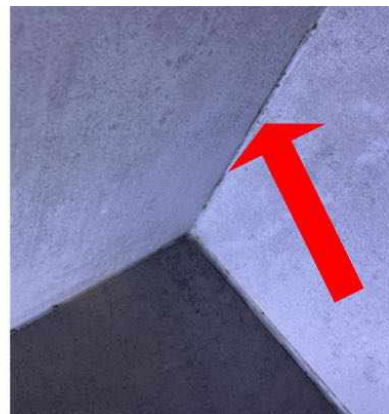
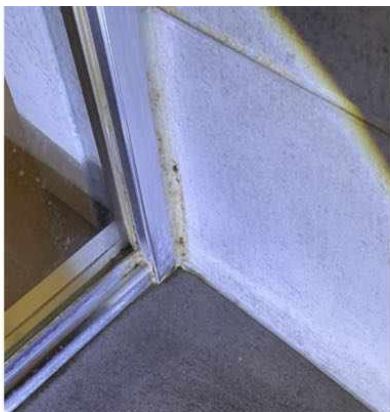
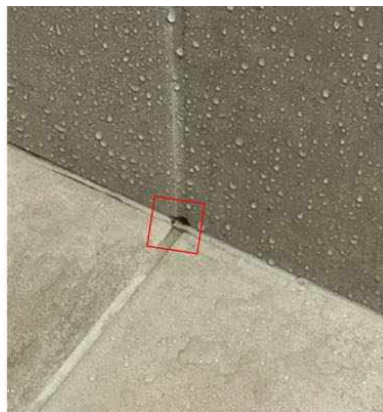
Defects 3.04

Building:	Main Building
Location:	Ensuite - Master
Finding:	Sealant and grouting - Deteriorated
Information:	It was noted on inspection that sealant or grout is degraded to the tiled shower alcove and or other areas of the bathroom.

Different materials and floor areas move at different rates, generally causing cracking to grout or sealant at this point. A flexible sealant is required to allow for expected expansion and contraction, while keeping the joint water tight and protective of all associated building materials.

Flexible and mould resistant materials should be applied to affected areas to prevent any subsequent water damage that is likely to occur. Regular maintenance and replacement of damage or missing or damaged sealant and grout is highly recommended to the wet areas, as this is a regular wear and tear defect. Sealant and grouting in areas that come into regular contact with water should be maintained for the long term care of your property.

A sealant specialist or tiling contractor should be appointed to complete these works as soon as possible

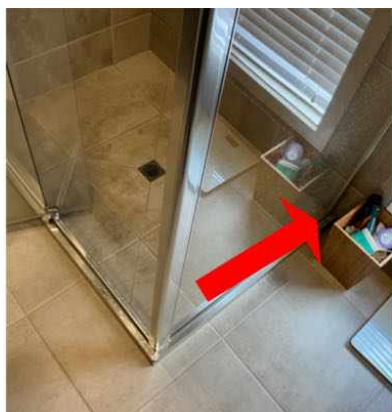
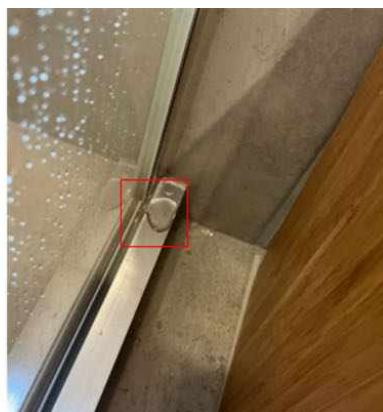
Defects 3.05

Building:	Main Building
Location:	Ensuite - Master
Finding:	Shower screen - Leaking
Information:	Leaking was evident to the ensuite's shower screen at the time of inspection. It is suspected that the leaking has occurred as a result of deteriorated or missing caulking to the shower or general ageing of the building elements.

Leaking from the shower where left unattended, is likely to lead to water damage to adjoining flooring and walls. Such damage can lead to water damage and necessitate extensive remedial works being required. Active water leaks may also create an environment that is susceptible to the formation and development of mould.

Appointment of a caulking contractor is required to repair or replace the caulking to the shower area. Such works should be performed as soon as possible to ensure that no further damage occurs.

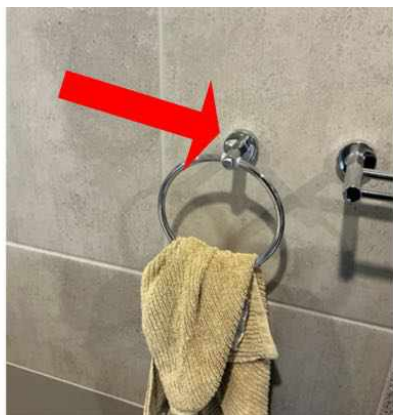
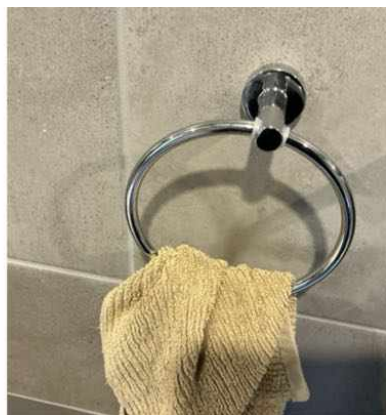
Defects 3.06

Building:	Main Building
Location:	Ensuite - Master
Finding:	Towel holder - Loose

Information: Upon visual inspection, we found that the towel holder in the master en-suite is loose. This condition may affect its functionality and could lead to further damage if not addressed.

Re-tightening or replacement of these fixtures is advised to ensure proper use and prevent any subsequent issues. A relevant tradesperson may be appointed to perform these works at the client's discretion.

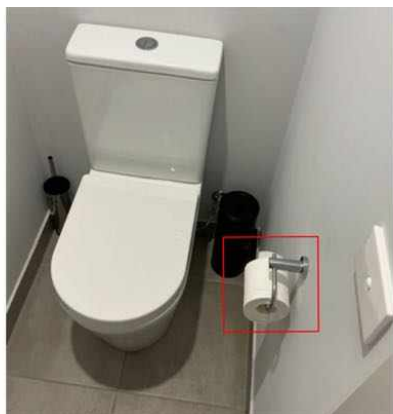
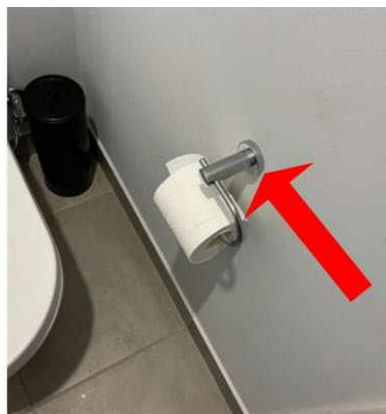
Defects 3.07

Building: Main Building
 Location: Ensuite - Master
 Finding: Toilet roll holder - Loose
 Information: The toilet roll holder was found to be loose at the time of inspection. While not a major operational defect, function can deteriorate if the problem is left unmanaged.

It is advised that the homeowner performs remedial works to re-attach the toilet roll holder to its original fixing. A general handyperson may be required to perform these works.

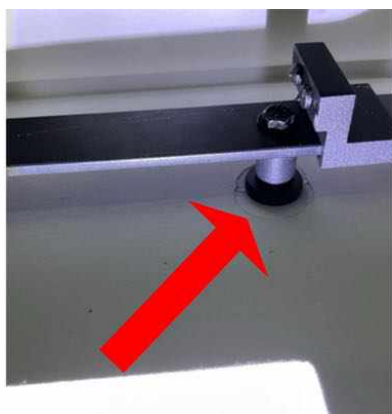
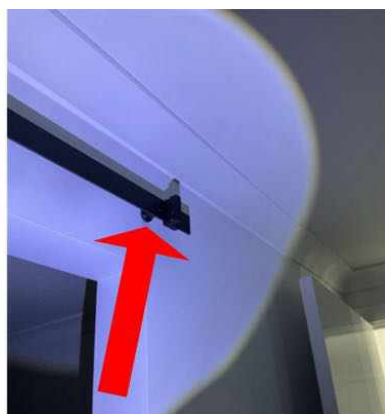
Defects 3.08

Location: Bedroom - Master
 Finding: Minor Plaster Damage Above Opening – Master Bedroom to Walk-in Robe
 Information:

Minor damage to the plasterboard was observed above the opening between the master bedroom and the walk-in robe at the time of the inspection. The damage appears to be associated with the installation of a sliding door track in this location, where the plasterboard has been slightly chipped and uneven around the track area.

If left unrectified, the damaged plaster may affect the visual finish of the opening and may deteriorate further over time if the area is subjected to movement or continued use.

It is recommended that a qualified plasterer attend the property to repair the affected plasterboard area, including patching, sanding, and refinishing the surface to achieve a smooth and uniform finish consistent with the surrounding wall and ceiling surfaces.

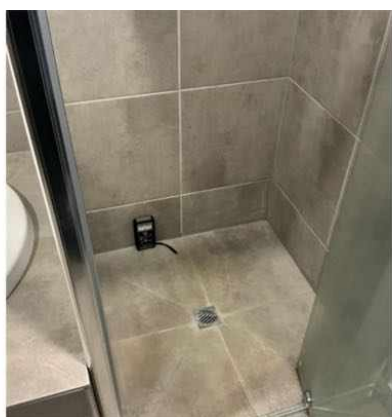
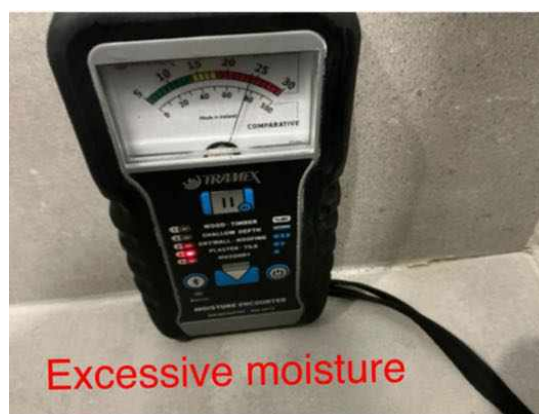
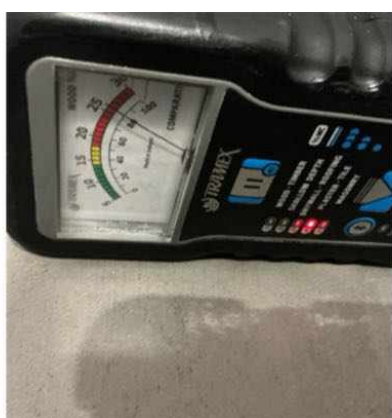
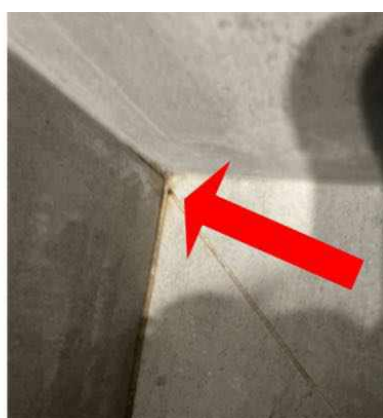
Defects 3.09

Building: Main Building
 Location: Bathroom 2
 Finding: Dampness Detected in Shower Alcove
 Information: Upon inspection, dampness was evident along the lower 300mm of the wall in the shower alcove. A moisture meter was used to assess the area, and excessive moisture readings were detected at the bottom tiles of the shower. This defect is commonly caused by moisture permeating through deteriorated grouting in the area, with leaking pipes within the adjoining wall also being a potential contributing factor.

Damp (or structural damp) refers to the presence of unwanted moisture in the structure of a building, typically due to water intrusion from external sources or condensation from within. In this case, moisture is likely entering through compromised grout, or possibly from leaking pipes behind the wall.

If left unaddressed, damp conditions in the shower recess can lead to the formation of mould and fungi, which could decay associated building materials and compromise their structural integrity. The World Health Organisation has noted that excess

moisture promotes the growth of microbes such as moulds, fungi, and bacteria, which release spores and other contaminants into the air, potentially leading to a variety of respiratory and health-related issues.

It is strongly recommended that a licensed plumber or bathroom specialist be engaged immediately to identify the source of the moisture and carry out necessary repairs. If mould growth is present, further inspection by an environmental health inspector should also be considered to assess the extent of the contamination.

To prevent future issues, it is essential that the sealant and grout in the shower area are maintained in good condition.

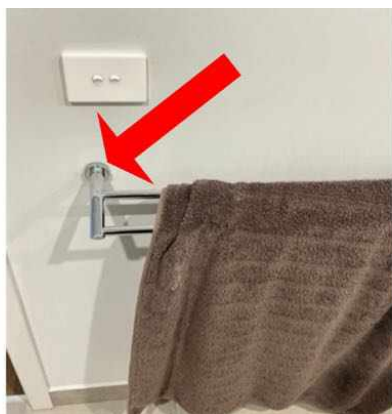
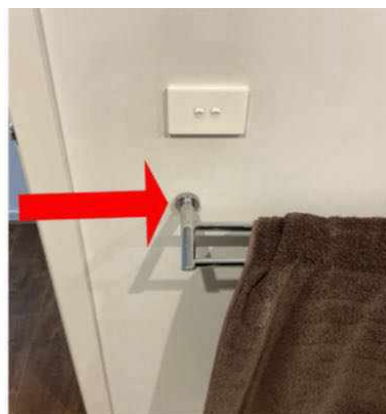
Defects 3.10

Building:	Main Building
Location:	Bathroom 2
Finding:	Towel rail - loose
Information:	The towel rail was found to be loose at the time of inspection. While not a major operational defect, function can deteriorate if the problem is left unmanaged.

It is advised that the homeowner performs remedial works to re-attach the towel rail to its original fixing. A general handyperson may be required to perform these works.

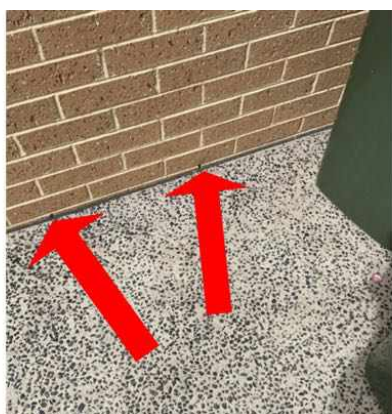
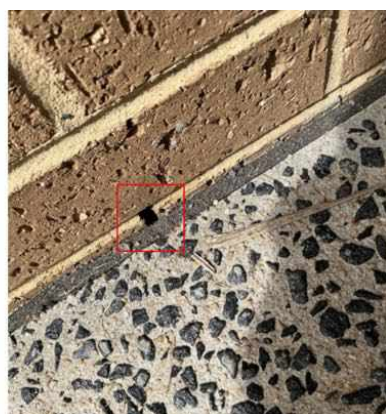
Defects 3.11

Building: Main Building
Location: All External Areas
Finding: Weep holes - Blocked
Information: It was noted during the time of inspection that some of the weep holes to the brickwork were blocked. Weep holes are designed to allow water from leaks or seepages in brickwork to be directed to the external environment, prior to entering the wall cavity or associated building materials. Weep holes should therefore be kept clean and free of debris or blockages.

Blocked weep holes are likely to result in the presence of excessive moisture within the brickwork and associated structures, creating potential for water damage and moisture problems.

Depending on the nature of the blockage, the homeowner may be able to undertake remedial works to remove blockages. Alternatively, appointment of a registered builder may be required to remove blockages. Preventative works are necessary in ensuring the structural integrity of the affected brickwork and should be performed as soon as possible.

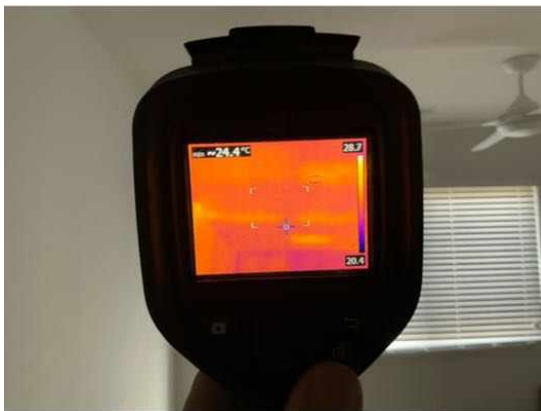
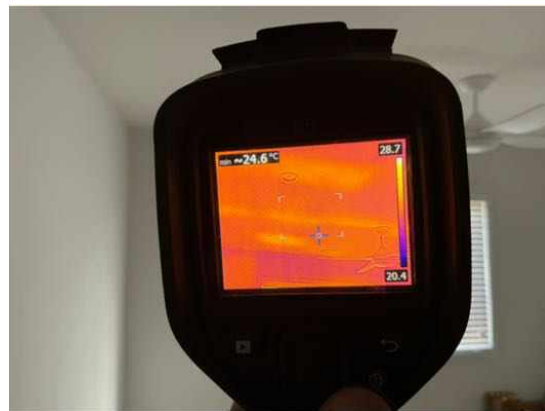
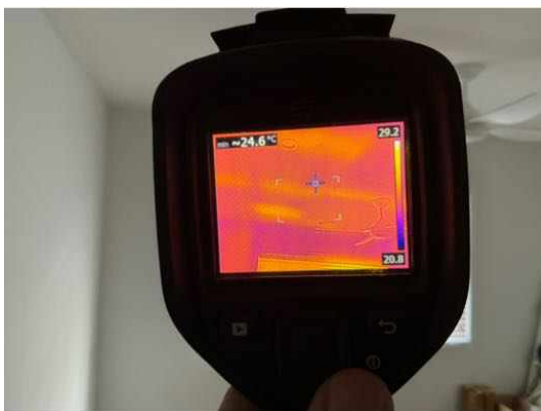
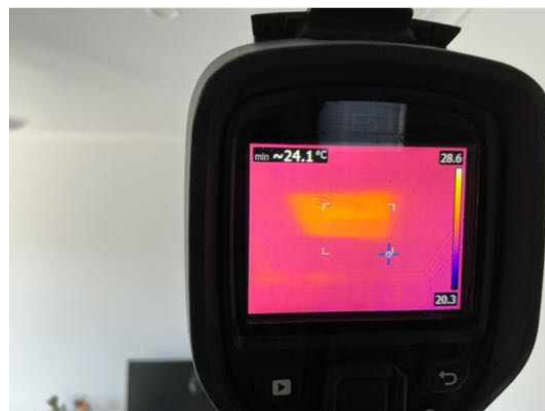
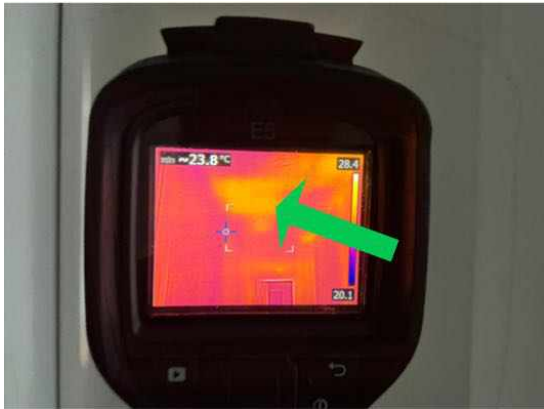
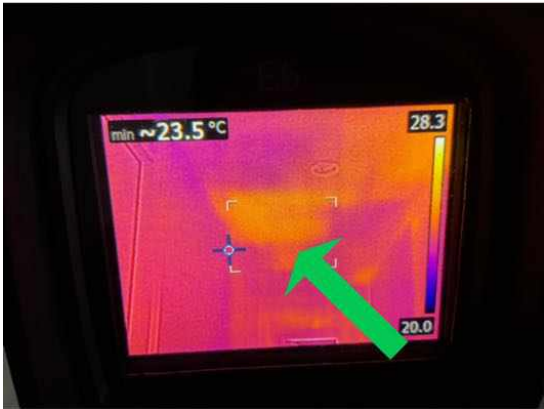
Defects 3.12

Finding: Inconsistent Thermal Performance to Ceiling Areas – Suspected Insulation Deficiencies

Information: Thermal imaging conducted to internal ceiling areas at the time of inspection identified inconsistent heat patterns, which are indicative of variations in thermal performance across the roof space. These patterns are commonly associated with areas of missing, displaced, or insufficient insulation above the ceiling linings.

Inadequate or uneven insulation coverage can reduce the energy efficiency of the dwelling, contribute to heat loss in cooler periods and heat gain in warmer conditions, and may result in reduced occupant comfort and increased heating and cooling costs. Due to the non-invasive nature of the inspection, the exact extent and condition of insulation could not be confirmed visually in all affected areas.

It is recommended that a qualified insulation contractor inspect the roof space, assess insulation coverage and condition, and top up or reinstate insulation where required to achieve consistent thermal performance throughout the property.

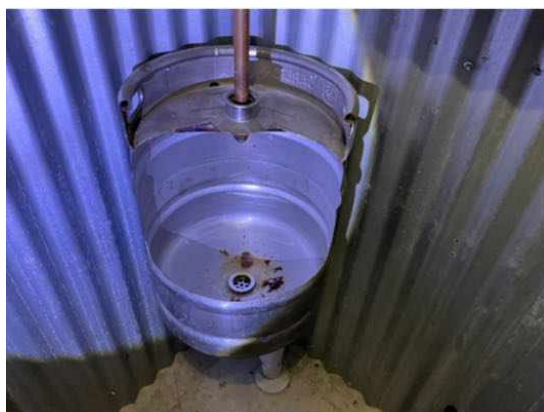
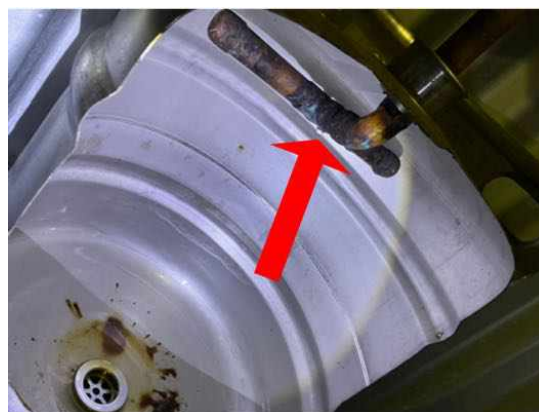
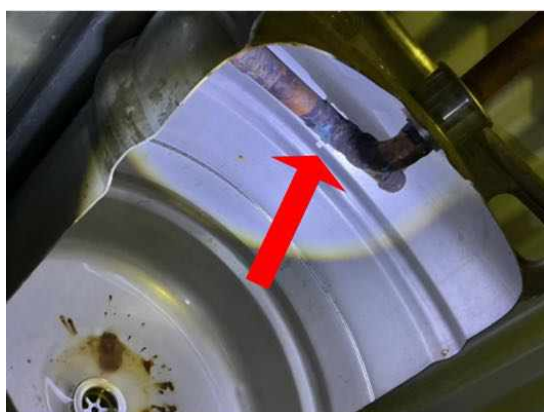
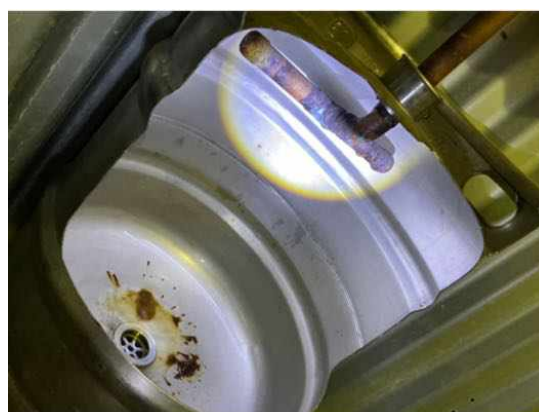
Defects 3.13

Building: Main Building
 Location: Shed
 Finding: Leaking Urinal Water Supply
 Information:

The urinal located within the external toilet area in the shed was observed to be continuously dripping water at the time of inspection. Water appeared to be leaking from the pipework connected to the urinal, resulting in a constant drip into the fixture.

Continuous leakage may lead to unnecessary water wastage and may also contribute to staining, deterioration of surrounding surfaces, or increased moisture in the area over time if not addressed.

It is recommended that a licensed plumber attend the property to inspect the urinal water supply pipework and associated fittings, identify the source of the leak, and carry out the necessary repairs or replacement of defective components to ensure the fixture operates correctly without ongoing leakage.

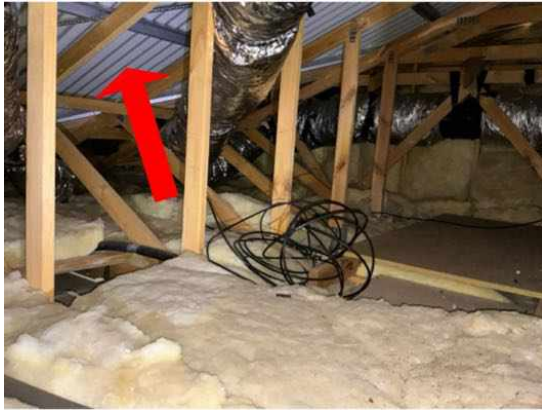
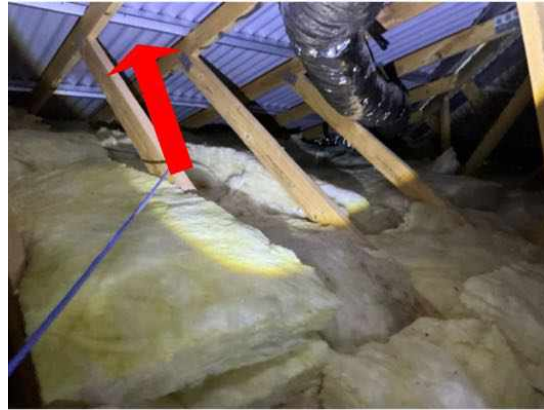
Defects 3.14

Building: Main Building
 Location: Roof Void
 Finding: Sarking - Missing
 Information: Sarking is missing under the roof sheeting. Sarking acts as an insulator that helps with

Although not a requirement at the time of construction, replacement of any missing building element is advisable (although this can be quite expensive to do after the time of construction). Where sarking is missing, regular inspections of the roof sheets and potential moisture penetration is required.

Sarking may be retrospectively fitted by a registered builder at the discretion of the client.

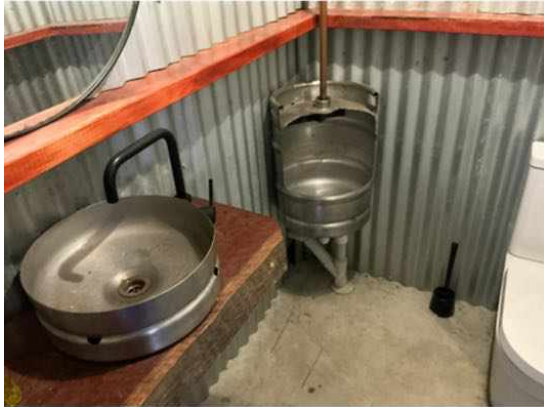
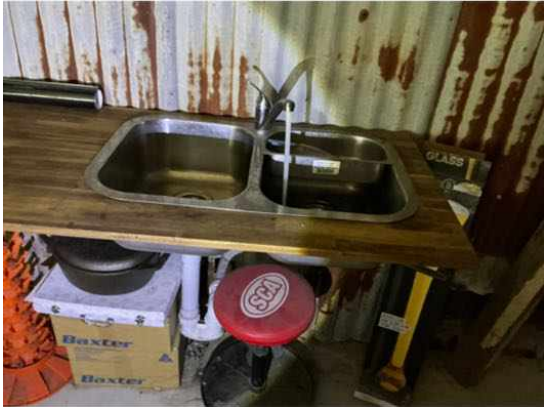
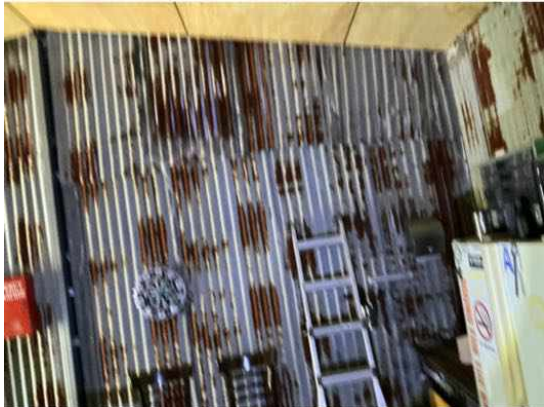
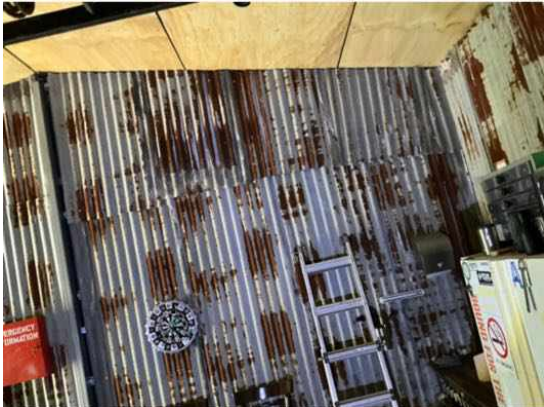
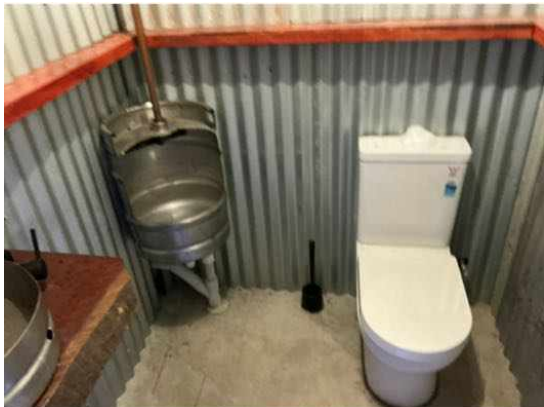
Building:	Main Building
Location:	Toilet (WC)
Finding:	Additional structure built without a permit (Suspected) - FOR YOUR INFORMATION ONLY (NOT A Defect)
Information:	The shed structure / the additional living space along with the installed toilet, sinks and urinal on the rear side of the house are suspected to have been constructed without a building permit. A building permit would be required for the structure.

It is highly advised to request that the current owner provide a Defect report (Owner Builder/Section 137b) for this structure. This would involve a structural engineer or a

licenced building surveyor conducting an inspection of the structure and advising of any defects and/or areas of non-compliance in accordance with the current building codes. The current owner should then attend to any issues on this report prior to settlement.

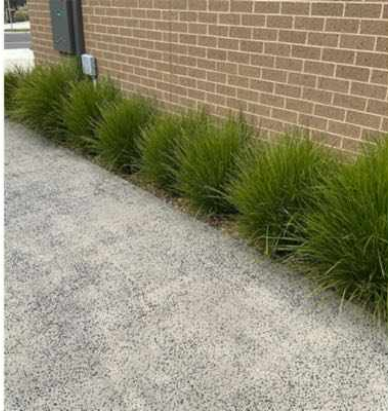
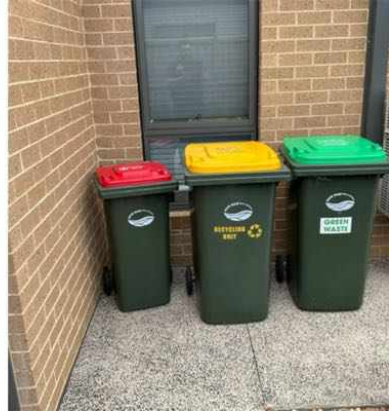
Finding: Obstructions and Limitations - Exterior

Information: These photographs are an indication of the obstructions and limitations which impeded the inspection of the external areas of the property at the time of inspection. These obstructions can hide an array of defects and should be removed to allow full inspection to be carried out. A re-inspection is recommended once the areas are made accessible.

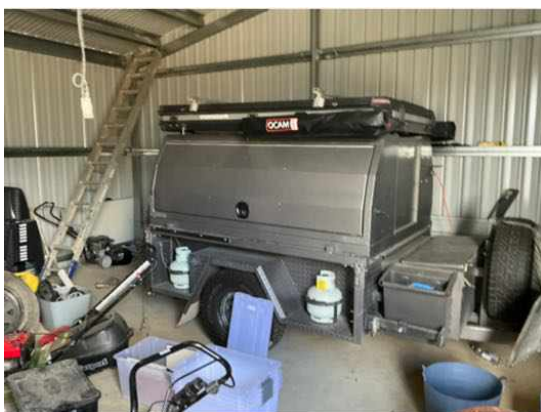
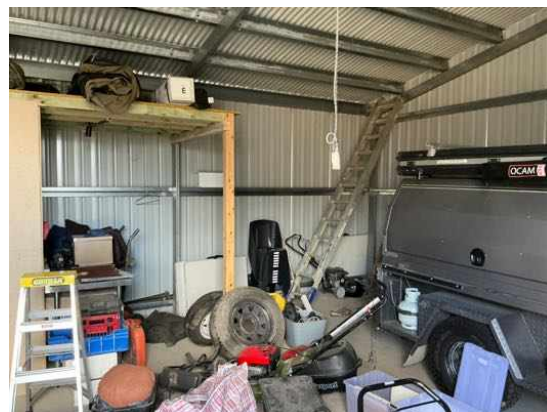
Finding: Obstructions and Limitations - Interior

Information: These photographs are an indication of the obstructions and limitations which impeded the inspection of the internal areas of the property at the time of inspection. These obstructions can hide an array of defects and should be removed to allow full inspection to be carried out. A re-inspection is recommended once the areas are made accessible.

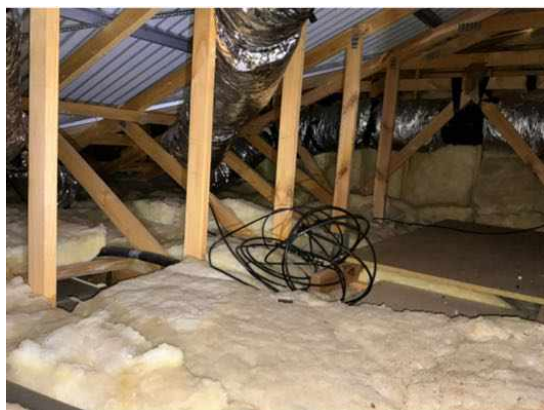
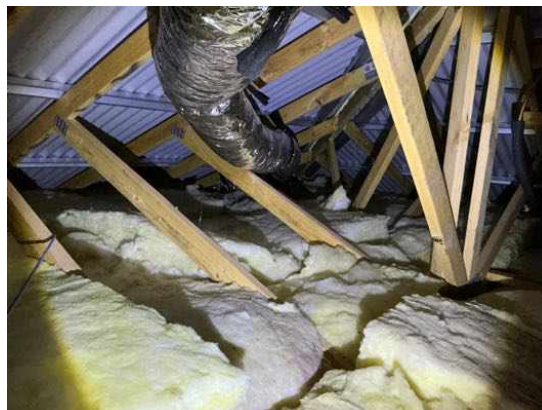
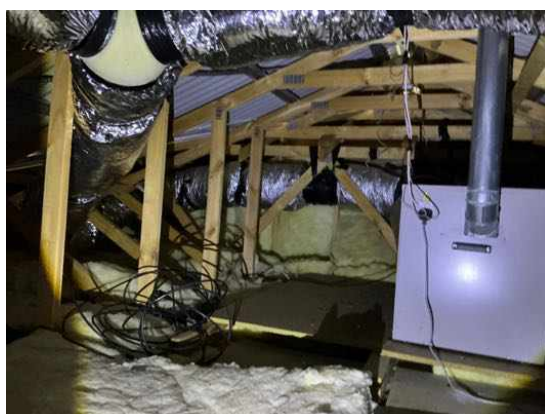
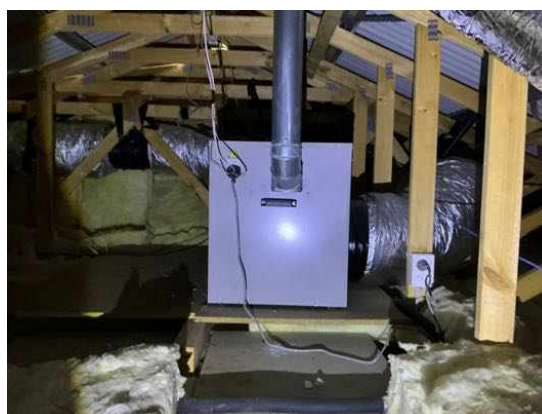
Finding: Obstructions and Limitations - roof cavity

Information: These photographs are an indication of the obstructions and limitations which impeded the inspection of the roof cavity area of the property at the time of inspection. These obstructions can hide an array of defects and should be removed to allow full inspection to be carried out. A re-inspection is recommended once the areas are made accessible.

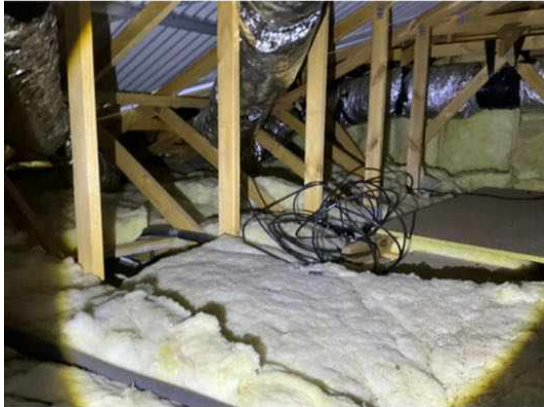
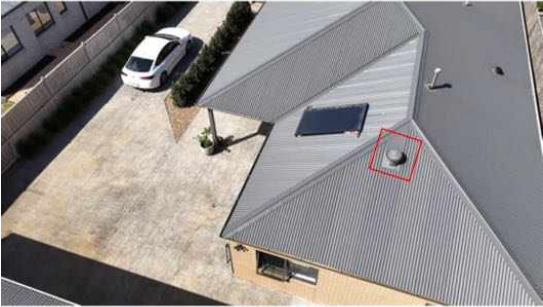
Building: Main Building
 Location: Roof Void
 Finding: Roof Void Ventilation – Advisory
 Information:

For your information, the roof void was noted to have one whirlybird ventilation unit installed at the time of inspection. While this provides a level of ventilation to the roof space, additional ventilation may further assist in improving air circulation within the roof void.

The client may consider installing one or two additional roof ventilation units (such as whirlybirds) to further improve ventilation. This recommendation is advisory only and

can be undertaken at the client's discretion if they wish to enhance the ventilation performance of the roof space.
