Building and Timber Pest Inspection Report

Inspection Date: Tue, 24 Mar 2026

Property Address: 4/53 Carruthers Dr, Modbury North SA
5092, Australia

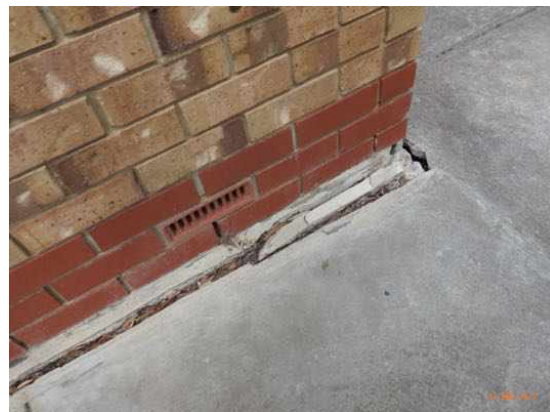
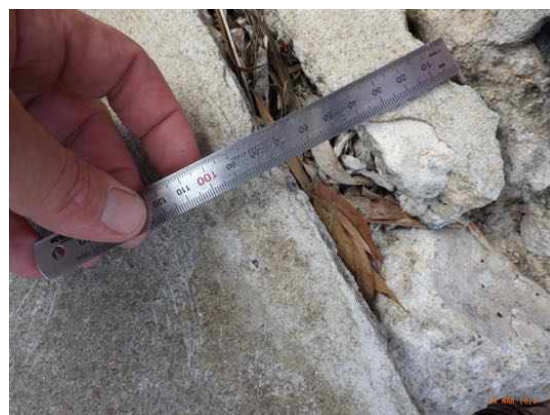
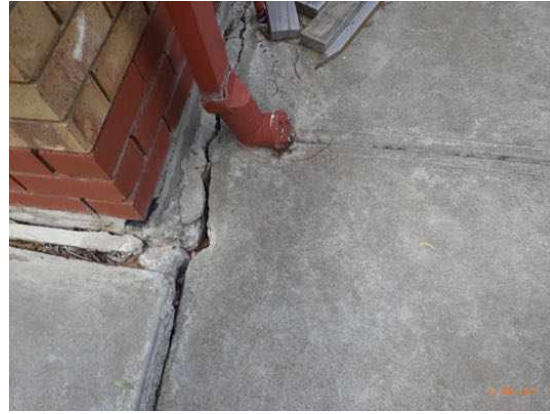
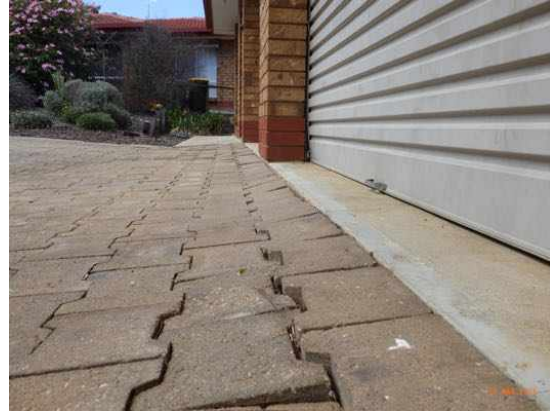
Finding: Cracking - External Concrete Paving Damage Category 4 - Gaps in Slab (4mm - 10mm +)

Information: Wide cracks/ movement was identified in external concrete paving to the front area at the time of inspection. The concrete movement along with the settlement of the dwelling are likely indicators of highly reactive soil/ foundation in the area.

Movement is significant and has lead to the development of a safety hazard.

General age and or deterioration of the paved areas is a common cause of this type of cracking. However, expansion and contraction of the slab may also have occurred due to environmental factors. Such factors include variable moisture and weather conditions, the presence of trees and their roots, poorly managed stormwater having a settling or lifting affect on the soil over a sustained period of time.

Cracking to this degree may also be due to poor original installation of the concrete. Factors such as poor compaction of the sub surface and/or inadequate reinforcing of the slab may create cracking and other secondary defects. Gaps in the concrete paving may also have a more significant structural cause, such as subsidence of soils.

Significant repair and likely replacement of the concrete paving is probable and should be conducted by a licensed concrete paving company.

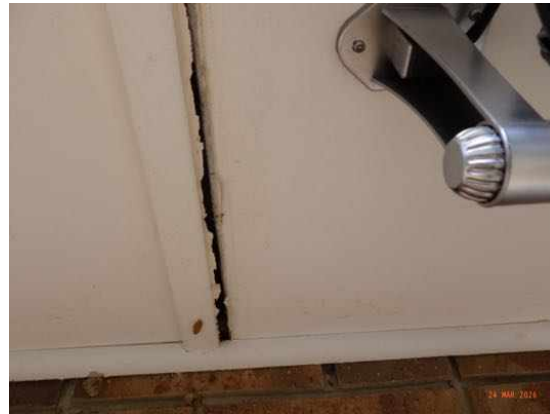
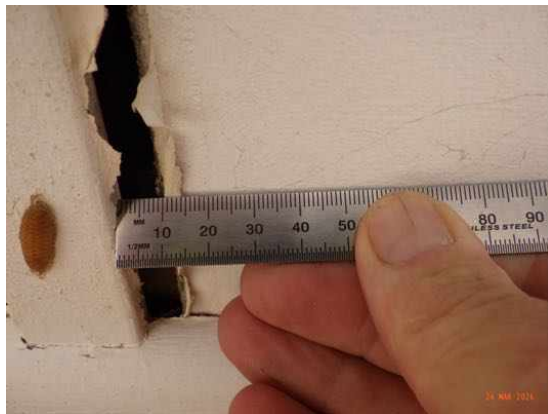
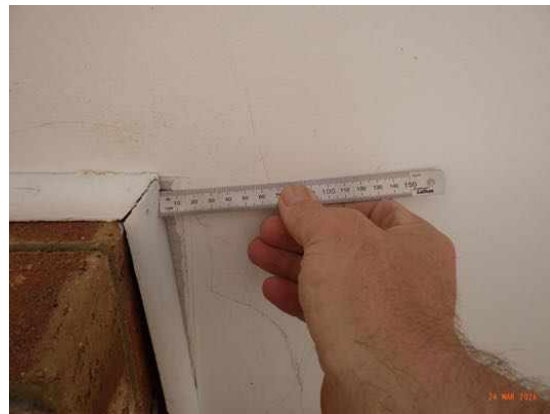
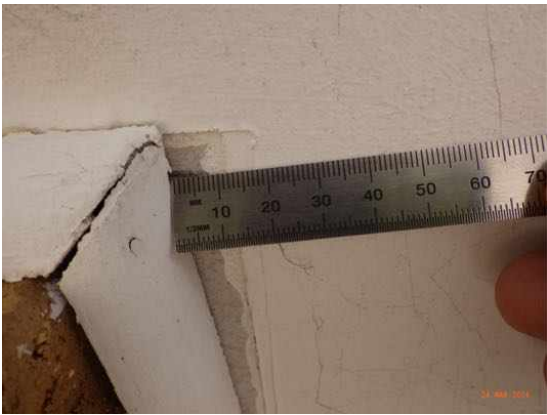
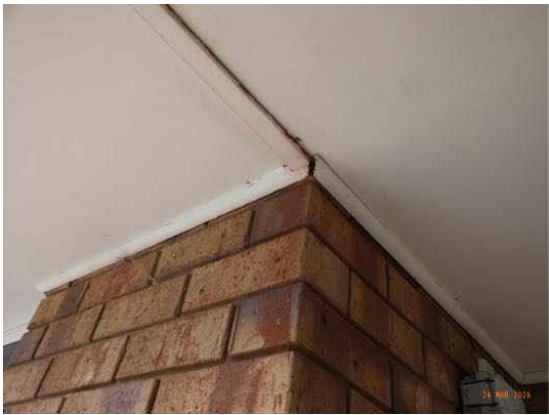
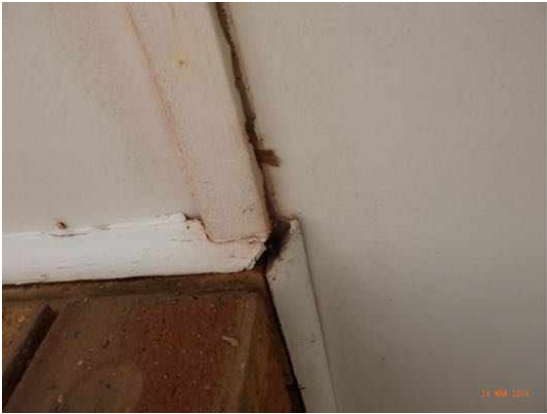
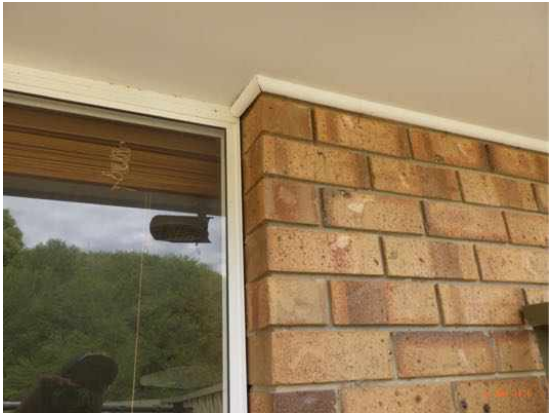
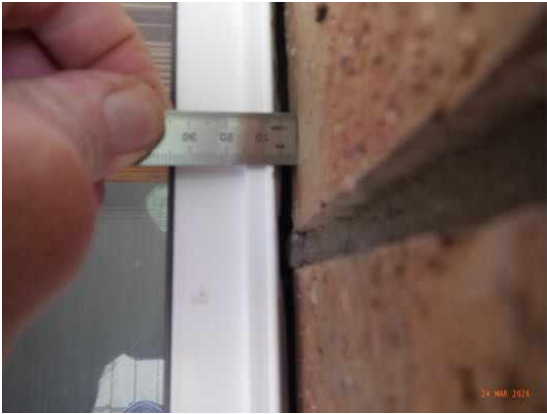
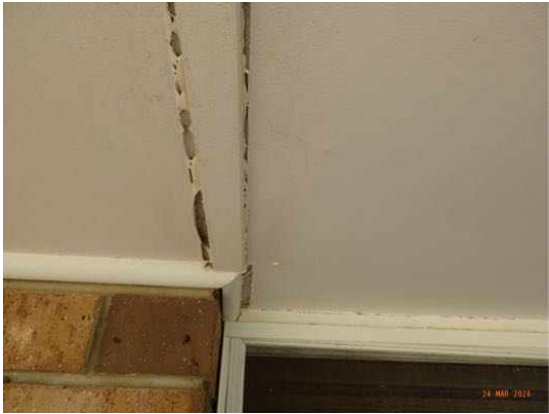
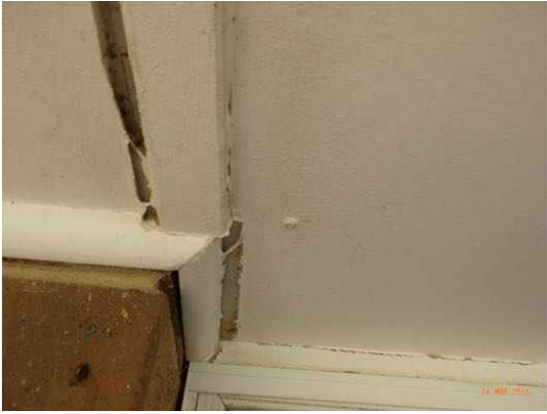
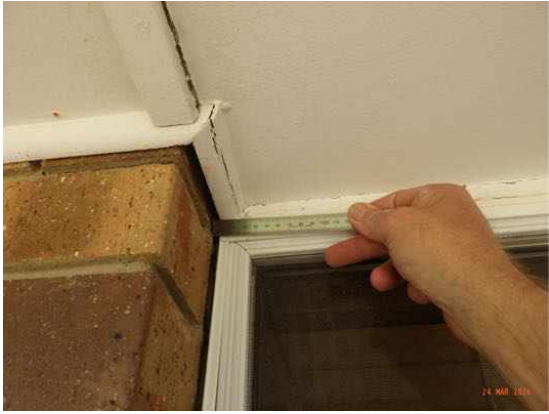
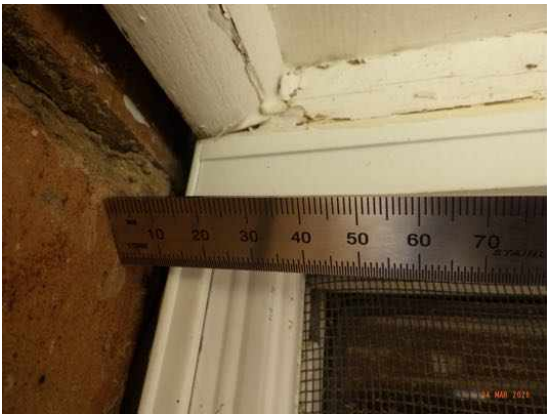
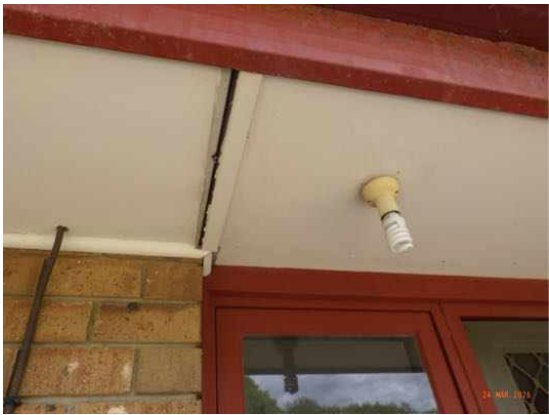
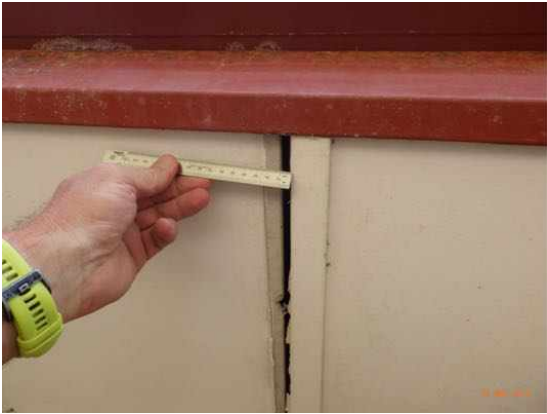
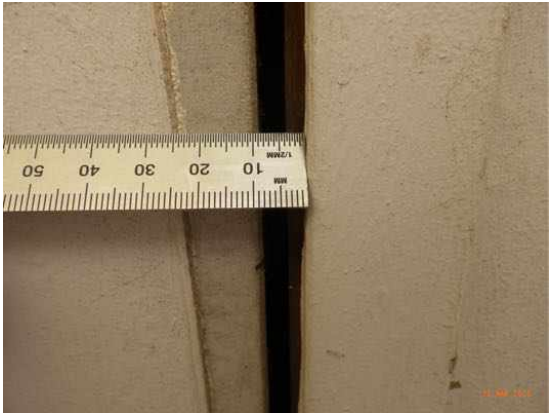
Finding 2.02

Building: Building 1
 Location: Exterior walls
 Finding: Brickwork / Eaves linings cracks and gaps >10mm
 Information: There are several minor cracks evident throughout the exterior of the dwelling at the rear right hand corner. These cracks are commonly less than 5mm in width and are expected in a property of this age and can be easily filled and monitored in the future.

Floors were found to be out of level by approximately 40mm over the bedroom and some brick walls were out of plumb by 30mm over the height of the wall.

There are also several larger more noticeable major cracks and all gaps around

windows and to eaves linings to the dwelling. These cracks usually coincide with openings (windows and doors) however they can present in other areas also. Cracks of this type are likely to have been caused by minor expected movement of building elements, but may also have a structural cause that is more significant.

Noticeable cracks in brickwork may develop if left unattended with the potential of necessitating remedial works or replacement of sections of brickwork. Always monitor these cracks and contact a building inspector should cracks widen lengthen or become more numerous.

Consultation with a structural engineer may be required where structural instability is found to be the underlying cause of the cracking. Following this repair works could be carried out by a structural repair company and may include some form of underpinning when this level of movement is observed. It is also prudent to have all plumbing in the area. Forensically checked to ensure that there is no damaged plumbing which could be exacerbating the movement to the dwelling.

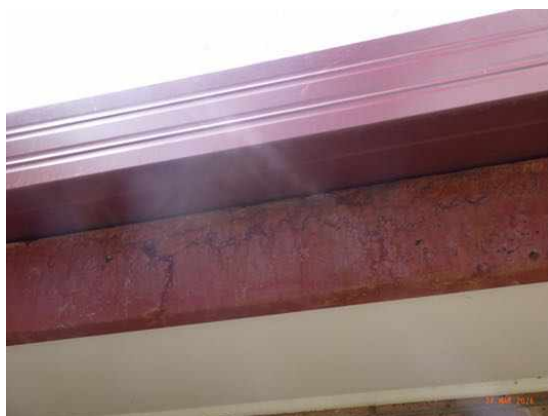
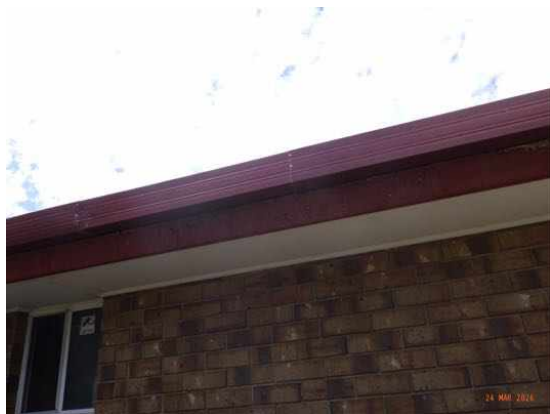
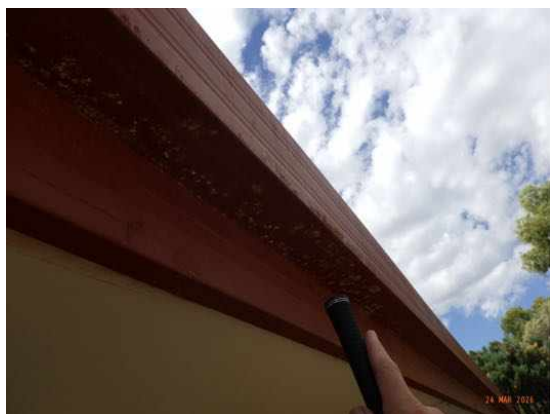
Building: Building 1
Location: Roof Exterior
Finding: Roof plumbing - Rusted or corroded
Information: The roof plumbing has areas of rust and corrosion. It is suspected that this has been caused by blockages, resulting in pooling or standing water, that have prematurely rusted elements of the roof plumbing.

Rusted roof plumbing will generally develop holes and leaks that can affect other building elements with poor drainage of storm water.

Poorly drained roof areas will also lead to damp conditions surrounding the base perimeter of the building which, if left unmanaged, can lead to a range of secondary building defects.

Repair and/or replacement of rusted roof plumbing is highly required in order to reinstate the roof drainage system to a fully operational level.

To further maintain these areas, gutters should be cleaned frequently, allowing the avoidance of any partial blockages.

A licensed plumber or specialist roof restoration company should be appointed to undertake these works. It is advised that such works be completed as soon as possible to prevent any further damage and deterioration.

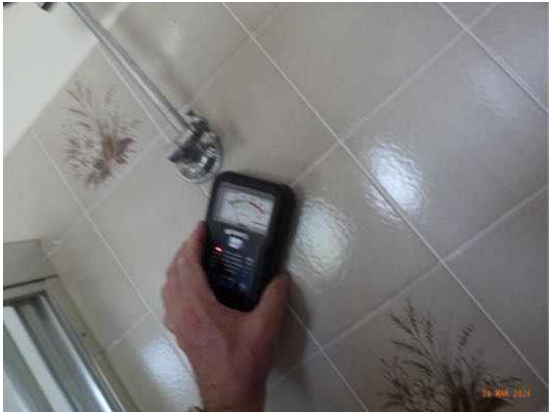
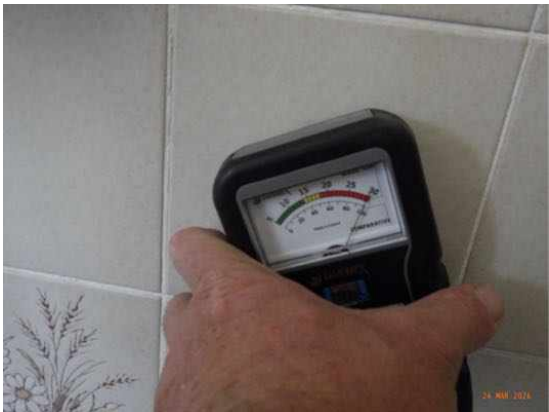
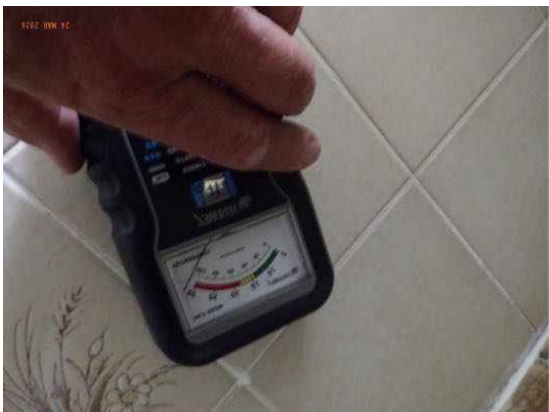
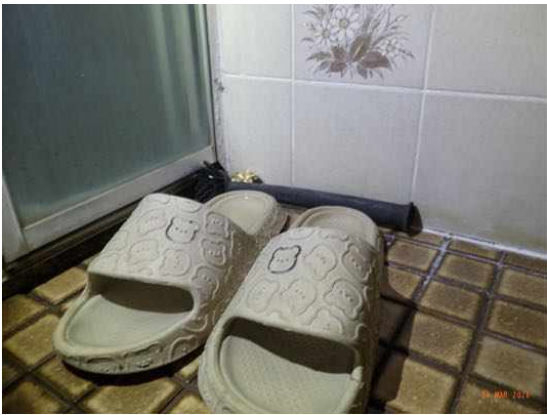
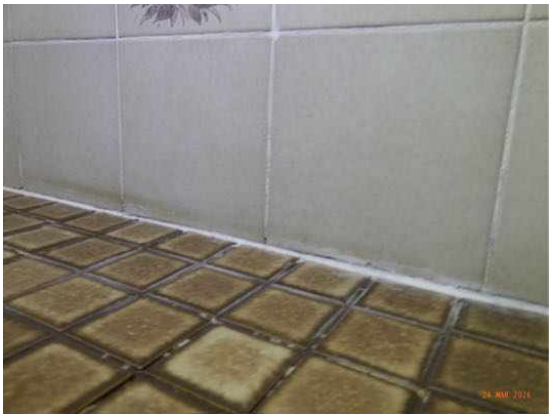
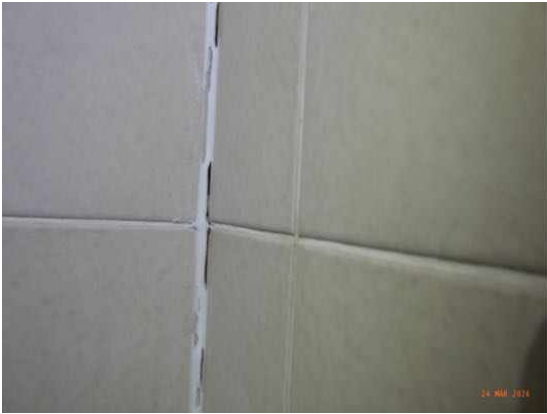
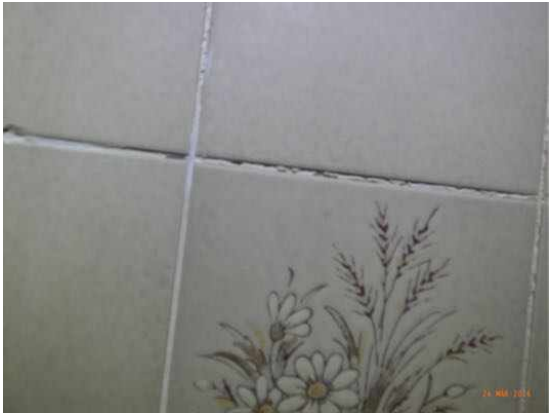
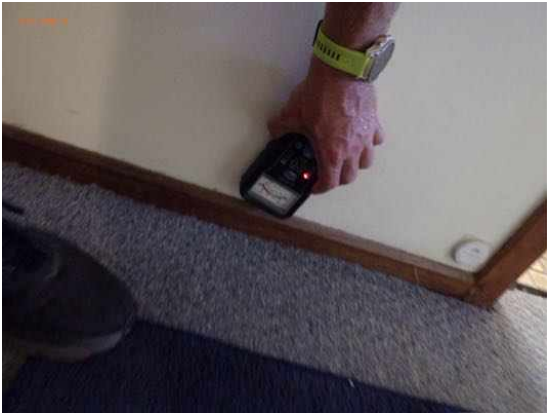
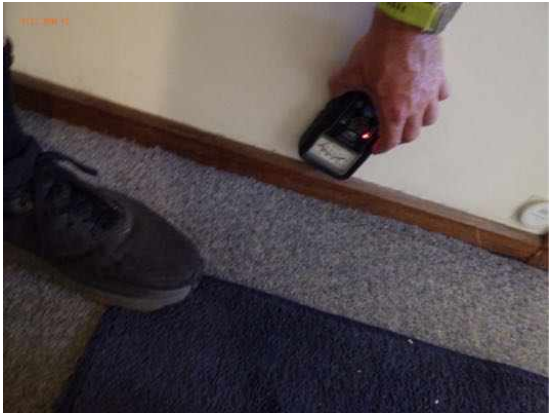
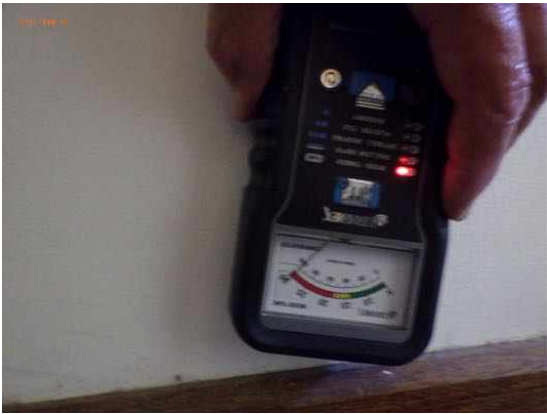
Finding 2.05

This defect is quite common, and is suspected to have been caused by moisture permeating through the tiling, grouting and or sealant in this area, which shows evidence of deterioration. There are also a few drummy tiles evident to the walls.

Leaking pipes within the adjoining wall is also a possible cause however it seems unlikely in this instance as there are only small areas of high moisture transferring to the other side of the wall

Damp (or structural damp) refers to the presence of unwanted moisture in the structure of a building, either as the result of intrusion from outside, or condensation from within the structure.

In the shower area, internal water leaks or other sources of excessive moisture are generally the cause of damp.

Unmanaged damp in the shower recess is likely to facilitate the formation and development of mould and fungi growth, decaying associated building materials and

compromising their structural integrity. High moisture around timber elements also creates an environment that is conducive to termite activity. Further investigation would likely uncover currently concealed defects.

Consultation with a qualified plumber or bathroom specialist is advised immediately to identify the cause of damp and to perform remedial works as required.

As the bathroom is getting quite old for bathroom renovation will likely be required in the Short to midterm

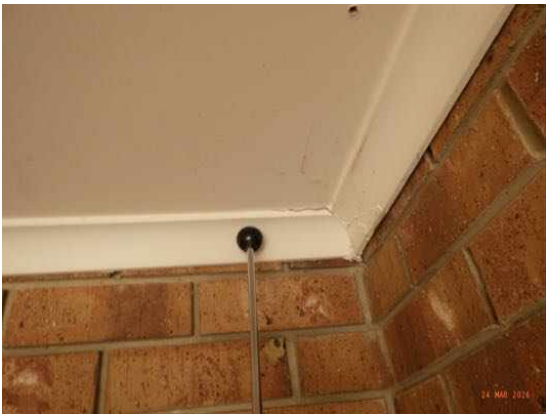
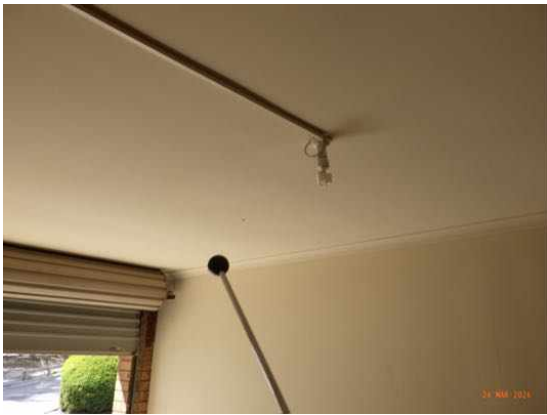
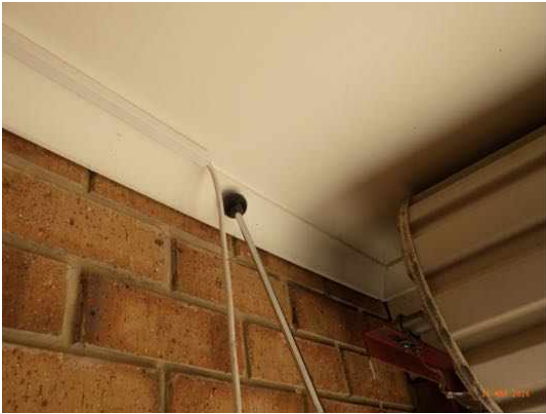
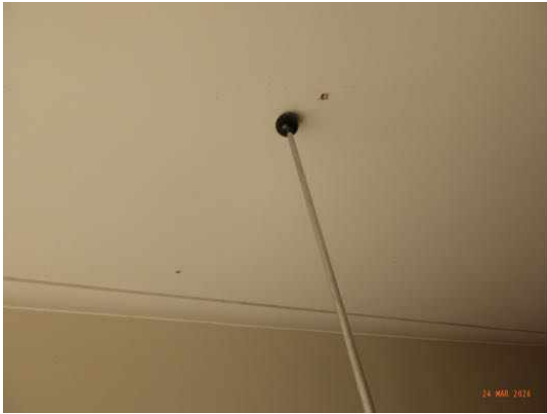
| Information: | Sections of the garage ceiling were found to be sagging at the time of inspection. Sagging to the fixed ceiling structure generally indicates that the building materials have swollen, due to contact with water, or that fixings (e.g. nails or glue) have become loose and require reattachment. |

This is a very common defect in garages due to their lack of insulation, vibration from automatic doors and or their susceptibility to moisture.

Such works may be performed by relevant tradespeople, such as carpenters, plasterers and painters along with repairing the cracks.

It is recommended to insulate the area also to prevent further damage in the future.

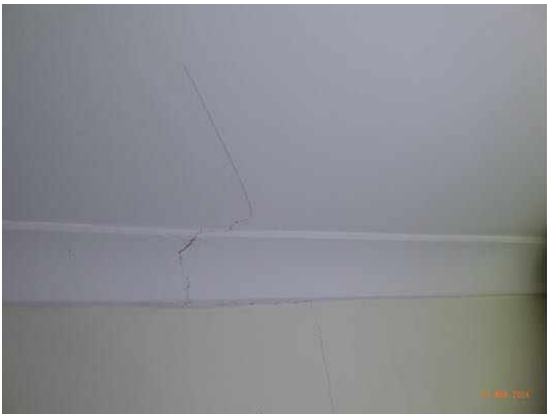
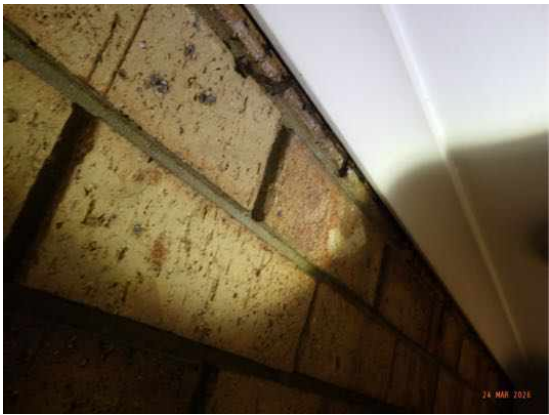
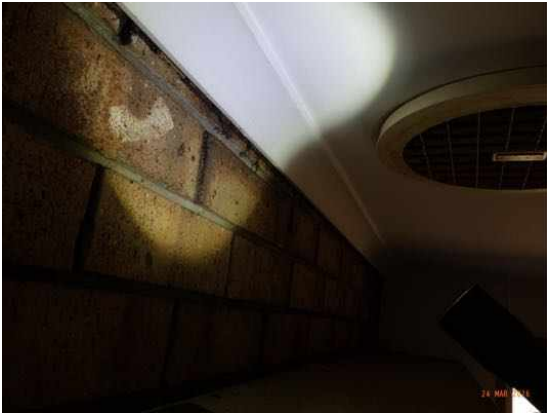
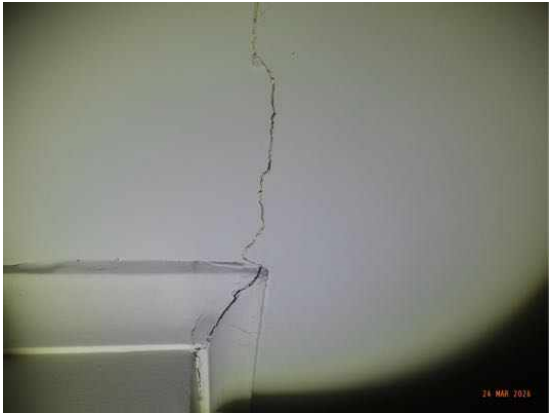
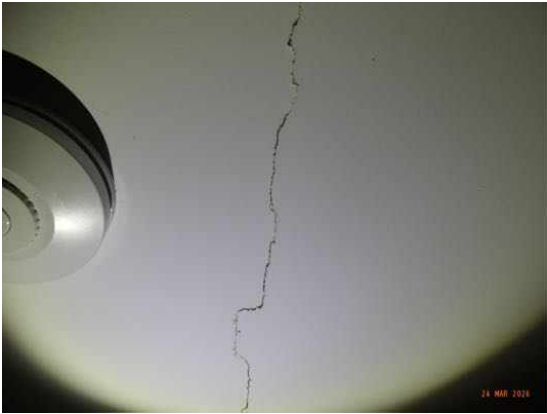
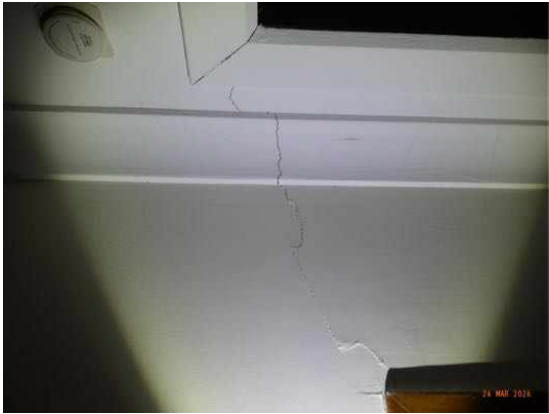
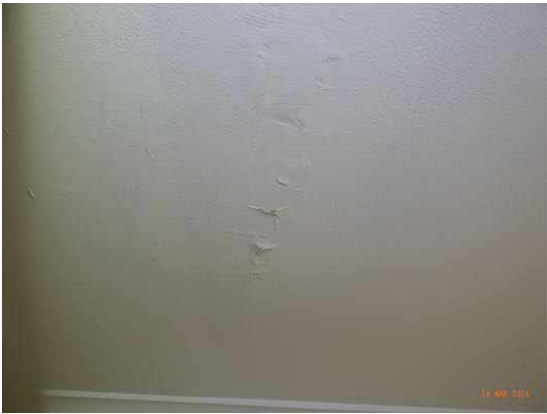
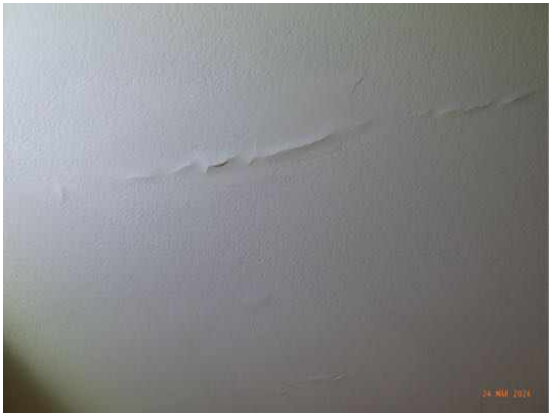
| Finding: | Cracking - Damage Category 2 - Noticeable (up to 5mm) |
| Information: | There were many cracks and crack repairs evident to walls and ceilings throughout the interior of the dwelling at the time of inspection. |

Noticeable cracks are a common occurrence as a result of many primary defects. Such causes may include age, general wear and tear, expected building movement, general expansion/contraction of building materials in different weather conditions, and/or minor failings in the installation or application of building materials.

Noticeable cracks may result in minor sticking or jamming of associated doors and windows, which require easement. However, noticeable cracks are easily filled and repaired.

Monitoring of all cracking should be conducted frequently. Always contact a building inspector should cracks widen, lengthen, or become more numerous. Additionally, your building inspector should also be contacted if associated building elements such as doors and windows become more difficult to operate over time.

Relevant tradespeople, such as carpenters, painters and plasterers, should be appointed to perform remedial works, as deemed necessary.

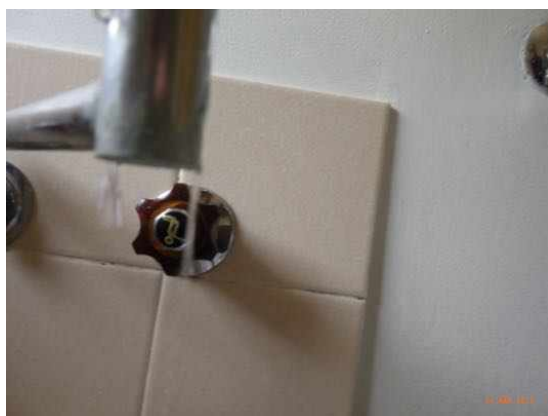
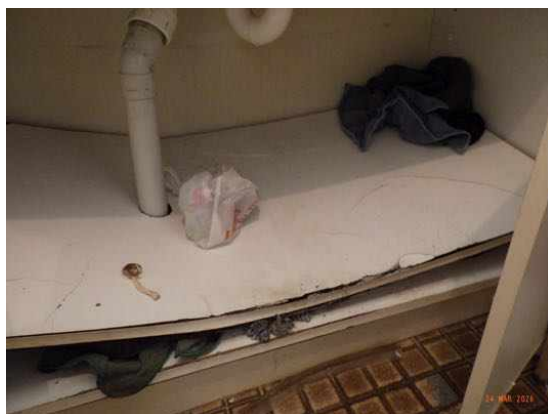
Finding 3.04

Building: Building 1
Location: All Areas
Finding: Minor defects present
Information: Minor defects were evident throughout the dwelling at the time of inspection, which are consistent with normal wear and tear and considered appropriate for a property of this age.

These defects are typical of ongoing material ageing, settlement, and general use over time, and include, but are not limited to:

- Roller door opening has spread and door is out of track
- Leak to laundry tap
- Kitchen and vanity are deteriorated.

While these defects are not considered structurally significant at present, they should be addressed as part of routine and ongoing property maintenance to prevent further deterioration. Repairs and maintenance works should be carried out by appropriately licensed and qualified tradespeople to ensure the continued serviceability and longevity of the dwelling.

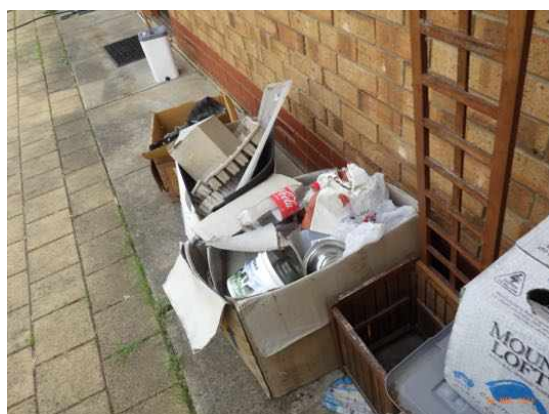
Where the slab edge cannot be properly inspected, it is highly recommended that termite or timber pest inspections be carried out every 6-12 months to aid protection of the property against infestation and termite treatment advice is followed closely.
