Building Inspection Report

Inspection Date: Thu, 8 Jan 2026

Property Address: 24/21-27 Meadow Cres, MEADOWBANK,
NSW, 2114, Australia

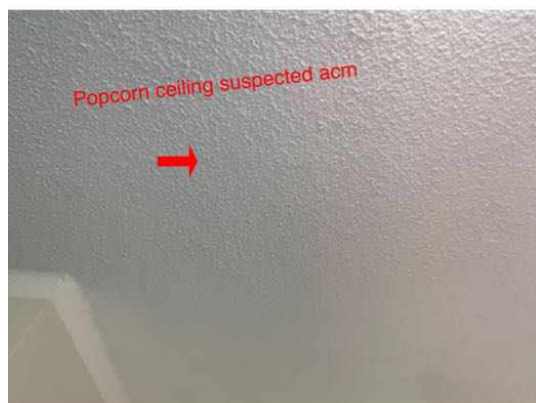
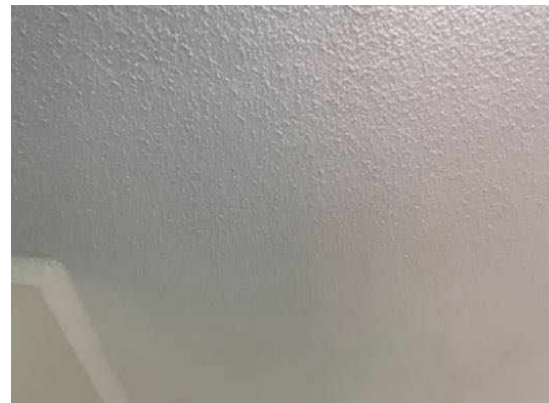
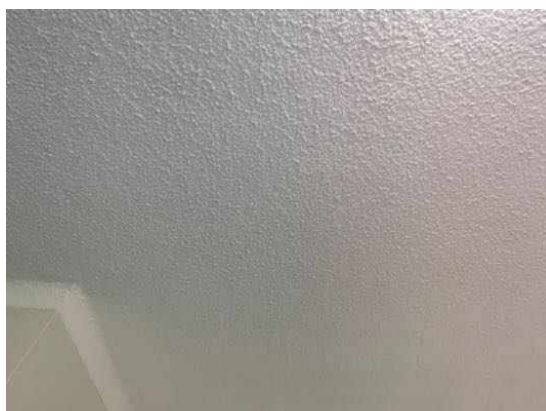
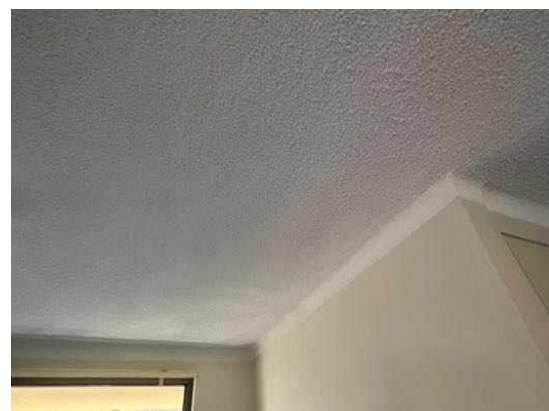
Defects 1.01

Building:	Main Building
Location:	All Areas
Finding:	Asbestos - Suspected ACM Identified on Site
Information:	Reporting on Asbestos is outside the Scope of this Report. This suspected defect is highlighted as a caution only. We suspect, based on our experience in the building industry, that there is a higher risk of the identified building element containing asbestos.

As Asbestos Reporting is outside the scope of this report, we advise that you consider a separate Asbestos Inspection and Condition Audit, which can include the taking of samples for definitive confirmation of the presence of Asbestos.

In the interim, the client is advised to act with caution, especially when considering any damage to building materials general wear and tear renovations extensions demolition and general maintenance activities due to the suspected presence of Asbestos.

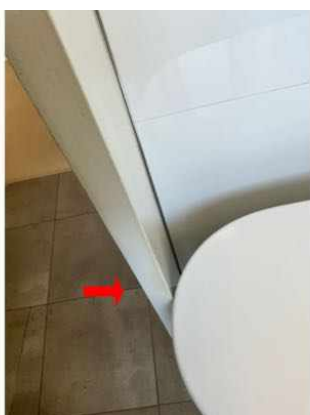
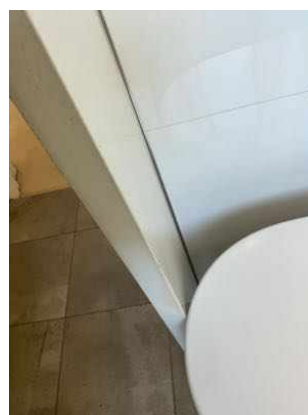
Defects 1.02

Building: Main Building
Location: Bathroom
Finding: Door - Hitting toilet seat
Information: A safety hazard was identified in the bathroom of the property. The issue pertains to the door, which, when fully opened, makes contact with the adjacent toilet. This situation poses an immediate risk to the safety and well-being of occupants due to the potential for accidents and injuries.

Collision between the door and the toilet can cause injury to individuals using the bathroom.

The repeated contact between the door and the toilet can also result in damage to both fixtures, leading to costly repairs or replacements.

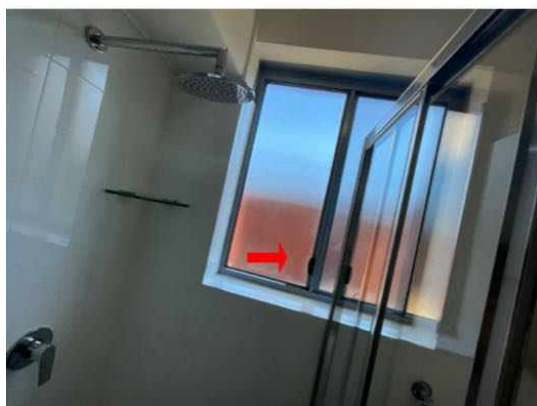
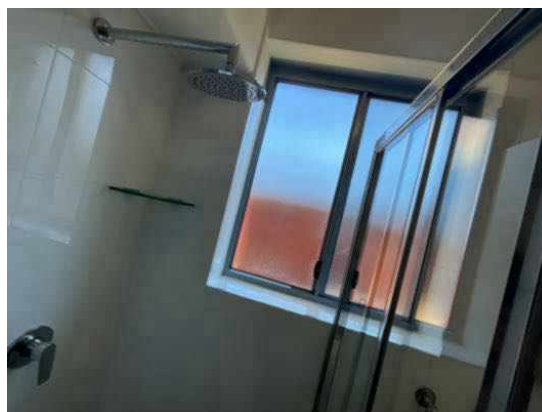
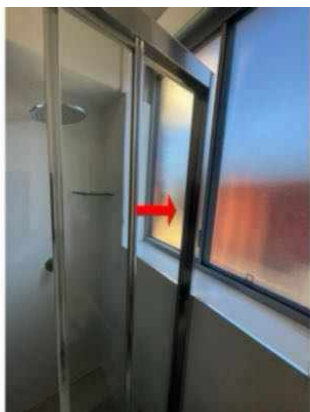
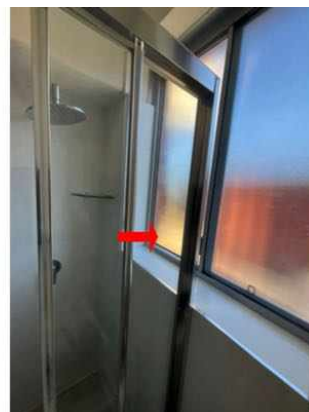
Defects 2.01

Building: Main Building
Location: Bathroom
Finding: Shower Screen – Non-Compliant
Information: The shower screen installation is non-compliant, with inadequate clearance and positioning in close proximity to the window opening. This may impact safe operation, waterproofing performance, and ongoing maintenance. Rectification by a licensed glazier or bathroom contractor is recommended.

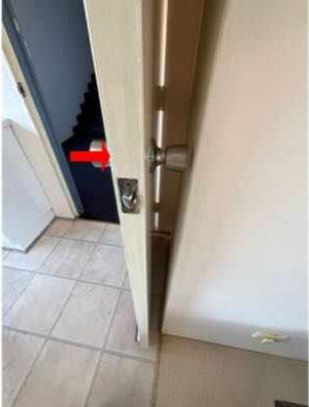
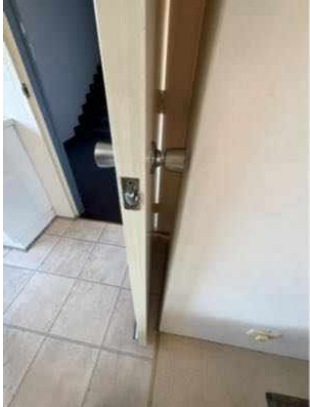
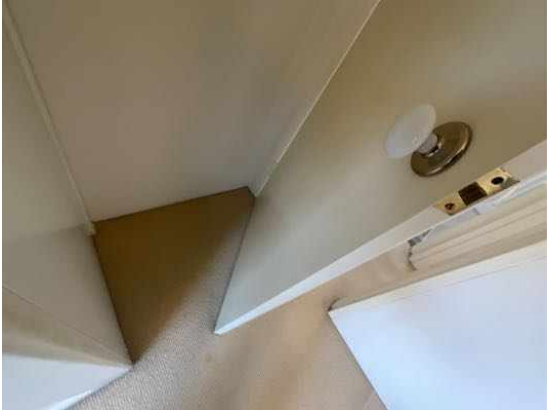
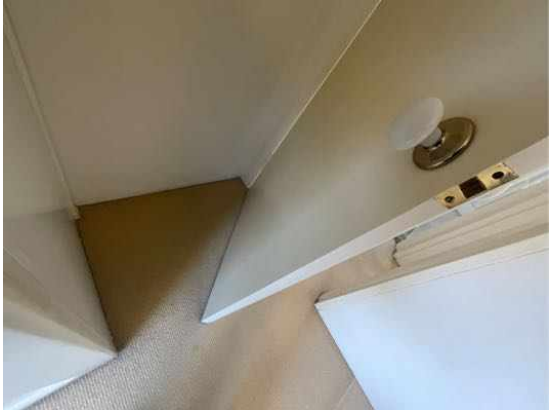
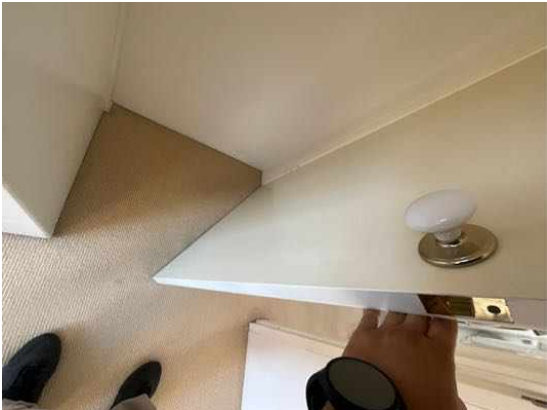
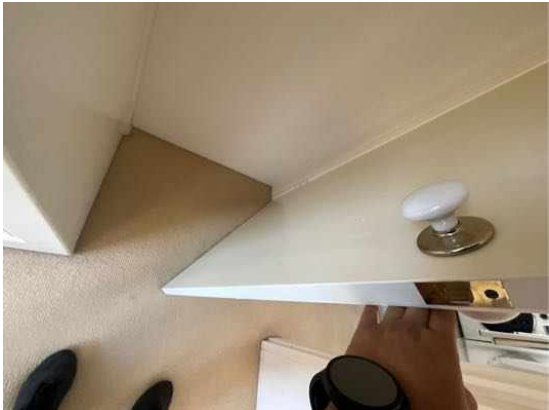
Defects 3.01

Building:	Main Building
Location:	All Areas
Finding:	Missing Door Stopper
Information:	The door lacks a stopper, which is essential to prevent the door from swinging too far and potentially damaging the wall or the door handle. The absence of a door stopper increases the likelihood of impact damage to both the door and surrounding surfaces over time.

- **Damage Risk:** Moderate risk of damage to the door handle, wall, or door itself from repeated impacts when the door is opened forcefully or by a gust of wind.
- **Wear and Tear Risk:** Increased wear on door hardware and hinges due to the potential for abrupt stops without a dedicated stopper.

- **Engage a Handyperson or Carpenter:** A handyperson or carpenter should install a

suitable door stopper to prevent excessive door movement. This could be a floor-mounted or wall-mounted stopper depending on the space and door design.

This issue is a minor defect but should be addressed to prevent potential damage and maintain the integrity of the door and surrounding areas.

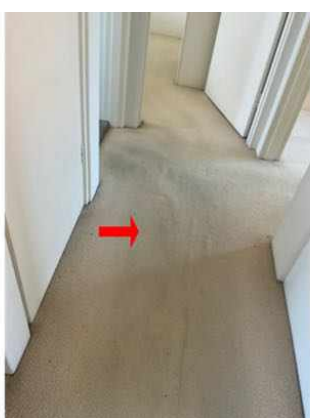
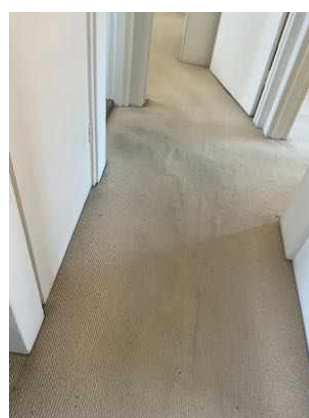
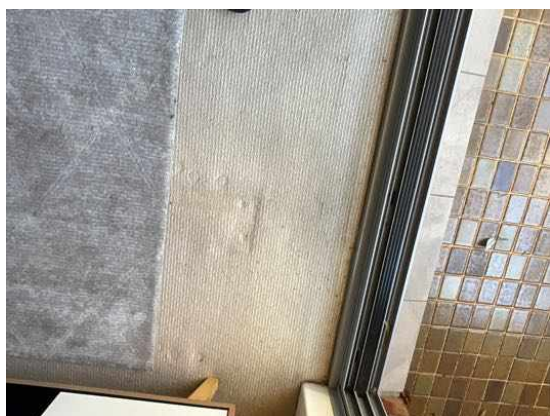
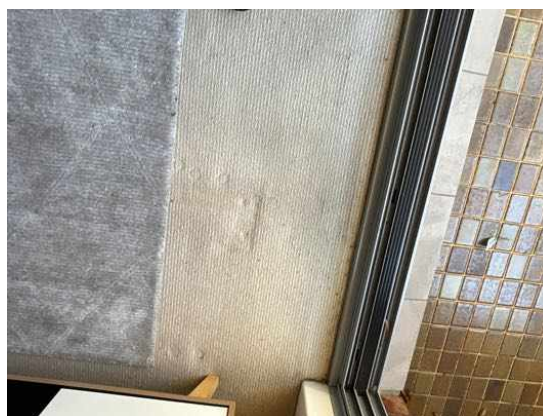
Defects 3.02

Building:	Main Building
Location:	All Areas
Finding:	carpet exhibits visible signs of aging
Information:	Carpets are exhibiting visible signs of aging, including fraying edges, faded colors, and

flattened fibers, diminishing their aesthetic appeal and functional quality.

The risk associated with aging carpets includes diminished appearance, decreased comfort, potential tripping hazards due to frayed edges, and a negative impact on indoor air quality if fibers begin to degrade and release particles into the air.

Professional carpet cleaning and restoration services can address issues such as deep cleaning to rejuvenate colors, repairing frayed edges, and restoring fibers. Additionally, replacing the carpets entirely may be necessary in severe cases of aging or damage beyond repair.

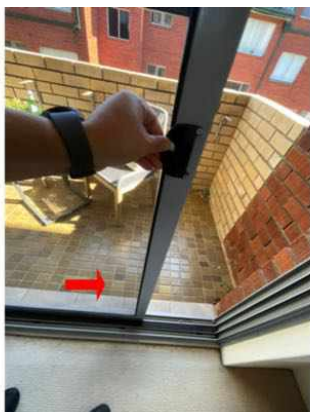
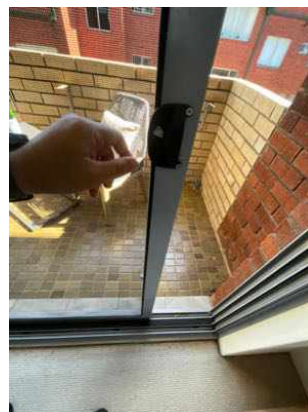
Defects 3.03

Building:	Main Building
Location:	Living Room
Finding:	Door - stiff to slide
Information:	The door to this area was difficult to operate at the time of inspection. This is likely due to damaged wheels which help the door to operate in a smooth fashion.

Doors provide ventilation and exits to the adjoining area and should be at a fully

operational level to ensure user comfort and safety. Restricted function of the door may also pose as a potential safety hazard if required for emergency egress from the building.

Generally, factors such as general age of the building element and a lack of maintenance are the usual causes for this type of defect.

Replacement of door running hardware may be required, as well as minor repairs and cleaning. A registered builder or general handy person will be required to repair the sliding door.

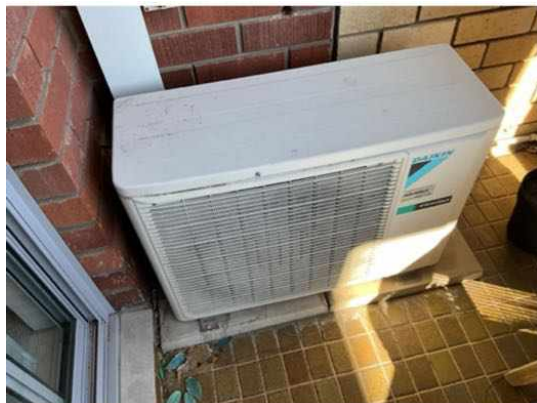
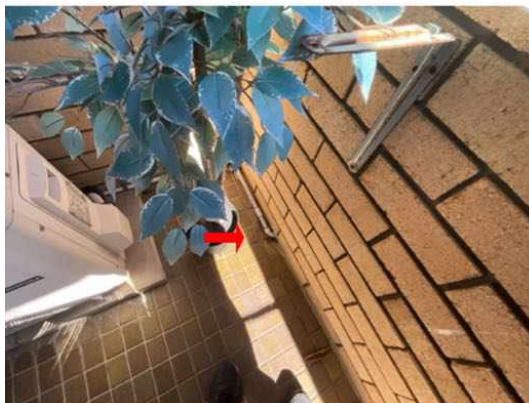
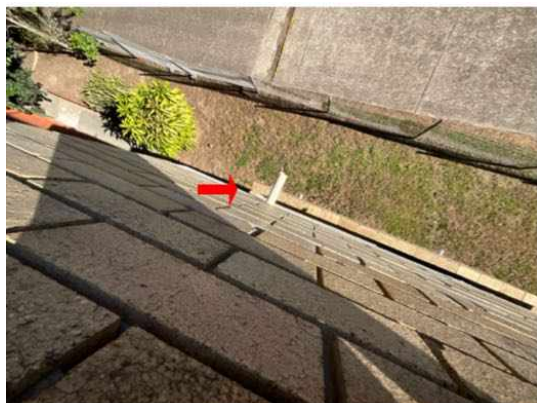
Defects 3.04

Building:	Main Building
Location:	Balcony
Finding:	Air conditioner - Disconnected overflow
Information:	The Air Conditioner (A/C) overflow was found to be disconnected from storm water drainage and is creating excessive moisture in the surrounding area.

Such leaking creates an environment which is conducive to an array of defects, including water damage to associated building elements and the attraction of termite or timber pest infestation.

It is highly recommended that a licensed plumber be appointed to connect the A/C overflow in order to prevent such an environment from being created. These minor works should be carried out as soon as possible.

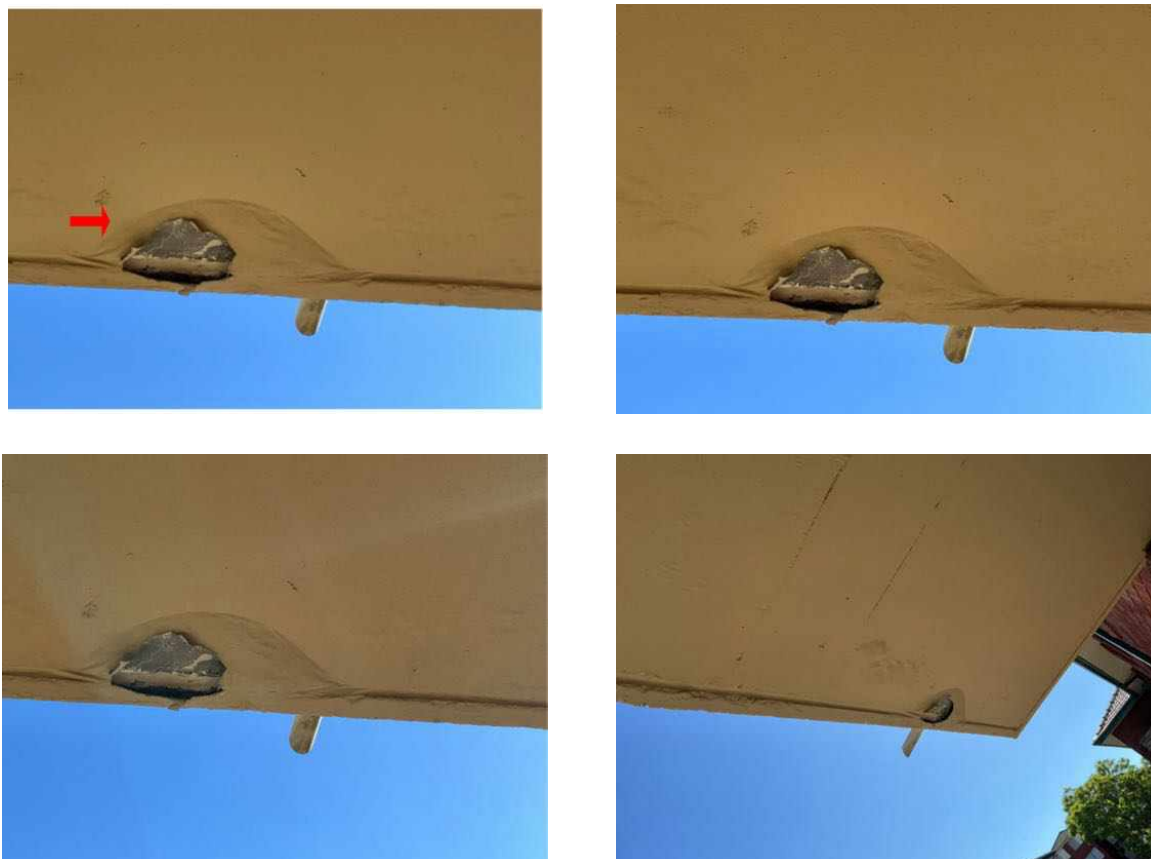
Defects 3.05

Building:	Main Building
Location:	Balcony
Finding:	Soffit- Water stained
Information:	Water staining to Soffit in this area was evident at the time of inspection. Water staining indicates that surfaces have been exposed to excessive moisture over time. The minerals and other elements in the water lead to staining, which may graduate to corrosion and deterioration if left unmanaged.

While mostly an appearance defect, water staining can be indicative of more serious defects, which may be currently concealed by interior ceilings.

Where water staining is active, a licensed plumber must be consulted to identify the cause of the staining and to provide advice on any reparation works that may be required. Replacement of any damaged structures is advised.

Conversely, where water staining is old and inactive, affected building materials may be repaired or replaced at client discretion.

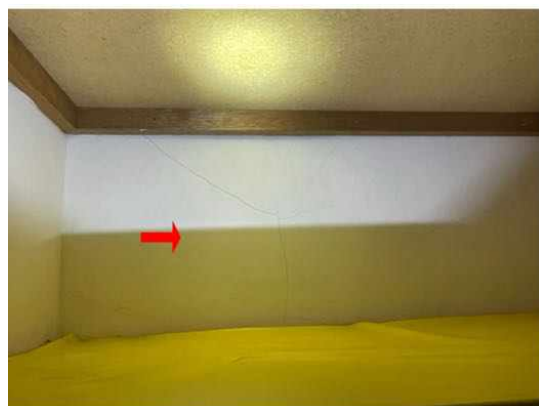
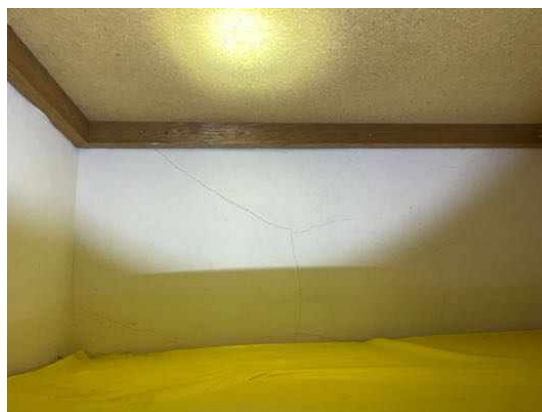
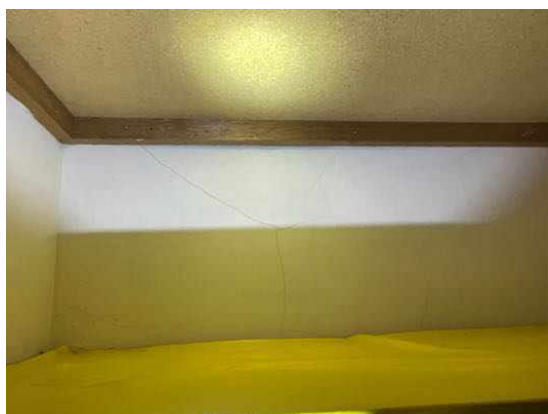
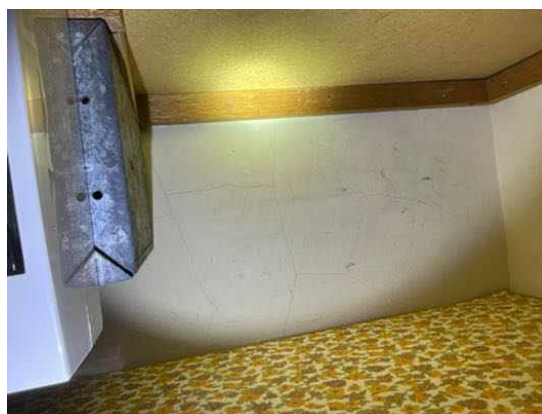
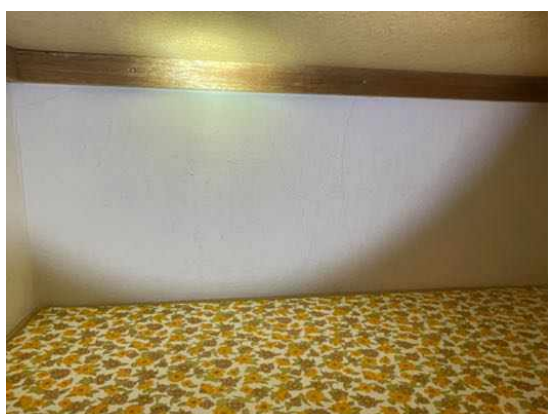
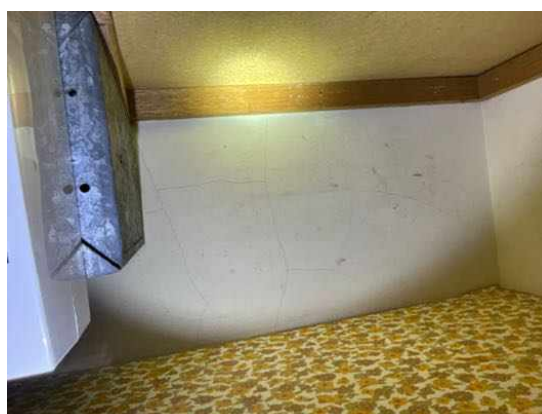
Defects 3.06

Building:	Main Building
Location:	Inside Cabinetry
Finding:	Brickwork - Cracking [Fine]
Information:	<p>Although fine cracks are quite noticeable, they are often only considered to be an appearance defect and usually do not indicate any structural damage. Generally, the cause of a fine crack is indicative of a separation between brickwork and mortar throughout the structure, but single bricks may also show cracks of this nature.</p> <p>Cracking of this nature can generally be repaired with minor filling and should be conducted by a qualified bricklayer.</p> <p>Always contact a building inspector should cracks widen lengthen or become more numerous.</p>

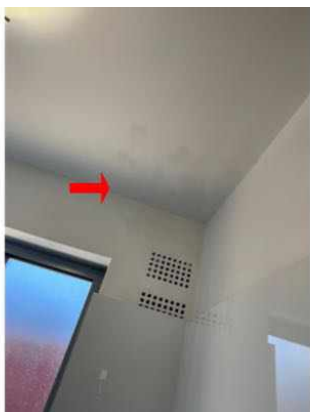
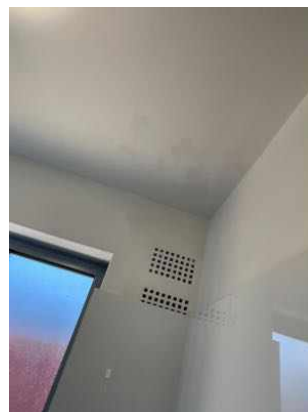
Defects 3.07

Building: Main Building

Location: Bathroom

Finding: Water staining

Information: Water staining was evident in this area at the time of inspection. Water staining indicates that surfaces have been exposed to excessive moisture over time. The minerals and other elements in the water lead to staining, which may graduate to corrosion and deterioration if left unmanaged.

While mostly an appearance defect, water staining can be indicative of more serious defects, which may be currently concealed by other building elements.

Where water staining is active, a licensed plumber must be consulted to identify the cause of the staining and to provide advice on any reparation works that may be required. Replacement of any broken or damaged structures is advised.

Conversely, where water staining is old and inactive, affected building materials may be repaired or replaced at client discretion. A qualified carpenter or registered builder may be appointed to perform these works.

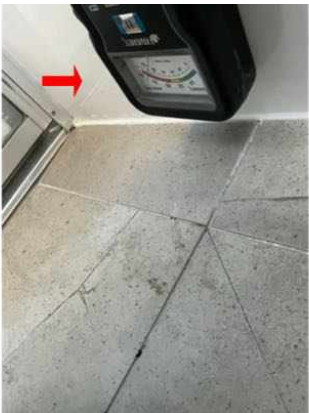
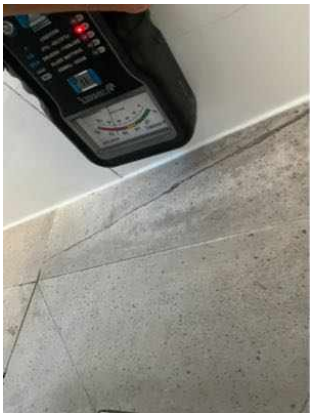
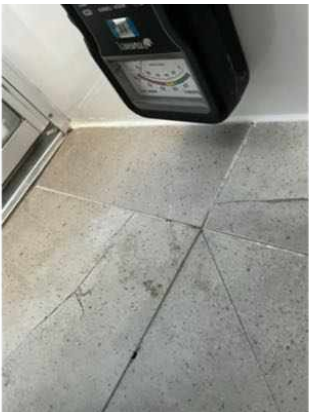
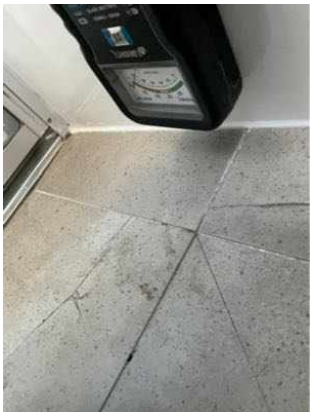
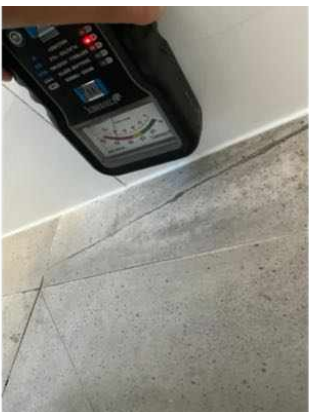
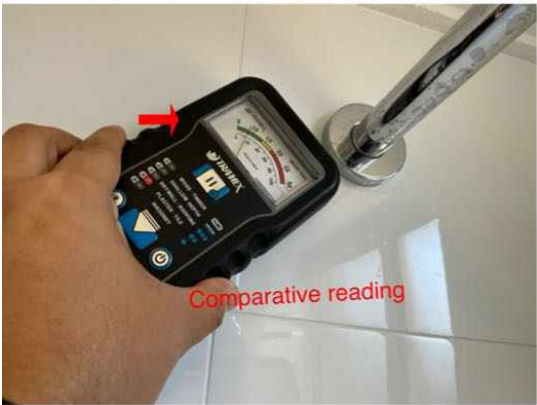
Defects 3.08

Building:	Main Building
Location:	Bathroom
Finding:	Shower - Damp
Information:	Damp is evident to the lower 300mm of wall to the shower alcove. This defect is quite common, and is suspected to have been caused by moisture permeating through the grouting in this area, which shows evidence of deterioration. Leaking pipes within the adjoining wall is also a possible cause.

Damp (or structural damp) refers to the presence of unwanted moisture in the structure of a building, either as the result of intrusion from outside, or condensation from within the structure. In the shower area, internal water leaks or other sources of excessive moisture are generally the cause of damp.

Unmanaged damp in the shower recess is likely to facilitate the formation and development of mould and fungi growth, decaying associated building materials and compromising their structural integrity. It is important to address damp conditions, as the World Health Organisation notes that excess moisture leads - on almost all indoor materials - to growth of microbes such as moulds, fungi and bacteria, which subsequently emit spores and other matter into the indoor air. Exposure to these contaminants is associated with a wide range of respiratory and other health-related problems.

Consultation with a qualified plumber or bathroom specialist is advised immediately to identify the cause of damp and to perform remedial works as required. Where excessive mould growth is present, further inspection by a specialist environmental

health inspector should also be considered.

Always ensure that sealant and grout is in good condition to prevent any moisture issues occurring in the future.

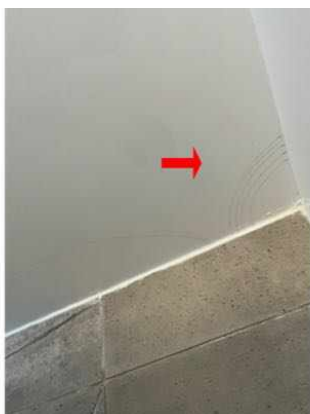
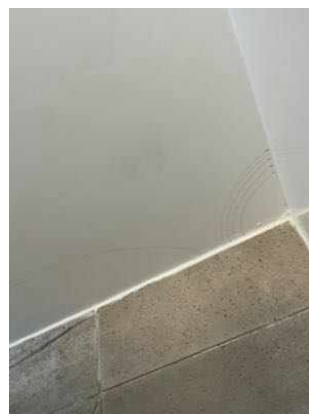
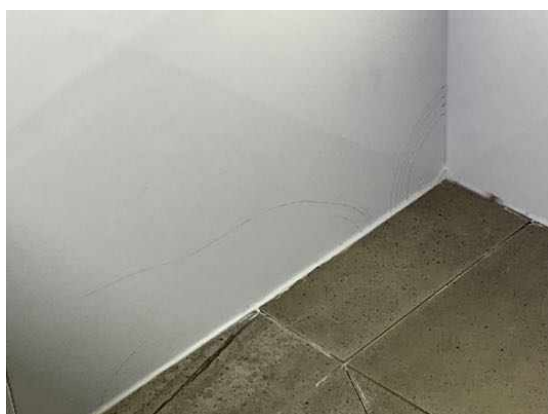
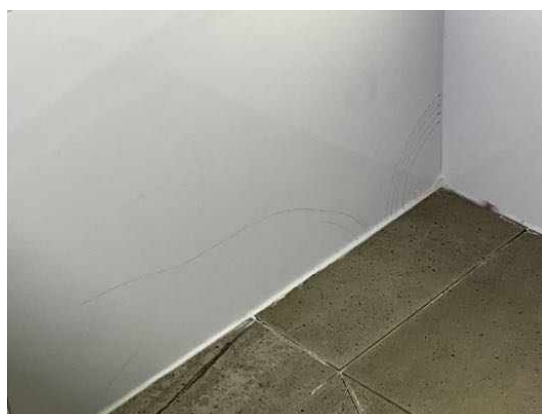
Defects 3.09

Building:	Main Building
Location:	Bathroom
Finding:	Tiles Visible surface scratches
Information:	Visible surface scratches were observed on the bathroom wall tiles,. While this is primarily a cosmetic defect, it can negatively impact the visual appeal and reduce the

durability of the tile glaze over time.

A qualified tiler or handyman should assess the extent of the damage. Minor scratches may be polished or concealed with appropriate tile repair products, while deeper scratches may require tile replacement to restore the original finish. Consider installing a protective hose holder to prevent future damage.

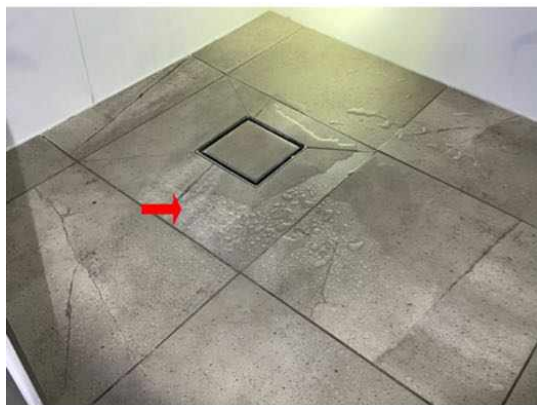
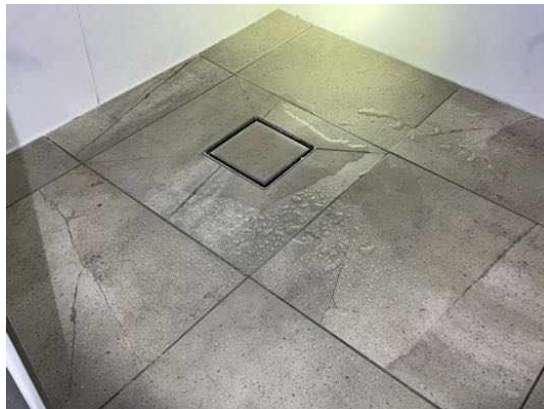
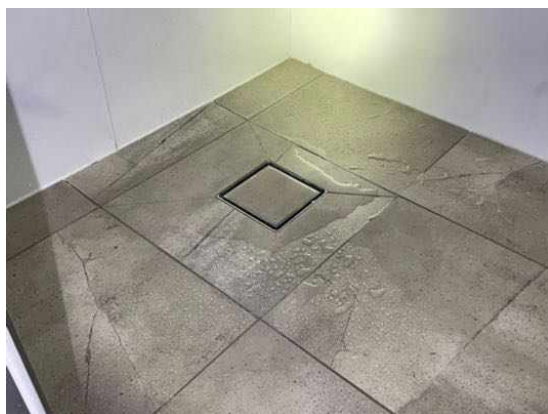
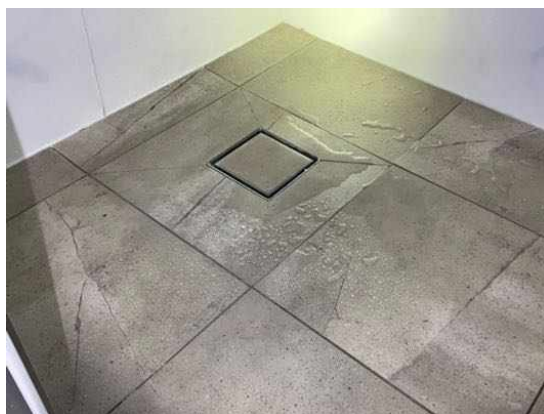
Defects 3.10

Building:	Main Building
Location:	Bathroom
Finding:	Shower base - Water pooling
Information:	Evidence of water pooling around the floor waste in the shower recess was noticed at the time of inspection. It is suspected that this excessive moisture is attributed to insufficient fall in the shower floor tiles.

This pooling is minor overall but is still considered unsatisfactory, as standard tiling practices would not permit this situation to occur. Pooling water around floor wastes can create a slip hazard in extreme cases and create conditions that are conducive to mould growth over time. Where left unmanaged, the degradation of sealant and grouting is also likely to occur, possibly necessitating further repair works.

Remedial works may involve some sections of tiling and flooring repair and replacement. A tiling contractor or bathroom specialist should be appointed to provide further advice on reparation options and to perform works as necessary.

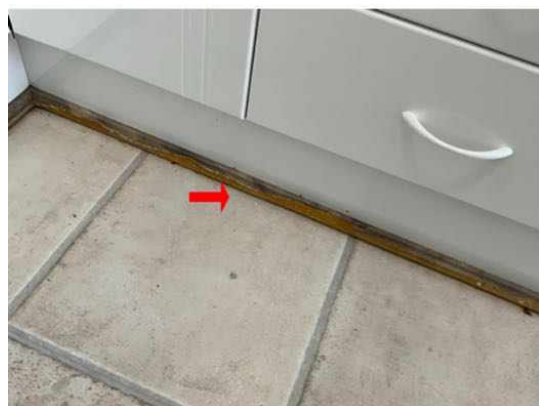
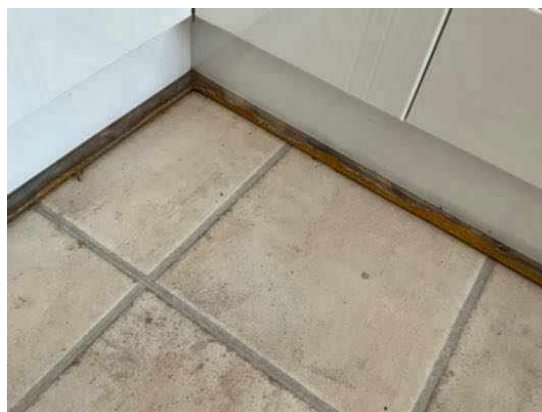
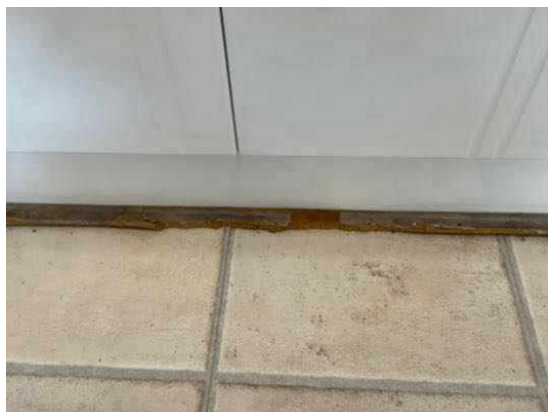
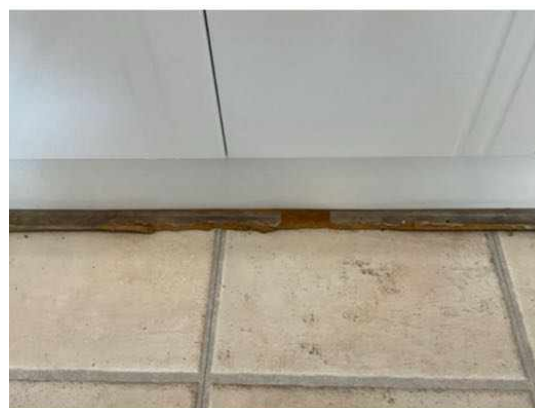
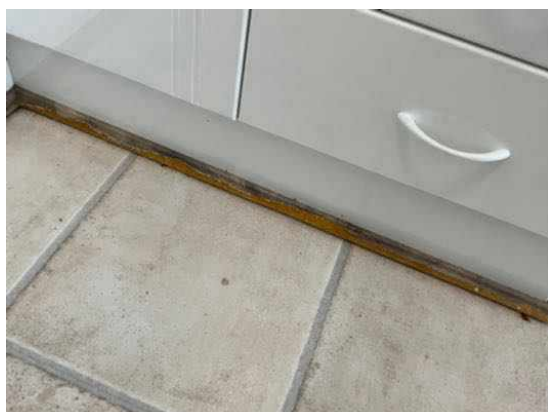
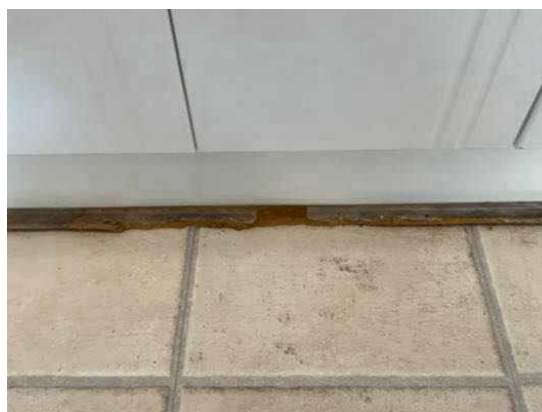
Defects 3.11

Building:	Main Building
Location:	Kitchen
Finding:	Trim – Deteriorated
Information:	Deterioration and delamination were noted to the trim, consistent with moisture exposure. Ongoing deterioration may occur if not rectified. Repair or replacement by a licensed carpenter is recommended.

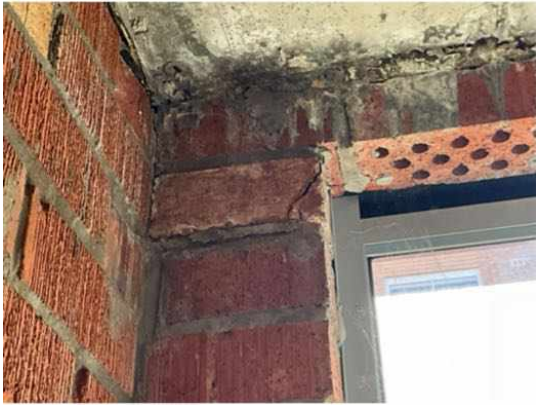
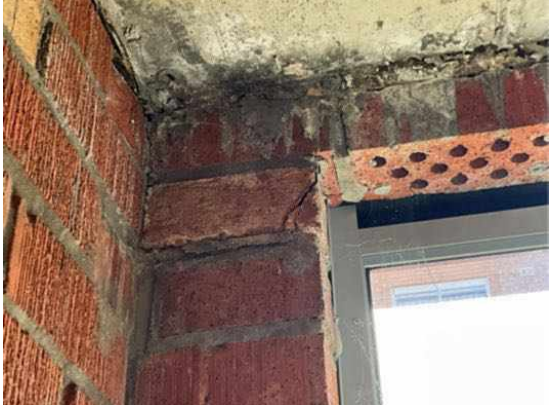
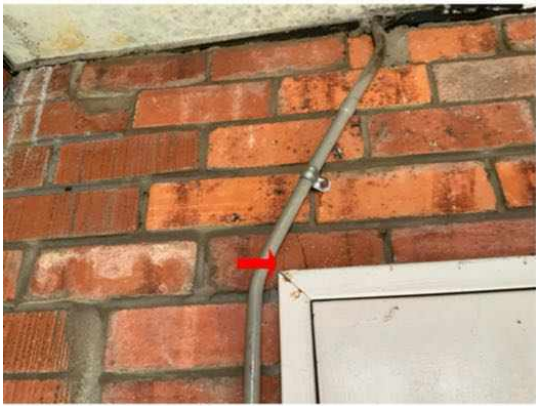
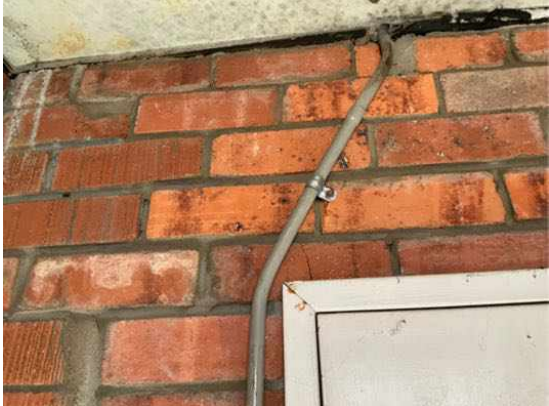
Defects 3.12

Building: Main Building

Location: Store Room

Finding: Brickwork - Cracking [Fine]

Information: Although fine cracks are quite noticeable, they are often only considered to be an appearance defect and usually do not indicate any structural damage. Generally, the cause of a fine crack is indicative of a separation between brickwork and mortar throughout the structure, but single bricks may also show cracks of this nature.

Cracking of this nature can generally be repaired with minor filling and should be conducted by a qualified bricklayer.

Always contact a building inspector should cracks widen lengthen or become more numerous.
