Building and Timber Pest Inspection Report

Inspection Date: Sat, 7 Mar 2026

Property Address: 1 Mayo Ct, Golden Square VIC 3555,
Australia

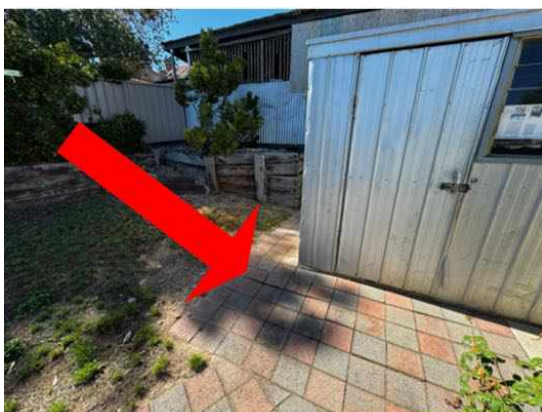
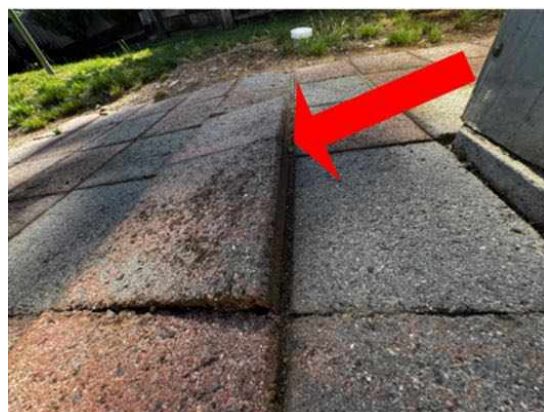
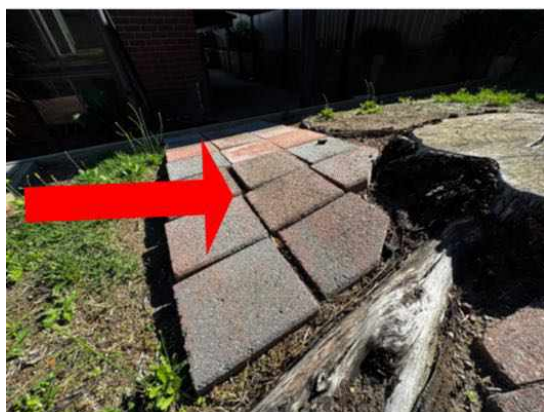
Building: Main Building
 Location: Yard - Back > Rear
 Finding: Safety Hazards – Rear Yard Paving and Decking
 Information: Safety hazards were observed in the rear yard area during the inspection. Sections of paving were found to be uneven, with some pavers noticeably lifted above the surrounding surface. This condition presents a trip hazard for occupants and visitors when walking through the area.

In addition, a makeshift timber decking and boardwalk structure was observed in the rear yard. This structure appeared to be of do-it-yourself construction, and some balustrade sections were found to be broken. Damaged balustrade components creates a potential fall hazard, as the decking area is elevated above the surrounding ground level.

In accordance with the defect definitions outlined in AS 4349.1-2007, conditions that present a risk of injury to occupants or visitors are considered Safety Hazards.

Sections of paving in the rear yard were uneven, with some pavers significantly lifted above surrounding levels, creating a trip hazard for occupants and visitors.

A makeshift timber decking and boardwalk structure was observed in the rear yard. Several balustrade sections were broken or missing from the top rail, creating a potential fall hazard where the deck is elevated.

It is recommended that the uneven paving be lifted and relaid or otherwise rectified to provide a level walking surface. The decking and boardwalk structure should be assessed for structural integrity, including reinstating the missing or damaged balustrade sections to restore adequate edge protection.

Immediate, as these conditions present potential trip and fall hazards to occupants and visitors.

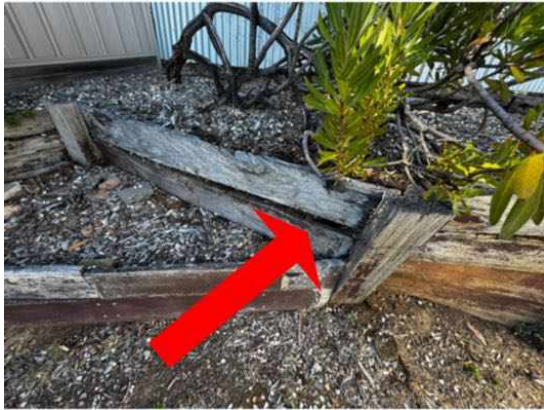
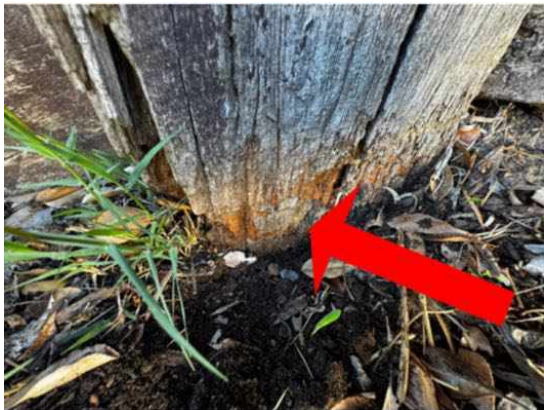
Finding 2.01

Building:	Main Building
Location:	Retaining Walls > Front,Rear
Finding:	Deteriorated Timber Retaining Wall Structures
Information:	Timber retaining walls located to both the front and rear yards of the property were found to be heavily deteriorated, with visible timber rot and decay affecting the structural integrity of the retaining elements.

At the front of the property, a timber retaining wall adjacent to the driveway along the left-hand boundary side was observed to have partially collapsed sections. The retaining wall in this area was approximately 600 mm in height, and a section of the garden bed that should have been retained by this structure was observed to have failed and no longer existed, indicating loss of structural support to the retained soil.

At the rear boundary of the property, a second timber retaining wall retaining an elevated garden bed was observed to be approximately 800 mm in height. This retaining structure was found to be significantly deteriorated, with extensive timber rot and decay visible to the retaining timbers. The condition of the wall suggests that it is approaching structural failure and may collapse if not rectified.

In accordance with the definition of defects under AS 4349.1–2007 (Inspection of Buildings), deterioration of structural elements that affects their structural performance or serviceability is considered a Major Defect.

Timber retaining walls to the front and rear yards were found to be heavily deteriorated with timber rot and decay. The front retaining wall (approximately 600 mm high) adjacent to the driveway had partially collapsed sections, and a section of the retained garden bed had already failed. The rear retaining wall (approximately 800 mm high) supporting an elevated garden area was also significantly deteriorated and approaching structural failure. These retaining walls require replacement or reconstruction.

It is recommended that the affected retaining walls be assessed and replaced or reconstructed by a suitably qualified contractor. Consideration should be given to using durable retaining materials such as treated structural timber, concrete sleepers or masonry retaining systems designed to withstand soil loads and moisture exposure.

Immediate, as the retaining walls are structurally compromised and may continue to deteriorate or collapse, potentially causing soil movement and further damage to surrounding landscaping areas.

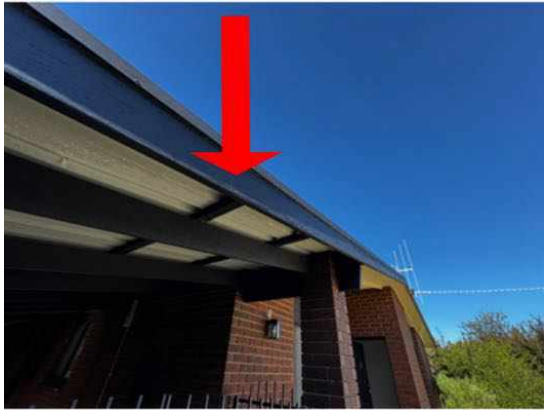
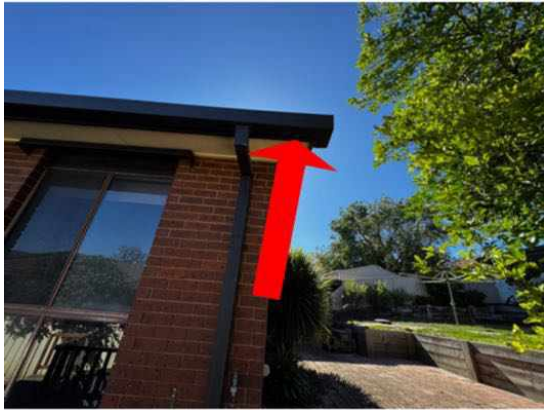
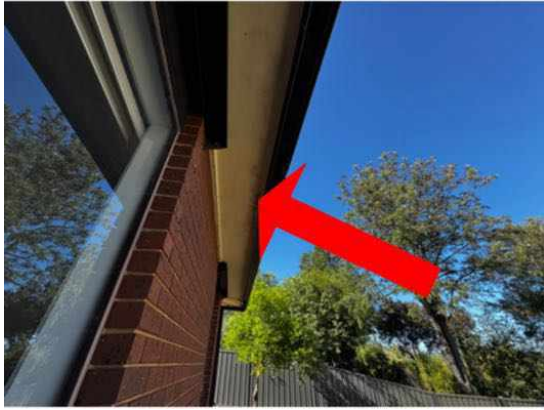
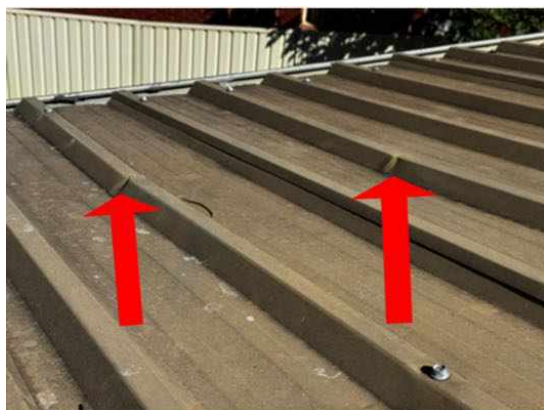
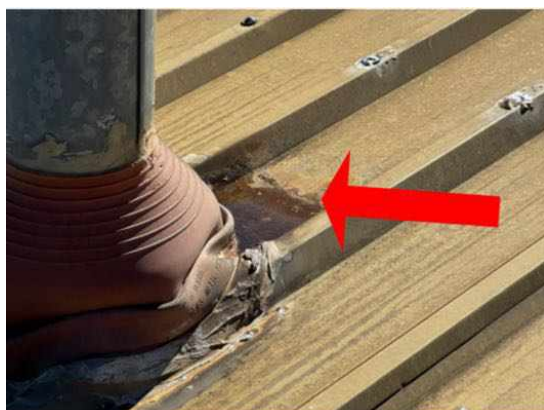
Finding 3.01

Building: Main Building
Location: All Areas > All Areas
Finding: External Building Defects
Information: Several minor defects were observed to the external elements of the building during the inspection. A cracked concrete step was observed at the main entrance to the building. The crack appears to have occurred as a result of drilling or fastening of pipework to the face of the step and does not appear to be structural in nature.

The timber fascia to the front elevation of the building was observed to be aged and weathered, however the deterioration appears to have been recently concealed with paint. While this improves the appearance, the underlying timber may continue to deteriorate if not properly maintained.

The roof gutter to the rear elevation of the building was observed to be slightly separating from the fascia, leaving a minor gap which may allow water to discharge behind the gutter during rainfall events.

Mould and moisture staining were observed to the eave linings on the right-hand rear side of the building. No immediate roof defects were observed above this area at the time of inspection. The staining is suspected to be associated with historical gutter blockages or previous water overflow events. A further possible contributing cause may be the separation of the roof gutter from the fascia/eave in this section, which could allow rainwater to escape behind the gutter and contribute to moisture staining and mould growth on the eave lining.

Additional defects observed during the inspection included damaged window sill tiles to a bedroom window, rusting cladding to the external shed, and a broken shed door. Minor dents were also observed to some roof sheets. Water pooling was observed around a roof penetration flashing, suggesting that the flashing may have been poorly installed, allowing water to accumulate around the penetration.

In accordance with AS 4349.1–2007, these issues are considered Minor Defects as they are generally maintenance-related and do not appear to significantly affect the structural performance of the building at the time of inspection.

It is recommended that the affected external elements be repaired and maintained by a licensed builder or appropriate tradesperson. Maintenance should include repairing the concrete step if required, securing the rear roof gutter to the fascia, addressing mould staining to eaves, repairing shed elements, and rectifying the roof penetration flashing to ensure proper water shedding.

Maintenance recommended in the short to medium term to prevent further deterioration of building elements.

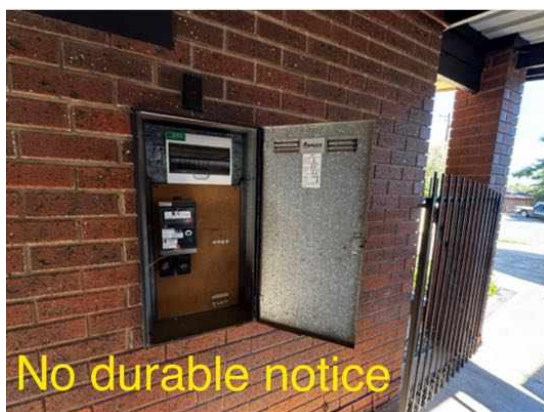
Building: Main Building
 Location: Meter Box > All Areas
 Finding: Termite management system - no evidence of chemical installation (TP)
 Information: At the time of inspection, there was no visible evidence to suggest that a chemical termite management system has been installed or remains effective. In addition, no durable notice was observed within the electrical switchboard to identify the presence, type, or date of any termite protection measures.

For this reason, the installation of a post-construction chemical termite management system is highly recommended to reduce the risk of termite activity. A durable notice should also be installed within the electrical switchboard to clearly identify the treatment provided and support ongoing inspection and maintenance.

Engagement of a licensed termite management or pest control contractor is recommended as a matter of priority to assess the site conditions, consider local termite risk, and determine the most appropriate treatment method and procedures for this property.

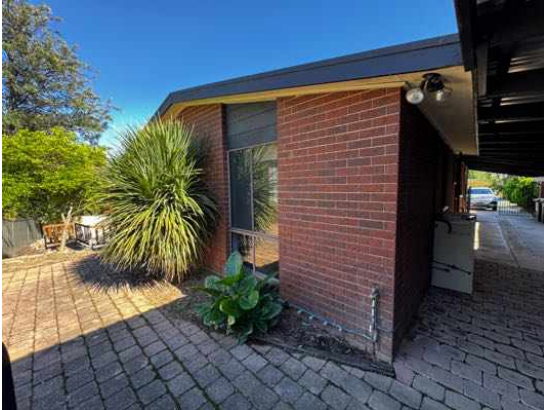
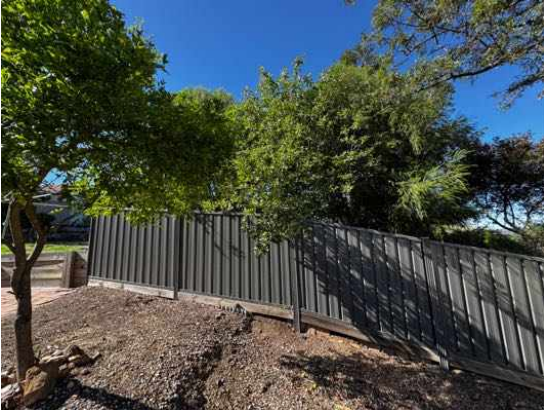
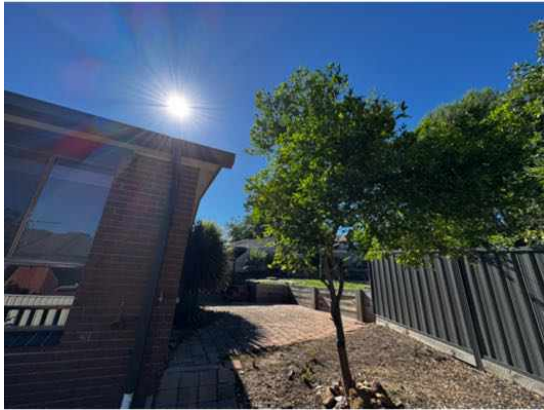
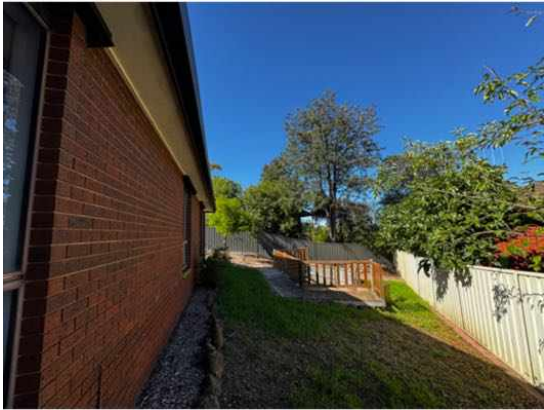
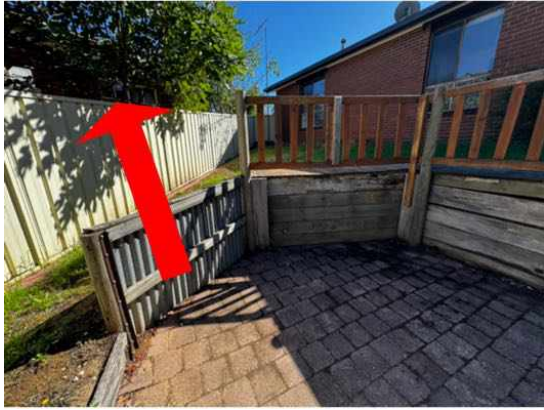
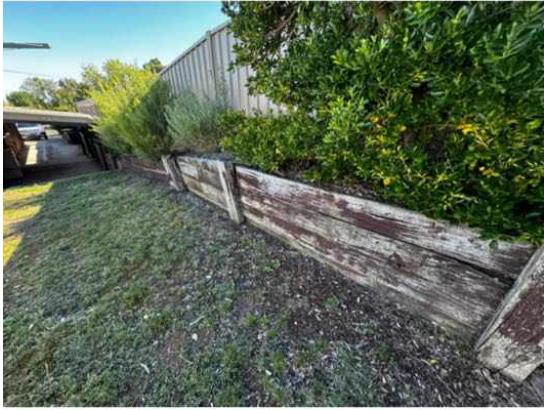
Finding 6.02

Building:	Main Building
Location:	All Areas > All Areas
Finding:	Landscaping & vegetation increasing termite risk (TP)
Information:	At the time of inspection, landscaping, vegetation and mulching was observed around the property, including multiple garden beds, shrubs and plants in close proximity to the dwelling and mature trees located along the outside boundary of the property.

Environmental conditions that promote moisture retention, provide concealed shelter, or support termite foraging activity are recognised as increasing termite risk to existing buildings. Mature trees, mulched garden beds, irrigation systems can all maintain damp soil conditions and may harbour termite colonies, allowing concealed termite activity to develop and potentially extend toward the building without early detection.

As a result, the extent of vegetation and moisture-retaining landscaping is considered to significantly increase the overall risk of termite activity to the property. It is recommended that a licensed termite management or pest control contractor be engaged to assess the site conditions and provide advice on appropriate risk reduction measures, which may include managing vegetation and mulch, controlling moisture sources, and integrating suitable termite management strategies appropriate for the existing building and site conditions.

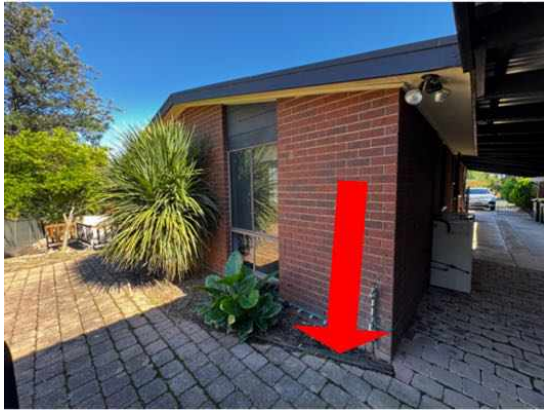
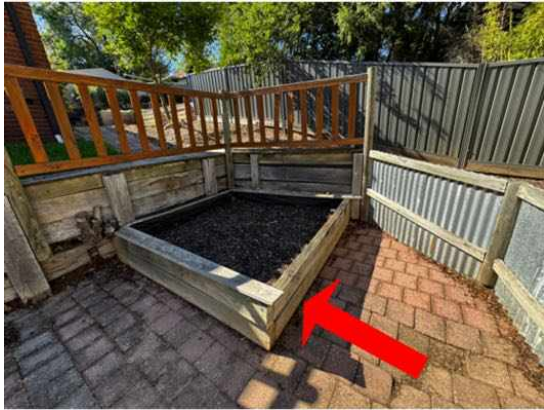
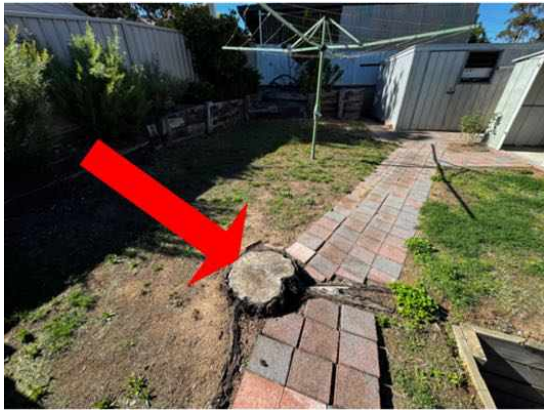
Finding 6.03

Building:	Main Building
Location:	All Areas > All Areas
Finding:	Inground timber contact (TP)
Information:	At the time of inspection, in-ground timber contact was observed to the front, side and rear yards, including timber garden edging, planter boxes, decking, timber retaining walls, and dead tree stumps all in direct contact with the ground. These timber elements are positioned within the soil zone and in close proximity to the building and associated structures.

In accordance with AS 3660.2, conditions that facilitate termite access or provide a direct food source are recognised as increasing the risk of termite activity to existing buildings. Timber elements in direct contact with the ground are particularly vulnerable, as they can attract subterranean termites and support concealed foraging activity, potentially allowing termite colonies to establish and migrate toward nearby structures without early detection.

As a result, the presence of in-ground timber elements is considered to increase the risk of termite activity to the property. It is recommended that a licensed termite management or pest control contractor be engaged to assess these conditions and provide advice on appropriate risk mitigation measures, which may include removal or replacement of timber elements with non-susceptible materials, isolation of timber from soil contact, and integration of suitable termite management measures to suit the existing site conditions.

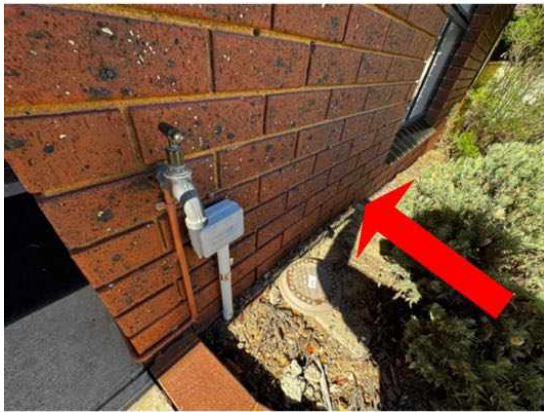
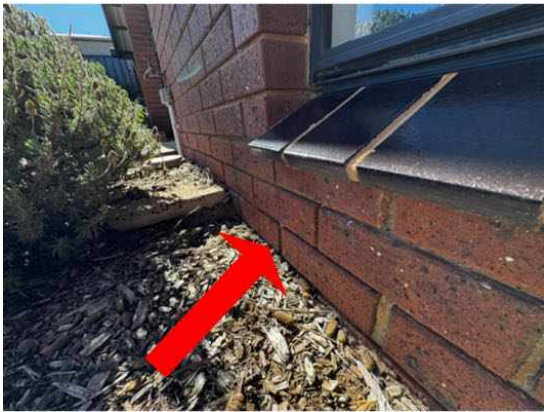
Finding 6.04

Building:	Main Building
Location:	All Areas > All Areas
Finding:	Slab edge - concealed (TP)
Information:	At the time of inspection, the slab edge to most areas of the building was observed to be concealed behind concrete paving and landscaping. This condition restricts clear visibility of the slab perimeter and limits the ability to visually inspect critical inspection zones intended for the early detection of termite activity.

Where slab edges and inspection zones are concealed, concealed termite entry paths may develop without early warning. In accordance with AS 3660.2, existing buildings are required to maintain conditions that allow for effective inspection and management of termite risk, noting that obstructions such as paving, paths, or landscaping can compromise the effectiveness of termite management measures. Where inspection zones are obstructed, the likelihood of undetected termite activity is increased.

As a result, the current configuration is considered to increase the risk of concealed termite entry to the building. It is recommended that a licensed termite management or pest control contractor be engaged to assess the extent of the concealed slab edges and provide advice on rectification options, which may include modifying paving or landscaping to reinstate suitable inspection access and integrating appropriate termite management measures to suit the existing conditions.

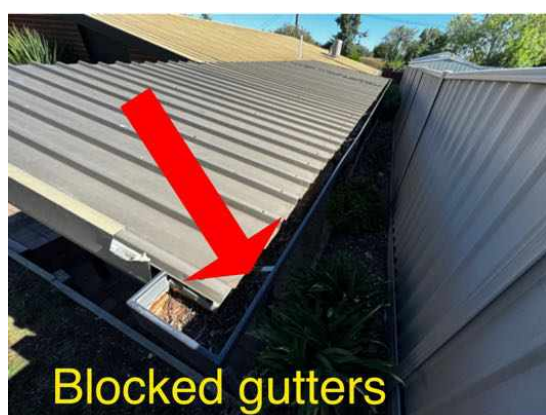
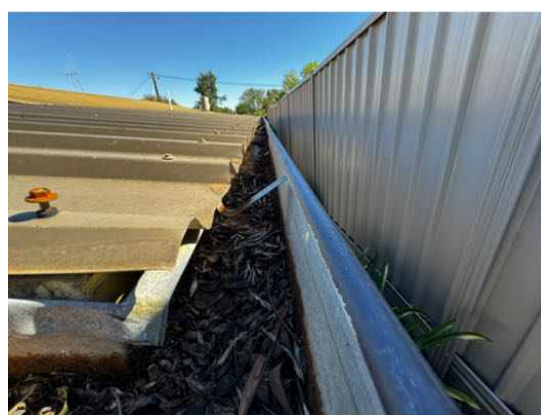
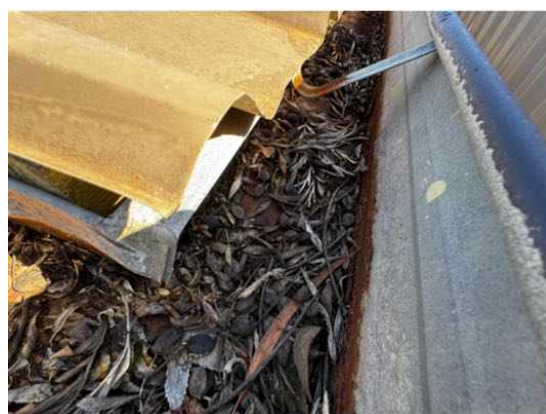
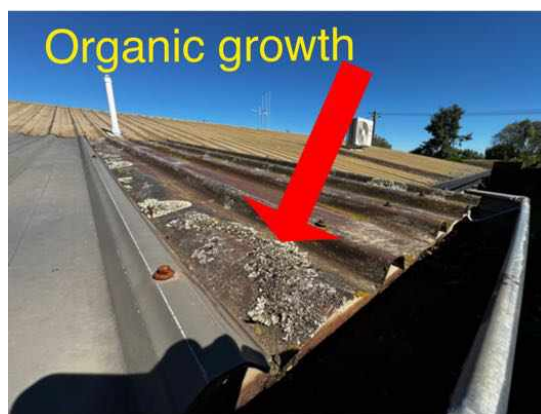
Finding 6.05

Building: Main Building
 Location: Pergola > Centre Left
 Finding: Blocked gutters and organic growth (TP)
 Information: At the time of inspection, organic debris and organic growth was observed to the pergola/carport roof areas, together with partially blocked gutters and downpipes. These conditions promote prolonged moisture retention and reduced effectiveness of roof drainage, the issue is suspected to be associated with a lack of routine maintenance.

In accordance with AS 3660.2, conditions that promote ongoing dampness, moisture

accumulation, or inadequate drainage are recognised as increasing termite risk to existing buildings, as elevated moisture levels can create environments conducive to termite foraging and concealed activity. Blocked gutters and downpipes may allow water to overflow or discharge against building elements, increasing moisture exposure to adjacent materials and reducing the effectiveness of termite risk management through visual inspection.

As a result, the observed organic debris and drainage issues are considered to increase moisture-related deterioration and elevate the overall risk of termite activity. It is recommended that an appropriately qualified roof plumber be engaged to clean and service the gutters and downpipes and that roof surfaces be maintained to reduce moisture retention, with ongoing monitoring and advice from a licensed termite management or pest control contractor where elevated termite risk is identified.

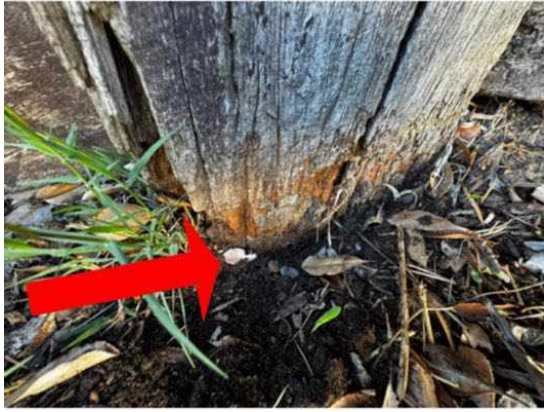
Building:	Main Building
Location:	All Areas > All Areas
Finding:	Timber decay & rot - Conducive conditions (TP)
Information:	At the time of inspection, timber decay and rot was observed to the front and rear retaining walls as well as to some garden edging to the rear yard.

These conditions are suspected to have developed over time due to prolonged moisture exposure and a lack of appropriate timber maintenance, allowing moisture ingress and decay to progress within the timber elements. In accordance with AS 3660.2, deteriorated and moisture-affected timber is recognised as increasing the risk of termite activity, as decayed timber can attract termites and may provide concealed access or harbourage, particularly where defects are obscured by finishes such as paint.

As a result, these conditions are considered to present an elevated risk of ongoing deterioration and potential termite susceptibility. It is recommended that an appropriately qualified builder or carpenter be engaged to further assess the extent of timber decay, remove any concealed deteriorated material, and undertake suitable repairs or replacement, with consideration also given to advice from a licensed termite

management or pest control contractor where termite risk is identified.
