Building Inspection Report

Inspection Date: Thu, 5 Feb 2026

Property Address: 6 Queenie Wy, Cranbourne West VIC 3977,
Australia

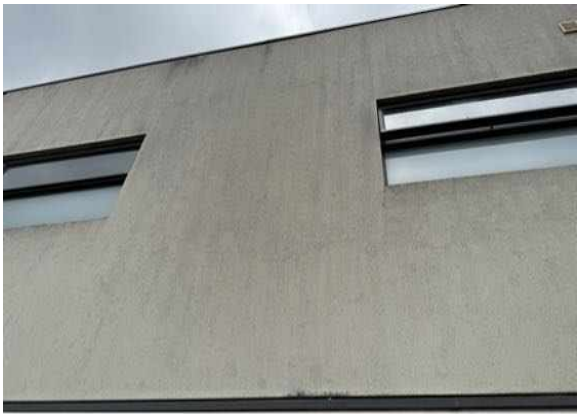
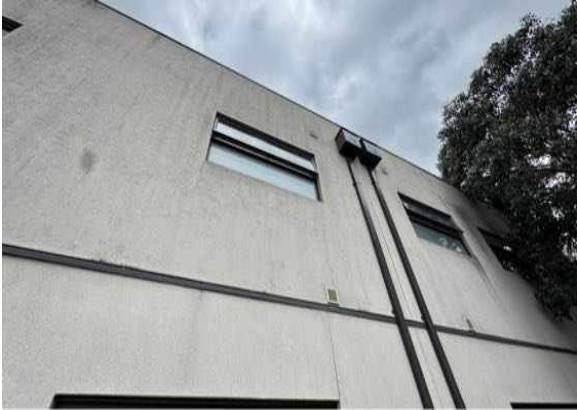
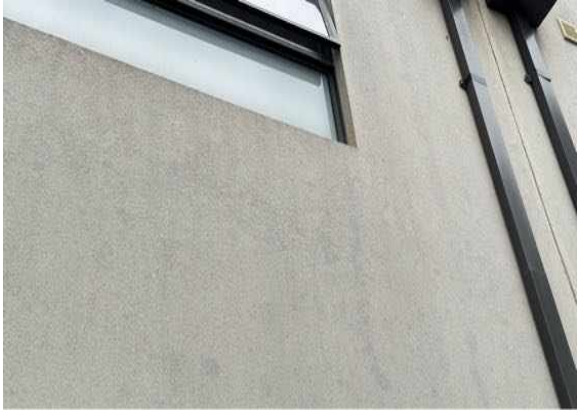
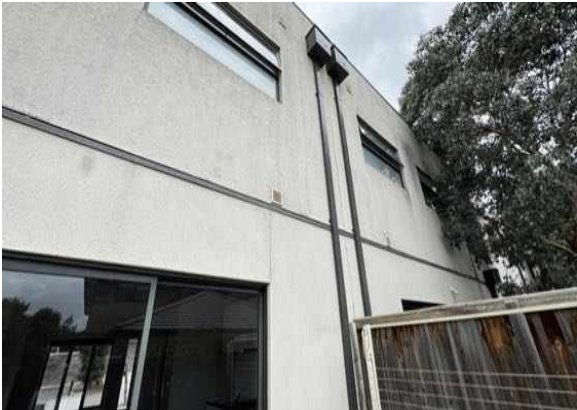
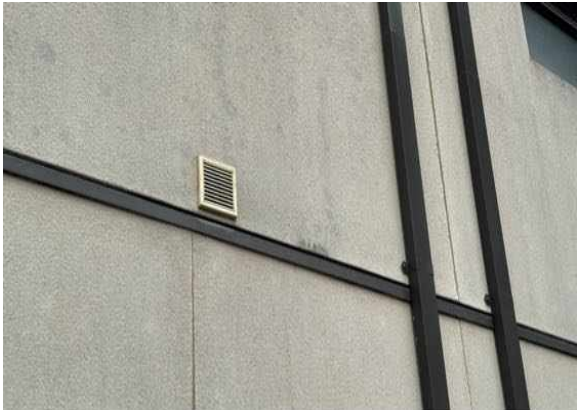
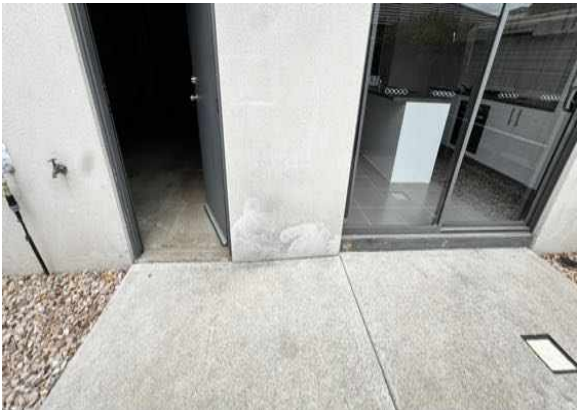
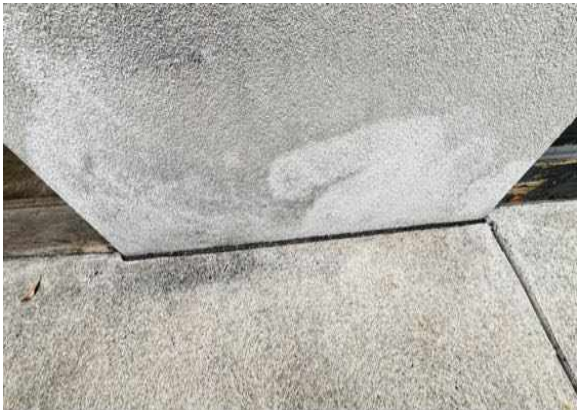
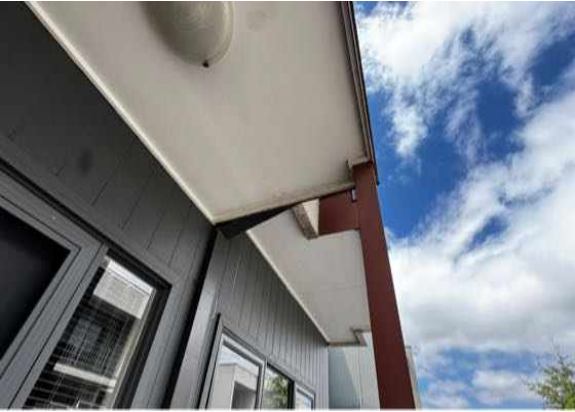
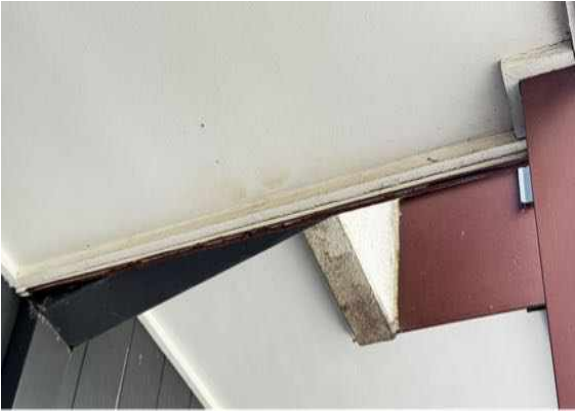
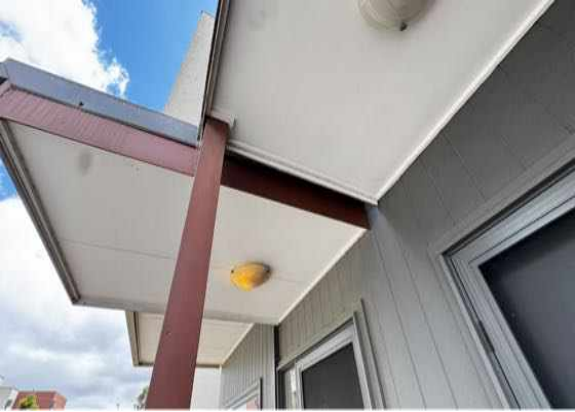
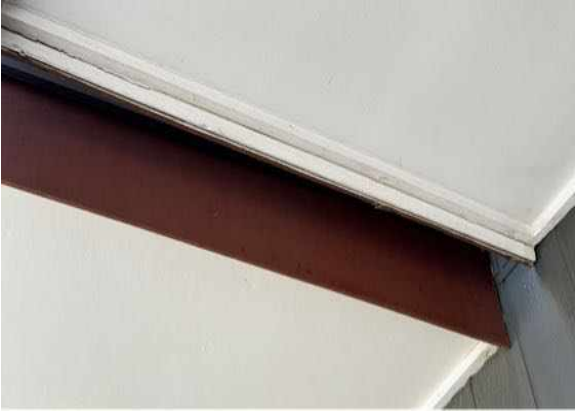
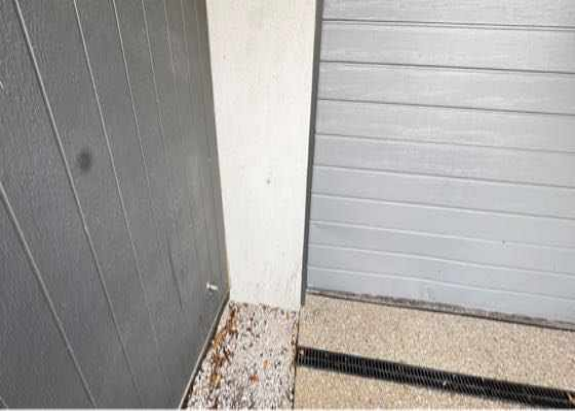
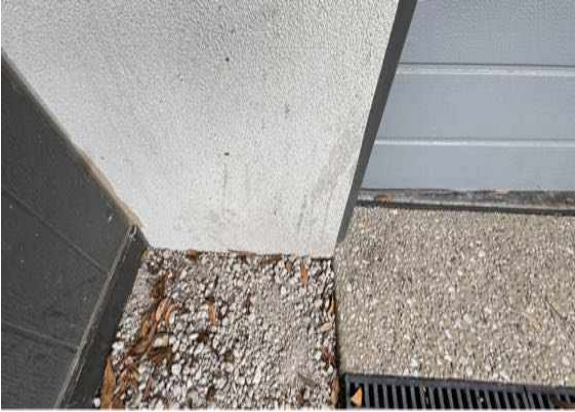
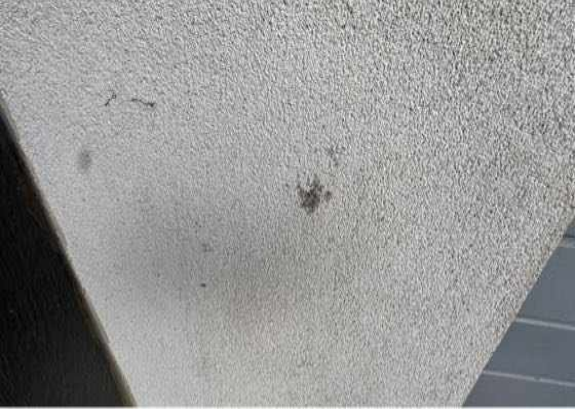
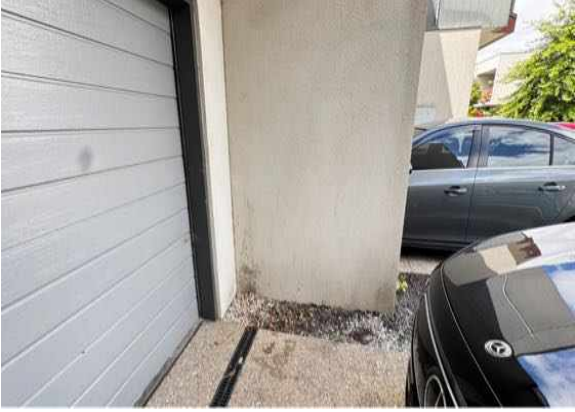
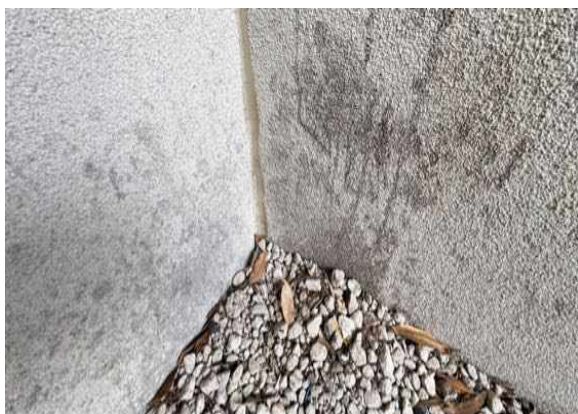
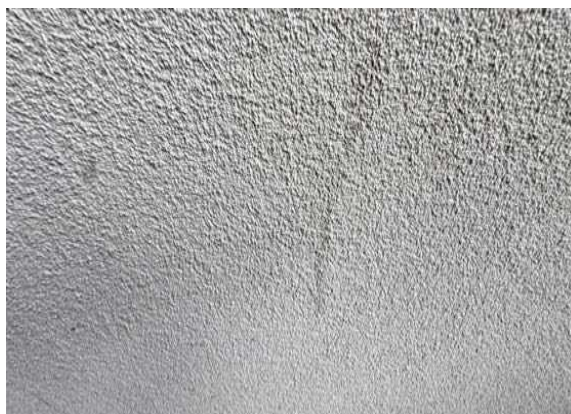
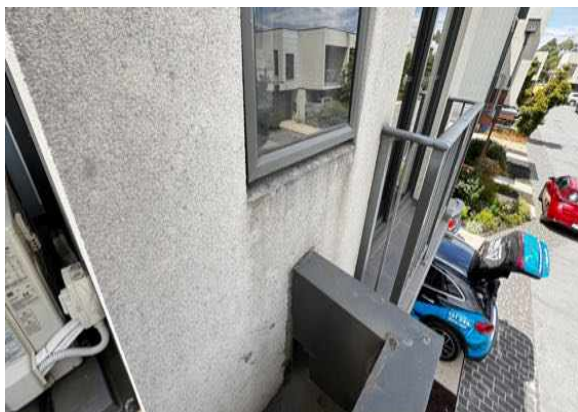
Defects 3.06

Building: Main Building
Location: All External Areas
Finding: External Walls - Paint Finishes Discolouration
Information: The external walls were inspected for paint and or surface condition, and discolouration was observed in this area.

While primarily a cosmetic issue, the affected areas may indicate age-related wear, poor surface preparation, or previous repairs.

When practical, a qualified painter should be engaged to prepare and repaint the affected areas. Addressing paint deterioration will improve the appearance of the ceilings and help protect the surfaces from further wear.

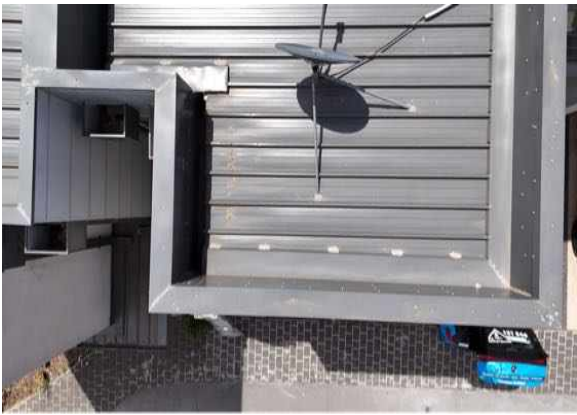
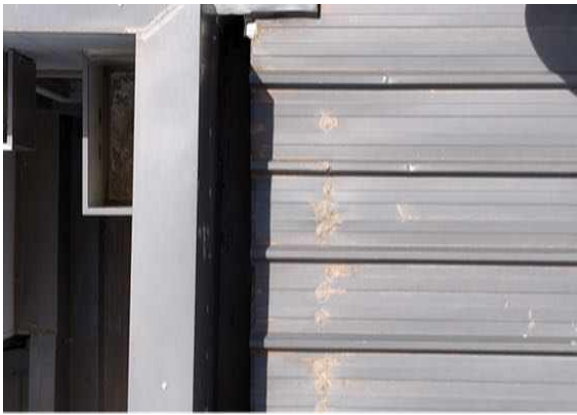
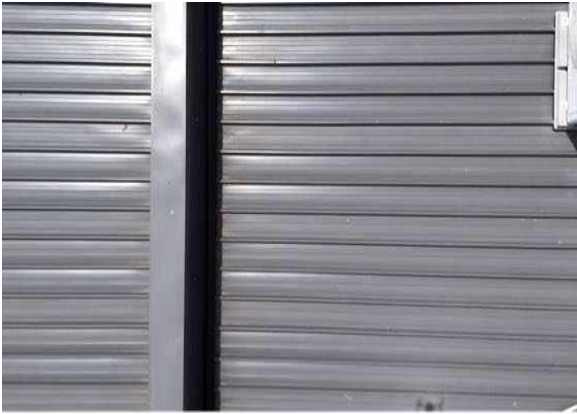
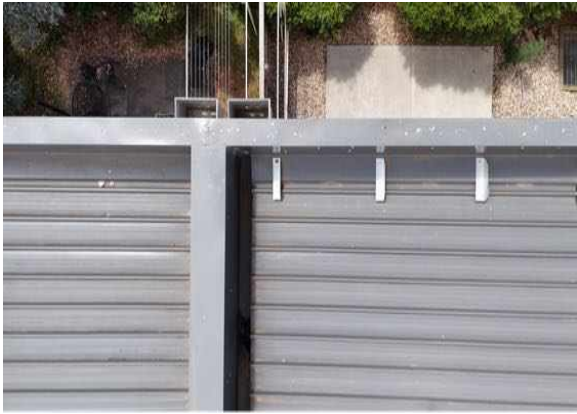
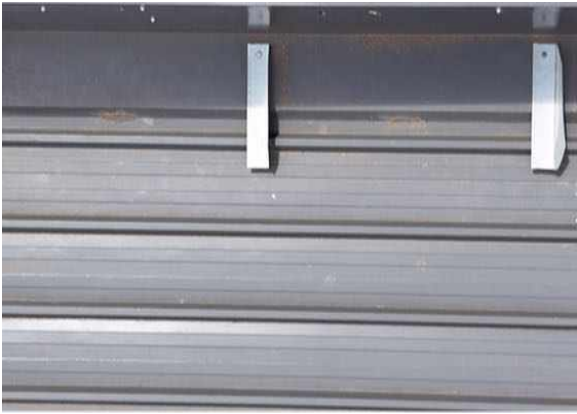
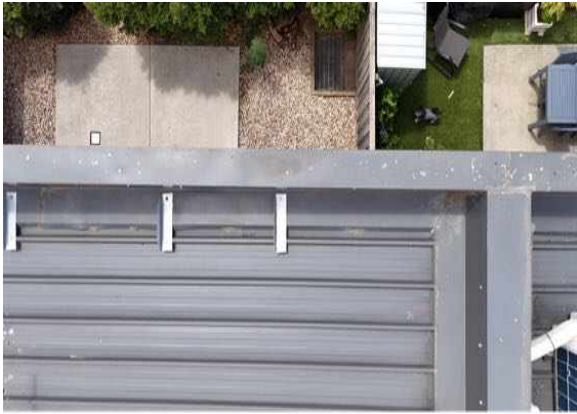
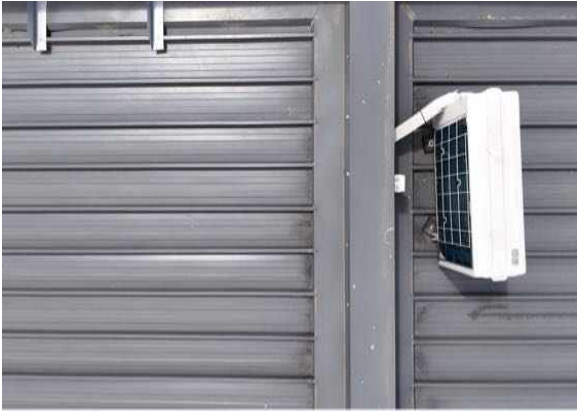
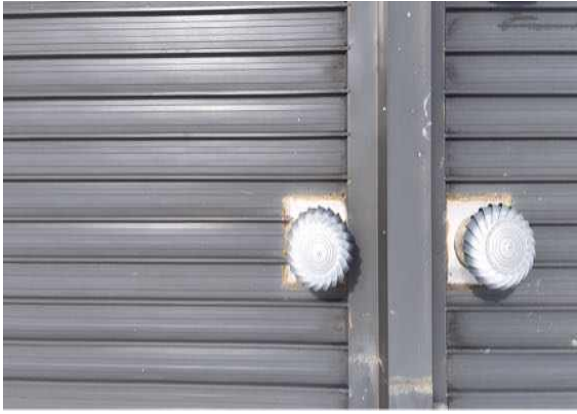
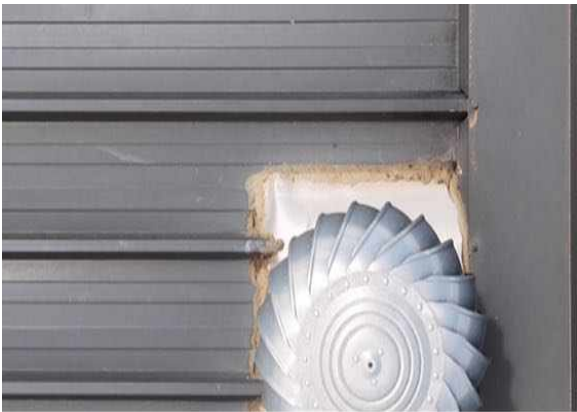
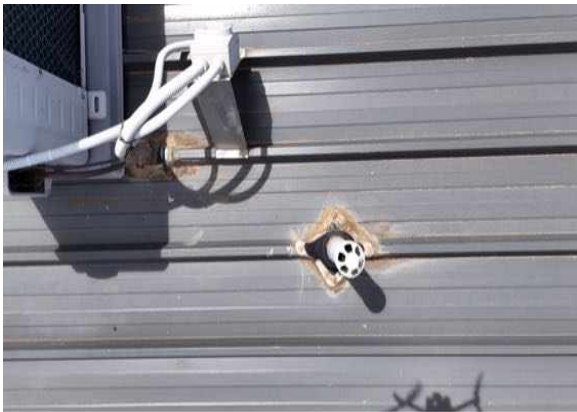
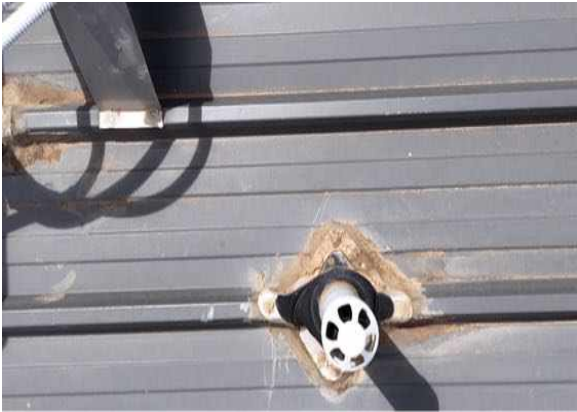
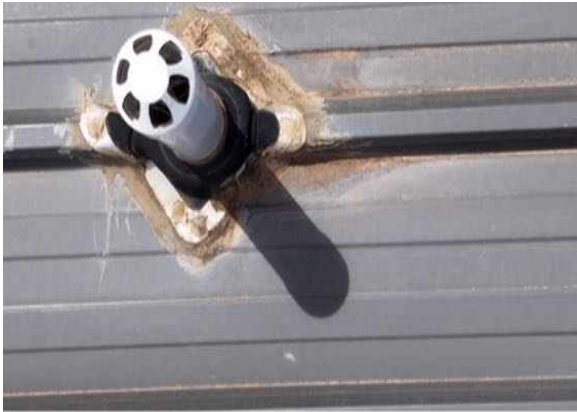
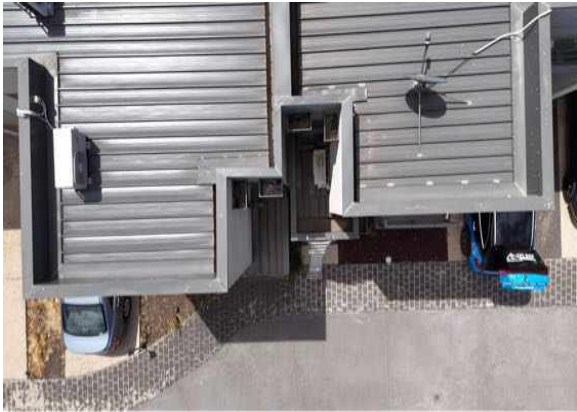
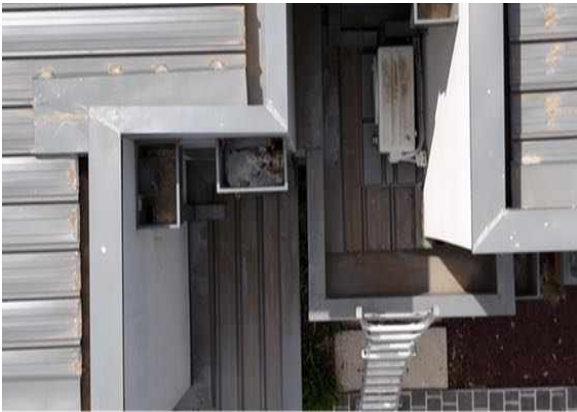
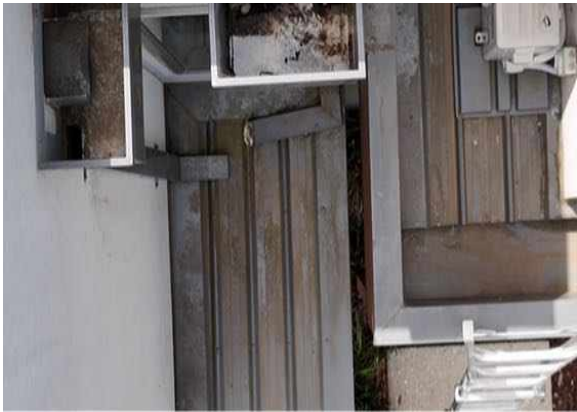
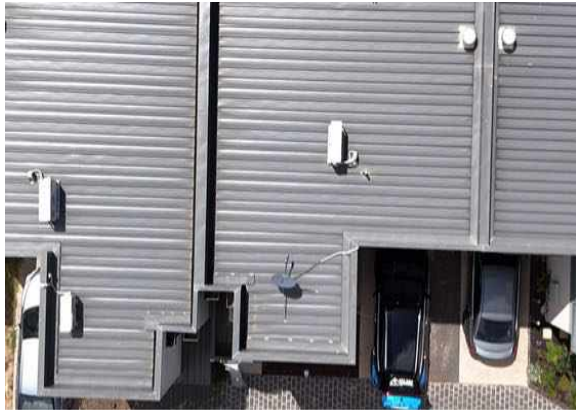
Noted Item

Building: Main Building
Location: All External Roofing Areas
Finding: Roof Plumbing - Images For Your Information
Information:

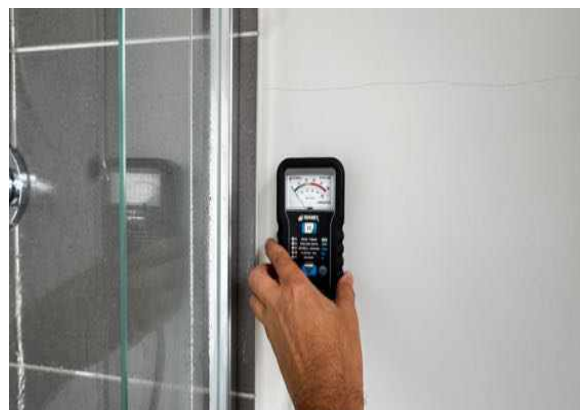
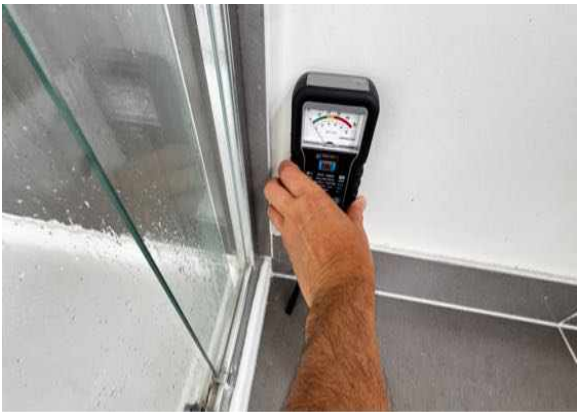
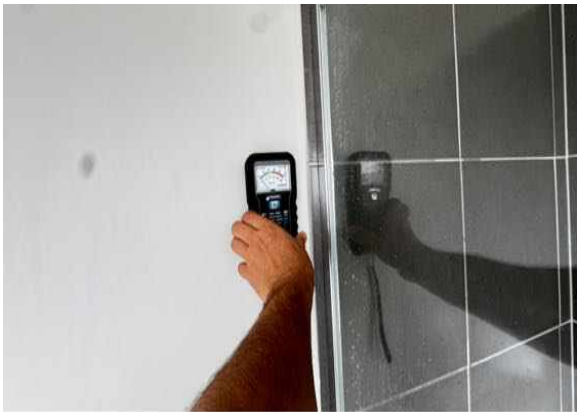
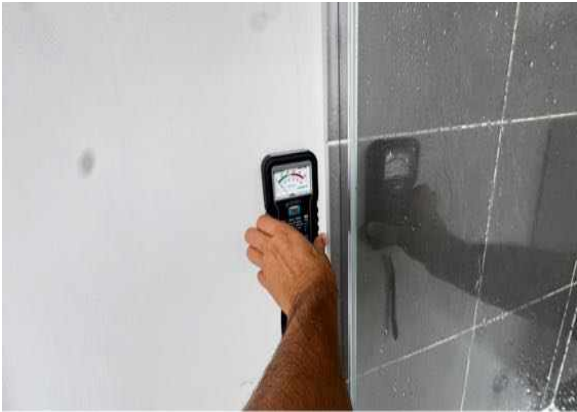
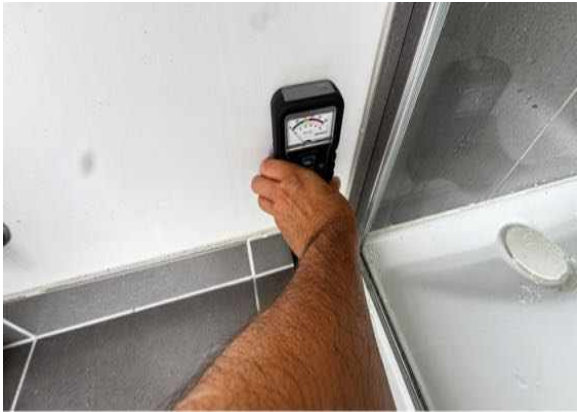
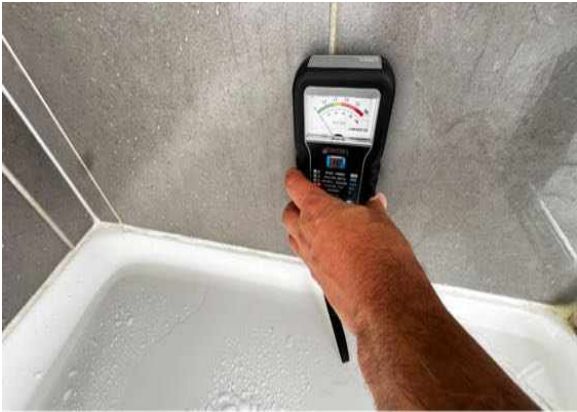
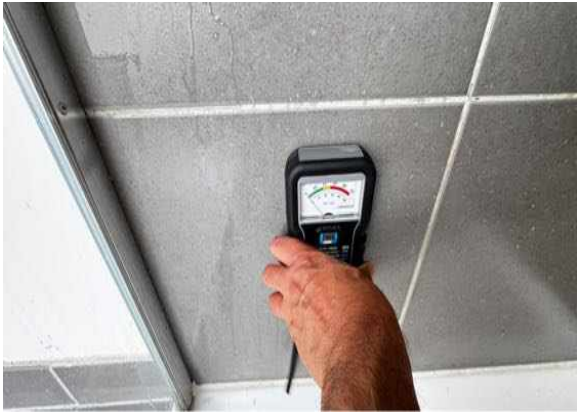
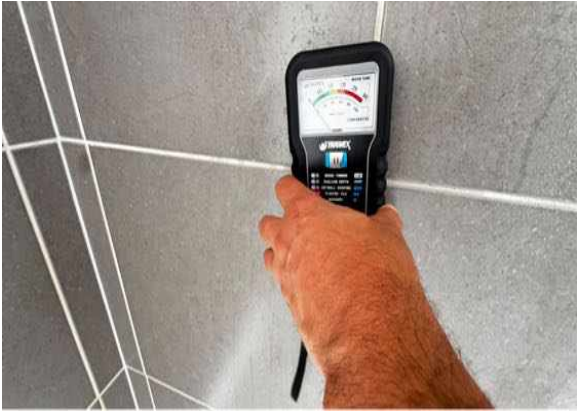
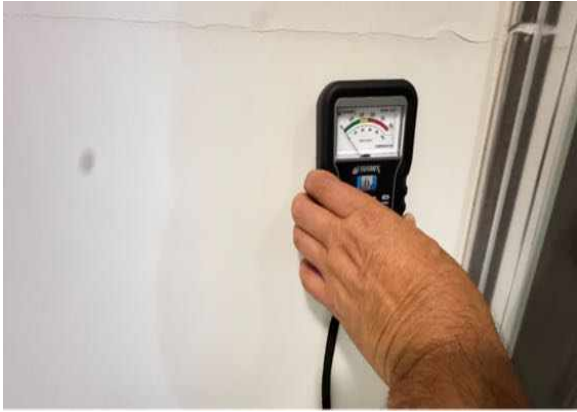
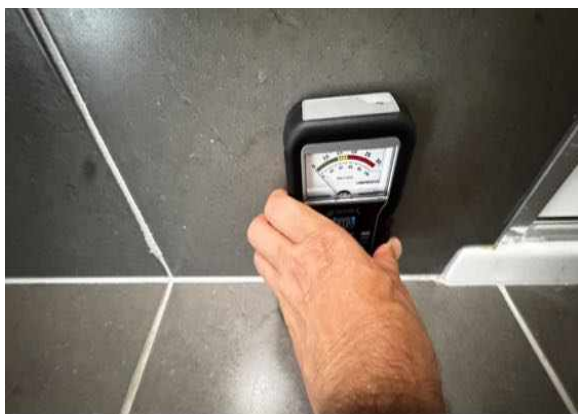
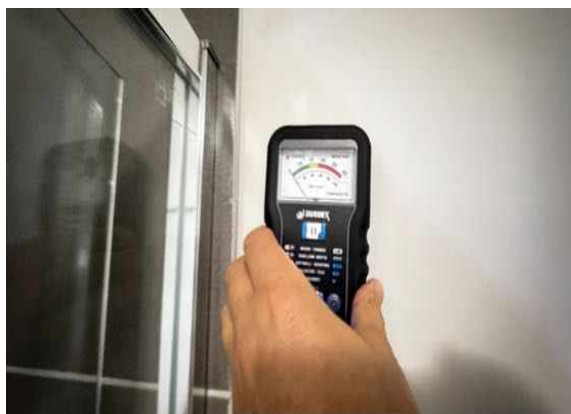
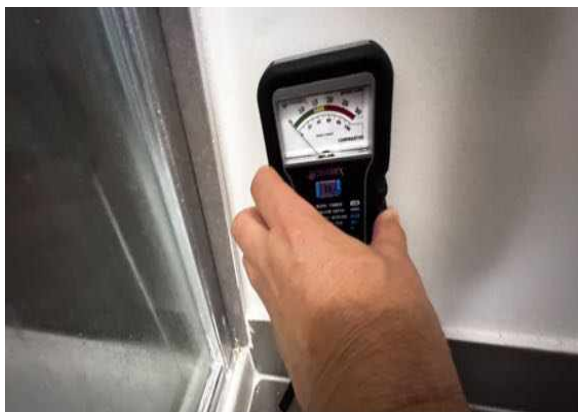
Noted Item

Building: Main Building
 Location: All Areas Interior & Exterior
 Finding: Moisture Levels - Advisory - No Elevated Moisture Levels Present
 Information: At the time of inspection, no elevated moisture levels were detected in these areas. Moisture readings were taken (using a Tramex Moisture Meter) and non-invasive testing methods and reflect conditions present at the time of inspection only. This item is noted for advisory purposes and should not be relied upon as a guarantee that moisture issues are not present elsewhere or may not occur in the future.

It is important to note that moisture levels can fluctuate due to weather conditions, plumbing usage, seasonal changes, or intermittent leaks. Concealed moisture within wall cavities, subfloor areas, or other inaccessible locations may not be detected during a visual or limited moisture assessment.

Ongoing monitoring of the property is recommended, and further investigation by a qualified tradesperson should be considered if signs of water ingress, dampness, staining, mould growth, or material deterioration become apparent.
