Building Inspection Report

Inspection Date: Thu, 22 Jan 2026

Property Address: 30 Croziers Rd, Jaspers Brush NSW 2535,
Australia

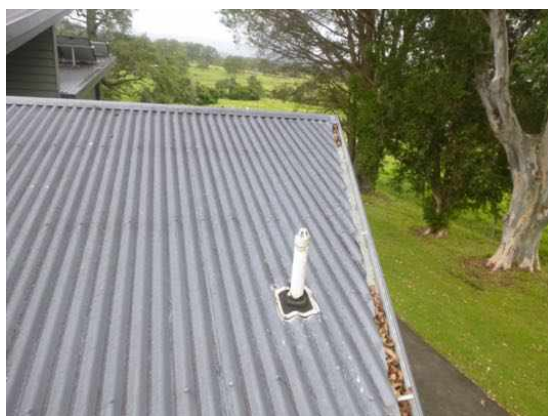
Defects 3.02

Blocked gutters are likely to lead to high levels of moisture in the affected areas. Such moisture will not only cause rust and decay of the associated building materials, but can also provide conditions that are conducive to termite and timber pest activity. Blockages in gutters should therefore be removed immediately to ensure dry conditions are maintained.

Consult a Licensed Plumber for further specific advice on remedial works that may be required. In the interim, it is highly advised that blocked gutters be removed by the homeowner or a general handyperson as a matter of urgency.

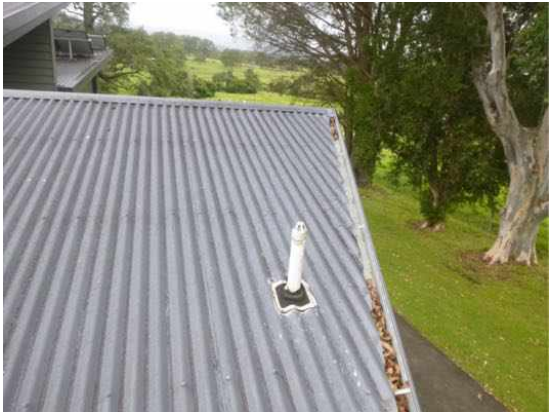
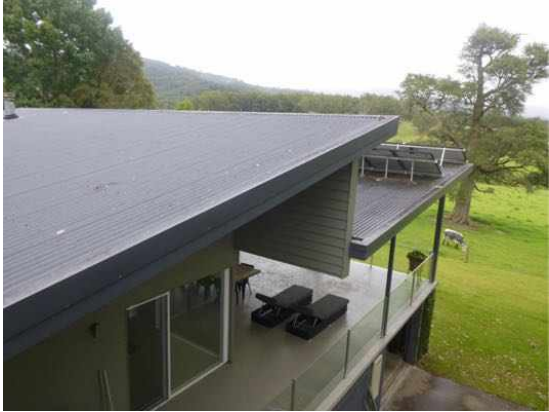
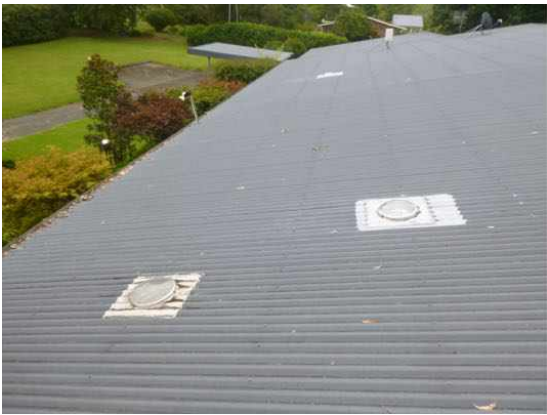
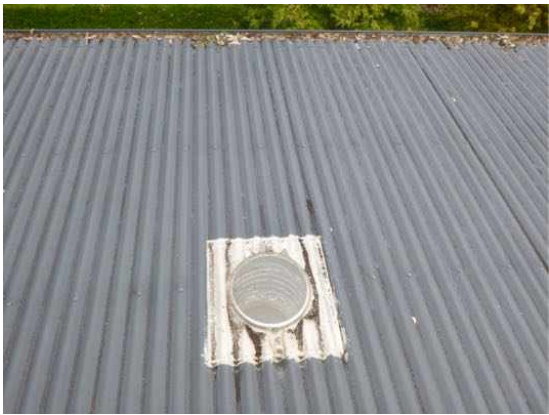
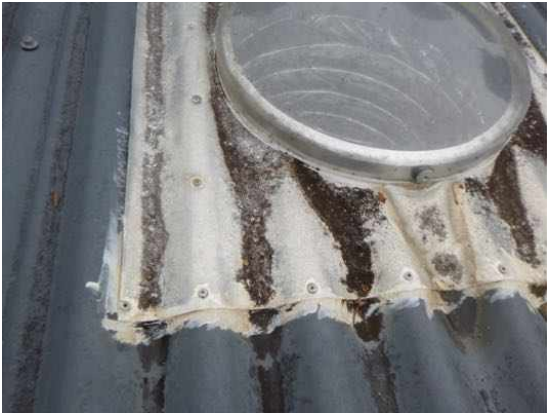
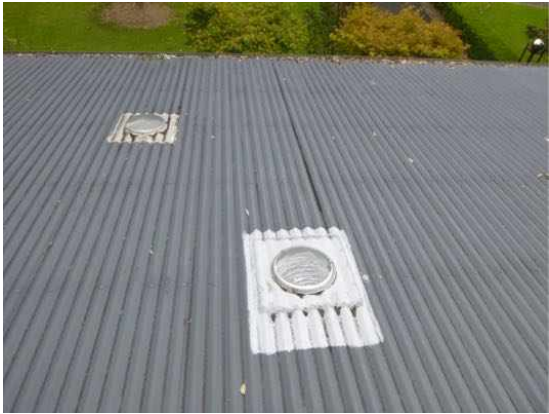
Noted Item

Building: Main Building
Location: Roof Exterior
Finding: Additional Photos - Obstructions and Limitations
Information: These photographs are an indication of the obstructions and limitations which impeded full inspection of the property at the time of inspection. These obstructions can hide an array of defects and should be removed to allow full inspection to be carried out. A re-inspection is recommended once the areas are made accessible.

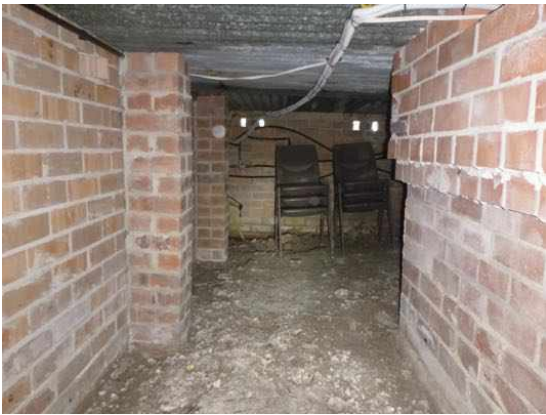
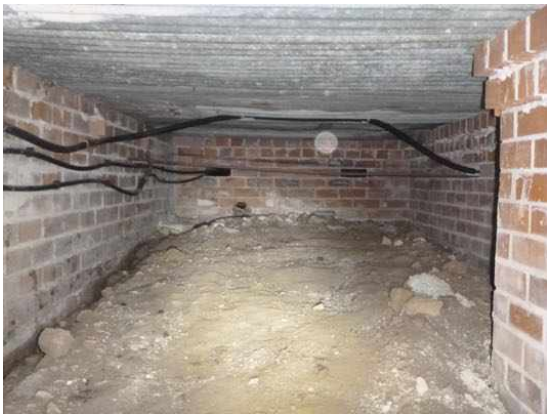
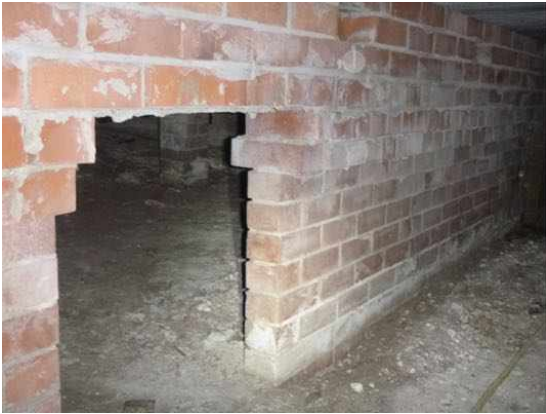
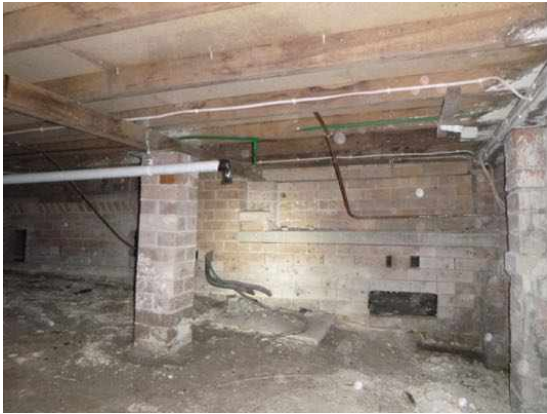
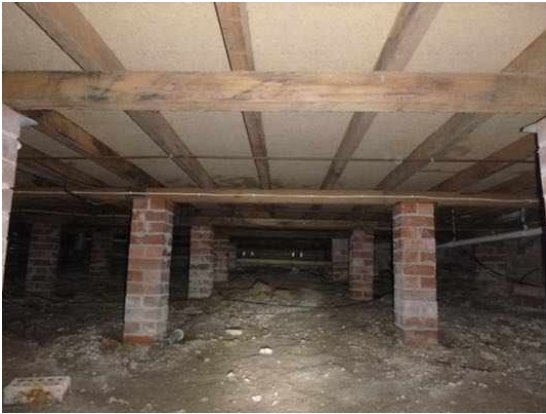
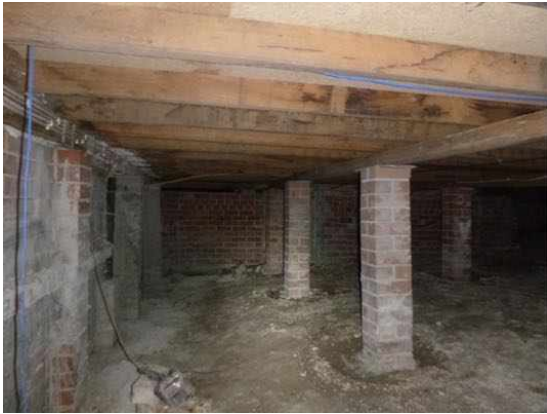
Building: Main Building
 Location: Subfloor
 Finding: Additional Photos - Obstructions and Limitations
 Information: These photographs are an indication of the obstructions and limitations which impeded full inspection of the property at the time of inspection. These obstructions can hide an array of defects and should be removed to allow full inspection to be carried out. A re-inspection is recommended once the areas are made accessible.

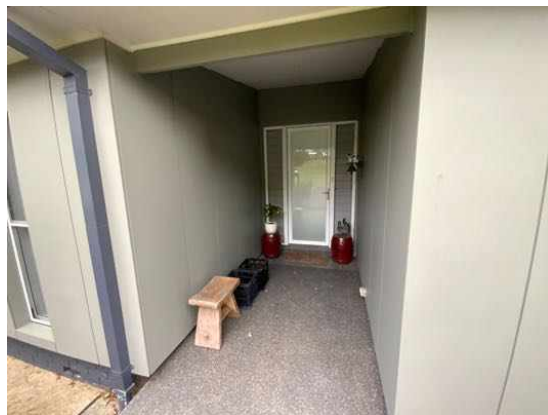
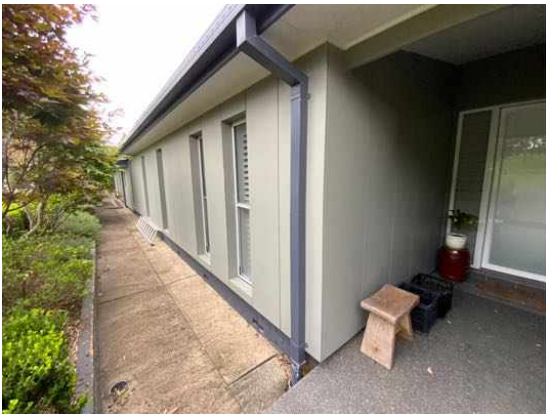
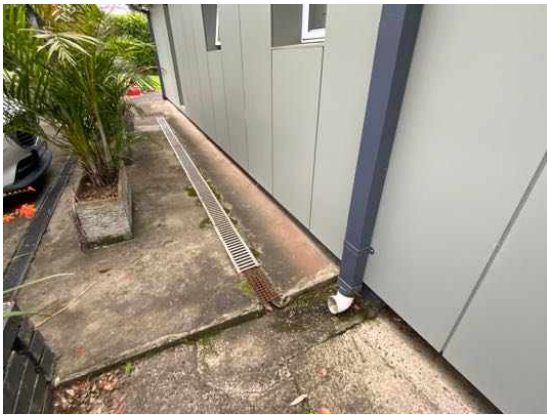
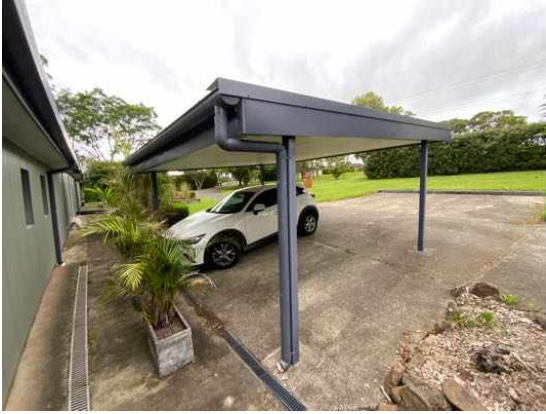
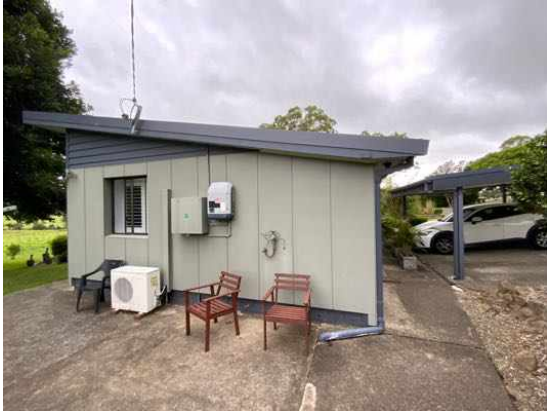
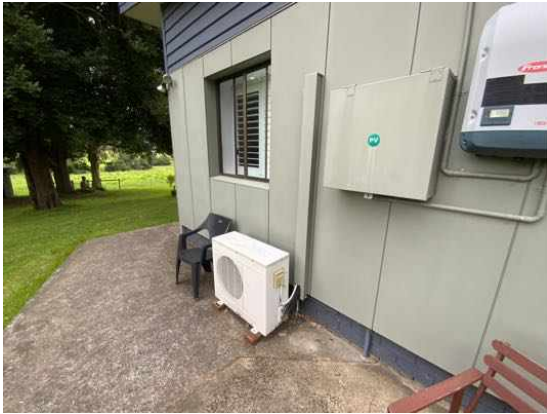
Noted Item

Building: Main Building
 Location: All Areas
 Finding: Additional Photos - Obstructions and Limitations
 Information: These photographs are an indication of the obstructions and limitations which impeded full inspection of the property at the time of inspection. These obstructions can hide an array of defects and should be removed to allow full inspection to be carried out. A re-inspection is recommended once the areas are made accessible.

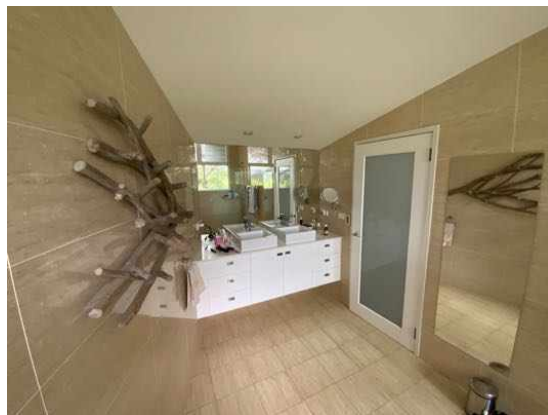
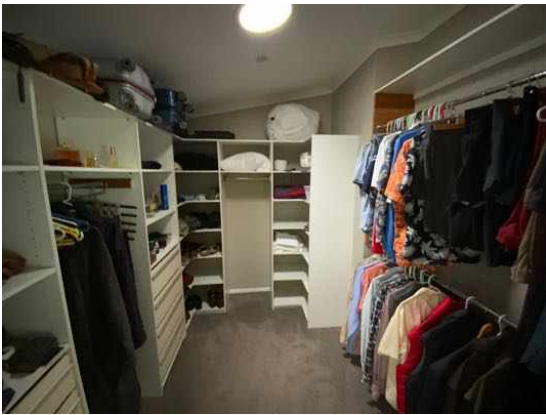
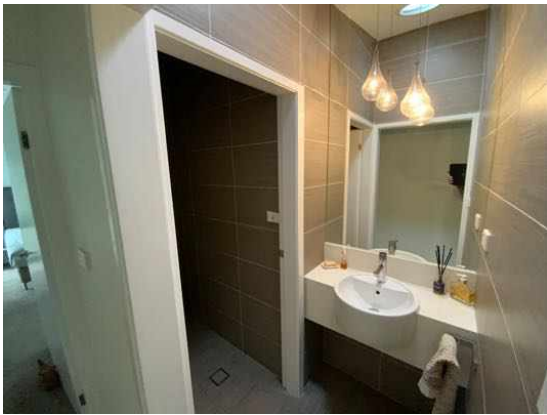
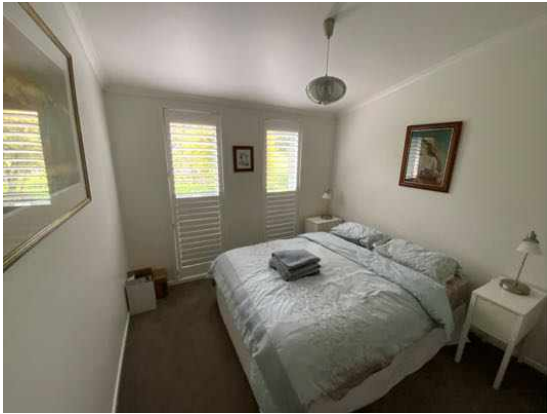
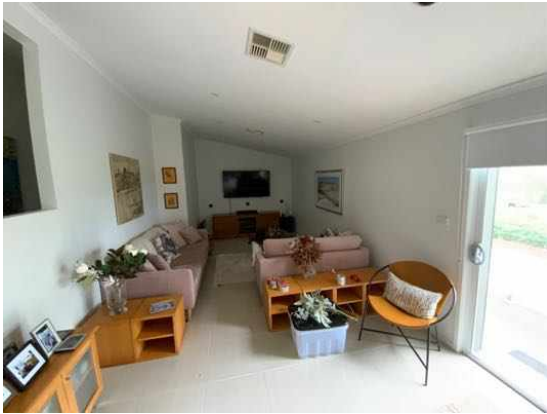
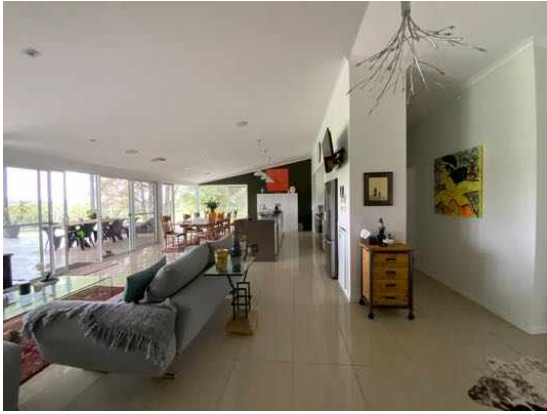
Noted Item

Building: Main Building
 Location: All Areas
 Finding: Additional Photos - Obstructions and Limitations
 Information: These photographs are an indication of the obstructions and limitations which impeded full inspection of the property at the time of inspection. These obstructions can hide an array of defects and should be removed to allow full inspection to be carried out. A re-inspection is recommended once the areas are made accessible.

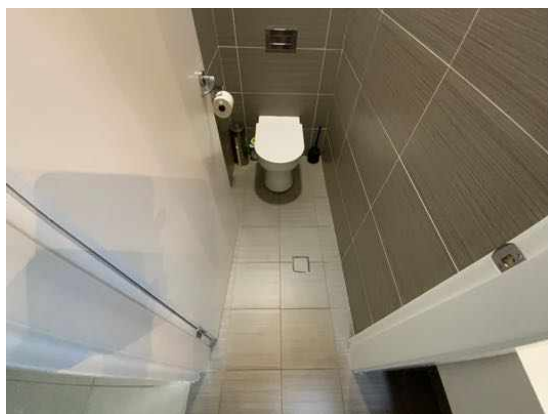
Noted Item

Building: Main Building
 Location: All Wet Areas
 Finding: Water Proofing Membranes - Information Only
 Information: Internal Water Proofing Membranes, are crucial in preventing water ingress into the property is important to know that the Membrane System used is to Australian Standards and has been installed correctly.

With older property's where this information is unavailable all wet areas should be monitored. Generally waterproofing certificates are only valid for approximately 7-8yrs. If any leaks, water staining, peeling or bubbling of the paint become evident to any adjacent walls or ceilings below a licensed builder or waterproofing specialist is recommended to investigate further.

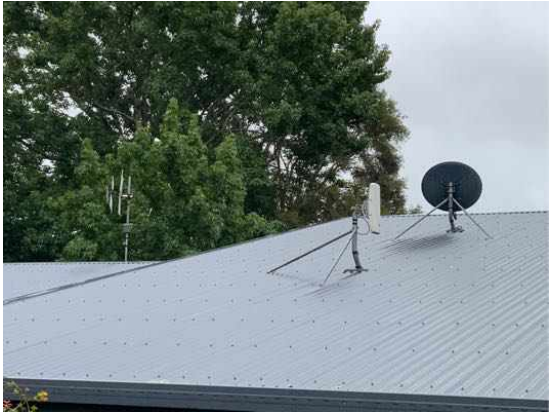
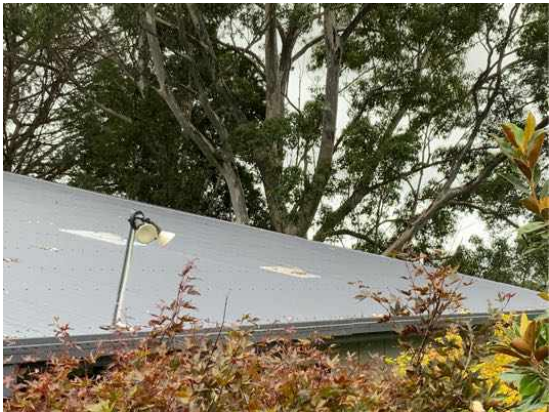
Noted Item

Building: Main Building
 Location: Roof Exterior
 Finding: External Roof Coverings & Plumbing
 Information: The New South Wales area experiences major weather events annually. These periods of storms and torrential & driving rains from certain angles can overwhelm residential roofs, waterproofed areas, skylights, flashings & guttering causing water ingress into properties that other wise would not happen in normal rain conditions. Therefore no guarantee can be given against any future roof leak.

A further inspection by a Licensed Roofing contractor is recommended to go over the complete roof covering and advise on the extent of replacement/ repair &

maintenance items.
