# Building and Timber Pest Inspection Report

Inspection Date: Mon, 23 Mar 2026

Property Address: 50 Vista Ave, Copacabana NSW 2251,  
Australia

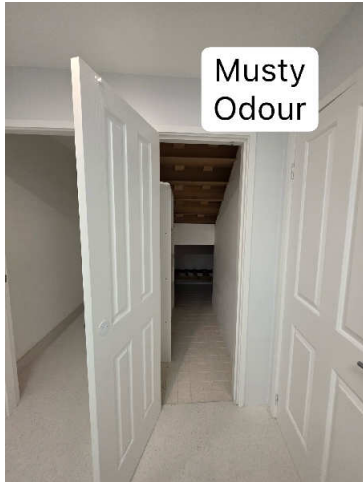
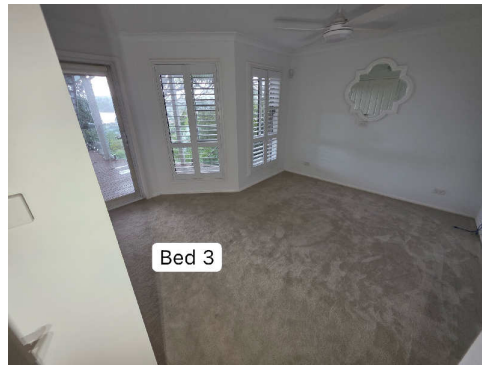
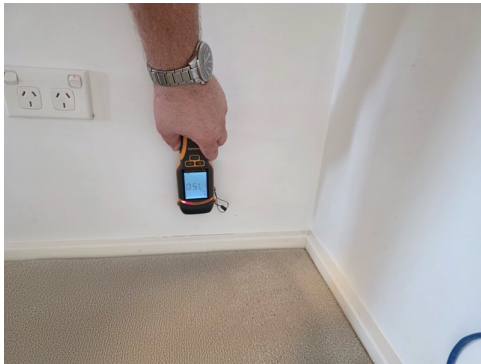
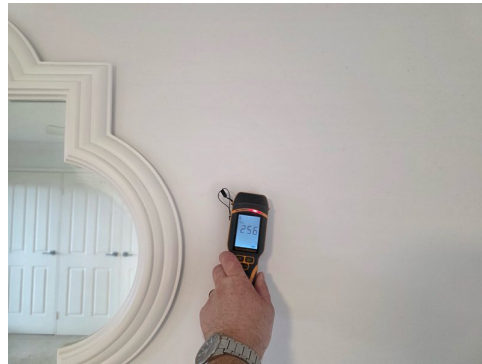
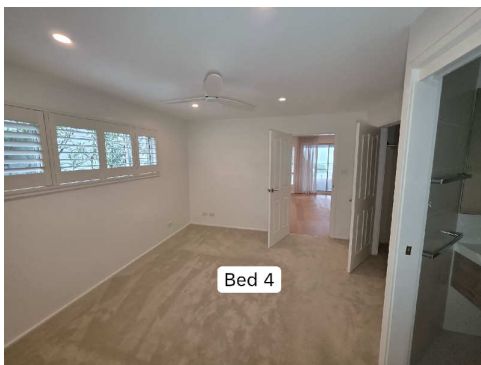
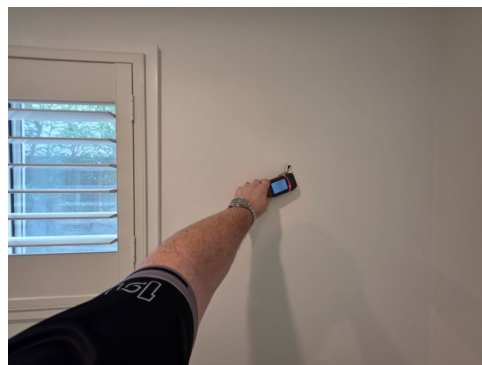
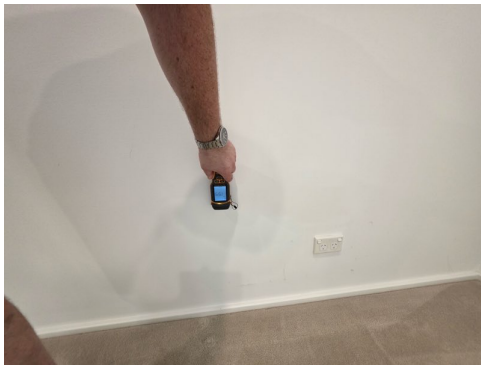
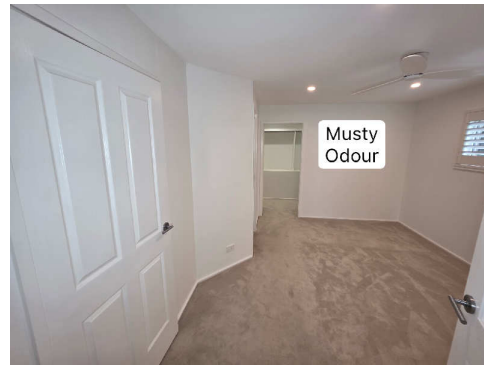
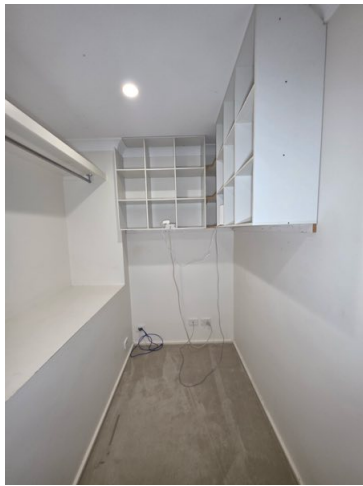
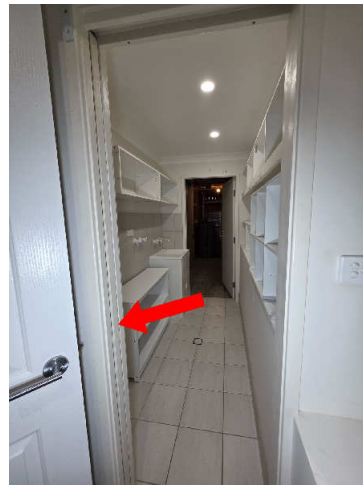
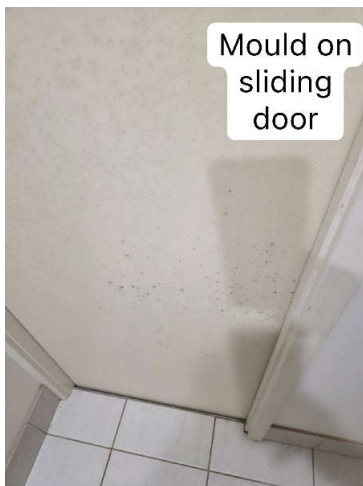
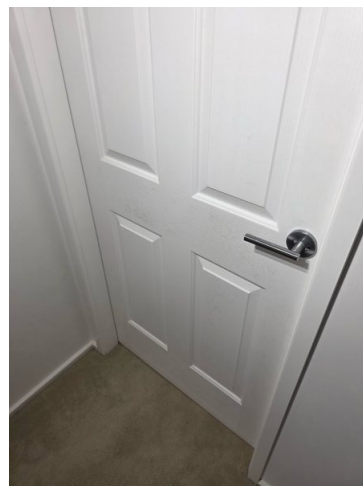
#### Finding 3.01

Building:	Main Building
Location:	Multiple Areas
Finding:	Internal moisture, mould growth and ventilation concerns – Multiple areas
Information:	<p>Elevated moisture readings were recorded across multiple internal wall surfaces, with visible mould growth observed to areas including window reveals, internal doors, and fittings. Moisture readings taken to the raked ceiling in the living area were generally consistent, with elevated readings noted toward the lower sections where the ceiling meets the wall. A musty odour was noted to enclosed areas, particularly to the under-stairs area and storage areas in bedrooms 3 and 4. The dwelling was vacant at the time of inspection, which may contribute to reduced ventilation. The exact source of moisture could not be confirmed.</p> <p>Prolonged elevated moisture levels may contribute to ongoing mould growth and deterioration of finishes and materials. While no single source was confirmed, the issue appears widespread and may involve ventilation or building envelope factors. A licensed builder should be engaged to assess, investigate and advise on rectification as required. This should be done as soon as practicable.</p>

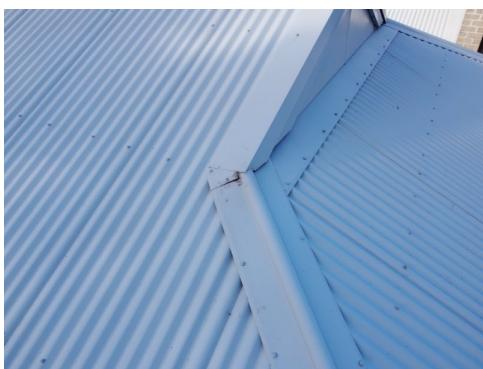
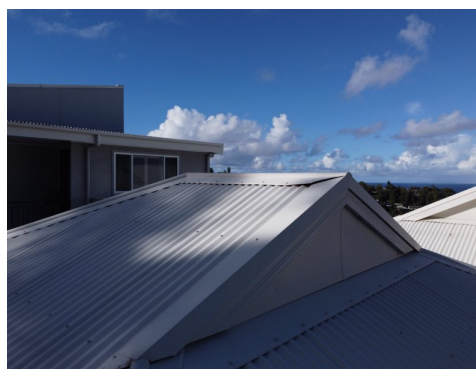
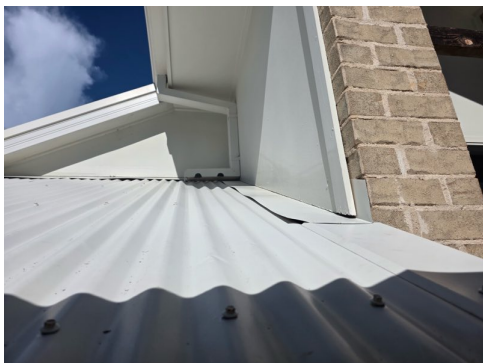
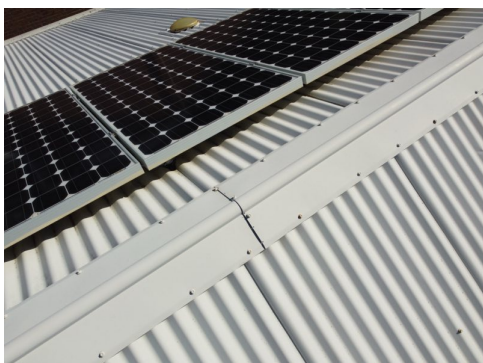
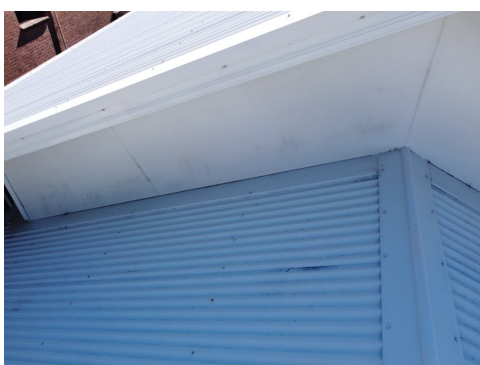
**Finding 3.02**

Finding: Defective roof flashings, sheeting and drainage – Main roof / Lifted flashing – Garage roof

Information: Multiple defects were observed to the roof, including incorrectly installed flashings, inadequate detailing at junctions, corrosion to fixings, and debris build-up at gutter joints. The roof sheeting appears to be lapped in the incorrect direction, which may allow wind-driven rain to enter. Fibre cement sheeting above the deck roof is in direct contact with flashing, with visible discolouration consistent with moisture wicking. A section of flashing to the garage roof was also observed to be lifted and not sitting as intended. This appears consistent with poor installation, although the flashing appeared stable at the time of inspection.

The client has advised me that a previous water stain and mould growth had been observed to the living room ceiling, which was reportedly cleaned following an alleged repair of a minor leak. No visible evidence of staining, moisture ingress or active leakage was observed at the time of inspection. However, the adequacy of any prior repairs if carried out could not be verified. Given the defects noted to the roof coverings and flashings, further investigation is recommended to confirm the roof is performing as intended as intermittent leaks may still be present.

These conditions may allow water ingress and contribute to progressive deterioration of roofing and adjacent materials. The defects are widespread and affect the overall performance of the roof system. A licensed roofer should be engaged to carry out further investigation and rectify as required. This should be done as soon as practicable.

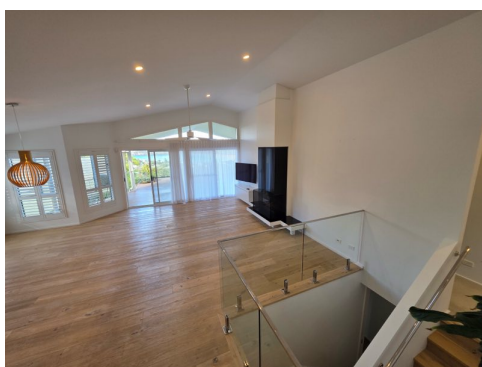
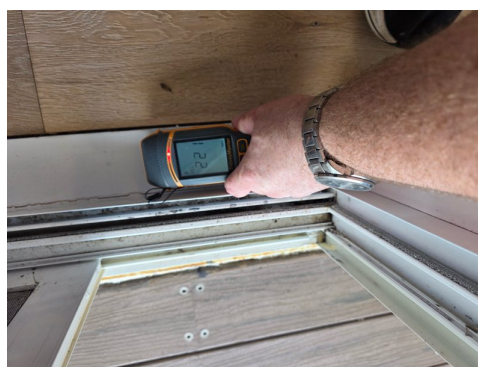
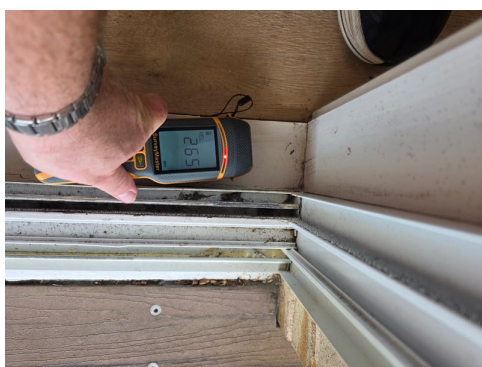
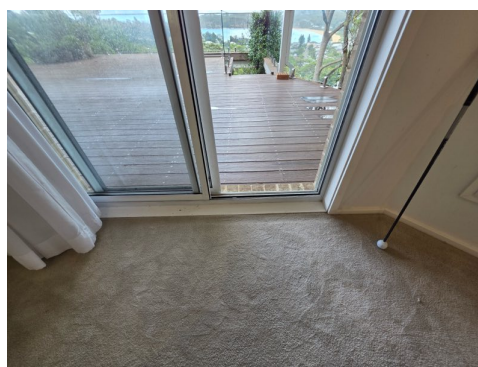
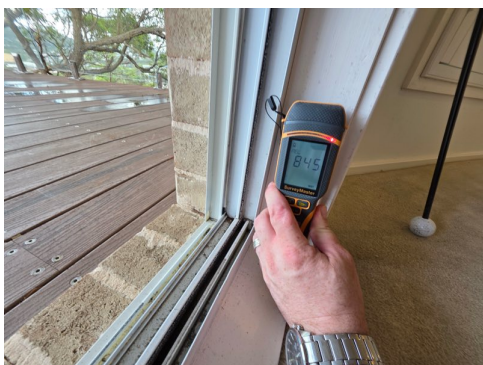
**Finding 3.03**

Finding: Elevated moisture to sliding door reveals – Multiple areas

Information: Elevated moisture readings were recorded to the sliding door reveals and sill areas in both the main living area and bedroom 2. Higher readings were noted to the lower sections, particularly on the lock side in bedroom 2. The source of moisture could not be confirmed from the visible inspection.

These conditions may indicate moisture ingress at door thresholds and may lead to deterioration of adjacent materials over time. Concealed damage cannot be ruled out. A licensed builder should be engaged to carry out further investigation and rectify as required. This should be done as soon as practicable.

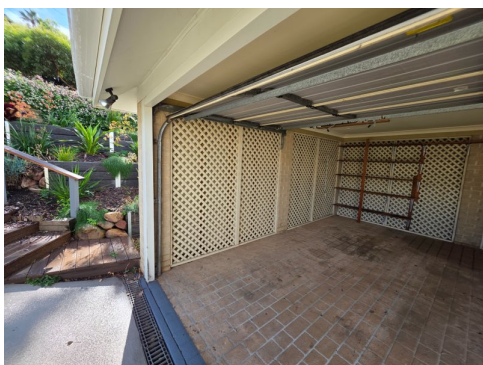
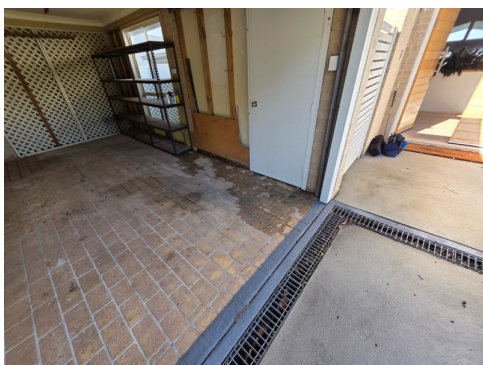
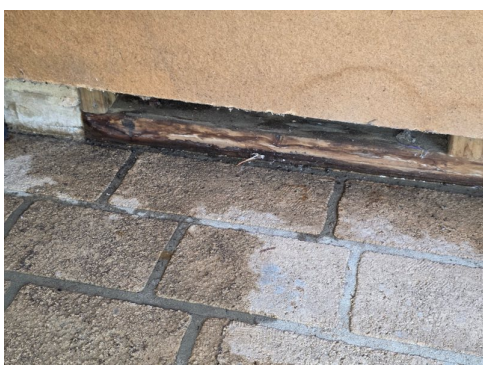
### Finding 3.04

Information: The garage walls have been infilled without visible waterproofing measures along the bottom, and water ingress was observed entering beneath the wall along the side of the garage. The wall appears to be in direct contact with the ground without a physical barrier, which is not appropriate and may allow moisture to track into the wall structure.

Ongoing water entry may lead to deterioration of wall materials and adjacent areas. A licensed builder should be engaged to investigate and rectify as required. This should be done as soon as practicable.

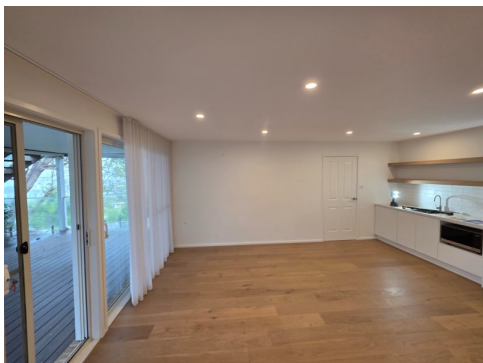
### Finding 3.05

Information: Multiple LED lights were observed to flicker intermittently across different areas of the property. Flickering appeared to shift between lights, with one downlight stopping as another in the same room began, and additional flickering noted in a separate room when lights were switched off. This pattern suggests a broader electrical issue rather than an isolated fitting fault.

Intermittent faults may worsen over time and may indicate underlying electrical concerns. A licensed electrician should be engaged to investigate and rectify as required. This should be done as soon as practicable.

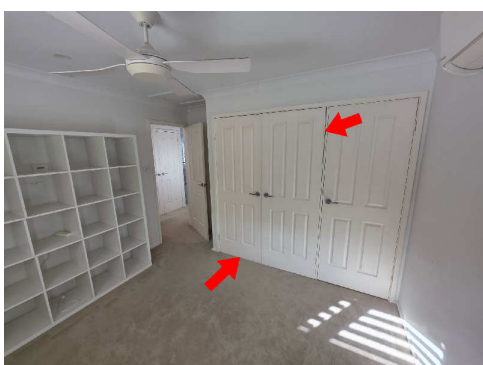
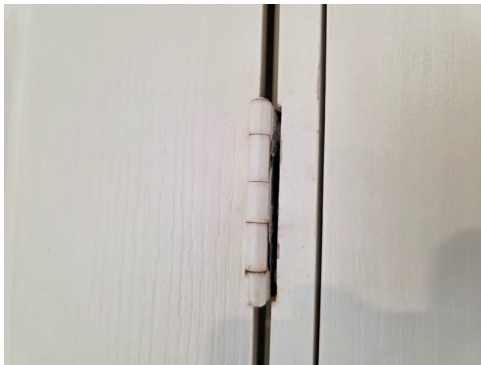
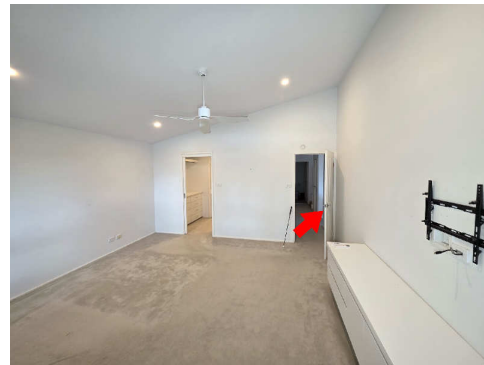
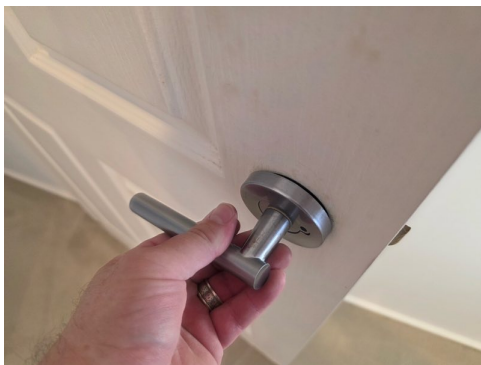
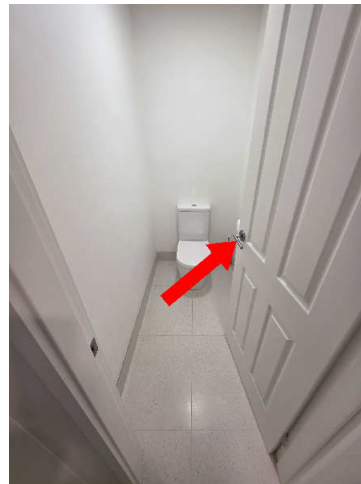
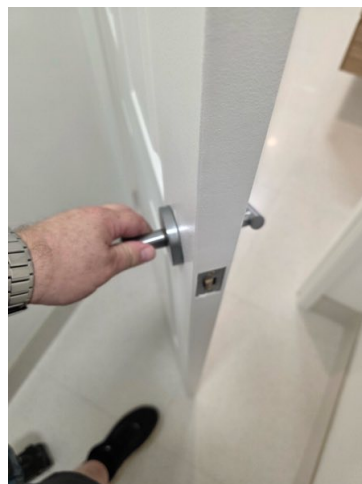
### Finding 3.06

Information: Multiple internal doors were observed to be rubbing against floor coverings, and several door handles were loose at the time of inspection. These conditions are consistent with minor wear and general use.

If left unaddressed, wear to door edges, finishes, and hardware may continue. A qualified carpenter should be engaged to adjust and secure components as required. This should be done as soon as practicable.

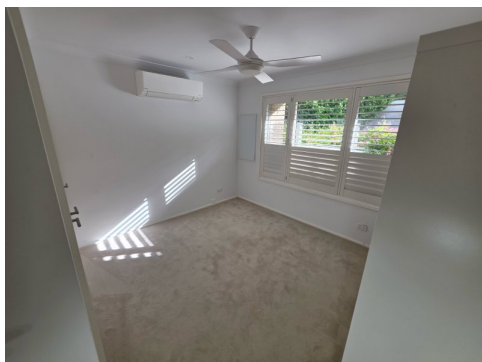
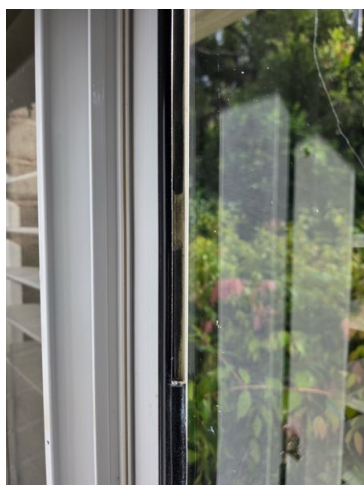
**Finding 3.07**

Finding: Damaged window seals – Bedroom 1

Information: The rubber seals to one bedroom window were observed to be damaged and partially missing. This appears consistent with age-related wear.

This may reduce the effectiveness of the window seal against weather and air infiltration. A qualified carpenter should be engaged to assess and replace seals as required. This should be done as soon as practicable.

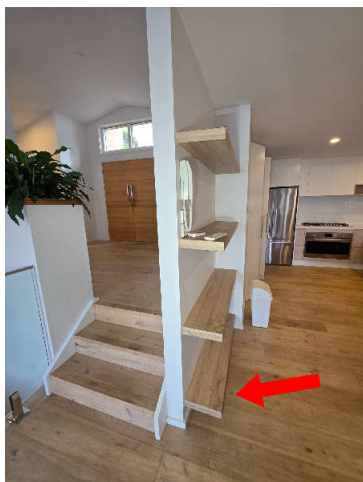
### Finding 3.08

Finding: Damaged and unstable floating shelf – Kitchen

Information: A floating shelf in the kitchen was observed to be damaged, not level, and pulling away from the wall. This may be due to inadequate fixings or loading over time.

The shelf may continue to loosen and could detach if not addressed. A qualified carpenter should be engaged to secure or replace as required. This should be done as soon as practicable.

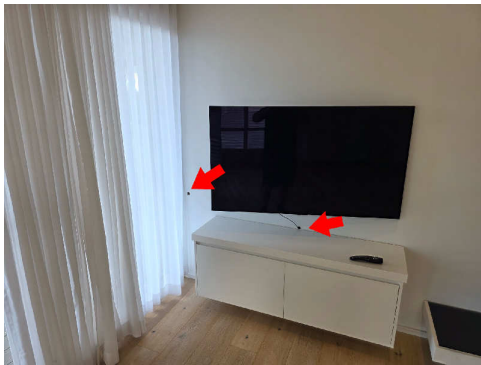
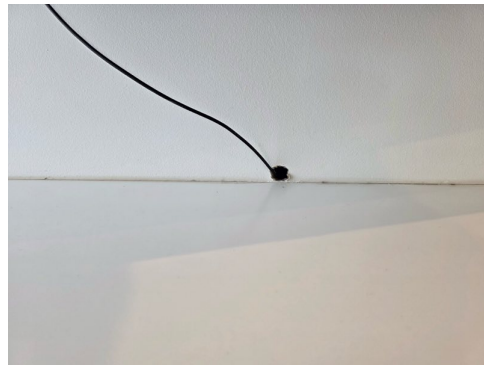
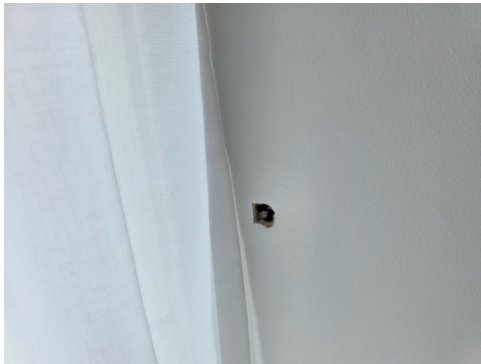
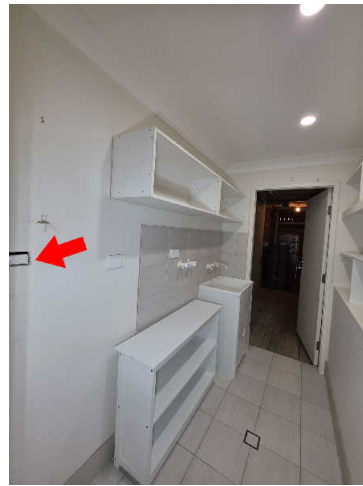
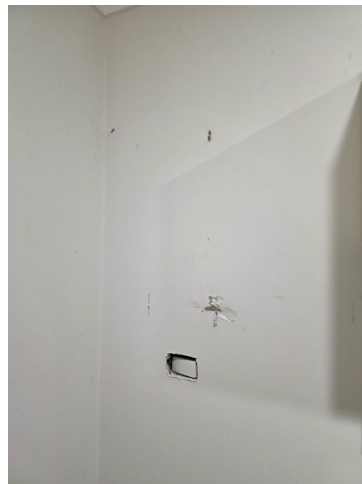
### Finding 3.09

Finding: Minor wall damage – Living room and laundry

Information: Minor damage to wall linings was observed, including small holes and surface imperfections consistent with impact.

This is cosmetic in nature but may affect presentation. A qualified carpenter should be engaged to repair as required. This should be done at the owner's discretion.

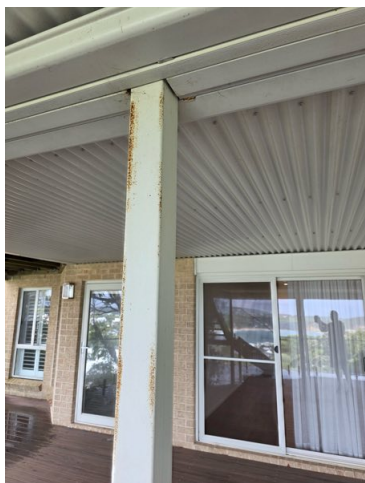
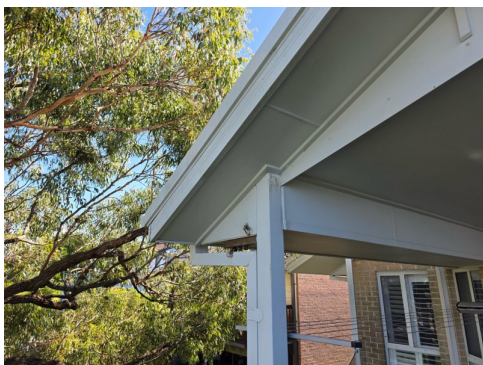
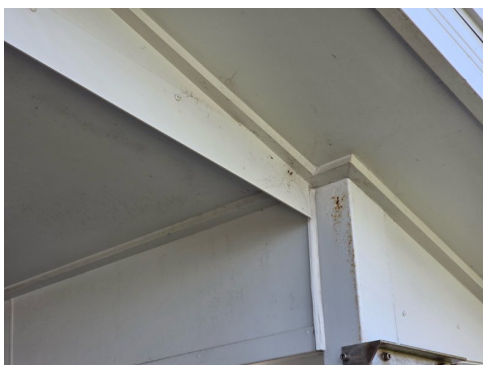
**Finding 3.10**

Finding: Surface rust to steel elements – Deck structure

Information: Surface rusting was observed to steel components within the deck structure. No significant section loss was evident.

If left untreated, corrosion may progress over time. A licensed builder should be engaged to treat and protect affected elements. This should be done as soon as practicable.

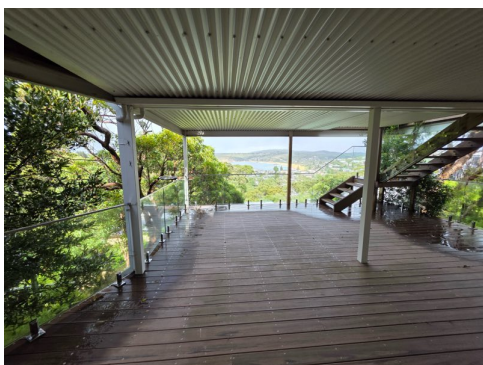
Information: An elevated external deck was observed at the property. Even if the structure appears sound or recently built, it may still pose a safety risk if inadequately supported. A detailed structural assessment is required to confirm its stability and load-bearing capacity.

A structural engineer should be engaged to carry out a structural assessment of the decks. Until this has been completed and any necessary rectification works undertaken, users should take care not to overload the structure.

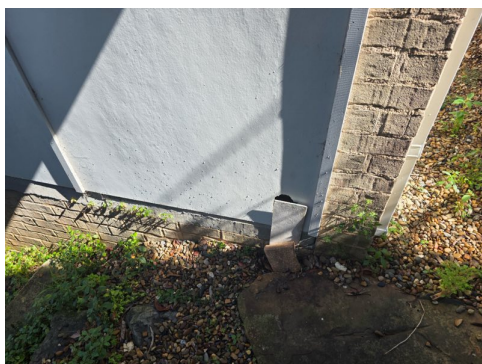
### Finding 3.13

Finding: Damaged wall sheeting – Garage rear wall

Information: A hole was observed in the garage wall sheeting with framing exposed.

This may allow moisture entry and pest access if left unaddressed. A qualified carpenter should be engaged to repair the wall. This should be done as soon as practicable.

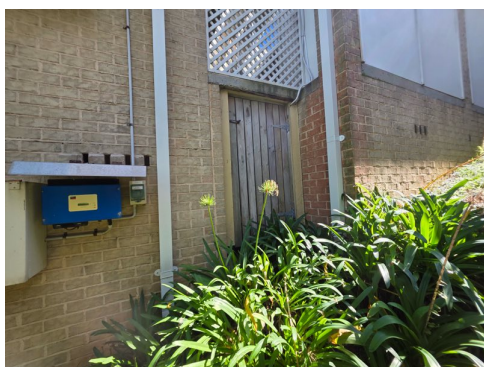
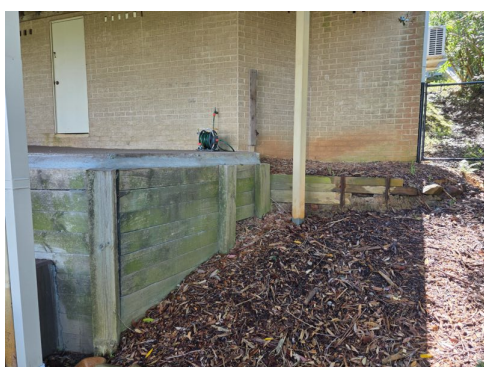
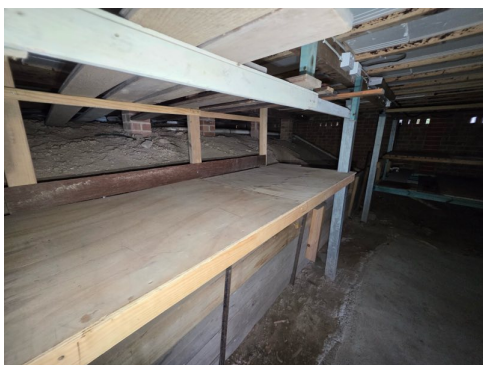
Timber elements in direct contact with the ground, and consequently exposed to moisture or dampness, create conditions conducive to termite activity. Whether timber is used as part of a building structure, such as a fence or retaining wall, or stored as unused material, it can attract termite infestations.

When exposed to excessive moisture, timber begins to decay and develop wood rot. Any timber in direct contact with the ground - especially untreated or non-durable timber - provides an easy entry point for subterranean termites into the material.

To minimize the risk of termite attack, it is recommended to remove any materials that could foster termite activity. If removal is impractical or undesirable, it is strongly advised that termite or timber pest inspections be conducted every 6 to 12 months to protect the property from potential infestation.

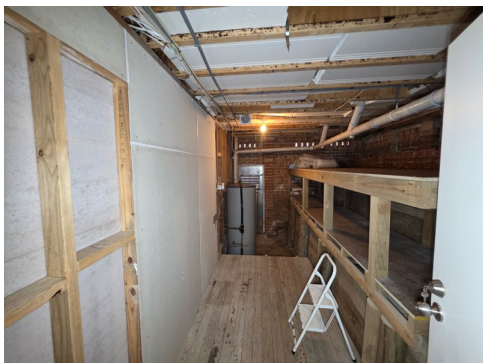
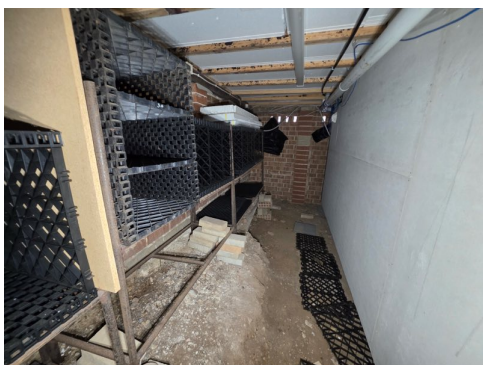
Finding: Ventilation - Inadequate subfloor ventilation

Information: Subfloor ventilation appears to be inadequate in one or more areas beneath the dwelling. Poor airflow can result in elevated moisture levels, which in turn create conditions conducive to fungal decay and termite activity. Signs of dampness or musty odours may also indicate restricted air movement.

Improved cross-ventilation should be established to help manage moisture and reduce the risk of concealed timber pest attack. A licensed builder should assess the subfloor and install additional vents or mechanical ventilation as needed. This should be addressed as soon as practicable.
