Building and Timber Pest Inspection Report

Inspection Date: Thu, 26 Feb 2026

Property Address: 1691 Coramba Rd, Megan NSW 2453,
Australia

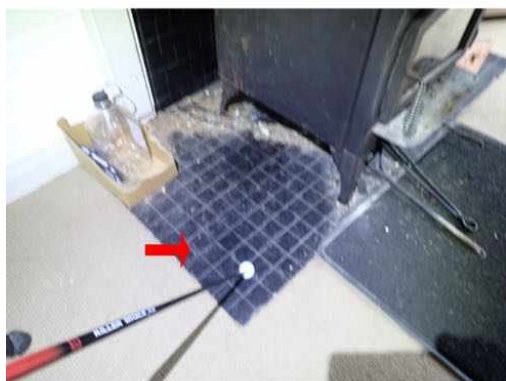
Finding 1.01

Building: Main Building
Location: Living Room
Finding: Insufficient Fireplace Hearth and Damaged Tiles
Information: The fireplace hearth was found to be too small and does not appear to extend sufficiently beyond the fireplace opening in accordance with current safety requirements. Damaged and cracked tiles were also noted to the hearth surface. In simple terms, the hearth in front of the fireplace is too small and the tiles are damaged. An undersized hearth may not provide adequate protection to surrounding flooring from heat or embers. It is recommended that a qualified builder assess and enlarge the hearth to meet current standards, and that a licensed tiler replace the damaged tiles as required. Rectification should be undertaken to improve safety and durability and can be arranged at the owner's discretion.

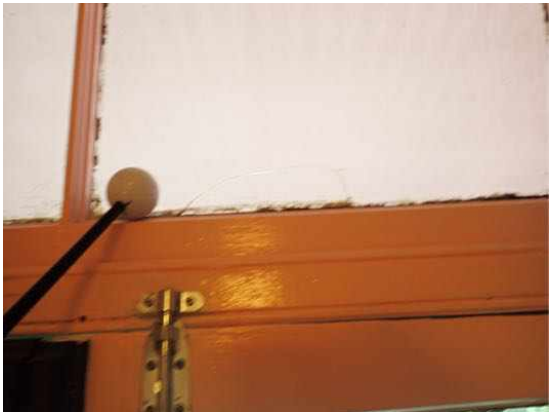
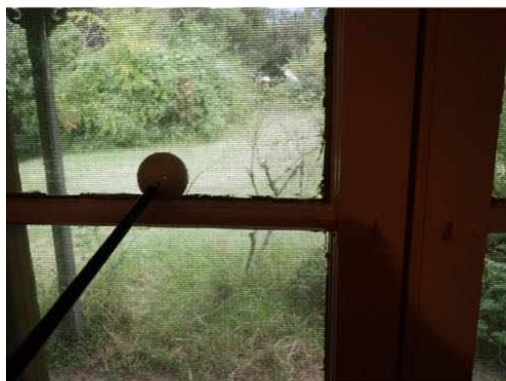
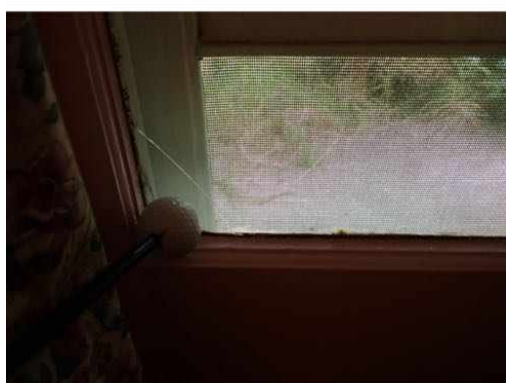
Finding 1.02

Finding: Cracked Window Panes to Bedroom Doors

Information: Cracked glass panes were identified to the window sections within the bedroom doors. The glazing is fractured and may be weakened, increasing the risk of further cracking or breakage. In simple terms, the glass in the bedroom doors is cracked. This type of damage is commonly caused by impact or stress to the glass. Cracked glazing may present a safety concern if it shatters. It is recommended that a qualified glazier remove and replace the damaged panes. Repairs can be undertaken at the owner's discretion to restore safety and functionality.

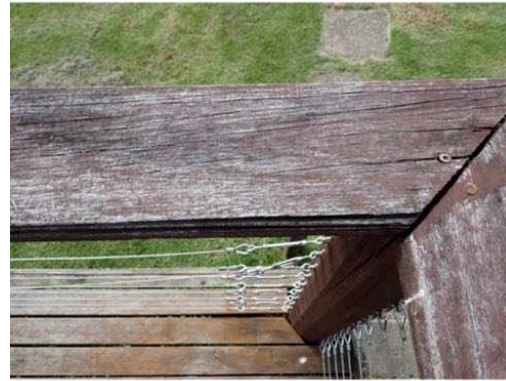
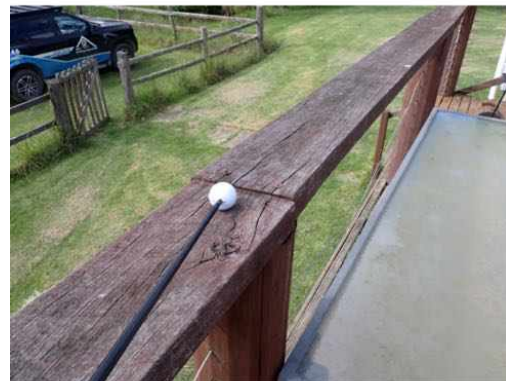
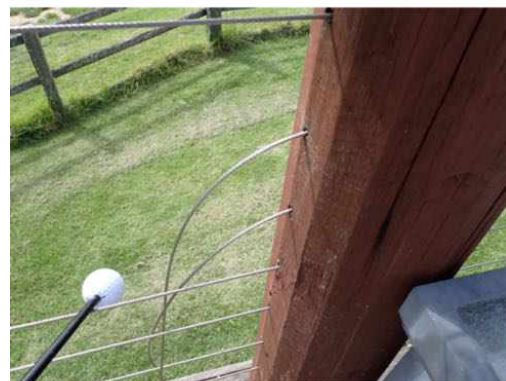
Finding 1.03

Building:	Main Building
Location:	Rear timber patio area
Finding:	Timber Patio Handrail/Balustrade Weathered with Two Broken Stainless Steel Wires
Information:	The timber patio handrail/balustrade was observed to be in a weathered condition, with two broken stainless steel wire infill strands identified. Deterioration of balustrade components and broken wires may reduce the effectiveness and safety of the barrier system. In plain terms, the patio railing is worn from weather exposure and two of the steel wires are broken, which may pose a safety concern. Possible causes include prolonged exposure to the elements, tension fatigue in the wires, corrosion at fixings, and lack of maintenance. It is recommended that the broken wires be replaced and the timber components repaired, re-coated, or replaced as required to maintain safety and durability. Works should be carried out by a licensed builder or suitably qualified carpenter. Rectification is recommended at the owner's discretion.

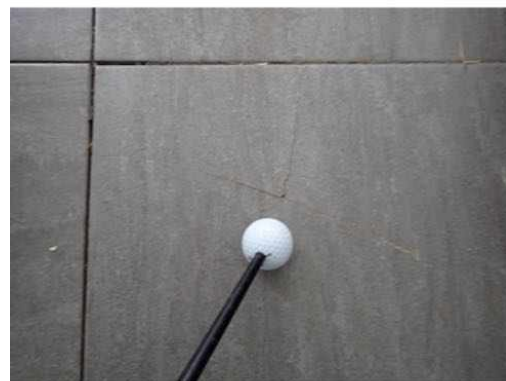
Finding 2.02

Building:	Main Building
Location:	Laundry, toilet, and entry hall
Finding:	Cracked and Drummy Floor Tiles with Missing/Deteriorated Grout – Bathroom, Laundry and Entry Hall
Information:	Cracked and drummy (hollow sounding) floor tiles were identified to the bathroom, laundry and entry hall, along with areas of missing and deteriorated grout. The hollow sound indicates possible loss of adhesion between the tiles and the underlying substrate. In simple terms, some tiles are cracked, sound hollow underfoot and the grout between them is missing or breaking down. This condition is commonly associated with substrate movement, inadequate adhesive coverage, age-related wear and moisture exposure. If left unaddressed, tiles may loosen further, crack or allow moisture to penetrate beneath the tiled surface. It is recommended that a licensed tiler assess the affected areas, replace damaged or loose tiles and reinstate grout as required. Rectification should be undertaken to prevent further deterioration and can be arranged at the owner's discretion.

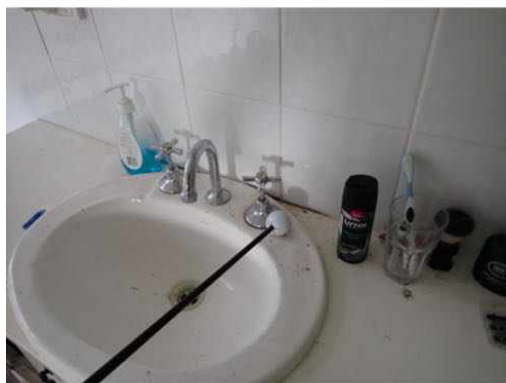
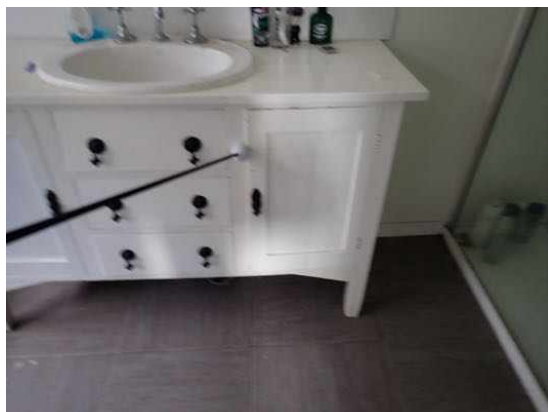
Finding 2.04

Building:	Main Building
Location:	Bathroom
Finding:	Bathroom Vanity Cupboard in Poor Condition
Information:	The bathroom vanity cupboard was found to be in poor condition. Defects observed include deteriorated silicone, drawers and doors that are difficult to open, poorly installed plumbing, and missing tiles where plumbing penetrations have been carried out. In simple terms, the vanity unit is run down, the silicone is failing, the drawers and doors don't operate properly, the plumbing installation appears substandard and tiles are missing around pipework. This condition is commonly associated with poor workmanship and age-related wear. If left unaddressed, continued deterioration and potential moisture ingress may occur within the cabinet and surrounding wall areas. It is recommended that a licensed plumber rectify the plumbing installation, that a licensed tiler reinstate missing tiles and sealing, and that a qualified cabinetmaker or carpenter repair or replace the vanity unit as required. Rectification can be undertaken at the owner's discretion to restore functionality and prevent further deterioration.

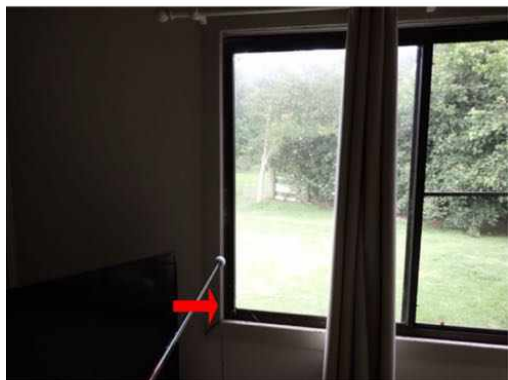
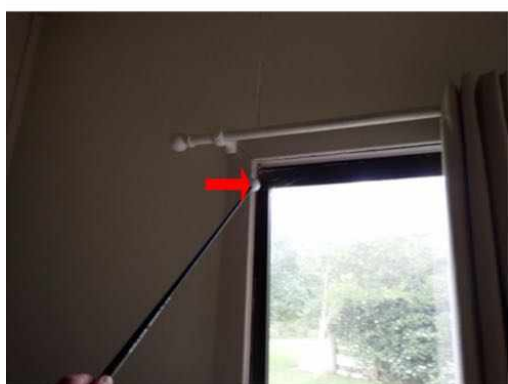
Finding 2.05

Finding: Replacement Aluminium Window Poorly Installed

Information: A replacement aluminium window was observed to be poorly installed. The installation appears substandard, with deficiencies noted in alignment, finishing and/or sealing. In simple terms, the window has not been fitted properly. Poor installation may affect weatherproofing, operation and long-term performance of the window assembly. If left unaddressed, defects in installation may allow moisture ingress or lead to movement and further deterioration. It is recommended that a qualified builder or window installer assess the installation and carry out rectification works to ensure the window is

properly secured, sealed and compliant with relevant standards. Rectification can be undertaken at the owner's discretion.

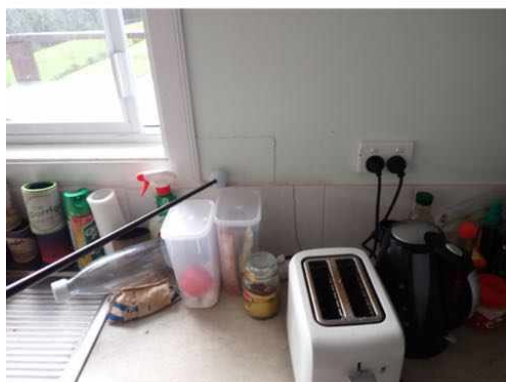
Finding 2.06

Building:	Main Building
Location:	Kitchen
Finding:	Crack to Kitchen Tiled Splashback and Plaster Above
Information:	<p>A crack was identified to the kitchen tiled splashback and the plaster wall above. Cracking in these areas may be associated with building movement, substrate movement, or shrinkage and, if left unaddressed, may allow moisture ingress behind the tiled surface. In plain terms, there is a visible crack in the kitchen tiles and the wall above, which could worsen over time and allow water to get in. Possible causes include settlement, movement in the wall framing, or poor installation. It is recommended that the crack be further assessed and repaired as required, with tiles re-fixed and plaster patched as necessary. Repairs should be carried out by a licensed builder or suitably qualified tiler and plasterer. Rectification is recommended at the owner's discretion to prevent further deterioration.</p>

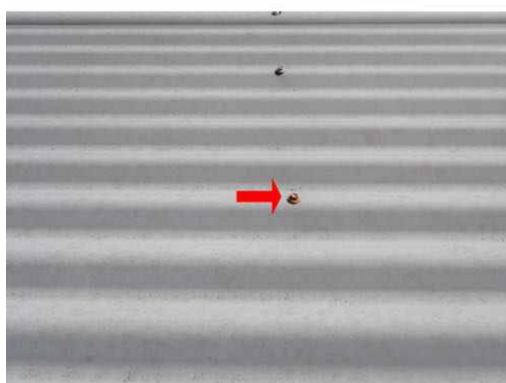
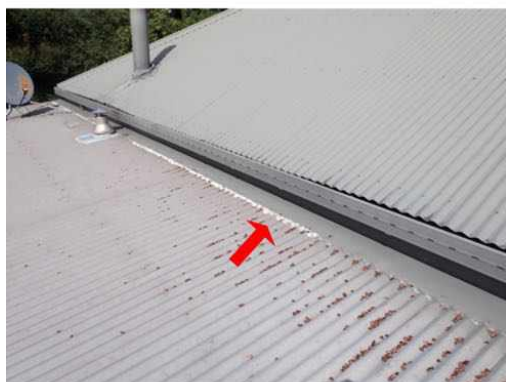
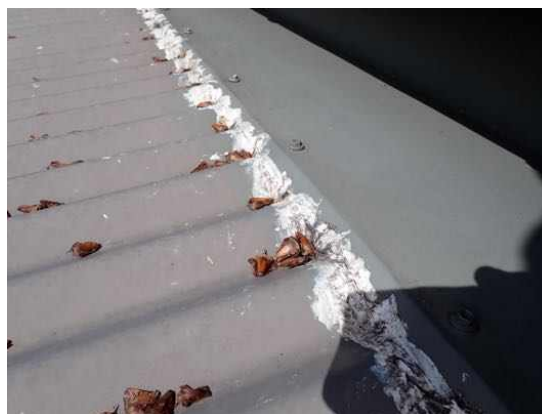
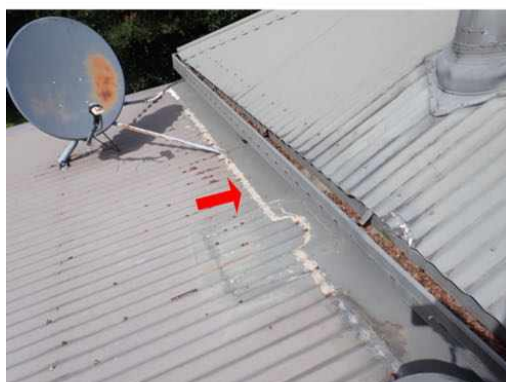
Finding 2.07

Building:	Main Building
Location:	Roof Exterior
Finding:	External Roof Cladding in Fair Condition – Although Defects Identified.
Information:	The majority of the external roof cladding was found to be in fair condition; however, rusted screw heads and multiple silicone patch repairs were identified. Rusted fixings may deteriorate over time and compromise the effectiveness of the roof sheeting, and silicone patching is generally considered a temporary repair method. In plain terms, the roof is generally okay but some screws are rusting and there have been patch-up repairs using silicone. Possible causes include age-related deterioration, weather exposure, and previous leak repairs. It is recommended that rusted fixings be replaced and patched areas monitored and properly repaired as required to ensure ongoing weatherproofing. Works should be carried out by a licensed roof plumber or suitably qualified roofing contractor. Rectification is recommended at the owner's discretion to prevent further deterioration.

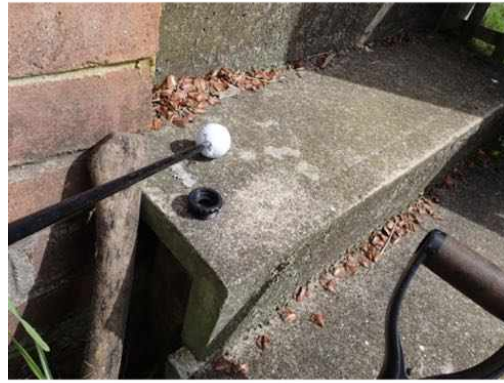
Finding 2.08

Building:	Main Building
Location:	Rear stairs
Finding:	Rear Concrete Stair Treads Loose
Information:	<p>The rear concrete stair treads were found to be loose under foot. Loose stair components may present a trip hazard and can worsen over time if not secured. In plain terms, the back steps move when stepped on and could become unsafe if not repaired. Possible causes include movement in the supporting structure, inadequate fixing, age-related deterioration, or ground movement. It is recommended that the stair treads be secured, repaired, or replaced as required to ensure stability and safety. Works should be carried out by a licensed builder or suitably qualified concreter. Rectification is recommended at the owner's discretion to maintain safety and prevent further deterioration.</p>

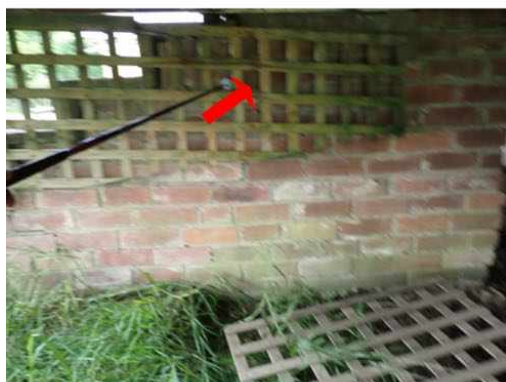
Finding 2.09

Finding: Major and Minor Cracking to Brickwork Beneath Rear Stairs

Information: Major and minor cracks were identified in the brickwork beneath the rear stairs. Cracking of this nature may be associated with movement in the footing, settlement, loading from the stair structure, or general age-related deterioration. In plain terms, there are both large and small cracks in the bricks under the back stairs, which may indicate movement in the supporting area. Possible causes include ground movement, inadequate footing support, moisture changes in the soil, or long-term structural loading. It is recommended that the cracking be further assessed and repaired as required, and that the underlying cause be investigated if movement is ongoing. Works should be carried out by a licensed builder or suitably qualified bricklayer. Rectification is recommended at the owner's discretion to prevent further deterioration.

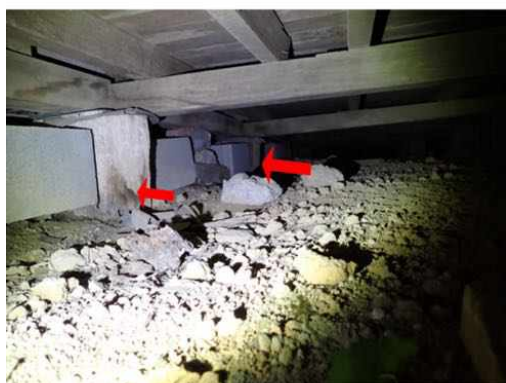
Finding 2.10

Building:	Main Building
Location:	Subfloor
Finding:	Building Mostly Re-Stumped – Remaining Timber Stumps at Front with Low Clearance
Information:	<p>The building appears to have been re-stumped at some stage; however, a number of original timber stumps remain at the front of the building. Access to these front stumps was restricted due to low subfloor clearance, limiting the ability to fully inspect their condition at the time of assessment. Timber stumps in contact with or in close proximity to the ground are also considered conducive to timber pest attack and decay. Mixed stump types can result in differential movement over time, particularly where older timber supports remain in service. In plain terms, some supports have been replaced, but older timber stumps still remain at the front, the tight space underneath made it difficult to properly check them, and timber supports can attract termites over time. Possible causes include staged repair works, partial upgrades, age-related deterioration, and ground contact. It is recommended that the remaining timber stumps be further assessed where adequate access can be obtained and replaced if required, and that appropriate termite management measures be maintained. Works should be carried out by a licensed builder in conjunction with a licensed timber pest specialist as required. Rectification and further assessment are recommended at the owner's discretion to reduce the risk of movement, decay, or timber pest attack.</p>

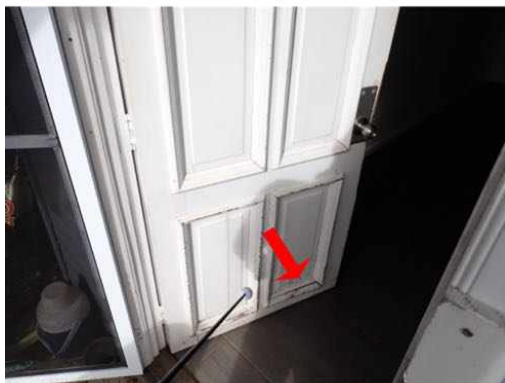
Finding 3.01

Building:	Main Building
Location:	Entry door
Finding:	Back Entry Door in Need of General Maintenance
Information:	The back entry door was found to be in need of general maintenance. Minor wear, surface deterioration and age-related defects were observed to the door and/or associated hardware. In simple terms, the back door is worn and needs attention. This condition is commonly associated with age and weather exposure. If left unmaintained, deterioration may progress and affect operation and weatherproofing. It is recommended that a qualified carpenter or suitably qualified tradesperson carry out adjustments, repairs and re-coating as required. Maintenance can be undertaken at the owner's discretion to prevent further deterioration.

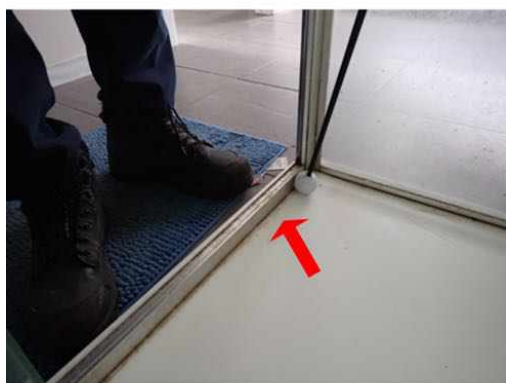
Finding 3.04

Building:	Main Building
Location:	Bathroom
Finding:	Deteriorated Silicone Around Shower Area
Information:	Deteriorated silicone sealant was identified around the shower area. The sealant is cracked, separating and breaking down, reducing its effectiveness in preventing moisture penetration at wall and floor junctions. In simple terms, the silicone around the shower is worn out and failing. This condition is commonly associated with age, regular water exposure and cleaning products. If left unaddressed, water may penetrate behind tiles and into adjoining wall or floor structures, potentially leading to further damage. It is recommended that a licensed tiler or suitably experienced handyman remove and replace the affected silicone to maintain a watertight seal. Repairs can be undertaken at the owner's discretion to prevent further deterioration.

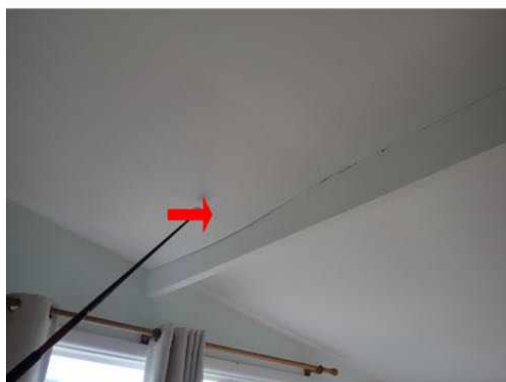
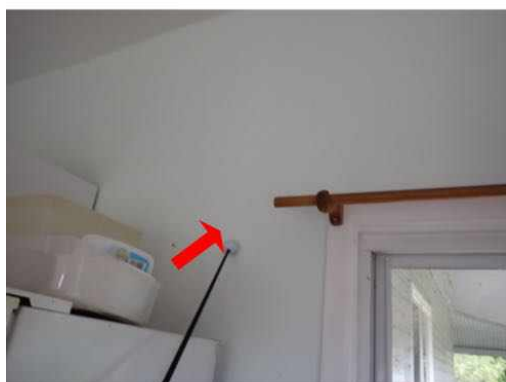
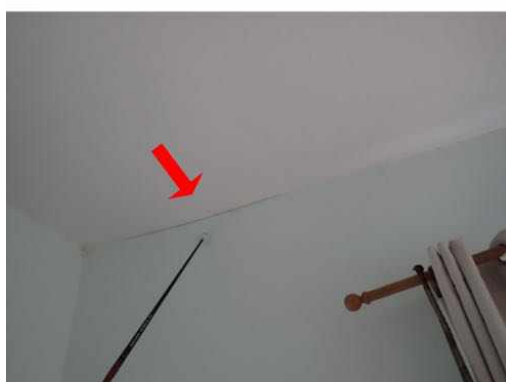
Finding 3.05

Building:	Main Building
Location:	All Areas
Finding:	Minor Cracking and Loose Internal Cladding to Multiple Areas
Information:	Minor cracking and loose sections of internal wall cladding were identified at several locations throughout the building. The cracking appears consistent with minor settlement and age-related movement, and some sheets were not securely fixed. In simple terms, there are small cracks in the wall linings and some areas feel loose. This is a common condition in buildings of this age. If left unaddressed, cracking may widen and loose cladding may move further or detach. It is recommended that a qualified builder or carpenter re-secure loose sheets and repair cracked areas as required. Rectification can be undertaken at the owner's discretion to prevent further deterioration and maintain internal finishes.

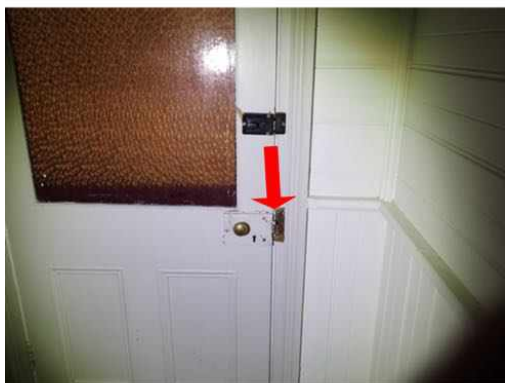
Finding 3.06

Building:	Main Building
Location:	Front door
Finding:	Damage to Front Door Handle
Information:	Damage was identified to the front entry door handle. The handle shows signs of wear and/or impact damage which may affect its operation and overall security. In simple terms, the front door handle is damaged. This condition is commonly caused by age, frequent use or accidental force. If left unaddressed, the handle may become difficult to operate or fail. It is recommended that a qualified locksmith or suitably qualified tradesperson repair or replace the damaged handle as required. Rectification can be undertaken at the owner's discretion to maintain proper function and security.

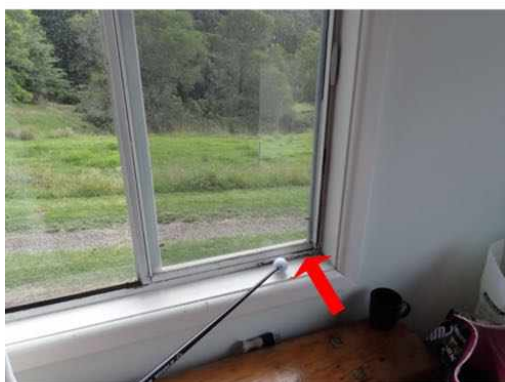
Finding 3.07

Finding: Kitchen Aluminium Window in Average Condition

Information: The aluminium window to the kitchen was operational at the time of inspection; however, it is in average condition with signs of general wear and age-related deterioration. While functional, components such as rollers, seals, tracks or hardware may require maintenance or replacement over time. In plain terms, the window works but is worn and may need attention in the future. Possible causes include normal ageing, weather exposure and lack of maintenance. It is recommended that the window and associated hardware be serviced and maintained as required to ensure continued operation. Repairs or servicing should be carried out by a licensed builder or suitably qualified tradesperson experienced in window repairs. Maintenance and any upgrades are recommended at the owner's discretion.

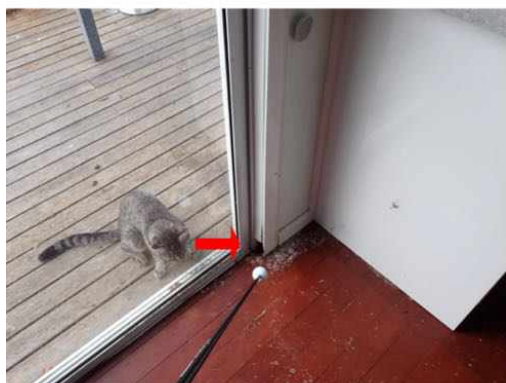
Finding 3.08

Finding: Damaged Sliding Door Jamb – Base

Information: Damage was identified to the lower section of the sliding door jamb. Deterioration at

the base of door frames is commonly associated with impact damage, moisture exposure, or general wear and tear. If left unaddressed, the damage may worsen and affect the operation of the door or allow moisture ingress. In plain terms, the bottom of the sliding door frame is damaged and may continue to deteriorate if not repaired. It is recommended that the affected section be repaired or replaced as required to maintain structural integrity. Repairs should be carried out by a licensed builder or suitably qualified carpenter. Rectification is recommended at the owner's discretion.

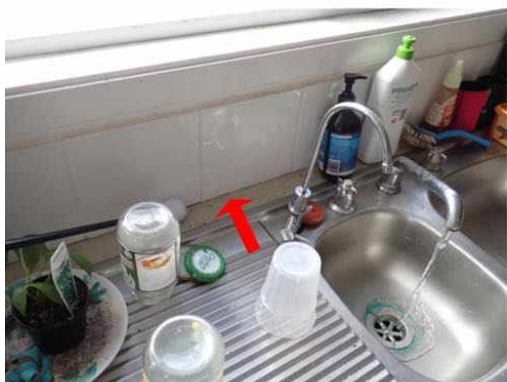
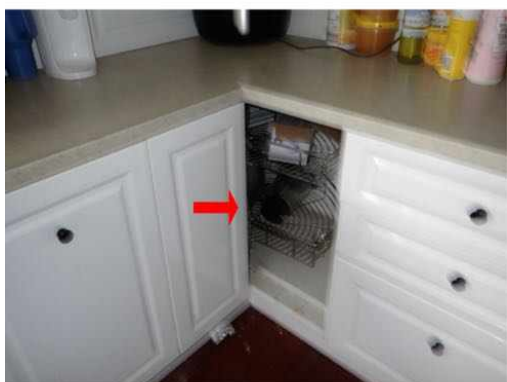
Finding 3.09

Finding: Kitchen in Fair Condition – General Wear

Information: The kitchen was found to be in fair overall condition; however, defects were identified including deteriorated silicone to the tiled splashback/benchtop junction, delaminated bench top edging and a missing cupboard door. The condition observed is consistent with general wear and tear and a lack of routine maintenance. Failed silicone can allow moisture penetration behind cabinetry and wall linings, potentially leading to swelling or further deterioration over time. In plain terms, the kitchen is generally okay but shows signs of age and use, the sealant along the bench has worn out, and one cupboard door is missing. Possible causes include age-related deterioration, regular use, and lack of general maintenance. It is recommended that the silicone be removed and replaced and the missing door repaired or replaced as required. Works should be carried out by a licensed builder, cabinet maker or suitably qualified tradesperson. Rectification is recommended at the owner's discretion to prevent further deterioration.

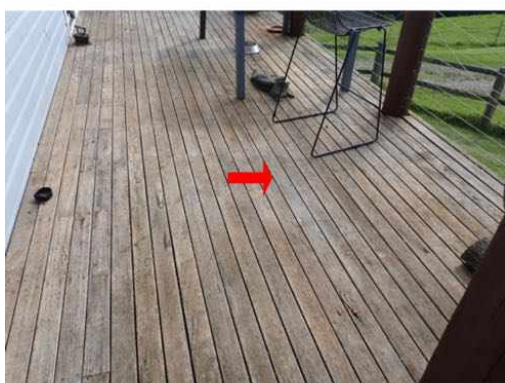
Finding 3.11

Building:	Main Building
Location:	Rear timber patio area
Finding:	Timber Decking in Weathered Condition
Information:	The timber decking was observed to be in a weathered condition with signs of surface deterioration consistent with prolonged exposure to the elements and general wear and tear. Weathered decking may deteriorate further if not maintained and can lead to splitting, cupping or decay over time. In plain terms, the deck timber is worn from age and weather and will continue to deteriorate if not maintained. Possible causes include sun exposure, moisture, lack of regular sealing or coating, and general ageing. It is recommended that the decking be cleaned, sanded and re-coated, and that any damaged boards be repaired or replaced as required. Works should be carried out by a licensed builder or suitably qualified carpenter. Maintenance and any upgrades are recommended at the owner's discretion.

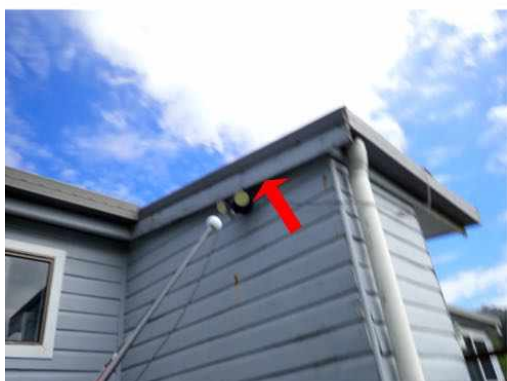
Finding 3.12

Building:	Main Building
Location:	Timber fascia boards
Finding:	Timber Fascia Boards in Weathered Condition – Several Locations
Information:	Timber fascia boards were observed to be in a weathered condition at several locations, with surface deterioration consistent with age, exposure to the elements,

and general lack of maintenance. Weathered fascia boards may continue to deteriorate over time and can lead to splitting, paint failure, or decay if not maintained. In plain terms, several of the fascia boards are worn from weather exposure and will worsen without upkeep. Possible causes include prolonged sun and moisture exposure and lack of regular painting or sealing. It is recommended that the affected fascia boards be prepared and re-coated, and any deteriorated sections repaired or replaced as required. Works should be carried out by a licensed builder or suitably qualified carpenter. Maintenance and any repairs are recommended at the owner's discretion to prevent further deterioration.

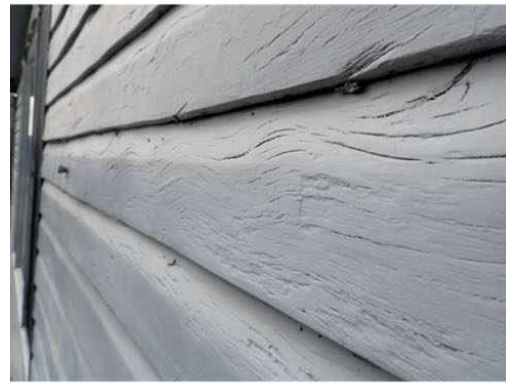
Finding 3.13

Building:	Main Building
Location:	External walls
Finding:	Timber Cladding in Fair Condition for Age
Information:	The timber cladding was found to be in fair condition for the age of the building; however, several areas of age-related deterioration were observed. Deterioration of external cladding may include surface weathering, minor splitting, paint breakdown, or early-stage decay and may worsen over time if not maintained. In plain terms, the cladding is generally reasonable for its age but shows signs of wear and ageing in a few areas. Possible causes include prolonged exposure to sun and moisture, natural ageing, and lack of regular maintenance. It is recommended that the affected areas be prepared, repaired, and re-coated as required, and that any deteriorated sections be

replaced where necessary. Works should be carried out by a licensed builder or suitably qualified carpenter. Maintenance and any repairs are recommended at the owner's discretion to prevent further deterioration.

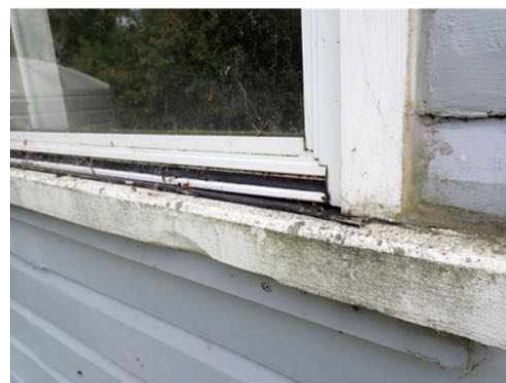
Finding 3.14

Finding: Timber Windows – Age-Related Deterioration

Information: The timber windows were observed to have age-related deterioration, including surface weathering and general wear consistent with the age of the building. Deterioration of timber windows may lead to paint failure, minor splitting, or early-stage decay if not maintained. In plain terms, the timber windows are showing signs of ageing and wear and will continue to deteriorate without upkeep. Possible causes include prolonged exposure to sun and moisture and lack of regular maintenance. It is recommended that the windows be prepared and re-coated, and that any deteriorated sections be repaired or replaced as required. Works should be carried out by a licensed builder or suitably qualified carpenter. Maintenance and any repairs are recommended at the owner's discretion to prevent further deterioration.

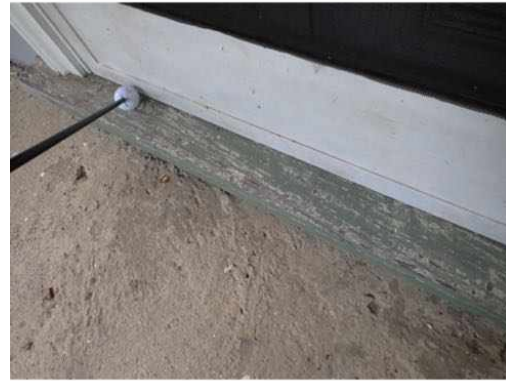
Finding 3.15

Building:	Main Building
Location:	Front door and bedroom doors
Finding:	Front and Bedroom Door Sills in Weathered Condition
Information:	<p>The front door and bedroom door sills were observed to be in a weathered condition with surface deterioration consistent with age, foot traffic and exposure to the elements. Weathered sills may continue to deteriorate over time and can lead to paint failure, minor splitting or decay if not maintained. In plain terms, the bottoms of the door frames are worn and showing signs of ageing and use. Possible causes include regular use, moisture exposure and lack of maintenance. It is recommended that the affected sills be prepared and re-coated, and any deteriorated sections repaired or replaced as required. Works should be carried out by a licensed builder or suitably qualified carpenter. Maintenance and any repairs are recommended at the owner's discretion to prevent further deterioration.</p>

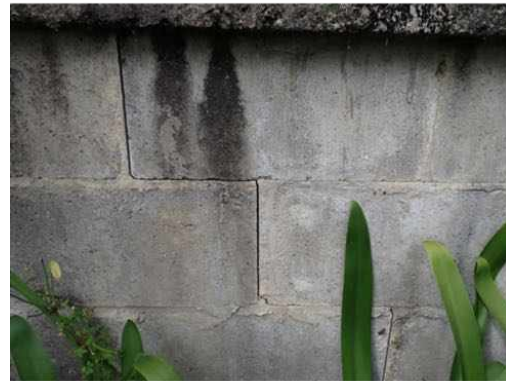
Finding 3.16

Building:	Main Building
Location:	Left hand side of building
Finding:	Minor Step Cracking to Blockwork – Left Hand Side of Building
Information:	<p>Minor step cracking was identified in the blockwork to the left-hand side of the building. Step cracking in masonry can be associated with movement in the footing, foundation settlement, or thermal expansion and contraction. In plain terms, there is a small crack following the mortar joints in the block wall on the left side of the house. Possible causes include minor ground movement, footing movement, or normal material movement over time. It is recommended that the cracking be monitored for any signs of progression and repaired as required to prevent moisture ingress. Repairs should be carried out by a licensed builder or suitably qualified bricklayer. Rectification and monitoring are recommended at the owner's discretion.</p>

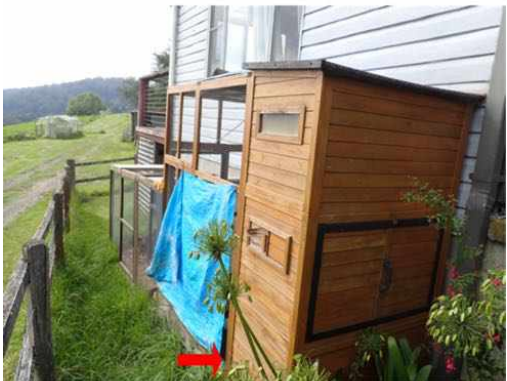
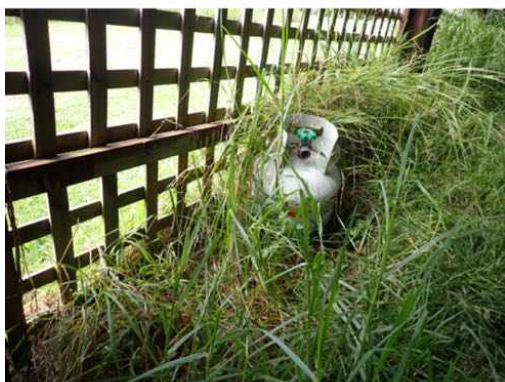
Building: Main Building
Location: Subfloor and perimeter of building
Finding: Timber in Direct Contact with Ground and Stored Timber – Conditions Conducive to Timber Pest Attack
Information: Areas were identified where timber elements, including timber stumps, are in direct contact with the ground, and stored timber was also noted in contact with soil. Timber-to-ground contact and stored timber against or on the ground create

conditions conducive to timber pest attack and increase the risk of decay due to moisture exposure. In plain terms, some structural timbers and stored wood are touching the soil, which makes them more likely to attract termites and rot over time. Possible causes include original construction methods, landscaping changes, ground level build-up, or storage practices. It is recommended that adequate ground clearance be established and maintained between soil and timber components, and that stored timber be removed or relocated off the ground and away from the building. A licensed builder should address any affected structural elements, and a licensed timber pest specialist should assess and advise as required. Rectification is recommended at the owner's discretion to reduce the risk of timber pest attack and deterioration.

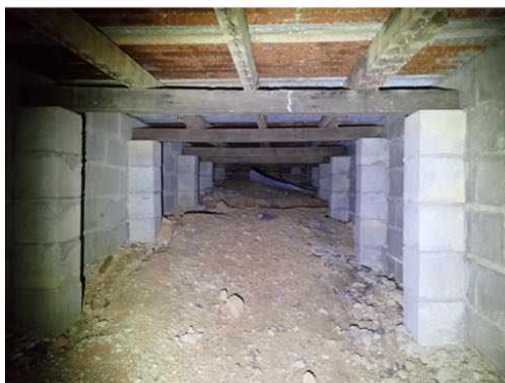
Finding 6.02

Building:	Main Building
Location:	Subfloor
Finding:	Missing Ant Caps – Multiple Locations
Information:	Ant caps were not present at multiple locations to timber supports. The absence of ant caps reduces the ability to detect and deter concealed termite entry into the building. In plain terms, there are no visible termite barriers on several timber supports, which can make it easier for termites to enter unnoticed. Possible causes include original construction practices, alterations, or removal during past works. It is recommended that appropriate termite management measures be installed in accordance with current standards. Works should be carried out by a licensed builder in conjunction with a licensed timber pest specialist. Rectification is recommended at the owner's discretion to reduce the risk of concealed timber pest attack.

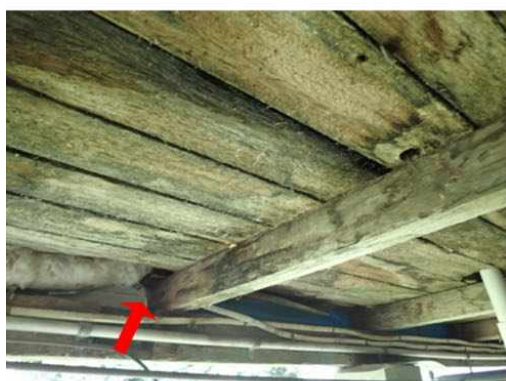
Finding 7.01

Building:	Main Building
Location:	Subfloor
Finding:	Minor Isolated Wood Rot to Subfloor Flooring – Bathroom Area

Information: Isolated areas of timber decay were identified to the subfloor flooring system, particularly beneath the bathroom area. Timber deterioration in wet areas is commonly associated with prolonged moisture exposure and is a common defect in homes of this age. If left unaddressed, decay may progress and impact the structural integrity of the flooring system. In plain terms, some of the timber under the bathroom has rotted, likely due to moisture over time, and could worsen if not repaired. Possible causes include historical or ongoing moisture ingress, inadequate ventilation to the subfloor, plumbing leaks, or failed waterproofing. It is recommended that the affected timbers be further assessed and repaired or replaced as required, and that the moisture source be identified and rectified. Repairs should be carried out by a licensed builder, with plumbing assessed by a licensed plumber if leaks are suspected. Rectification is recommended at the owner's discretion to prevent further deterioration.

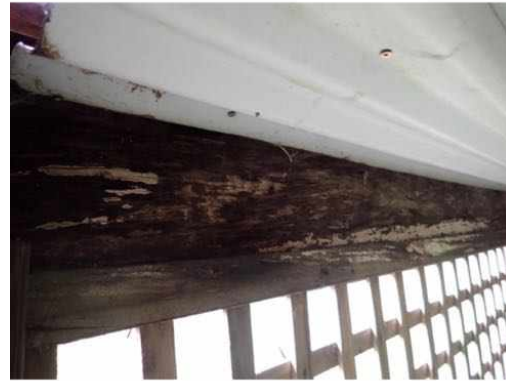
Finding: Wood Rot to Timber Lattice and Surrounding Framing

Information: Timber decay was identified to the lattice and adjacent timber framing. Wood rot in these areas is commonly associated with prolonged moisture exposure and lack of maintenance and may continue to deteriorate if not addressed. In plain terms, the lattice and the timber around it have rotted and will worsen over time if not repaired. Possible causes include weather exposure, water runoff, ground moisture, and failed coatings. It is recommended that the affected lattice and framing be repaired or replaced as required and that protective coatings be reinstated. Works should be carried out by a licensed builder or suitably qualified carpenter. Rectification is recommended at the owner's discretion to prevent further deterioration.

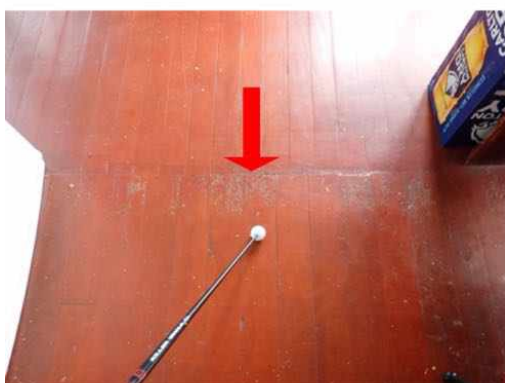
Finding 8.02

Building:	Main Building
Location:	Kitchen
Finding:	Wood Borer Damage to Kitchen Floorboards
Information:	Evidence of timber borer activity was identified to the upper surface of the kitchen floorboards. Timber pest damage can weaken the affected boards and, if active, may continue to cause deterioration. In plain terms, small insects have damaged the timber flooring and it may worsen if not treated. Possible causes include past or current timber borer infestation, elevated moisture levels, or untreated timber. It is recommended that the affected area be assessed to determine whether the infestation is active and treated if required, with damaged boards repaired or replaced as necessary. A licensed timber pest specialist should assess and treat, with repairs carried out by a licensed carpenter. Rectification is recommended at the owner's discretion.

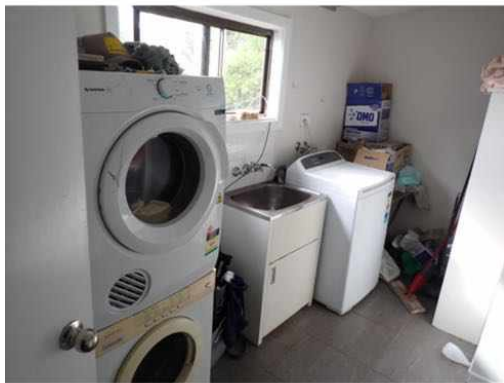
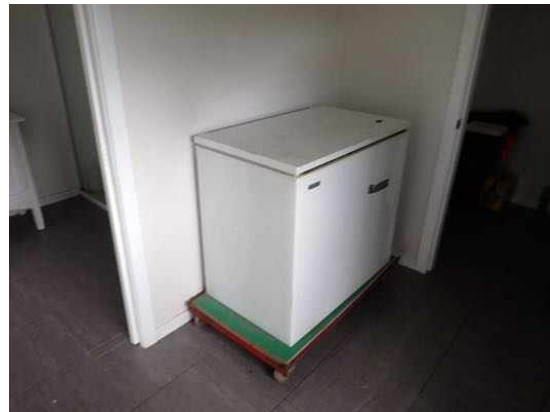
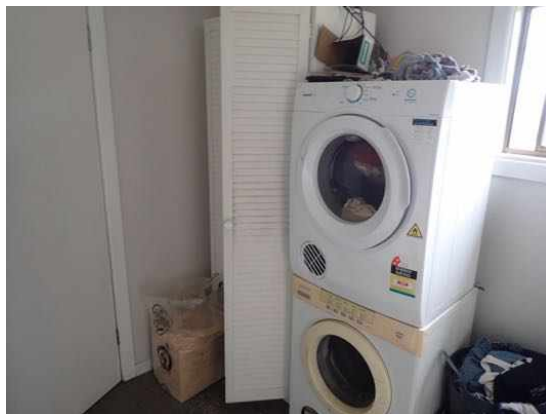
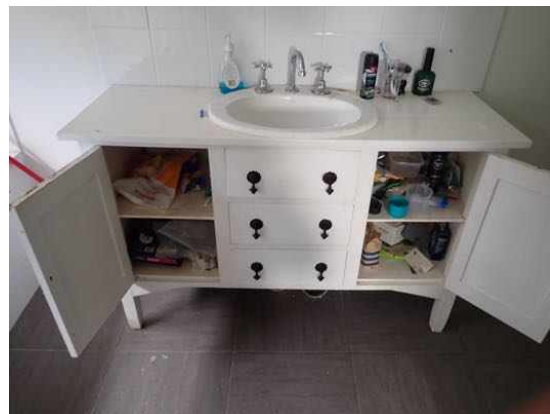
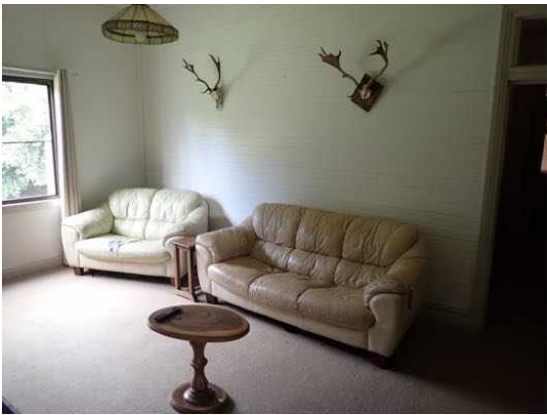
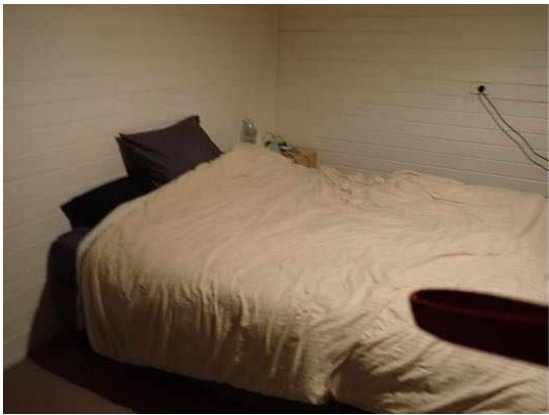
Building: Main Building
Location: All Areas
Finding: Additional Photos - Obstructions and Limitations
Information: These photographs are an indication of the obstructions and limitations which impeded full inspection of the area at the time of inspection. These obstructions can hide an array of defects and should be removed to allow full inspection to be carried out. A re-inspection is recommended once the areas are made accessible.
