Building and Timber Pest Inspection Report

Inspection Date: Wed, 11 Mar 2026

Property Address: 20 Grevillea Pl, Swan Bay NSW 2471,
Australia

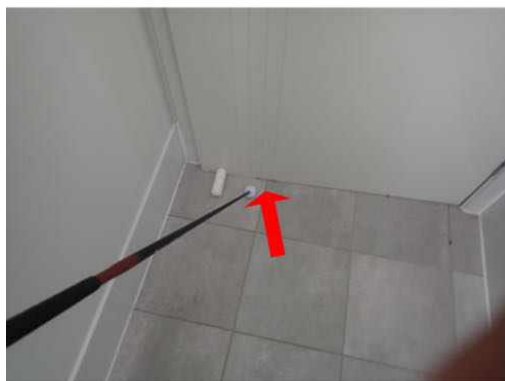
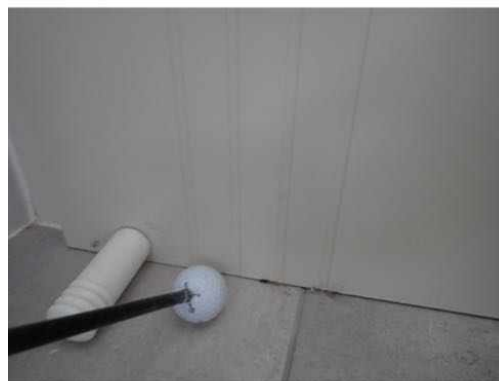
Finding 3.01

Building:	Main Building
Location:	Toilet (WC)
Finding:	Toilet Door Catching on Floor Tiles
Information:	The toilet door was observed catching on the floor tiles during normal operation. Possible causes include minor movement of the building structure, door misalignment, swelling of the door due to moisture, or settlement affecting the door frame. If left unaddressed, the issue may worsen and lead to damage to the door, tiles, or door hardware. Preventative measures include maintaining door hardware and ensuring door frames remain properly aligned. Adjustment, repair, or trimming of the door should be carried out by a licensed carpenter or suitably qualified contractor.

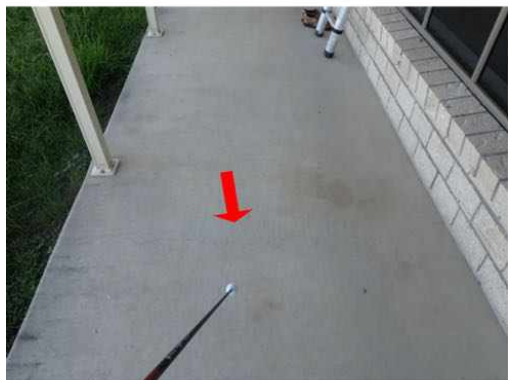
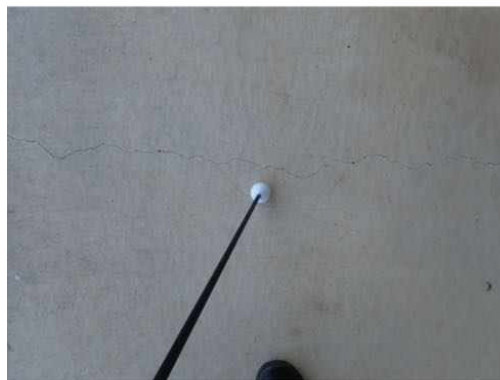
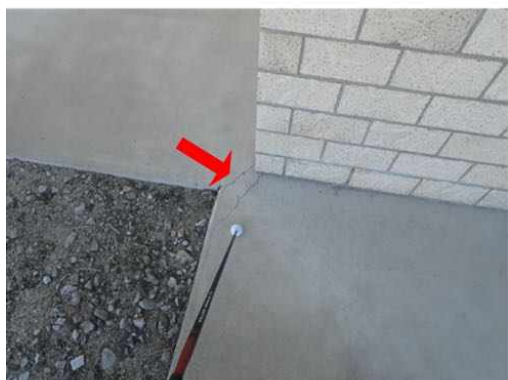
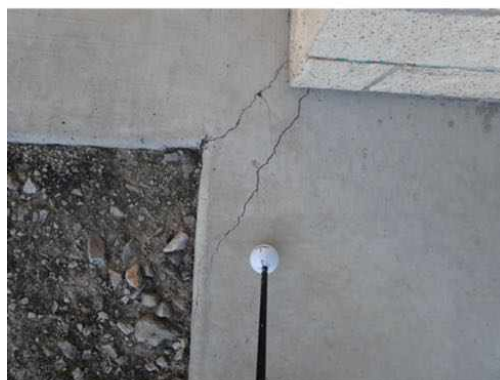
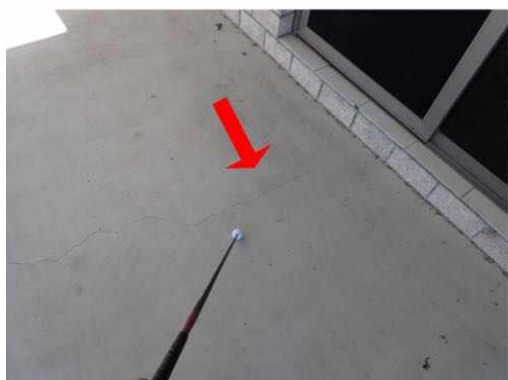
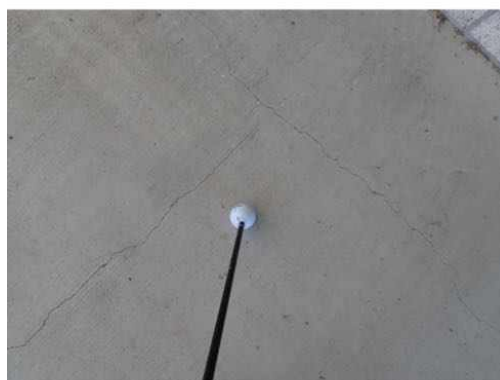
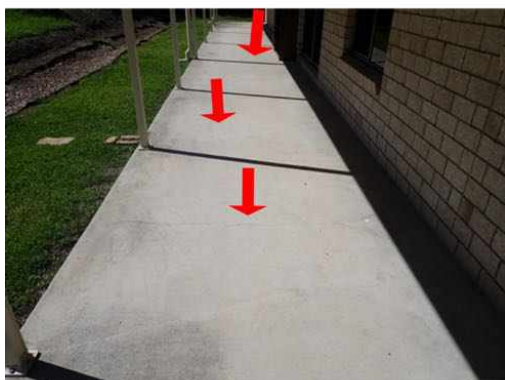
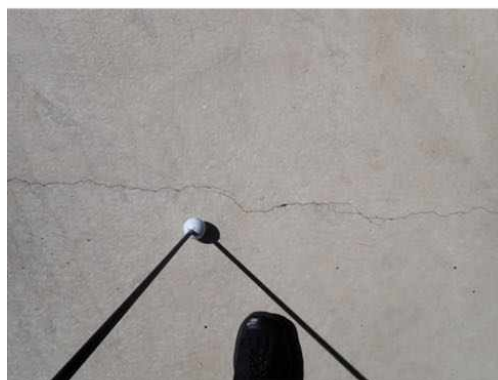
Finding 3.02

Building:	Main Building
Location:	Concrete porch around building
Finding:	Multiple Minor Cracks Identified to Concrete Patio Around Building
Information:	Multiple minor cracks were identified in the concrete patio areas around the building. Cracking of this nature can occur in concrete due to natural shrinkage during the curing process, minor ground movement, or normal settlement of the supporting

ground. Such cracking can occur even in relatively new concrete and is a common occurrence. Preventative measures include maintaining stable ground conditions. Any repairs, if considered necessary, should be carried out by a licensed concreter or builder.

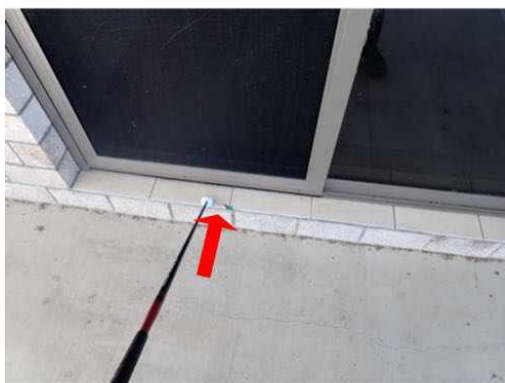
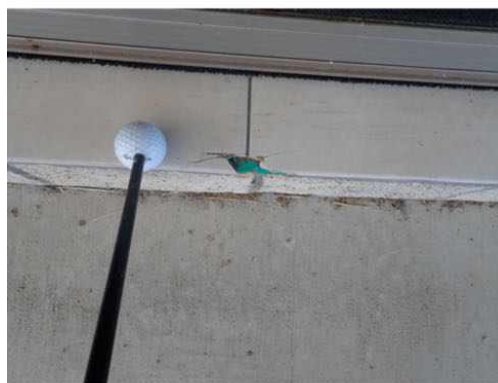
Finding 3.03

Building:	Main Building
Location:	Laundry sliding door
Finding:	Impact Damage to Tiled Sill Outside Laundry
Information:	Impact-related damage was identified to the tiled sill outside the laundry. Possible causes include accidental impact from foot traffic, moving items, or external objects striking the tiled surface. If left unaddressed, the damage may worsen and allow moisture penetration or further deterioration of the surrounding tiles and substrate. Preventative measures include avoiding heavy impact to tiled surfaces and maintaining surrounding finishes. Repairs or replacement of the affected tiles should be carried out by a qualified tiler or suitably licensed contractor.

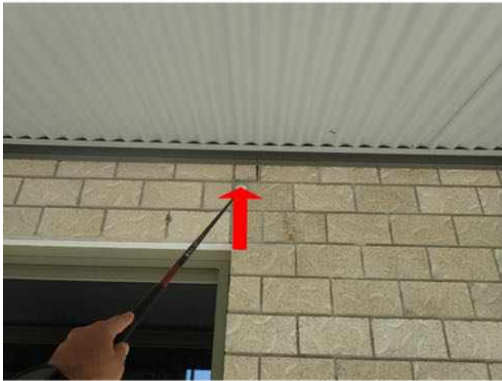
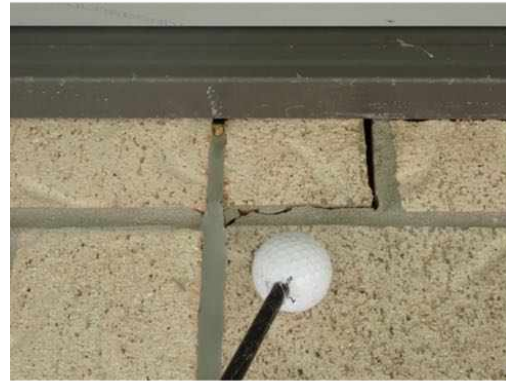
Finding 3.04

Building:	Main Building
Location:	Rear wall
Finding:	Loose Half Brick to Top of Rear Wall
Information:	A loose half brick was identified at the top of the rear wall approximately halfway along the wall. Possible causes include deterioration of the mortar, minor movement within the wall structure, or poor installation. If left unaddressed, the brick may become further loosened and allow continued deterioration of the surrounding mortar joint. Preventative measures include maintaining mortar joints. Re-bedding and securing of

the loose brick should be carried out by a qualified bricklayer or suitably qualified handyman.

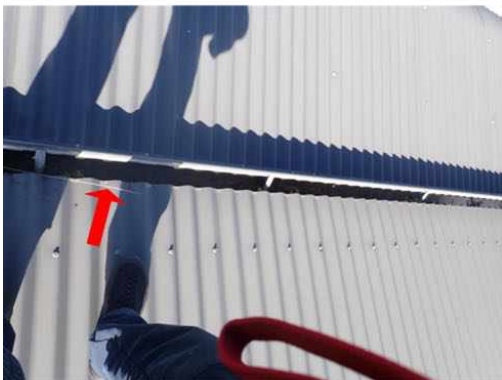
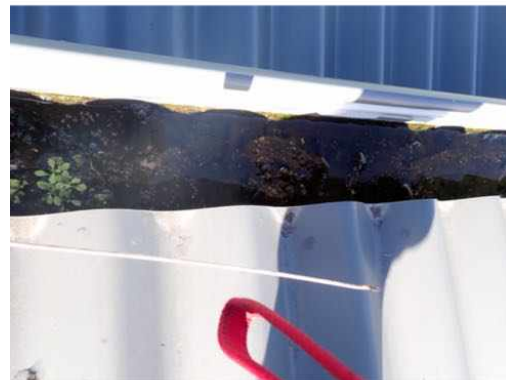
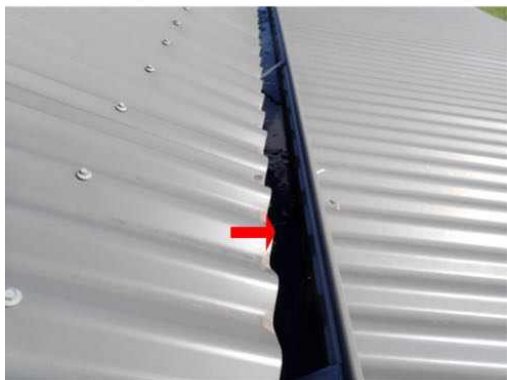
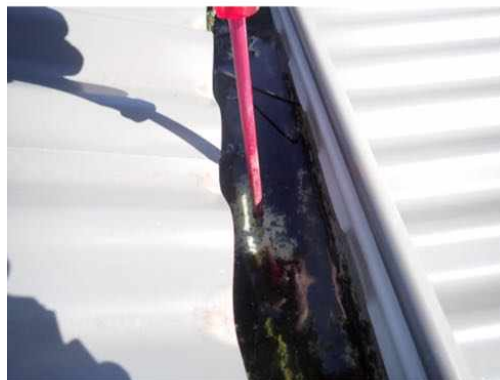
Finding 3.05

Building: Main Building

Location: Roof

Finding: Insufficient Fall to Front and Rear Right-Hand Side Gutters

Information: The front and rear right-hand side gutters were observed to have insufficient fall, resulting in approximately 10 mm of standing water within the gutters at the time of inspection. Standing water in gutters can contribute to accelerated deterioration of the guttering, accumulation of debris, and potential overflow during heavy rainfall. Preventative measures include ensuring gutters are correctly aligned and maintained to allow adequate drainage toward downpipes. Adjustment or re-falling of the affected gutters should be carried out by a licensed roofing plumber or suitably qualified contractor.

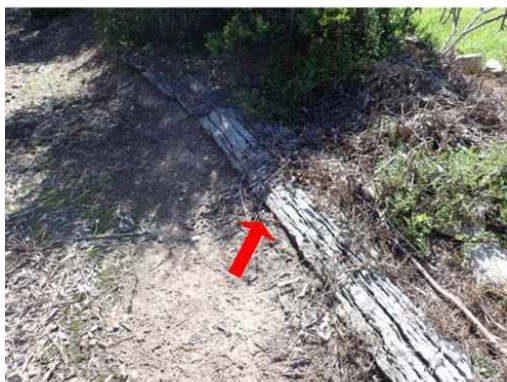
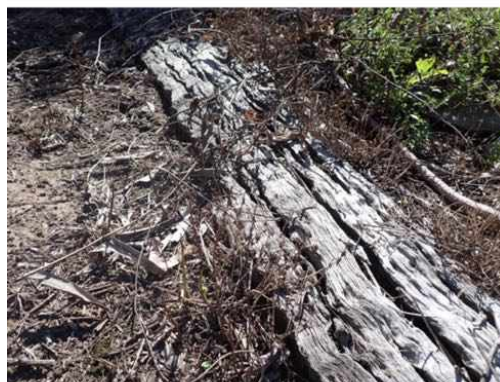
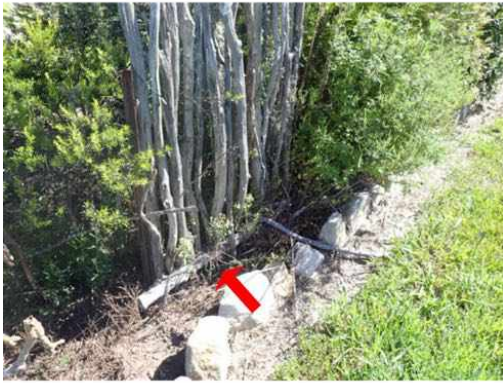
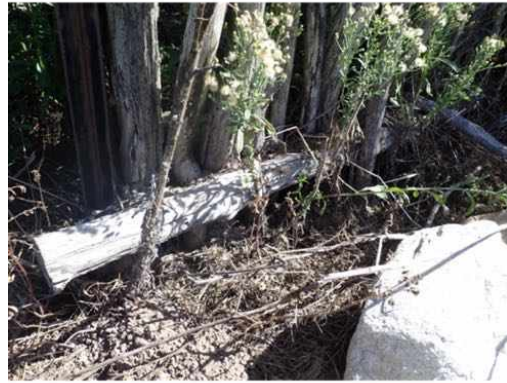
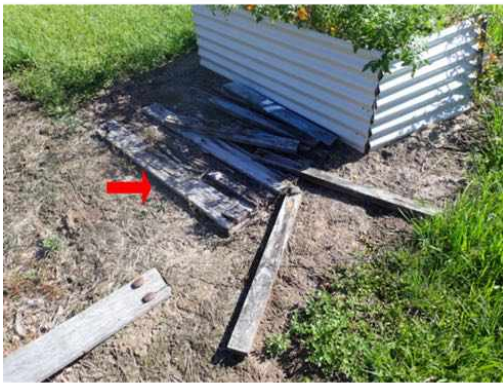
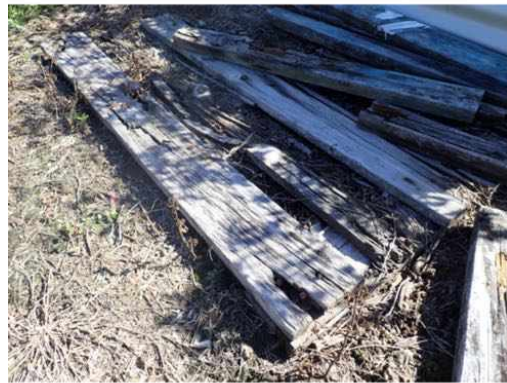
Finding 6.01

Building:	Yard
Location:	Yard
Finding:	Timber in Contact with Ground Around Yard
Information:	Timber elements were identified in direct contact with the ground in areas around the yard. Timber in contact with the ground is considered a condition conducive to termite attack and timber decay due to ongoing moisture exposure. If left unaddressed, the timber may deteriorate further and increase the risk of timber pest activity. Preventative measures include maintaining adequate ground clearance between timber and soil and ensuring surrounding areas are kept dry and well maintained. Rectification works should be carried out by a suitably qualified handyman or relevant contractor.

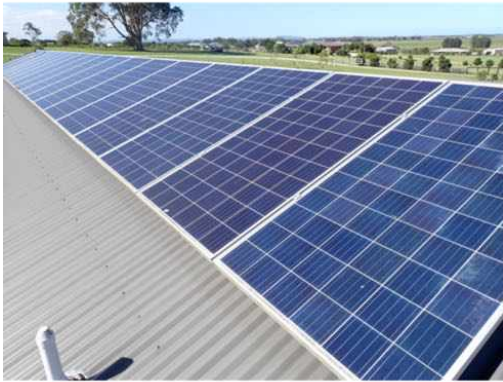
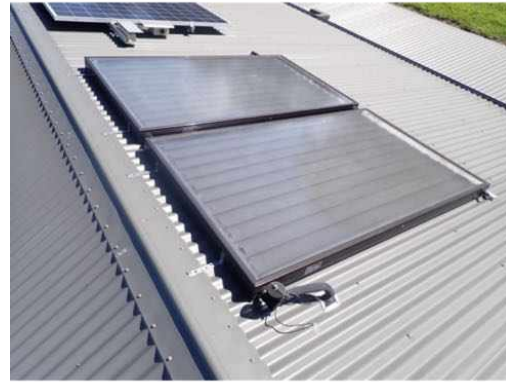
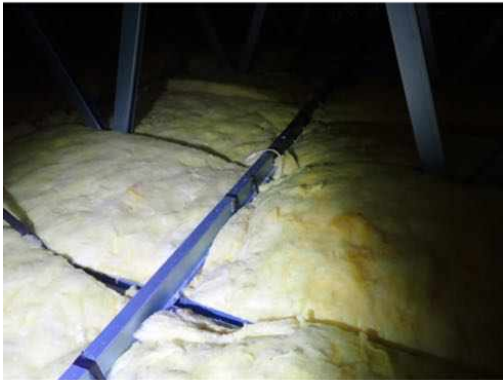
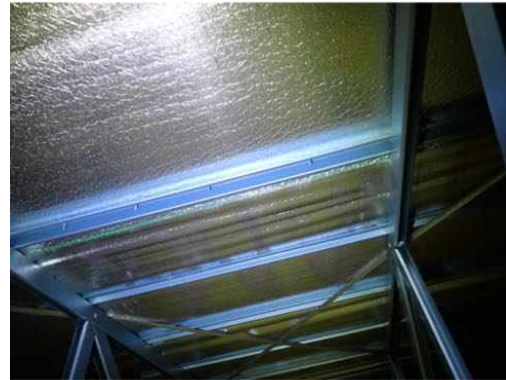
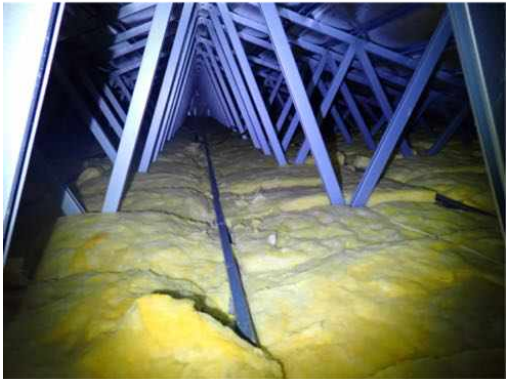
Noted Item

Building: Main Building
Location: All Areas
Finding: Additional Photos - Obstructions and Limitations
Information: These photographs are an indication of the obstructions and limitations which impeded full inspection of the area at the time of inspection. These obstructions can hide an array of defects and should be removed to allow full inspection to be carried out. A re-inspection is recommended once the areas are made accessible.

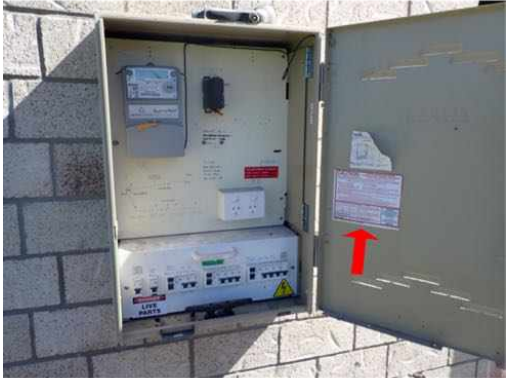
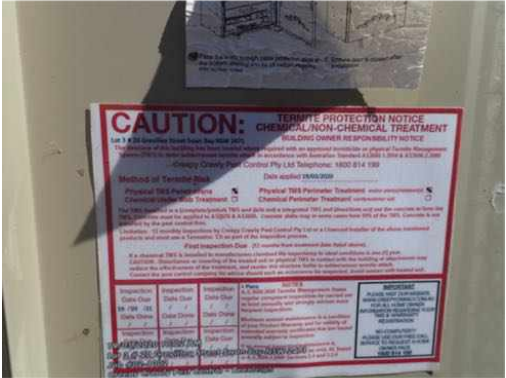
Noted Item

- Building: Main Building
- Location: Right hand side wall in meter box
- Finding: Evidence of a previous termite management system was identified
- Information: There are a number of factors which indicate the presence of a previously installed or applied termite barrier. The most common are a durable notice (to the inside of your meter box) observable physical barriers installed to building perimeter and in ground reticulation systems.

Where a Termite Management System has been identified you should refer to the type of barrier date of installation warranty conditions and any documentation provided by a builder or past owner. Consult the company who installed the barrier to confirm whether the system is still under warranty.
