Building and Timber Pest Inspection Report

Inspection Date: Thu, 15 Jan 2026

Property Address: 2/243 Tongarra Rd, Albion Park NSW 2527,
Australia

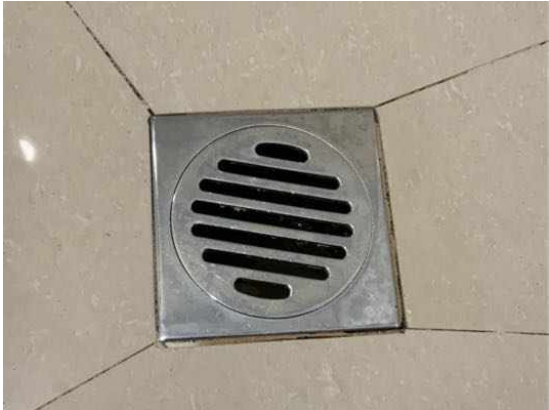
Building:	Main Building
Location:	All Wet Areas
Finding:	Sealant or Grout - Deteriorated, Missing or substandard installation
Information:	Sealant appears to be inadequate to these tiled areas. The different materials and floor areas move at different rates therefore cracking the grout at this point. A flexible sealant is required to allow for this expansion & contraction while keeping the joint water tight and without holes for long term care of all building materials.

Apply a flexible sealant to match the grout that is best suited to the purpose as per product specifications. Regular maintenance &/or replacement of damage or missing sealant is highly recommended to the kitchen benches/splashbacks, vanity top to wall/splashback, laundry tub edge/splashback, wet areas floor edges and the shower floor & wall corners for the long term care of your property.

As a main priority remove damaged grout where applicable and thoroughly clean the area from old sealant, grout and soap scum. (Mouldy sealant is usually caused by dirt & scum sitting behind the sealant from the sealant not sticking adequately to the dirty surfaces).

spray area with spray & wipe (or similar to avoid sealant smearing up the wall) then finally run your finger over the sealant to give a smooth final finish.

Regular maintenance &/or replacement of damage or missing sealant is highly recommended for the long term care of your property.

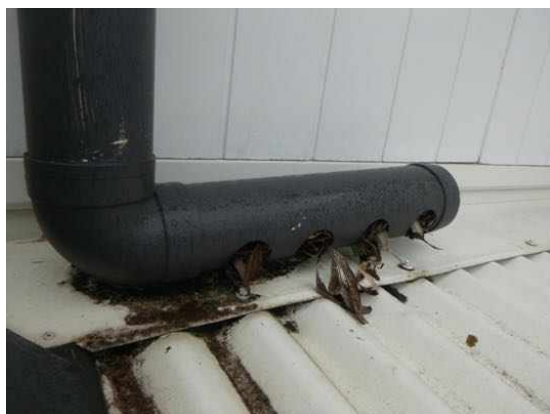
Finding 3.02

Blocked gutters are likely to lead to high levels of moisture in the affected areas. Such moisture will not only cause rust and decay of the associated building materials, but can also provide conditions that are conducive to termite and timber pest activity. Blockages in gutters should therefore be removed immediately to ensure dry conditions are maintained.

Consult a Licensed Plumber for further specific advice on remedial works that may be required. In the interim, it is highly advised that blocked gutters be removed by the homeowner or a general handyperson as a matter of urgency.

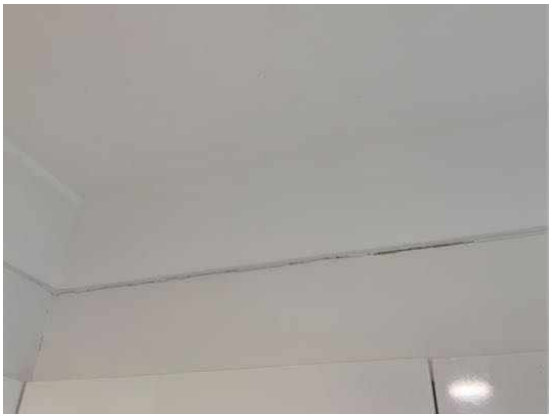
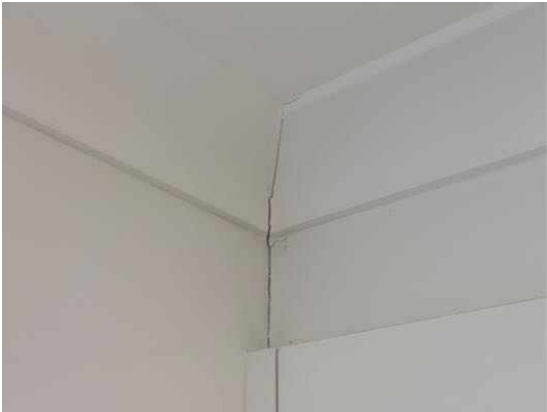
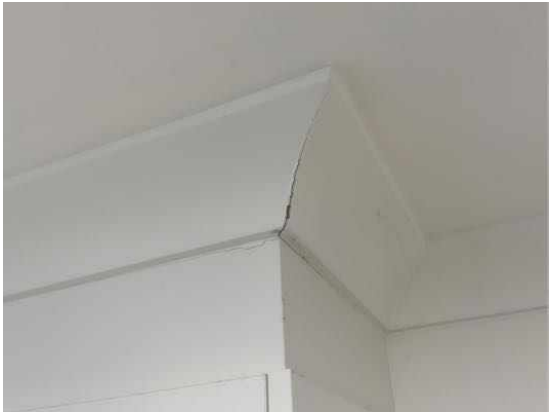
Building: Main Building
Location: All Areas
Finding: Cracking - Damage Category 1 - Fine (up to 1mm)
Information: Although fine cracks are quite noticeable, they are often only considered to be an appearance defect, and usually do not indicate any structural damage. Generally, the cause of a fine crack is indicative of a separation between building materials and finishes (e.g. paint, plaster, etc.) along joints.

Cracking of this nature can generally be repaired with minor sanding, filling and/or repainting. Such works should be performed by a qualified painter or a general handyman.

Monitoring of all cracking should be conducted frequently. Always contact a building inspector should cracks widen, lengthen, or become more numerous.

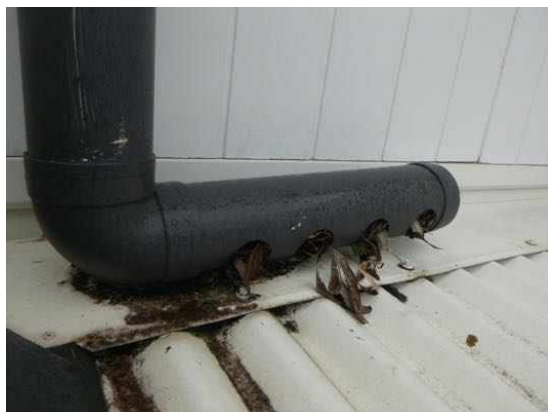
Finding 6.02

Blocked gutters are likely to lead to high levels of moisture in the affected areas. Such moisture will not only cause rust and decay of the associated building materials, but can also provide conditions that are conducive to termite and timber pest activity. Blockages in gutters should therefore be removed immediately to ensure dry conditions are maintained.

Consult a Licensed Plumber for further specific advice on remedial works that may be required. In the interim, it is highly advised that blocked gutters be removed by the homeowner or a general handyperson as a matter of urgency.

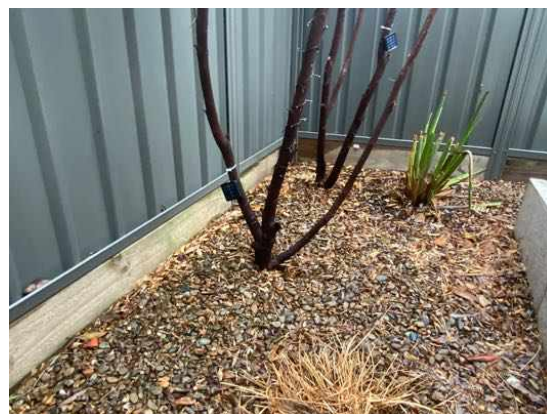
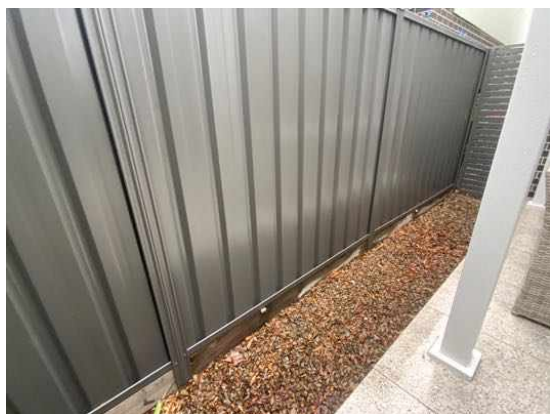
Untreated timbers in direct contact with the ground are likely to develop severe wood rot and/or fungal decay if left unattended creating attraction for subterranean termites to infest the timbers from surrounding areas.

If untreated or non-durable timbers are found to be in a hazardous environment it is highly advised that replacement of these building elements be performed as soon as possible to aid the protection of the property against termite / timber pest attack.

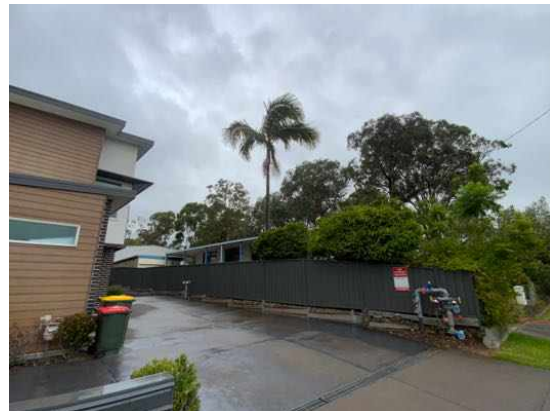
Building: Main Building
Location: All Areas
Finding: Trees within 50m of the property

Information: Trees within 50m of the property can be conducive to termite activity. It is recommended an invasive inspection of all trees with 50m to the property be carried out by a qualified pest control expert.

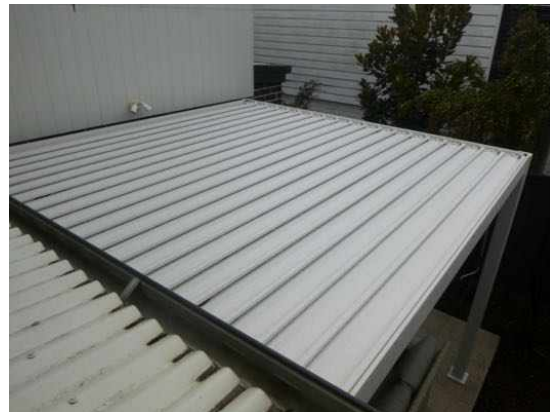
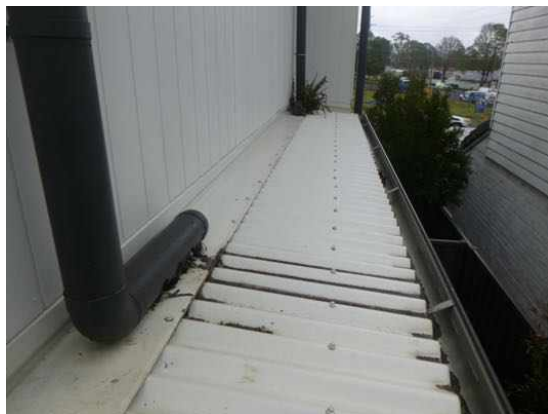
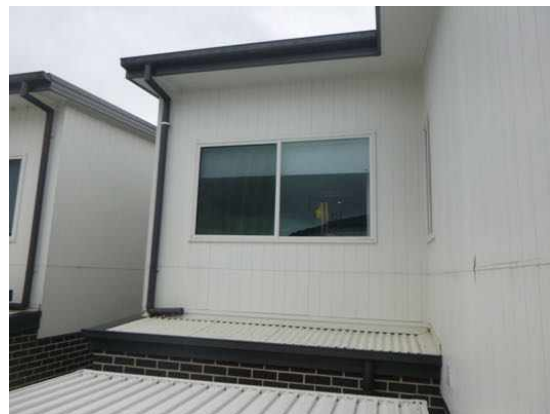
Building: Main Building
 Location: Roof Exterior
 Finding: Additional Photos - Obstructions and Limitations
 Information: These photographs are an indication of the obstructions and limitations which impeded full inspection of the property at the time of inspection. These obstructions can hide an array of defects and should be removed to allow full inspection to be carried out. A re-inspection is recommended once the areas are made accessible.

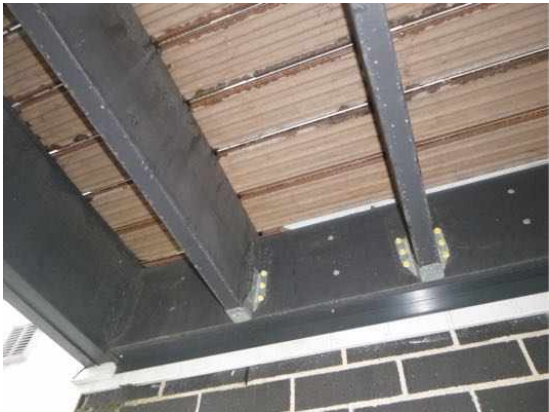
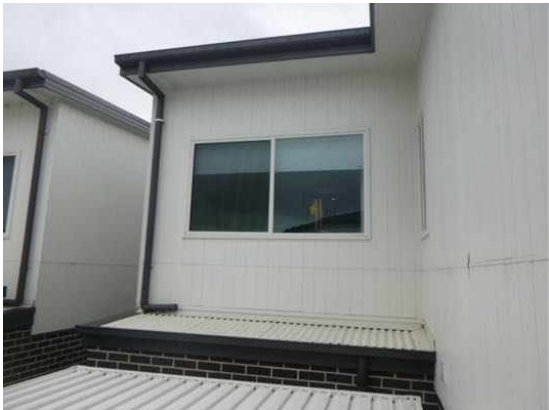
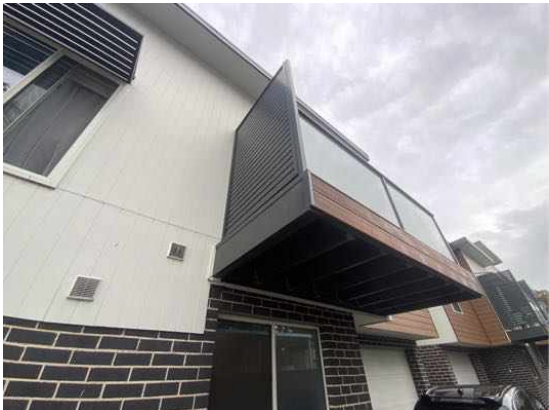
Building: Main Building
 Location: All Areas
 Finding: Additional Photos - Obstructions and Limitations
 Information: These photographs are an indication of the obstructions and limitations which impeded full inspection of the property at the time of inspection. These obstructions can hide an array of defects and should be removed to allow full inspection to be

carried out. A re-inspection is recommended once the areas are made accessible.

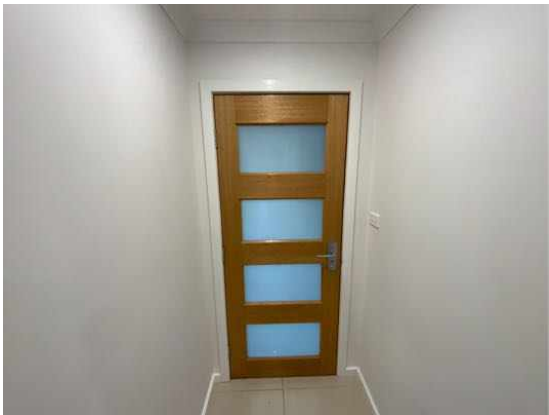
Building: Main Building
Location: All Areas
Finding: Additional Photos - Obstructions and Limitations
Information: These photographs are an indication of the obstructions and limitations which impeded full inspection of the property at the time of inspection. These obstructions can hide an array of defects and should be removed to allow full inspection to be carried out. A re-inspection is recommended once the areas are made accessible.

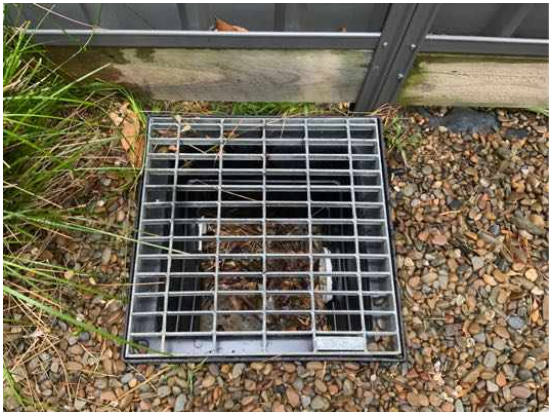
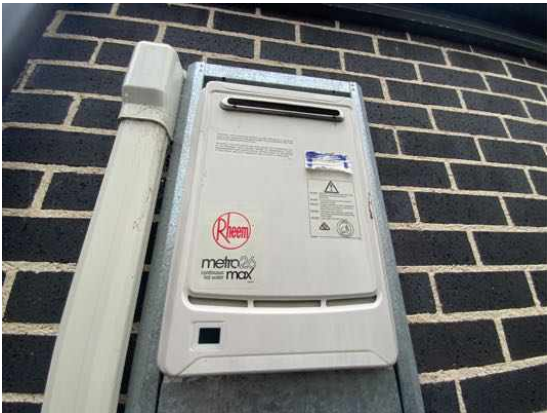
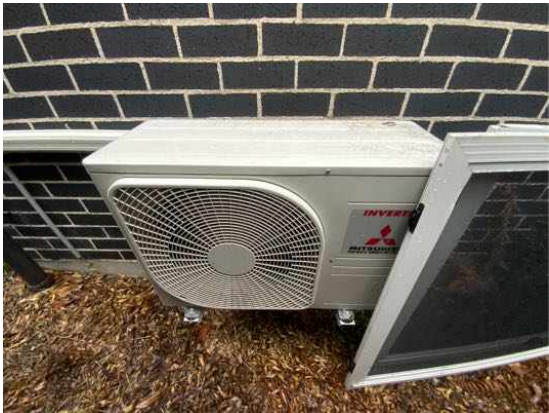
Building: Main Building
Location: All Areas
Finding: Additional Photos
Information:

Additional photos are provided for your general reference. Arrows have been included to highlight areas of importance. Please discuss these photos with your building consultant for clarification.

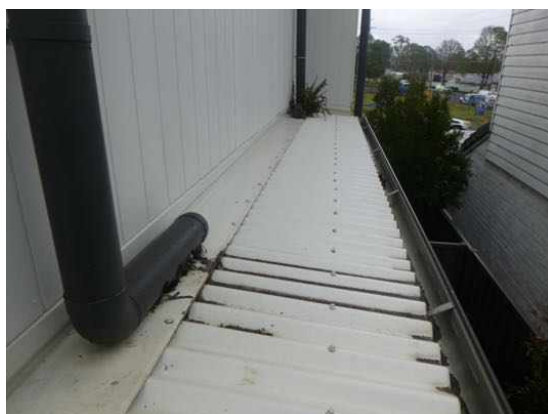
- Any flat roofs and/ or waterproofed areas should be monitored.

A further inspection by a Licensed Roofing contractor is recommended to go over the complete roof covering and advise on the extent of replacement/ repair & maintenance items.

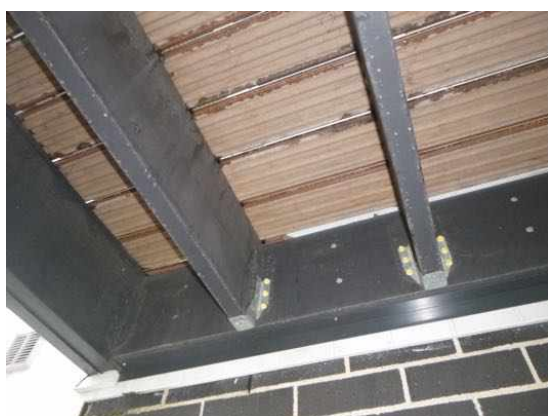
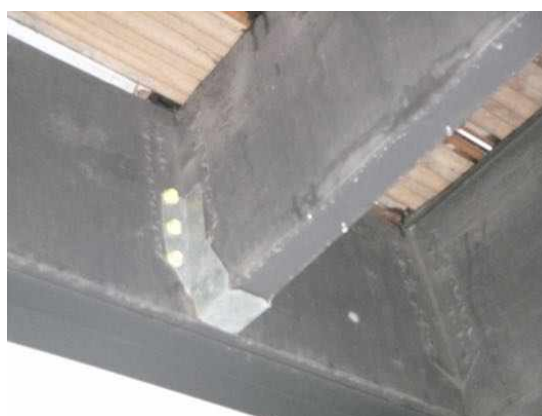
Building:	Main Building
Location:	Balcony, Deck, Verandah or Similar
Finding:	Elevated structure inspections (Elevated Structure)
Information:	Where any elevated Structure (deck, balcony, verandah etc) is present, and this elevated structure is designed to accommodate people, you MUST have this structure checked by an engineer or other suitably qualified person.

You should also arrange annual inspections of the structure by an engineer or other suitably qualified person to ensure any maintenance, that may become necessary, is identified. Care must be taken not to overload the structure.
