# Building and Timber Pest Inspection Report

Inspection Date: Wed, 1 Apr 2026

Property Address: 203 Lang St, Kurri Kurri NSW 2327, Australia

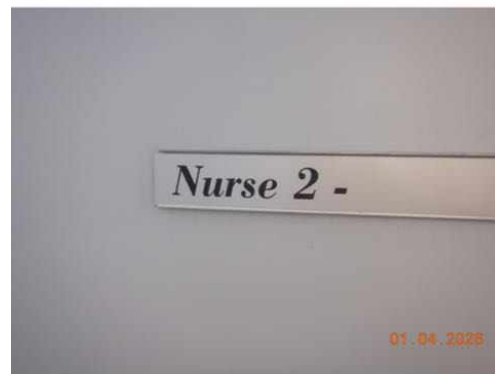
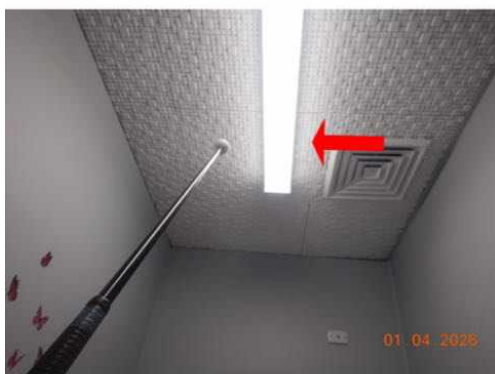
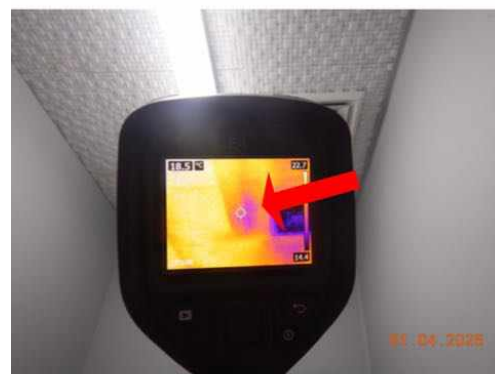
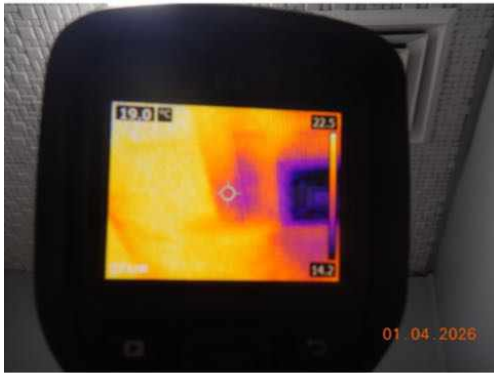
Building: Main Building  
Location: Nurse 2 / Store Room > All Areas  
Finding: Moisture / Light Fitting  
Information: The moisture detected around the fluorescent light fitting in the Nurse 2 / Store Room is a potential safety hazard. Consultation with a licensed electrician and air conditioning technician is advised immediately.

No other persons should be in contact with this light fitting including maintenance personnel until such time as this has been rectified.

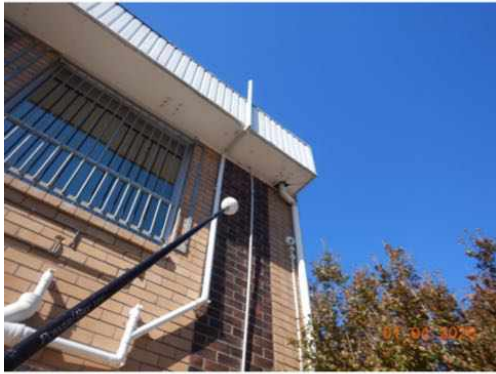
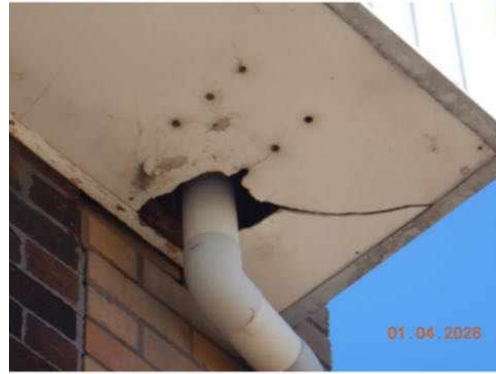
Building: Main Building  
 Location: Roof Exterior > All Areas  
 Finding: Asbestos - Suspected ACM Identified on Site  
 Information: The eaves linings at the rear of the building are suspected of being asbestos containing materials. Please note that a section of the eaves linings were found to be damaged. Reporting on Asbestos is outside the Scope of this Report. This suspected defect is highlighted as a caution only. We suspect, based on our experience in the building industry, that there is a higher risk of the identified building element containing asbestos.

a separate Asbestos Inspection and Condition Audit, which can include the taking of samples for definitive confirmation of the presence of Asbestos.

In the interim, the client is advised to act with caution, especially when considering any damage to building materials general wear and tear renovations extensions demolition and general maintenance activities due to the suspected presence of Asbestos.

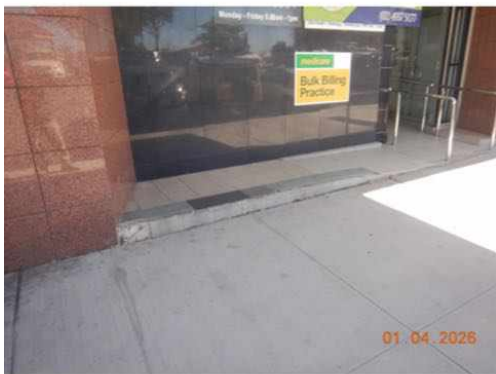
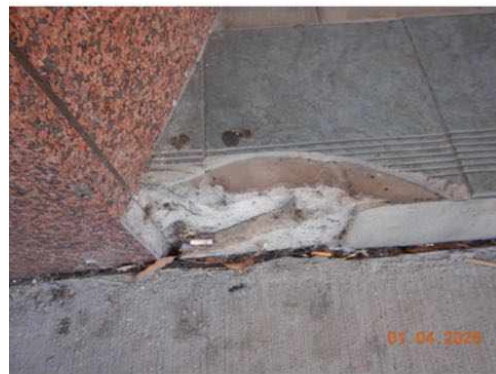
### Finding 1.04

Building:	Main Building
Location:	Front Elevation > All Areas
Finding:	Broken Tiles
Information:	Broken tiles at the front of the building are considered to be a potential safety hazard. Replacement as soon as practicable is advised, consultation with a tiling contractor should be considered.

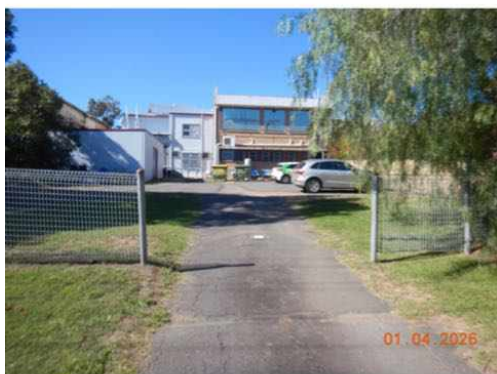
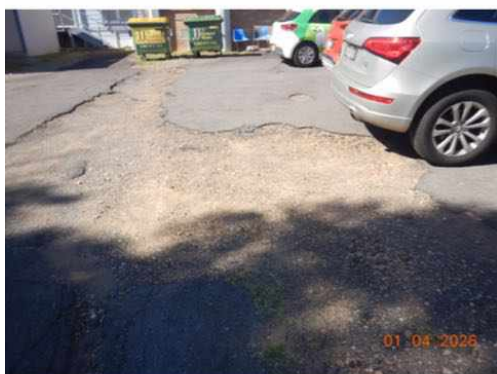
### Finding 1.06

Building: Main Building  
 Location: Rear Elevation > All Areas  
 Finding: Car Park - Deteriorated  
 Information: The deterioration to the car parking at the rear is a potential trip hazard and should be rectified as soon as practicable. Consultation with an asphalt contractor is advised at the client's discretion.

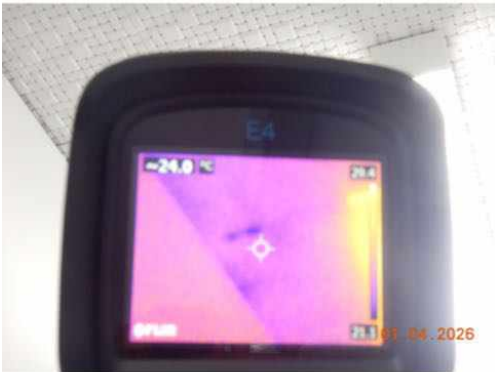
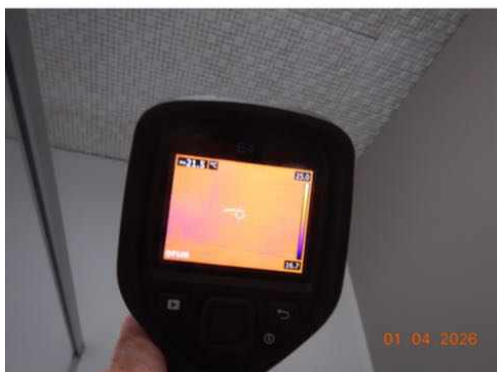
Building:	Main Building
Location:	All Internal Areas upstairs > All Areas
Finding:	Air Conditioning - Leaking
Information:	At the time of inspection water staining and or moisture was detected on the ceiling tiles in selected areas of the medical practice. The moisture detected with the thermal imaging camera indicates that the air conditioning unit and or the associated ducting is leaking.

Please note that the purple images on the screen of the thermal imaging camera highlight the moisture. It is strongly advised that an air conditioning technician be engaged to rectify any issues as soon as practicable.

It is important to note that I overheard a staff member saying that the air conditioning unit is in poor condition and that there is only one technician who is able to service and repair this item.

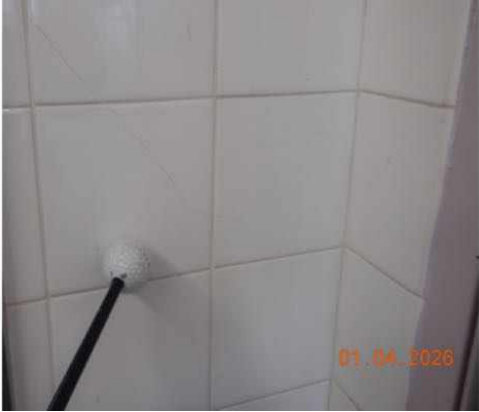
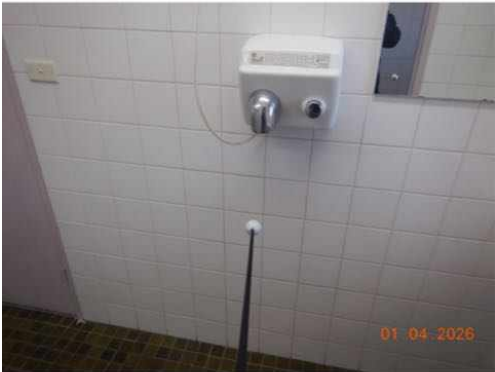
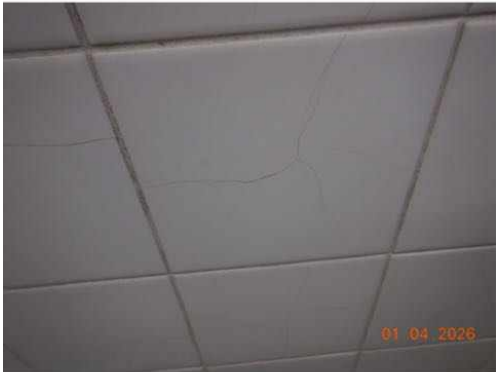
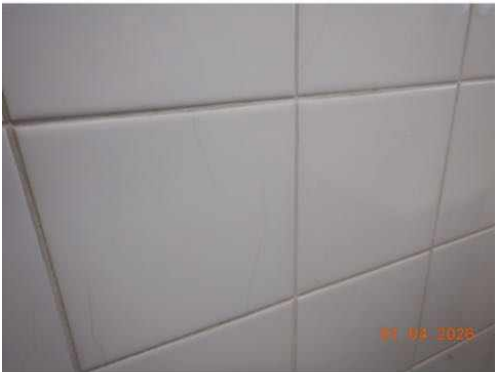
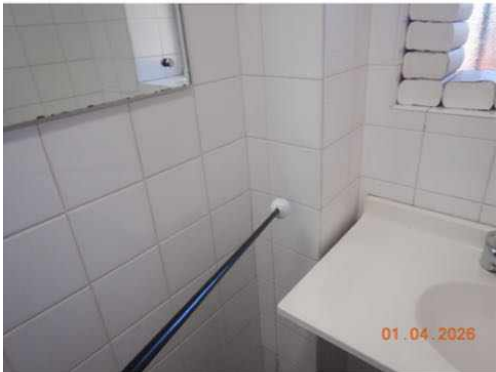
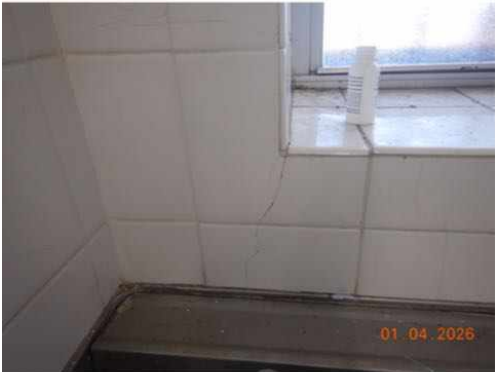
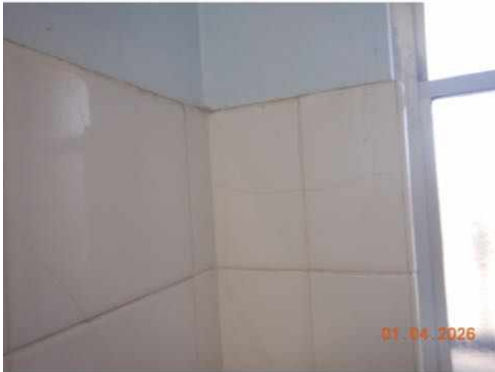
## Finding 2.02

Building:	Main Building
Location:	Toilet (WC) Downstairs > All Areas
Finding:	Tiles - Cracked or damaged
Information:	Cracking was evident to the tiling in this area at the time of inspection. While the cracking appears to be minor, this area is frequently exposed to water, allowing potential for water penetration into adjoining sections of walls or flooring.

If left unmanaged, water penetration to these areas may lead to subsequent water damage, which is likely necessitate repair work to affected building elements.

It is important to note that the majority of wall tiles in both downstairs toilet areas are cracked and or damaged.

A tiling contractor should be appointed to ensure that no further water damage occurs. The re-application of silicone and grouting throughout remaining tile work is also advised, to further protect the area against water penetration.

Where water penetration has led to water damage, appointment of a relevant tradesperson may be required to repair damaged building elements.

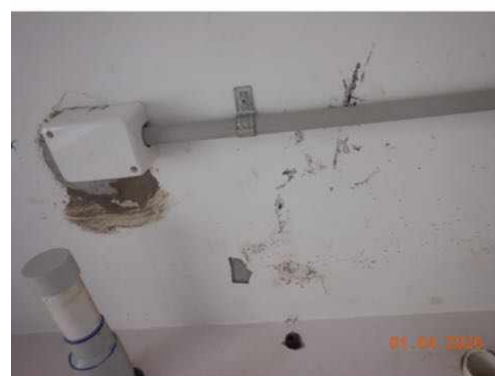
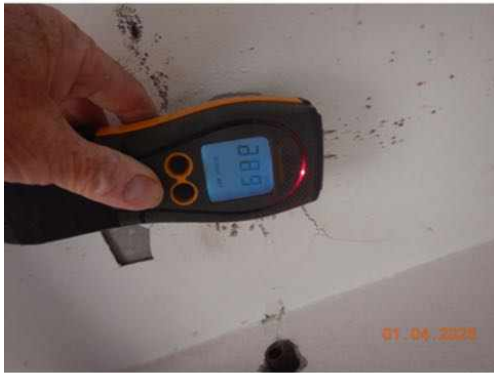
Finding 2.03

Building: Main Building  
Location: Toilet (WC) Downstairs > All Areas  
Finding: Mould - Present  
Information: What appears to be mould was noted to the toilet ceiling in the downstairs women's toilet, Moisture was detected in this area. Where evidence of mould growth was noted, there may be environmental, biological or health issues associated with the report. A specialist inspection by a suitably qualified environmental health inspector is warranted, where mould is extensive or where any queries regarding air quality spores or other related issues apply.

Please note that the highest detectable surface reading on this device is 999, the wet range starts at 200, the reading detected was 289.

Generally, the client is advised to ensure that the general environment is free of moisture and humidity to aid in the prevention of mould formation and development. Any mould found during the inspection should be cleaned immediately by a cleaning contractor or the homeowner as applicable.

Please note that severely affected building elements may require replacement by a registered builder or qualified carpenter.

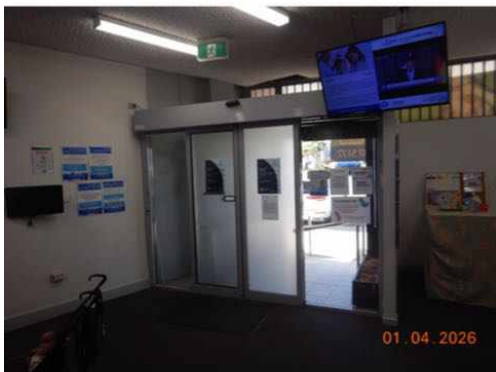
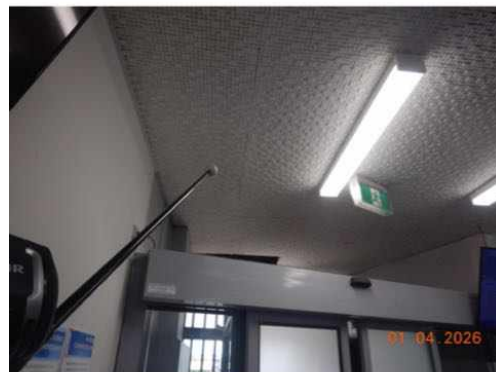
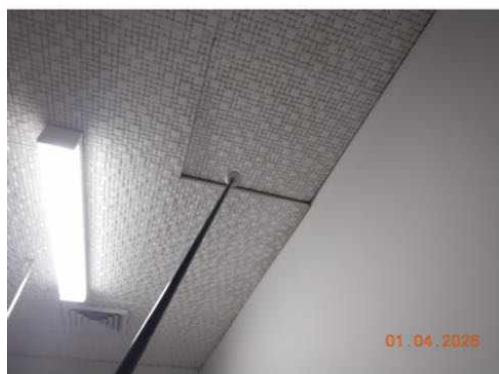
Building:	Main Building
Location:	All Internal Areas upstairs > All Areas
Finding:	Ceiling Tiles - Damaged / Deteriorated
Information:	Damaged and or deteriorated ceiling tiles were noted throughout the medical practice areas. While some of the damage is related to leaks from the air conditioning unit and associated ducting ( Please refer to defect related to Air Conditioning- Leaks ) the majority of the damage and or deterioration appears to be age appropriate.

Repair and or replacement of the affected ceiling tiles is at the client's discretion, consultation with a building contractor is advised.

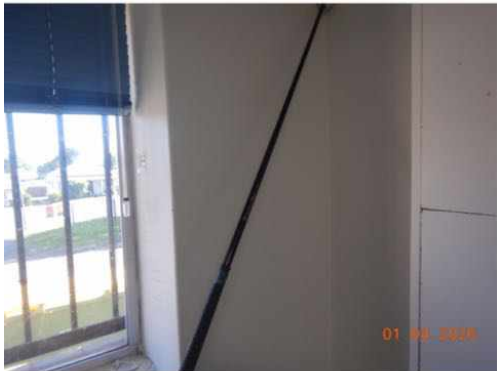
### Finding 3.02

Building:	Main Building
Location:	All Internal Areas > All Areas
Finding:	Render - Drummy
Information:	Drummy rendered areas were identified at the time of inspection. The term 'drummy' refers to render that has become detached from its fixing, despite it still being solid. Such defects are generally caused by physical or moisture damage to the area. Drummy render may also be a direct result of poor workmanship during the construction process.

Render may swell and shrink with changes in air humidity if the area has sustained moisture damage. Any exposure to moisture is capable of causing rendered areas to become drummy and/or cracked over a prolonged period of time. Drummy render generally requires chipping off and re-rendering or painting.

Please note that no moisture was detected in any of the affected areas.

Specialist trades are available for these types of services. A registered builder may be required to undertake works if damage is extensive, or if secondary building defects have resulted. Immediate action is recommended to ensure that no further damage is sustained in the affected area.

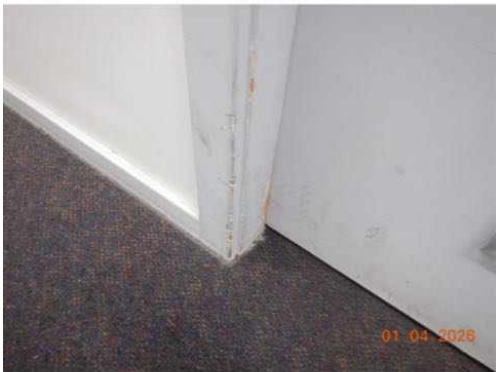
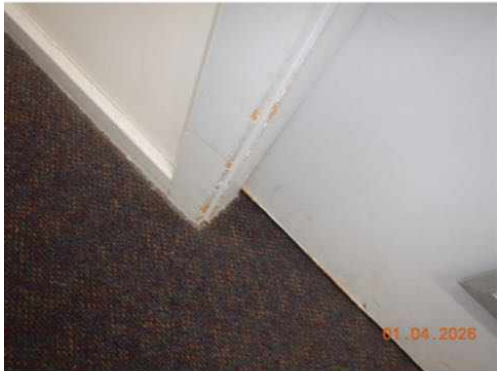
**Finding 3.03**

Building: Main Building  
Location: All Internal Areas upstairs > All Areas  
Finding: Minor Damage  
Information: Minor damage associated with general wear and tear was noted to architraves, skirtings and the bottom edge of a door. Replacement is at the client’s discretion.

Please note that the attached photos are not an exhaustive list, they are however an indication of the damage to these items throughout the medical practice.

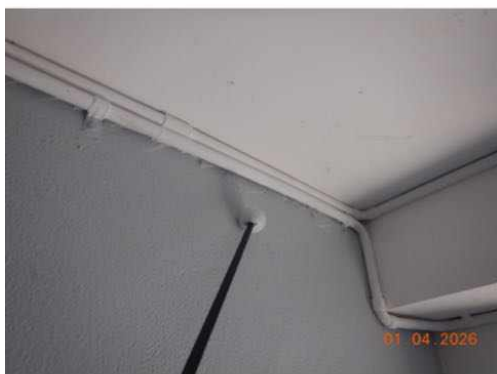
Building: Main Building  
Location: Stairs - Internal > All Areas  
Finding: Cracks to internal render - Category 3  
Information: It has been observed that cracking to internal rendered surfaces has occurred. The degree of damage falls within Category 3, described as cracks which can be repaired with consideration that a section of wall may need to re-rendered.

The cracks are generally 5-15mm in width, or may present as a number of cracks 3mm or more in a group. Damage of this category is a defect that requires rectification work, which may be more extensive.

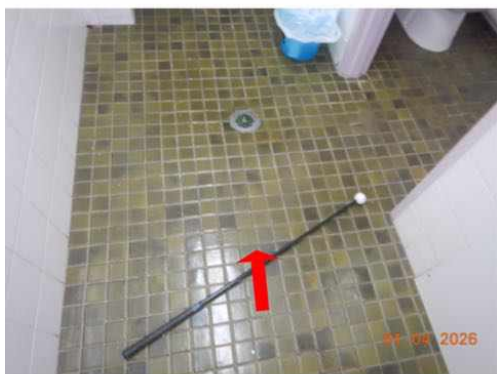
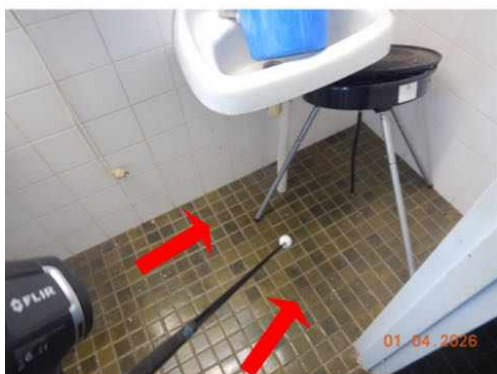
### Finding 3.06

Building:	Main Building
Location:	Toilet (WC) Downstairs > All Areas
Finding:	Tiles - Drummy
Information:	Drummy tiled areas were identified at the time of inspection. The term 'drummy' refers to tiles that have become detached from their fixing, despite otherwise being in relatively good condition. Such defects are generally caused by physical or moisture damage to the area. Drummy tiled areas may also be a direct result of poor workmanship during the construction process.

Tiled areas may swell and shrink with changes in air humidity if the area has sustained moisture damage. Any exposure to moisture is capable of causing tiled areas to become drummy and/or cracked over a prolonged period of time. Drummy tiled areas generally require removal and replacement of affected tiles, with adequate sealant and grouting.

Specialist trades are available for these types of services. A registered builder may be required to undertake works if damage is extensive or if secondary building defects have resulted. Otherwise, it is advised that a tiling contractor be appointed to perform works as necessary. Immediate action is recommended to ensure that no further damage is sustained in the affected area.

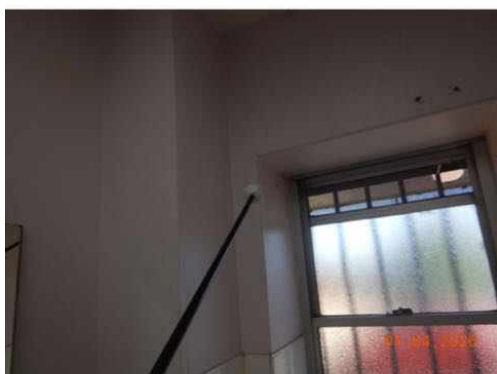
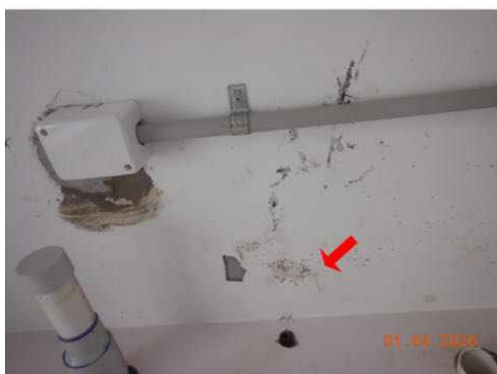
### Finding 3.07

Building: Main Building  
 Location: Toilet (WC) Downstairs > All Areas  
 Finding: Cracks to internal render - Category 1  
 Information: It has been observed that cracking to internal rendered surfaces has occurred. The degree of damage falls within Category 1, described as fine cracks that do not need repair and which are less than 1.0mm in width limit.

Damage of this category is not considered a defect for rectification. Always contact your building inspector should cracks widen, lengthen, or become more numerous.

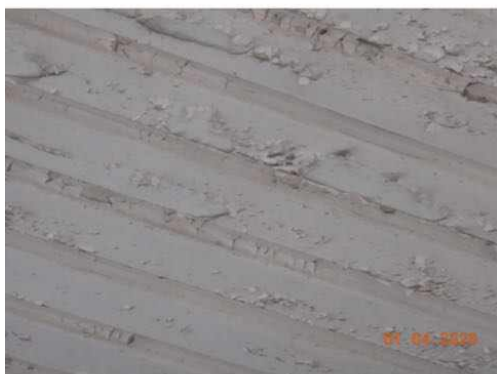
Building: Main Building  
Location: Roof Exterior > All Areas  
Finding: Awning Roof  
Information: The paint finish to the underside of the awning roof was found to be peeling and deteriorated. Consultation with a painting contractor is required to prevent further deterioration.

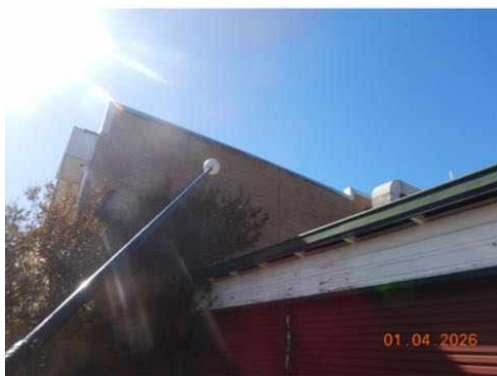
### Finding 3.10

Building:	Main Building
Location:	Roof Exterior > All Areas
Finding:	Roof Exterior
Information:	A flashing covering the top of an external brick wall on the right hand side of the building ( when looking from the rear of the building ) was found to have dislodged. Rectification is advised to prevent any damage from occurring. Consultation with a metal roofing contractor as soon as practicable is strongly advised.

It is important to note that the roof exterior was unable to be safely accessed, there is therefore a high risk of undetected defects in that area.

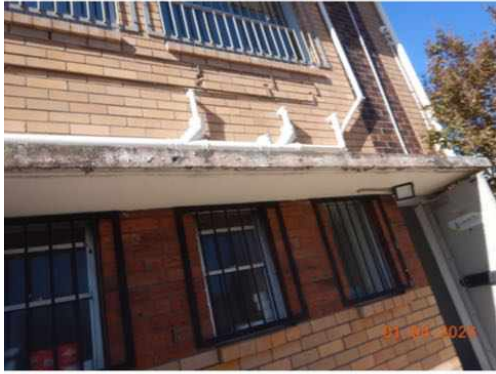
Building: Main Building  
Location: Exterior walls - rear > All Areas  
Finding: Concrete - Cracked  
Information: Cracking to the suspended concrete slab was noted at the rear of the building. Please note that the paint finish to the exposed part of the slab has deteriorated. Consultation with a painting contractor is advised.

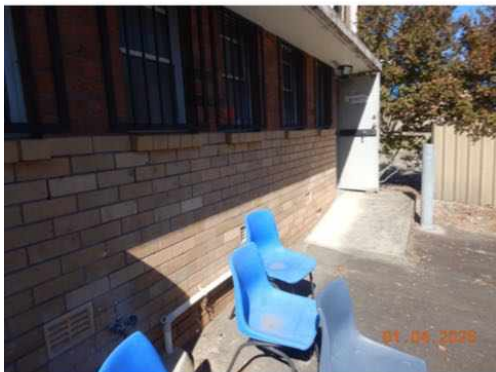
### Finding 3.13

Finding: Brickwork - Cracking [Fine]

Information: Although fine cracks are quite noticeable, they are often only considered to be an appearance defect and usually do not indicate any structural damage. Generally, the cause of a fine crack is indicative of a separation between brickwork and mortar throughout the structure, but single bricks may also show cracks of this nature.

Cracking of this nature can generally be repaired with minor filling and should be conducted by a qualified bricklayer.

Always contact a building inspector should cracks widen lengthen or become more numerous.

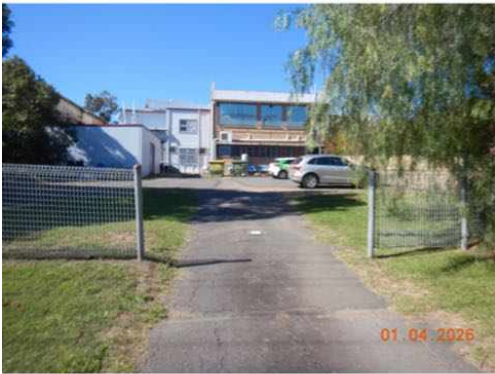
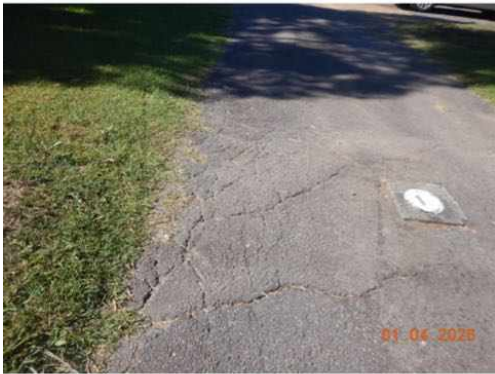
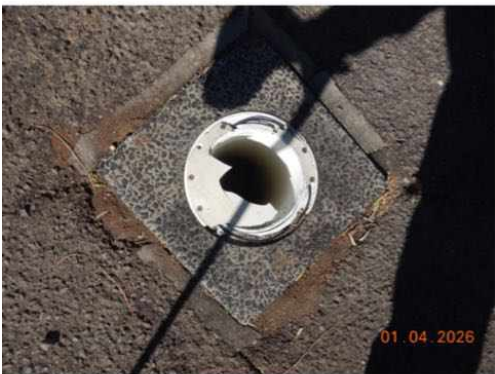
**Finding 3.14**

Building: Main Building  
Location: Rear Elevation > All Areas  
Finding: Plumbing Inspection Point  
Information: The cap associated with a plumbing inspection point was found to be broken , replacement is advised. Consultation with a plumber is advised.

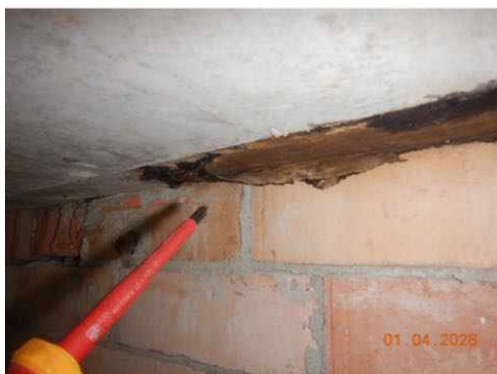
**Finding 3.15**

**Information:** The bitumen coated Malfoid flashing in the subfloor area is suspected of being an asbestos containing material. Reporting on Asbestos is outside the Scope of this Report. This suspected defect is highlighted as a caution only. We suspect, based on our experience in the building industry, that there is a higher risk of the identified building element containing asbestos.

As Asbestos Reporting is outside the scope of this report, we advise that you consider a separate Asbestos Inspection and Condition Audit, which can include the taking of samples for definitive confirmation of the presence of Asbestos.

In the interim, the client is advised to act with caution, especially when considering any damage to building materials general wear and tear renovations extensions demolition and general maintenance activities due to the suspected presence of Asbestos.

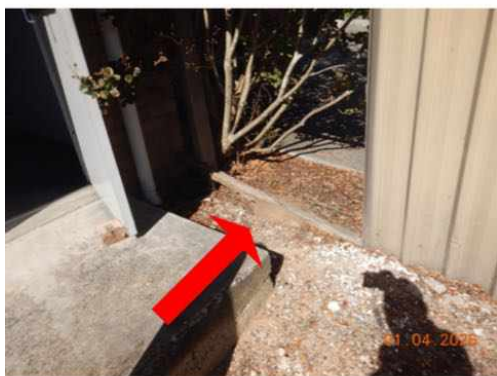
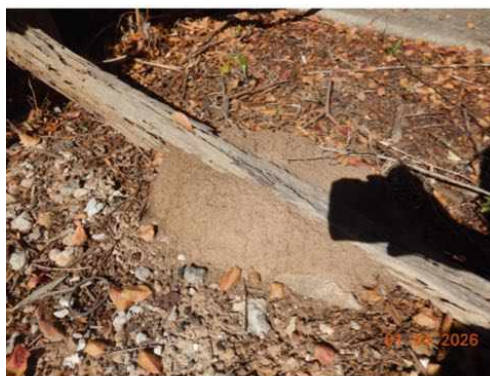
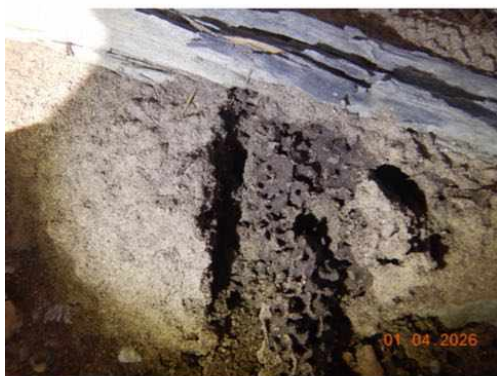
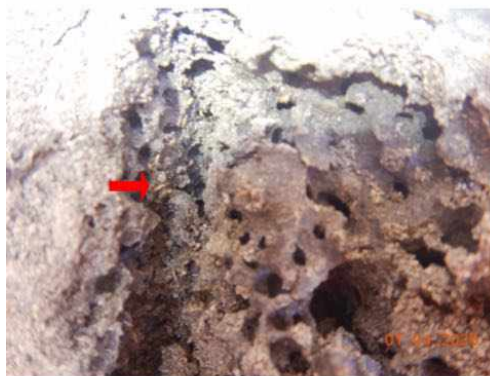
### Finding 4.01

This species is unique in that it generally only feeds on wood that is in a decaying state rather than attacking structural timbers that are in a good condition. The attack of this species therefore highlights the importance of a well-ventilated subfloor space. Nesting habits of this species involve the building of a mound around or over a stump

or other timber building element that may be in a decayed state and in direct contact with the ground.

If evidence of live *nasutitermes* spp activity is found during inspection treatment is required immediately to prevent any further damage that will inevitably ensue if left unattended. Treatment options include the installation of bait stations with the view of directly eradicating the colony or the installation of a post-construction chemical barrier which is designed to prevent the reoccurrence of termite infestation. Remedial works or replacement of affected timber builder elements may also be required.

In future it is highly advised that all timber elements throughout the property particularly if external and in contact with the ground are free of wood rot and / or decay. Creating greater ventilation to the subfloor space may help to ensure the adequate condition of structural timbers.

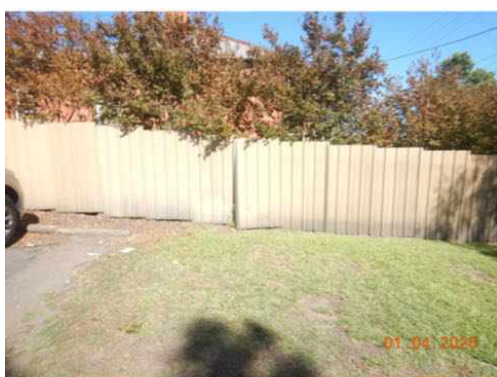
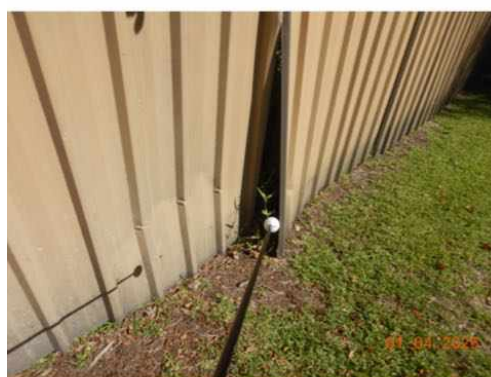
#### Finding 5.01

If left unattended, it is likely that further damage will occur. It is suspected that repair of several elements of the fencing may be required however replacement may be a consideration of the client also.

A licensed fencing contractor should be appointed to provide further advice and perform rectification works as necessary. Please note that the timber rails and posts have been severely damaged by termites.

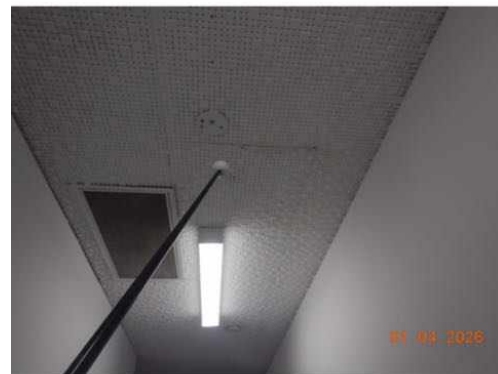
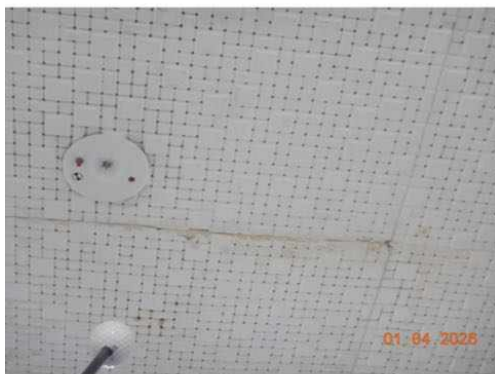
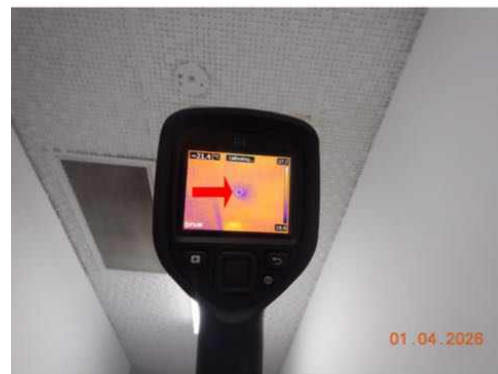
### Finding 6.01

growth and wood decay.

Please note that the highest detectable surface reading on this device is 999, the wet range starts at 200.

Prior to any remedial works being performed a qualified plumber should be appointed to further inspect the property and to identify the cause of the excessive moisture. Works to remove affected building elements may then be necessary and should be performed by an appropriate tradesperson.

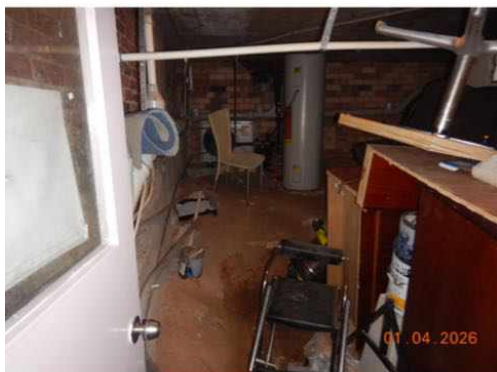
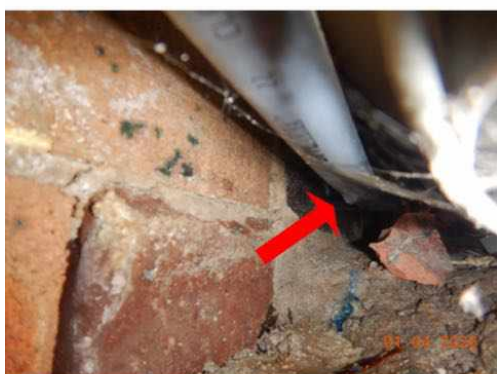
issues involved. In these cases an appropriately qualified inspector should also be contacted.

Prior to any remedial works being performed a qualified plumber should be appointed to further inspect the property and to identify the cause of the excessive moisture. Works to remove affected building elements may then be necessary and should be performed by an appropriate tradesperson.

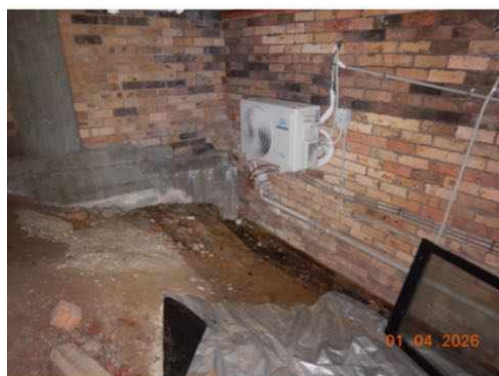
### Finding 6.03

Building:	Main Building
Location:	Subfloor > All Areas
Finding:	Damp
Information:	Damp (or structural damp) refers to the presence of unwanted moisture in the structure of a building, either as the result of intrusion from outside, or condensation from within the structure. Generally, structural damp is caused by rain penetration, rising damp, and leaks from plumbing pipes.

Consultation with a qualified plumber is advised immediately to identify the cause of damp and perform remedial works as required. Where excessive mould growth is present, further inspection by a specialist environmental health inspector should also be considered.
