# Building and Timber Pest Inspection Report

Inspection Date: Mon, 23 Mar 2026

Property Address: 7 Andrews Ct, Kyabram VIC 3620,  
Australia

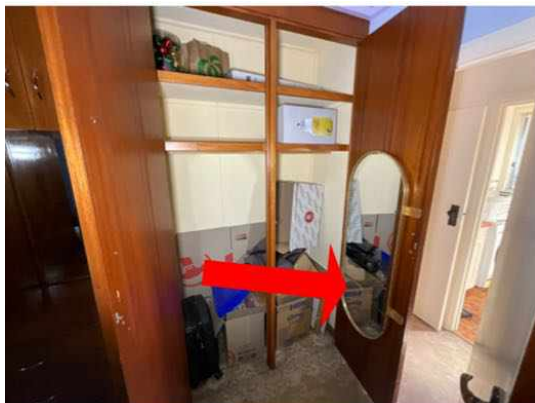
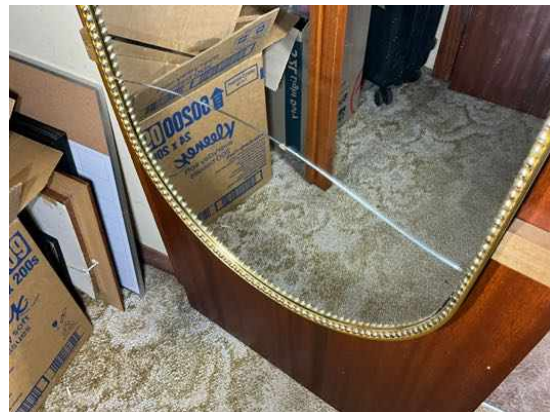
#### Finding 1.01

Building: Building 1  
 Location: Bedroom 3  
 Finding: Mirror - Cracked  
 Information: Cracks were identified in the mirror in this area. Cracking in mirrors is generally the result of impact damage, and is likely to develop further when left unmanaged.

Cracking affects the use and quality of the mirror and may cause damage to surrounding structures (e.g. tiling ingress of moisture) if the initial damage is not fixed or managed. The increased likelihood of the mirror further cracking and/or shattering also poses a safety hazard in the area.

A safety hazard is noted. The mirror in bed 3 is cracked. A glazier or mirror specialist should be contacted immediately to restore the area and prevent potential injury.

A qualified mirror or glass repair service may be required to repair the damage. Where damaged extensively, replacement of the mirror may be required. Alternatively, a carpenter or handyman can remove and rehang mirrors into built in cabinetry.

Please be advised that any persons coming into contact with the cracked mirror should do so with due caution to avoid any personal injury that may ensue.

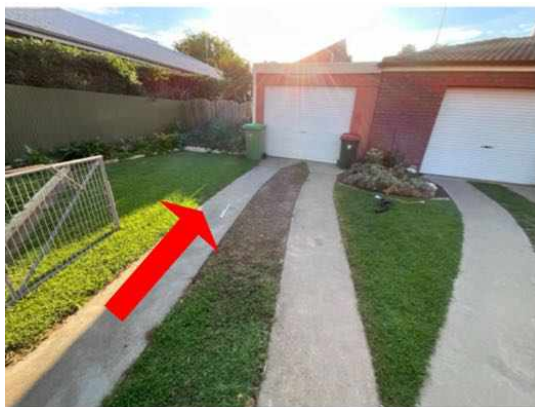
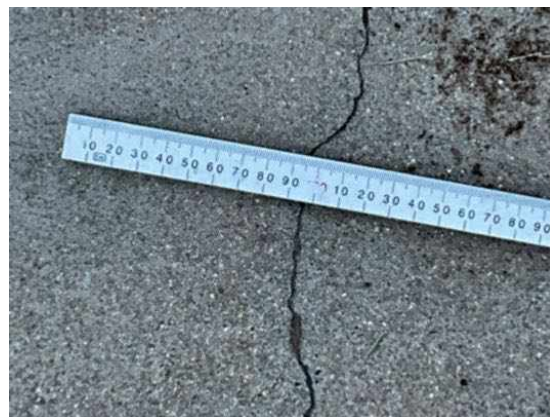
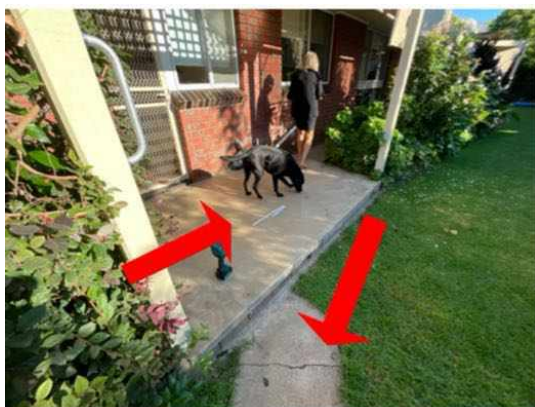
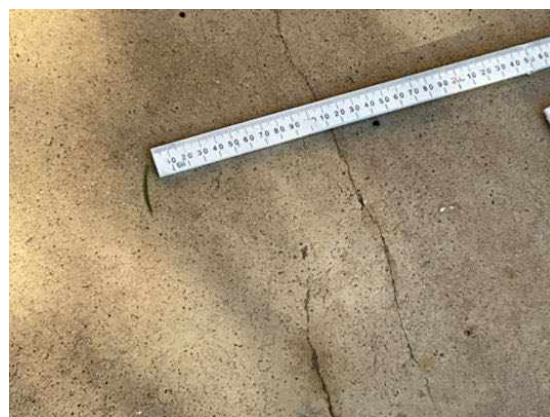
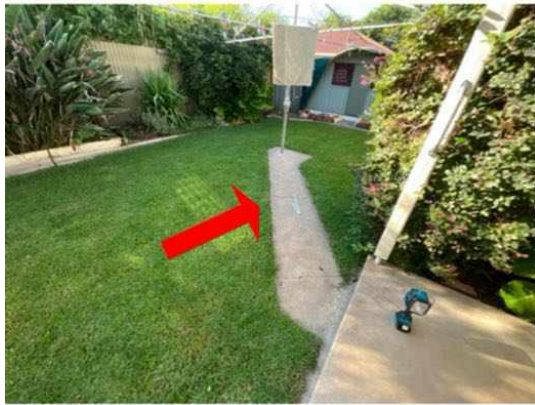
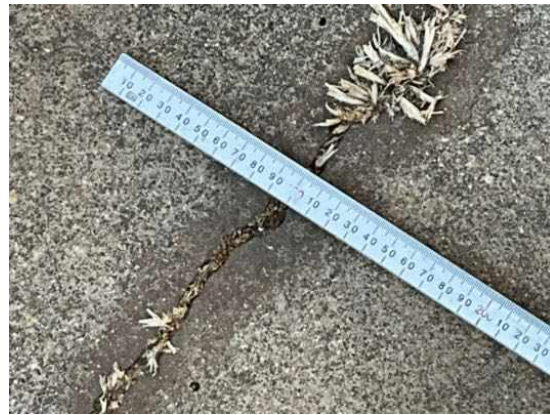
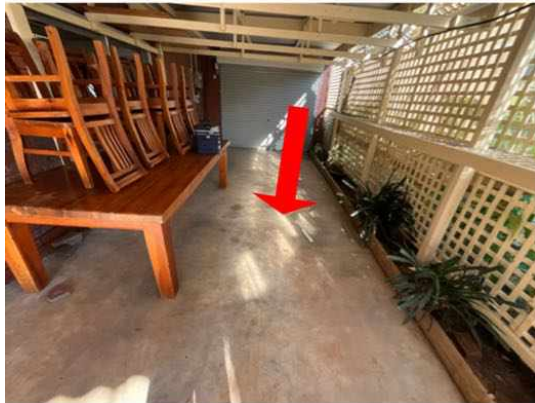
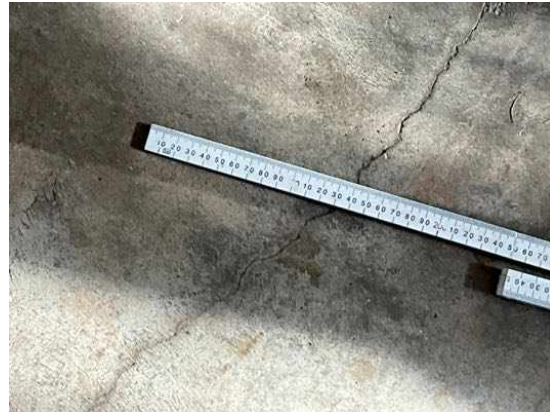
#### Finding 3.01

Location: Driveway, yard- back, carport,  
 Finding: Cracking - External Concrete Paving Damage Category 1 - Fine (less than 2mm)  
 Information: Fine cracks were identified in external concrete paving. Although fine cracks are quite noticeable, they are often only considered to be an appearance defect, and usually do not indicate any structural damage. To be considered a Category 1 or fine crack, the crack is found to be less than 2mm in width.

Generally the cause of a hairline crack in existing concrete paving such as driveways and pathways is indicative of the expansion and contraction of the concrete. Such causes are generally due to environmental factors, such as moisture levels, weather conditions, root systems of nearby trees or the soil types on which they are laid.

Fine cracks may also be due to poor original installation of the concrete. Factors such as poor compaction of the sub surface and/or inadequate reinforcing of the slab may create cracking and other secondary defects.

Monitoring of all cracking should be conducted frequently. Always contact a building inspector should cracks widen, lengthen, or become more numerous.

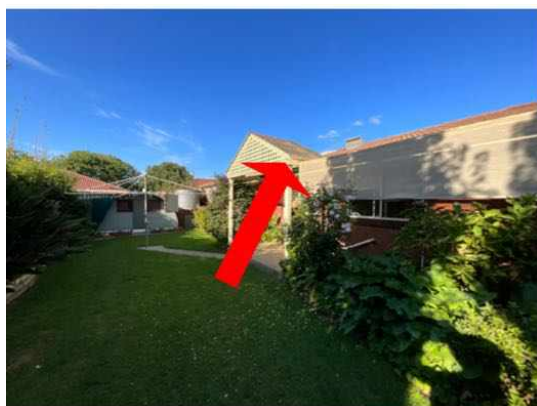
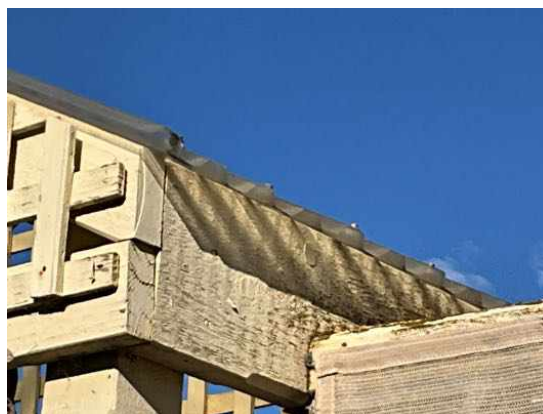
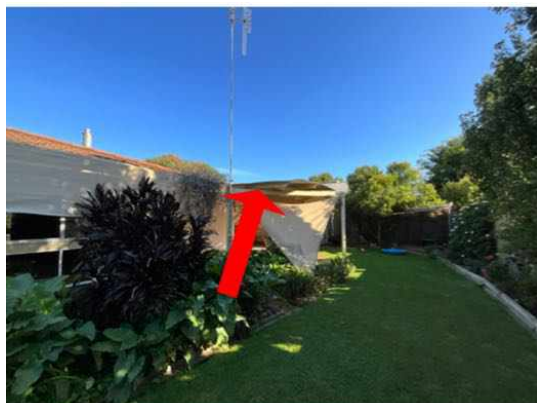
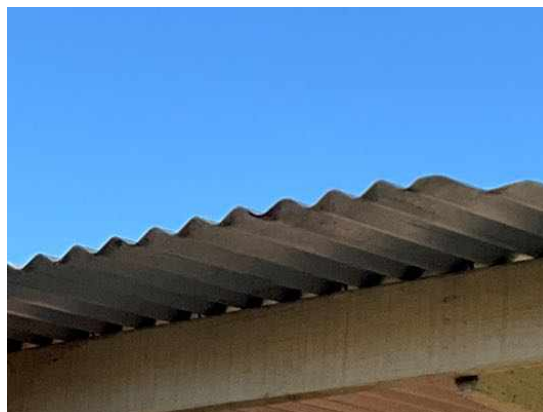
Building: Building 1  
Location: Yard - Back  
Finding: Guttering Missing  
Information: The Guttering in this area was missing at the time of inspection. Guttering, Downpipes and Stormwater drainage are vital to protect the integrity of the structure and to prevent an environment conducive to Timber Pest attack.

A Plumber should be contacted as soon as possible to replace and connect to drainage the missing Guttering.

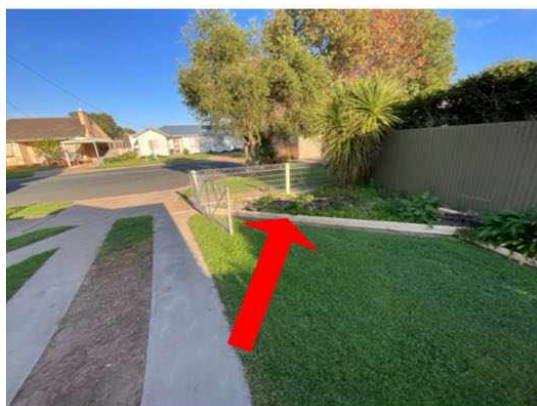
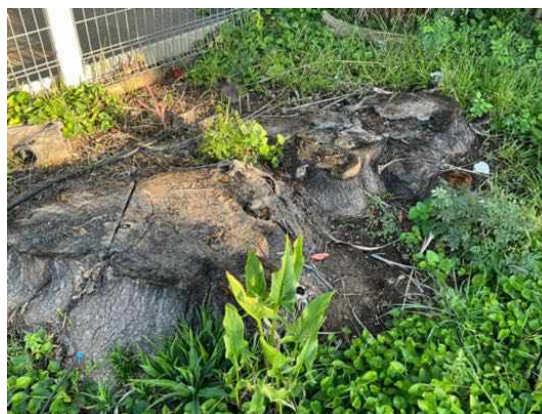
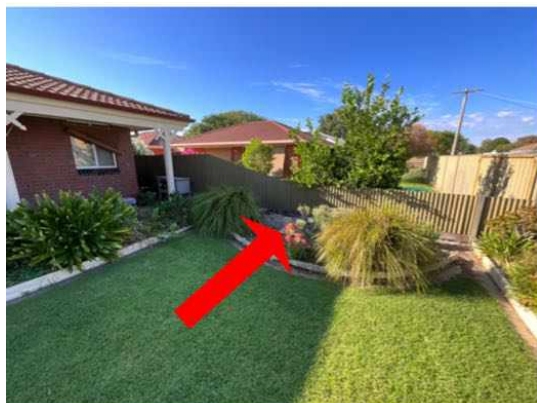
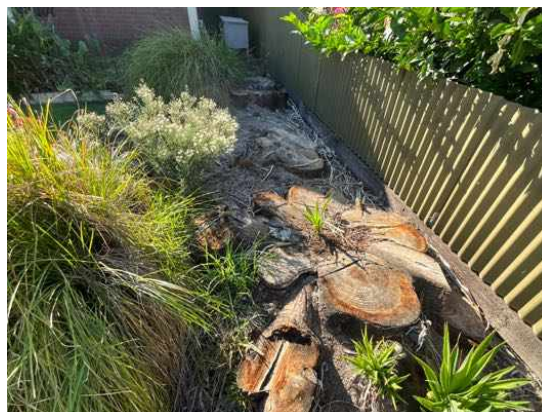
### Finding 6.02

Building:	Building 1
Location:	Yard - Front
Finding:	Tree Stump in Ground
Information:	Any tree stumps in the yard not removed during the tree removal process provides the opportunity for Termite infestation and is likely to be subject to decay from damp conditions against the stump.

All tree stumps should be removed by professional tree removal services where possible. Meanwhile regular inspections are advised to identify any termite activity in the areas identified.

Services for tree stump removal should be contacted as soon as possible to reduce the risk of timber pest attack.

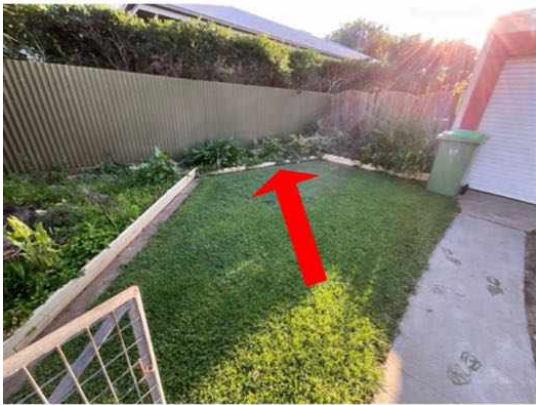
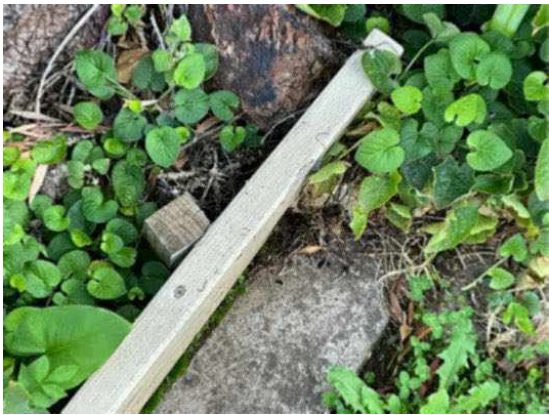
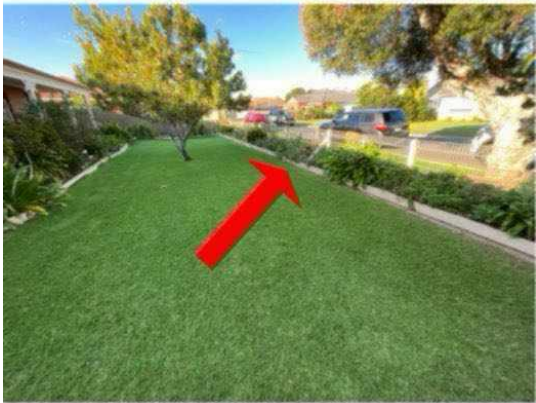
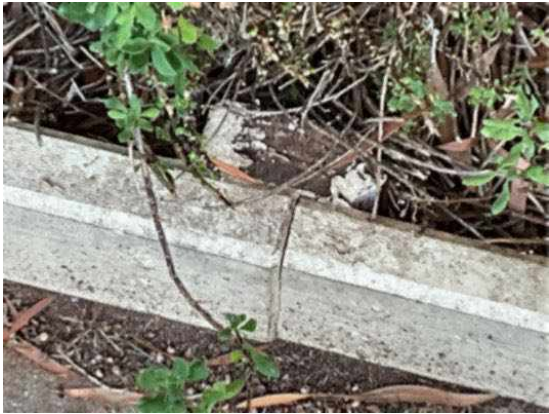
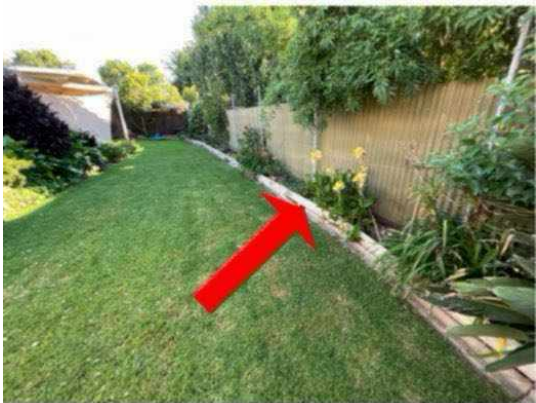
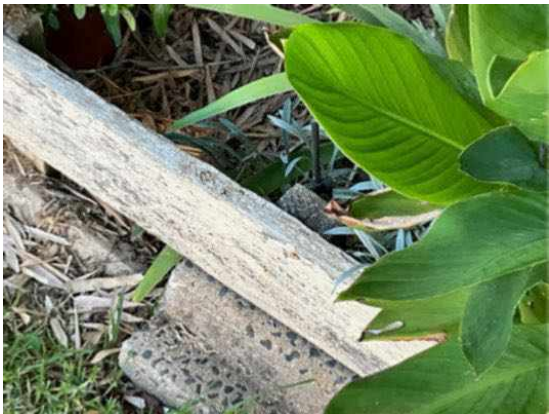
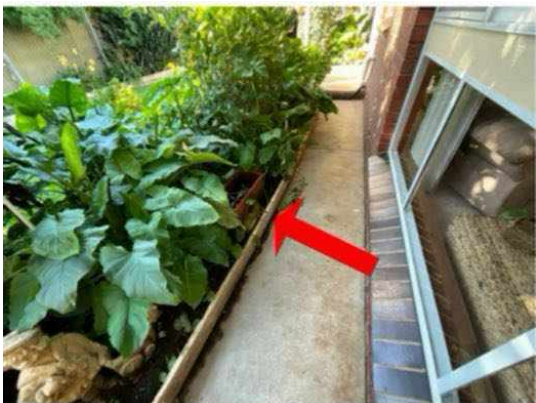
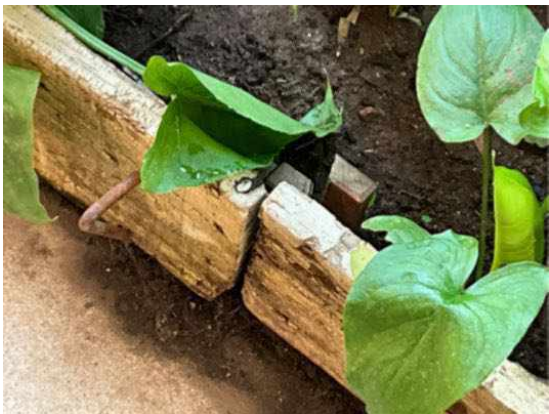
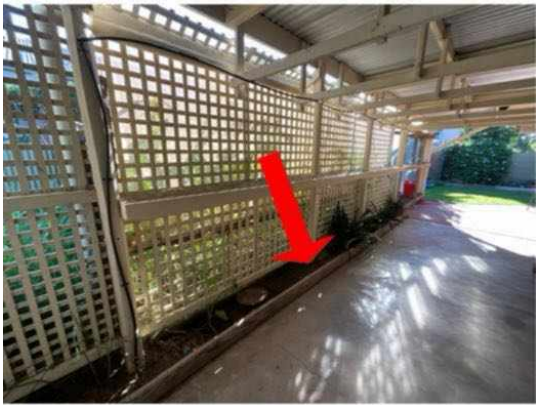
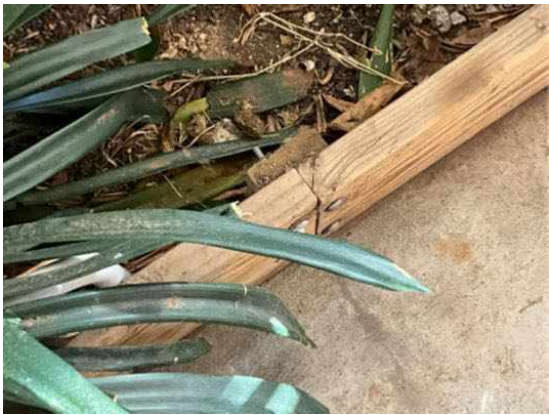
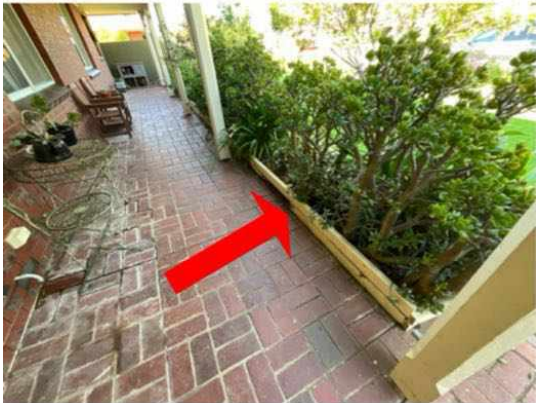
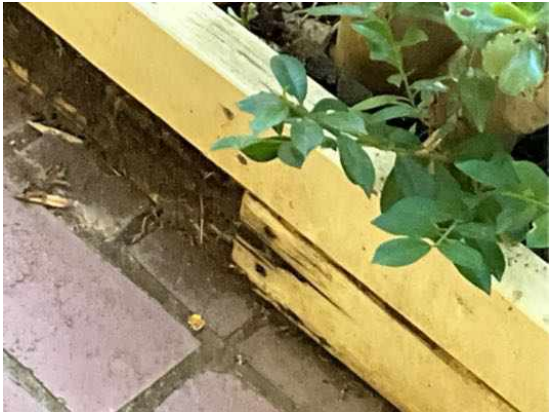
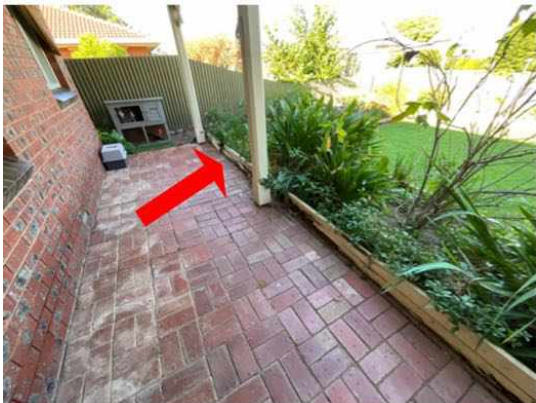
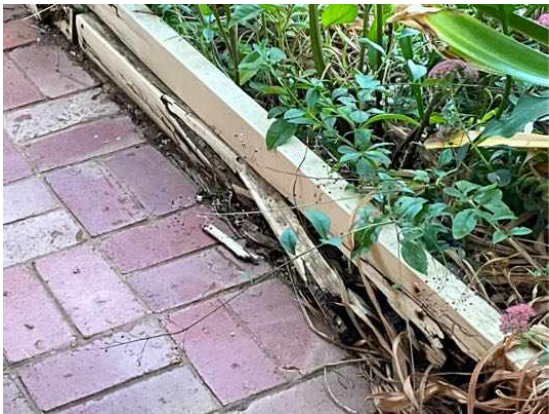
### Finding 6.03

Building:	Building 1
Location:	Yard - Front, back
Finding:	Untreated or non-durable timbers in a hazardous environment
Information:	To reduce the risk of timber pest attack it is essential that timber used in a hazardous environment (e.g. in direct contact with the ground or frequently exposed to damp conditions) is of sufficient durability and/or is adequately preservative treated.

Untreated timbers in direct contact with the ground are likely to develop severe wood rot and/or fungal decay if left unattended creating attraction for subterranean termites to infest the timbers from surrounding areas.

If untreated or non-durable timbers are found to be in a hazardous environment it is highly advised that replacement of these building elements be performed as soon as possible to aid the protection of the property against termite / timber pest attack.

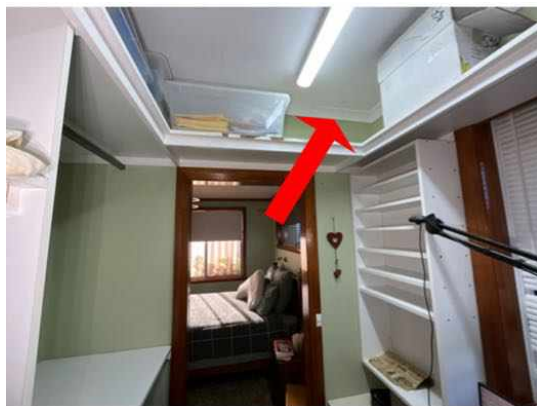
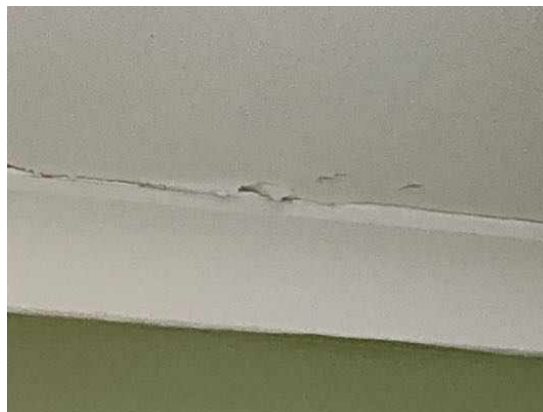
**Finding 6.04**

Building: Building 1  
Location: Walk In Robe  
Finding: Paint- Flaking  
Information: Sections of paint in this area was found to have deteriorated. Paint flaking is generally an indication of excessive moisture in the area, that is currently hidden by the painted surface.

The presence of excessive moisture can have major implications on associated building elements if left unattended. While only seemingly minor at this stage, the damage cannot be determined due to the paint obstructing any further inspection of the damage.

A qualified Painter should be contacted at the Owner's discretion to re-paint the area.

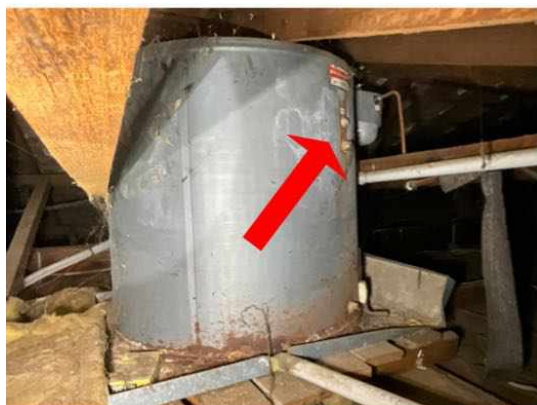
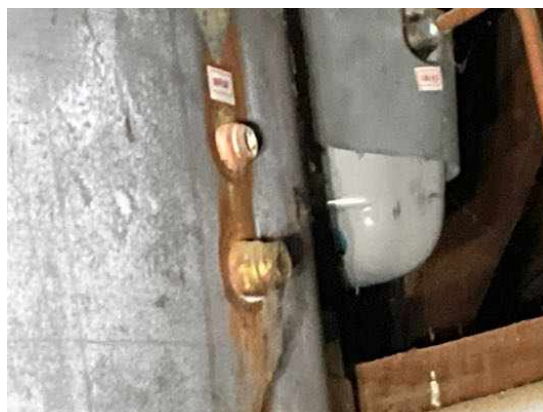
### Finding 6.05

Building:	Building 1
Location:	Roof Void
Finding:	Gravity-Fed HWS - Disconnected
Information:	It was noted at the time of inspection that a disconnected gravity-fed hot water system (HWS) remains in this area.

Despite this plumbing structure being unused, it is likely to be storing residual water, and is therefore susceptible to rust and corrosion. If allowed to continue, rust and corrosion is likely to lead to damage to adjoining building elements, and may also make the area susceptible to termite or timber pest activity.

While it is a costly exercise to remove the disused gravity-fed HWS, it is advisable in the short-term future to prevent any further damage to the area. Further consultation with a licensed plumber is required to gain further advice on removal of the structure.

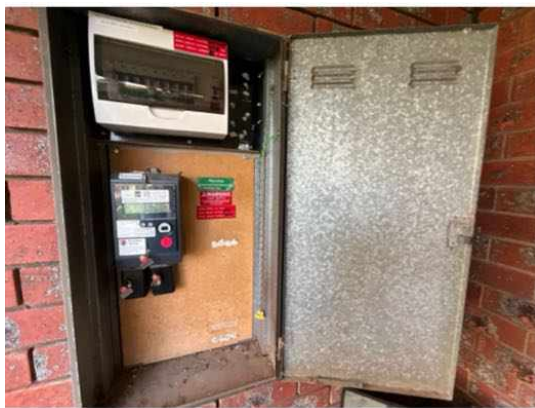
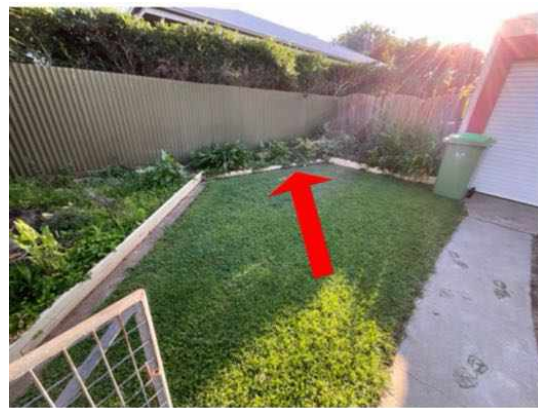
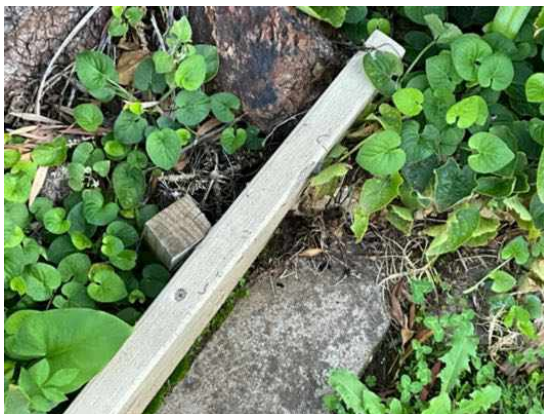
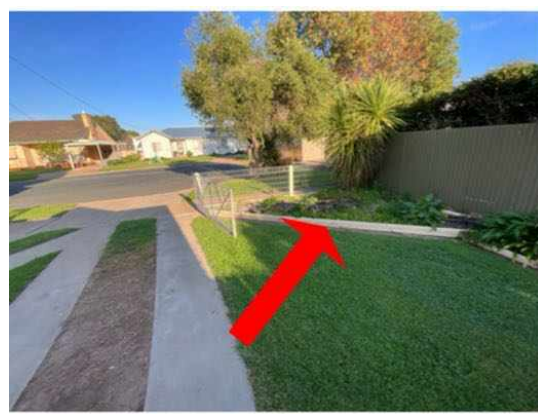
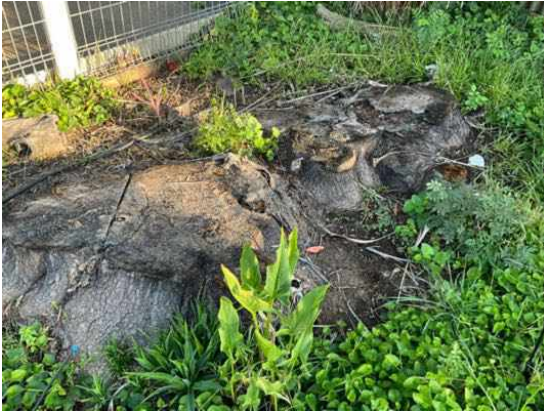
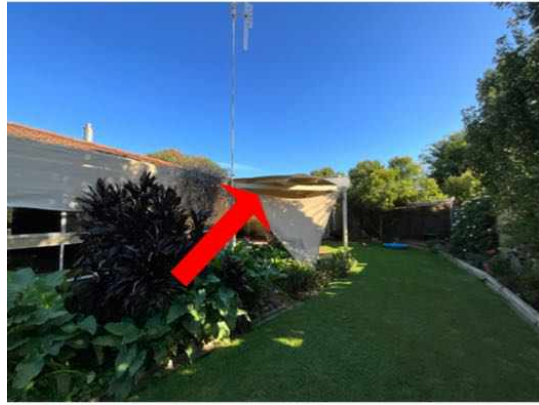
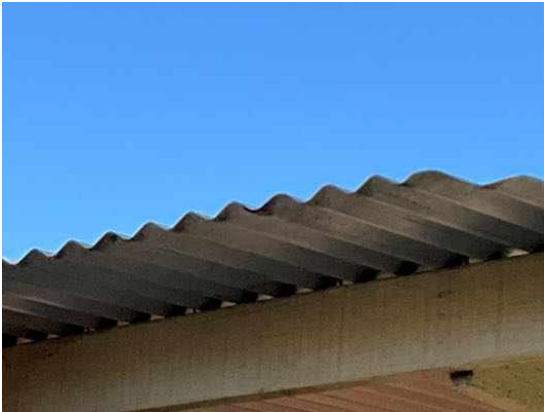
### Finding 6.06

Location: All External Areas

Finding: Termite Management System - no evidence of a chemical installation

Information: The application of a post-construction chemical termite barrier is highly recommended for all properties, particularly if live termite activity has been found on the site previously. Such barriers are highly effective in preventing termite attack on any timber building elements throughout the property.

A durable notice should be placed in the switchboard unit to indicate current termite barriers. At the time of inspection, it appeared as though no termite management system has been installed, with no evidence to suggest preventative works taking place.

The client may consider gaining further advice from a pest controller as to the costs and procedures involved with this application. It is recommended that obtaining such advice be a short-term priority.

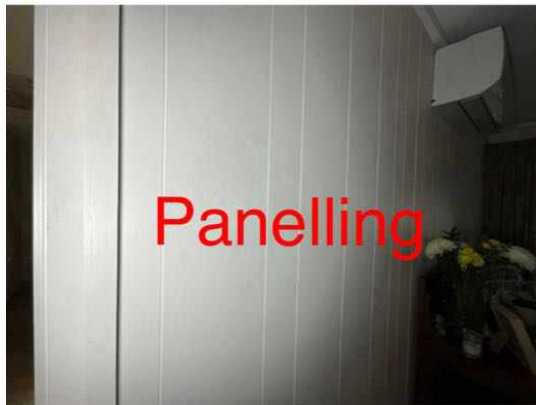
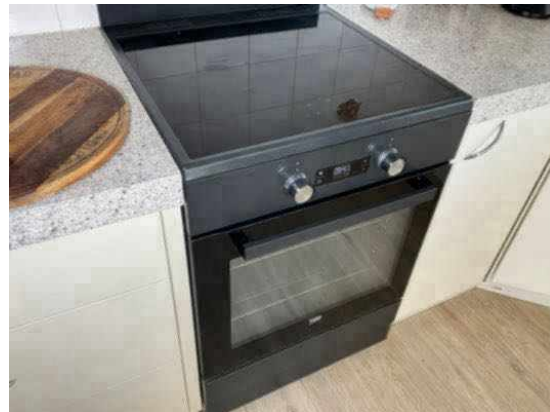
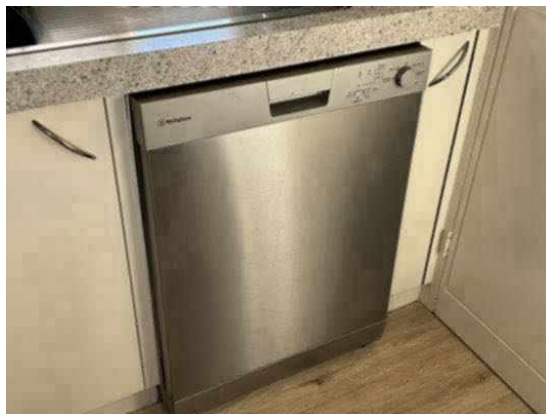
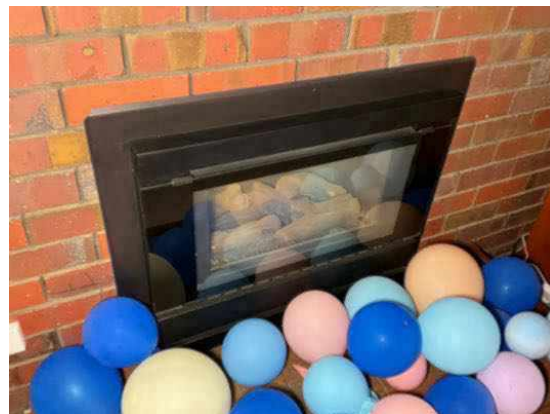
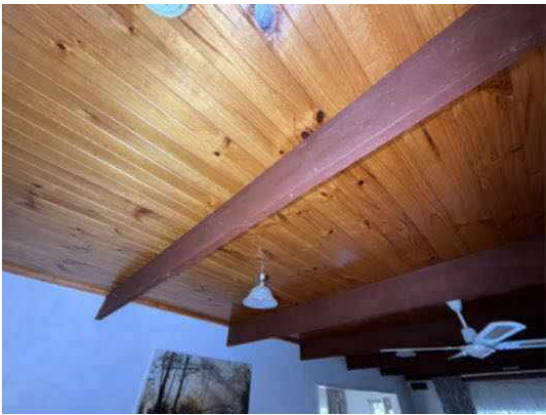
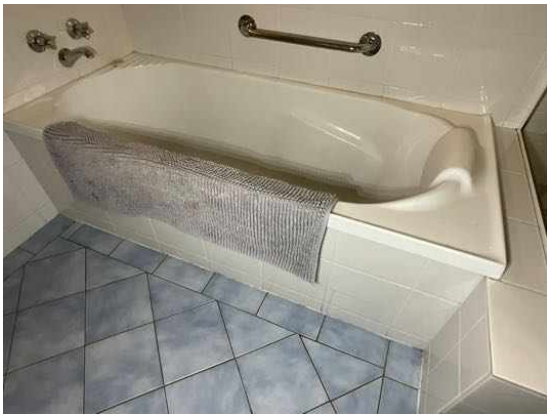
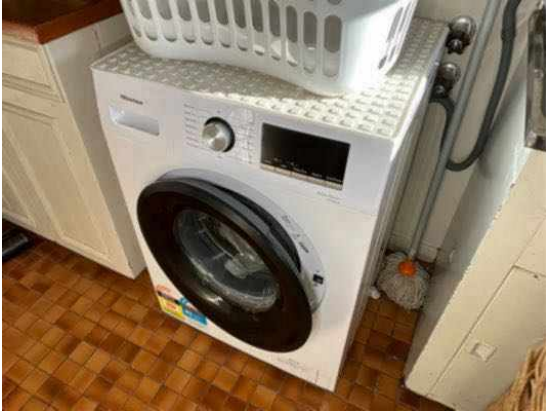
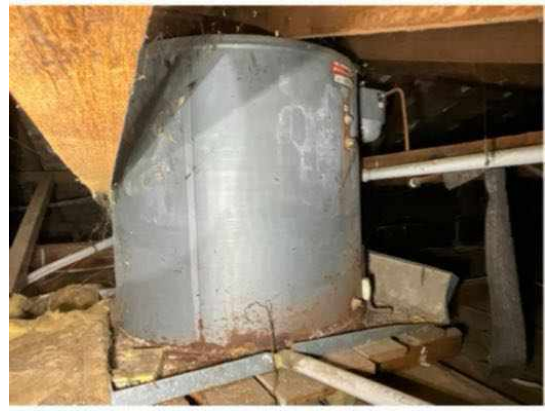
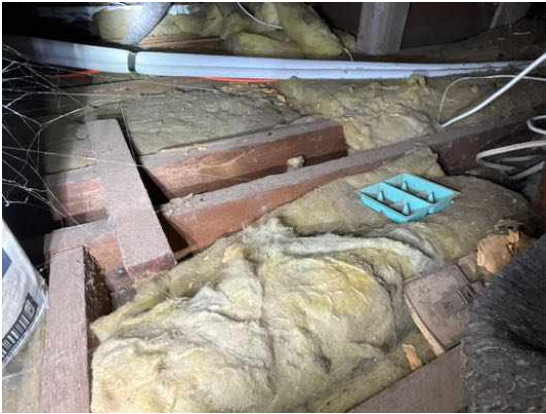
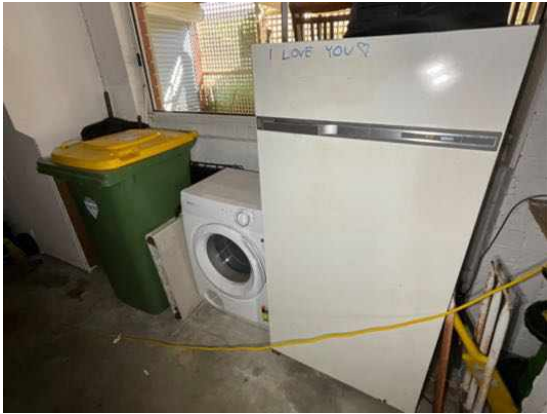
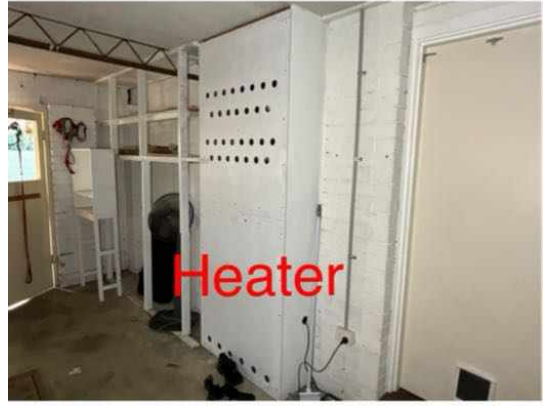
#### Noted Item

Building: Building 1  
Location: All Areas  
Finding: Additional Photos - Obstructions and Limitations  
Information: These photographs are an indication of the obstructions and limitations which impeded full inspection of the property at the time of inspection. These obstructions can hide an array of defects and should be removed to allow full inspection to be carried out. A re-inspection is recommended once the areas are made accessible.
