Building Inspection Report

Inspection Date: Mon, 16 Mar 2026

Property Address: 5/16 Landers Rd, Lane Cove North NSW
2066, Australia

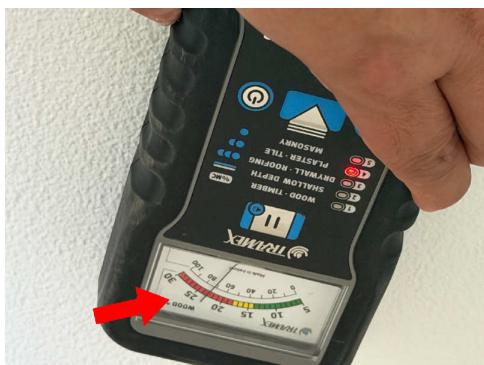
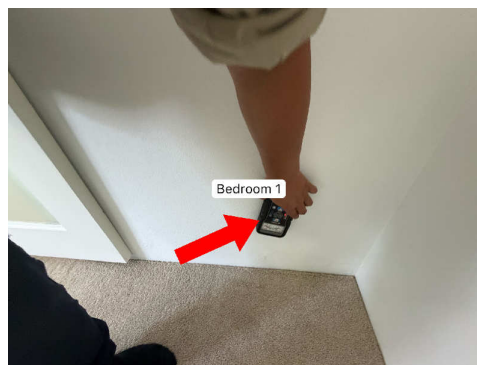
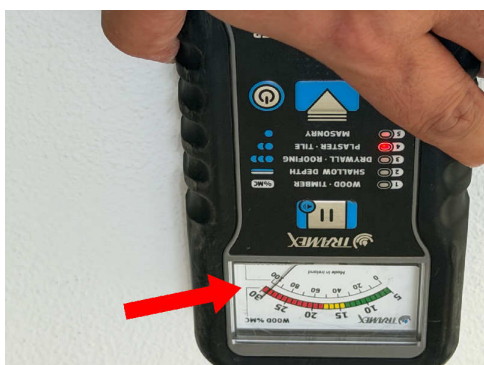
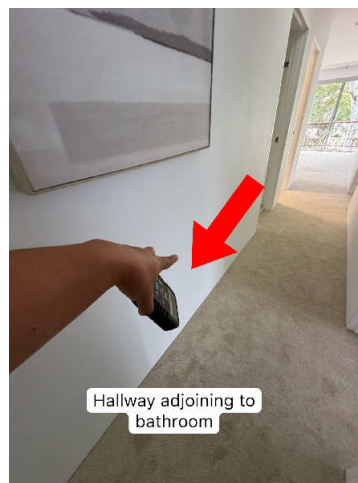
Defects 2.01

Location: Ensuite & Bathroom

Finding: Excessive moisture - Adjacent to Shower

Information: Moisture has been detected in the wall at bedroom 1 & Hallway where adjacent to the shower area in the ensuite & bathroom. This moisture may manifest as visible dampness, staining, or bubbling of paint or wallpaper.

The presence of moisture strongly suggests that water has penetrated the wall, possibly due to leaks or seepage from the shower area. Water damage may include structural deterioration, mold growth, or deterioration of wall materials.

The detection of moisture raises concerns about the integrity of the waterproofing membrane, which is designed to prevent water from infiltrating the wall structures. A compromised membrane can result in water intrusion.

Prior to any remedial works being performed a qualified plumber or waterproofing technician should be appointed to further inspect the property and to identify the cause of the excessive moisture. Works to remove affected building elements may then be necessary and should be performed by an appropriate tradesperson.

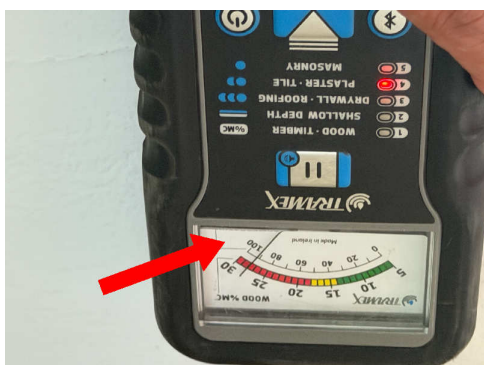
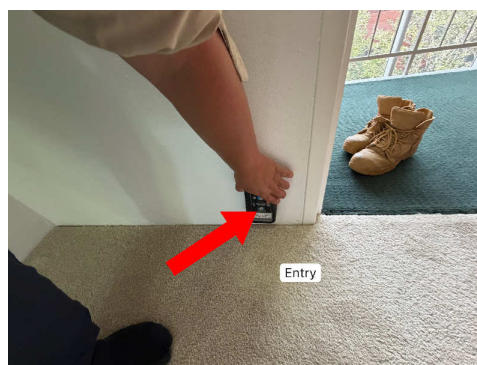
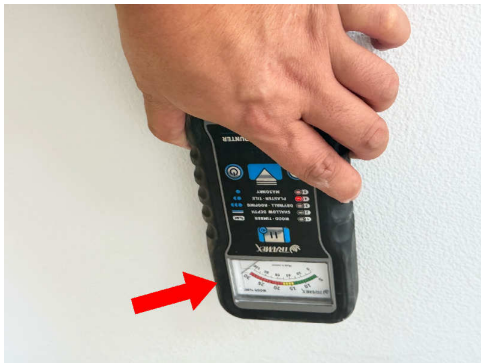
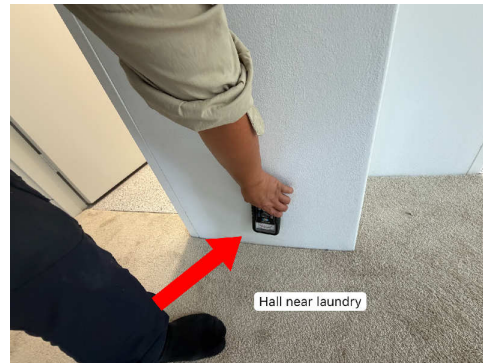
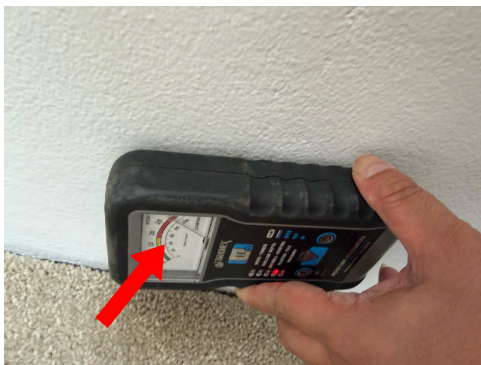
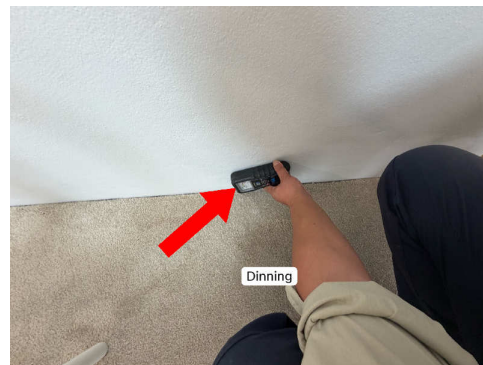
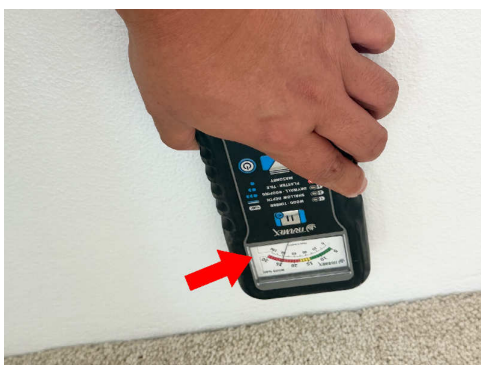
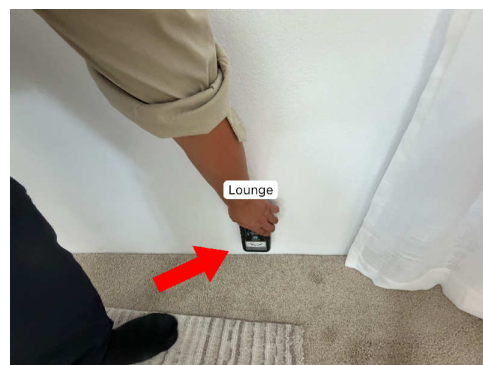
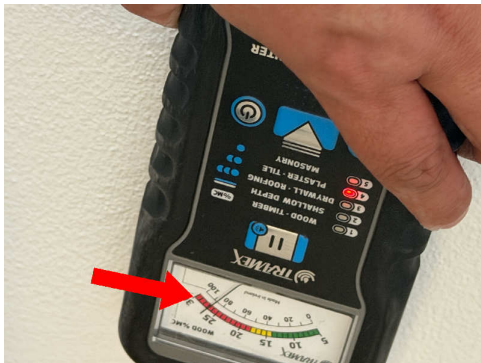
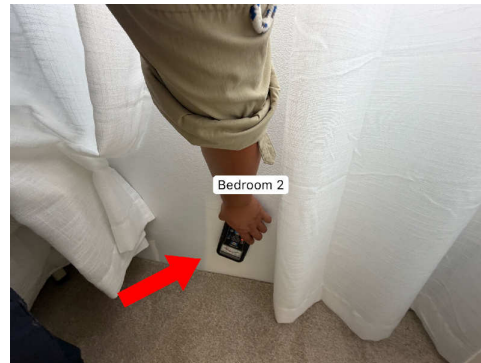
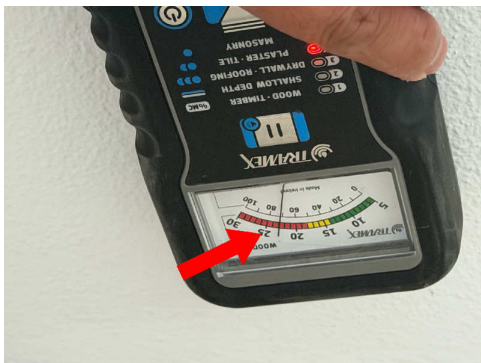
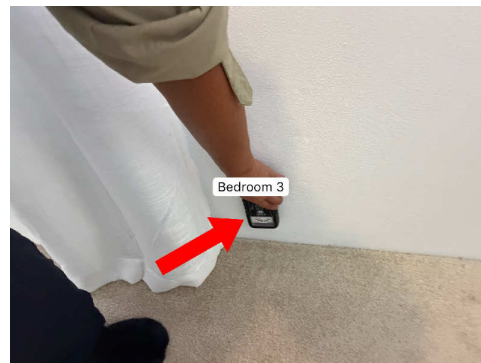
Defects 3.01

Building: Main Building
Location: All Internal Areas
Finding: Damp

Consultation with a qualified plumber is advised immediately to identify the cause of damp and perform remedial works as required. Where excessive mould growth is present, further inspection by a specialist environmental health inspector should also be considered.

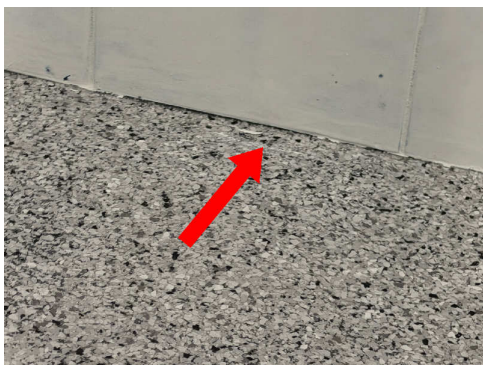
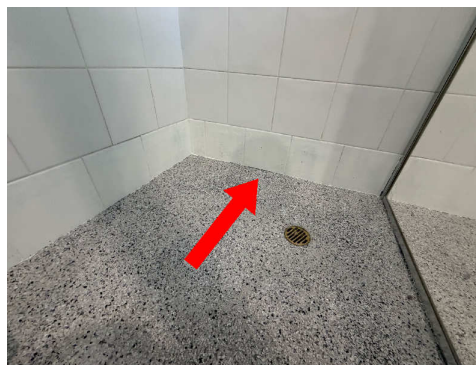
Defects 3.02

Building: Main Building
Location: All Internal Areas
Finding: Sealant and grouting - Missing or damaged

Information: It was noted on inspection that sealant or grout is degraded in multiple locations of the property.

Flexible and mould resistant materials should be applied to affected areas to prevent any subsequent water damage that is likely to occur. Regular maintenance and replacement of damage or missing or damaged sealant and grout is highly recommended to the wet areas, as this is a regular wear and tear defect. Sealant and grouting in areas that come into regular contact with water should be maintained for the long term care of your property.

A sealant specialist or tiling contractor should be appointed to complete these works as soon as possible

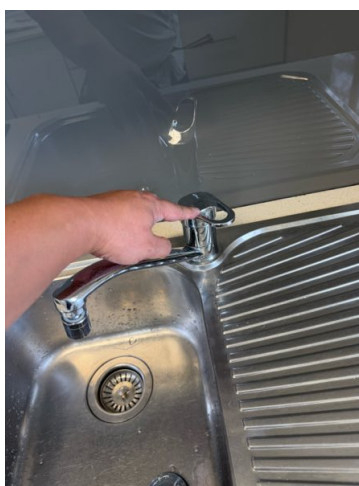
Defects 3.03

Building: Main Building
Location: Kitchen
Finding: Tap - Water hammer

Information: This tap shows evidence of water hammer being present. Water hammer, a pressure surge resulting when a fluid is forced to suddenly change direction, is a common defect in plumbing fittings, particularly those that are aged and not frequently maintained. Water hammer is generally caused by factors that create high water pressure in the affected plumbing fixture, usually evidenced by a faint banging noise during operation of the affected tap.

A licensed plumber should be appointed as soon as possible to replace any affected tap hardware and perform any remedial works as necessary. Please be advised that the appointment of a cabinet maker or qualified carpenter may be necessary if water damage to associated building elements has occurred.

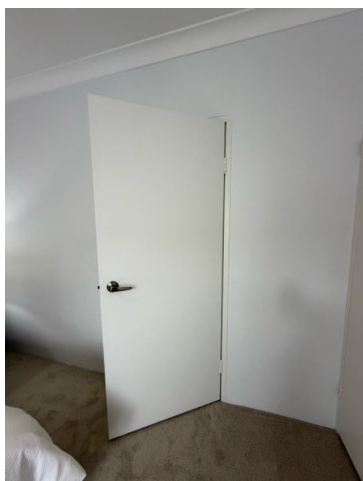
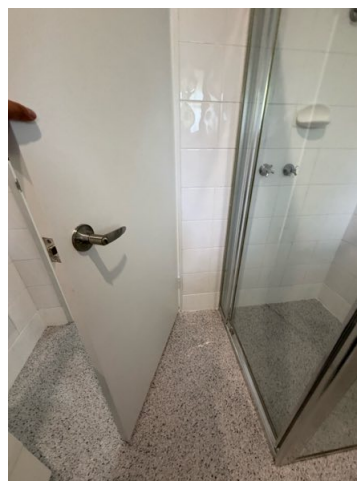
Defects 3.04

Location: All Internal Areas

Finding: Door stop - Missing

Information: The door stop is missing or is inadequate to stop the door handle from damaging the wall. Although some building elements may seem irrelevant or unnecessary, all building elements play a key role in the operation and function of the overall structure and its performance.

Re-installation or replacement of the door stop is advised as soon as possible to prevent any subsequent damage to the door or associated structures.

A general handyman may be appointed to perform these works and inspect all internal doors as recommended at client discretion.

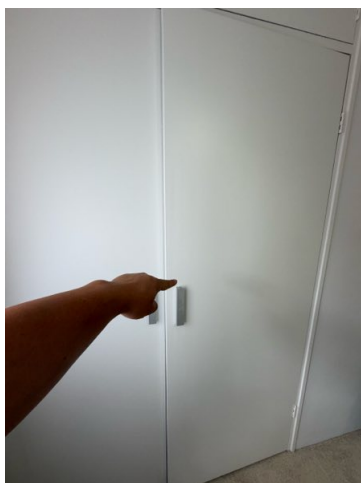
Defects 3.05

Location: Bedroom 2

Finding: Door - Binding/jamming

Information: Binding and/or jamming of this door is evident during standard operation. This defect inhibits the functionality of the affected door as well as creating potential for secondary defects to associated building elements, such as damage to the floor covering.

Where door binding/jamming appears to indicate major structural issues, a registered builder specialising in re-stumping should be appointed to provide an estimate on the cost of rectification.

For minor causes, a qualified carpenter or general handyperson should be appointed to perform minor rectification works at client discretion.

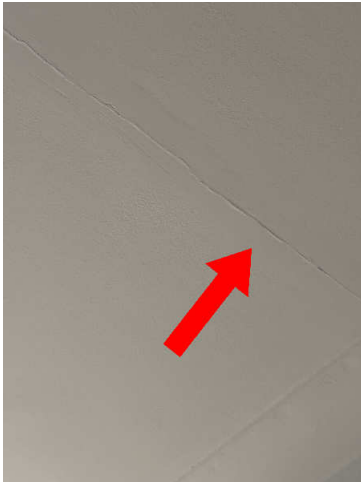
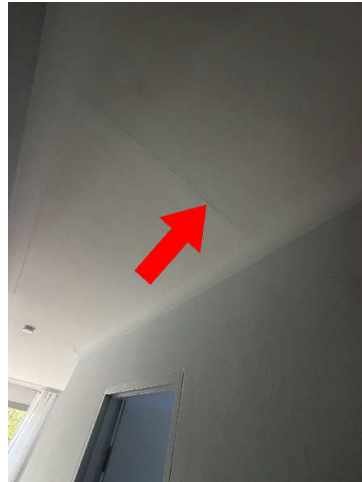
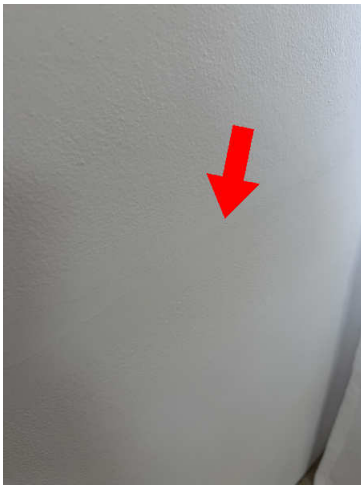
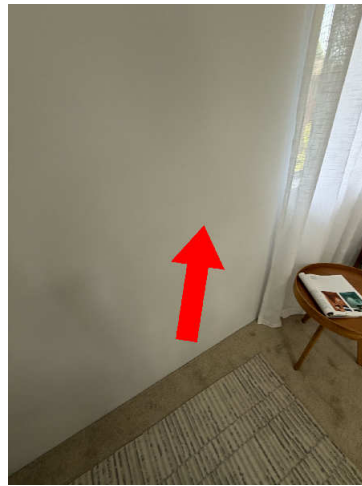
Defects 3.06

Location: All Internal Areas

Finding: Cracking - Damage Category 2 - Noticeable (up to 5mm)

Information: Noticeable cracks are a common occurrence as a result of many primary defects. Such causes may include age, general wear and tear, expected building movement, general expansion/contraction of building materials in different weather conditions, and/or minor failings in the installation or application of building materials.

Monitoring of all cracking should be conducted frequently. Always contact a building inspector should cracks widen, lengthen, or become more numerous. Additionally, your building inspector should also be contacted if associated building elements such as doors and windows become more difficult to operate over time.

Relevant tradespeople, such as carpenters, painters and plasterers, should be appointed to perform remedial works, as deemed necessary.

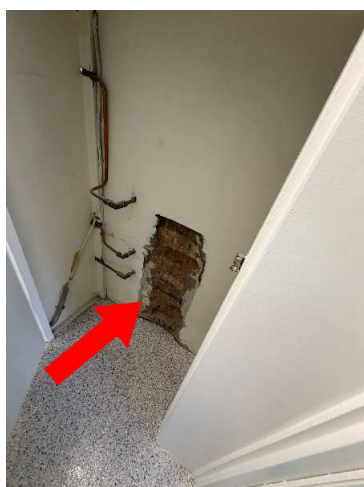
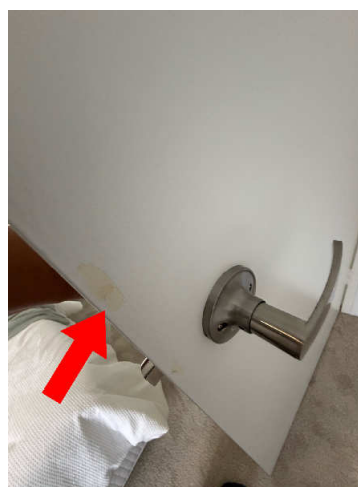
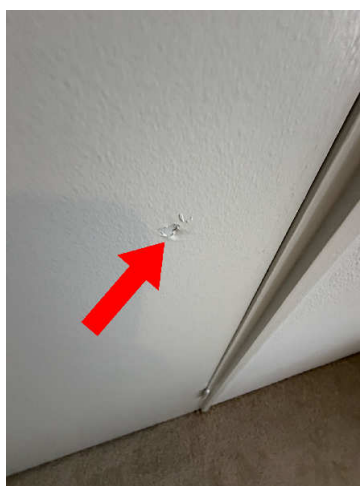
Finding: Incomplete or substandard works

Information: The works to this area appear to be incomplete or have been completed to a substandard level.

It is highly recommended that the relevant trades be appointed to complete these works and ensure the safety of the area and the longevity of all associated building elements.
