Building and Timber Pest Inspection Report

Inspection Date: Wed, 4 Mar 2026

Property Address: 18 Lancaster St, Thornton NSW 2322,
Australia

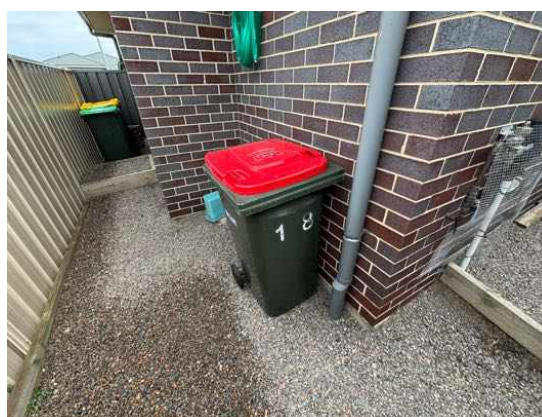
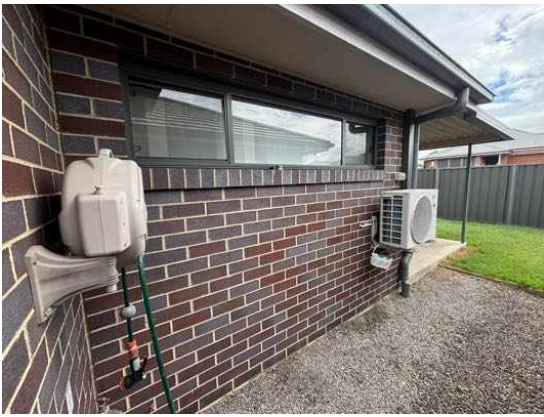
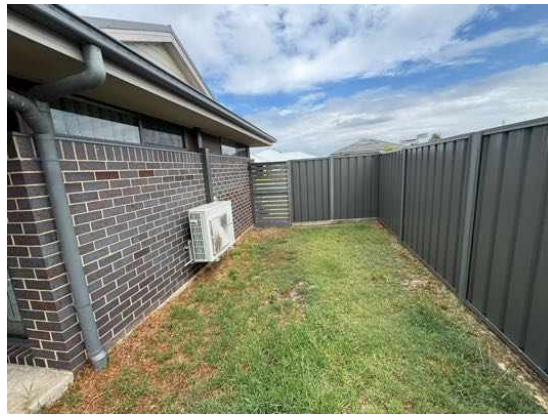
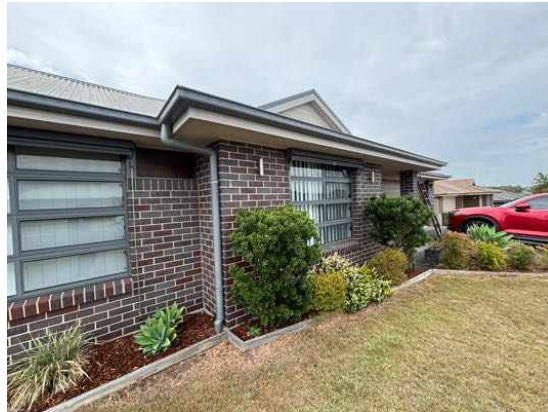
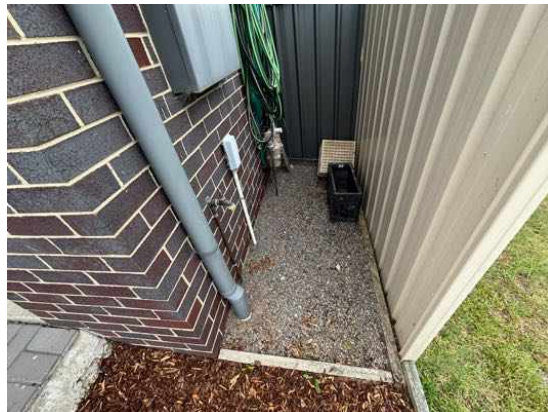
Building: Main Building
Location: All External Areas
Finding: Obstructions and Limitations - External Areas
Information: The attached photographs provide a visual representation of the obstructions and limitations that impeded a full inspection of the external areas of the property at the time of assessment. These obstructions, which may include vegetation, stored items, debris, or other physical barriers, can obscure potential defects and prevent a thorough evaluation of the property's condition. Obstructions of this nature can conceal a wide range of issues, such as structural damage, water ingress, pest infestations, or deteriorating building materials, which may not be visible during the initial inspection.

It is essential that these obstructions be cleared to allow for a comprehensive inspection of the external areas. Removing these barriers will enable a more accurate assessment of the property's condition and allow any hidden defects to be identified and addressed promptly. Failure to do so could result in undetected issues worsening over time, potentially leading to more costly repairs in the future.

Therefore, it is strongly recommended that the obstructions be removed and a re-inspection be scheduled once the affected areas are made fully accessible. This will ensure a complete evaluation of the property's exterior and provide the client with a clear understanding of any potential issues that may have been concealed during the initial inspection.

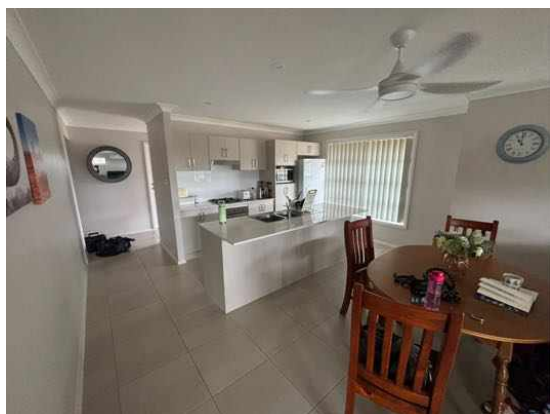
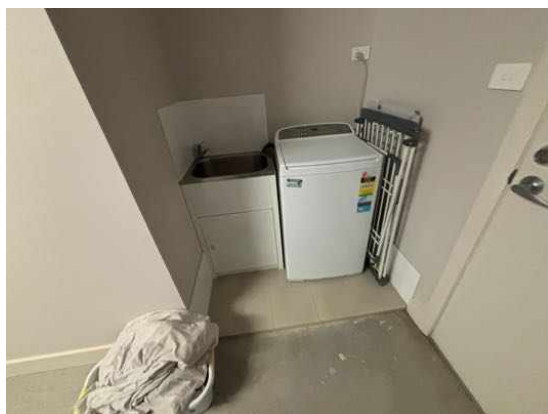
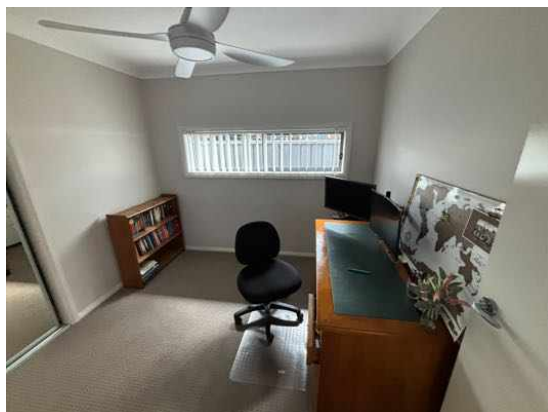
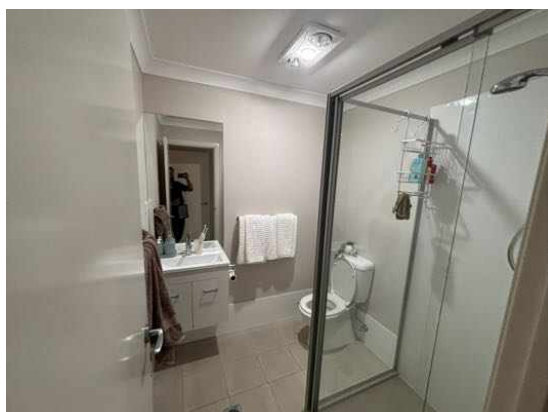
Building:	Main Building
Location:	All Internal Areas
Finding:	Obstructions and Limitations - Internal Areas
Information:	The accompanying photographs provide clear evidence of the obstructions and limitations that restricted a comprehensive inspection of the internal areas of the property at the time of assessment. These obstructions, which may include furniture, personal belongings, stored items, or structural elements such as wall coverings and built-ins, significantly hindered the ability to thoroughly evaluate these areas. It is important to note that such obstructions can potentially conceal a wide array of defects, ranging from hidden structural damage, water leaks, pest infestations, or

electrical issues, to deteriorating materials that may not be visible during the initial inspection.

The presence of these impediments means that critical areas of the property were not accessible, and therefore, any underlying defects that may affect the integrity and safety of the property could remain undetected. These hidden defects, if left unaddressed, could worsen over time and may result in costly repairs or pose potential safety hazards to the occupants.

It is highly recommended that all obstructions be cleared to facilitate a complete and thorough inspection of the internal areas. Once the obstructions have been removed and full access is available, a re-inspection should be carried out to ensure that any previously concealed issues can be properly identified and rectified. This follow-up inspection will provide a more accurate assessment of the property's internal condition and help the client make informed decisions about any necessary repairs or maintenance.

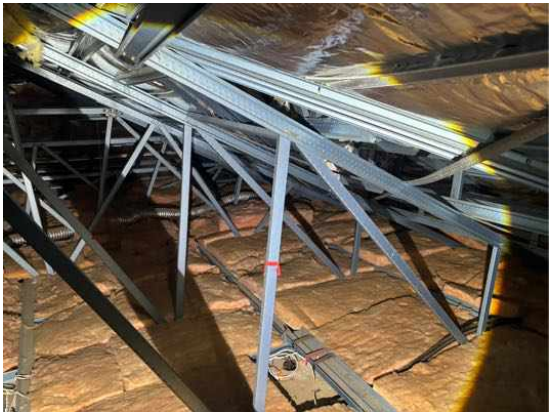
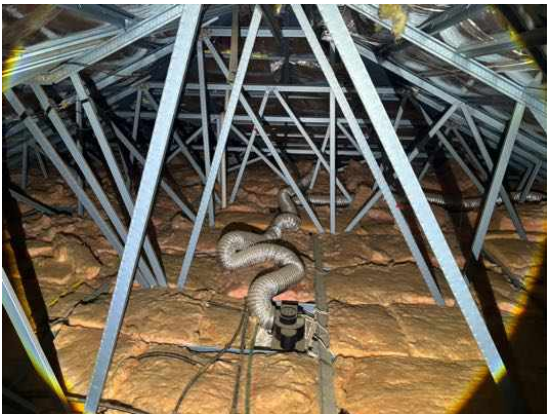
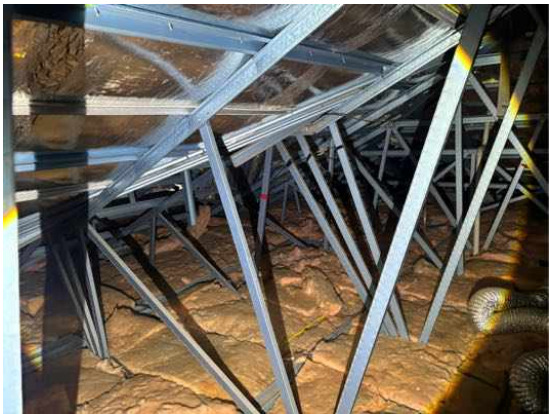
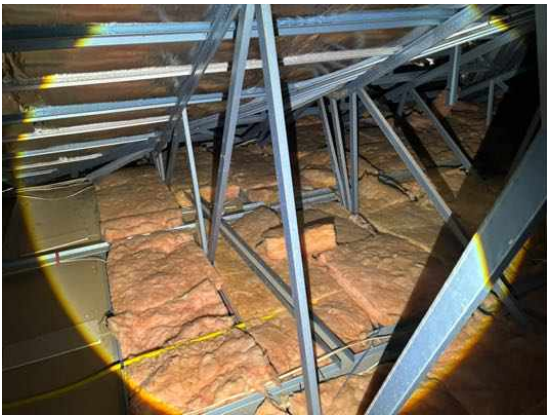
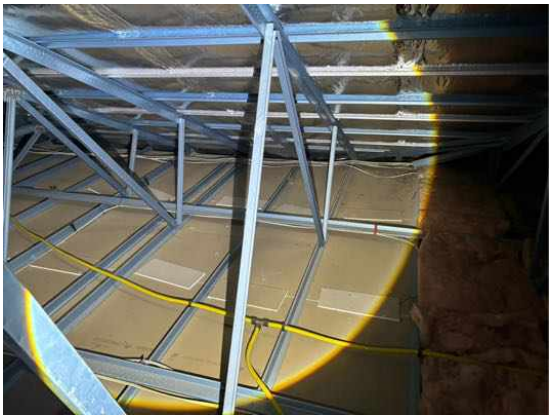
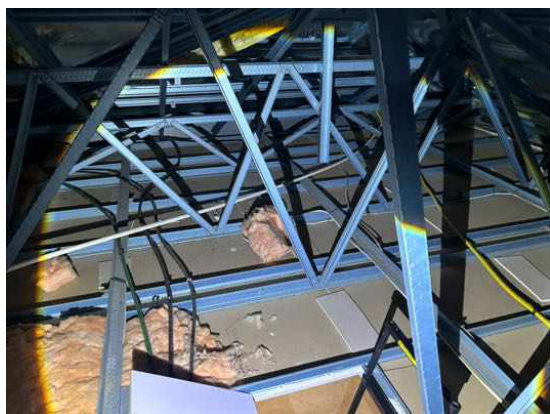
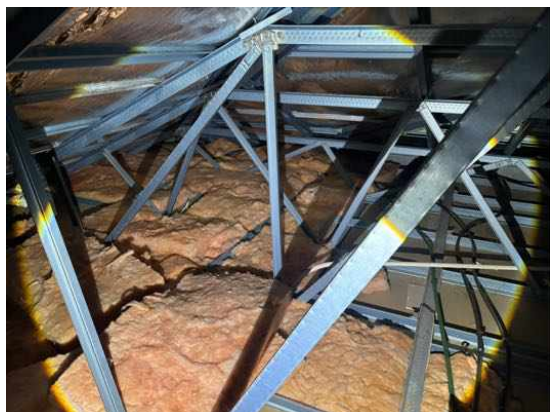
Building: Main Building
 Location: Roof Void
 Finding: Obstructions, Limitations, and General Roof Space Condition
 Information: The photographs provided document both the general condition and the obstructions and limitations that were present in the roof cavity of the main building at the time of inspection. These obstructions—such as insulation materials, stored items, structural elements, or electrical wiring—restricted safe and adequate access to key areas within the roof space. As a result, a comprehensive inspection of all components could not be completed.

Obstructions of this nature may conceal a variety of potential defects, including

damaged framing, compromised insulation, evidence of moisture ingress, pest activity, or electrical hazards. While no major issues were observed in the visible areas, the presence of these limitations means that some defects may remain undetected.

It is recommended that these barriers be removed or repositioned to facilitate full and safe access to the roof space. Once clear, a follow-up inspection should be conducted to allow for a thorough assessment of all concealed areas. This will help ensure that the condition of the roof cavity is accurately evaluated and any hidden issues are appropriately identified and addressed.

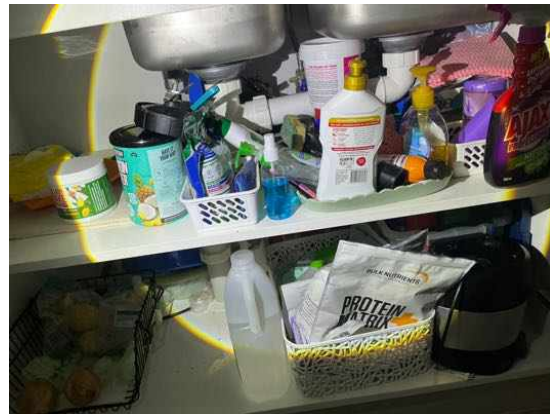
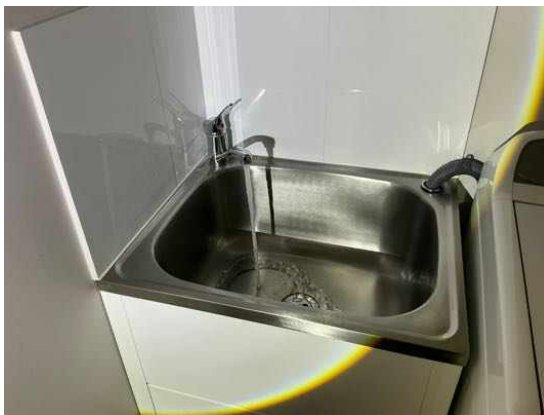
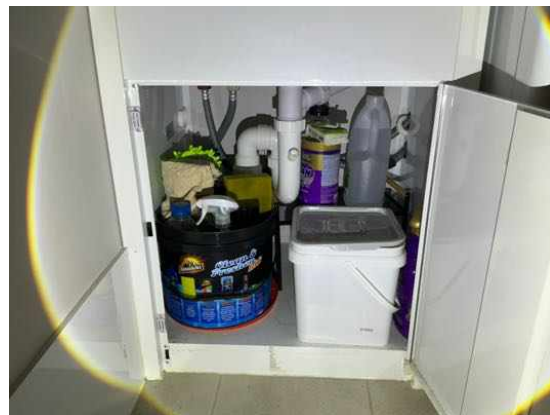
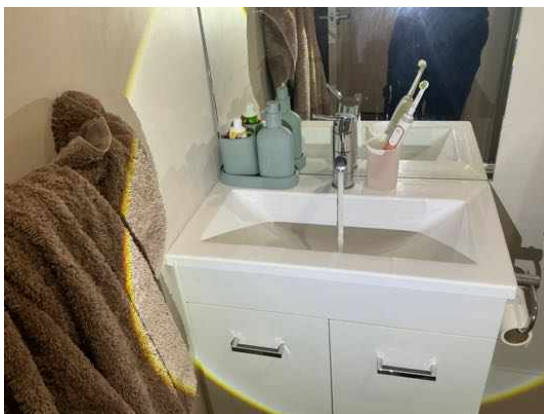
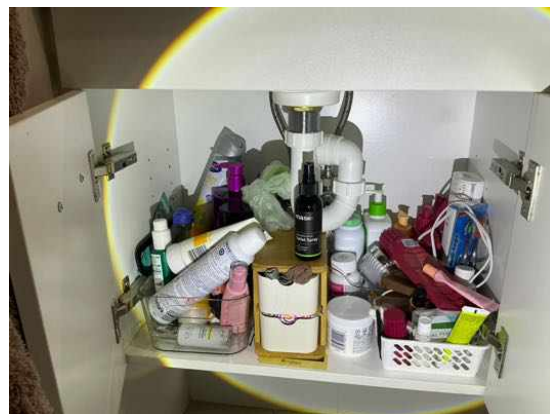
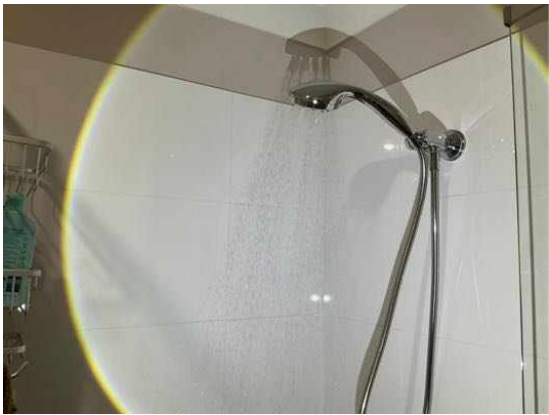
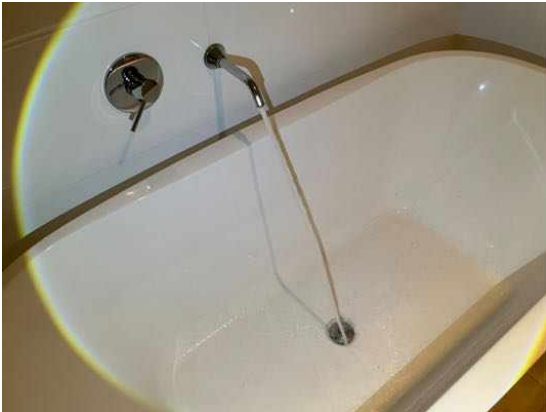
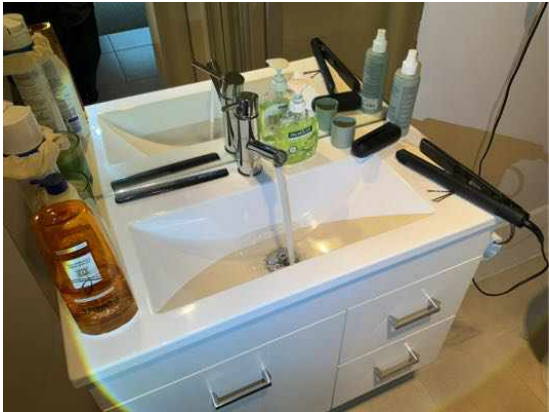
beneath sinks and vanities was undertaken, stored personal items and fixtures presented obstructions that limited full visibility of the internal areas. As per standard inspection practices, inspectors are not permitted to move or disturb personal belongings during the inspection process. Therefore, only visible and accessible sections were inspected, and concealed water damage or plumbing defects may not have been detected.

Given this, a re-inspection is recommended after all obstructions have been cleared to allow for a comprehensive assessment of these areas. Regular maintenance and monitoring of plumbing and drainage systems is also advised to ensure ongoing functionality and early detection of potential issues.

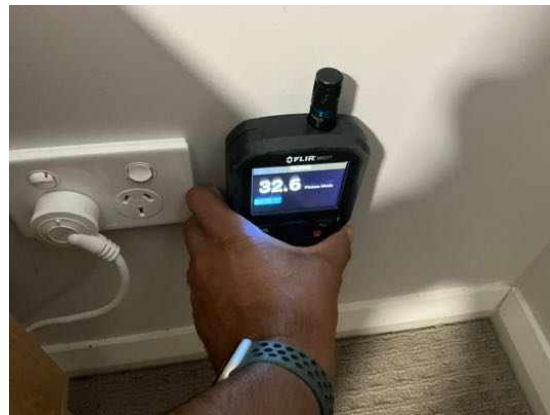
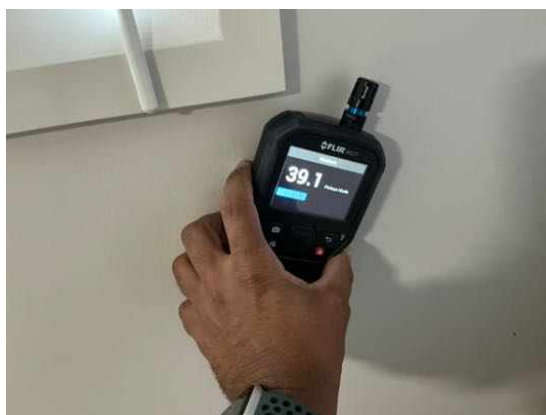
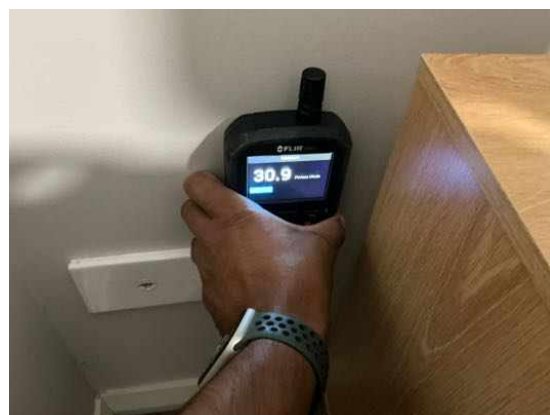
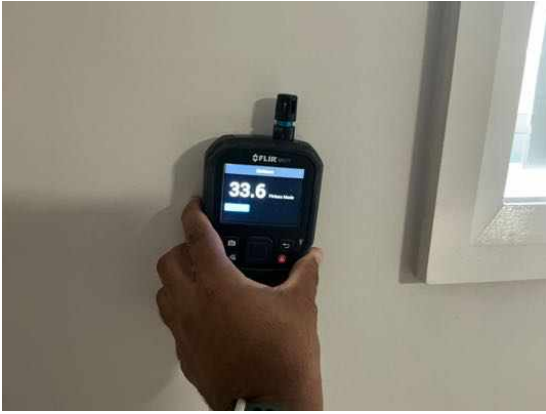
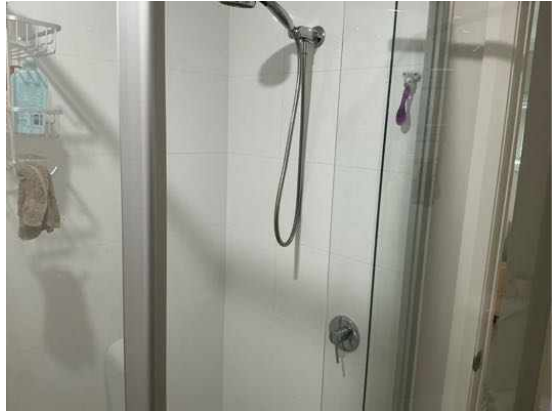
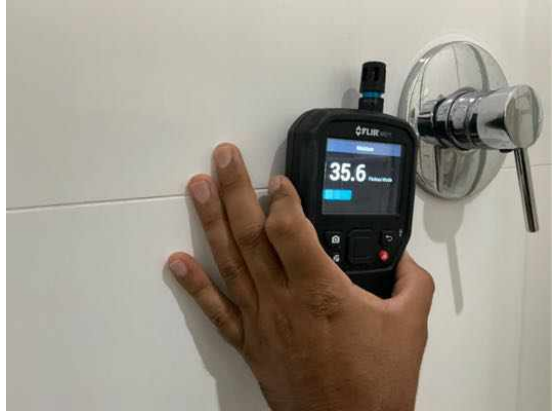
Building: Main Building
Location: All Areas
Finding: Additional Photos - Moisture Meter Readings
Information: Additional moisture meter reading photos have been provided for the property to offer further clarity on areas tested during the inspection. These photos are intended to give a visual reference for the specific locations where moisture levels were measured. These readings were taken at the time of the inspection to assess any potential moisture-related issues within the property. Any defects related to moisture that were identified during the inspection have been separately mentioned in the defect statements within the report.

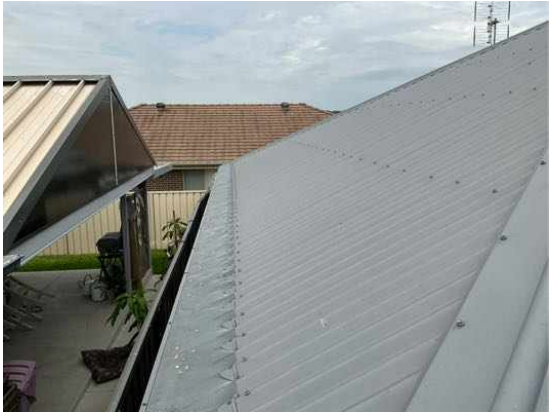
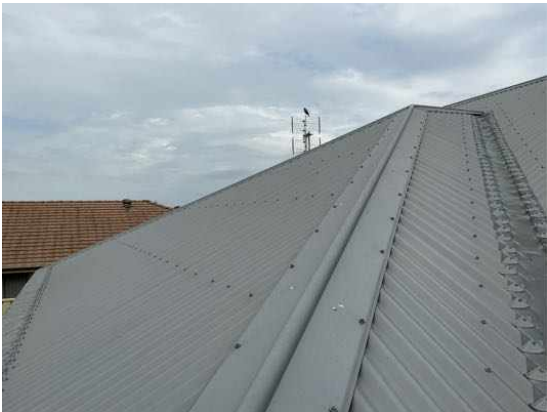
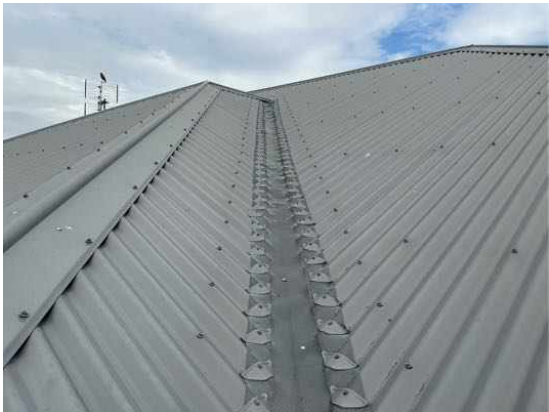
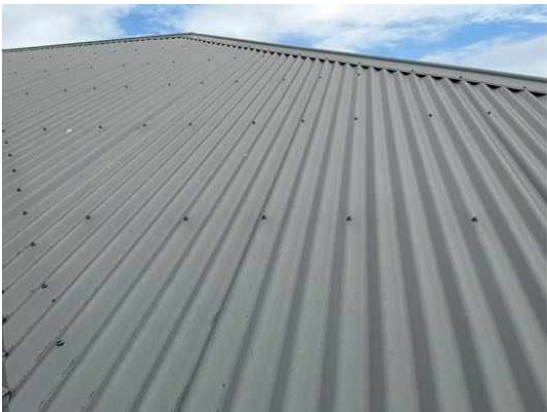
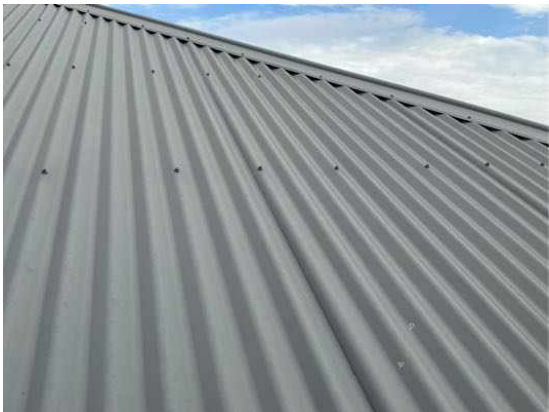
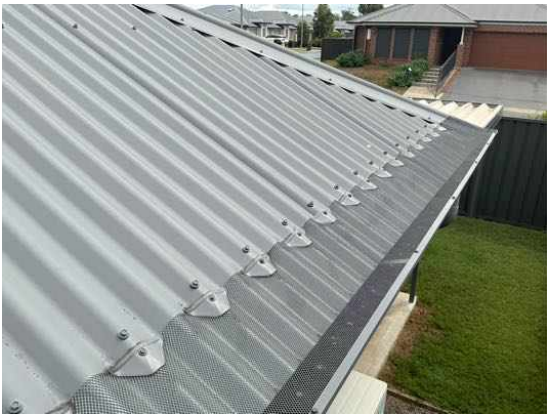
Building: Main Building
Location: Roof Exterior
Finding: Additional Roof Photos

Information: As part of the information provided, please note that the attached roof photos represent the condition of the roof at the time of inspection. These photos are for visual reference only and do not constitute a detailed roofing assessment. Any defects or issues identified with the roof are mentioned separately in the defect statements. It is strongly recommended that the client engage a qualified roofer to conduct a thorough inspection of the roof, ensuring that any potential issues, such as leaks, structural integrity, or wear and tear, are properly identified and addressed.

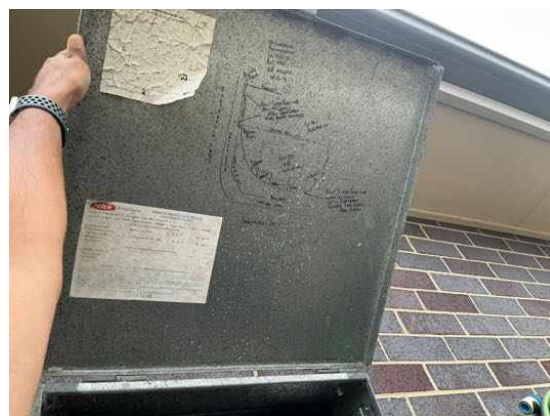
In accordance with standard requirements, a durable notice should be located within the electrical switchboard to detail any termite protection systems applied, including chemical treatments. No such notice was observed during the inspection.

It is recommended that the client engage a licensed pest controller to assess the suitability of installing a chemical barrier, and to provide advice on associated costs and procedures. This should be considered a short-term priority, particularly if the property has any history of termite activity or is located in a high-risk area.

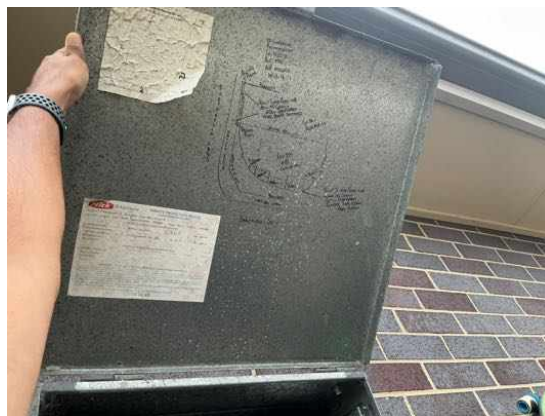
Where a Termite Management System has been identified you should refer to the type of barrier date of installation warranty conditions and any documentation provided by a builder or past owner. Consult the company who installed the barrier to confirm whether the system is still under warranty.

Most chemical termite management systems expire and require replenishment and all physical systems are primarily designed to prevent concealed entry.
