Building and Timber Pest Inspection Report

Inspection Date: Thu, 5 Feb 2026

Property Address: 7 Jacaranda Avenue, Bradbury NSW 2560

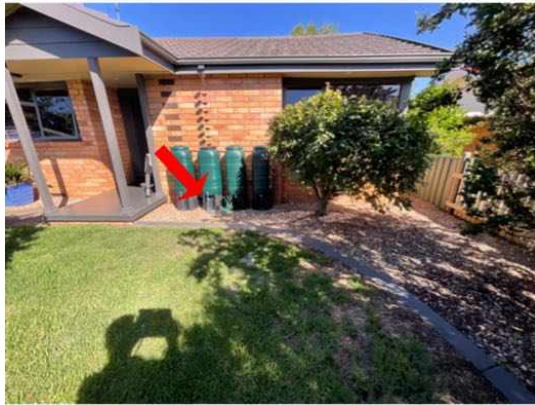
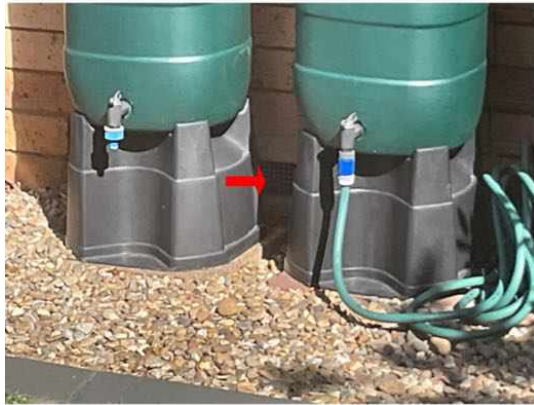
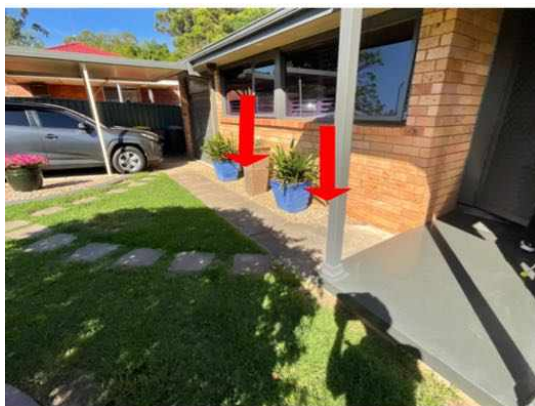
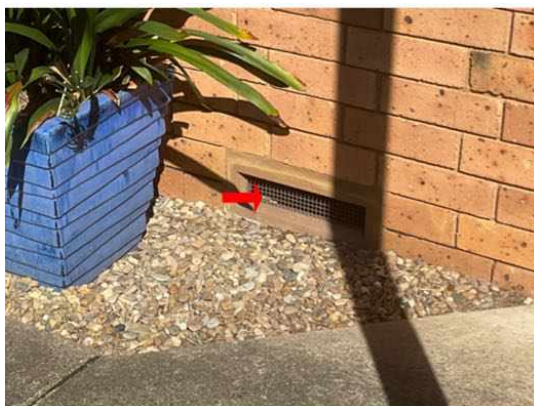
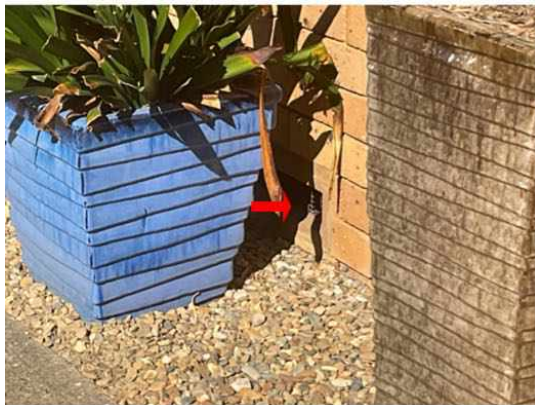
Building:	Main Building
Location:	Exterior walls - front
Finding:	Subfloor ventilation - Too low.
Information:	Subfloor Ventilation and Ground Levels – Moisture Risk

Subfloor wall vents in the inspected locations were found to be positioned too low due to substandard external landscaping and ground levels. The external ground raised adjacent to the building perimeter, increasing the likelihood that rainwater can enter the subfloor via the vents during wet conditions.

Ongoing moisture ingress into the subfloor can result in persistently elevated moisture levels. If left unrectified, these conditions may promote fungal growth, timber decay, deterioration of mortar and brickwork, and cracking or subsidence of supporting piers. Elevated moisture levels also increase the susceptibility of the property to termite and other timber pest activity. Secondary water damage is likely to occur over time if the issue remains unmanaged.

Perimeter landscaping and ground levels should be rectified to expose and ensure adequate airflow through vents and fall away from the building. As a general guide, paved surfaces should fall away from the structure by a minimum of 25 mm over the first metre, and bare ground should fall away by approximately 50 mm over the first metre. This will assist in preventing moisture from pooling against the building and entering the subfloor.

Where site drainage is inadequate or rectification is complex, a qualified plumber and landscaping contractor should be engaged to further assess the site and undertake

appropriate remedial works to achieve and maintain a dry subfloor environment.

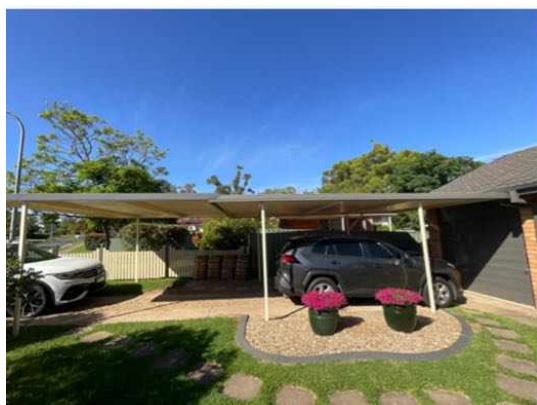
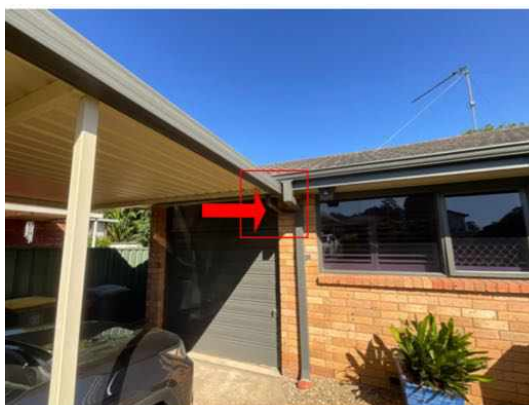
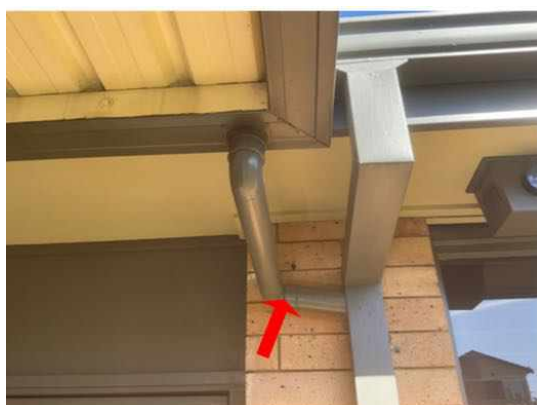
Finding 3.02

Building: Carport
 Location: Roof Exterior
 Finding: Roof Plumbing - Insufficient Capacity and Overflow Risk.
 Information: Observation:

During heavy rainfall, the roof plumbing overflows, causing damp conditions against external surfaces and the building perimeter base. This creates a risk of water damage and increased susceptibility to termite and timber pest activity.

- Engage a licensed and registered roofing plumber to assess and upgrade the roof drainage system as needed to ensure proper function.
- In the interim, ensure all gutters and downpipes are clear of debris and blockages to reduce overflow risk.

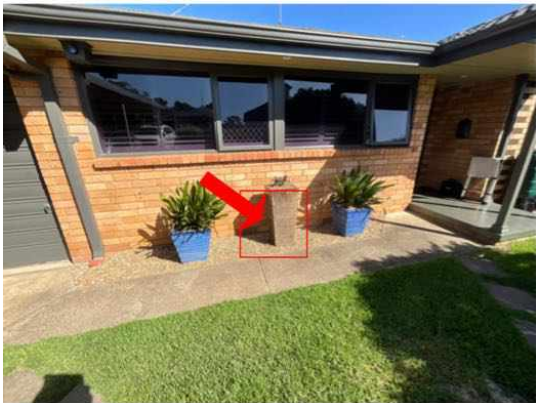
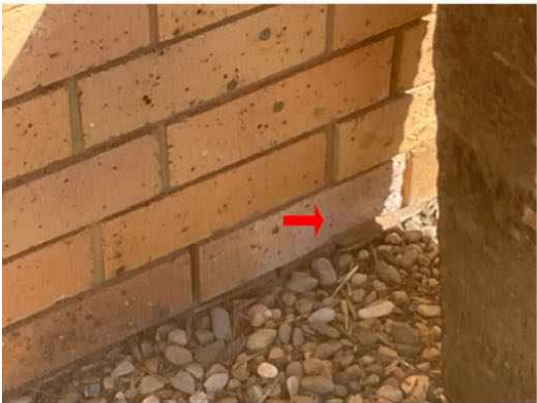
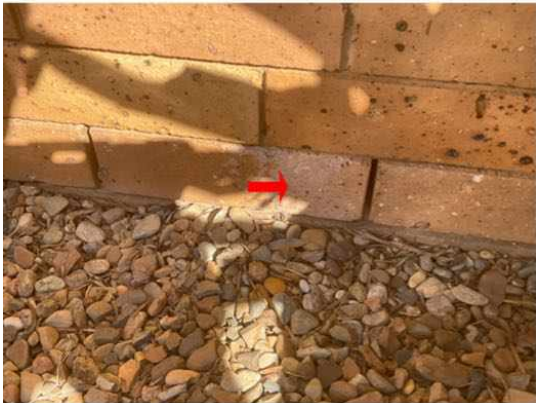
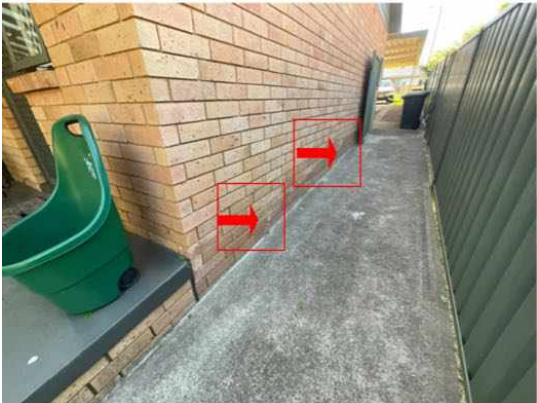
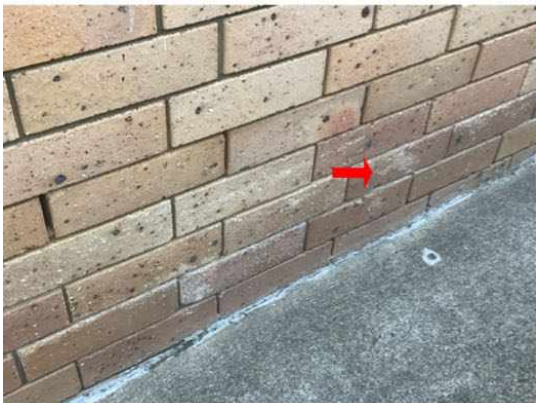
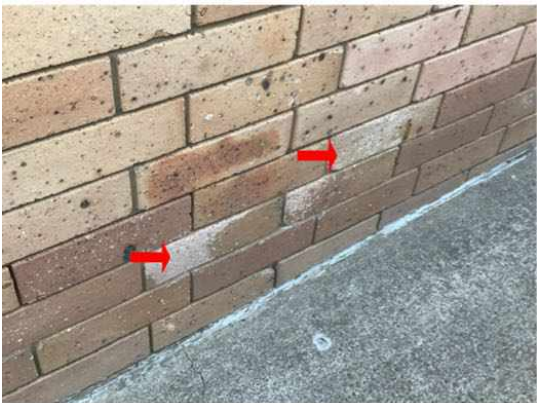
Finding 3.03

Building:	Main Building
Location:	Exterior walls - Front & Left side
Finding:	Deterioration to Lower Brickwork (Fretting Brickwork).

Deterioration consistent with fretting (corrosion or erosion) of the brickwork was observed in sections of the lower external wall at the time of inspection. This condition is commonly caused by prolonged moisture exposure and salt crystallisation within the brick material.

The bricks and surrounding mortar appear brittle in isolated areas, with some evidence of surface flaking and mortar becoming powdery. While currently considered minor, continued exposure to moisture may accelerate the deterioration and reduce the structural integrity of the affected brick piers or walls.

- Improve site drainage to reduce moisture exposure at the base of the walls. A licensed drainage plumber should be appointed to assess and implement appropriate site water management solutions.
- Monitor affected areas for worsening conditions, particularly during periods of heavy rain.
- Where fretting is advanced, damaged bricks and mortar should be replaced by a licensed bricklayer experienced in masonry repairs and salt-damage mitigation.

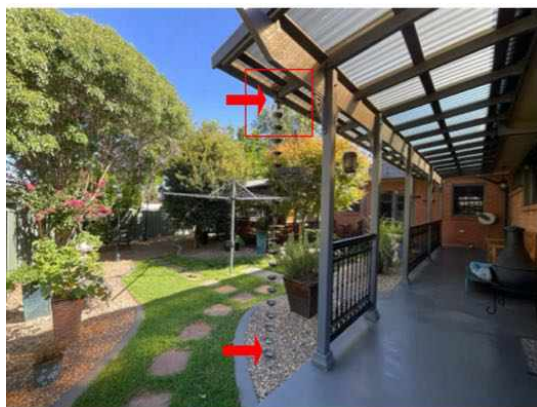
Finding 3.04

Building: Main Building
Location: Roof Exterior Rear/left
Finding: Downpipe - Unconnected.
Information: Observation:

A section of roof plumbing was found where the downpipe is not connected to the stormwater drainage system.

Excessive moisture from uncontrolled roof runoff can create conditions that promote termite activity and timber decay.

It is advised that a licensed plumber be engaged to:

- Inspect the affected roof plumbing area, and
- Connect the downpipe to a compliant stormwater drainage system, or alternatively, install appropriate drainage measures to manage water flow and mitigate potential property damage or pest risks.

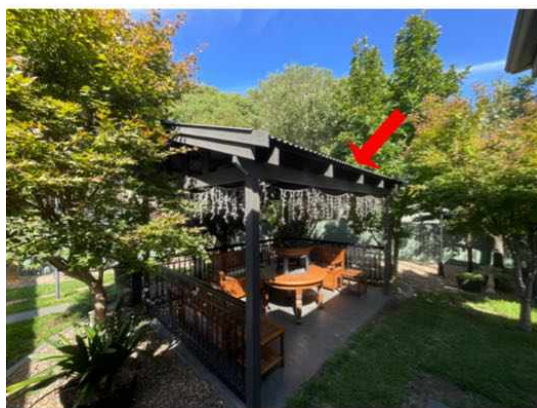
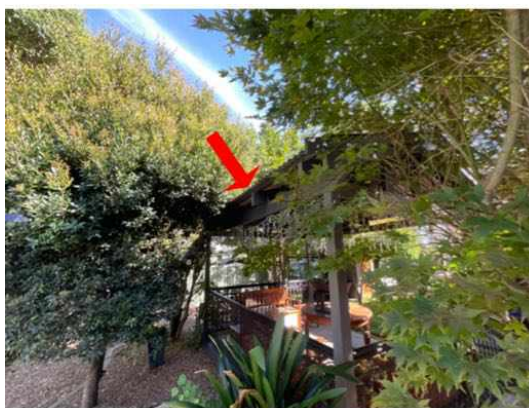
Finding 3.05

Building:	Yard
Location:	Roof Exterior - Cabana
Finding:	Roof plumbing - Missing.
Information:	During the inspection, it was observed that roof plumbing components (e.g. gutters, downpipes, or flashings) were missing from the roof covering in this location.

While no immediate signs of water damage or impact to the building were noted at the time of inspection, the surrounding ground appears to slope away from the structure, assisting with natural surface water runoff.

We recommend monitoring the area during wet weather to assess whether water is being effectively diverted away from the building.

At the client's discretion, a licensed roofing plumber should be engaged to install the appropriate roof plumbing materials (e.g. gutters and/or downpipes) to ensure compliant and effective water management.

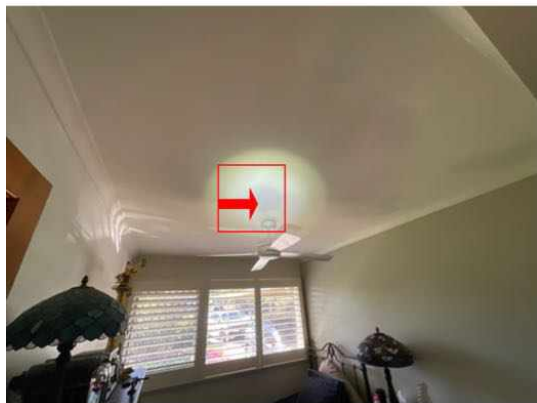
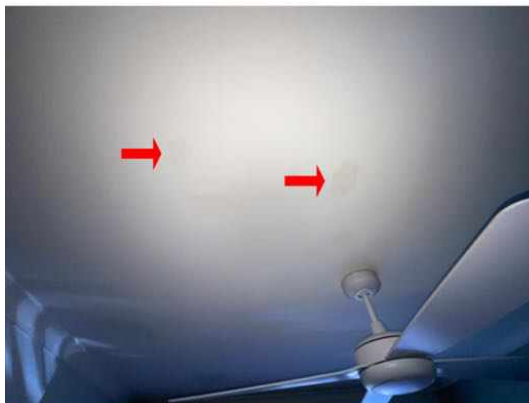
Finding 3.06

Building:	Main Building
Location:	Bedroom
Finding:	Ceiling - Water stained
Information:	Water staining to ceiling linings in this area was evident at the time of inspection. Water staining indicates that surfaces have been exposed to excessive moisture over time. The minerals and other elements in the water lead to staining, which may graduate to corrosion and deterioration if left unmanaged.

While mostly an appearance defect, water staining can be indicative of more serious defects, which may be currently concealed by interior ceilings.

Where water staining is active, a licensed plumber must be consulted to identify the cause of the staining and to provide advice on any reparation works that may be required. Replacement of any damaged structures is advised.

Conversely, where water staining is old and inactive, affected building materials may be repaired or replaced at client discretion.

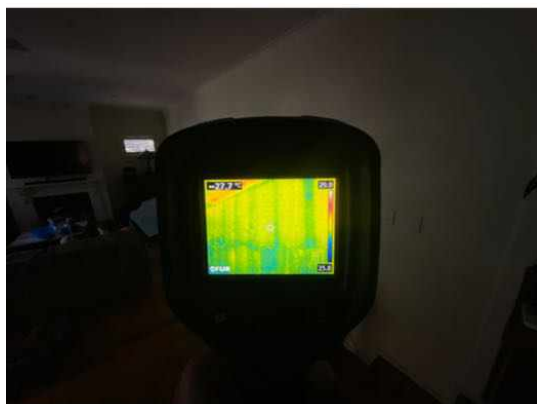
Building:	Main Building
Location:	All Areas
Finding:	Evidence of live termite activity was not visible at the time of the inspection..
Information:	Termite Activity – Important Advisory

At the time of the inspection, no abnormalities indicating live termite activity were

observed. However, it's important to note that various factors—such as obstructions, ambient temperature, and wall material/thickness—can impact the accuracy of thermal readings. In cases where surfaces are visually restricted or obstructed, a comprehensive thermal scan may not always be feasible.

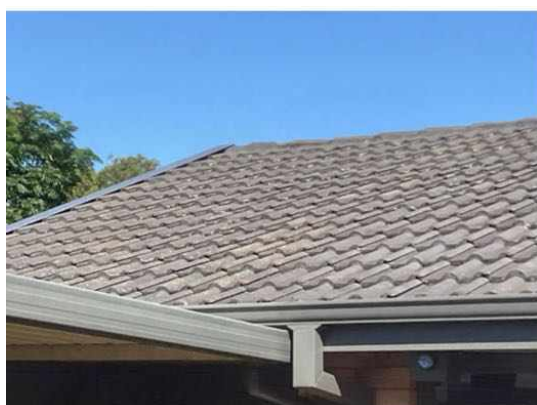
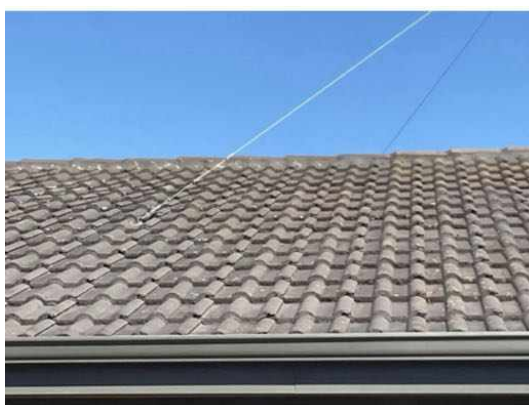
Building: Main Building
 Location: Roof Exterior
 Finding: Roof Tiles – General Condition.
 Information: Condition Overview:

Based on the limited visual inspection, the roof and guttering system appears to be in a generally serviceable condition. A further investigation by a roofing specialist to ensure the integrity of non-visible areas.

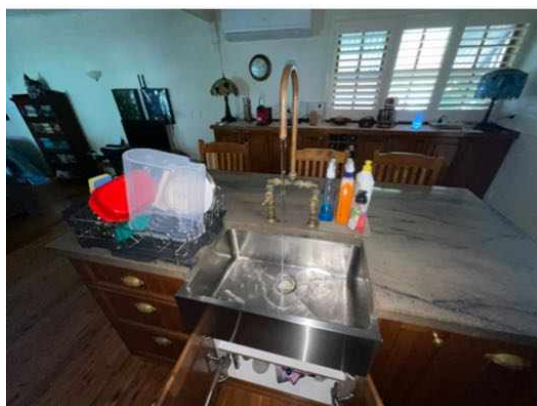
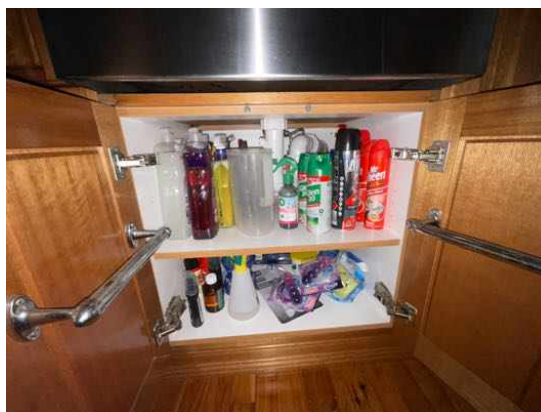
Building: Main Building
 Location: Kitchen
 Finding: Kitchen Sink – Overall Condition & Recommendations.
 Information: Observations:

- Further monitoring and testing are recommended once the tap(s) are in constant use, to identify any drainage issues or signs of slow leaks not evident during the limited inspection.
- It is recommended that the stored items beneath the sink be removed to allow for a full re-inspection of the plumbing and cabinetry, ensuring no concealed defects are present.

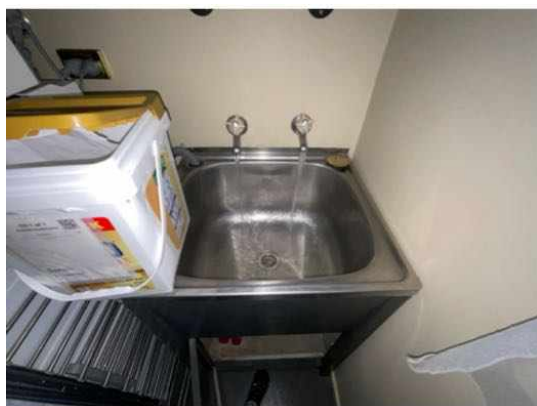
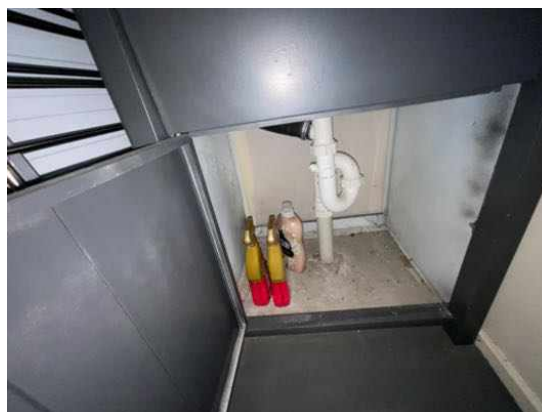
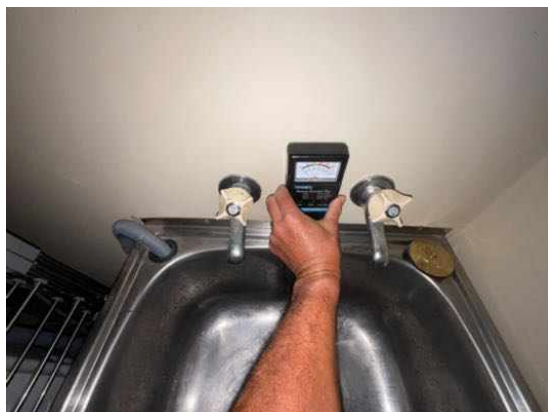
Building: Main Building
 Location: Laundry
 Finding: Laundry - Taps/Plumbing/Drainage.
 Information: Observation: Laundry Tub – Taps, Plumbing, and Cabinetry

- Further monitoring or testing is recommended once the taps are placed into regular use, to ensure no leaks develop over time and that the drainage system continues to perform adequately.
- Flexible and mould-resistant sealant should be applied to junctions between the basin and the wall to prevent water ingress that may lead to damage.
- Regular maintenance and prompt replacement of missing or deteriorated sealant is highly recommended, as this is a common wear-and-tear issue.
- Sealant and grouting in wet areas should be maintained as part of the long-term care and upkeep of the property.
- Where required, a sealant specialist or qualified tiling contractor should be appointed to carry out remedial sealing works.

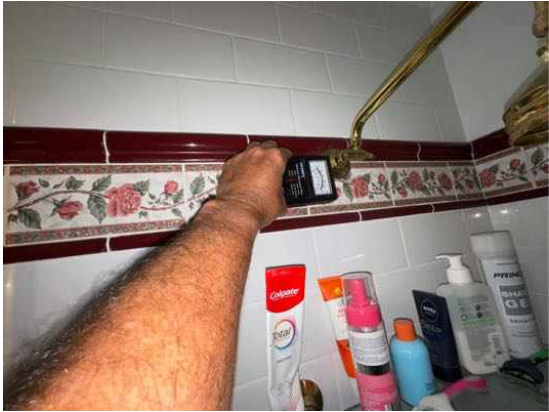
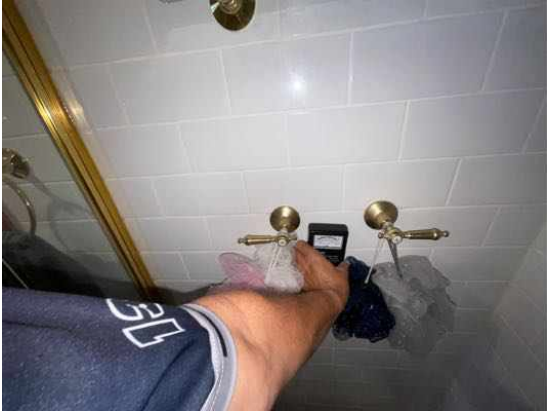
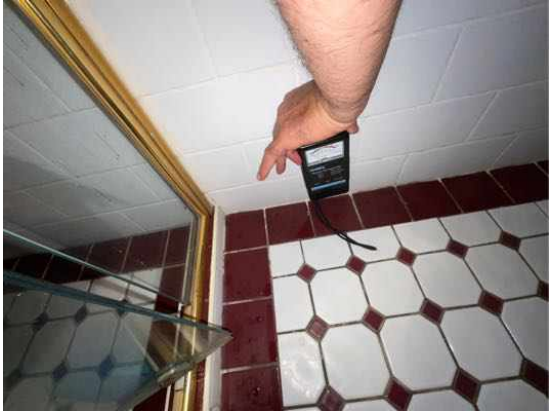
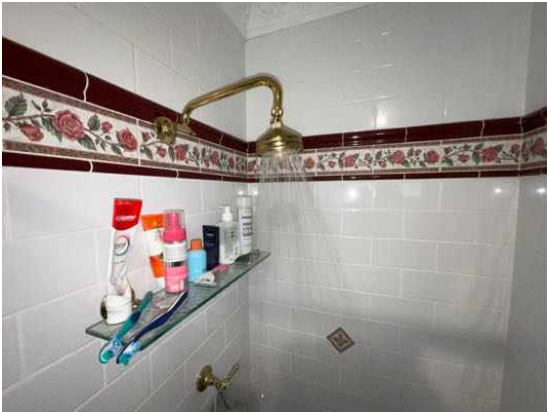
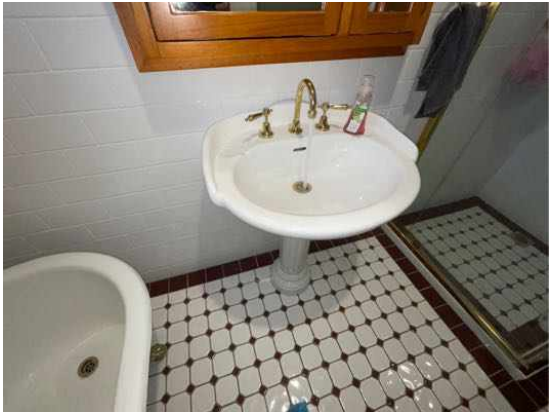
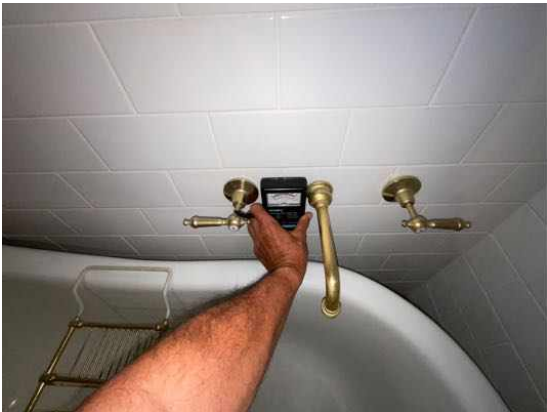
Building: Main Building
 Location: Bathroom
 Finding: Wet Areas - Bathroom(s) - Overall Condition & Recommendations.
 Information: Overall Condition & Recommendations

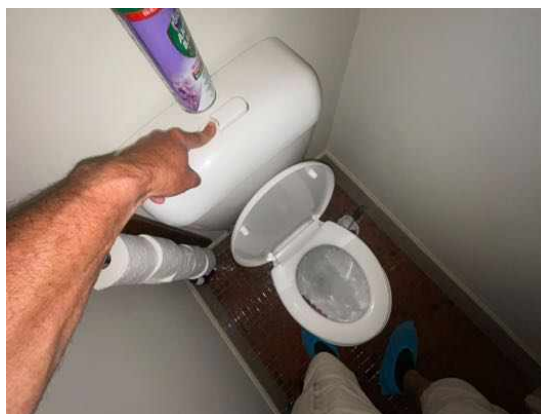
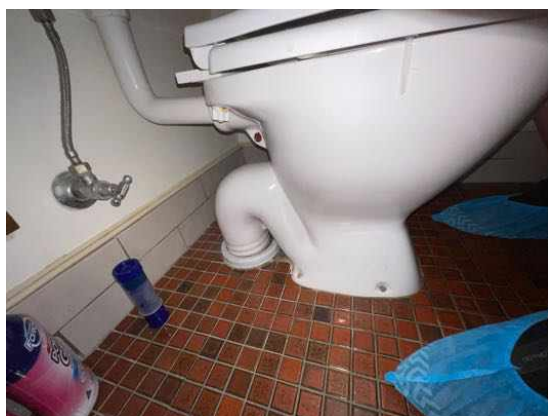
Building: Main Building
 Location: Toilet (WC)
 Finding: Overall Condition: Toilet.
 Information: TOILET ASSESSMENT

- No leaks were observed during the flushing process.
- The toilet operated normally with no signs of malfunction or abnormal water flow.
- The toilet pan was securely fixed to the floor at the time of inspection.
