Building and Timber Pest Inspection Report

Inspection Date: Thu, 22 Jan 2026

Property Address: 74 Australia St, Bass Hill NSW 2197,
Australia

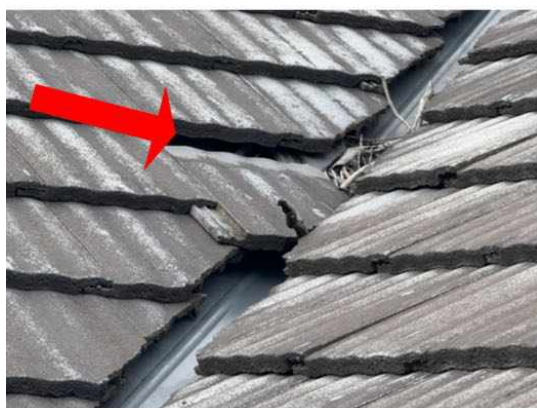
Building: Main Building
 Location: Roof Exterior
 Finding: Exterior roof - Leaking
 Information: Active roof leaks were evident at the time of inspection. Roof leaks can have a number of causes, including damage to roof coverings, deterioration of roof fixtures and fittings, or loosely associated materials (fascias etc.).

Where water leaks are active, rain penetration is likely to cause water damage to associated structures and building elements in this area, which can have a range of implications. If left unmanaged, the development of major structural damage to the roofing and associated structures may occur.

A roof plumber should be appointed as soon as possible to primarily identify the cause of the leak, and to provide subsequent repair works as necessary. Depending on the extent of the damage, replacement of sections of the roof covering and/or roofing structures may be required, and may be performed by a registered builder or qualified carpenter.

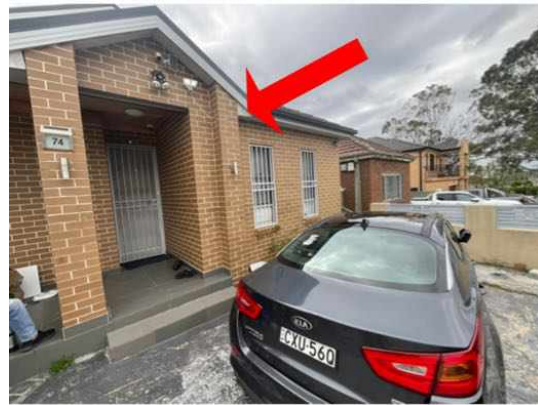
Finding: Eaves - Damaged

Information: The eaves around the external property were found to be in a visibly poor condition. The damage may have been sustained as a result of a number of possible causes, including poor roof drainage, leaking roof plumbing or minor impact damage.

The damage to the eave sheeting in this area detracts from the appearance of the structure, as well as potentially compromising the structural integrity of the roofing area.

Where eaves show moderate to severe damage, remedial works may be required. Where water damage is suspected as being the underlying cause, appointment of a licensed plumber is advised as a matter of urgency to identify the source of the water leak.

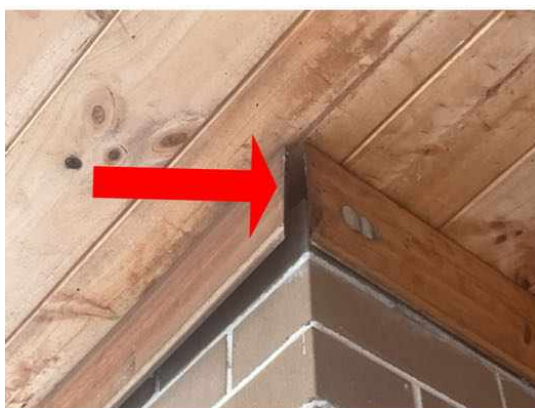
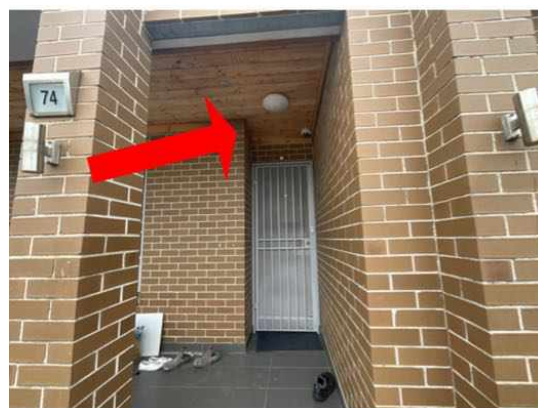
Finding 3.02

Finding: Beads - Damaged

Information: Beading acts (like cornice or skirtings) to cover the intersection or joins of building materials. It was noted at the time of inspection that beading in this area has deteriorated. This deterioration is suspected to have been caused by general ageing and frequent exposure to weather, which is expected in a building of this age and condition.

Beading is important in weatherproofing the surrounding building elements and preventing termite or pest ingress. Furthermore, beading works to protect the joins of building materials, which are more susceptible to deterioration and decay.

Repair or replacement of the beading is advised to ensure the protection and longevity of any associated building elements. Such works may be performed by a general handyman or qualified carpenter.

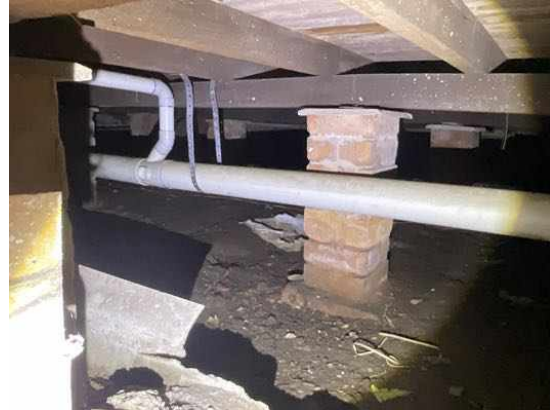
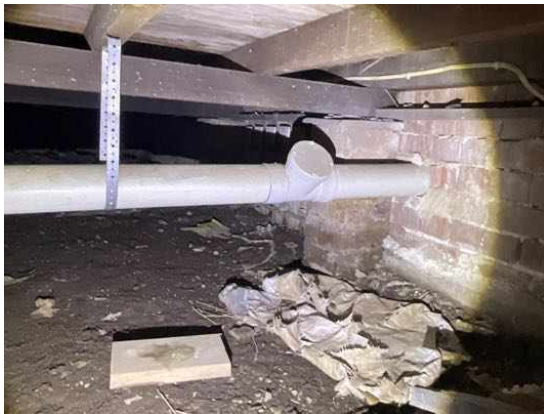
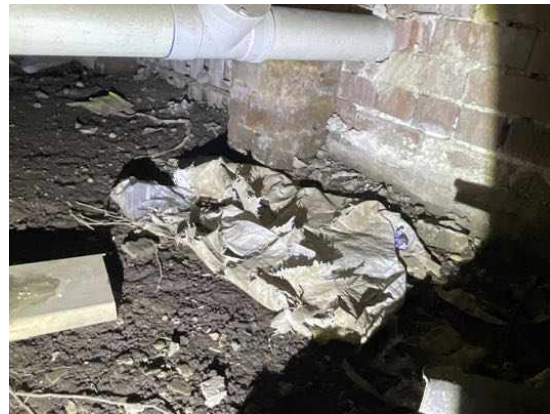
Information: It was noted at the time of inspection that the subfloor area lacks adequate ventilation. Ventilation can be restricted by a variety of minor defects, including obstructions in the subfloor space, a lack of vents or a low clearance.

A well ventilated subfloor aids in maintaining dry conditions, preventing secondary damage such as wood rot and pest activity, as well as preventing the development of mould and mildew (which can lead to respiratory safety hazards for occupants).

The initial step in improving ventilation is to ensure that the subfloor area is free of any debris or stored items. Where ventilation is still inadequate, it is advised to ensure that all vents are clear of blockages, and additional vents may be installed.

The client may also consider mechanical ventilation (powered fans) to improve subfloor airflow. Remedial works should be conducted as a matter of urgency to protect against the development of potentially harmful subfloor conditions.

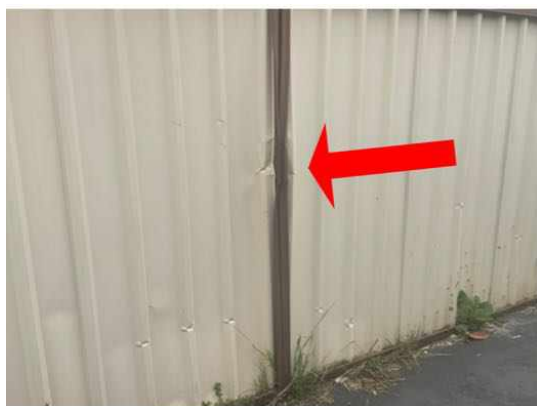
Building:	Main Building
Location:	All External Areas
Finding:	Fencing - Deteriorated
Information:	It was noted at the time of inspection that sections of the fencing throughout the property have deteriorated. Typically fencing deteriorates due to age and or wear and or rust which is generally expected for a structure of this age, due to prolonged exposure to weather conditions. Sometimes inadequate installation or maintenance can be to blame.

If left unattended, it is likely that further damage will occur. It is suspected that repair of several elements of the fencing may be required however replacement may be a consideration of the client also.

A licensed fencing contractor should be appointed to provide further advice and perform rectification works as necessary.

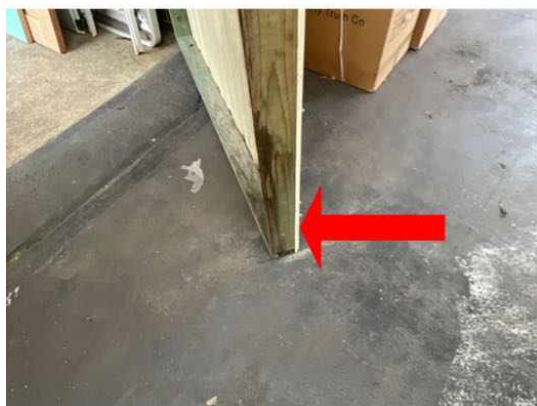
Finding 3.07

Building:	Main Building
Location:	All External Areas
Finding:	Gate - Binding / Jamming
Information:	Binding and/or jamming of this gate is evident during standard operation. This defect inhibits the functionality of the affected gate as well as creating potential for secondary defects to associated building elements, such as damage to the walls. A gate that binds to gate frame may have several causes, ranging from minor defects, such as poor installation of the gate or deteriorated hinges, through to major structural issues, such as damage to post or wall structures. For minor causes, a qualified carpenter or general handyperson should be appointed to perform minor rectification works at client discretion.

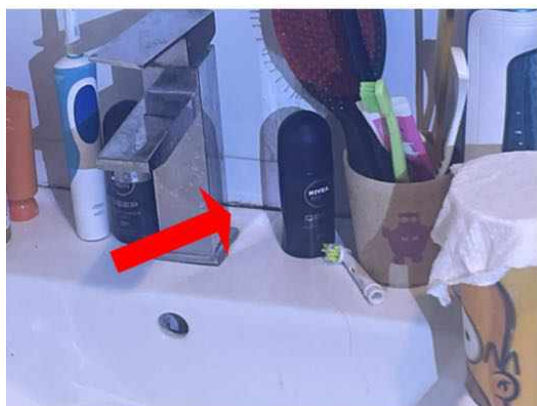
Building:	Main Building
Location:	Wet areas
Finding:	Sealant and grouting - Missing or damaged
Information:	It was noted on inspection that sealant or grout is degraded to the tiled shower alcove and or other areas of the bathroom.

Different materials and floor areas move at different rates, generally causing cracking to grout or sealant at this point. A flexible sealant is required to allow for expected expansion and contraction, while keeping the joint water tight and protective of all associated building materials.

There appears to be excessive mould to the sealant and grout which will likely require scraping out and replacement.

Flexible and mould resistant materials should be applied to affected areas to prevent any subsequent water damage that is likely to occur. Regular maintenance and replacement of damage or missing or damaged sealant and grout is highly recommended to the wet areas, as this is a regular wear and tear defect. Sealant and grouting in areas that come into regular contact with water should be maintained for the long term care of your property.

A sealant specialist or tiling contractor should be appointed to complete these works as soon as possible

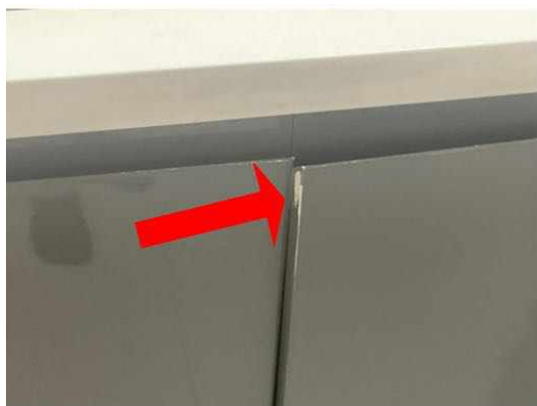
Finding 3.15

Building: Main Building
Location: All Internal Areas
Finding: Cabinet doors - misaligned
Information: It is observed that some of the cabinet doors are not aligned and / or have inconsistent gaps between the doors.

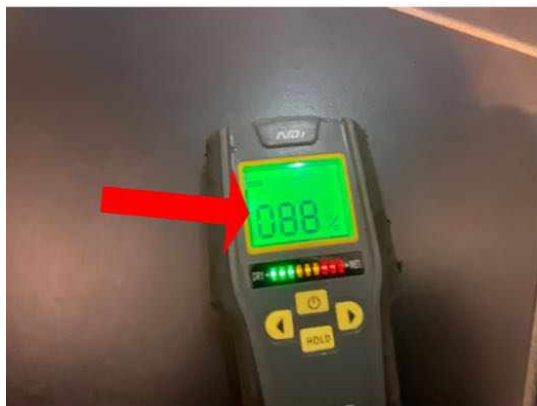
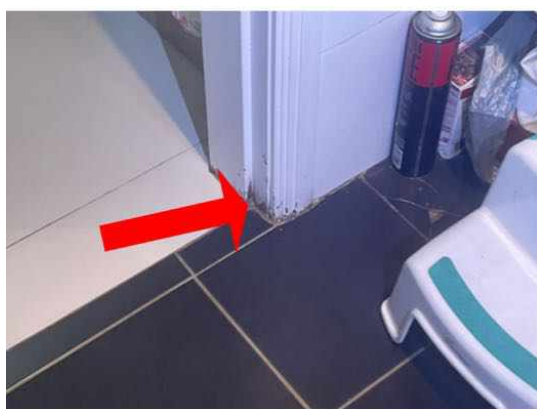
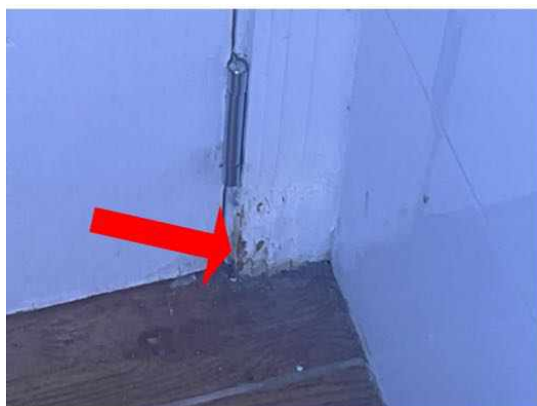
Finding 3.16

Information: Damp is evident to the lower 300mm of wall to the bathroom alcove. This defect is quite common, and is suspected to have been caused by moisture permeating through the grouting in this area, which shows evidence of deterioration. Leaking pipes within the adjoining wall is also a possible cause. Damp (or structural damp) refers to the presence of unwanted moisture in the structure of a building, either as the result of intrusion from outside, or condensation from within the structure. In the bathroom area, internal water leaks or other sources of excessive moisture are generally the cause of damp. Unmanaged damp in the bathroom recess is likely to facilitate the formation and development of mould and fungi growth, decaying associated building materials and compromising their structural integrity. It is important to address damp conditions, as the World Health Organisation notes that excess moisture leads - on almost all indoor materials - to growth of microbes such as moulds, fungi and bacteria, which subsequently emit spores and other matter into the indoor air. Exposure to these contaminants is associated with a wide range of respiratory and other health-related problems. Consultation with a qualified plumber or bathroom specialist is advised immediately to identify the cause of damp and to perform remedial works as required. Where excessive mould growth is present, further inspection by a specialist environmental health inspector should also be considered.

Always ensure that sealant and grout is in good condition to prevent any moisture issues occurring in the future.

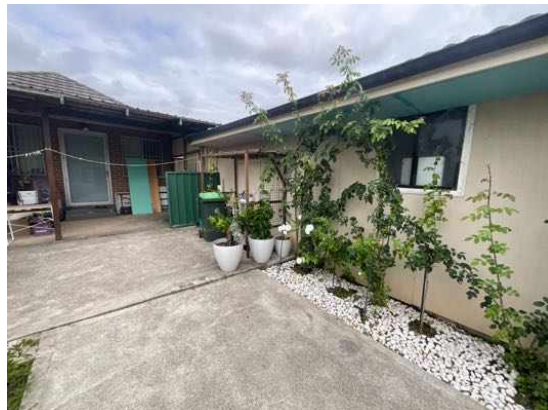
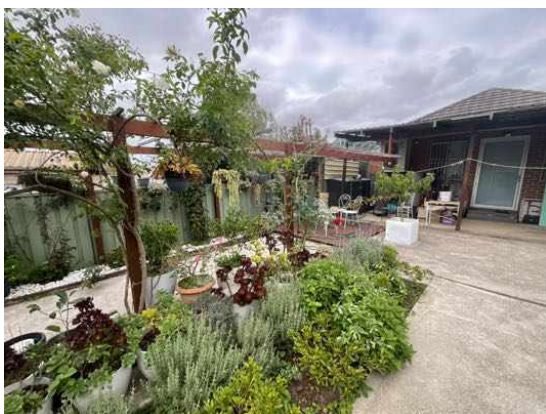
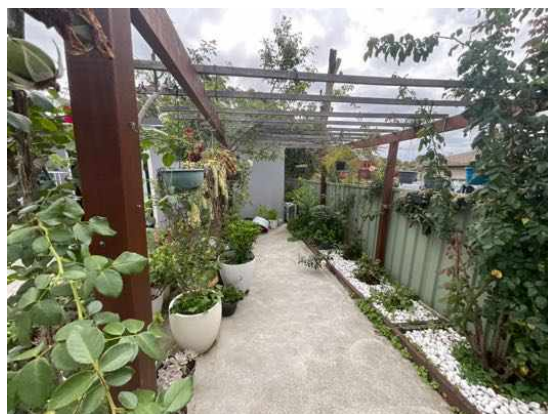
Finding 6.01

Building: Main Building
Location: All Areas
Finding: Garden Beds - Conditions Conducive to Termites
Information: Garden beds were found to be evident in the garden area. These garden beds can include untreated timber, and with a combination of moisture from watering hosing can make conditions conducive to termite activity and termite ingress.

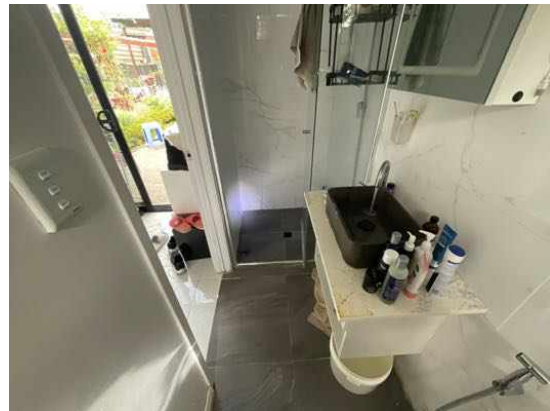
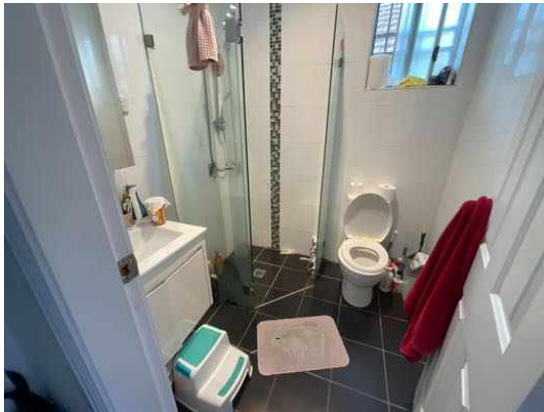
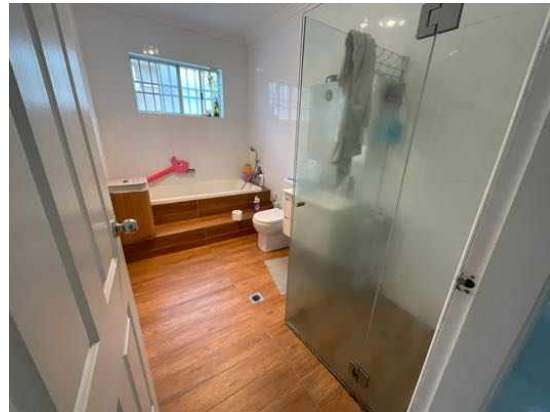
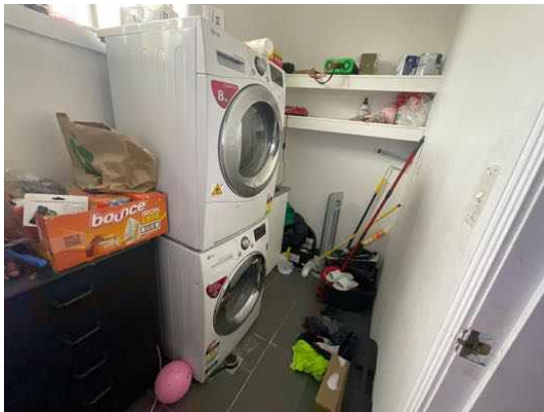
Building:	Main Building
Location:	All Areas
Finding:	Water Proofing Membranes - Information Only
Information:	Internal Water Proofing Membranes, are crucial in preventing water ingress into the property is important to know that the Membrane System used is to Australian Standards and has been installed correctly. Please refer to the original Building Documents or Maintenance Schedule for the relevant information including; - Membrane used and Manufacturers Specifications. - The Installer and Installation Certification. Especially with older property's where this information is unavailable, all wet areas should be monitored. Generally new waterproofing with a certificate may

only have a guarantee of 8yrs. If any leaks, water staining, peeling or bubbling of the paint become evident to any adjacent walls or ceilings below a licensed builder or waterproofing specialist is recommended to investigate further.

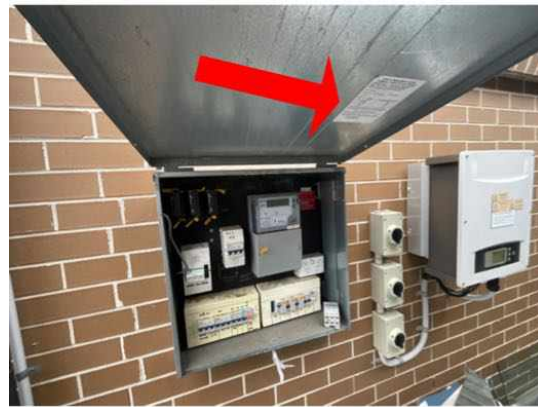
Building:	Main Building
Location:	All Areas
Finding:	Evidence of a chemical treated zone barrier was identified
Information:	During inspection of the property, it was noted that works to install a chemical treated zone barrier had previously been completed. A chemical treated zone barrier is likely to ensure effective protection against termites.

Where a Termite Management System has been identified, the client should identify to the type of barrier, date of installation, warranty conditions and any documentation provided by a builder or past owner. Consult the company who installed the barrier to confirm whether the system is still under warranty.

Most chemical termite management systems expire and require replenishment. All physical systems are primarily designed to prevent concealed entry.
