Building and Timber Pest Inspection Report

Inspection Date: Thu, 12 Feb 2026

Property Address: 18 Harrow St, Tumbarumba NSW 2653,
Australia

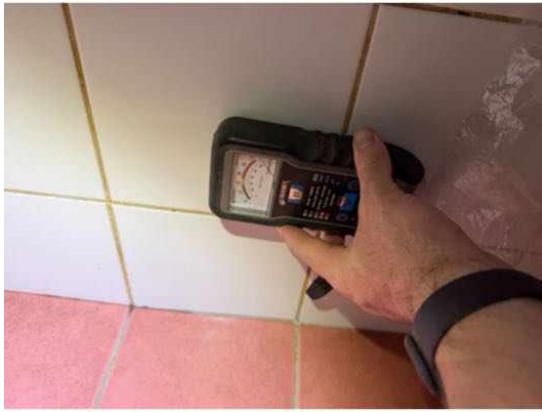
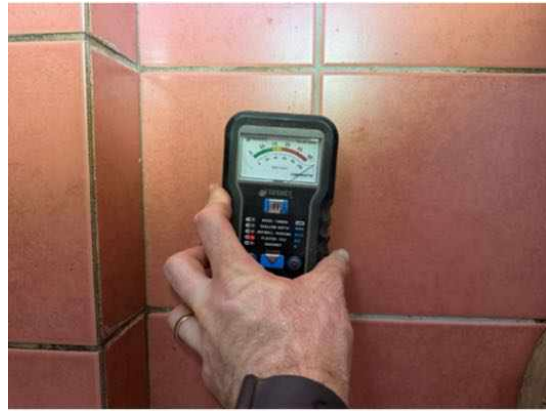
Finding 2.01

Building: Main Building
Location: Shower, Toilet & Bathroom Floor
Finding: Shower & Toilet - Leaking / High Moisture
Information: It appears that high moisture is present at but not limited to, the base of the shower walls, in the wall outside the shower, beneath the toilet plumbing & the bathroom floor. Potential causes of leaking include but are not limited to loose or damaged plumbing fittings and fixtures, and/or deteriorated seals or waterproofing. Areas of leaking and high moisture create an environment conducive to termite activity and therefore should not be neglected.

If neglected secondary building defects will ensue. A more invasive inspection may reveal secondary building defects.

A licensed plumber is required promptly, to provide remedial works where necessary, to ensure no further water damage occurs.

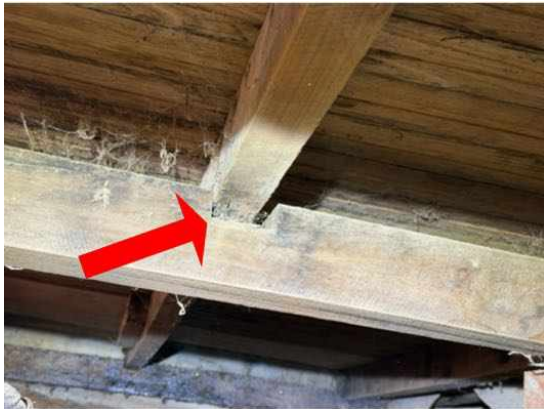
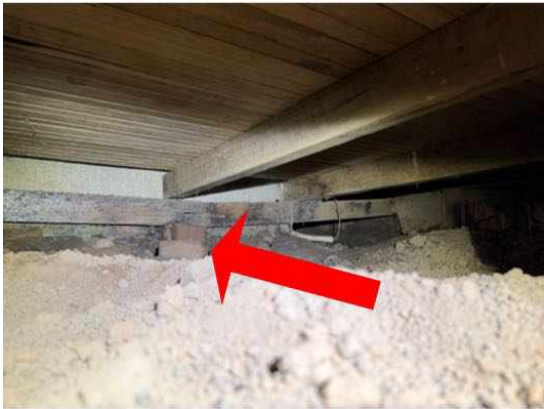
Finding 3.01

Building: Main Building
Location: Subfloor
Finding: Subfloor piers - Insufficient support
Information: It was noted that some piers were not fully supporting the bearers, with gaps in between the top of the pier and the bearer. Where bearers are not being fully supported by the piers, sagging of the subfloor structure is likely to occur overtime.

A registered builder or licensed carpenter should be engaged in the short term to install packing to these areas, to ensure the bearers are sufficiently supported.

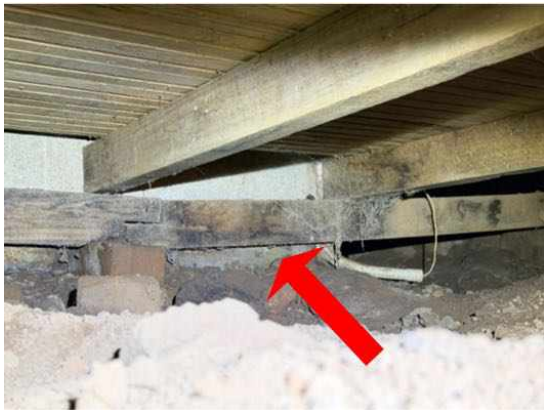
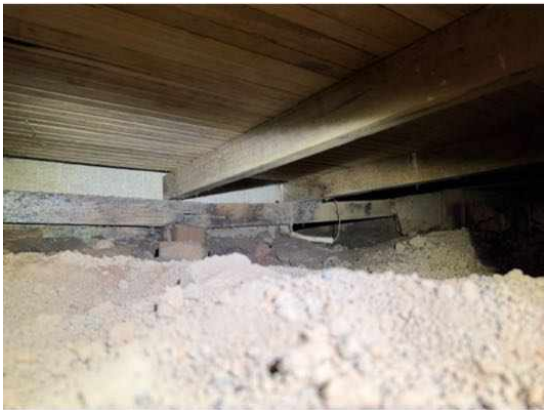
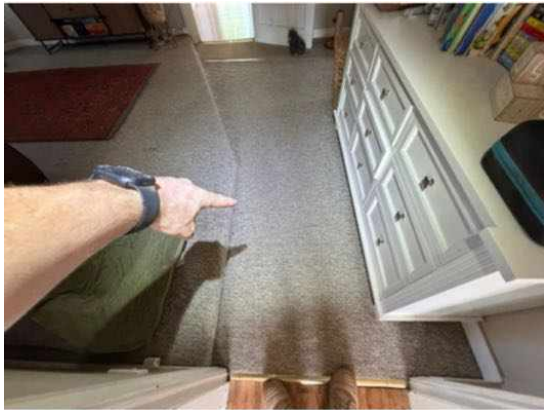
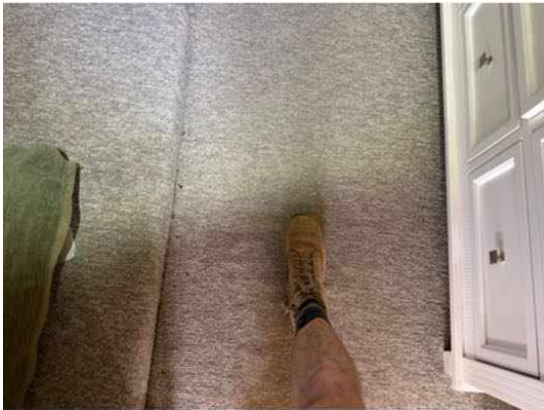
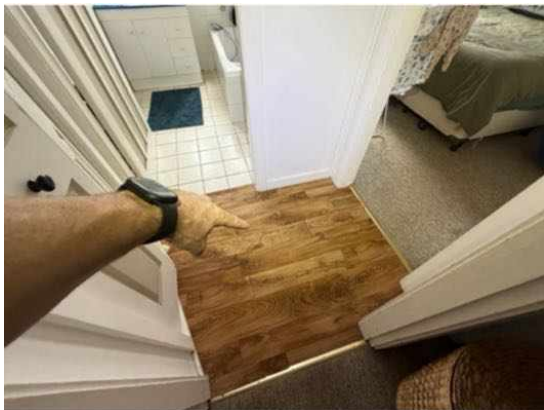
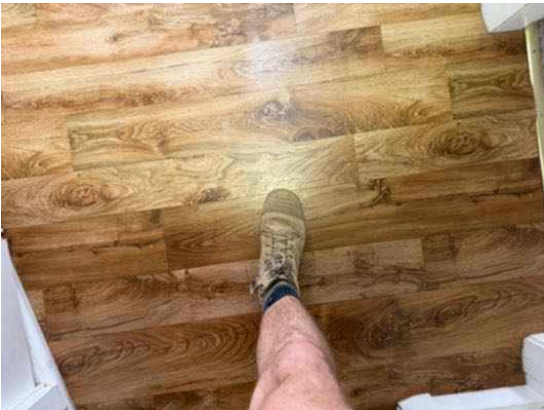
Finding 3.02

Building: Main Building
Location: All Areas
Finding: Flooring - Uneven
Information: Some areas, of the flooring & subfloor bearers throughout the building appear to be sagging & uneven. Recommend consulting with a structural engineer and/or registered builder in the short term, to provide further advice and remedial works where necessary.

Further sagging and the development of secondary building defects are likely to ensue, if neglected.

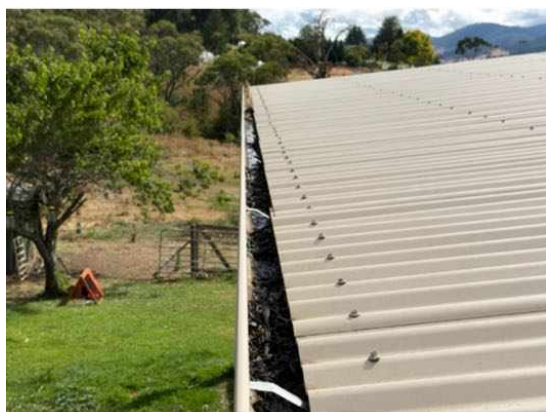
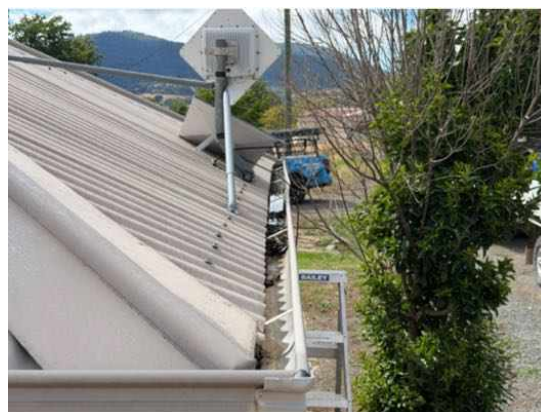
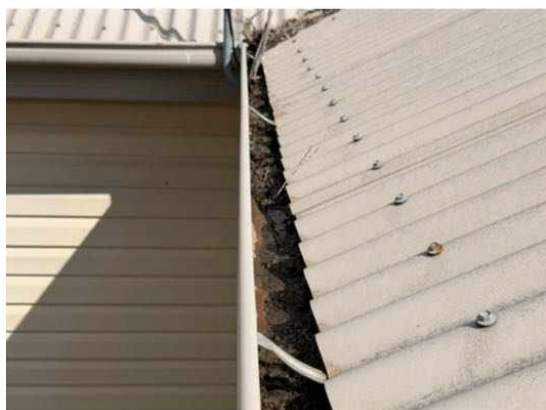
Finding 3.03

Building:	Main Building
Location:	Guttering
Finding:	Gutters - Debris & Water pooling
Information:	Water pooling and debris were noted in sections of the guttering at the time of inspection, likely due to sagging or blockages. Water pooling can lead to deterioration of the roof plumbing over time, if neglected.

A licensed roof plumber should be engaged in the short term, to provide further advice & maintenance works to ensure adequate roof drainage is achieved. All debris should be cleared promptly to ensure proper drainage and prevent overflows.

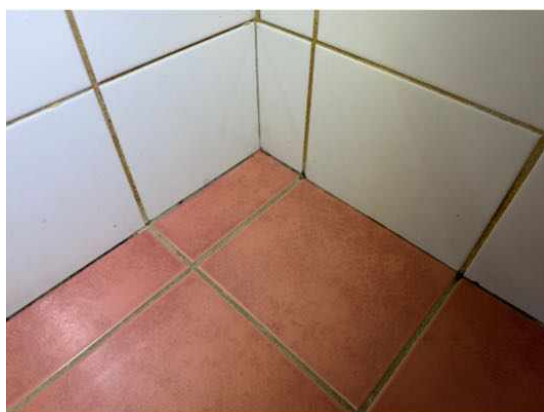
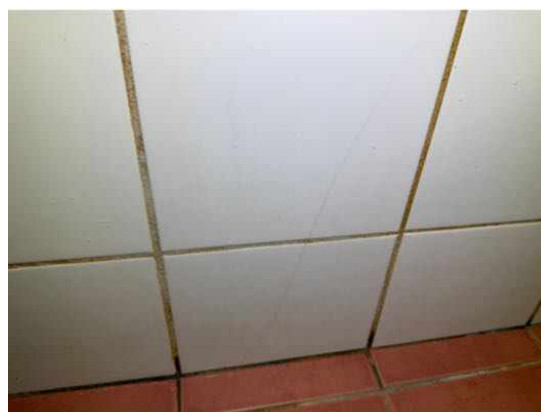
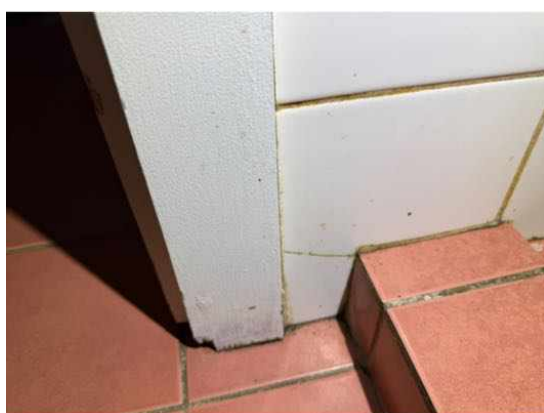
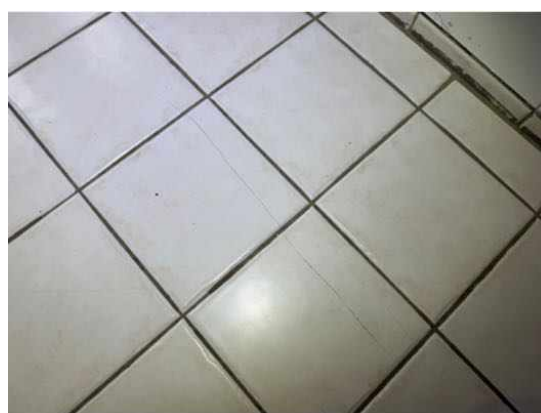
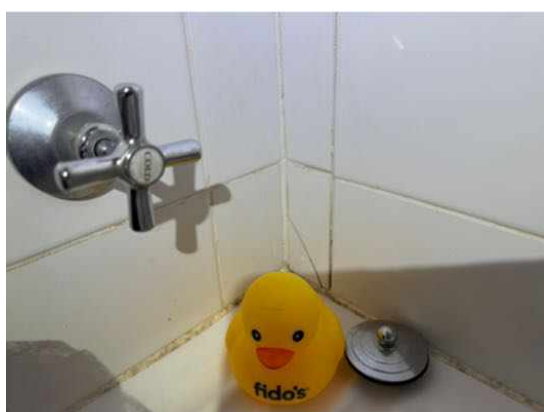
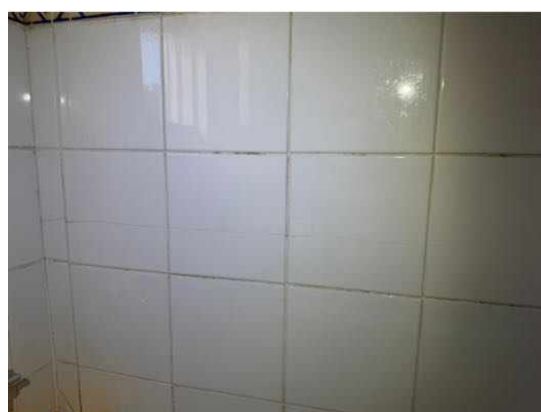
Finding 3.04

Building:	Main Building
Location:	Tiled Areas
Finding:	Sealant / grouting - deteriorated or missing & Cracked Tiles
Information:	It appears that the sealant and grout has deteriorated in some tiled areas, a common defect in buildings of a similar age. Areas of cracked tiles were also noted, which can allow for moisture ingress behind the tiles, if neglected.

Sealant and grouting in areas that come into regular contact with water should be maintained for the long term care of your property.

Recommend engaging a licensed tiling contractor in the short term, to provide maintenance works where necessary.

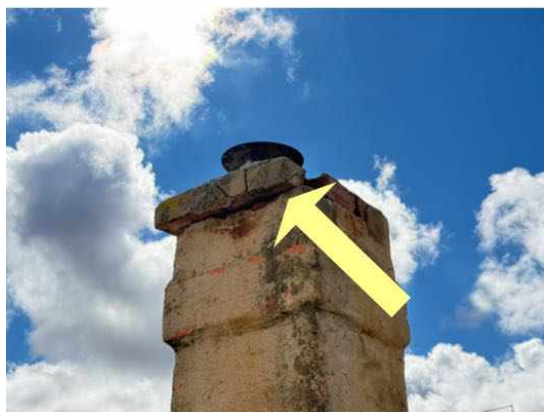
Finding 3.07

Building:	Main Building
Location:	Roof Exterior
Finding:	Fireplace Brickwork - Loose
Information:	It appears that the brickwork of the fireplace on the roof exterior were loose. Recommend engaging a licensed bricklayer in the short term, to provide maintenance works to ensure the bricks are secure.

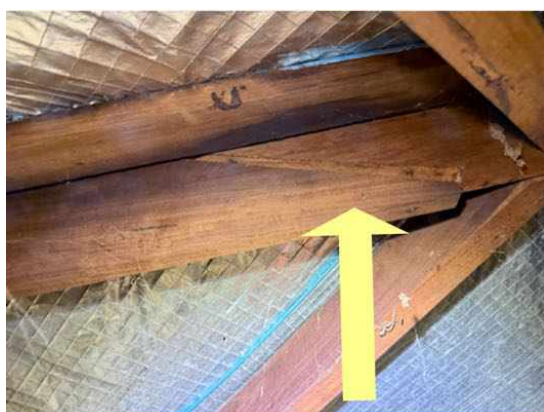
Finding 3.08

Building:	Main Building
Location:	Roof Void
Finding:	Roof Framing - Additional Fixings Required
Information:	It appears that a section of the hip framing has pulled apart at the join. It is advised that additional fixings are installed to this area to avoid further separation. Recommend engaging a licensed carpenter in the short term, to provide minor remedial works.

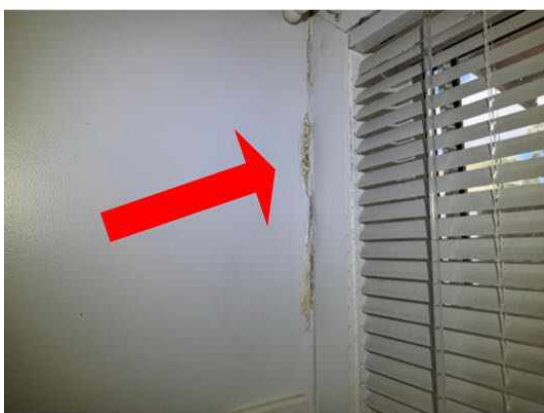
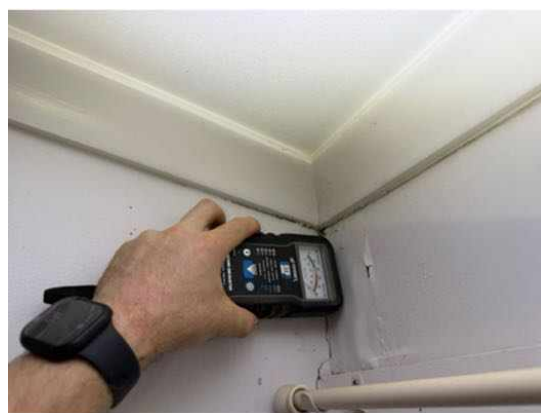
Finding: Ceiling Leak

Information: High moisture was identified at, but not limited to the laundry/bathroom ceiling. Potential causes of leaking include damaged plumbing fittings and fixtures, or deterioration of the roof plumbing. This creates an environment conducive to termite activity & water damage to surrounding materials.

Recommend engaging a licensed roof plumber or roofing contractor promptly to provide remedial works.

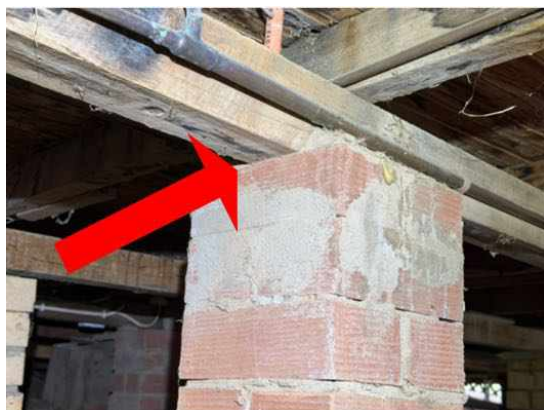
Finding 6.04

Building:	Main Building
Location:	Subfloor
Finding:	Ant caps - Not Installed
Information:	It was found that ant caps have not been installed to the piers. Ant caps are designed to easily identify termite ingress from piers to the adjoining bearers. Where ant caps have not been installed, this creates an obstruction for inspection and frequent monitoring of these areas should be carried out in order to identify any signs of termite workings. It is advised that sufficient ant caps be installed to the piers by a licensed carpenter.

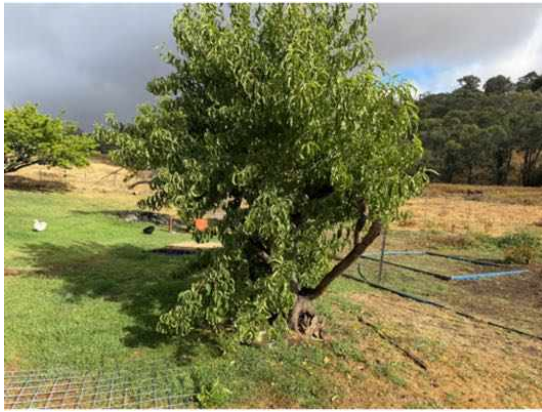
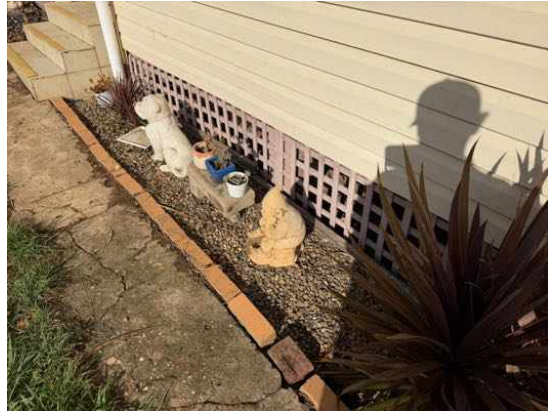
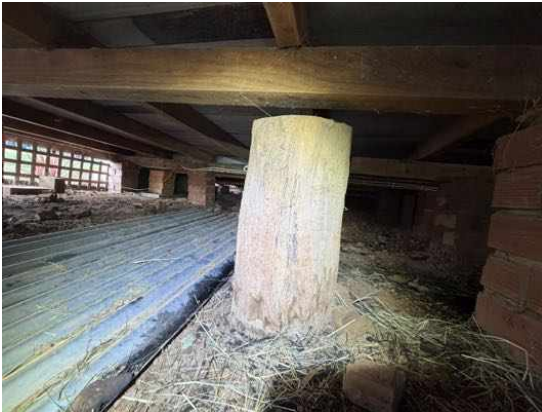
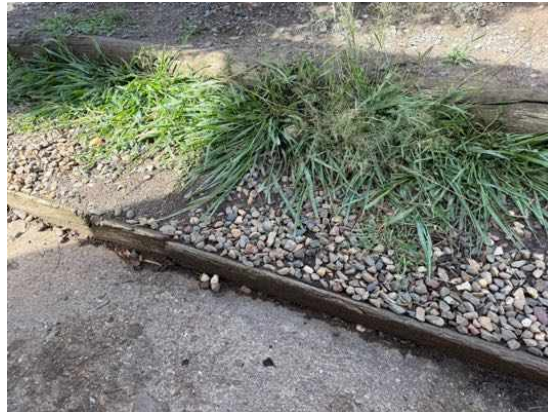
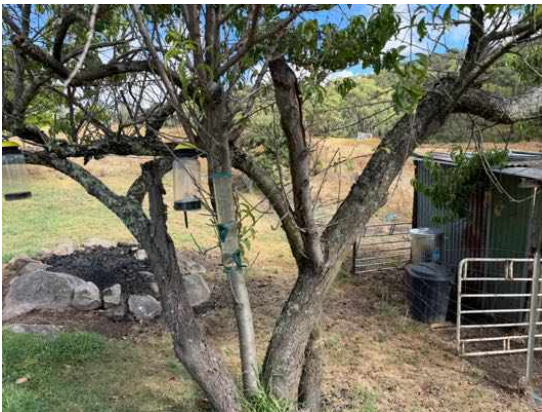
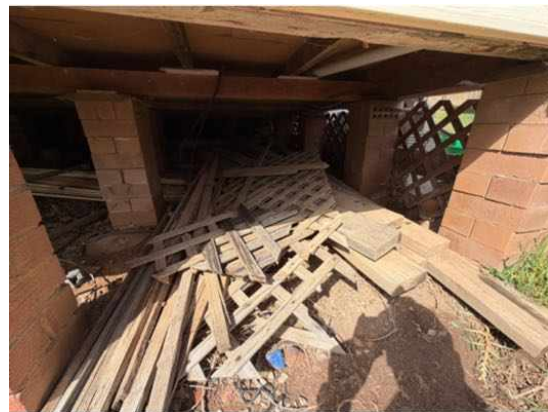
Finding 6.05

Building:	Main Building
Location:	All External Areas, landscaping timbers, stumps, trees
Finding:	Timber in direct ground contact & trees - conducive to termites
Information:	Where timber materials are in direct contact with the ground and consequently moisture, they become conducive to termite activity. The tree stumps, timber debris in the subfloor, landscaping timbers and trees surrounding the building create an environment conducive to termite infestation.

Where feasible, any timbers in direct contact with the ground should be removed and any trees in close proximity to the building should be removed or test drilled (inspected) at least annually to reduce the risk of termite infestation & detect any early signs of termite activity.

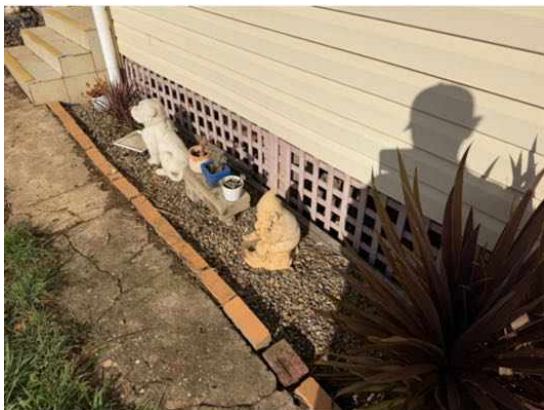
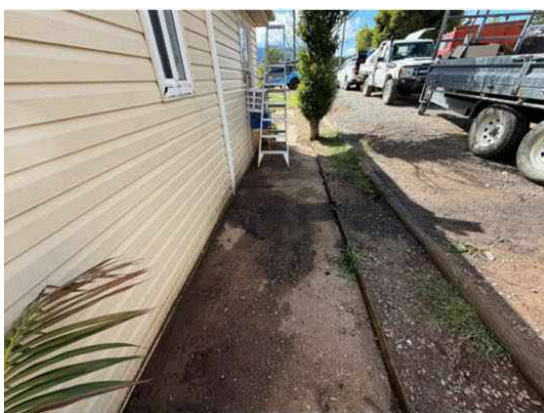
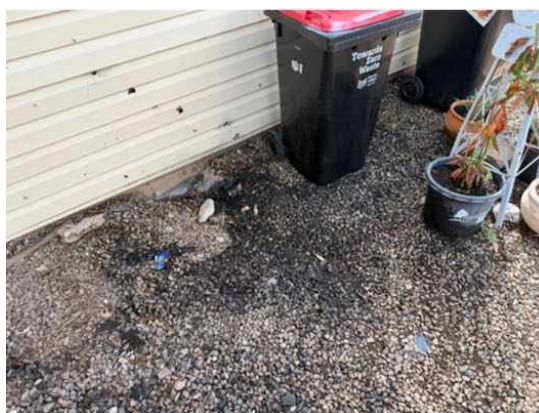
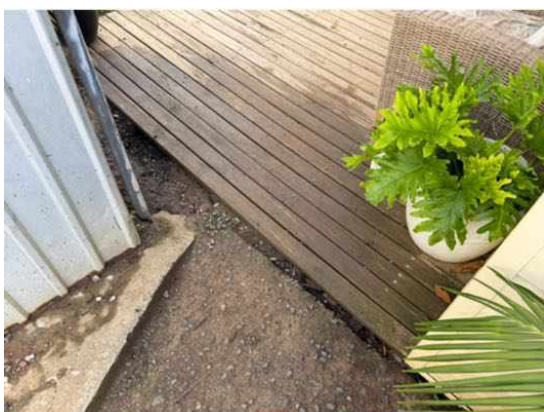
Finding 6.06

Building:	Main Building
Location:	All external areas
Finding:	Potential Water pooling - against property
Information:	It appears that there are potential areas around the perimeter of the property that could be susceptible to water pooling.

Where insufficient drainage of taps, hot water system & aircon overflows, insufficient site drainage, and garden beds against the house are present, water pooling is likely to occur, and can create areas conducive to timber pests and potential damage to the subfloor structure overtime, if neglected.

Recommend consulting with a licensed plumber in the short term to further assess and provide remedial advice.

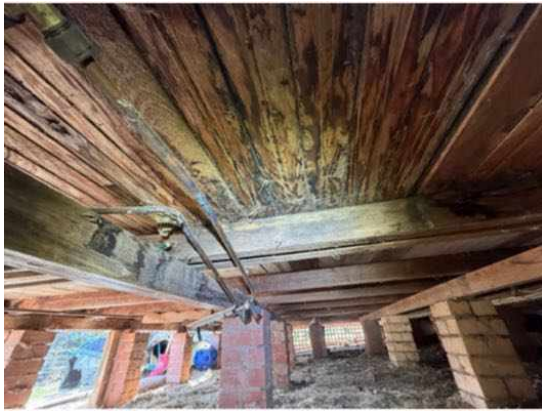
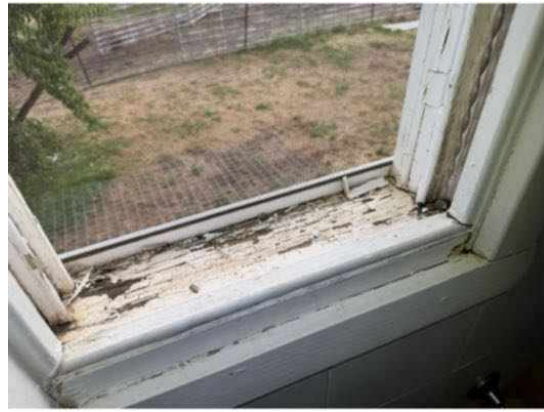
Finding 7.01

Building:	Main Building
Location:	Floorboards, bearers, window frames, external timbers, fascias
Finding:	Fungal decay & weathering
Information:	Areas of fungal decay (wood rot) & weathering were identified at but not limited to

some floorboards, timber bearers, window frames, external timbers & fascias. For areas where structural timbers are affected by wood rot (subfloor timbers) a registered builder should be engaged promptly to replace affected materials where necessary.

For areas where fungal decay is superficial, the client can engage a licensed carpenter at their discretion to replace affected materials.

For areas of general weathering, it is advised the client engage a licensed painter to apply protective sealant or coating to areas of weathered external timbers.

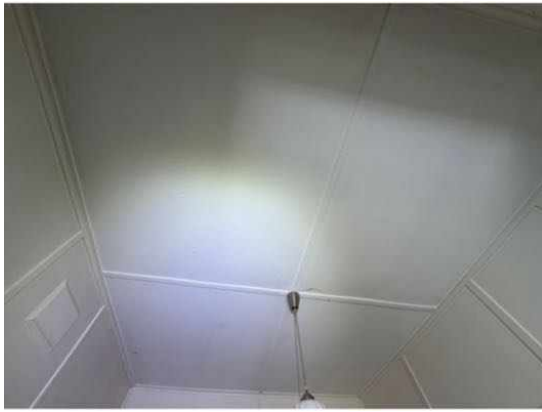
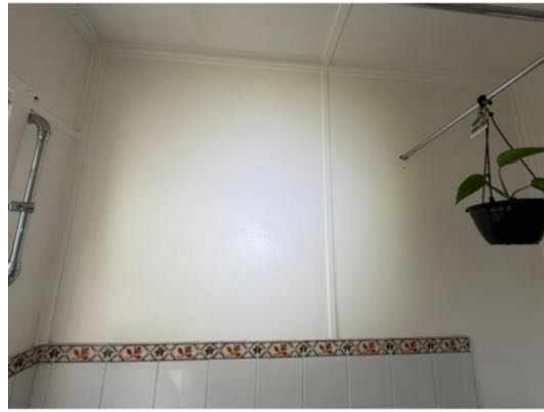
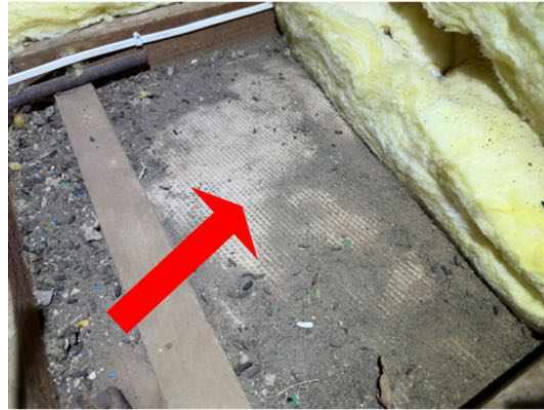
Building: Main Building
 Location: Original Cladding, Wall & Ceiling Linings, Debris Subfloor
 Finding: Asbestos - Suspected ACM Identified on Site
 Information: This suspected defect is highlighted as a caution only as reporting on asbestos is outside the scope of this report. It is suspected that the materials including but not limited to original cladding, wall & ceiling linings and packing & debris in the subfloor may be ACM's (Asbestos containing materials)

It is advised that the client consider a separate Asbestos Inspection and Condition Audit, which can include the taking of samples for definitive confirmation of the presence of Asbestos, carried out by a licensed Asbestos Inspector.

In the interim, no works should be conducted to these areas without further specialist advice.

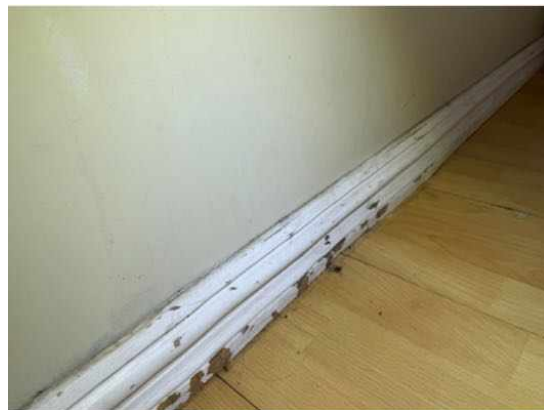
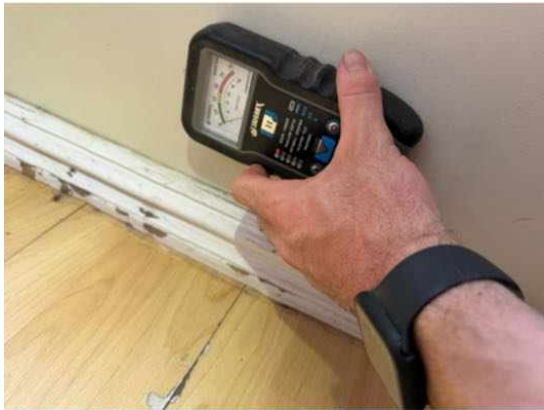
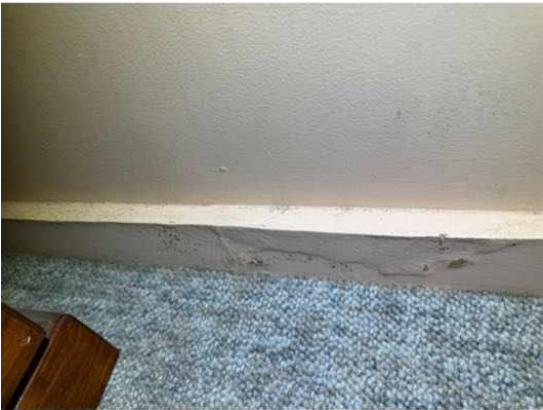
Building: Main Building
 Location: Window Frames, Skirting
 Finding: Water Staining Present
 Information: It appears that water staining / damage was present including but not limited to, some window frames & skirting boards. Potential causes of leaking include deteriorated roof cladding, deteriorated seals, or damaged plumbing fittings and fixtures. No high moisture was evident in these areas at the time of inspection.

It is recommended that the client monitor these areas and engage a licensed roof plumber and/or carpenter promptly, should the leak persist or return.
