Building and Timber Pest Inspection Report VR

Inspection Date: Tue, 17 Mar 2026

Property Address: 263 Prince St, Grafton NSW 2460, Australia

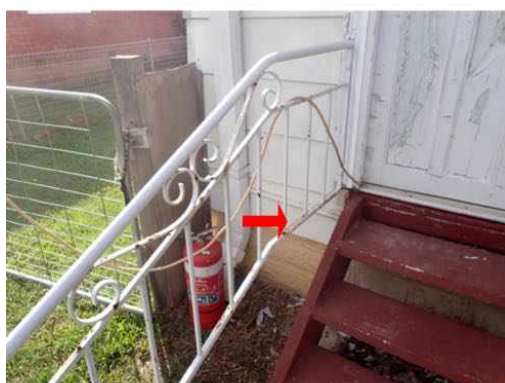
Finding 1.01

Building:	Main Building
Location:	Rear of building
Finding:	Rear Handrail – Poor Condition with Rust and Instability
Information:	The rear handrail was found to be in poor condition, with rust identified and the structure noted as unstable at the time of inspection. The condition is consistent with age, weathering, and lack of maintenance, and may result in further deterioration if not addressed. In plain English, the rear handrail is rusty and not secure. A licensed builder or suitably qualified tradesperson should assess and carry out repairs as required, which may include repair or replacement of affected sections and re-fixing to ensure stability. Ongoing maintenance will assist in preventing further deterioration. Maintenance and repairs should be undertaken as soon as possible.

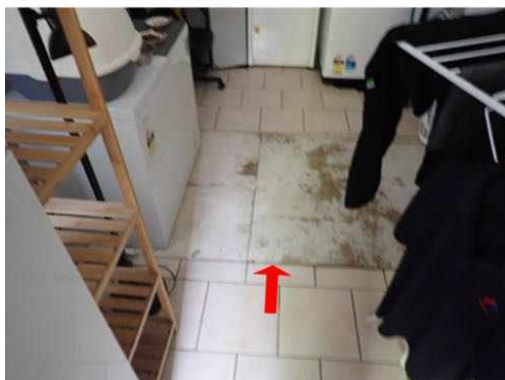
Finding 2.01

Building:	Main Building
Location:	Laundry
Finding:	Laundry Floor – Section of Tiled Area Replaced with Plywood
Information:	A section of the laundry floor tiled area has been removed and replaced with plywood flooring. The modification appears inconsistent with surrounding finishes and may indicate previous repairs or alterations. Further invasive investigation is recommended to gain a better understanding of why the tiled flooring was removed and replaced with plywood and to assess the condition of the underlying structure and materials. In plain English, part of the tiled laundry floor has been taken out and replaced with timber sheeting, and more investigation is needed to find out why. A licensed builder or

flooring contractor should assess the area and carry out repairs as required, which may include reinstating appropriate flooring and ensuring the substrate and waterproofing (if applicable) are adequate for a wet area. Ensuring suitable materials and finishes are used will assist in preventing deterioration and moisture-related issues. Maintenance and repairs should be undertaken where considered necessary.

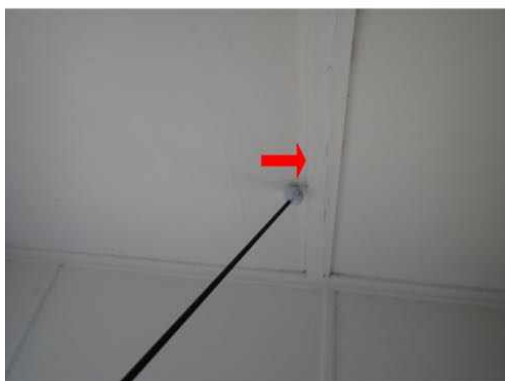
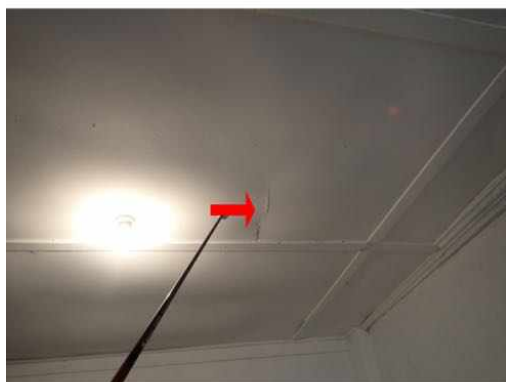
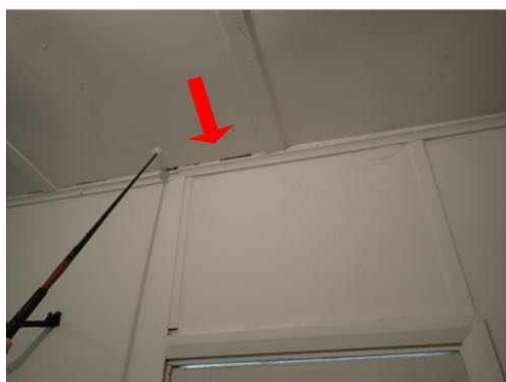
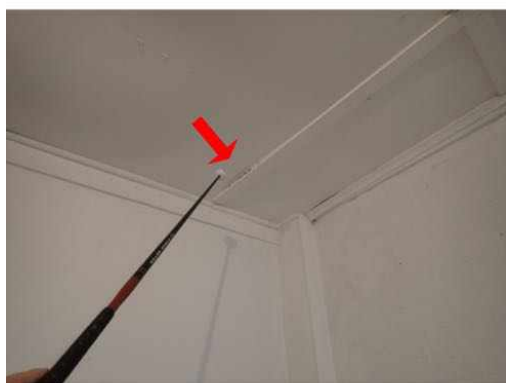
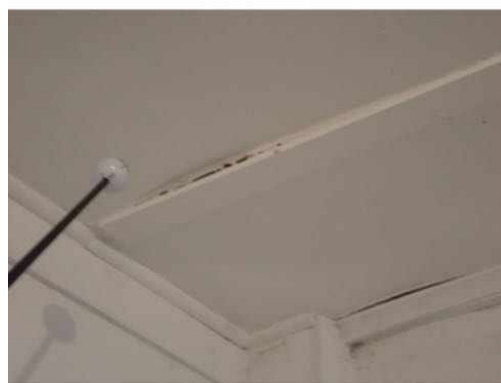
Finding 2.02

Building:	Main Building
Location:	Laundry
Finding:	Laundry Ceiling Damage – Cracking and Dropping
Information:	Damage was identified to the laundry ceiling, including visible cracking and areas of sagging/dropping. This may be indicative of moisture ingress, material deterioration, inadequate fixing, or structural movement and is a common defect with a home of this age. In plain English, the laundry ceiling is cracked and starting to sag. A licensed builder should assess and carry out repairs as required. Further investigation is recommended to determine the cause and extent of the damage, with repairs to be completed accordingly. Prompt repairs and maintenance will assist in preventing further deterioration. Maintenance and repairs should be undertaken at the owners discretion.

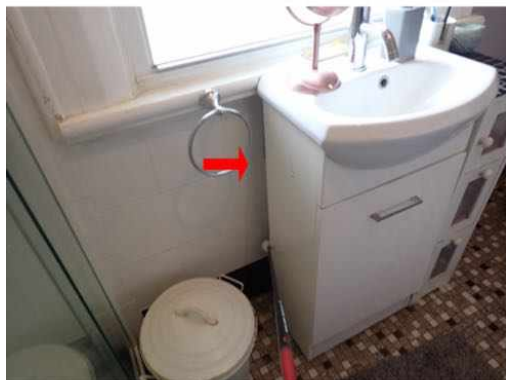
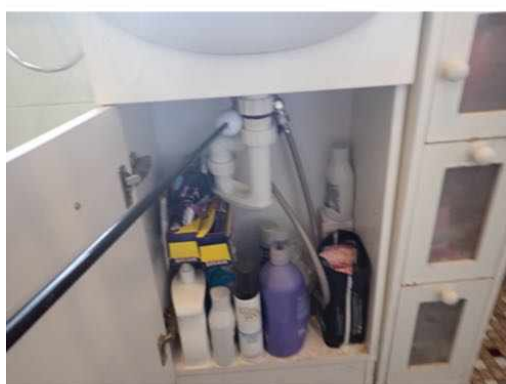
Finding 2.03

Building:	Main Building
Location:	Bathroom
Finding:	Bathroom Vanity Not Secured to Wall and Waste Pipe Poorly Installed
Information:	The bathroom vanity was found not to be adequately secured to the wall, and the associated waste pipe was poorly installed at the time of inspection. This may result in movement during use and could lead to leaks or damage to surrounding materials. In plain English, the vanity is loose and the waste pipe underneath has been installed poorly. A licensed plumber should assess and rectify as required, which may include securing the vanity to the wall and reinstalling the waste pipe using appropriate fittings and methods. Proper installation and maintenance will assist in preventing movement,

leaks, and further deterioration. Maintenance and repairs should be undertaken where considered necessary.

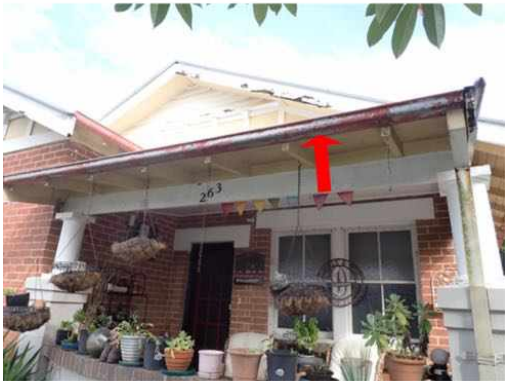
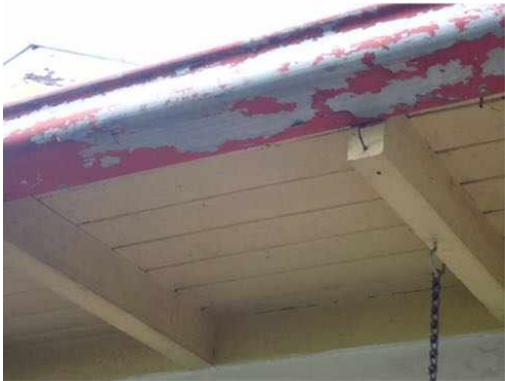
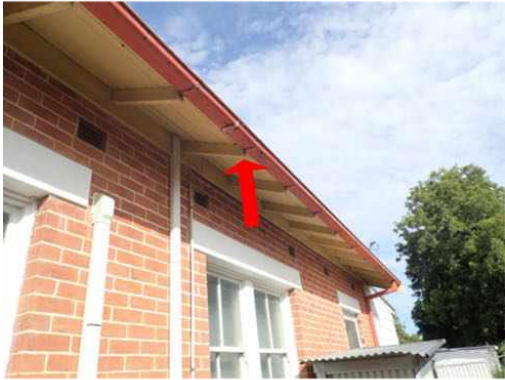
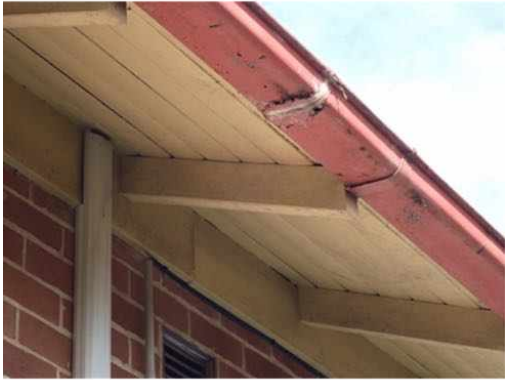
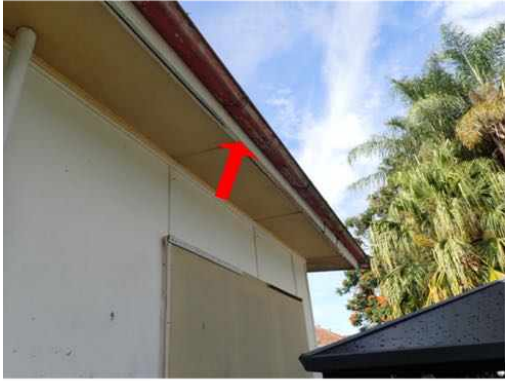
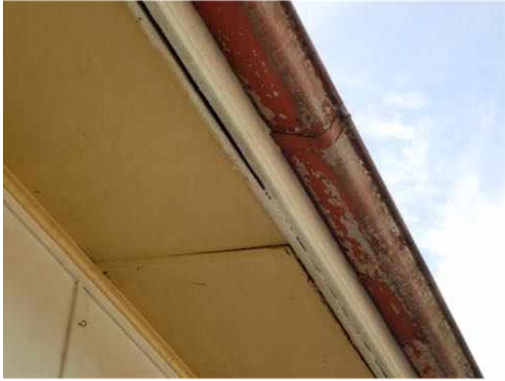
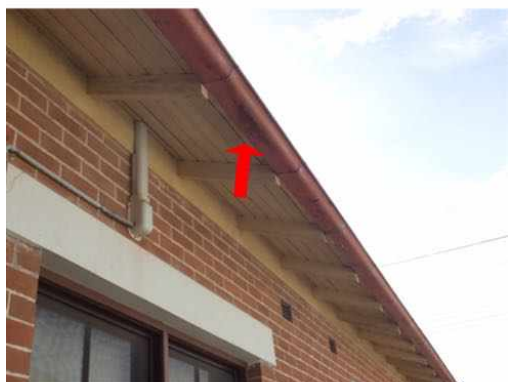
Finding 2.05

Building: Main Building
Location: Gutters
Finding: Gutters – Rust and Deteriorated Paintwork with Limited Inspection
Information: Rust and deteriorated paintwork were identified to the gutters. The condition is consistent with age, weathering, and lack of maintenance and may lead to further corrosion and reduced service life if not addressed. Inspection of the gutters was limited due to height restrictions at the time of inspection. In plain English, the gutters are rusty and the paint is worn, and they could not be fully checked due to access limitations. A suitably qualified tradesperson should assess and carry out repairs, including cleaning, rust treatment, sealing, repainting, or replacement of affected

sections as required. Ongoing maintenance will assist in preventing further deterioration. Maintenance and repairs should be undertaken where considered necessary.

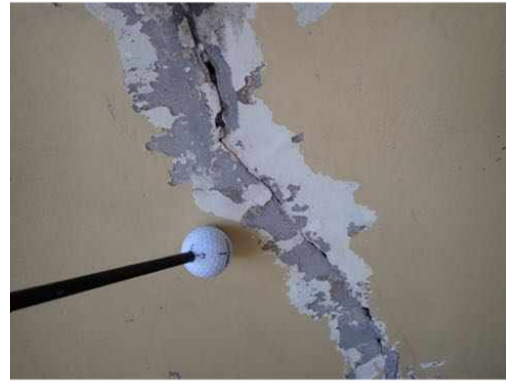
Finding 2.06

Building:	Main Building
Location:	Front porch balcony wall
Finding:	Front Porch Balustrade Wall – Large Crack Identified
Information:	A large crack was identified to the front porch balustrade wall. The extent of the cracking may indicate movement, material deterioration, or structural stress and is a common defect with a home of this age. In plain English, there is a large crack in the front porch balustrade wall. A licensed builder or suitably qualified tradesperson should assess and carry out repairs as required, which may include crack repair, reinforcement, or rebuilding of affected sections. Further investigation is recommended to determine the cause and extent of the cracking. Ongoing maintenance will assist in preventing further deterioration. Maintenance and repairs should be undertaken as soon as possible.

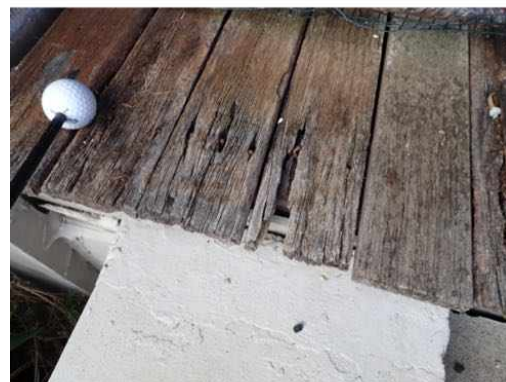
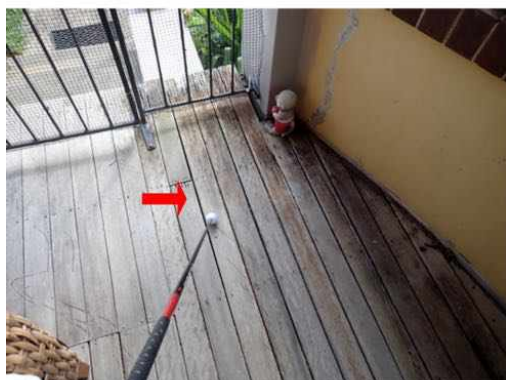
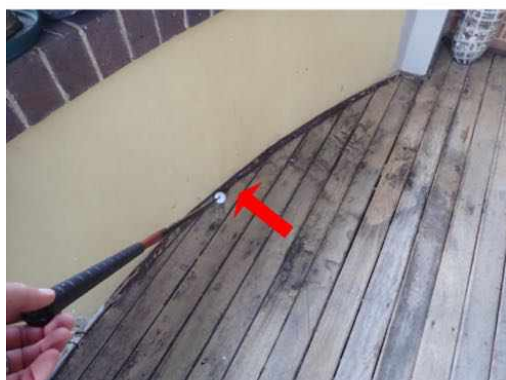
Finding 2.07

Building:	Main Building
Location:	Front porch balcony wall
Finding:	Front Porch Deck and Framing – Poor Condition with Wood Rot and Limited Subfloor Access
Information:	The front porch deck and supporting framing were found to be in poor condition, with evidence of wood rot, bouncy/unstable framing, and general deterioration. The condition may indicate loss of structural integrity and ongoing deterioration associated with age, moisture exposure, and lack of maintenance, and is a common defect with a home of this age. No access was available to the subfloor area at the time of inspection, limiting the ability to fully assess the extent of damage. In plain English, the front deck is in poor shape, with rotting timber and movement underfoot, and the area underneath could not be inspected. A licensed builder or carpenter should assess and carry out repairs as required, which may include replacement of affected timbers and structural rectification. Further invasive investigation is recommended to determine the full extent of the damage. Maintenance and repairs should be undertaken as soon as possible.

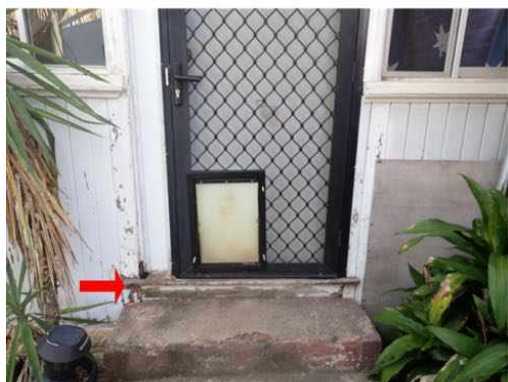
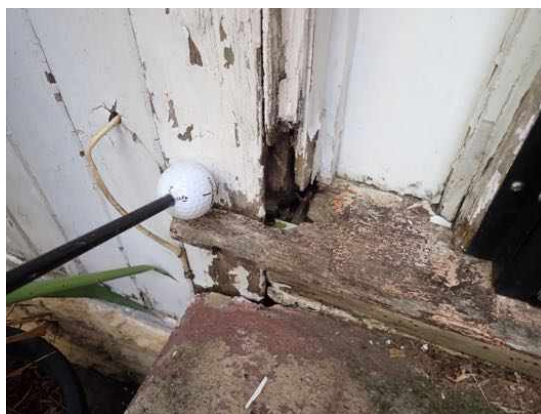
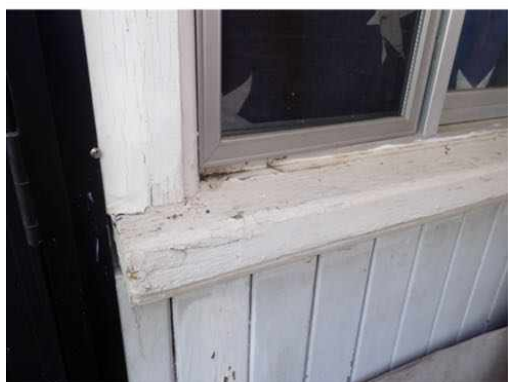
Building: Main Building
Location: Rear of building
Finding: Laundry Doors, Windows and Timber Trims – Poor Condition with Timber Decay and Deteriorated Paintwork
Information: The doors, windows and associated timber trims to the laundry were found to be in poor condition, with timber decay and deteriorated paintwork identified. The condition is consistent with age, weathering, and lack of maintenance, and is a common defect with a home of this age. Deterioration may affect operation and allow water ingress, leading to further damage of surrounding materials. In plain English, the laundry doors, windows and trims are in poor shape, with decayed timber and worn paint. A licensed builder, carpenter, or suitably qualified tradesperson should assess and carry out repairs as required, which may include repair or replacement of affected components and repainting/sealing to protect against further deterioration. Ongoing maintenance will assist in preventing recurrence. Maintenance and repairs should be undertaken where considered necessary.

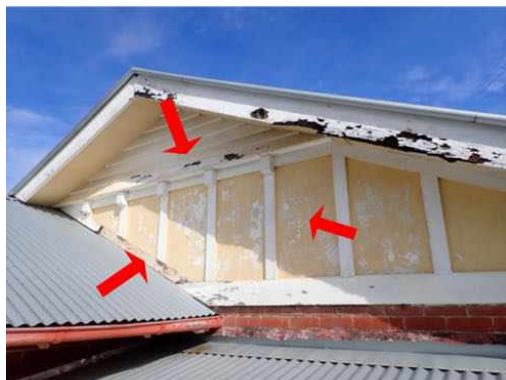
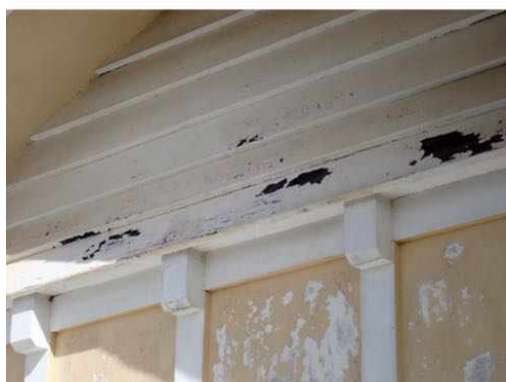
Finding 2.10

Building:	Main Building
Location:	End gables
Finding:	Roof End Gable Cladding and Timber Trims – Timber Decay and Deterioration
Information:	Timber decay and general deterioration were identified to the roof end gable cladding and associated timber trims. The condition is consistent with prolonged exposure to weather, moisture ingress, and lack of maintenance, and is a common defect with a home of this age. Deterioration of these elements may allow water ingress and further damage to underlying building materials. In plain English, the timber cladding and trims at the end of the roof are deteriorated and breaking down. A licensed builder or carpenter should assess and carry out repairs as required, which may include removal and replacement of affected sections and repainting/sealing to protect against further deterioration. Ongoing maintenance will assist in preventing recurrence. Maintenance and repairs should be undertaken where considered necessary.

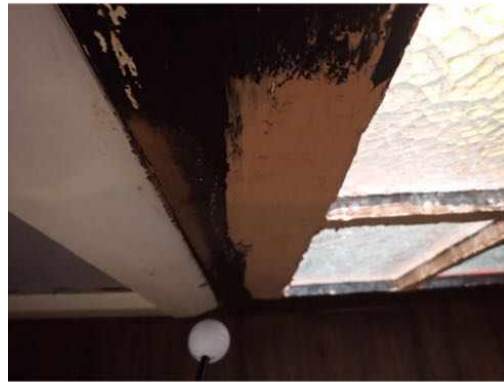
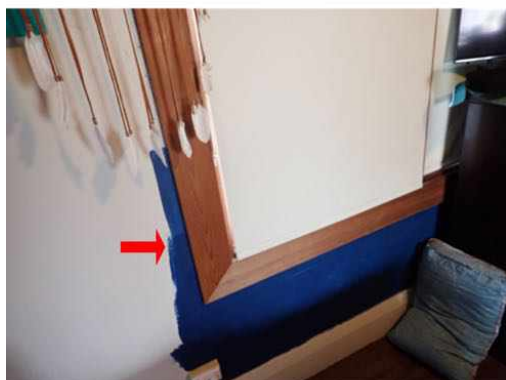
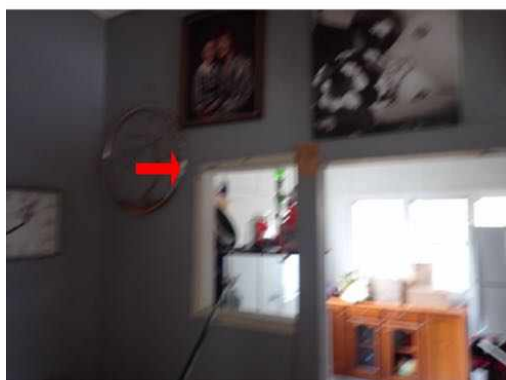
Finding 3.02

Building:	Main Building
Location:	All Areas
Finding:	Internal Painted Surfaces, Windows and Doors Requiring Repainting
Information:	Multiple internal areas were found to be in need of repainting, including sections of walls, and ceilings, as well as various windows and doors. The condition is consistent with general wear and tear, ageing of paint finishes, and lack of routine maintenance. In plain English, a number of areas inside the house, including some windows and doors, need a fresh coat of paint. A licensed painter or suitably qualified tradesperson should carry out preparation and repainting works as required. Proper surface preparation, including sanding, filling and priming, is recommended to ensure a durable finish and to prevent premature deterioration. Owner discretion is advised where the issue is considered cosmetic.

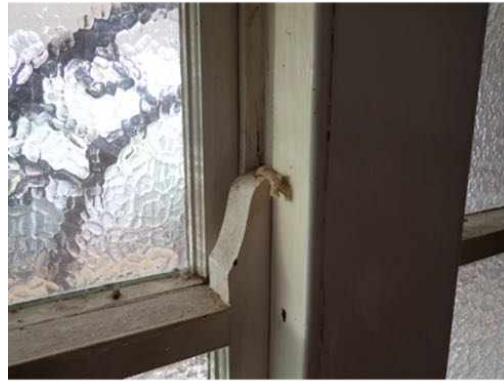
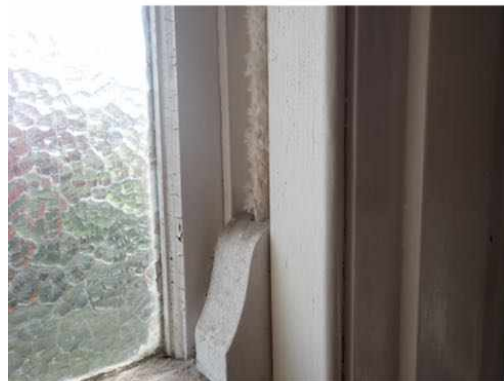
Finding 3.03

Building:	Main Building
Location:	Windows living room
Finding:	Double Hung Windows to Living Room Requiring General Maintenance
Information:	The double hung windows in the living room were operational at the time of inspection; however, they were found to be in need of general maintenance. Issues may include wear to cords, balances, tracks, or hardware, and deterioration to painted finishes consistent with age and use. In plain English, the windows open but need maintenance to keep them working properly. A licensed builder, carpenter, or window specialist should assess and carry out maintenance as required, which may include adjustment, repair or replacement of components and repainting. Ongoing maintenance is recommended to ensure continued operation and to prevent further deterioration. Maintenance should be undertaken as part of routine upkeep where considered necessary.

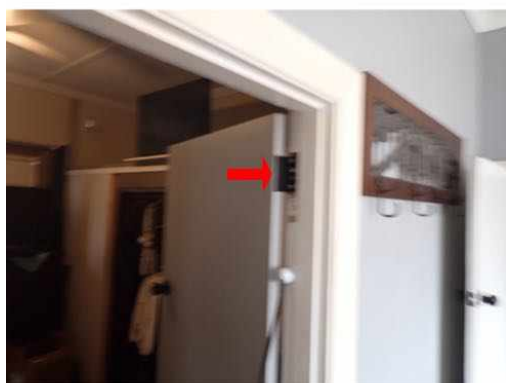
Finding 3.04

Building:	Main Building
Location:	Bedroom
Finding:	Bedroom Door Hinges Poorly Installed and Damage to Door Jambs
Information:	The bedroom door hinges were found to be poorly installed, with associated damage to the door jambs from previous hinge fixings. This may affect the alignment and operation of the door and is indicative of substandard installation and past repairs. In plain English, the hinges have been fitted poorly and have caused damage to the door frame. A carpenter, or handyman should assess and carry out repairs as required, which may include refitting or replacing hinges and repairing the damaged door jamb to ensure proper operation. Ongoing maintenance and correct installation practices

will assist in preventing further damage. Maintenance and repairs should be undertaken where considered necessary.

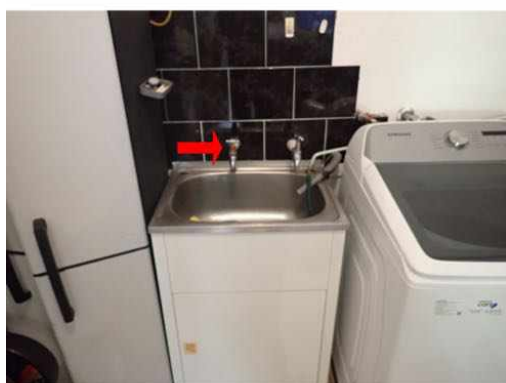
Finding 3.05

Building:	Main Building
Location:	Laundry
Finding:	Laundry Cabinet Tub Tap Wall Penetrations Not Sealed
Information:	Wall penetrations around the laundry tub tap within the cabinet were not sealed at the time of inspection. Unsealed penetrations may allow water ingress and contribute to deterioration of surrounding building materials. In plain English, the holes around the laundry taps are not sealed properly. A suitably qualified tradesperson should seal all penetrations using appropriate materials to prevent water ingress and maintain the integrity of the surrounding surfaces. Proper sealing and ongoing maintenance will assist in preventing deterioration. Maintenance and repairs should be undertaken where considered necessary.

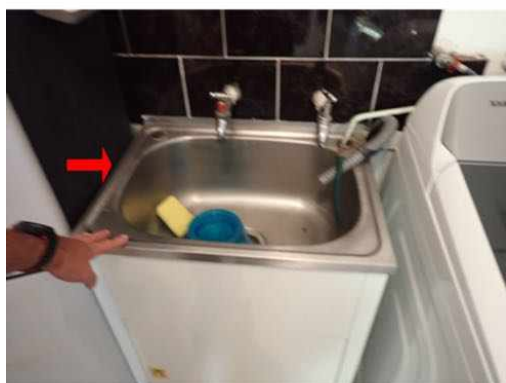
Finding 3.06

Building:	Main Building
Location:	Laundry
Finding:	Laundry Cabinet Tub Not Secured to Wall
Information:	The laundry cabinet tub was found not to be adequately secured to the wall at the

time of inspection. This may result in movement during use and could lead to damage to associated plumbing connections and surrounding finishes. In plain English, the laundry tub cabinet is loose and not fixed properly to the wall. A licensed plumber or suitably qualified tradesperson should secure the unit to the wall in accordance with standard installation practices and check for any associated damage. Proper installation and maintenance will assist in preventing movement and further deterioration. Maintenance and repairs should be undertaken where considered necessary.

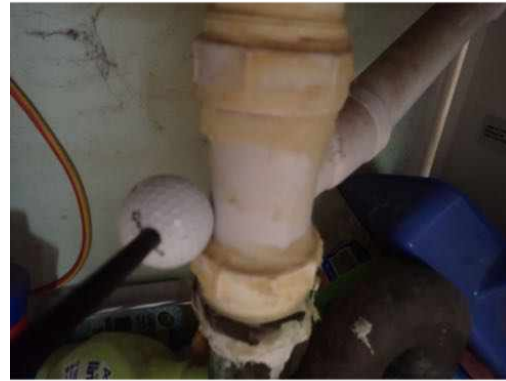
Finding 3.07

Building:	Main Building
Location:	Laundry
Finding:	Laundry Tub Waste Plumbing Poorly Installed with Excessive Silicone
Information:	The laundry tub waste plumbing was found to be poorly installed, with excessive silicone used around pipe penetrations and connections. This may indicate substandard workmanship and could lead to leaks, blockages, or difficulty in maintenance. In plain English, the waste pipes under the laundry tub have been installed poorly and have too much silicone around them. A licensed plumber should assess and rectify the installation as required, which may include refitting pipework and ensuring appropriate fittings and sealing methods are used. Proper installation and maintenance will assist in preventing leaks and ongoing issues. Maintenance and repairs should be undertaken where considered necessary.

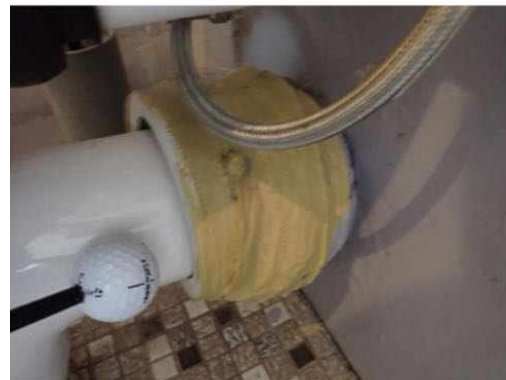
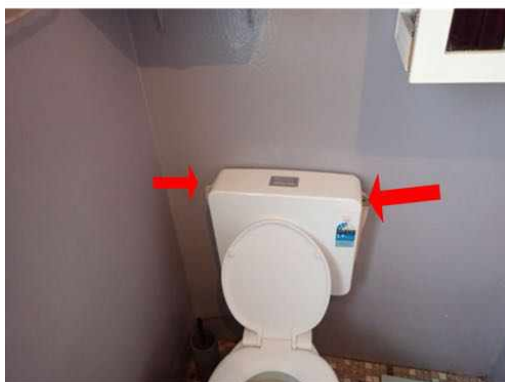
Finding 3.08

Finding: Toilet Wall Fitting Wrapped with Duct Tape and Wall Damage from Previous Installation

Information: Duct tape was wrapped around the toilet wall fitting at the time of inspection; although no active leaks were observed, this is not an appropriate or compliant repair method. Damage to the wall was also noted from a previous cistern installation. This may indicate prior plumbing issues and substandard repair works. In plain English, tape has been used on the toilet pipe instead of a proper fix, and the wall has been damaged from earlier work. A licensed plumber should assess and carry out proper repairs, which may include replacing or correctly sealing the fitting and repairing the damaged wall surface. Proper installation and maintenance will assist in preventing leaks and further deterioration. Maintenance and repairs should be undertaken where considered necessary.

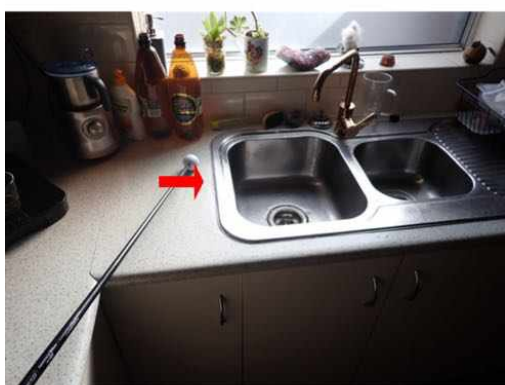
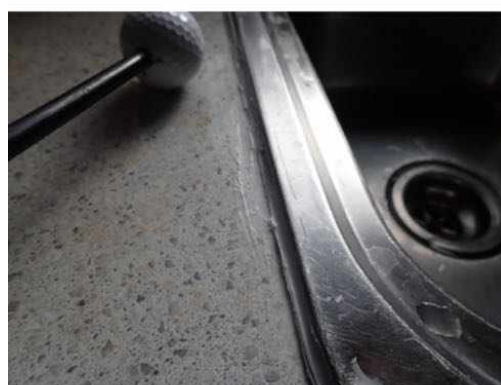
Finding 3.09

Building:	Main Building
Location:	Kitchen
Finding:	Kitchen Sink and Benchtop Splashback Junctions – Poor and Over-Applied Silicone Work
Information:	Poor and over-applied silicone work was identified around the kitchen sink and benchtop splashback junctions. The sealant appears inadequately finished and excessive in application, which may reduce effectiveness and allow water ingress, leading to deterioration of surrounding cabinetry and building materials. In plain English, too much silicone has been applied around the sink and splashback and it has not been finished properly, which may let water get in. A suitably qualified tradesperson should remove and replace the silicone using appropriate materials and correct application methods to ensure a neat and watertight seal. Proper sealing and ongoing maintenance will assist in preventing water damage and deterioration. Maintenance and repairs should be undertaken where considered necessary.

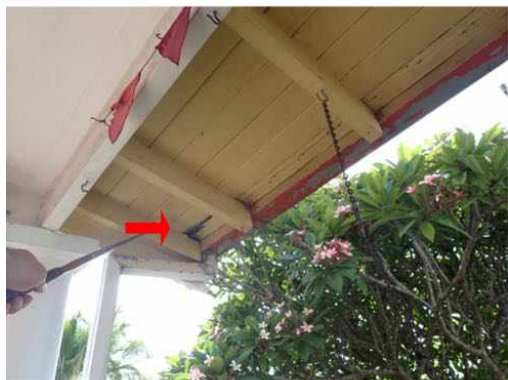
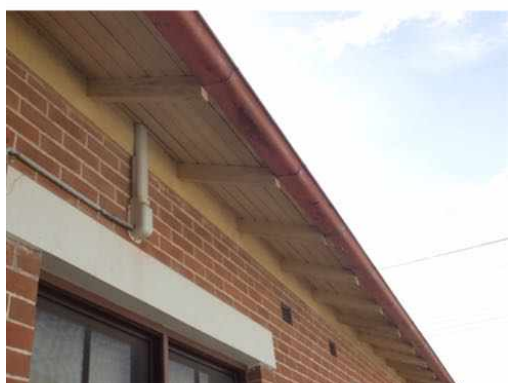
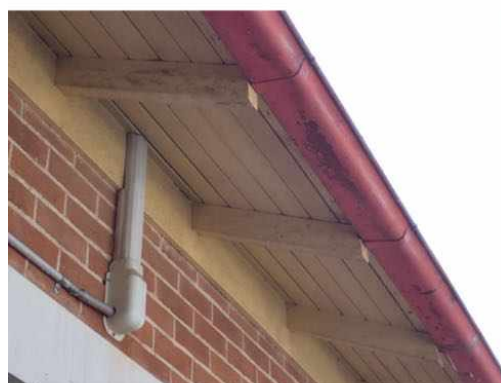
Finding 3.10

Building:	Main Building
Location:	Eaves
Finding:	Timber Eaves – Damage and Deteriorated Paintwork
Information:	Damage and deteriorated paintwork were identified to the timber eaves. The condition

is consistent with age, weathering, and lack of maintenance and may lead to further deterioration of the underlying timber if not addressed. In plain English, the timber eaves are damaged and the paint is worn. A licensed builder or carpenter should assess and carry out repairs as required, which may include repairing or replacing affected sections and repainting to protect the timber. Ongoing maintenance will assist in preventing further deterioration. Maintenance and repairs should be undertaken where considered necessary.

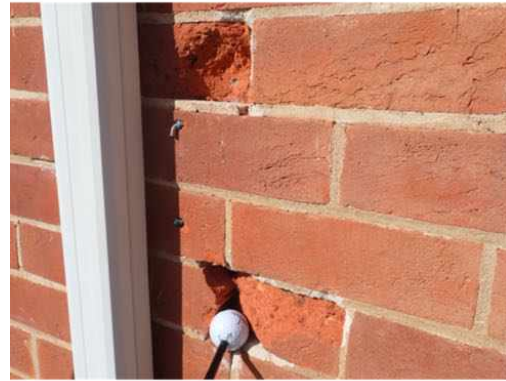
Finding 3.11

Building:	Main Building
Location:	Right hand side wall
Finding:	Right Hand Side Wall – Two Damaged Bricks
Information:	Two damaged bricks were identified to the right hand side wall. The damage appears localised and is most likely associated with a previous installation or removal of fixtures. In plain English, two bricks on the side of the house are damaged, likely from something that was previously installed. A suitably qualified tradesperson should assess and carry out repairs as required, which may include replacement or repair of the affected bricks and mortar. Ongoing maintenance will assist in preventing further deterioration. Maintenance and repairs should be undertaken where considered necessary.

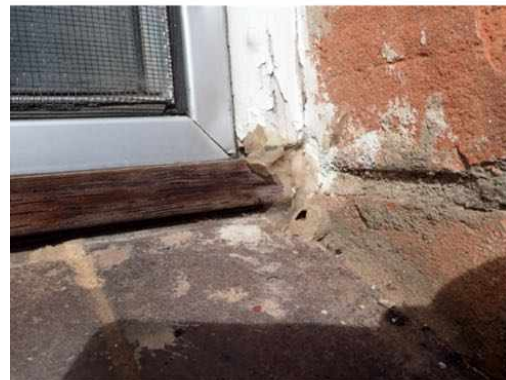
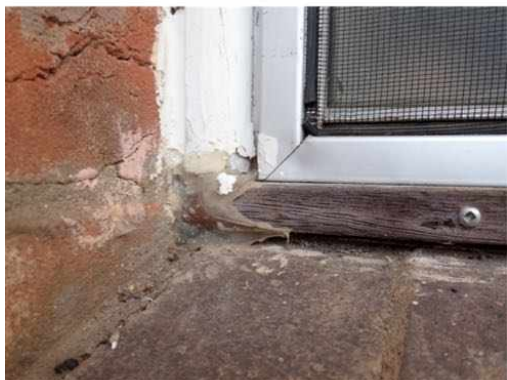
Finding 3.12

Building:	Main Building
Location:	Right hand side wall
Finding:	Kitchen External Window – Deterioration and Poor Silicone Sealing
Information:	The external kitchen window was found to be deteriorated, with poor silicone work identified around the frame. The sealant appears inadequately applied and may allow water ingress and contribute to deterioration of surrounding building materials. In plain English, the kitchen window is worn and the sealing around it has been done poorly, which may let water in. A suitably qualified tradesperson should assess and carry out repairs as required, which may include repair or replacement of deteriorated components and reapplication of silicone to achieve a proper watertight seal. Proper sealing and ongoing maintenance will assist in preventing water ingress and further deterioration. Maintenance and repairs should be undertaken where considered necessary.

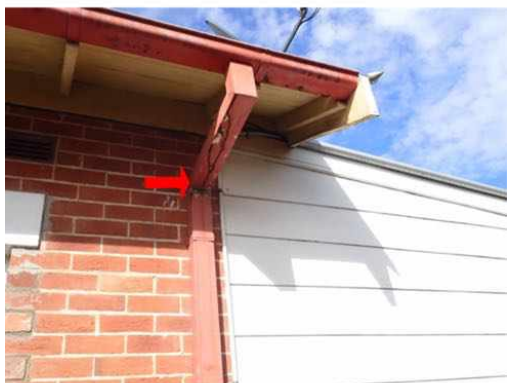
Finding 3.13

Building:	Main Building
Location:	Down pipes
Finding:	Downpipes – Minor Rust and Poorly Applied Silicone Work
Information:	Minor rust and poorly applied silicone work were identified to the downpipes. The condition is consistent with age, weathering, and substandard sealing practices, and may lead to further deterioration or water leakage if not addressed. In plain English, the downpipes have some rust and the sealing around them has been done poorly. A suitably qualified tradesperson should assess and carry out repairs as required, which may include cleaning, rust treatment, sealing, and reapplication of silicone using appropriate methods. Ongoing maintenance will assist in preventing further deterioration. Maintenance and repairs should be undertaken where considered necessary.

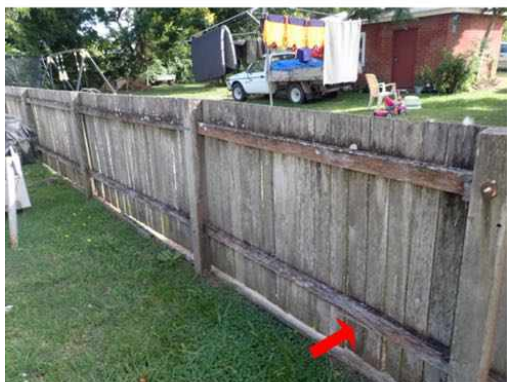
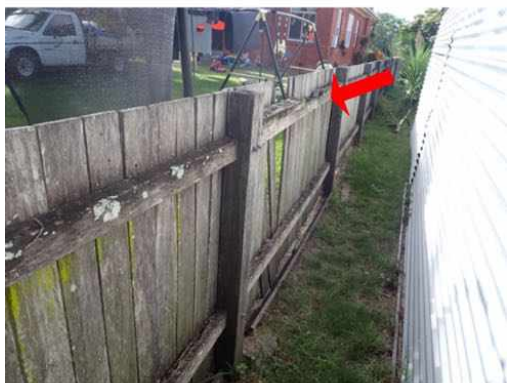
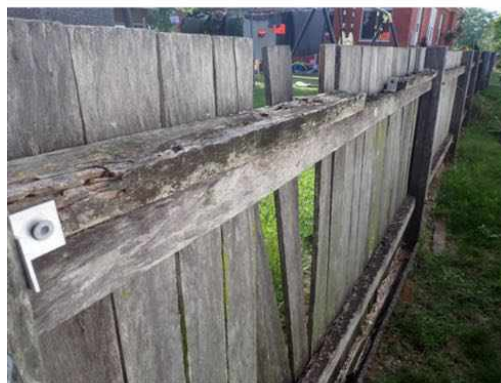
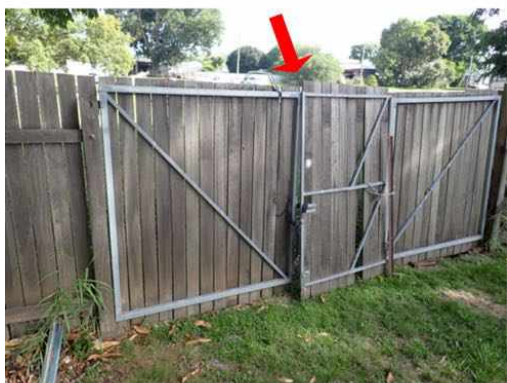
Finding 3.14

Building:	Yard
Location:	Boundary fences
Finding:	Timber Fence and Rear Gate – Sections in Poor Condition with Timber Decay
Information:	Sections of the timber fence and the rear gate were found to be in poor condition, with timber decay identified. The condition is consistent with age, weathering, and lack of maintenance and may affect functionality and ongoing serviceability. In plain English,

parts of the timber fence and rear gate are worn and have areas of decayed timber. A suitably qualified tradesperson should assess and carry out repairs as required, which may include repair or replacement of affected sections to ensure proper function. Ongoing maintenance will assist in preventing further deterioration. Maintenance and repairs should be undertaken where considered necessary.

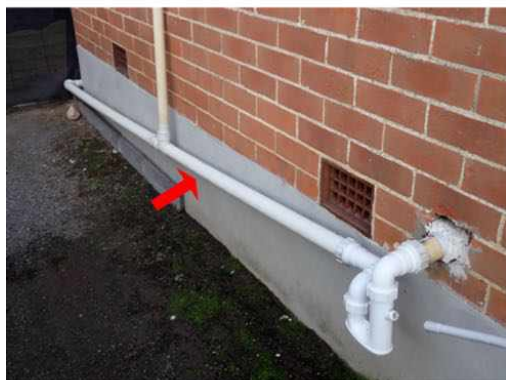
Finding 3.15

Building:	Main Building
Location:	Left hand wall
Finding:	External Bathroom Plumbing – Poor Installation and Not Secured to Wall
Information:	The external bathroom plumbing was found to be poorly installed and not adequately

clipped or secured back to the wall at the time of inspection. This may result in movement, strain on fittings, and potential for leaks or damage over time. In plain English, the pipes outside the bathroom are not installed properly and are not fixed to the wall. A licensed plumber should assess and carry out rectification as required, which may include securing pipework and ensuring correct installation in accordance with standard practices. Proper installation and maintenance will assist in preventing movement and further deterioration. Maintenance and repairs should be undertaken where considered necessary.

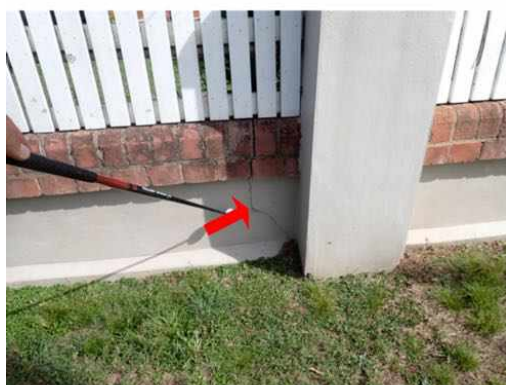
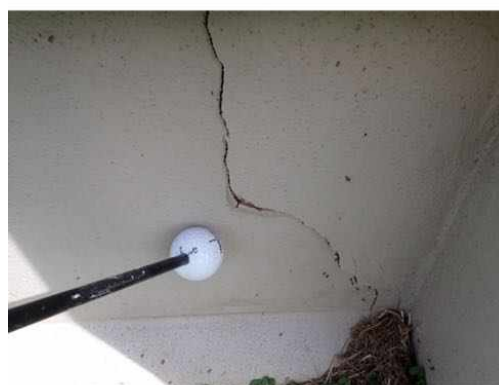
Finding 3.16

Building:	Yard
Location:	Front brick fence
Finding:	Front Fence Brickwork – Crack Identified
Information:	A crack was identified in the front fence brickwork. The cracking may be associated with movement, minor settlement, or age-related deterioration and is a common defect with structures of this type. A suitably qualified tradesperson should assess and carry out repairs as required, which may include crack repair, re-pointing, or rebuilding of affected sections. Ongoing maintenance will assist in preventing further deterioration. Maintenance and repairs should be undertaken where considered necessary.

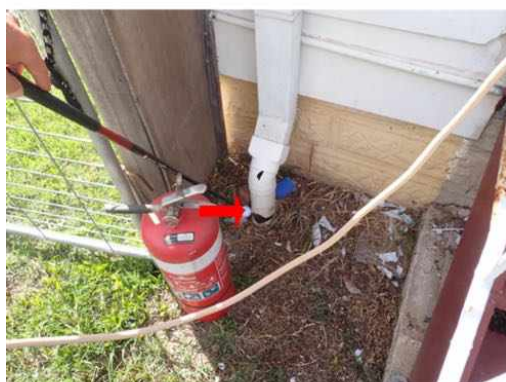
Finding 3.17

Building:	Main Building
Location:	Rear right hand corner
Finding:	Downpipe to Rear Right-Hand Corner – Damaged
Information:	The downpipe to the rear right-hand corner of the building was found to be damaged at the time of inspection. The damage may affect the effective discharge of roof water and contribute to water overflow or localised moisture issues if not addressed. A suitably qualified tradesperson should assess and carry out repairs or replacement as required to ensure proper operation. Ongoing maintenance will assist in preventing further deterioration. Maintenance and repairs should be undertaken where considered necessary.

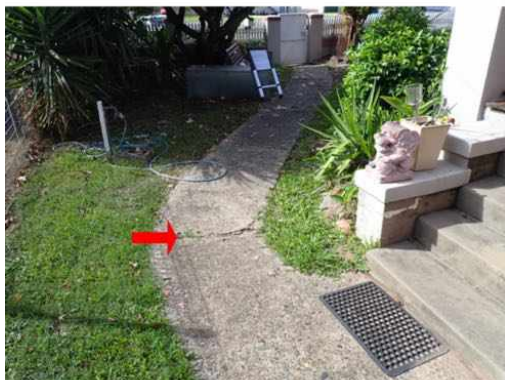
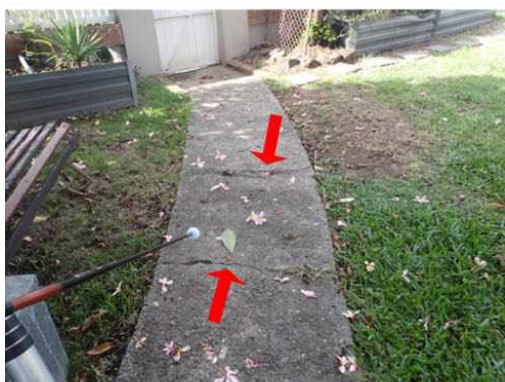
Finding 3.18

Building:	Main Building
Location:	Front concrete path
Finding:	Front Concrete Path – Large Cracks Identified
Information:	Large cracks were identified to the front concrete path. The cracking may be associated with ground movement, settlement, or age-related deterioration and is a common defect with concrete of this age. A suitably qualified tradesperson should assess and carry out repairs as required, which may include crack repair, resurfacing, or replacement of affected sections. Ongoing maintenance will assist in preventing further deterioration. Maintenance and repairs should be undertaken where considered necessary.

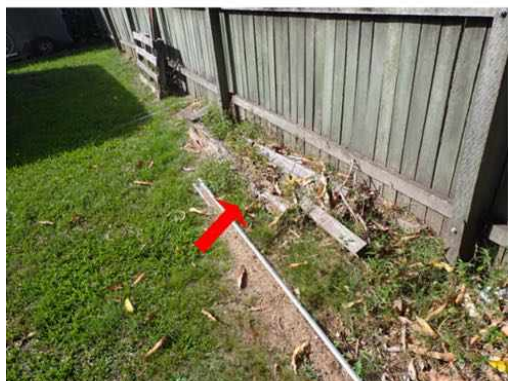
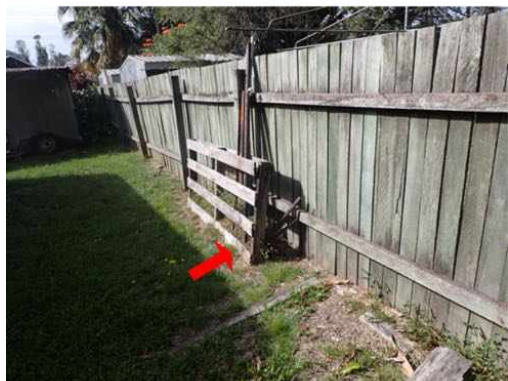
Building:	Yard
Location:	All areas
Finding:	Stored Timber and Structures in Contact with Ground – Conditions Conducive to Termite Attack
Information:	Stored timber was identified lying around the yard, and shed structures and fences were noted to be in direct contact with the ground. These conditions are conducive to termite attack, as they provide a food source and concealed access pathways for termites. In plain English, timber around the yard and structures touching the ground can attract termites. A suitably qualified tradesperson or timber pest specialist should assess and carry out recommendations as required, which may include removal of

stored timber and modifying structures to reduce ground contact. Implementing and maintaining a termite management plan will assist in reducing the risk of infestation. Maintenance and rectification should be undertaken where considered necessary.

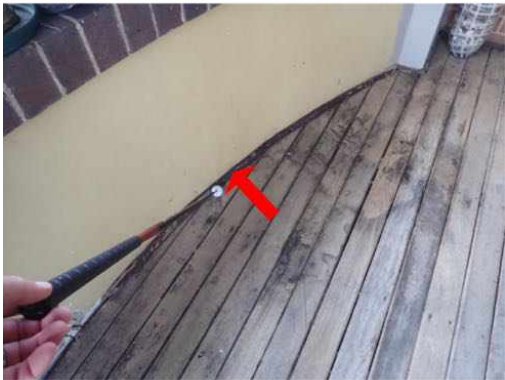
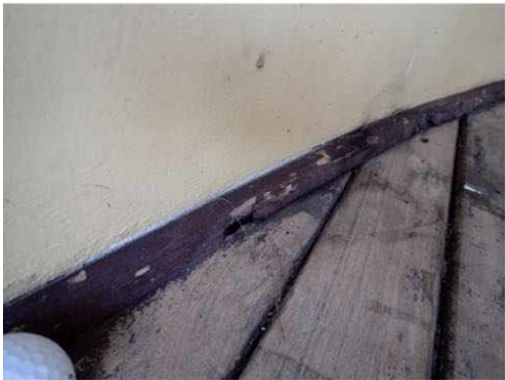
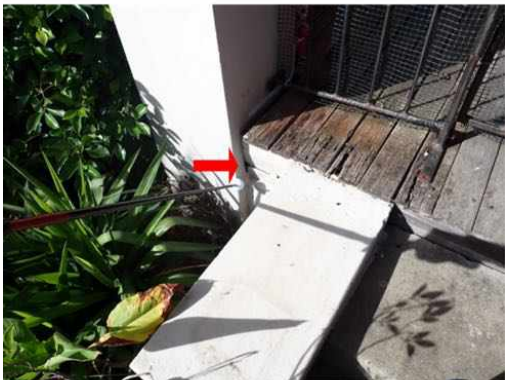
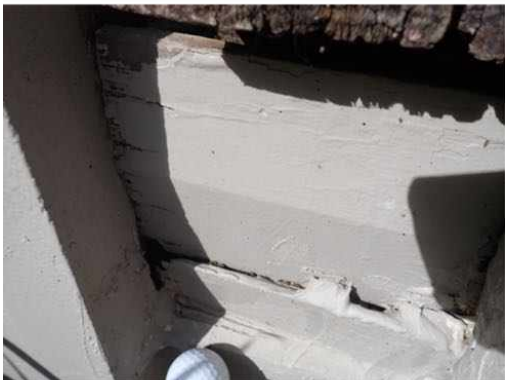
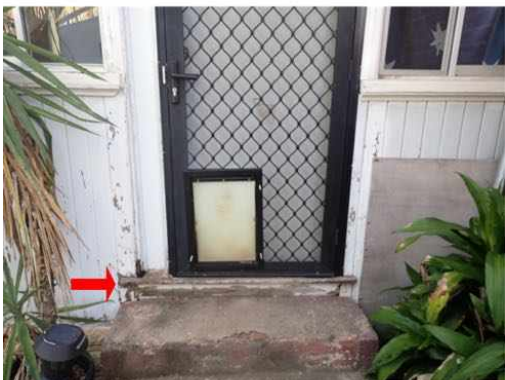
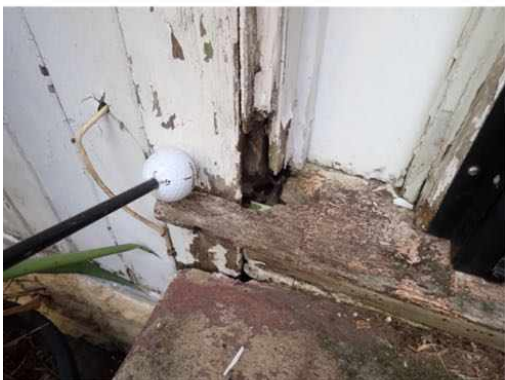
Building:	Main Building
Location:	Perimeter of building
Finding:	Multiple Areas Conducive to Concealed Termite Attack and No Subfloor Access
Information:	Multiple areas around the building were identified as being conducive to concealed termite attack, combined with no access to the subfloor area at the time of inspection. Contributing factors may include timber in contact with ground, limited ventilation, obstructions, and inability to inspect critical areas. This significantly limits the ability to detect termite activity or damage. In plain English, there are several areas around the house that could attract termites, and the subfloor could not be checked. A licensed builder or timber pest specialist should assess and carry out further investigation as required, which may include improving access, removing conducive conditions, and implementing a termite management plan. Further invasive inspection is recommended to better understand the condition of concealed areas. Ongoing maintenance and termite protection measures will assist in reducing the risk of infestation. Maintenance and further investigation should be undertaken as soon as possible.
