Building Inspection Report

Inspection Date: Mon, 12 Jan 2026

Property Address: 84 Crole Dr, Warragul VIC 3820, Australia

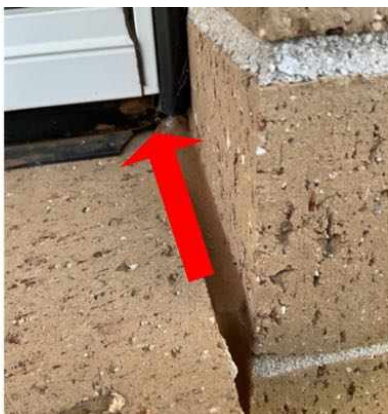
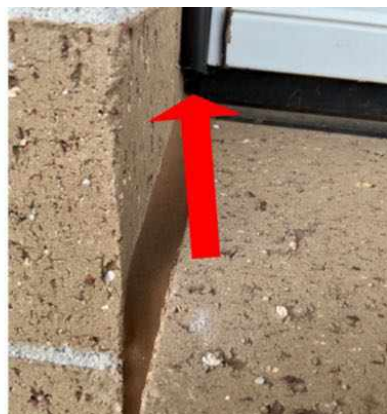
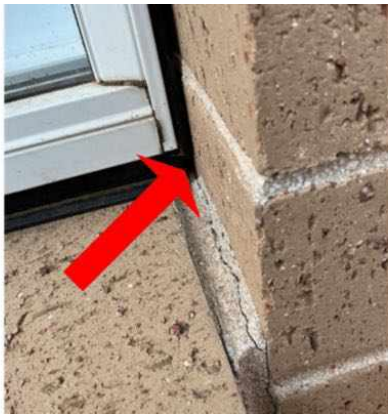
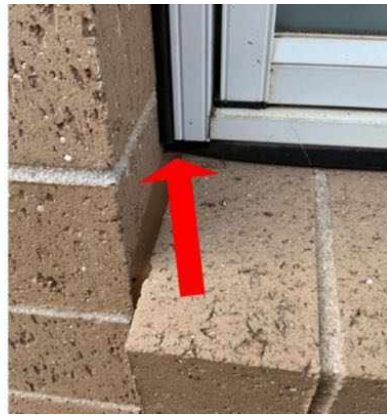
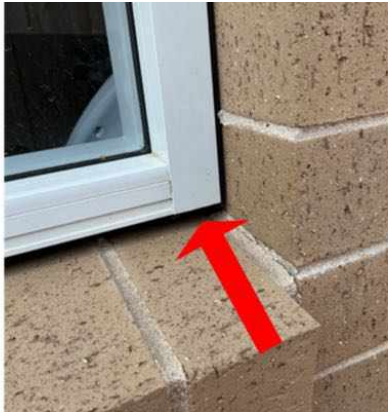
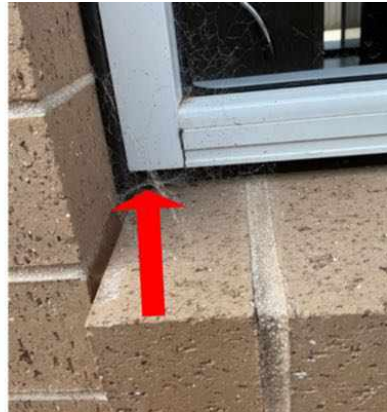
Defects 3.01

Building:	Main Building
Location:	All External Areas
Finding:	Gaps Around External Window Frames
Information:	Multiple gaps were identified between the external window frames and the adjoining brickwork across several elevations. These gaps appear to be the result of either poor or inconsistent sealant application during installation, or deterioration of the original sealant over time.

Unsealed or poorly sealed gaps can allow moisture ingress, wind-driven rain, draughts, and provide potential entry points for pests. Ongoing exposure to moisture may also contribute to internal dampness and premature deterioration of surrounding building elements.

A qualified handyman or registered builder should apply a consistent, waterproof, flexible exterior-grade sealant around all affected windows to ensure adequate weatherproofing and protection against moisture and pest entry.

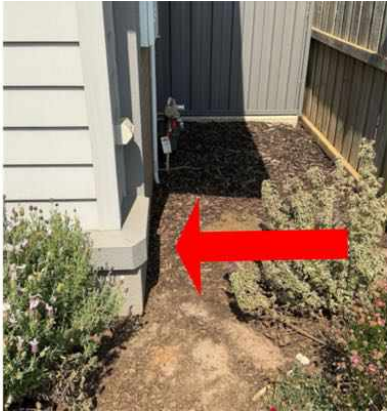
Defects 3.02

Building:	Main Building
Location:	Right hand side yard
Finding:	Site drainage - Inadequate
Information:	The site drainage in the front yard/RHS corner was found to be inadequate at the time of inspection, creating potential for subsequent water damage to associated building elements.

It is important that water does not lie against the base of walls; surrounding paths and ground levels should be sloped to drain water away from walls. Downpipes should not discharge stormwater onto lower walls or plinths. Stormwater should be carried away by large, regularly cleaned drains. Ground levels may need to be lowered to expose a buried DPC.

Where site drainage is inadequate, installation of an Agricultural (Aggie) Drain may be required. A qualified plumber should be appointed to further inspect the property and perform any remedial works as necessary. Water damage and secondary defects are likely to occur if left unmanaged.

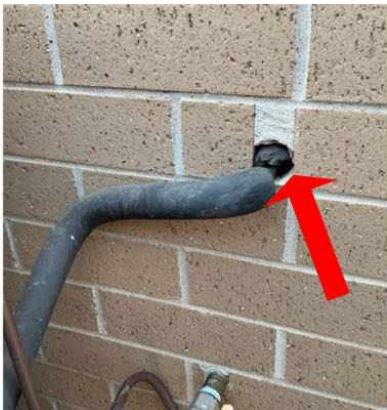
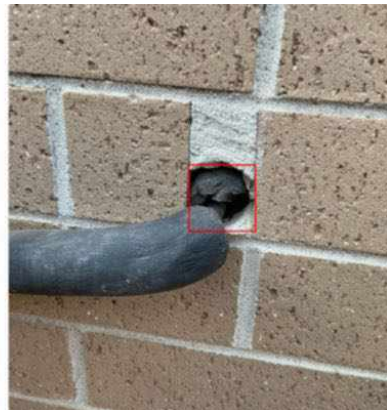
Defects 3.03

Building:	Main Building
Location:	Yard - RHS
Finding:	Incomplete Sealing Around Pipe Penetration – Right-Hand Side Yard
Information:	Upon visual inspection, we found that the pipe HWS penetration through the external brick wall in the right-hand side yard has not been properly sealed. There are visible gaps around the pipe, exposing the internal wall cavity to potential water ingress, pest entry, and further deterioration of the surrounding materials.

If left unaddressed, moisture intrusion could lead to structural damage, including brick deterioration and internal dampness. Additionally, unsealed penetrations can provide an entry point for pests.

We recommend engaging a handyman or a caulking contractor to properly seal the penetration with a suitable weatherproof material and repair any affected brickwork to prevent further issues.

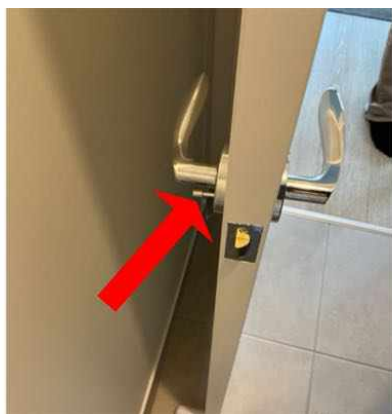
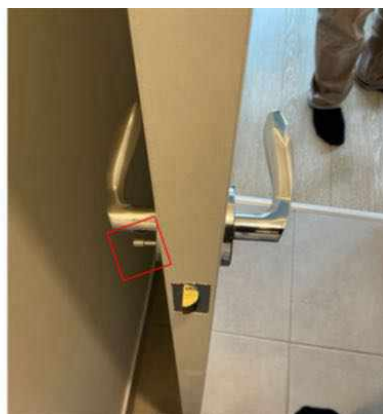
Defects 3.04

Building:	Main Building
Location:	Toilet (WC)
Finding:	Non-Operational WC Door Lock

Information: The WC door lock is not functioning, preventing proper locking and privacy. The issue may be due to misalignment, or internal wear within the locking mechanism.

A faulty door lock compromises privacy and security, which is particularly important in a bathroom setting. If not addressed, the issue could worsen, potentially leading to difficulty in opening or closing the door.

A qualified handyman should inspect the lock to repair the lock accordingly as required to restore proper functionality.

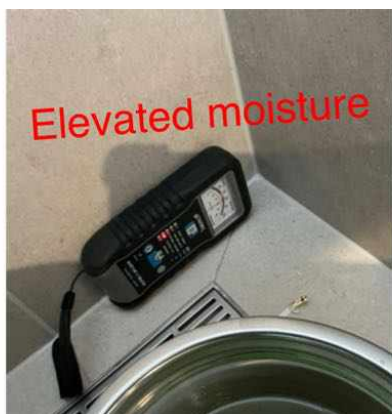
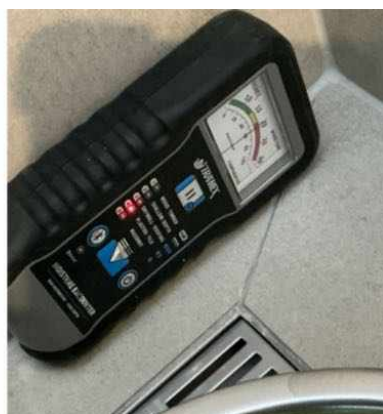
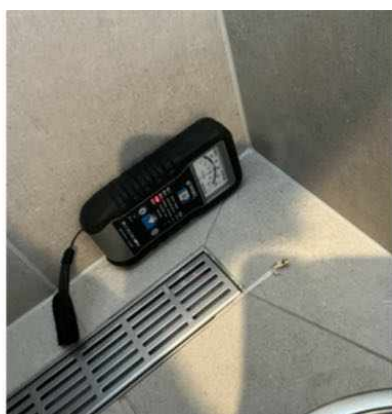
Defects 3.05

Building: Main Building

Location: Ensuite

Finding: Shower - Damp

Information: Damp is evident to the lower 300mm of wall to the shower alcove. This defect is quite common, and is suspected to have been caused by moisture permeating through the grouting in this area, which shows evidence of deterioration. Leaking pipes within the adjoining wall is also a possible cause.

Damp (or structural damp) refers to the presence of unwanted moisture in the structure of a building, either as the result of intrusion from outside, or condensation from within the structure. In the shower area, internal water leaks or other sources of excessive moisture are generally the cause of damp.

Unmanaged damp in the shower recess is likely to facilitate the formation and development of mould and fungi growth, decaying associated building materials and compromising their structural integrity. It is important to address damp conditions, as the World Health Organisation notes that excess moisture leads - on almost all indoor materials - to growth of microbes such as moulds, fungi and bacteria, which subsequently emit spores and other matter into the indoor air. Exposure to these contaminants is associated with a wide range of respiratory and other health-related problems.

Consultation with a qualified plumber or bathroom specialist is advised immediately to

identify the cause of damp and to perform remedial works as required. Where excessive mould growth is present, further inspection by a specialist environmental health inspector should also be considered.

Always ensure that sealant and grout is in good condition to prevent any moisture issues occurring in the future.

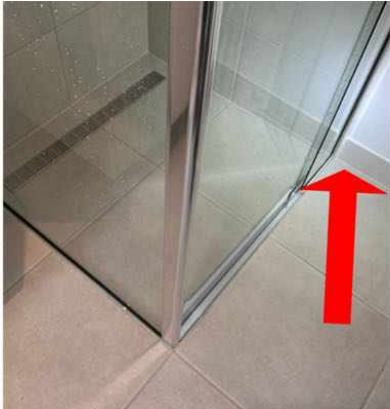
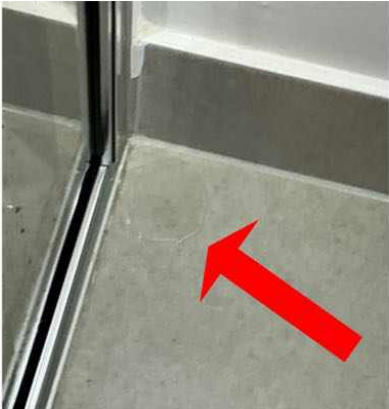
Defects 3.06

Building:	Main Building
Location:	Bathroom 2
Finding:	Shower screen - Leaking
Information:	Leaking was evident to the 2nd bathroom's shower screen at the time of inspection. It is suspected that the leaking has occurred as a result of deteriorated or missing caulking to the shower or general ageing of the building elements.

Leaking from the shower where left unattended, is likely to lead to water damage to adjoining flooring and walls. Such damage can lead to water damage and necessitate extensive remedial works being required. Active water leaks may also create an environment that is susceptible to the formation and development of mould.

Appointment of a caulking contractor is required to repair or replace the caulking to the shower area. Such works should be performed as soon as possible to ensure that no further damage occurs.

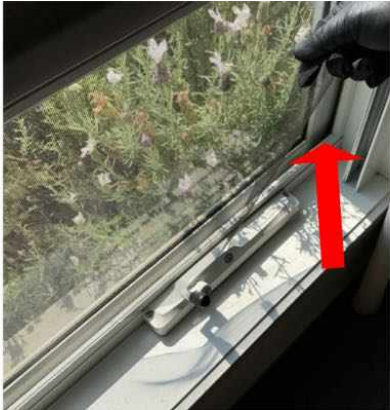
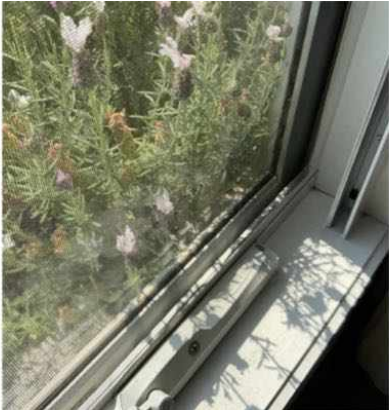
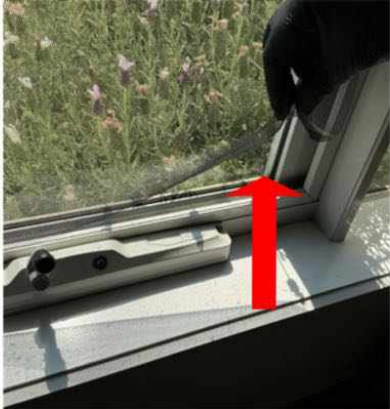
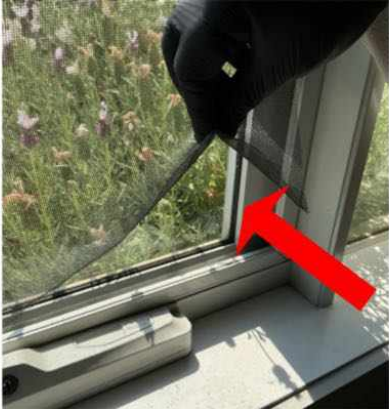
Defects 3.07

Building: Main Building
Location: All Internal Areas
Finding: Flyscreens - damaged
Information: Upon visual inspection, we found that the some of the internal fly screens are damaged. This condition could compromise insect protection and allow pests to enter through the open window, potentially affecting indoor comfort and hygiene. We recommend engaging a qualified tradesperson to repair or replace the damaged flyscreen at the earliest convenience to restore its functionality.

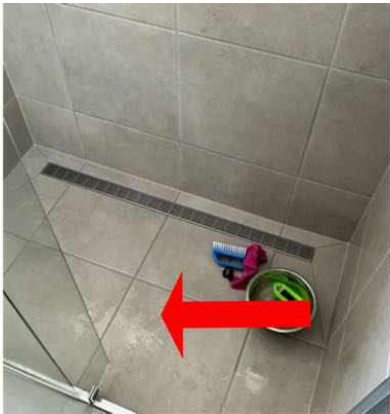
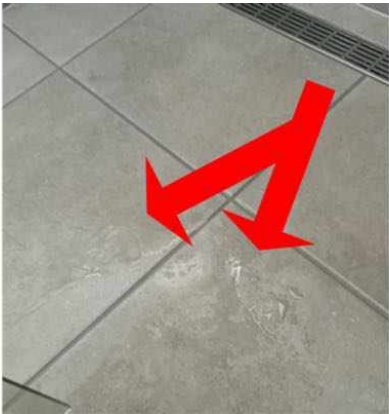
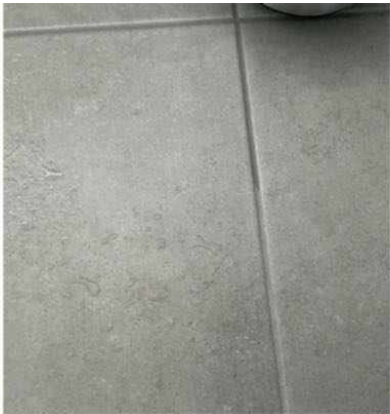
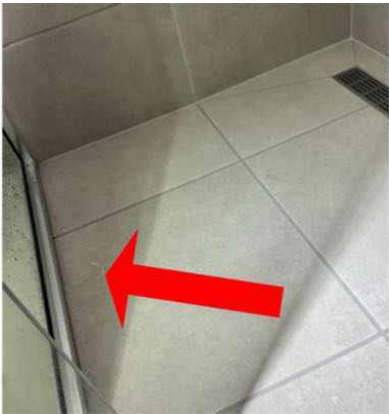
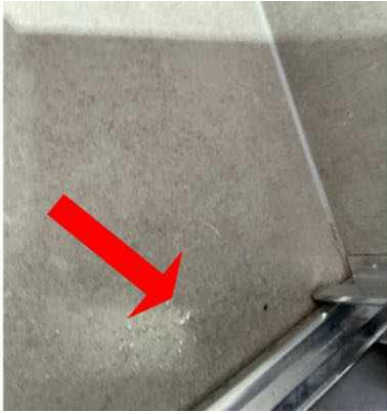
Defects 3.08

Building: Main Building
Location: Ensuite - Master
Finding: Insufficient Shower Floor Gradient – Ensuite Bathroom
Information:

During the inspection, it was observed that the ensuite shower floor has a formed slope; however, the gradient is insufficient. As a result, water was noted to pool on the shower floor after use rather than draining completely toward the waste outlet.

An insufficient shower floor gradient can result in standing water, which increases the risk of mould growth, water staining, and accelerated deterioration of grout and sealants. Over time, this condition may contribute to moisture ingress and potential damage to the subfloor structure and adjacent finishes, in addition to creating a potential slip hazard.

It is recommended that the client maintain the shower area in a dry condition after use, including wiping down excess water, to help protect the grout and waterproofing.

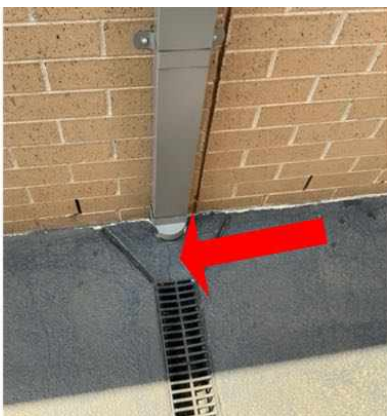
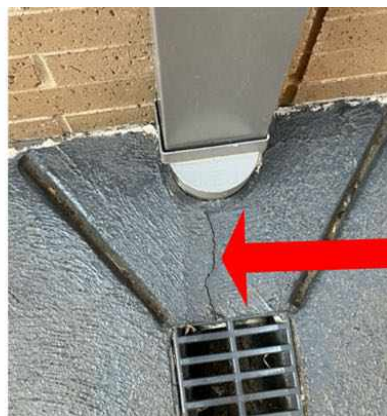
Defects 3.09

Building:	Main Building
Location:	RHS yard
Finding:	Cracking - External Concrete Paving Damage Category 1 - Fine (less than 2mm)
Information:	Fine cracks were identified in external concrete paving. Although fine cracks are quite noticeable, they are often only considered to be an appearance defect, and usually do not indicate any structural damage. To be considered a Category 1 or fine crack, the crack is found to be less than 2mm in width.

Generally the cause of a hairline crack in existing concrete paving such as driveways and pathways is indicative of the expansion and contraction of the concrete. Such causes are generally due to environmental factors, such as moisture levels, weather conditions, root systems of nearby trees or the soil types on which they are laid.

Fine cracks may also be due to poor original installation of the concrete. Factors such as poor compaction of the sub surface and/or inadequate reinforcing of the slab may create cracking and other secondary defects.

Monitoring of all cracking should be conducted frequently. Always contact a building inspector should cracks widen, lengthen, or become more numerous.

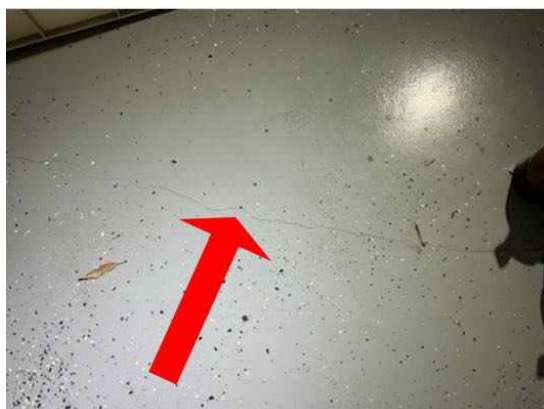
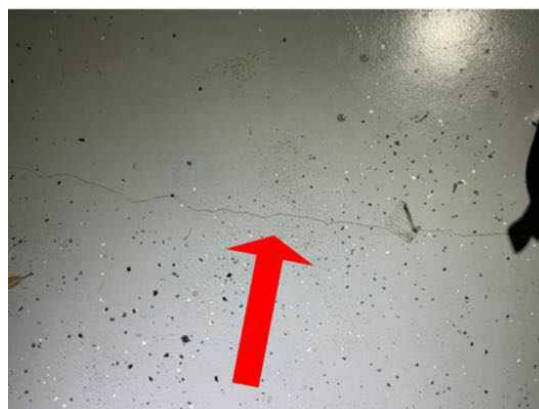
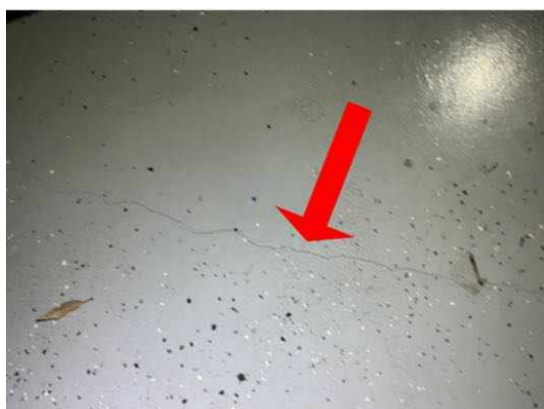
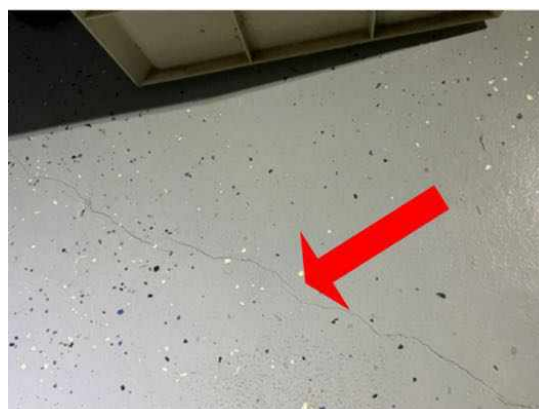
Defects 3.10

Building: Main Building
 Location: Garage
 Finding: Noticeable cracks in concrete slab of the the garage floor
 Information: During the inspection, multiple noticeable cracks were identified in the concrete slab of the garage floor. These cracks vary in size and location, which may indicate underlying movement or stress within the slab. While they do not currently appear to significantly impact the structural integrity, their presence suggests potential early-stage deterioration.

It is recommended that the cracks be monitored closely over the next 12 months. If any of the cracks widen or worsen during this period, it is critical to engage a structural engineer immediately to assess the situation and recommend appropriate rectification measures to prevent further damage and ensure the long-term stability of the structure.

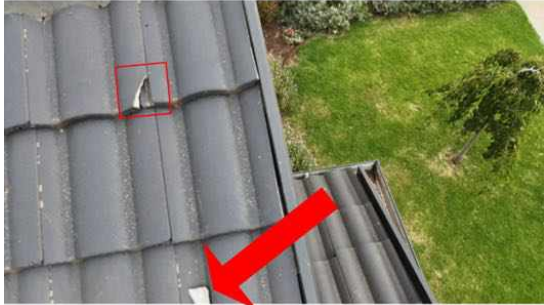
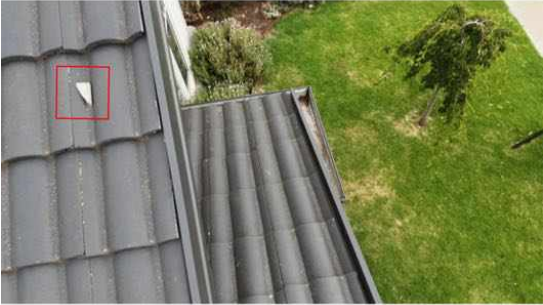
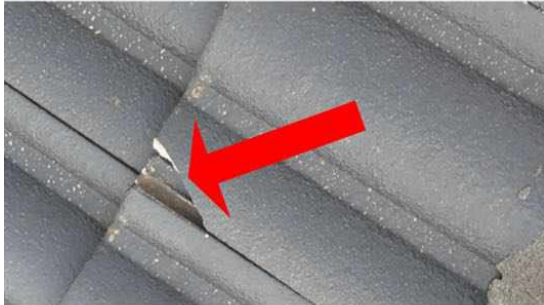
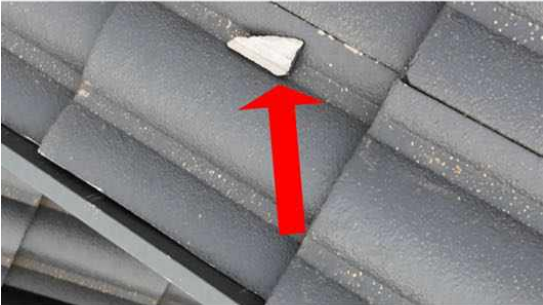
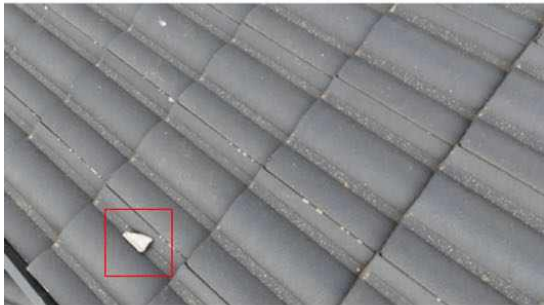
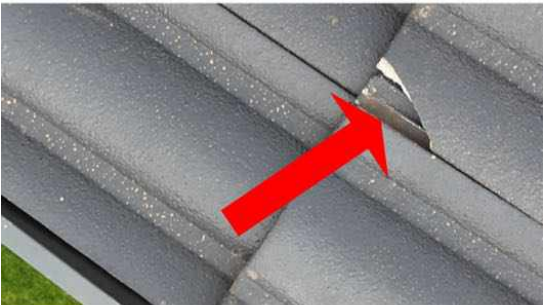
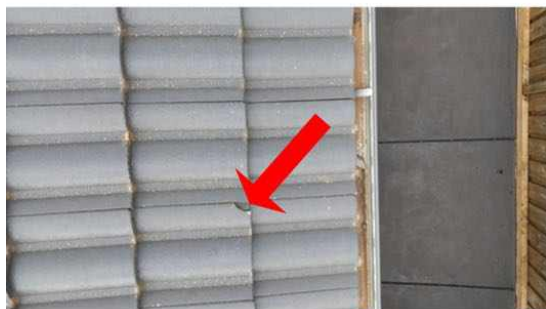
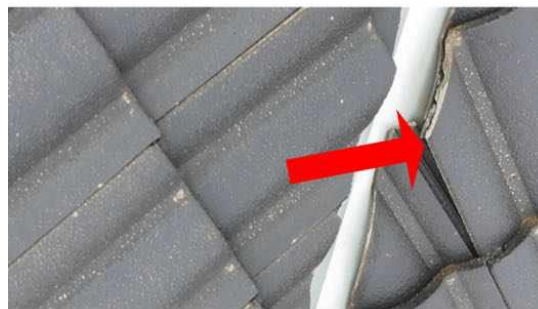
Defects 3.11

Building: Main Building
 Location: Roof Exterior
 Finding: Roof tiles - Broken
 Information: Upon inspection of the exterior roof covering, broken roofing tiles were identified. Broken and friable roof tiles are generally the result of ageing and weathering of what is essentially a porous material.

If left to further deteriorate, broken and brittle roof tiles are likely to lead to water penetration via the roof into the ceiling space, causing secondary damage to ceiling linings, insulation and roof structures. Broken roof tiles are also likely to detract from the effectiveness of the roof drainage system, creating potential for secondary damage to the exterior roof covering and roof plumbing.

Replacement of broken tiles is required and should be performed by a roofing contractor as soon as possible.

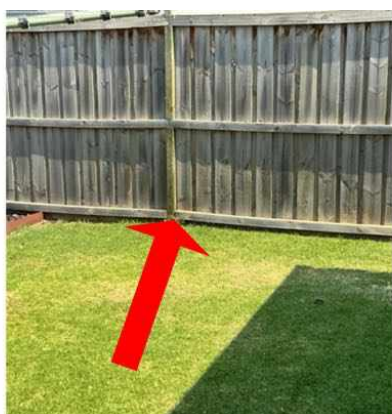
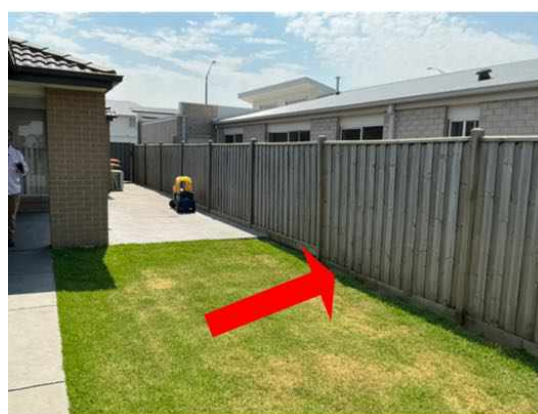
Defects 3.12

Building:	Main Building
Location:	All External areas
Finding:	In Ground Contact - Conducive Conditions to timber pest activity
Information:	Any timbers in direct ground contact provide an opportunity for concealed termite entry and are likely to be subject to premature rot and decay due to soil retaining moisture or creating damp conditions against the timber surfaces.

Untreated timber in direct contact with the external ground should be removed. Consider replacing with more durable materials, such as appropriately treated timber or non-timber elements, to reduce the risk of decay and termite attack.

Frequent pest inspections by a licensed pest control technician are recommended to readily identify any termite activity in these areas and ensure early intervention if required.

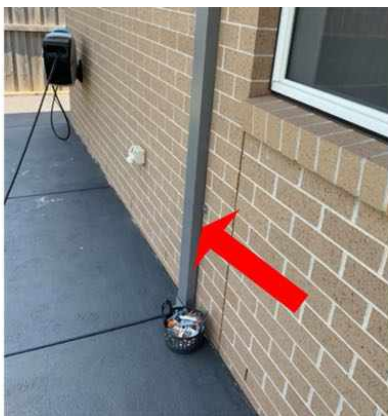
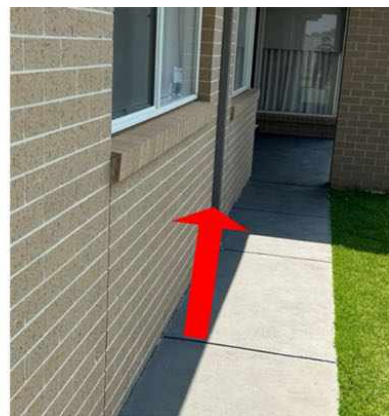
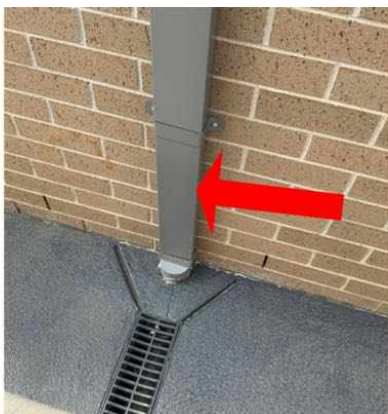
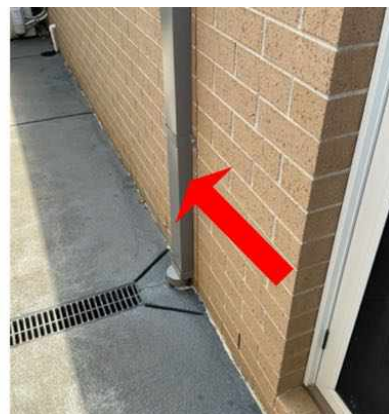
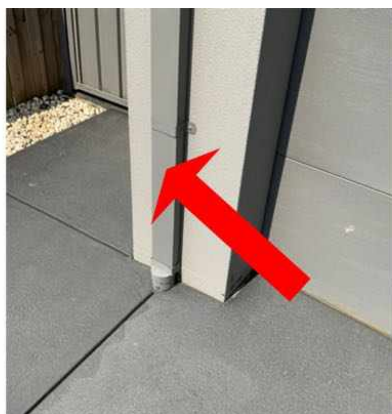
Defects 3.13

Building:	Main Building
Location:	All External areas
Finding:	Bridging Attachments to the Building - Conducive Conditions to timber pest activity
Information:	Bridging occurs when items fixed or placed against a building create concealed

pathways for termites to bypass any existing termite management system and gain access to the structure undetected. Typical bridging elements include attachments such as hot water services, downpipes, verandahs, decks, steps, fences, and service conduits, where insufficient clearance exists between these elements and the building structure.

Where attachments are not isolated and do not maintain a clear inspection gap of at least 25mm from the building, they create a potential risk of concealed termite entry. Such concealed pathways compromise the effectiveness of any termite management system in place.

It is recommended that these areas be regularly inspected by a licensed and qualified pest inspector. Where bridging is identified, modifications should be made to restore adequate clearance or install appropriate barriers to mitigate the risk of concealed termite ingress.

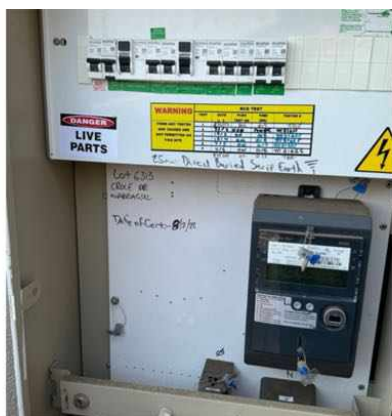
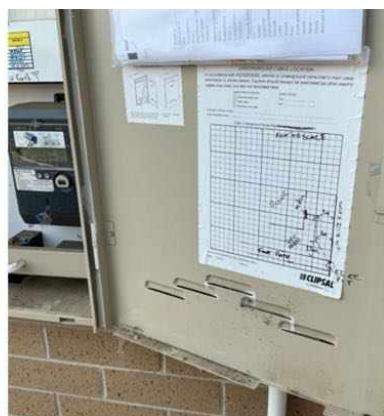
Defects 3.14

Building:	Main Building
Location:	All external areas
Finding:	Termite Management System - no evidence of a chemical installation - Conductive Conditions to timber pest activity
Information:	At the time of inspection, there was no evidence to indicate that a previous or current termite management (protection) system has been installed at the property. No durable notice was observed within the electrical switchboard or elsewhere on site to confirm the presence of any chemical or physical termite protection measures. Additionally, there were no visible indicators to suggest that preventative termite treatments or barriers have been applied in the past.

The absence of a termite management system leaves the property vulnerable to potential termite attack, which could lead to significant damage to timber building elements if left unaddressed.

It is highly recommended that the client consult with a licensed pest controller regarding the installation of a post-construction chemical termite barrier. Such systems are proven to be effective in preventing termite ingress and should be considered a priority, particularly where no existing protection is in place. A durable notice confirming the installation of any future system should be affixed within the switchboard in accordance with AS 3660.

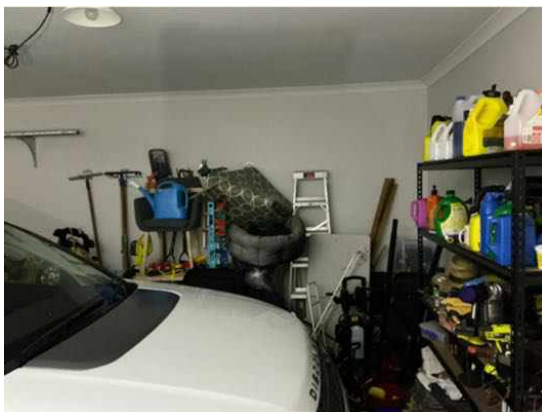
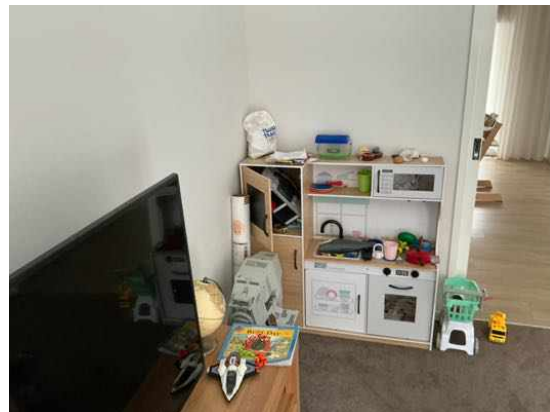
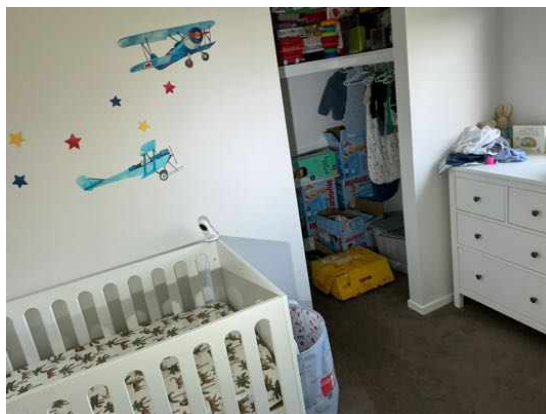
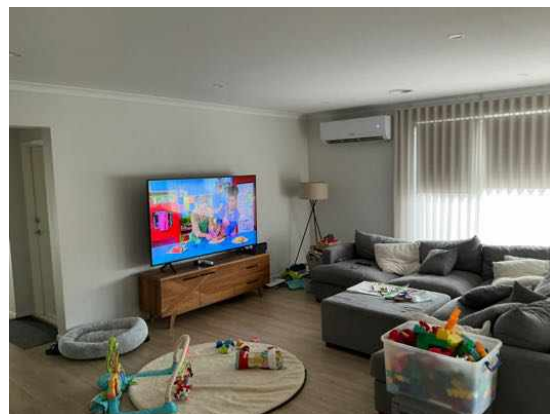
Noted Item

Building: Main Building
 Location: All Internal Areas
 Finding: Obstructions and Limitations - Interior
 Information: These photographs are an indication of the obstructions and limitations which impeded the inspection of the internal areas of the property at the time of inspection. These obstructions can hide an array of defects and should be removed to allow full inspection to be carried out. A re-inspection is recommended once the areas are made accessible.

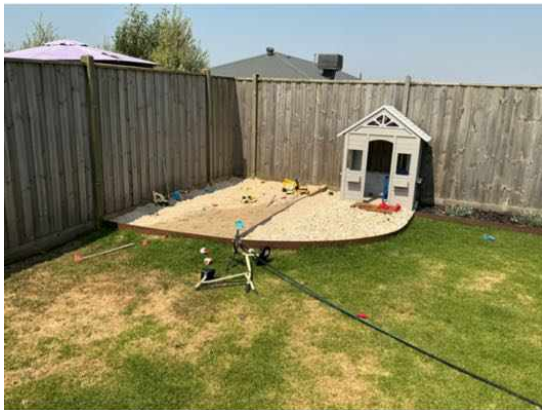
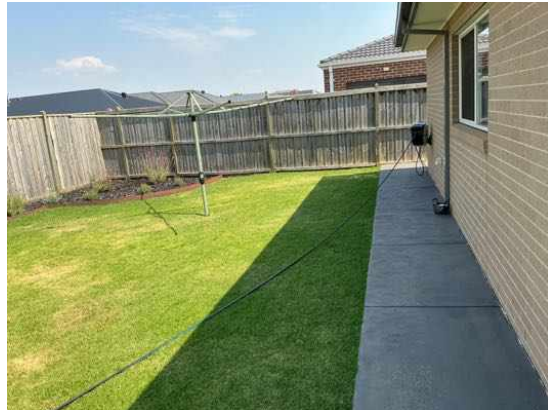
Noted Item

Building: Main Building
 Location: All External Areas
 Finding: Obstructions and Limitations - Exterior
 Information: These photographs are an indication of the obstructions and limitations which impeded the inspection of the external areas of the property at the time of inspection.

These obstructions can hide an array of defects and should be removed to allow full inspection to be carried out. A re-inspection is recommended once the areas are made accessible.

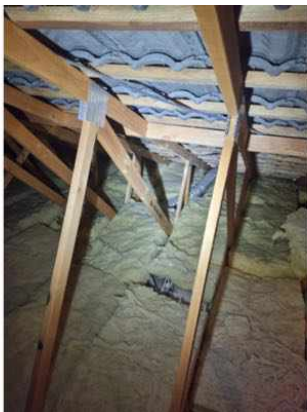
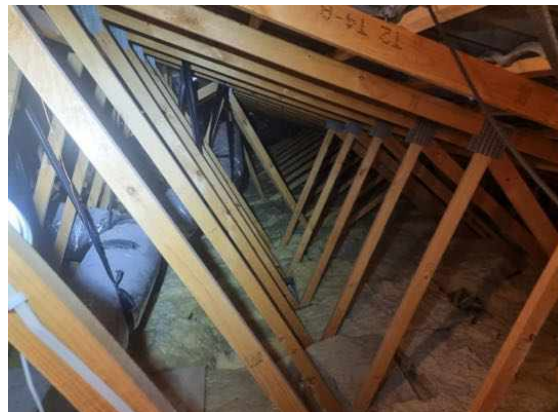
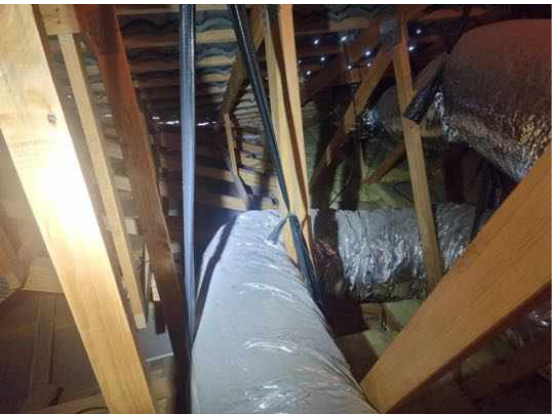
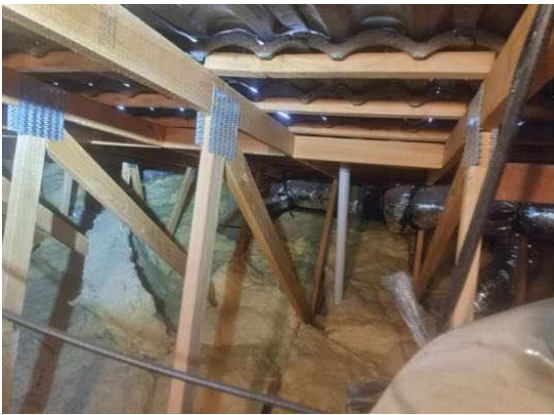
Noted Item

Building: Main Building
Location: Roof Void
Finding: Obstructions and Limitations - roof cavity
Information: photographs illustrate the obstructions and limitations that impeded the inspection of the roof cavity area of the property at the time of inspection. The access hole was particularly small, measuring approximately 35cm, which is below the minimum size required by Australian Standard AS4349.1. Such obstructions can conceal a range of defects and should be removed to allow a full inspection to be carried out. A re-inspection is recommended once the areas are made accessible.
