Building and Timber Pest Inspection Report

Inspection Date: Wed, 28 Jan 2026

Property Address: 13 Cambridge Cres, White Hills VIC 3550,
Australia

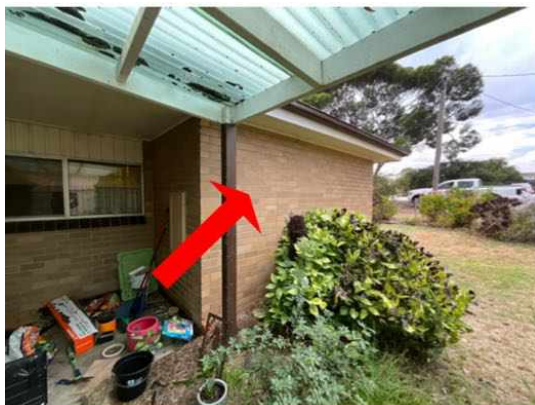
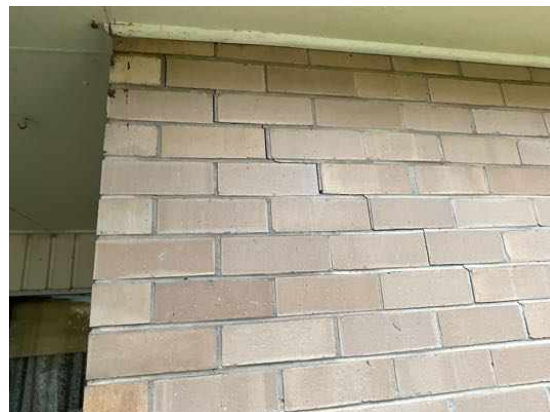
Building: Building 1
 Location: Front wall
 Finding: Brickwork - Step cracking
 Information: Step cracking was identified to the brickwork in this area at the time of inspection. Step cracking, which is similar to other forms of cracking, has a variety of possible causes. However, the most common is the subsidence of adjacent footings.

Step cracking is a relatively common defect, and is most likely to occur adjacent to windows, doors and other openings. Mortar failure in the gaps between affected bricks indicates the stresses and tensions affecting the wall.

Where step cracking is extensive or severe, the client is advised to consult a structural engineer. Minor step cracking can be used as a warning sign to address factors causing stress to the wall, which can include the effect of surrounding trees, water leaks, soil erosion, or even the presence of reactive soils in the surrounding area.

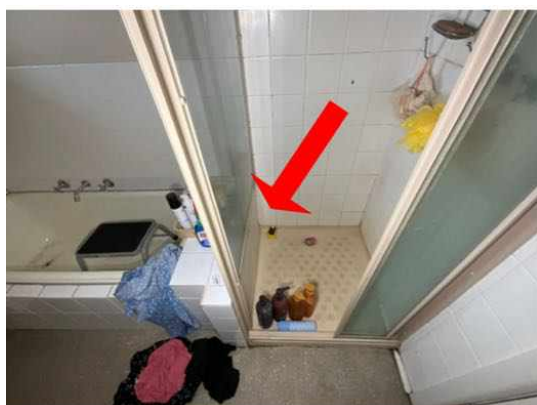
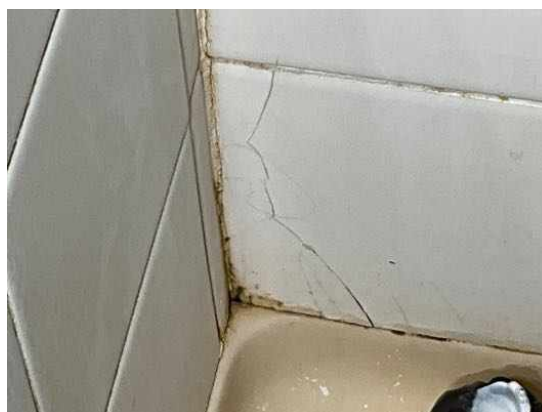
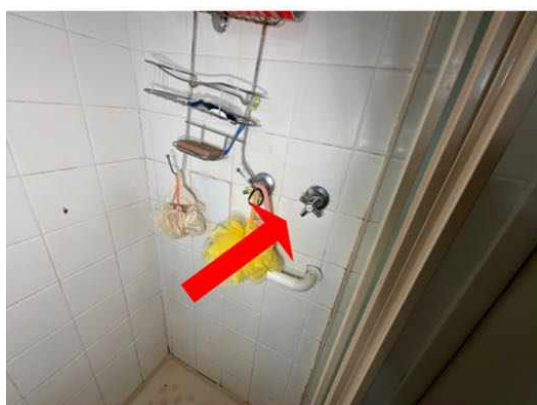
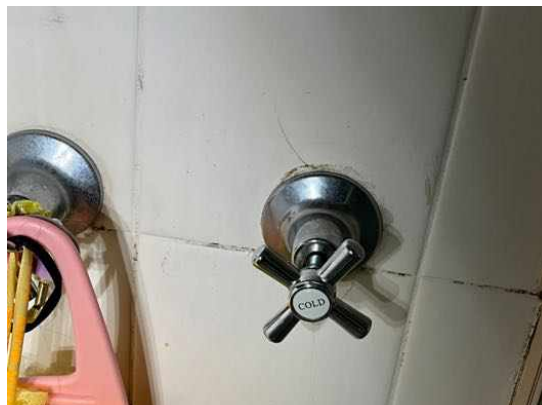
Finding 3.02

Building: Building 1
 Location: Bathroom

Finding: Wall Tiles- Cracked
 Information: Cracked tiles within the household detract from the overall appearance of the affected areas, as well as creating potential for water penetration to adjoining building elements. If left unmanaged, water damage may occur as a result of constant water penetration over a prolonged period of time.

While not considered a matter of urgency, replacement of tiles is advised as a solution. A Tiling Contractor may be appointed to perform these works at client discretion.

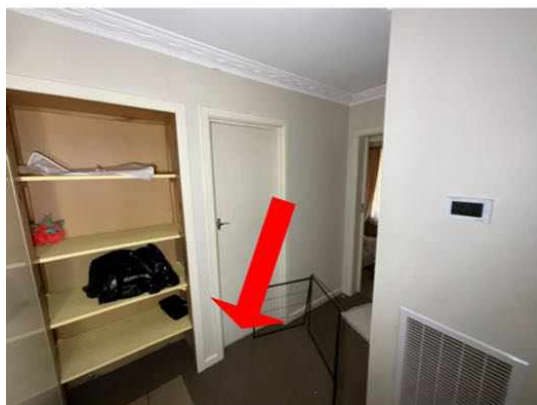
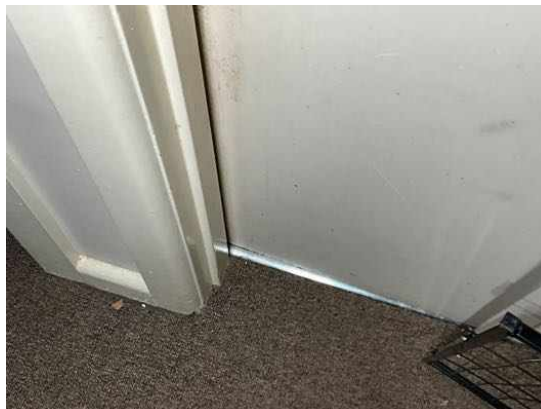
Finding 3.03

Building: Building 1
 Location: Bathroom
 Finding: Door- Binding
 Information: Binding and/or jamming of this door is evident during standard operation. This defect inhibits the functionality of the affected door as well as creating potential for secondary defects to associated building elements, such as damage to the floor covering.

A door that binds to flooring or to the associated door frame may have several causes, ranging from minor defects, such as poor installation of the door or deteriorated hinges, through to major structural issues, such as damage to subfloor structures.

A qualified carpenter or general handyperson should be appointed to perform minor rectification works at client discretion.

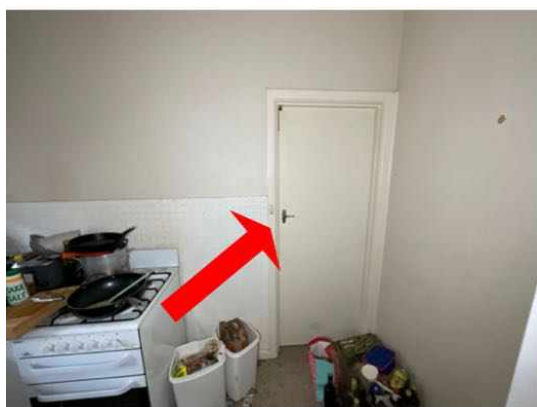
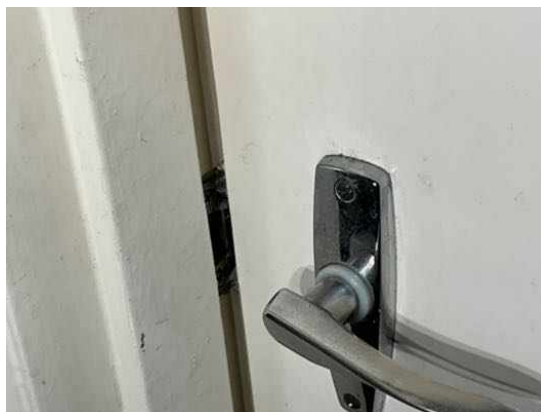
Finding 3.04

This is a common defect and is expected in a property of this age, whether being due to substandard installation or general deterioration of the door hardware.

Readjustment of the striker plate is recommended at client discretion. Works such as these can be completed by a general handyman or qualified carpenter.

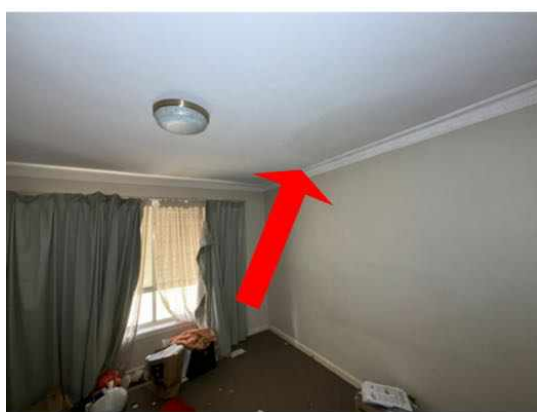
Finding 3.05

Finding: Ceiling - Water stained

Information: Water staining to ceiling linings in this area was evident at the time of inspection. Water

staining indicates that surfaces have been exposed to excessive moisture over time. The minerals and other elements in the water lead to staining, which may graduate to corrosion and deterioration if left unmanaged.

While mostly an appearance defect, water staining can be indicative of more serious defects, which may be currently concealed by interior ceilings.

Where water staining is active, a licensed plumber must be consulted to identify the cause of the staining and to provide advice on any reparation works that may be required. Replacement of any damaged structures is advised.

Conversely, where water staining is old and inactive, affected building materials may be repaired or replaced at client discretion.

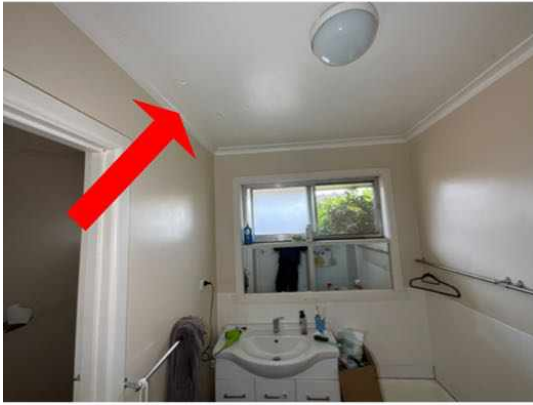
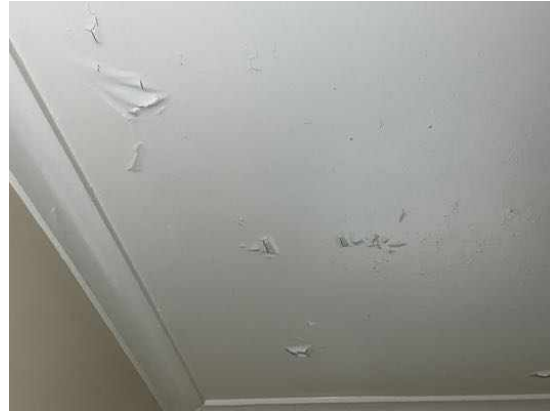
Finding 3.06

Building:	Building 1
Location:	Bathroom
Finding:	Paint- Flaking
Information:	Sections of paint in this area was found to have deteriorated. Paint flaking is generally an indication of excessive moisture in the area, that is currently hidden by the painted surface.

The presence of excessive moisture can have major implications on associated building elements if left unattended. While only seemingly minor at this stage, the damage cannot be determined due to the paint obstructing any further inspection of the damage.

A qualified Painter should be contacted at the Owner's discretion to re-paint the area.

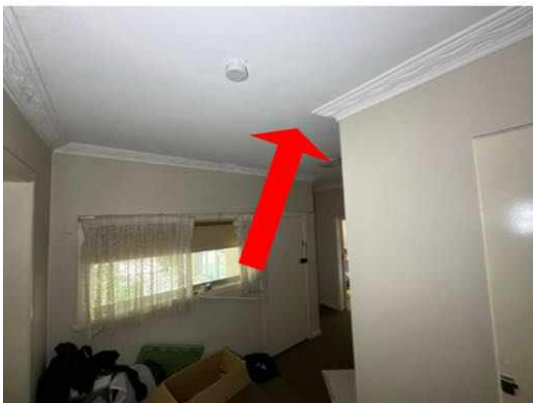
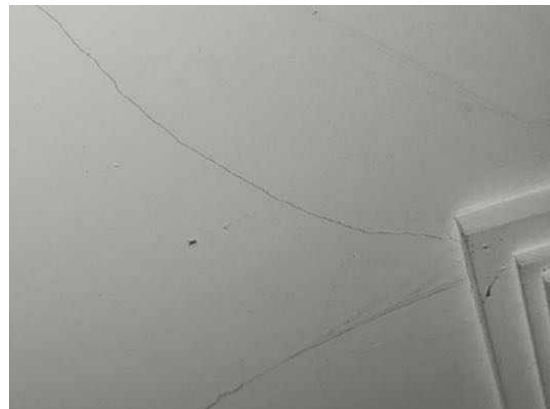
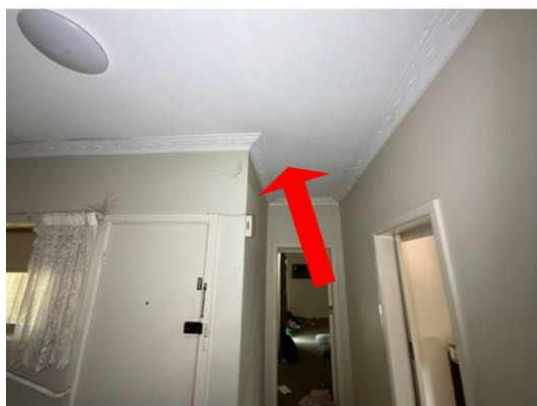
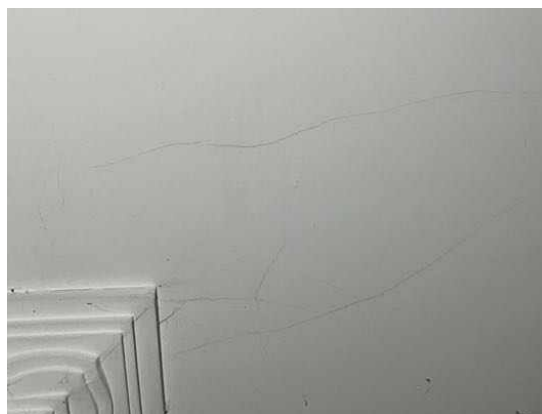
Finding 3.07

Building:	Building 1
Location:	Hall
Finding:	Cracking - Damage Category 1 - Fine (up to 1mm)
Information:	Although fine cracks are quite noticeable, they are often only considered to be an appearance defect, and usually do not indicate any structural damage. Generally, the cause of a fine crack is indicative of a separation between building materials and finishes (e.g. paint, plaster, etc.) along joints.

Cracking of this nature can generally be repaired with minor sanding, filling and/or repainting. Such works should be performed by a qualified painter or a general handyman.

Monitoring of all cracking should be conducted frequently. Always contact a building inspector should cracks widen, lengthen, or become more numerous.

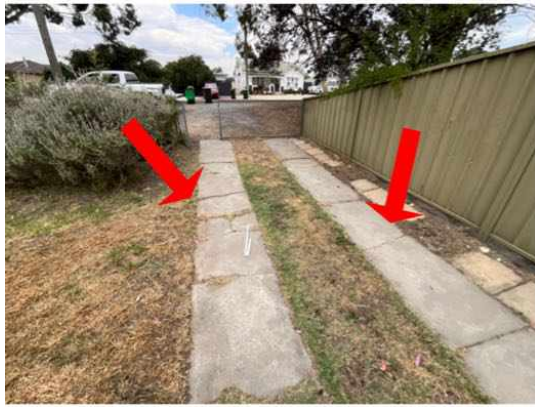
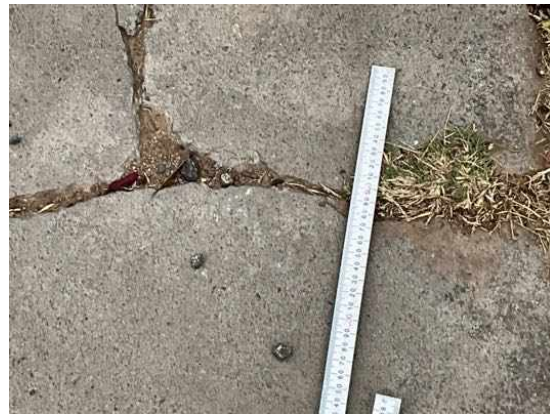
Finding 3.08

Building:	Building 1
Location:	Driveway
Finding:	Cracking - External Concrete Paving Damage Category 3 - Wide Cracks (2mm - 4mm)
Information:	Wide cracks were identified in external concrete paving. Wide cracks are significant and are likely to lead to the development of safety hazards and secondary defects if left unmanaged.

General age and expected deterioration of the paved areas is a common cause of this type of cracking. However, expansion and contraction of the slab may also have occurred due to environmental factors. Such factors include variable moisture and weather conditions, the presence of trees and their roots having a settling or lifting effect on the soil, or the effect of load bearing, e.g. heavy vehicles over a sustained period of time.

Cracking to this degree may also be due to poor original installation of the concrete. Factors such as poor compaction of the sub surface and/or inadequate reinforcing of the slab may create cracking and other secondary defects. Wide cracks may also have a more significant structural cause, such as subsidence of soils.

Where the crack is located adjacent to structural elements of the building, the advice of a Structural Engineer is advisable before undertaking repairs. Significant repair and likely replacement of the concrete paving is probable.

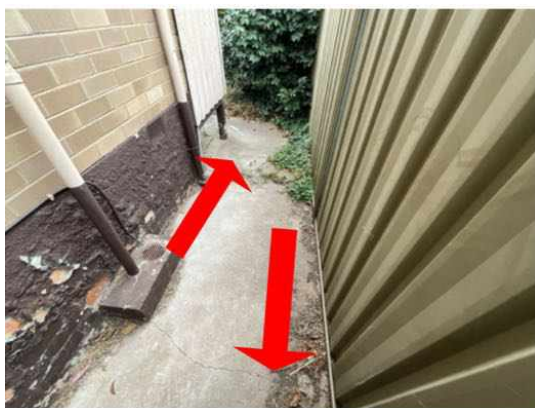
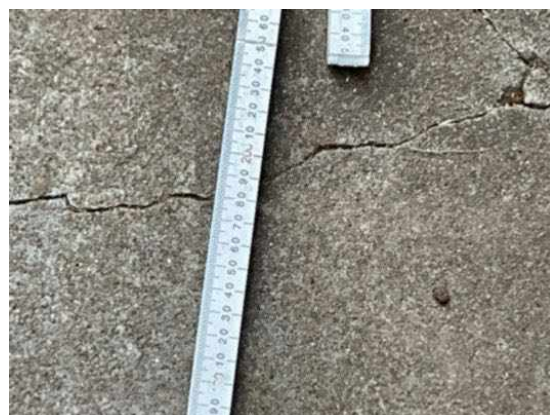
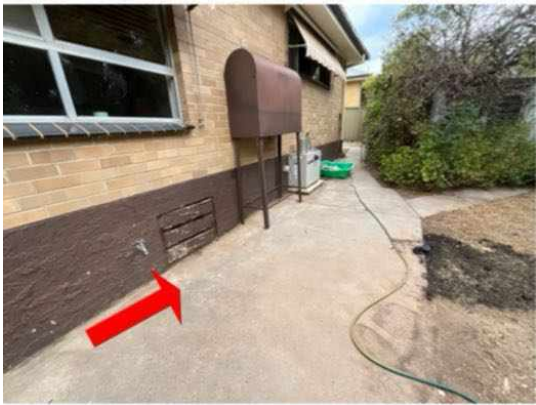
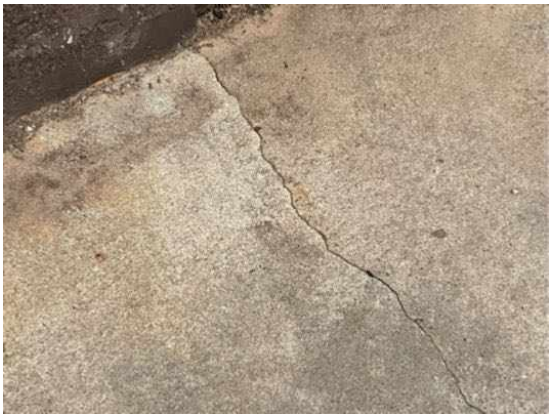
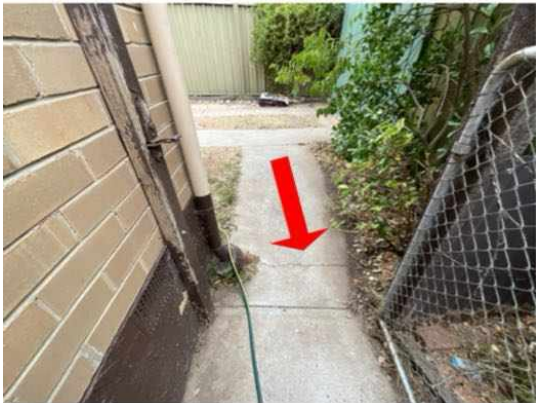
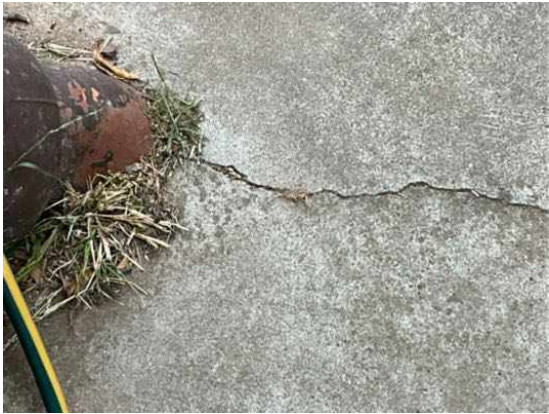
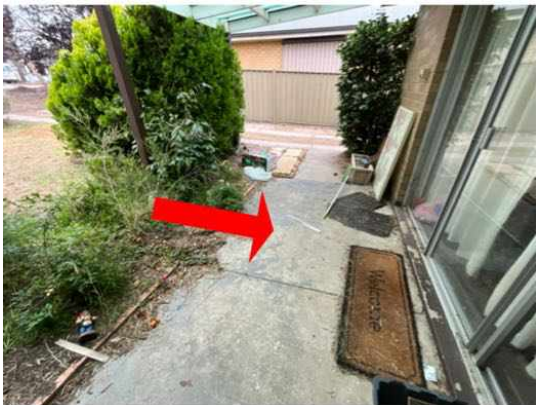
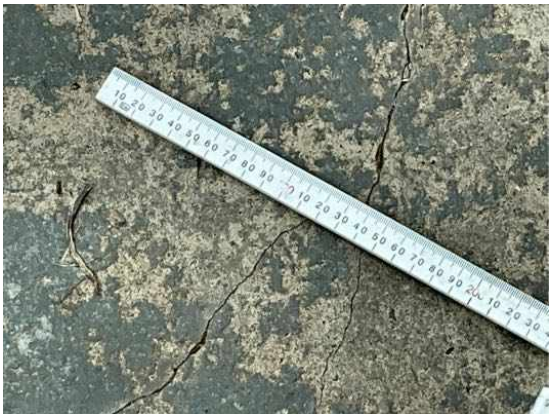
Finding 3.09

Building:	Building 1
Location:	Yard - Back, verandah
Finding:	Cracking - External Concrete Paving Damage Category 1 - Fine (less than 2mm)
Information:	Fine cracks were identified in external concrete paving. Although fine cracks are quite noticeable, they are often only considered to be an appearance defect, and usually do not indicate any structural damage. To be considered a Category 1 or fine crack, the crack is found to be less than 2mm in width.

Generally the cause of a hairline crack in existing concrete paving such as driveways and pathways is indicative of the expansion and contraction of the concrete. Such causes are generally due to environmental factors, such as moisture levels, weather conditions, root systems of nearby trees or the soil types on which they are laid.

Fine cracks may also be due to poor original installation of the concrete. Factors such as poor compaction of the sub surface and/or inadequate reinforcing of the slab may create cracking and other secondary defects.

Monitoring of all cracking should be conducted frequently. Always contact a building inspector should cracks widen, lengthen, or become more numerous.

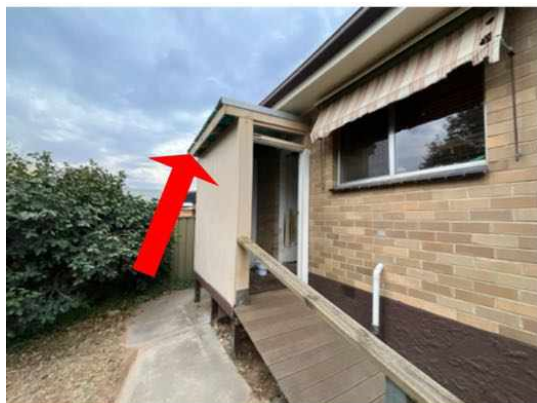
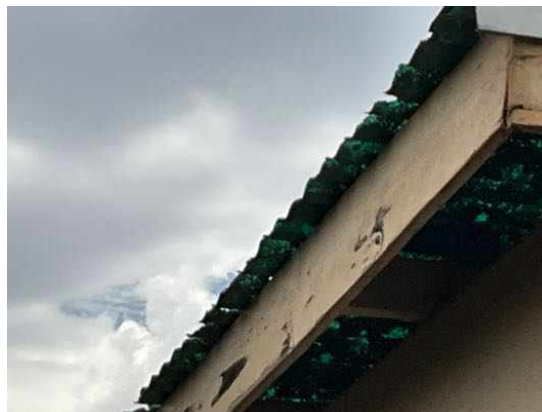
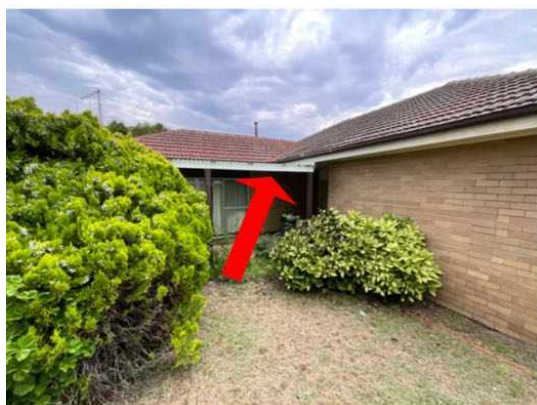
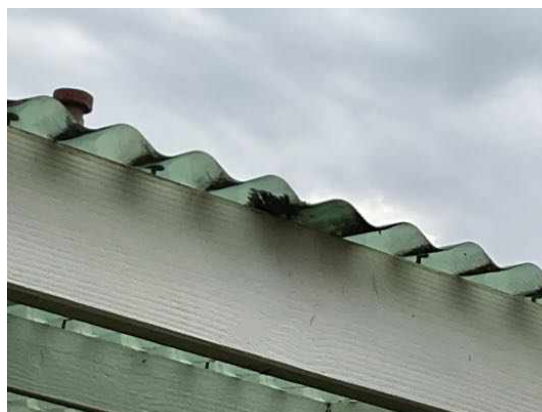
Building: Building 1
 Location: Rear door, verandah
 Finding: Guttering Missing
 Information: The Guttering in this area was missing at the time of inspection. Guttering, Downpipes and Stormwater drainage are vital to protect the integrity of the structure and to prevent an environment conducive to Timber Pest attack.

A Plumber should be contacted as soon as possible to replace and connect to drainage the missing Guttering.

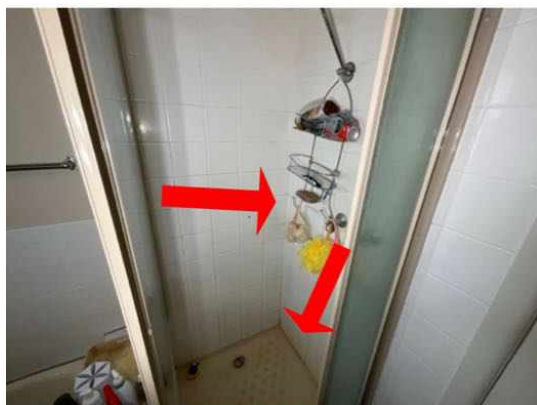
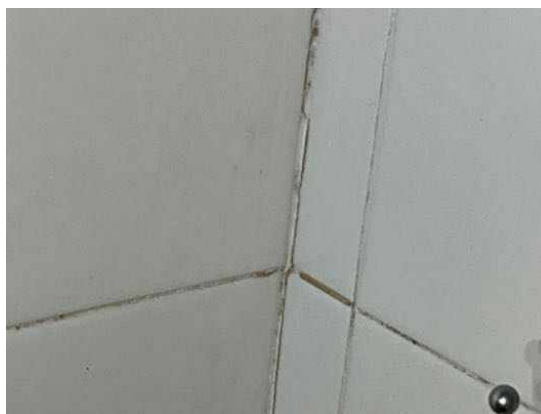
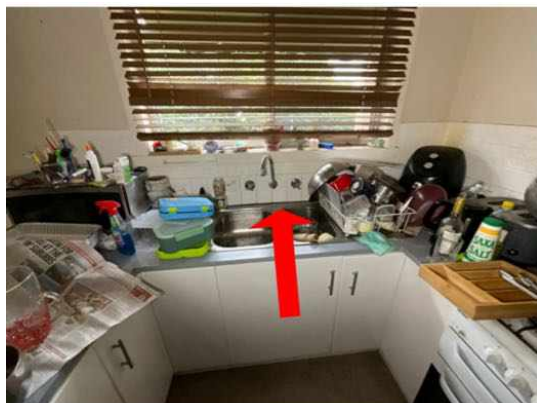
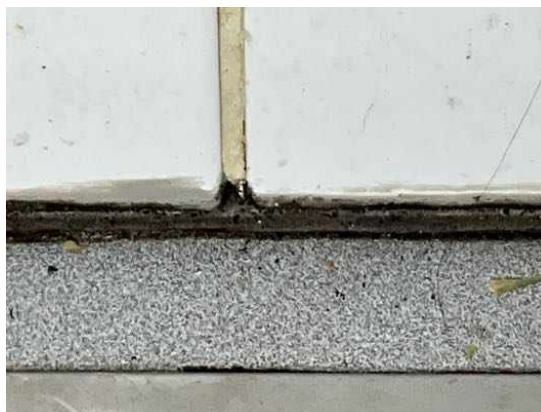
Finding 6.02

Building: Building 1
 Location: Bathroom, kitchen
 Finding: Inadequate sealant or Grout
 Information: This area has a lack of effective Sealant or Grout. This is allowing the ingress of water to the structure inside the wall.

The presence of water encourages Termite attack, Mould and Fungal Decay.

A Tiler or General Handy person must be contacted as soon as possible to effect repairs and prevent further deterioration.

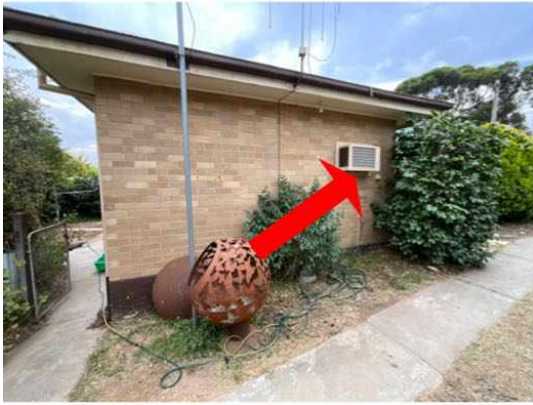
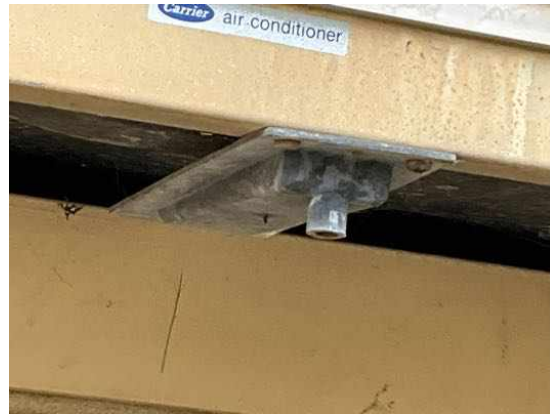
Finding 6.03

Building:	Building 1
Location:	Driveway
Finding:	Air conditioner - Disconnected overflow
Information:	The Air Conditioner (A/C) overflow was found to be disconnected from storm water drainage and is creating excessive moisture in the surrounding area.

Such leaking creates an environment which is conducive to an array of defects, including water damage to associated building elements and the attraction of termite or timber pest infestation.

It is highly recommended that a licensed plumber be appointed to connect the A/C overflow in order to prevent such an environment from being created. These minor works should be carried out as soon as possible.

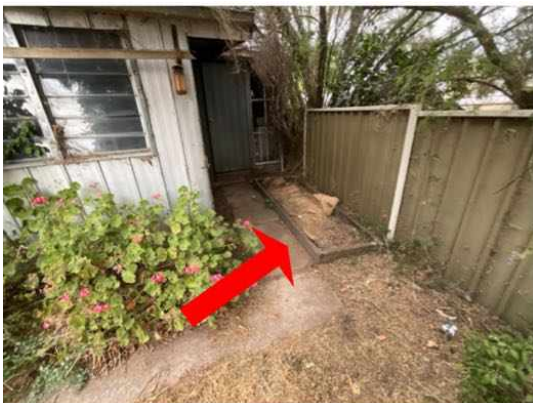
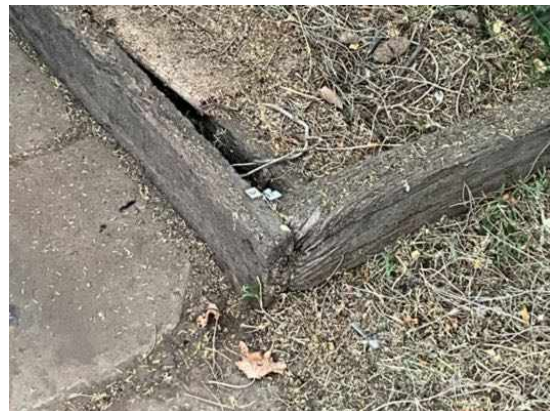
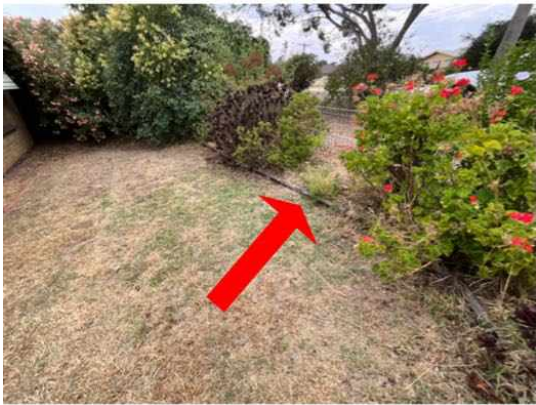
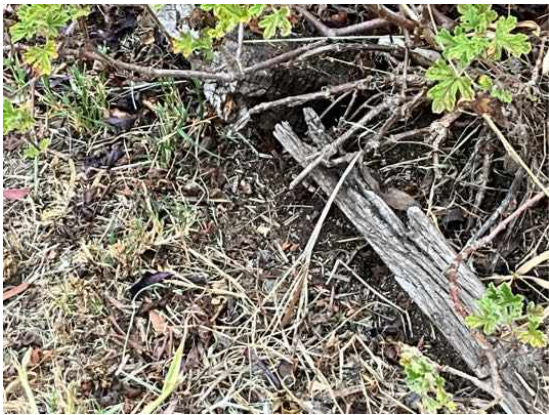
Finding 6.04

Building:	Building 1
Location:	Yard - Back, front
Finding:	Untreated or non-durable timbers in a hazardous environment
Information:	To reduce the risk of timber pest attack it is essential that timber used in a hazardous environment (e.g. in direct contact with the ground or frequently exposed to damp conditions) is of sufficient durability and/or is adequately preservative treated.

Untreated timbers in direct contact with the ground are likely to develop severe wood rot and/or fungal decay if left unattended creating attraction for subterranean termites to infest the timbers from surrounding areas.

If untreated or non-durable timbers are found to be in a hazardous environment it is highly advised that replacement of these building elements be performed as soon as possible to aid the protection of the property against termite / timber pest attack.

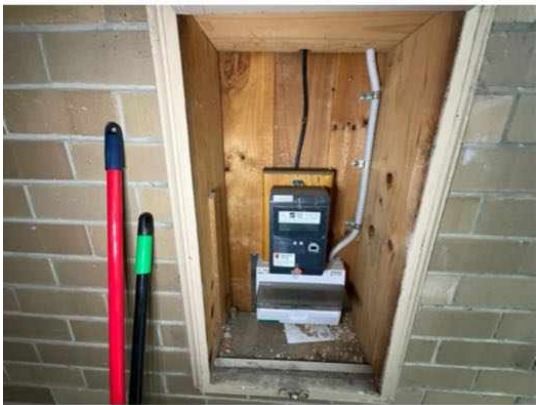
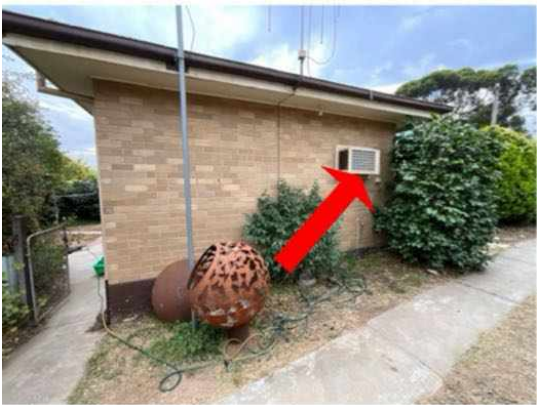
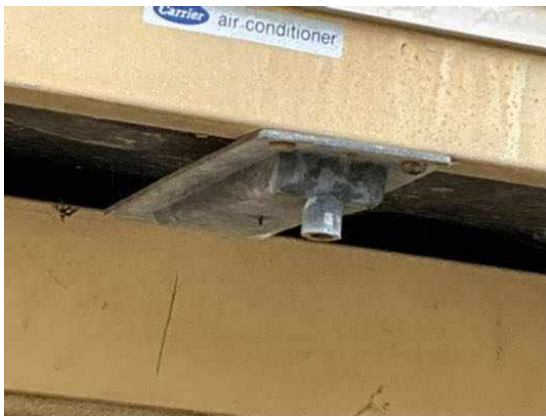
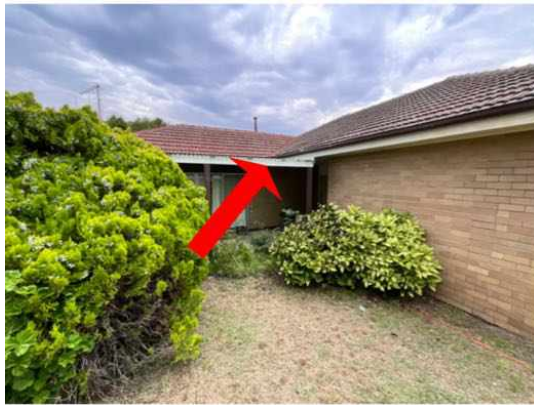
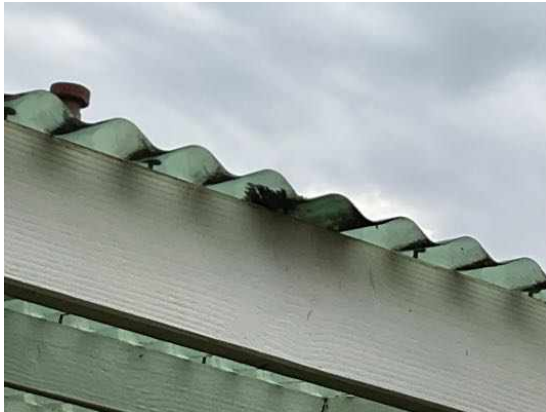
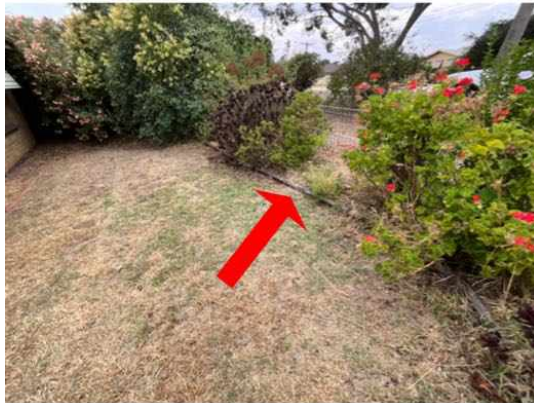
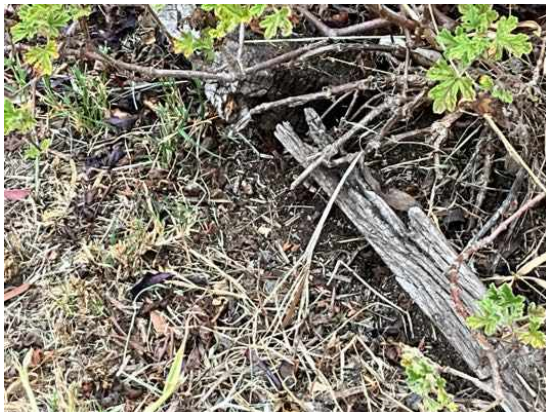
Finding 6.05

Building: Building 1
Location: All External Areas
Finding: Termite Management System - no evidence of a chemical installation
Information: The application of a post-construction chemical termite barrier is highly recommended for all properties, particularly if live termite activity has been found on the site previously. Such barriers are highly effective in preventing termite attack on any timber building elements throughout the property.

A durable notice should be placed in the switchboard unit to indicate current termite barriers. At the time of inspection, it appeared as though no termite management system has been installed, with no evidence to suggest preventative works taking place.

The client may consider gaining further advice from a pest controller as to the costs and procedures involved with this application. It is recommended that obtaining such advice be a short-term priority.

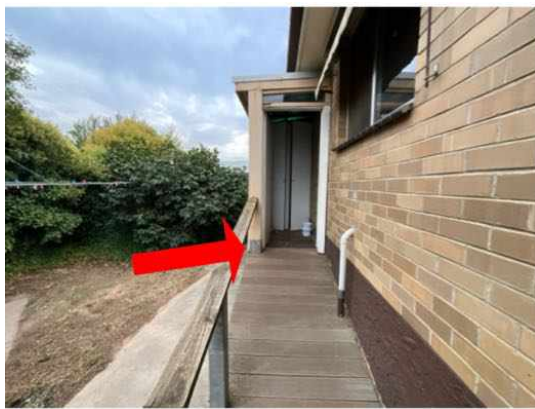
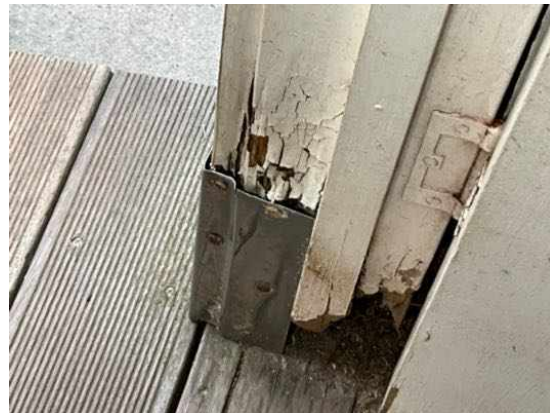
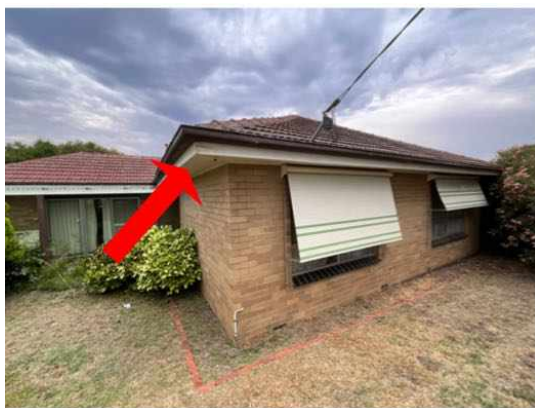
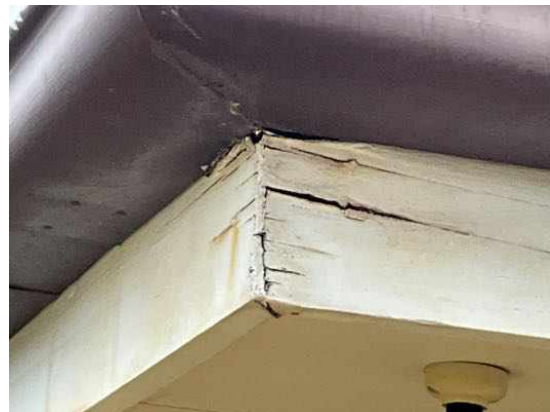
Finding 7.01

Building:	Building 1
Location:	Rear door, eaves
Finding:	Fungal decay - present
Information:	Fungal decay is also known as wood decay or wood rot generally refers to the deterioration of timber elements when in contact with excessive levels of moisture for a prolonged period of time.

The development of fungal decay is accelerated by temperatures in the range of 5degreeC to 40degreeC as well as the presence of oxygen. Generally fungal decay develops on timber elements that are in use in an external environment which are exposed to rain penetration.

In this case, fungal decay appears to have become widespread and is likely to have affected any adjoining timber elements/structures. The widespread development of fungal decay is likely to have heavily impacted the structural integrity and tensile strength of the affected timber elements and the associated structure.

Timbers affected by widespread fungal decay should be replaced immediately. The cause of the moisture that has led to the development of such decay should also be identified and dealt with in an appropriate manner.

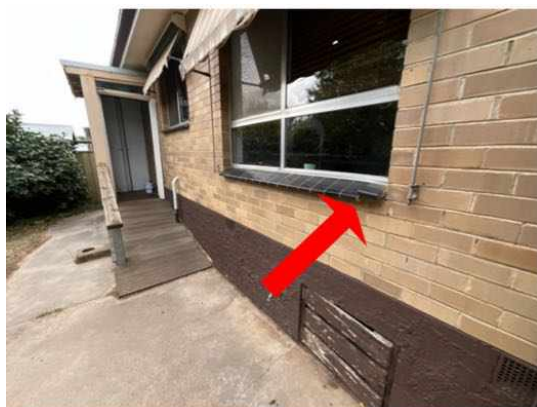
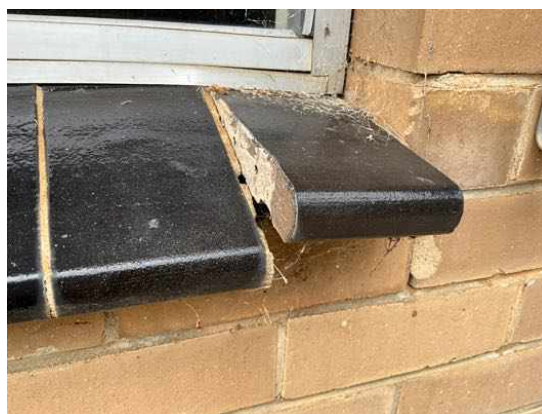
Building: Building 1
 Location: Dining window
 Finding: Brickwork - Deteriorated mortar
 Information: Mortar, or 'bedding', is the material which fills joins and intersections between bricks in masonry walls and structures. Sections of mortar in this brickwork were identified as having deteriorated, which is generally expected for a property of this age and condition.

Mortar may deteriorate as a result of age of building materials, minor movement of bricks, or frequent exposure to weathering. Mortar should be replaced to ensure that bricks remain in their intended location and to prevent gaps, which would allow water or moisture ingress and secondary damage as a result.

Mortar deterioration can be addressed by a bricklayer where areas of deterioration are localised and easily accessible. Alternatively, appointment of a registered builder is advised, to repoint large areas of decaying mortar. Where secondary structural defects have become evident, consultation with a structural engineer may be required.

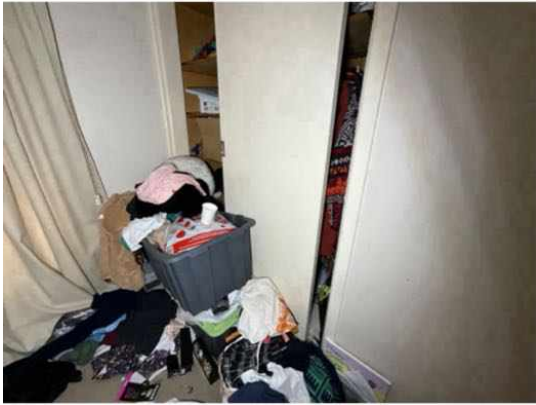
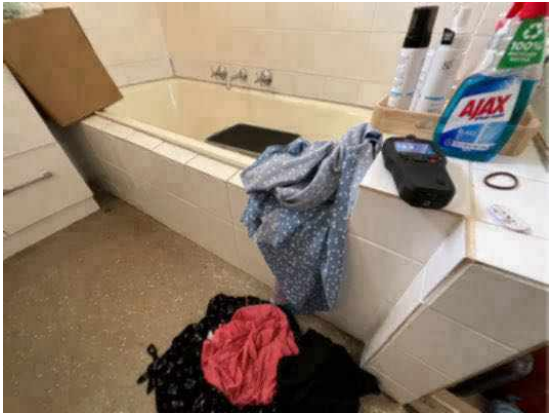
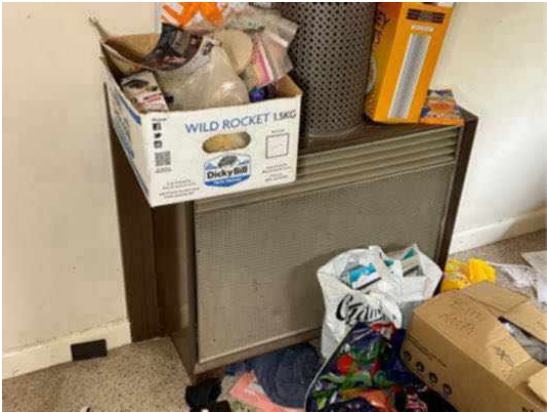
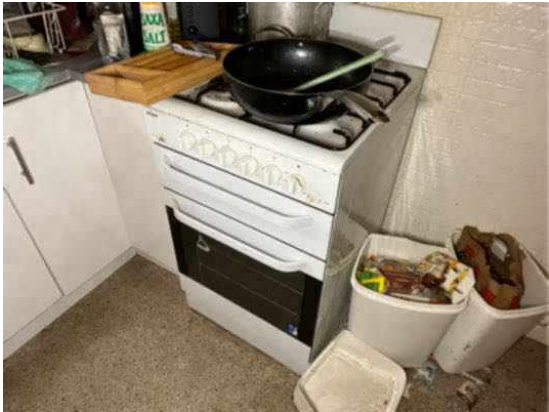
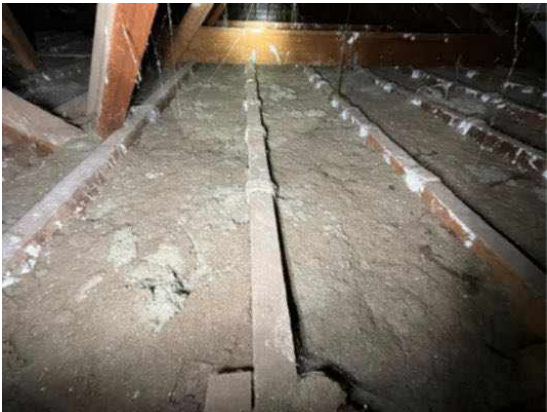
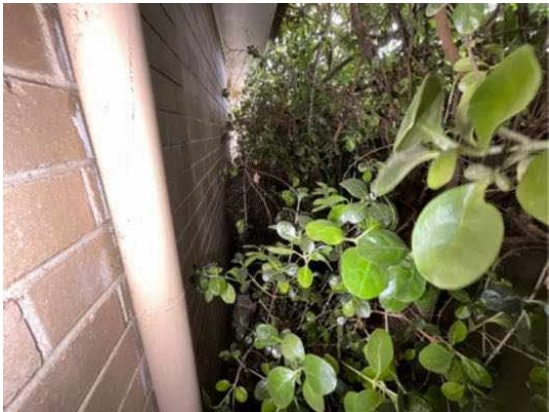
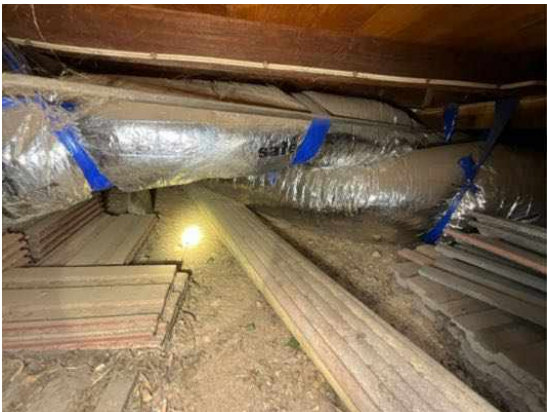
Building: Building 1
 Location: All Areas
 Finding: Additional Photos - Obstructions and Limitations
 Information: These photographs are an indication of the obstructions and limitations which impeded full inspection of the property at the time of inspection. These obstructions can hide an array of defects and should be removed to allow full inspection to be carried out. A re-inspection is recommended once the areas are made accessible.
