Building and Timber Pest Inspection Report

Inspection Date: Tue, 31 Mar 2026

Property Address: 40 Ray St, Sussex Inlet NSW 2540, Australia

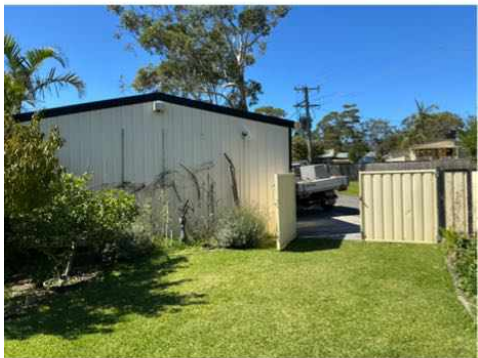
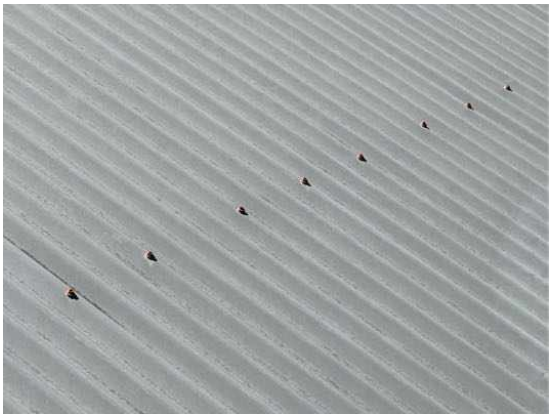
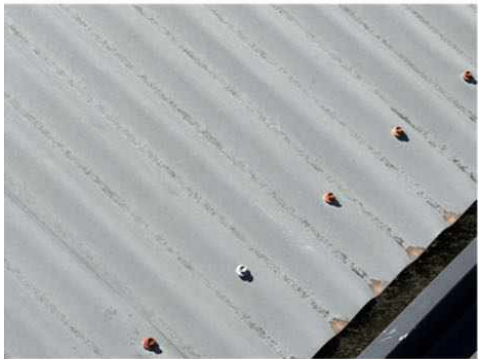
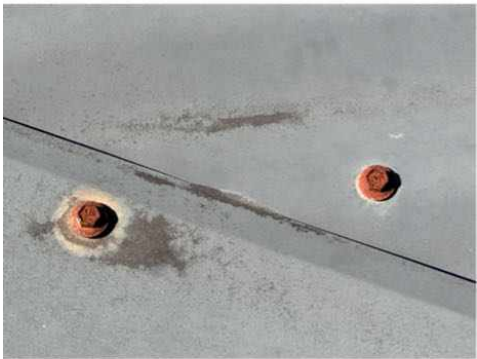
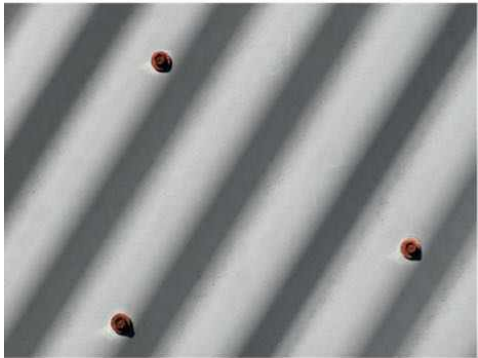
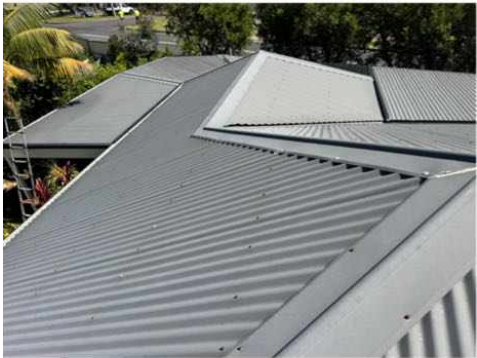
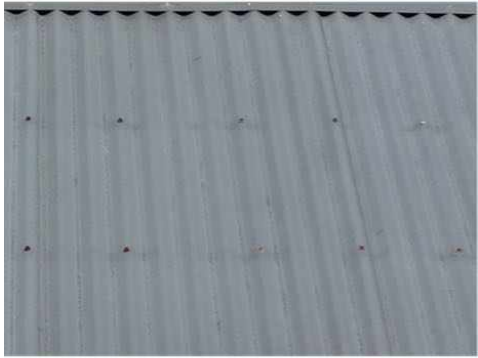
Finding 3.01

Building: Main Building
Location: All Areas
Finding: Building element - Rusted or corroded
Information: This building element shows evidence of rusting and corrosion, which is likely to have developed as a result of excessive exposure to moisture and or inadequate coatings. Rusted items include;

- isolated sections of fencing require treatment
- some roofing screws require replacement before their rust begins to affect the roof sheets.

As surface rust provides no protection to the underlying iron, the deteriorating condition is likely to worsen if not addressed in the short-term future. Where possible, the use of galvanized (treated) metals or aluminium coated metals aid in rust prevention, as does regular general maintenance. Rust formation can be controlled with coatings, such as paint, that isolate the iron from the environment.

Rusting and corrosion should be managed by ideally removing or limiting the affected surface from exposure to moisture. A registered builder may be appointed to replace any building elements that have been severely affected by rust or water damage.

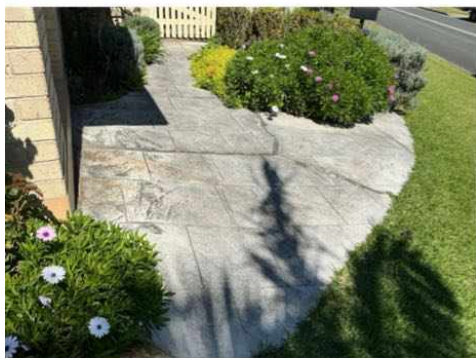
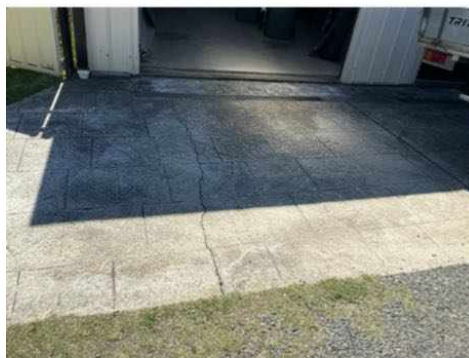
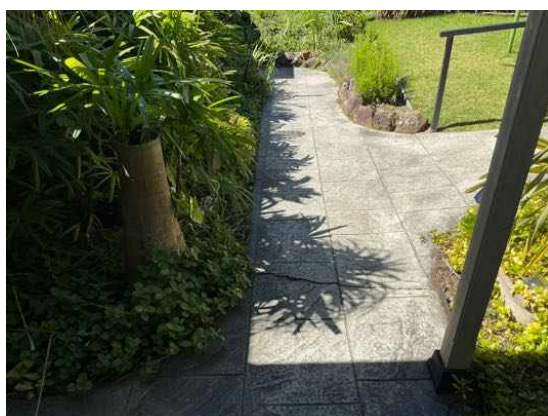
Finding 3.02

Building:	Main Building
Location:	All Areas
Finding:	Crack in concrete slab - Category 1
Information:	A crack coded as Category 1 was identified in the slab. A Category 1 crack is described as a fine but noticeable crack, with the slab at an otherwise reasonable level.

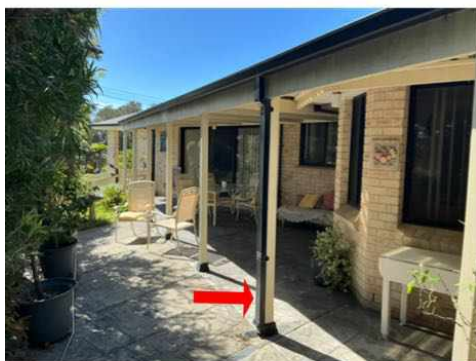
Finding 3.03

Building:	Main Building
Location:	Patio
Finding:	Gutters and Down Pipes Leaking
Information:	The gutters and down pipes were found to be leaking creating excessive moisture in the surrounding areas.

These damp conditions can lead to secondary defects such as rot, rust or corrosion of associated building elements, the formation of fungal decay, or even the creation of potential slip hazards. When coupled with poor site drainage, pooling of water may also attract termite activity to this area.

It is highly recommended that a licensed plumber be appointed to connect the gutters and down pipes in order to prevent such an environment from being created. These minor works should be carried out as soon as possible.

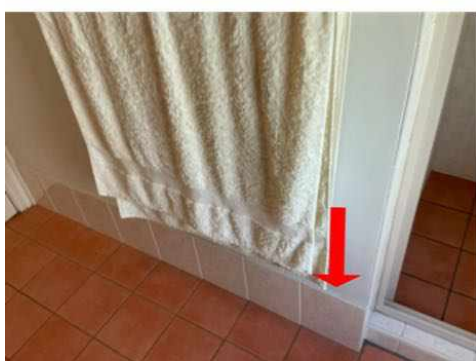
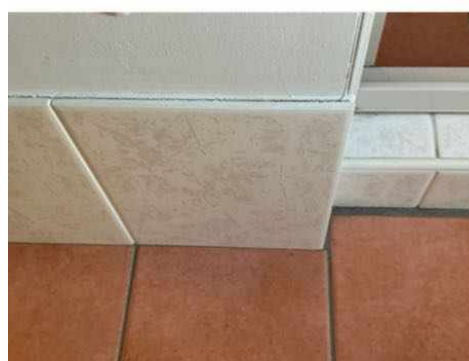
Finding 3.04

Finding: Tiles - Drummy

Information: Drummy tiled areas were identified at the time of inspection. The term 'drummy' refers to tiles that have become detached from their fixing, despite otherwise being in relatively good condition. Such defects are generally caused by physical or moisture damage to the area.

One tile directly outside the bathroom shower door has become loose. Tiled areas may swell and shrink with changes in air humidity if the area has sustained moisture damage. Any exposure to moisture is capable of causing tiled areas to become drummy and/or cracked over a prolonged period of time. Drummy tiled areas generally require removal and replacement of affected tiles, with adequate sealant and grouting.

It is advised that a tiling contractor be appointed to perform works as necessary. Immediate action is recommended to ensure that no further damage is sustained in the affected area.

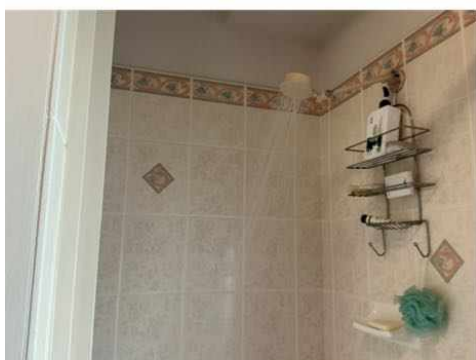
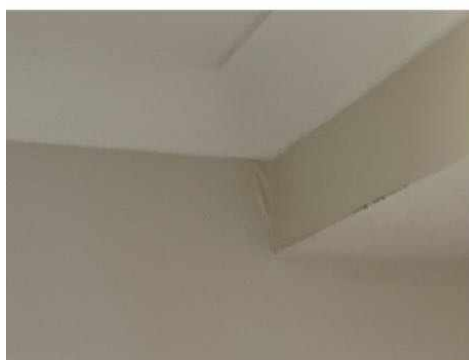
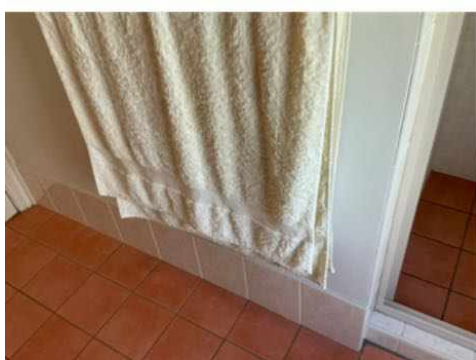
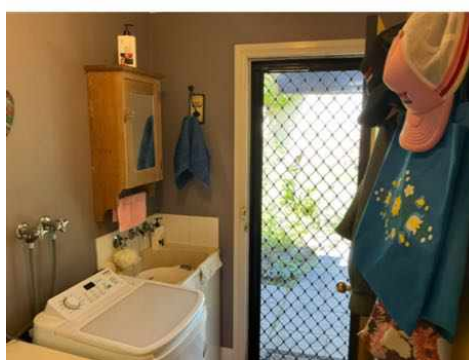
Finding 3.05

Building:	Main Building
Location:	All Areas
Finding:	Painted surface - deteriorated
Information:	Sections of paint in this area was found to have deteriorated. Deteriorating paint is generally an indication of exposure, age or poor surface preparation prior to application.

This defect is quite common in a building of this age. It is recommended that the affected area be cut back, sanded and cleaned in preparation for repairs and painting. Failure to do so will result in the further deterioration of the peeling surface. Exposed materials require frequent maintenance.

Remedial works such as this can be undertaken by an experienced painter.

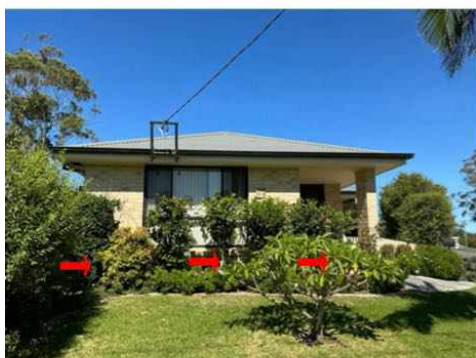
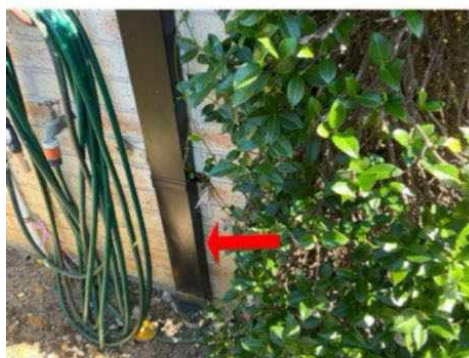
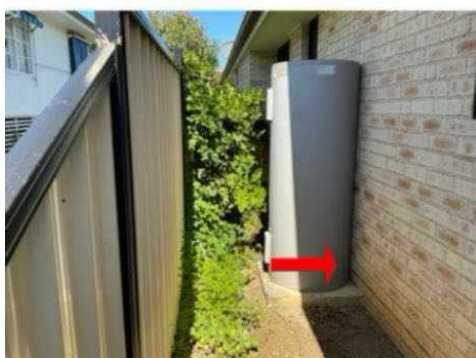
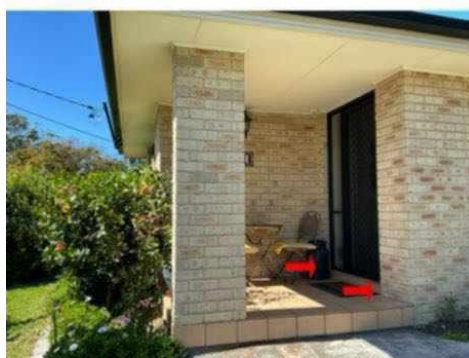
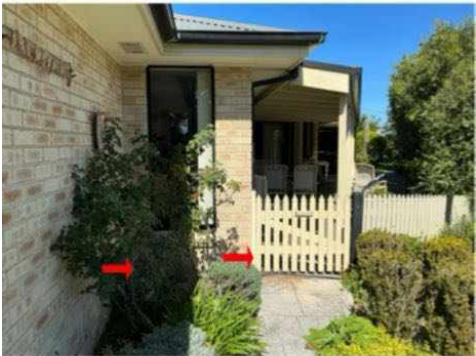
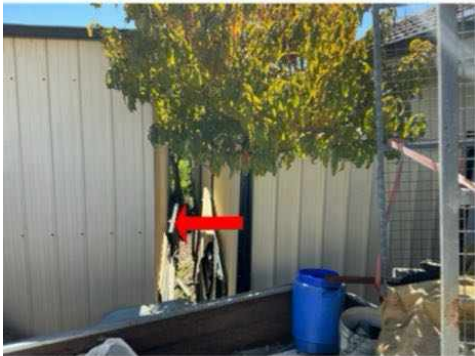
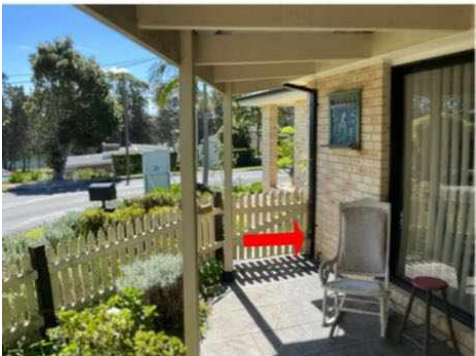
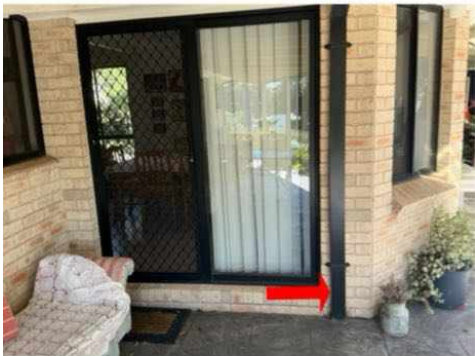
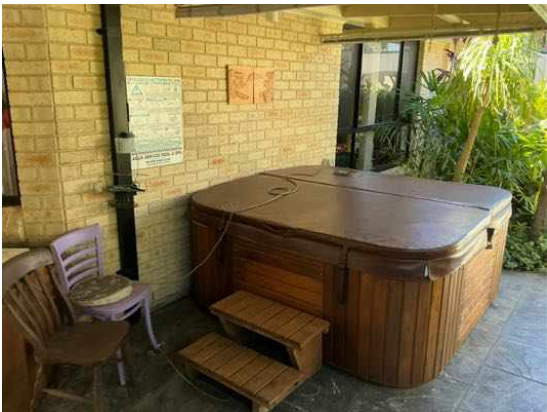
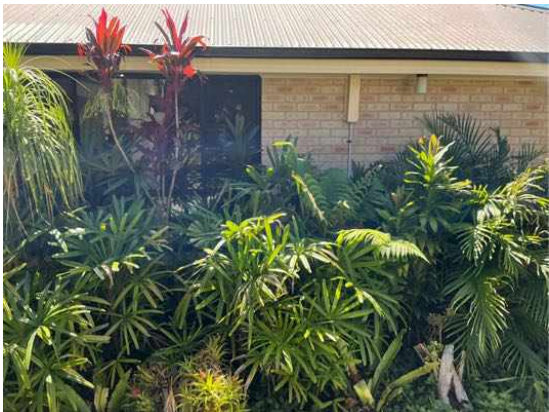
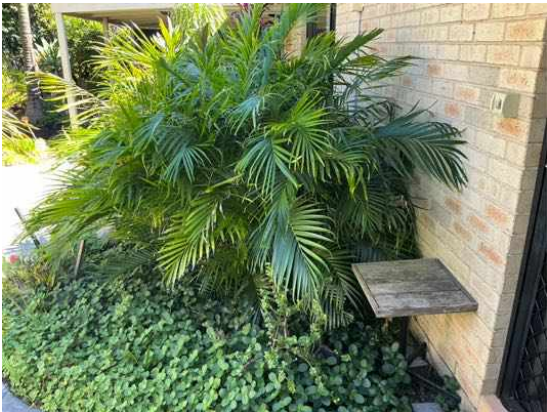
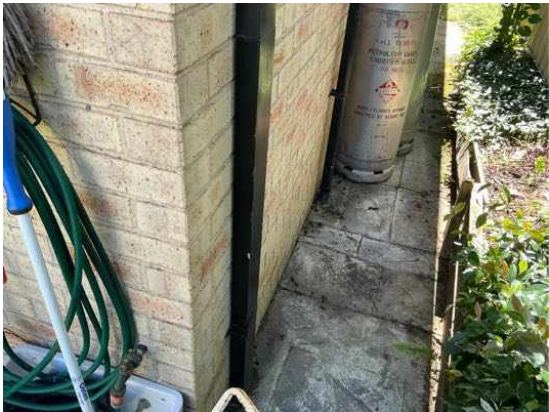
Finding 6.01

Building: Main Building
 Location: All Areas
 Finding: Bridging of Termite Management System
 Information: Bridging of termite management system occurs when a termite management system or inspection zone are covered by exterior objects where termites can enter a structure undetected. Due to the bridging this property it is considered High Risk for concealed termite ingress which should be treated and inspected every 6-12 months.

Generally this takes the form of finished ground levels external paving, concrete, fencing posts, gardens, vegetation, plumbing, stored items etc being retrospectively installed above the ant cap level or weep and ventilation holes.

Where bridging of the termite management system has occurred full inspection is prevented and termites may enter a property in a concealed or undetectable manner.

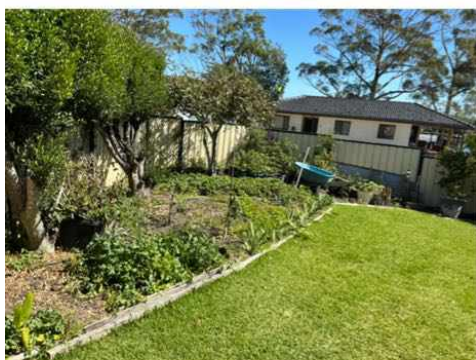
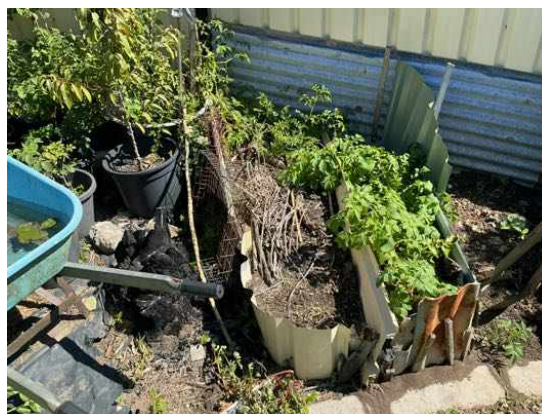
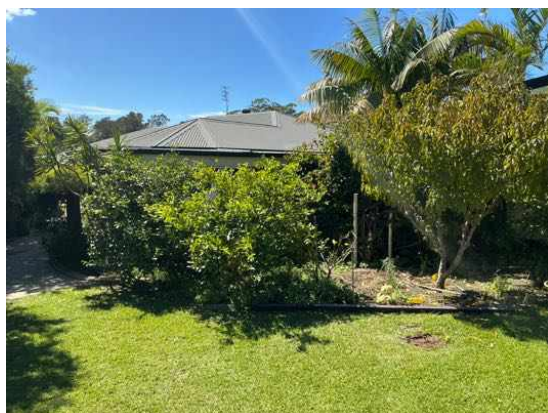
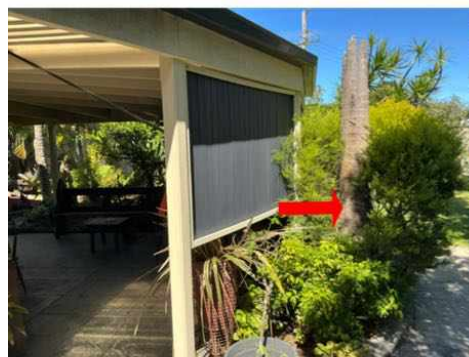
Finding 6.02

Building:	Main Building
Location:	All Areas
Finding:	In ground contact
Information:	Any timbers in direct ground contact provide opportunity for concealed termite entry and are likely to be subject to premature rot and decay as the soil retains moisture or damp conditions against the timbers.

Remove untreated timber that is in direct contact with external grounds. Consider replacement with more durable materials i.e. treated timber or non timber elements. Frequent pest inspections are advised to readily identify any termite activity in these areas.

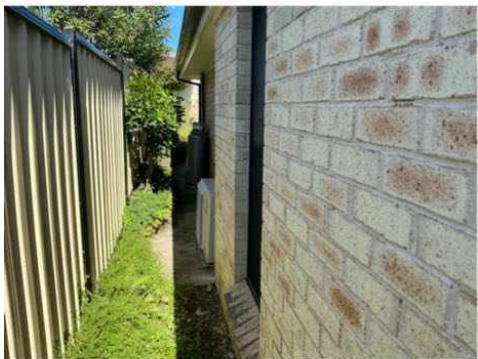
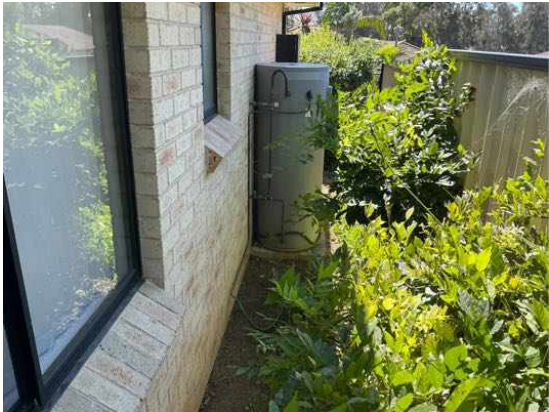
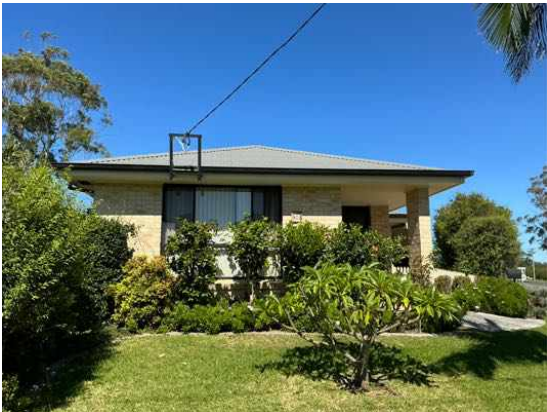
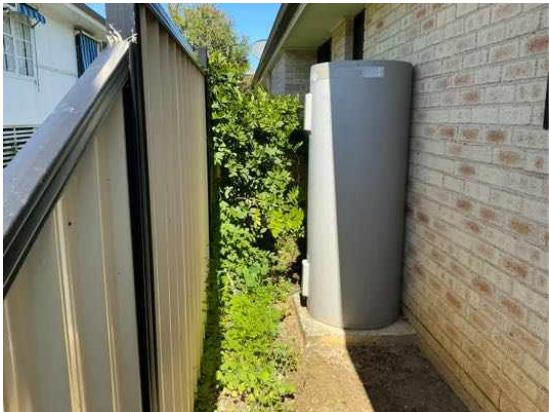
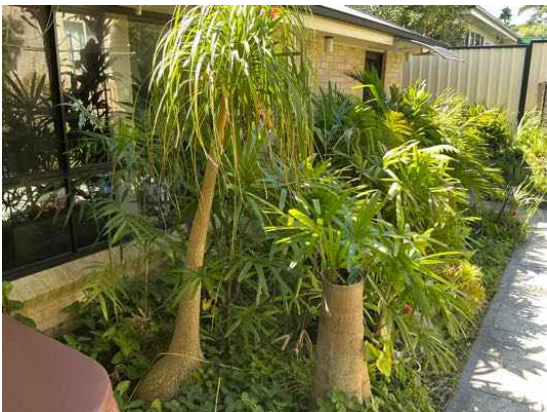
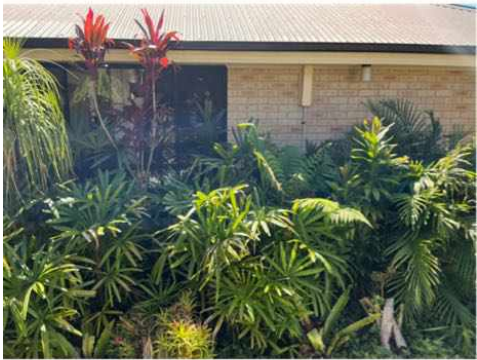
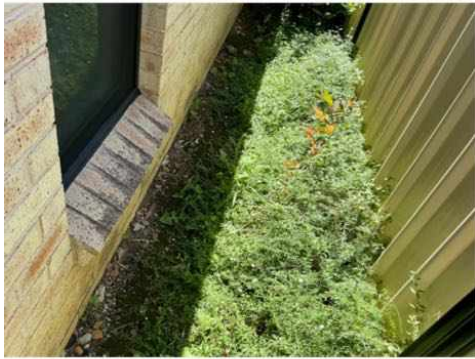
Finding 6.03

Building:	Main Building
Location:	External Walls
Finding:	Slab Edge - Exposure
Information:	An inspection zone of at least 75mm in relation to the exposed slab edge, between the bottom brick and the perimeter pavement, is required. This inspection zone should be maintained in order to force termites into the open where they can be detected more readily during regular inspections. The slab edge should not be concealed by anything that may prevent inspection of the area, including render, landscaping, soil, turf, paving, concrete cladding or other structures.

If the slab edge is not properly exposed there is a high risk of termite attack. Sometimes, in order to determine the type of slab, a suitably qualified person such as an architect or builder may be required to consult the construction plans.

Where the slab edge cannot be properly inspected, it is highly recommended that termite or timber pest inspections be carried out every 6-12 months to aid protection of the property against infestation.

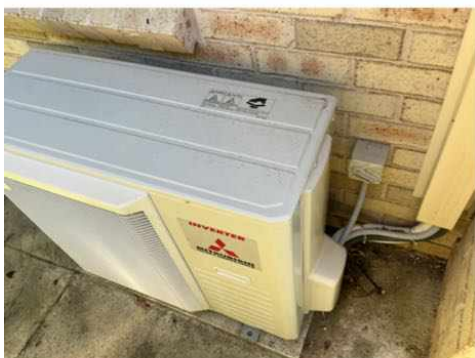
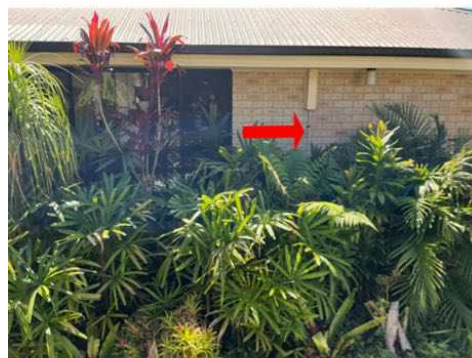
Finding 6.04

Building:	Main Building
Location:	Exterior walls
Finding:	Air-conditioning unit - Condensation Pipe Leak
Information:	Leaking from an external air-conditioning unit condensation pipe is a normal function of the unit, however this should be plumbed into the house drainage or directed away from the house structure.

Heavy leaking from the air-conditioning unit is likely to produce damp conditions in the surrounding area conditions which are conducive to termite attack. If left unattended, such leaking can develop into water pooling below the unit, creating potential for subsequent water damage to associated building elements.

A refrigeration mechanic or licensed plumber should be appointed to assess the condition of the unit and to perform any remedial works as necessary. While discharge from an air-conditioning unit can generally be managed through basic plumbing work, such appointments are deemed necessary to identify any major issues.

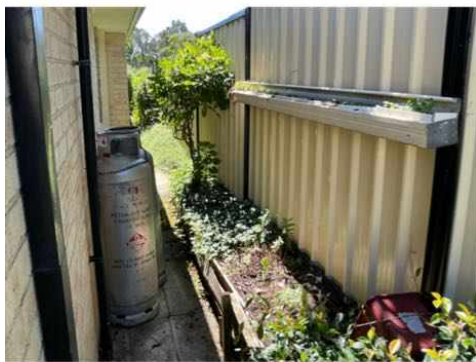
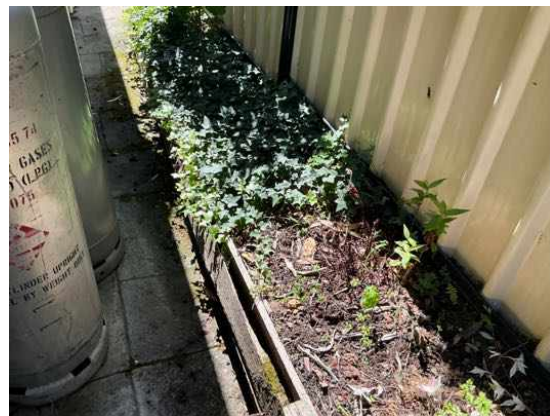
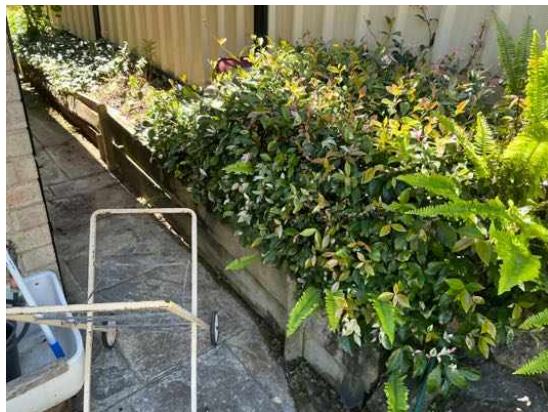
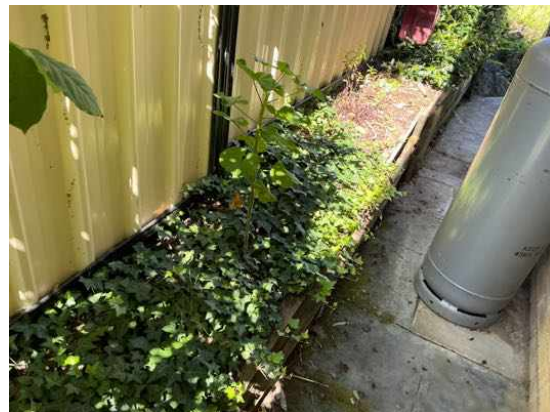
Finding 7.01

Building:	Main Building
Location:	All Areas
Finding:	Fungal decay - present (localised)
Information:	Fungal decay also known as wood decay generally refers to the deterioration of timber elements when in contact with excessive levels of moisture for a prolonged period of time. Generally fungal decay develops on timber elements that are in use in an external environment which are exposed to rain penetration.

In this case although the affected timber element is in a decaying state the extent of any visible damage appears to be localised to a specific area. The fungal decay is therefore likely to be of a relatively superficial nature with minimal impact on the structural integrity or tensile strength of the timber element.

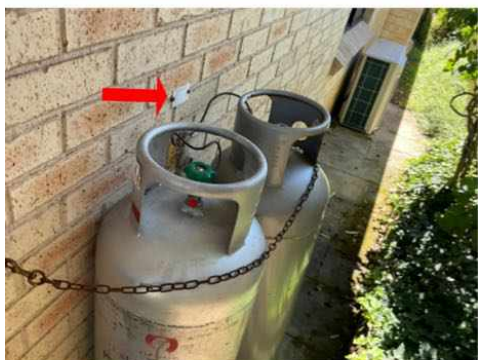
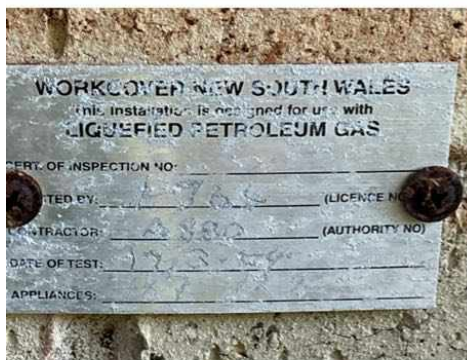
Building: Main Building
 Location: Exterior walls - rear
 Finding: Gas Bottle Regulator - Non-compliant
 Information: In the opinion of the inspector, the gas bottle regulator is non compliant. However, in relation to gas and related gas plumbing, you should always consult a licensed plumber/gas fitter for further advice. This gas bottle regulator compliance plate reads 17/3/04.

Where installation is out dated, the client should contact the responsible trade (gas plumber) to undertake further inspections.

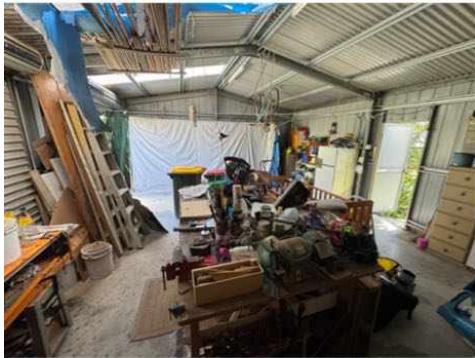
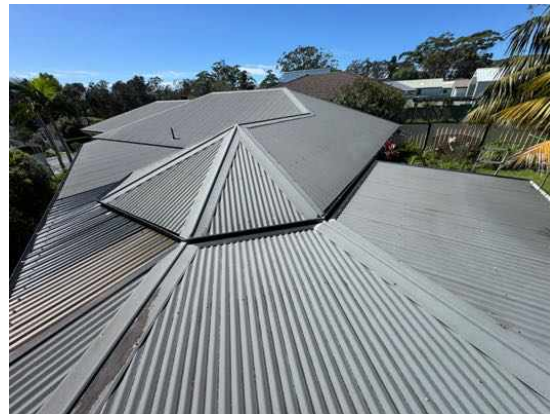
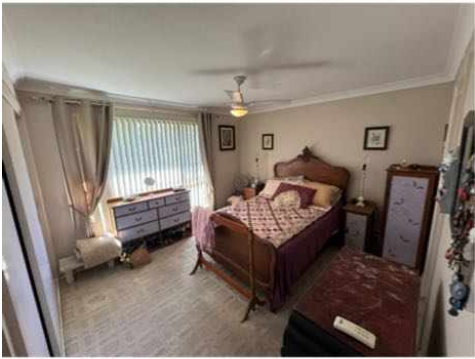
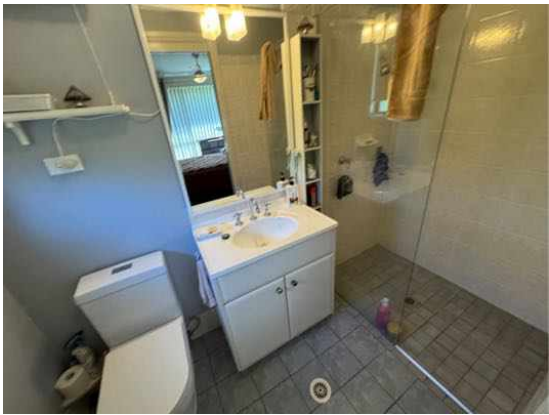
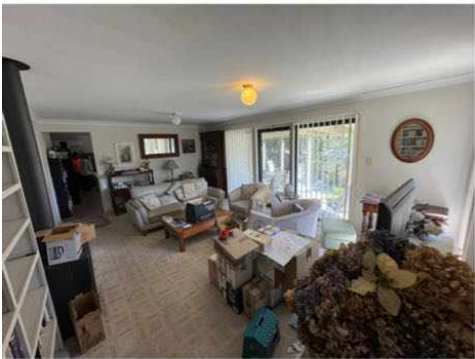
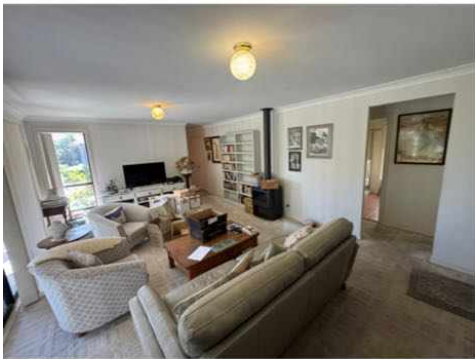
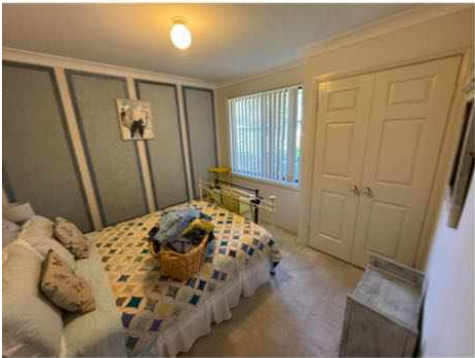
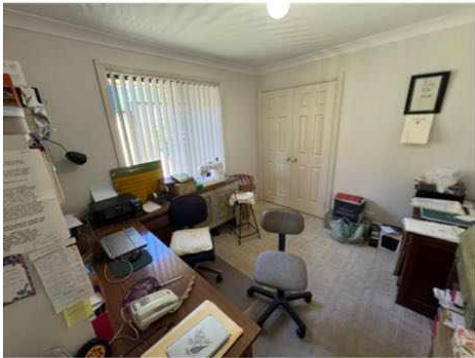
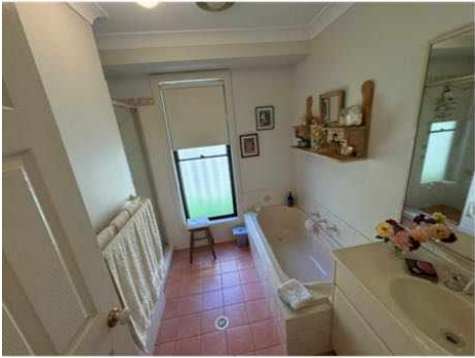
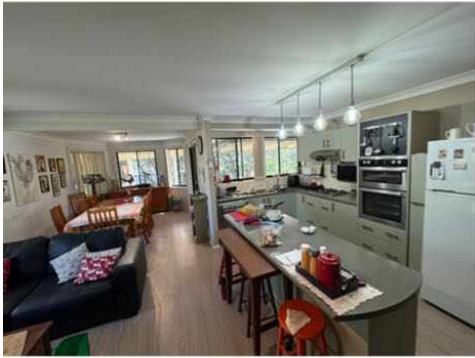
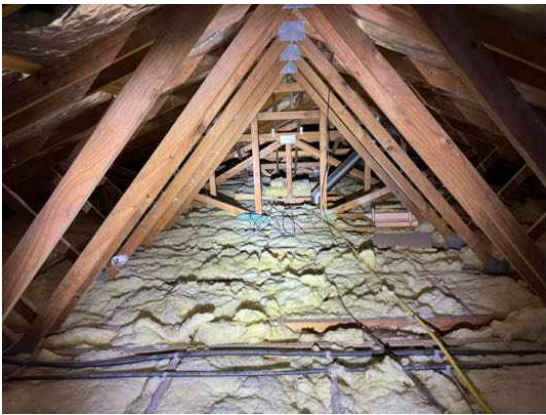
Building: Main Building
 Location: All Areas
 Finding: Additional Photos - Obstructions and Limitations
 Information: These photographs are an indication of the obstructions and limitations which impeded full inspection of the property at the time of inspection. These obstructions can hide an array of defects and should be removed to allow full inspection to be carried out. A re-inspection is recommended once the areas are made accessible.

A further invasive inspection is recommended to these areas immediately.

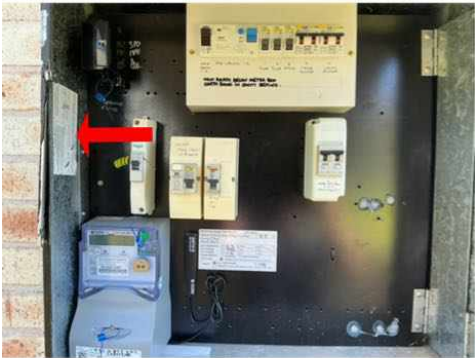
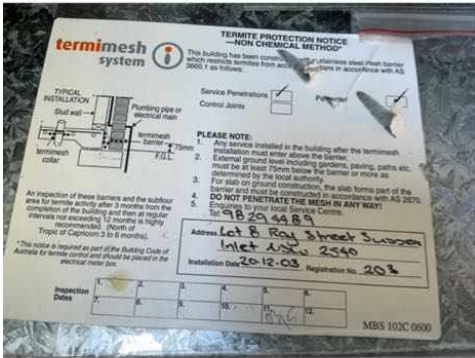
Where a Termite Management System has been identified you should refer to the type of barrier date of installation warranty conditions and any documentation provided by a builder or past owner. Consult the company who installed the barrier to confirm whether the system is still under warranty.

Most chemical termite management systems expire and require replenishment and all physical systems are primarily designed to prevent concealed entry.
