Building Inspection Report

Inspection Date: Tue, 16 Dec 2025

Property Address: 11 Wilga Rd, Risdon Vale TAS 7016,
Australia

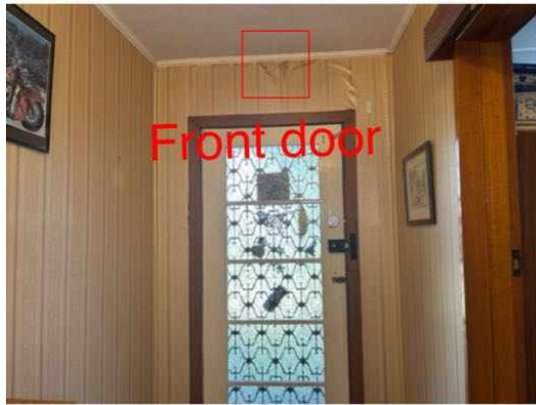
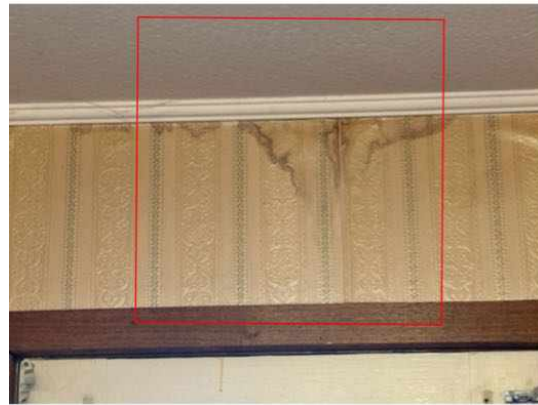
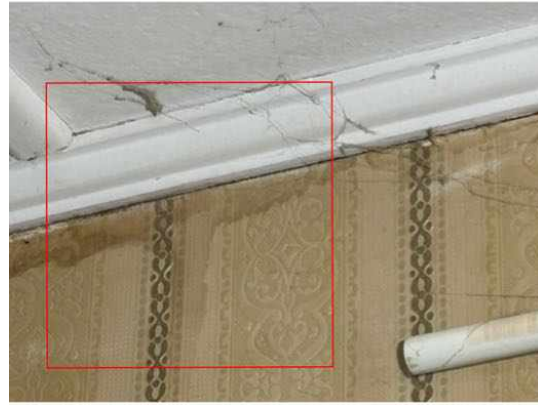
Defects 3.01

Finding: Water staining

Information: In the multiple locations there is water staining to the walls (in the hallway above the front door, the middle front bedroom and back bedroom). The staining was all dry at the time of inspection. The moisture meter or thermal imaging did not indicate any elevated moisture readings. These may have been old leaks or condensation events or vermin waste.

Water staining was evident in this area at the time of inspection. Water staining indicates that surfaces have been exposed to excessive moisture over time. The minerals and other elements in the water lead to staining, which may graduate to corrosion and deterioration if left unmanaged.

While mostly an appearance defect, water staining can be indicative of more serious defects, which may be currently concealed by other building elements.

Recommend client monitor.

If signs of moisture re-occurs, recommend client engage a Lic Plumber as soon as possible.

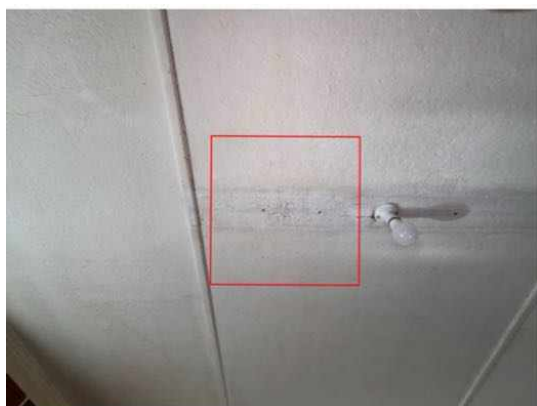
Defects 3.02

Building:	Main Building
Location:	Kitchen
Finding:	Kitchen paint deterioration
Information:	In the kitchen, the paint to the ceiling is deteriorated. There may have been an old light installed in this location in the past, that has been removed.

Paint deterioration is due to a lack of regular maintenance. Early intervention will prolong the useful life of these building elements.

Recommend client engage a Handy Person/Painter to rectify at clients convenience.

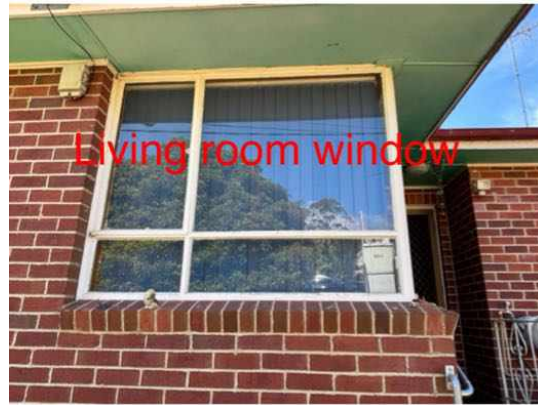
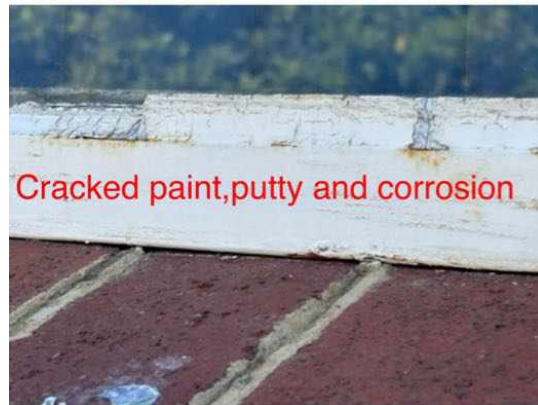
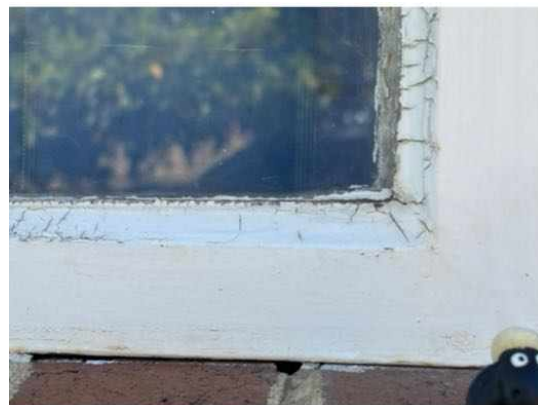
Defects 3.03

Building:	Main Building
Location:	Multiple locations
Finding:	Metal windows maintenance
Information:	In multiple locations through out the house, the windows require some maintenance. The windows are in fair condition on the interior and exterior.

There is some rust and corrosion due to the condensation where the water runs down the glass and onto the metal. The corrosion needs to be prepped, treated with rust neutraliser and painted.

Many of the windows have pivot screws missing from the window stays. Instead there are some improvised solutions, but they are preventing the windows from operating fully. Recommend that the current repairs be removed and have a short nut and bolt fitted (similar to the original pivot screws). This will improve the function of the windows.

The bathroom window in particular needs attention as the paint is very deteriorated, there is corrosion and mould.

Generally, factors such as general age of the building element and a lack of maintenance are the usual causes for this type of defect.

Recommend client engage a Handy Person to rectify as soon as possible.

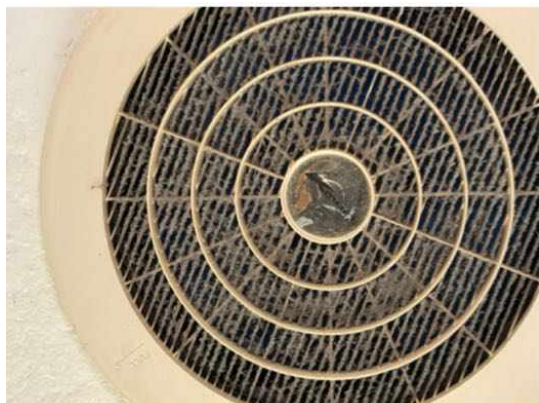
Defects 3.08

Building: Main Building
Location: Toilet
Finding: Exhaust fan toilet
Information: The exhaust fan in the toilet is very dirty and noisy when operated. This defect impedes the function of the fan. The fan is at the end of its serviceable life and requires replacement.

Recommend client engage a Lic Electrician to install a new unit as soon as practicable.

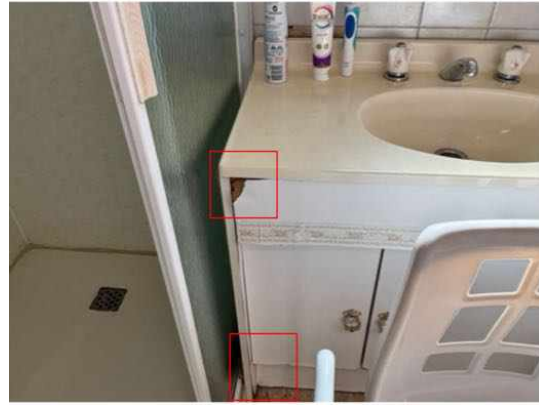
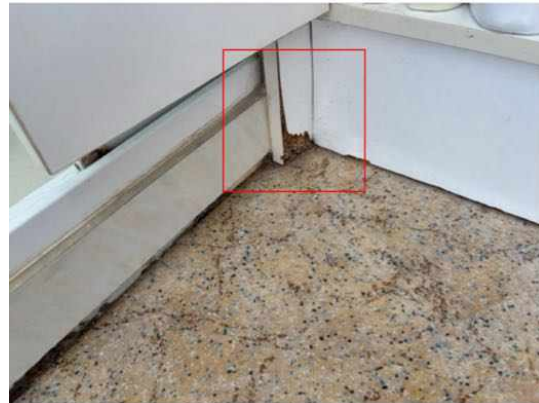
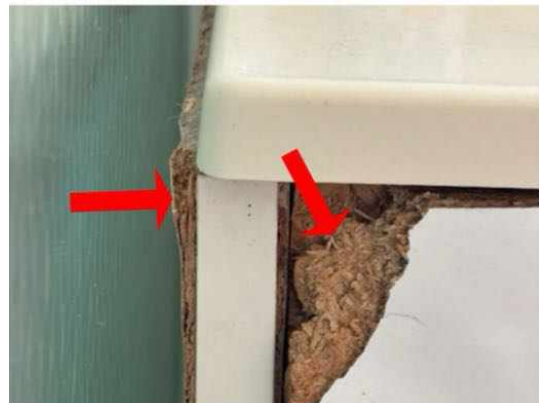
Defects 3.09

Building: Main Building
Location: Bathroom
Finding: Bathroom vanity sink cabinet
Information: The bathroom vanity sink cabinet is badly water damaged. It is still functioning however it will need replacement in the medium term.

I recommend that the client engage lic plumber to replace the cabinet /sink as soon as practicable.

When the cabinet is out, the missing tiles could be replaced and the wall and floor checked for any damage.

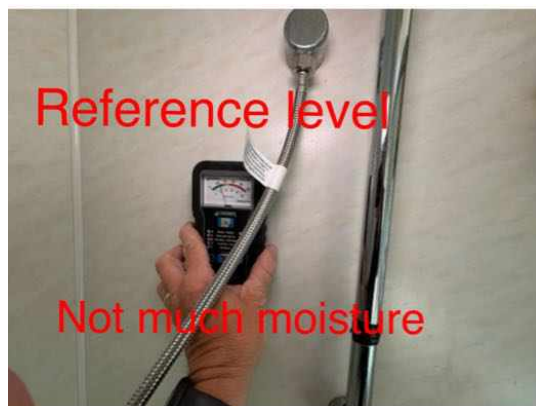
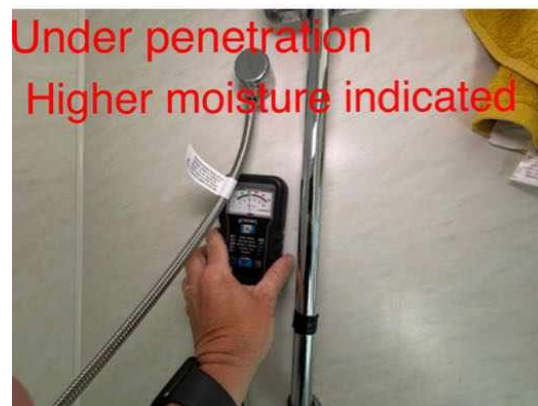
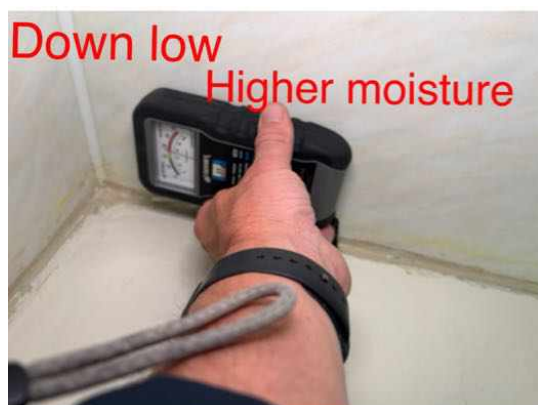
Defects 3.11

Building:	Main Building
Location:	Bathroom
Finding:	Shower penetrations elevated moisture indications
Information:	In the bathroom there were elevated moisture readings, behind the shower wall panels

If not rectified, water will continue to ingress and may lead to water damage and deterioration of the surrounding building elements if the water proofing membrane is not intact or absent. There may already be some damage. However our non invasive inspection is unable to determine the adequacy of the water proofing system.

Recommend client engage a Lic Plumber to remove the penetrations to the shower, and seal/silicone them as soon as possible. Whilst on site I also recommend that the plumber perform a more invasive inspection to determine if there is any damage inside the walls where there are elevated moisture indications behind the shower wall panelling.

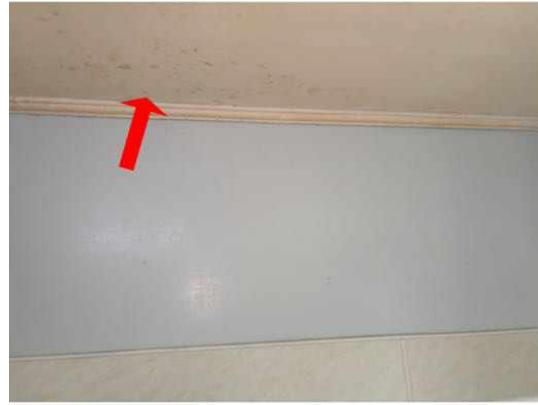
Defects 3.12

Building:	Main Building
Location:	Bathroom
Finding:	Water staining to bathroom ceiling
Information:	In the bathroom there is water staining to the bathroom ceiling. This is due to the bathroom being a high moisture environment.

Water staining was evident in this area at the time of inspection. Water staining indicates that surfaces have been exposed to excessive moisture over time. The minerals and other elements in the water lead to staining, which may graduate to corrosion and deterioration if left unmanaged.

While mostly an appearance defect, water staining can be indicative of more serious defects, which may be currently concealed by other building elements.

Recommend client monitor.

If moisture re-occurs recommend client engage a Lic Plumber as soon as possible.

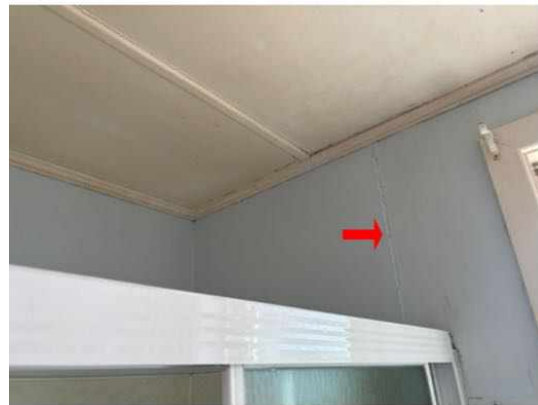
Defects 3.13

Building: Main Building
 Location: Bathroom
 Finding: Gap above shower
 Information: In the bathroom above the shower, there is no joining strip to the junction of two panels, the gap is caulked but not well. This may allow moisture ingress.

Recommend client engage a Handy Person to caulk and paint as soon as possible, to prevent water ingress.

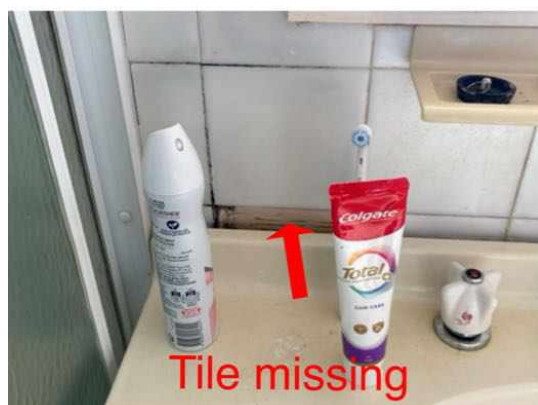
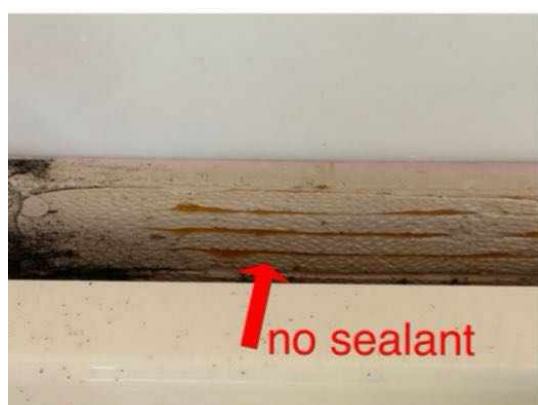
Defects 3.14

Building: Main Building
 Location: Bathroom
 Finding: Missing tiles/grout deteriorated and silicone missing
 Information: In the bathroom there are missing tiles behind the vanity cabinet. Also the grout has deteriorated to the wall tiles and there is no silicone to the gap between the sink and the wall.

Tiles and grout are used to protect building materials to ensure that they are water-tight and prevent water penetration to the associated structures. Always ensure that silicone, sealants and/or grout is in good condition to prevent any moisture issues occurring in the future.

Recommend client engage a Handy Person to rectify as soon as possible.

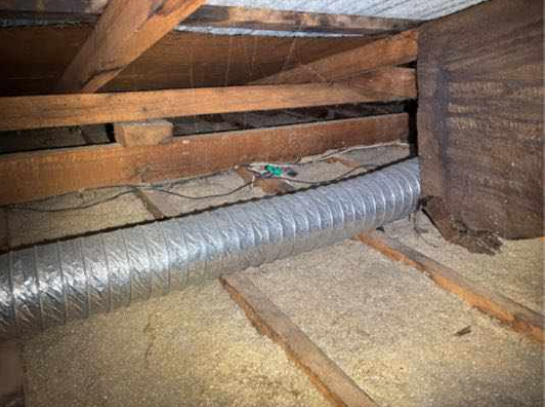
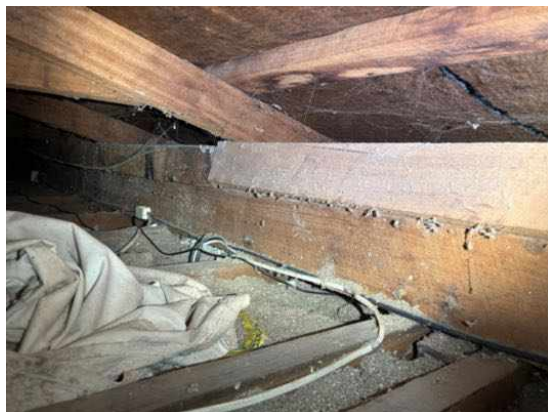
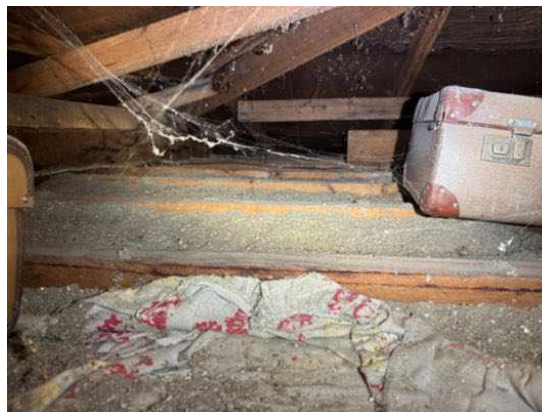
Defects 3.16

Building: Main Building
Location: Roof void
Finding: FYI roof void access
Information: FYI there was very little limited access to the roof void. Due to the low roof pitch and the way the timber is framed.

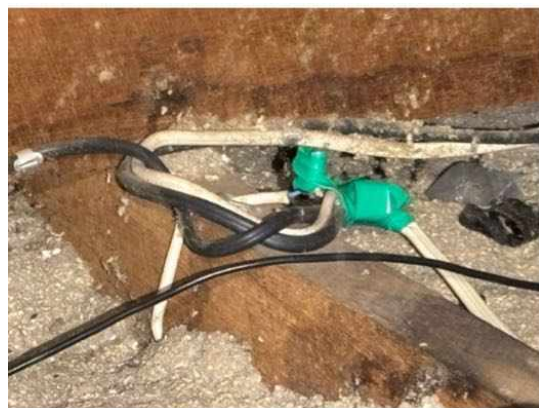
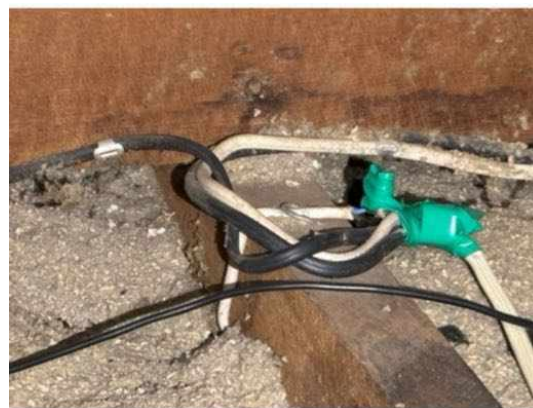
Defects 3.17

Building:	Main Building
Location:	Roof void
Finding:	Unorthodox electrical wiring roof void
Information:	There is unorthodox electrical wiring in the roof void. All electrical work should be carried out by a Lic Electrician.

Unorthodox electrical wiring could potentially be a safety hazard.

Recommend client engage a Lic Electrician to inspect and rectify (if necessary) as soon as possible.

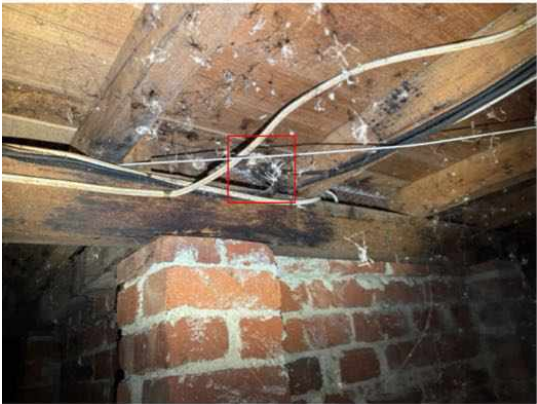
Defects 3.18

Building:	Main Building
Location:	Switchboard
Finding:	Switchboard and black wiring assessment
Information:	The switchboard is the original that was installed when the house was constructed. The switchboard has ceramic fuses and no safety switches. Also in the roof void and subfloor there is a lot of older black electrical wiring.

Recommend client engage a Lic Electrician to inspect, advise and rectify if required, as soon as possible.

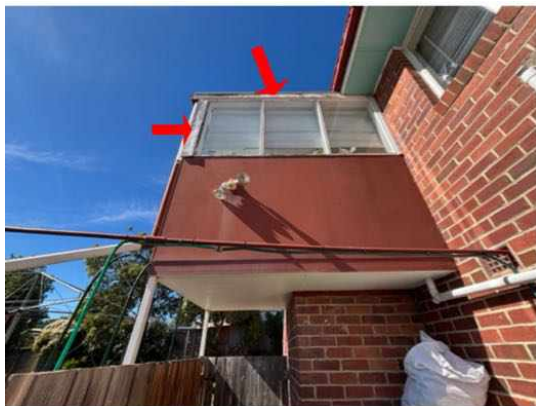
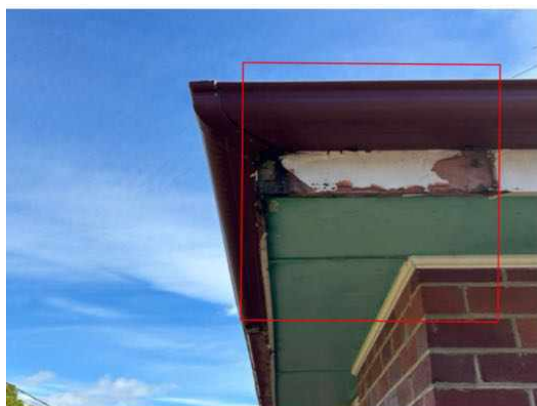
Defects 3.19

Building:	Main Building
Location:	Multiple locations
Finding:	Paint Deterioration to exterior timbers
Information:	On the exterior of the house, the paint is very deteriorated to exterior timbers including the subfloor access door, frame, fascias, laundry etc.

It is likely that paint deterioration has developed as a result of frequent exposure to rain and other weather conditions.

Failure to maintain the timbers over a prolonged period has resulted in them deteriorating at an accelerated rate, increasing their susceptibility to the development of wood rot. Early intervention and regular maintenance will prolong the useful life of these building elements.

Recommend client engage a Handy Person/Painter to rectify as soon as practicable.

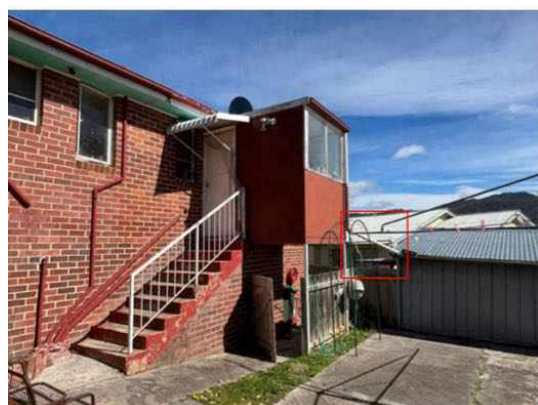
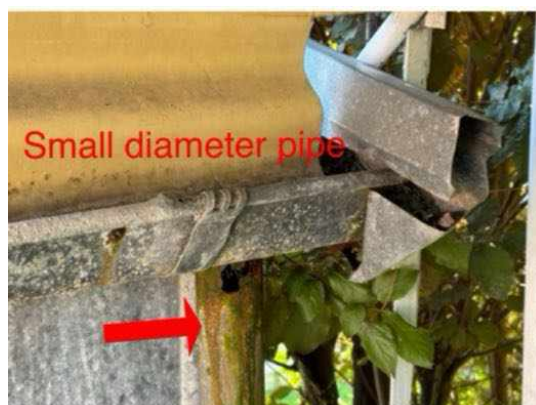
Defects 3.21

Down pipes discharging directly to the ground can cause damage to the footings of buildings and subsidence.

Recommend client engage a Lic Roof Plumber to inspect and rectify as soon as possible.

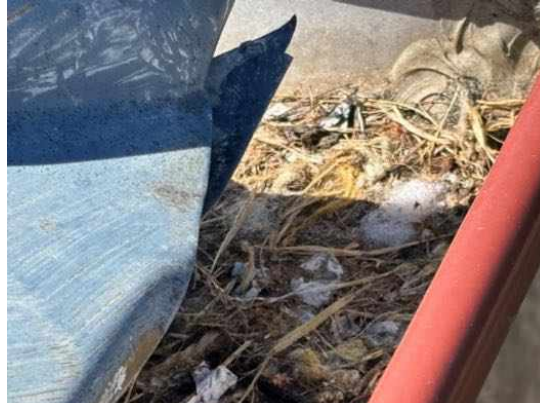
Defects 3.22

Building:	Main Building
Location:	Roof
Finding:	Gutter leaks
Information:	There are gutters leaks in multiple locations (right hand side rear and right hand side front of the house). Two gutter clips have come loose and need to be replaced/re-secured. Some of the guttering has been replaced in the recent past. Some of the staining and damage below the new sections may not be leaks at these locations, just the old damage that was not fixed when new guttering was installed. However the remaining guttering is in very poor condition, there is corrosion and there are holes in some sections. The remaining guttering needs to be replaced as soon as practicable.

Blocked gutters are likely to lead to high levels of moisture in the affected areas. Such

moisture can cause rust and decay of the associated building materials. Blockages in gutters should therefore be removed immediately to ensure dry conditions are maintained.

Recommend client engage a Lic Roof Plumber to rectify as soon as practicable.

Recommend client ensure that all gutters be maintained on a frequent basis to ensure the condition of roof plumbing.

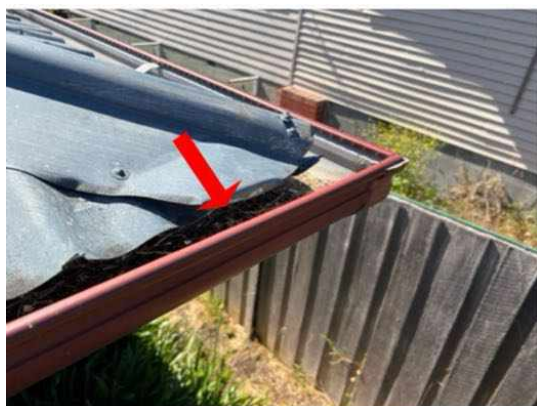
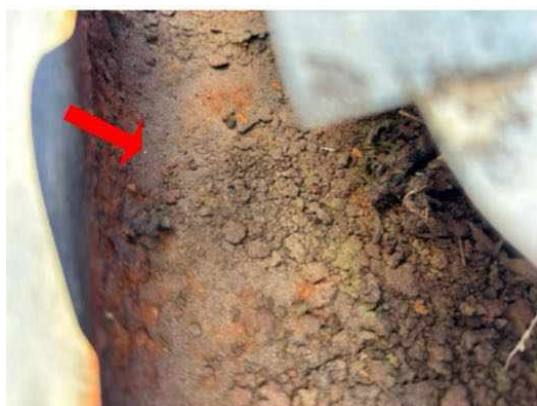
Defects 3.23

Building:	Main Building
Location:	Multiple locations
Finding:	House - gutters require cleaning
Information:	The gutters require cleaning. If client is going to replace them, then don't clean first just replace. However if you decide to defer replacement, then I recommend client engage a Handy Person to clean the gutters as soon as possible.

Blocked gutters are likely to lead to high levels of moisture in the affected areas. Such moisture can cause rust and decay of the associated building materials. Blockages in gutters should therefore be removed immediately to ensure dry conditions are maintained.

Recommend client ensure that all gutters be maintained on a frequent basis to ensure the condition of roof plumbing.

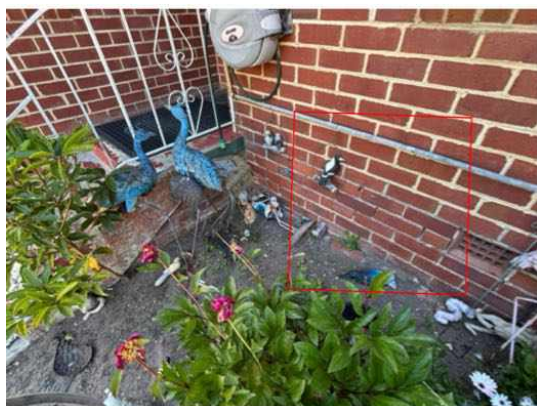
Defects 3.24

Building:	Main Building
Location:	Exterior walls - front
Finding:	Mortar degraded
Information:	The mortar (pointing) on the brickwork near the front steps, has deteriorated and is in need of repair.

Degraded pointing is likely due to weather and movement. Also some mortar mixes may not have been equal at time of construction. Failure to repair will potentially allow more movement of brickwork and lead to water ingress.

Recommend client engage a qualified Bricklayer to rectify at clients convenience.

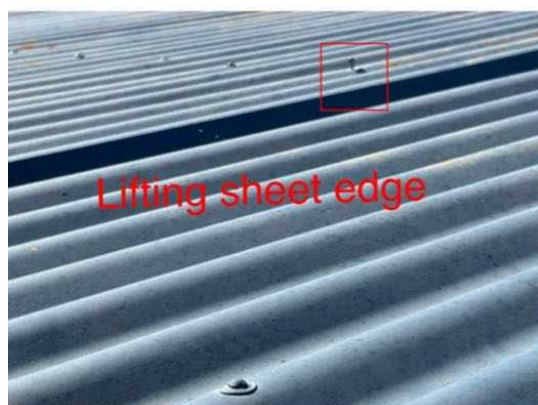
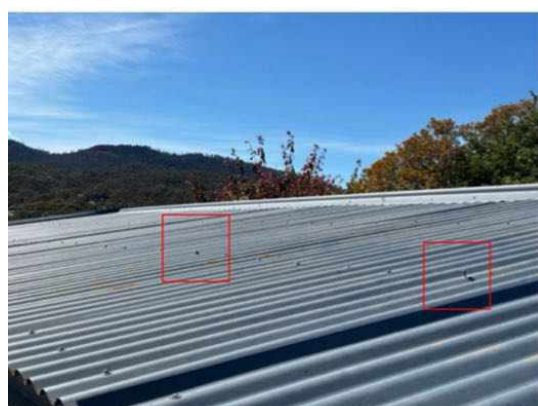
Defects 3.26

The roof is held down by nails, which was normal practice at the time of construction. However as the timber dries and shrinks the nails and timber lose friction and the suction of the roof by winds, works the nails loose.

Recommend client engage a Handy Person to rectify as soon as possible.

Any loose nails should be replaced by roof screws which offer superior hold down power. This is the minimum recommendation.

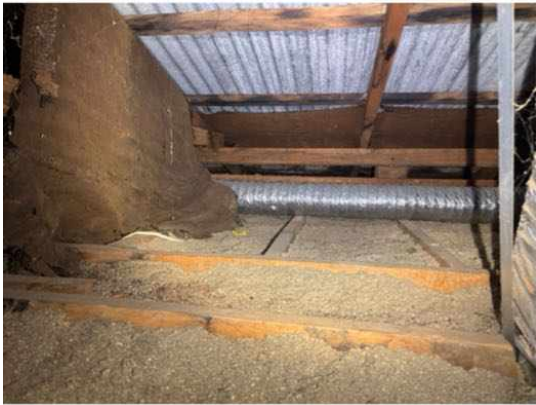
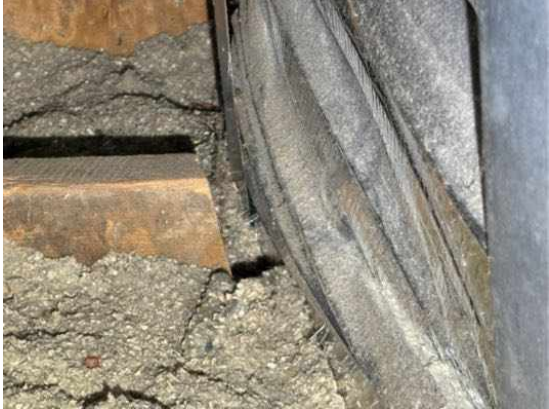
Building: Main Building
 Location: Roof void
 Finding: FYI insulation
 Information: FYI there is blown in insulation in the roof void.

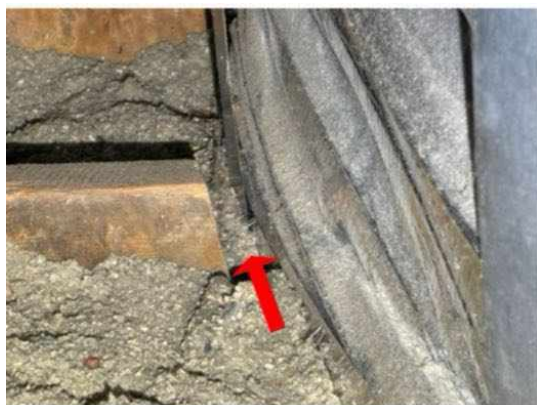
Building: Main Building
 Location: Roof void
 Finding: FYI - Joist compromised roof void
 Information: In the roof void two joists has been compromised/cut to install the skylight. These timbers are carrying the ceiling load, so not a lot of weight. However they are right near the access hatch, so someone kneeling on them could cause movement and ceiling damage. They appear to have metal straps connecting them to the roof framing as some method of supporting them, however this not a method I have seen before.

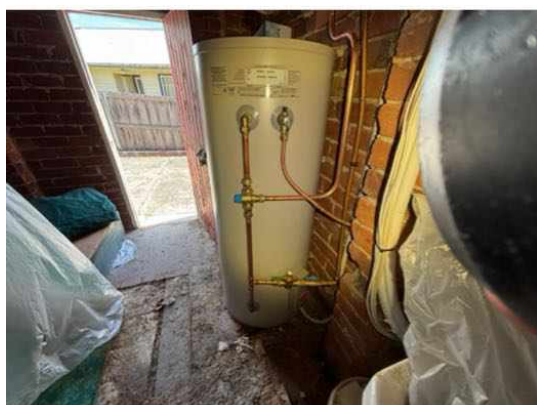
Building: Main Building
 Location: Subfloor
 Finding: FYI Hot Water System
 Information: FYI the hot water system was installed in 2025.

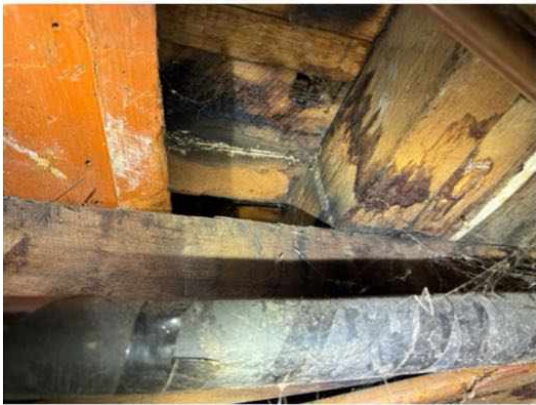
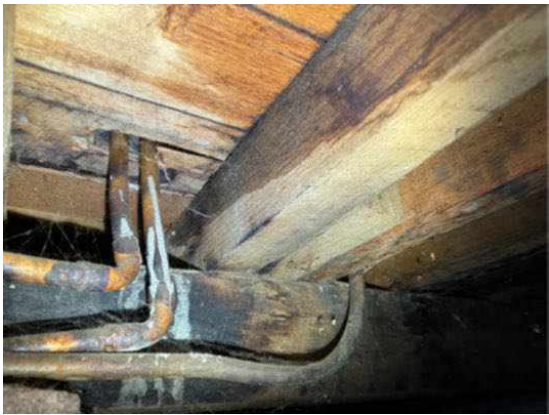
Building: Main Building
 Location: Subfloor
 Finding: FYI Water staining in subfloor - laundry
 Information: FYI In the subfloor there is water staining to the area underneath the old laundry. However it was dry to touch at the time on the inspection.

While mostly an appearance defect, water staining can be indicative of more serious defects, which may be currently concealed by other building elements.
