## Building and Timber Pest Inspection Report

Inspection Date: Thu, 12 Mar 2026

Property Address: 13/387 New Canterbury Rd, Dulwich Hill  
NSW 2203, Australia

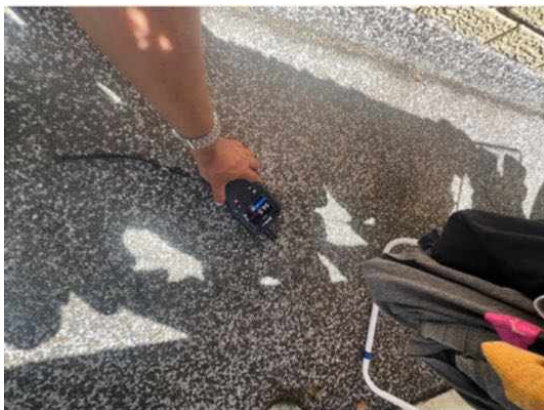
Finding: Balcony Moisture damage - Strata (Possible waterproofing)

Information: Elevated moisture was recorded at the base of the balcony wall and balcony soffit had damage and associated staining consistent with water exposure. While no internal damage was visible at the time of inspection, balconies in multi-unit dwellings are high-risk areas for waterproofing failure, which can lead to leaks into adjoining units and significant rectification costs. Further investigation by a licensed waterproofing contractor is strongly recommended.

Depending on the strata plan, this area may form part of the common property, in which case remedial responsibility may rest with the owners corporation (strata). Purchasers should seek clarification from the strata manager and legal adviser prior to purchase.

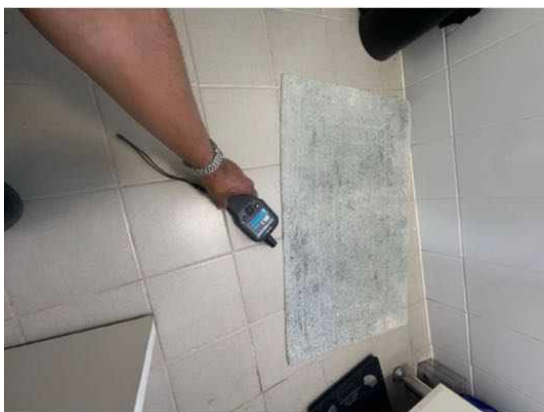
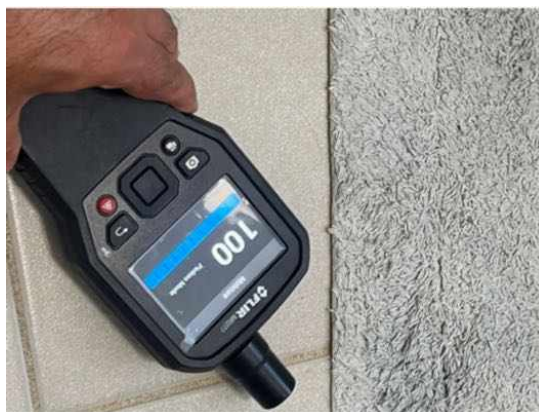
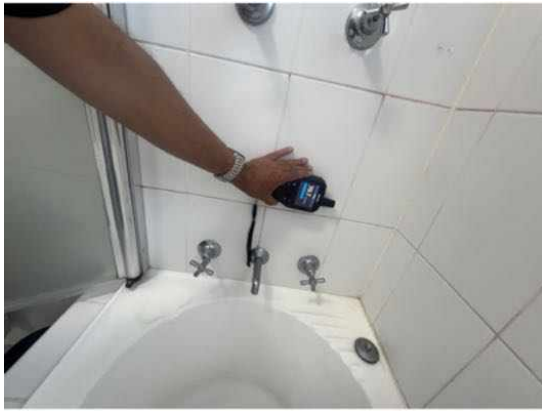
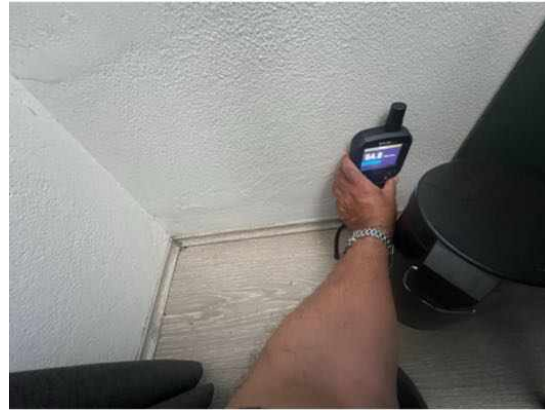
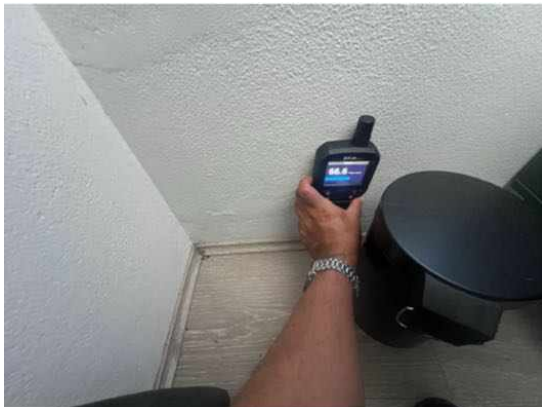
## Finding 2.02

Building:	Main Building
Location:	Bathroom
Finding:	Elevated Moisture Bathroom & Back of shower (Further investigation required)
Information:	Elevated moisture levels were detected to tiled surfaces in bathroom/shower areas. This may be due to porous or missing grout, cracked tiles or recent use, however the possibility of waterproofing membrane failure or plumbing leaks cannot be excluded. Persistent moisture ingress can lead to concealed damage, including timber rot and mould growth. The back of shower area also showed elevated moisture with visible minor deterioration and evidence of previous repairs evident at the time of inspection. Further investigation by a licensed plumber and/or waterproofing contractor is recommended as soon as possible.

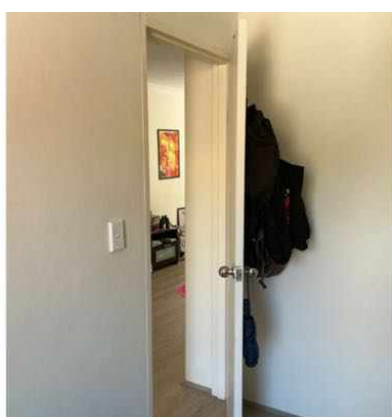
### Finding 3.01

Building:	Main Building
Location:	Bedroom
Finding:	Door - Binding/jamming
Information:	Binding and/or jamming of this door is evident during standard operation. This defect inhibits the functionality of the affected door as well as creating potential for secondary defects to associated building elements, such as damage to the floor covering.

A door that binds to flooring or to the associated door frame may have several causes, ranging from minor defects, such as poor installation of the door or deteriorated hinges, through to major structural issues, such as damage to subfloor structures.

Where door binding/jamming appears to indicate major structural issues, a registered builder specialising in re-stumping should be appointed to provide an estimate on the cost of rectification.

For minor causes, a qualified carpenter or general handyperson should be appointed to perform minor rectification works at client discretion.

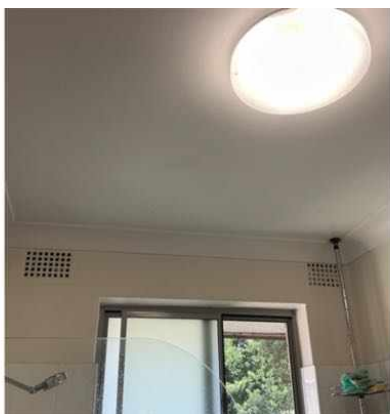
### Finding 3.02

Building:	Main Building
Location:	Bathroom
Finding:	Water Staining - Humidity or Ventilation
Information:	The ceiling surface shows peeling paint and water staining on the walls faint commonly consistent with humidity-related staining, often found in bathroom or wet areas with insufficient ventilation. While there is no visible sagging or major water damage, the pattern suggests prolonged moisture exposure, possibly due to steam accumulation or minor condensation issues. According to AS 4349.1–2007 (Appendix C), this would be classified as a minor defect unless further deterioration or active leaks are found. Recommend improving mechanical or natural ventilation, cleaning the surface with mould treatment, and monitoring for recurrence.

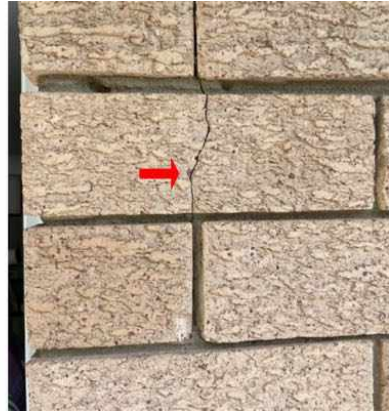
Building:	Main Building
Location:	All Internal Areas
Finding:	Brickwork - Cracking noticeable
Information:	There were several cracks and or crack repairs evident to external brickwork.

Noticeable cracks are a common occurrence in external brickwork and are a likely result of age expected building movement, general expansion, and/or contraction of building materials in different weather conditions. Noticeable cracks in brickwork may develop if left unattended, with potential for necessitating major remedial works or replacement of the brickwork.

It is highly advised that a qualified bricklayer be appointed to provide necessary works to cracked brickwork to prevent any further damage. Such works should be conducted as soon as possible.

Always monitor these cracks and contact a building inspector should cracks widen, lengthen, or become more numerous.

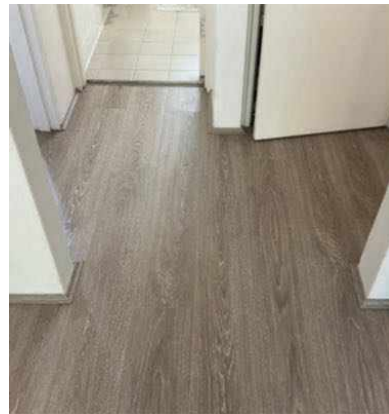
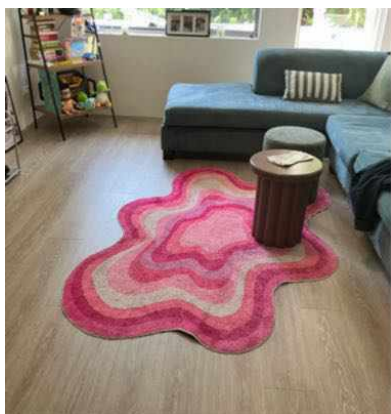
### Finding 3.06

Finding: Laminate Flooring Movement / Creaking

Information: Minor creaking and movement were noted when walking over sections of the laminate flooring. This condition is commonly associated with floating floor systems where slight movement occurs between boards or between the flooring and the underlying substrate, particularly if the subfloor is uneven or expansion clearances are limited. While this does not generally indicate a structural issue, ongoing movement may cause wear to the flooring over time. Monitoring is recommended, and rectification may involve lifting and reinstalling affected boards or improving subfloor preparation if the condition worsens.

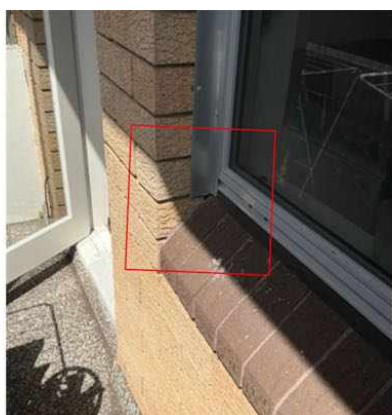
### Finding 3.07

Building:	Main Building
Location:	Balcony
Finding:	Gap Between door Frame and Masonry
Information:	A visible gap is present between the external door frame and the adjacent masonry wall. This gap may allow water ingress, air infiltration, and potential pest entry if not adequately sealed. Over time, such exposure can contribute to frame deterioration, internal water damage, or reduced thermal performance. Sealing or filling the gap with a suitable weatherproof compound is recommended to maintain the integrity of the building envelope, in accordance with good building practice and AS 4349.1

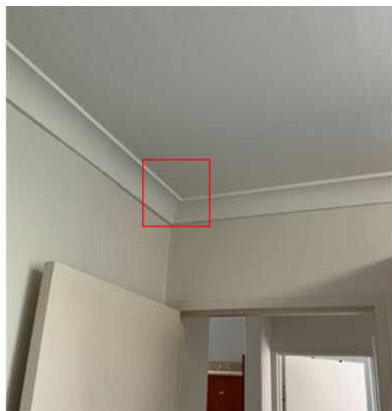
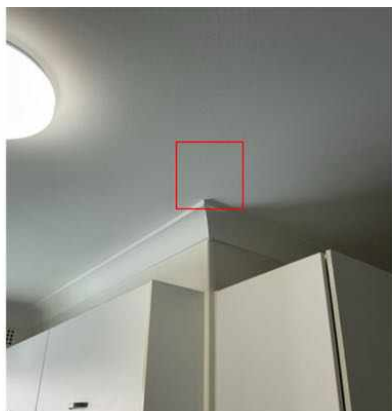
### Finding 3.08

Building:	Main Building
Location:	Kitchen
Finding:	Painted surface - Bubbling
Information:	Sections of paint in this area was found to have bubbled and deteriorated. Paint bubbling is generally an indication of excessive moisture in the area, that is currently hidden by the painted surface.

The presence of excessive moisture can have major implications on associated building elements if left unattended. While only seemingly minor at this stage, the

damage cannot be determined due to the paint obstructing any further inspection of the damage.

It is highly advised that the affected paint be cleaned to allow a further, more invasive inspection by a licensed plumber. Failure to act on this defect may necessitate major works in the future.

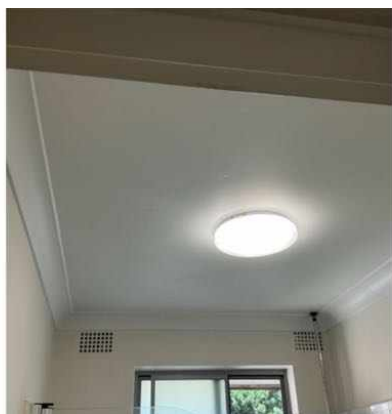
### Finding 3.09

Building:	Main Building
Location:	Bathroom, laundry
Finding:	Building element - Missing - No ventilation
Information:	Although some building elements may seem irrelevant or unnecessary, all building elements play a key role in the operation and function of the overall structure and its performance.

Replacement of any missing building element should be conducted as soon as possible to ensure that no damage or functional issues occur to associated building materials.

The appropriate tradesperson should be appointed as soon as possible to replace the missing building element.

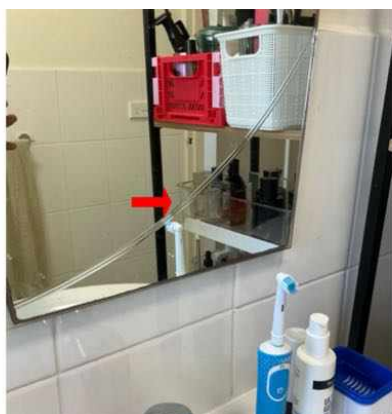
### Finding 3.10

Building:	Main Building
Location:	All External Areas
Finding:	Building element - Damaged - Cracked mirror bathroom
Information:	Breakage occurs generally when the building materials have either aged and decayed, or as a result of damage (accidental or deliberate).

Repair and/or replacement of broken elements is advised to ensure that additional secondary defects do not arise as a consequence. Such works are necessary, as all building elements play a key role in the operation and function of the overall structure and its performance.

A relevant tradesperson should be appointed to repair or replace the affected building element prior to any subsequent damage being caused.

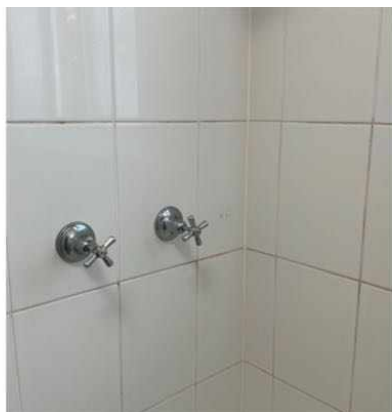
### Finding 3.11

Building:	Main Building
Location:	All Internal Areas
Finding:	Building element - Damaged - Holes in tile
Information:	Breakage occurs generally when the building materials have either aged and decayed, or as a result of damage (accidental or deliberate).

Repair and/or replacement of broken elements is advised to ensure that additional secondary defects do not arise as a consequence. Such works are necessary, as all building elements play a key role in the operation and function of the overall structure and its performance.

A relevant tradesperson should be appointed to repair or replace the affected building element prior to any subsequent damage being caused.

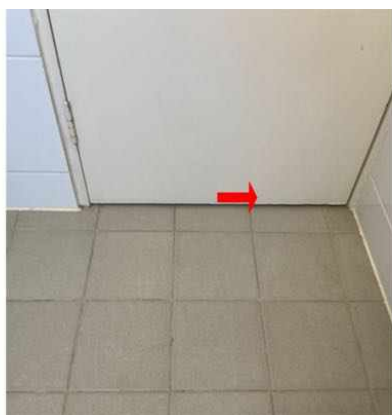
### Finding 3.12

Building:	Main Building
Location:	Bathroom
Finding:	Delamination of timbers
Information:	Localised delamination and surface deterioration were observed to sections of laminated joinery panels. This condition commonly occurs where moisture exposure or wear causes separation of laminate finishes from the underlying substrate. The defect is generally cosmetic in nature but may worsen over time if moisture exposure continues. Repair or replacement of affected joinery components may be considered as part of routine maintenance.

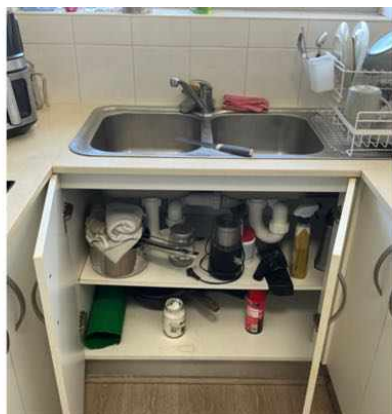
### Finding 3.13

Information: This tap shows evidence of water hammer being present. Water hammer, a pressure surge resulting when a fluid is forced to suddenly change direction, is a common defect in plumbing fittings, particularly those that are aged and not frequently maintained. Water hammer is generally caused by factors that create high water pressure in the affected plumbing fixture, usually evidenced by a faint banging noise during operation of the affected tap.

Although water hammer is generally considered to be a minor defect, subsequent damage such as erosion of tap hardware and/or water damage to associated building elements is likely to occur if left unmanaged.

A licensed plumber should be appointed as soon as possible to replace any affected tap hardware and perform any remedial works as necessary. Please be advised that the appointment of a cabinet maker or qualified carpenter may be necessary if water damage to associated building elements has occurred.

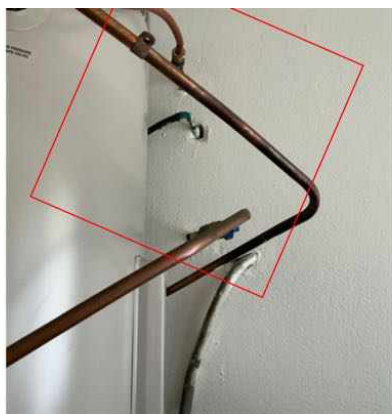
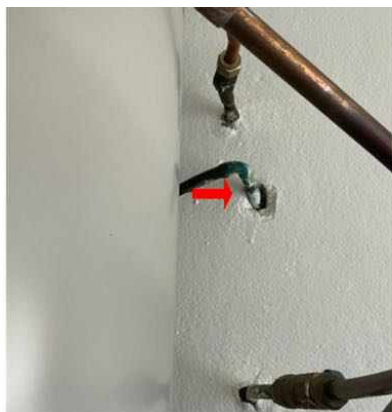
Building:	Main Building
Location:	All Areas
Finding:	Building element - Damaged - kitchen top cracked , holes not sealed laundry
Information:	Breakage occurs generally when the building materials have either aged and decayed, or as a result of damage (accidental or deliberate).

Repair and/or replacement of broken elements is advised to ensure that additional secondary defects do not arise as a consequence. Such works are necessary, as all building elements play a key role in the operation and function of the overall structure and its performance.

A relevant tradesperson should be appointed to repair or replace the affected building element prior to any subsequent damage being caused.

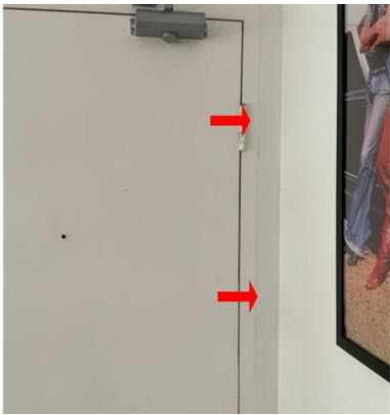
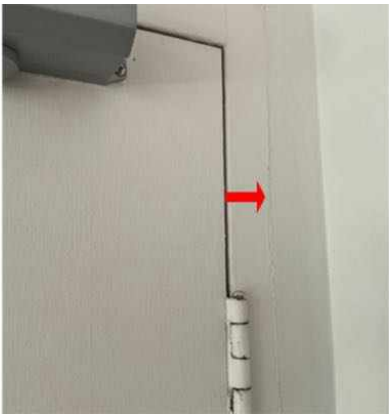
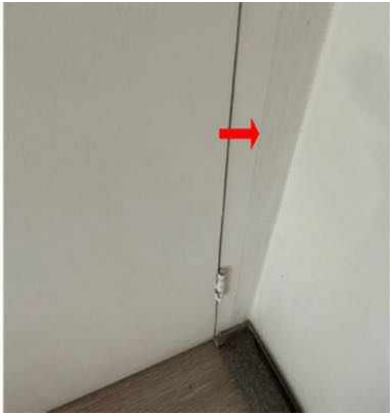
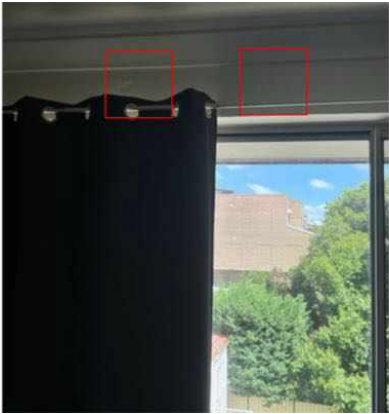
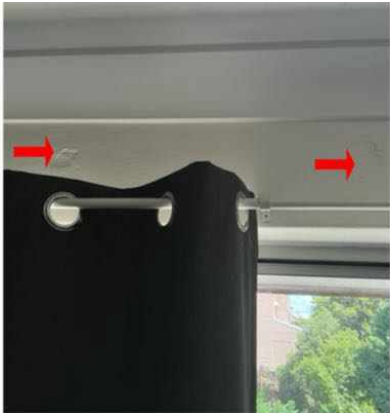
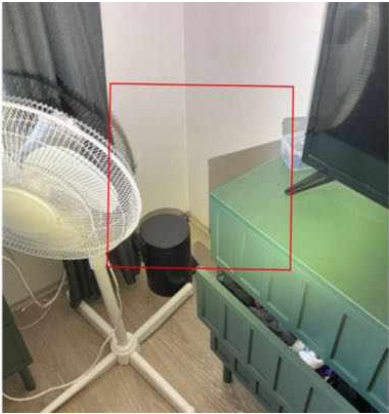
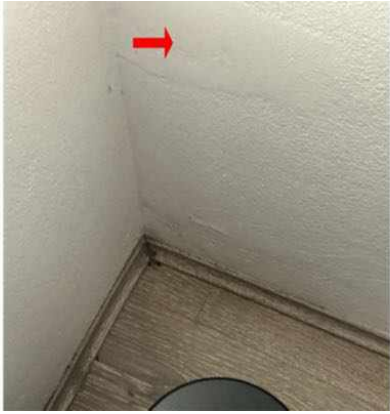
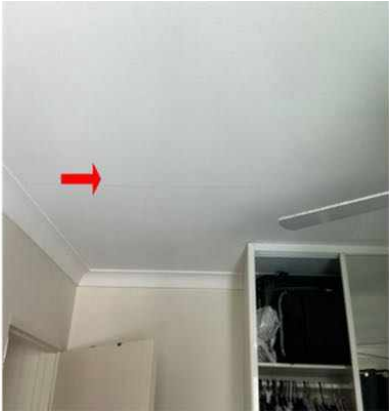
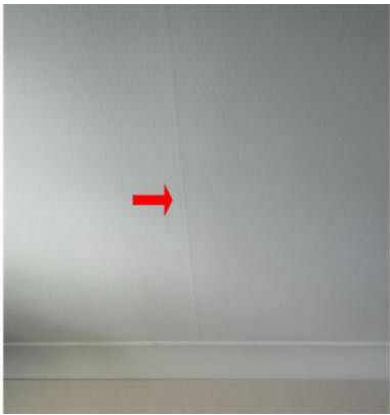
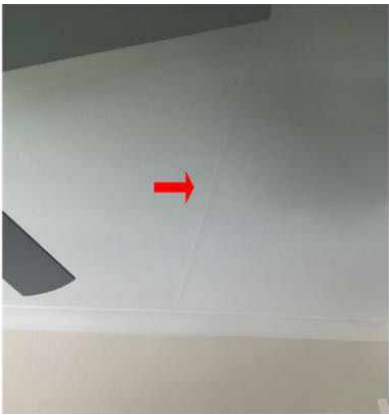
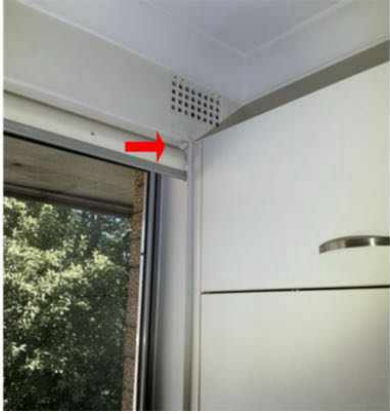
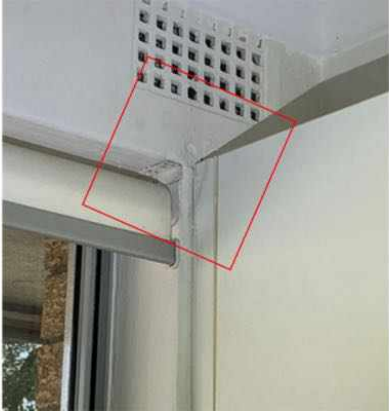
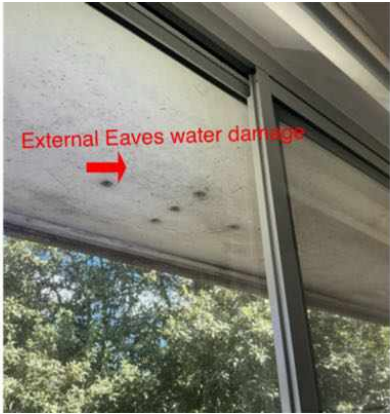
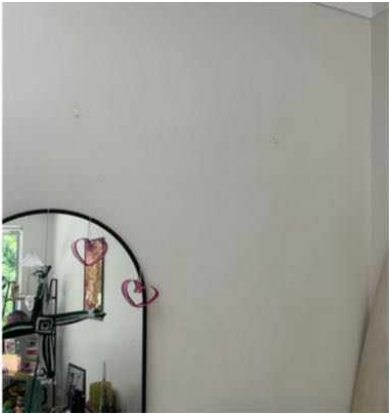
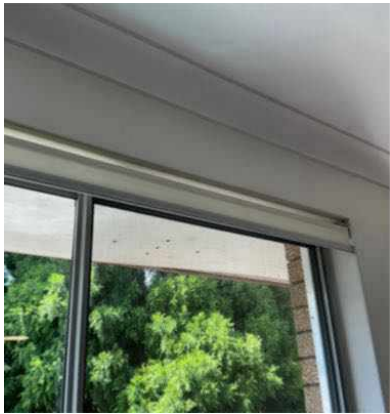
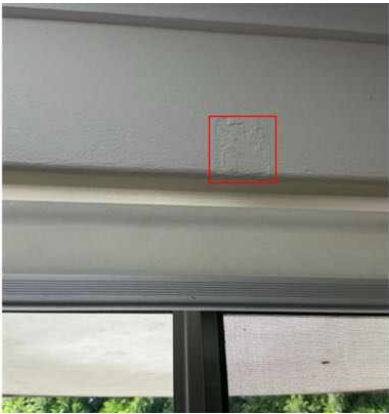
### Finding 3.16

Building:	Main Building
Location:	All Internal Areas
Finding:	Paint finish and hairline cracking
Information:	The paint finish in this area was identified as being incomplete at the time of inspection including some hairline minor cracking.

Whilst incomplete or missing paint finish is generally an appearance defect, it can also lead to the development of secondary building defects over time. Incomplete areas of paint finish expose the area to moisture, potentially accelerating the deterioration of underlying building materials.

Incomplete paint finishes should be sanded back, filled, leveled and painted, as applicable. Where inadequate or missing paint protection has led to the deterioration of the associated building element, repair and/or replacement of this building element may be required.

A painting contractor should be appointed as soon as possible to perform necessary works to aid the appearance of the affected area and to ensure the area is protected against further deterioration. Alternatively, the homeowner following manufacturer instructions may perform these works.

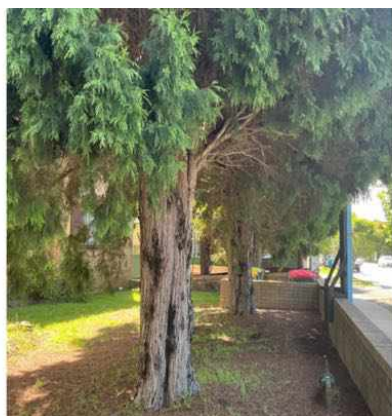
### Finding 6.01

Building:	Main Building
Location:	All External Areas
Finding:	Trees within 50m
Information:	Trees within 50m of the property can be conducive to termite activity. It is recommended an invasive inspection of all trees with 50m to the property be carried out by a qualified pest control expert.

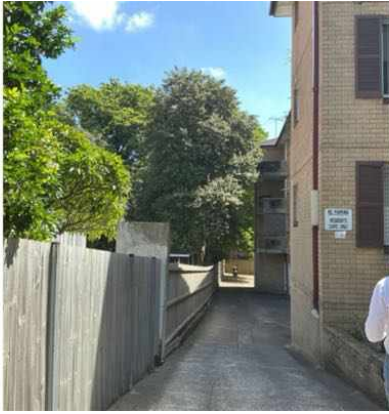
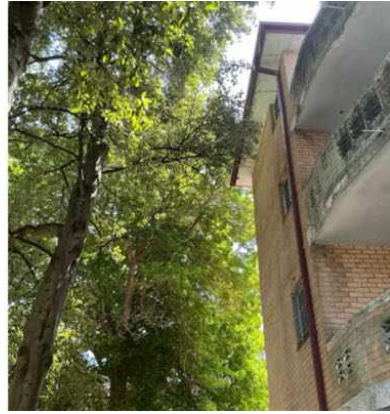
### Finding 6.02

Building:	Main Building
Location:	All External Areas
Finding:	Bridging - Vegetation
Information:	Where vegetation obstructs inspection of building elements, also known as bridging as it provides a bridging point for the access of termites, full inspection can not be achieved. Consequently moisture or dampness may be present and the areas becomes conducive to termite activity. Plants against or very close to buildings provide cover, shade and can provide an environment that is attractive to termite infestation.

The removal and replanting of species that do not provide "cover" or cutting back of existing vegetation will assist greatly in preventing Bridging from occurring.

The removal of any such materials that may be conducive to termite activity should be carried out as soon as possible and arrange re inspection to minimize the risk of termite attack.
