# Building and Timber Pest Inspection Report

Inspection Date: Fri, 6 Mar 2026

Property Address: 1460 Burraborang Rd, Oakdale NSW 2570,  
Australia

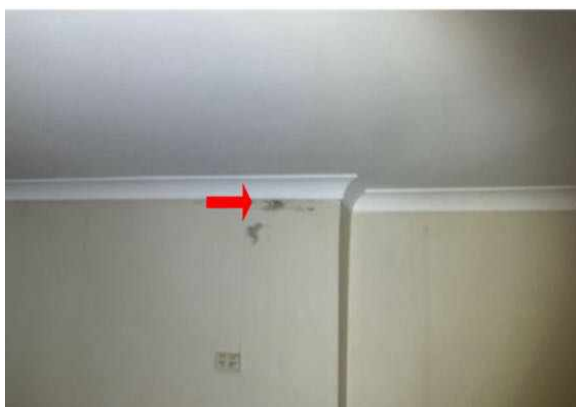
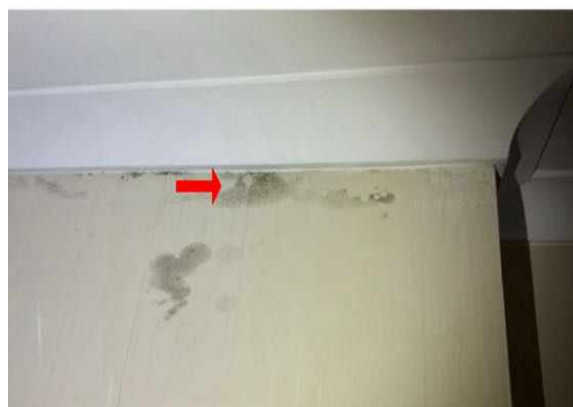
Building:	Main Building
Location:	All Areas
Finding:	Black Mould / Inadequate Roof Drainage
Information:	During the inspection, black mould growth was observed on the ceiling. This condition is likely the result of inadequate roof drainage, allowing moisture to penetrate or accumulate within the ceiling cavity. Prolonged dampness can lead to further mould growth, staining, and potential deterioration of building materials.

It is recommended that a licensed plumber inspect and rectify the roof drainage system, ensuring water is properly diverted away from the structure. The affected ceiling area should then be cleaned, treated, and repainted once the moisture source has been resolved to prevent recurrence.

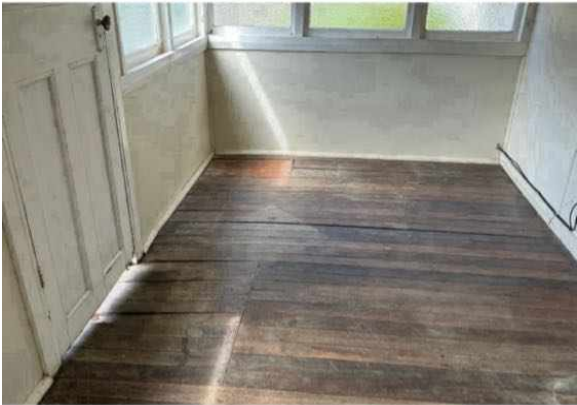
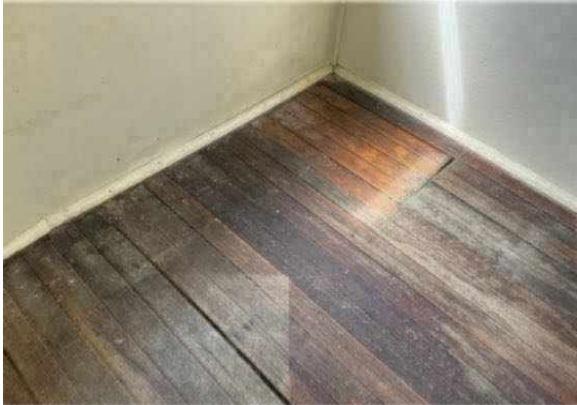
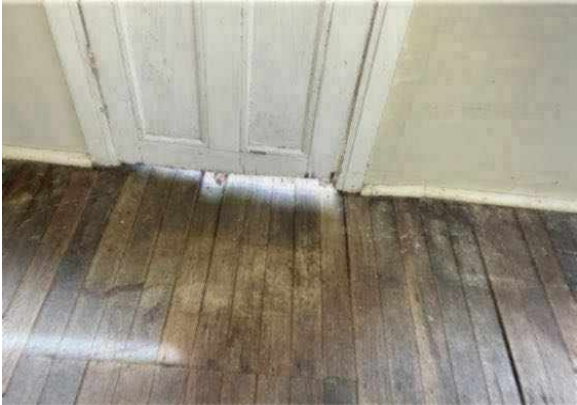
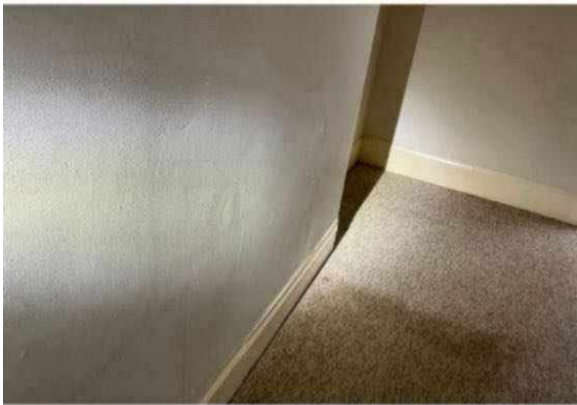
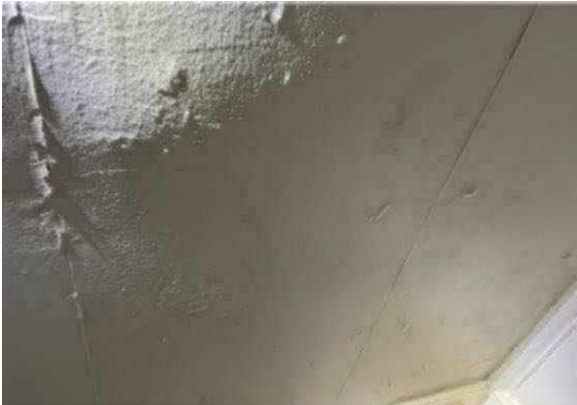
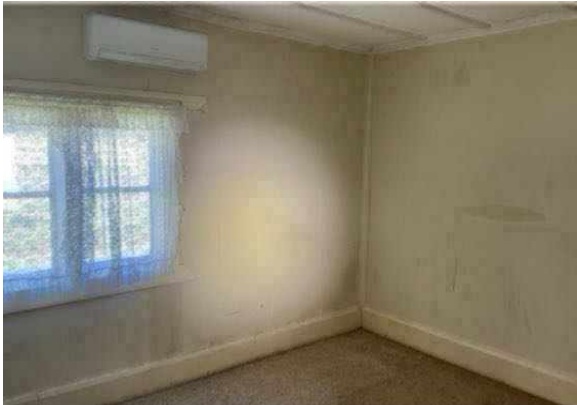
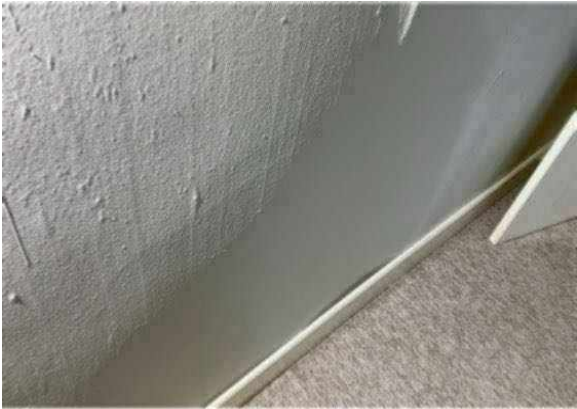
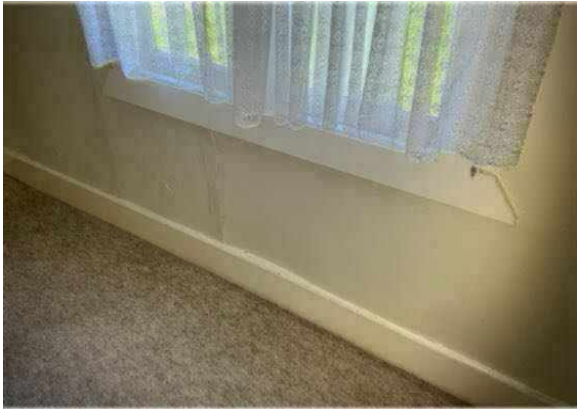
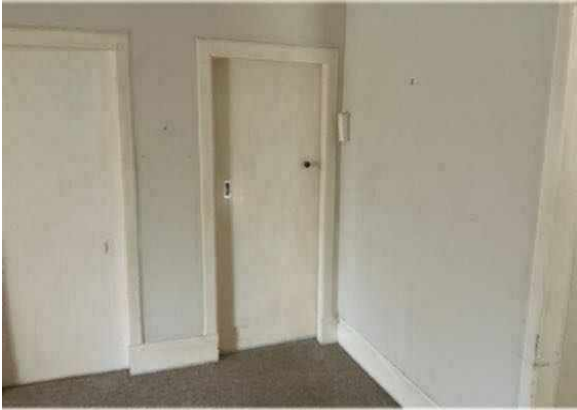
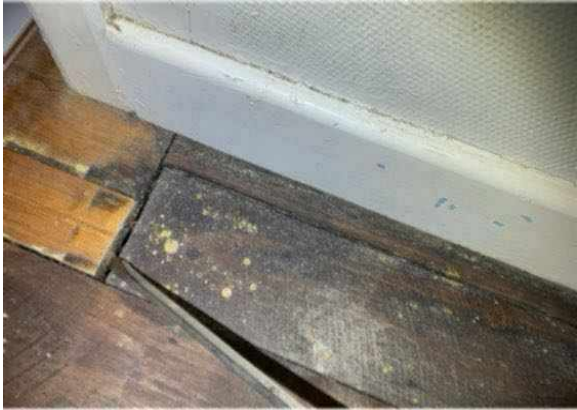
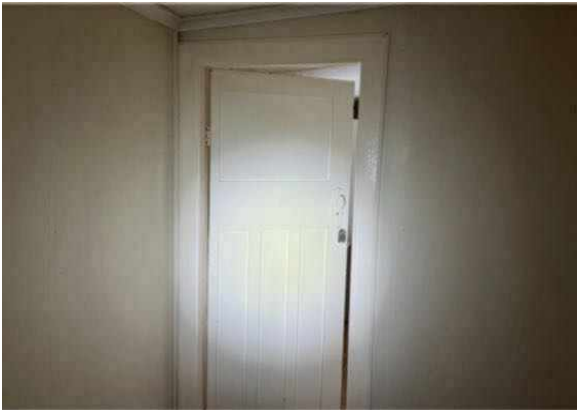
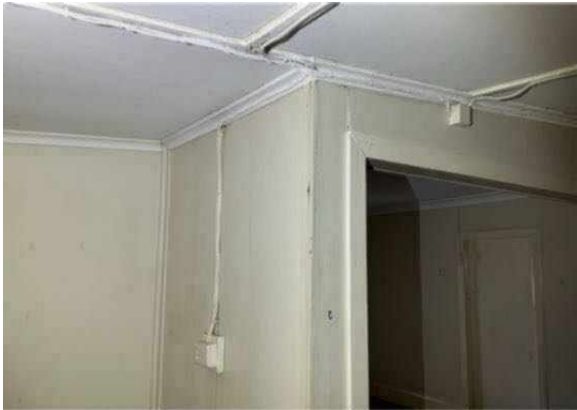
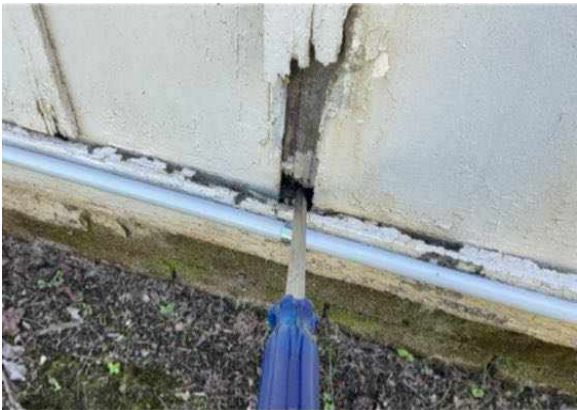
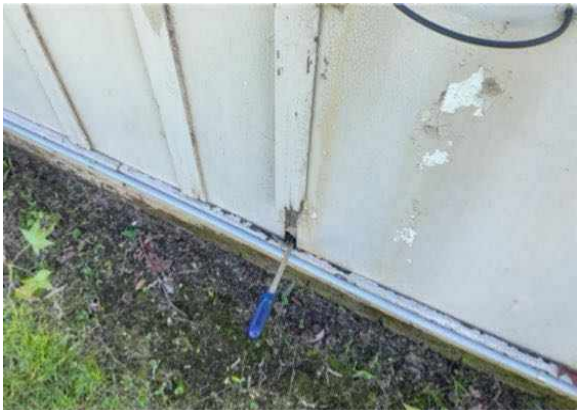
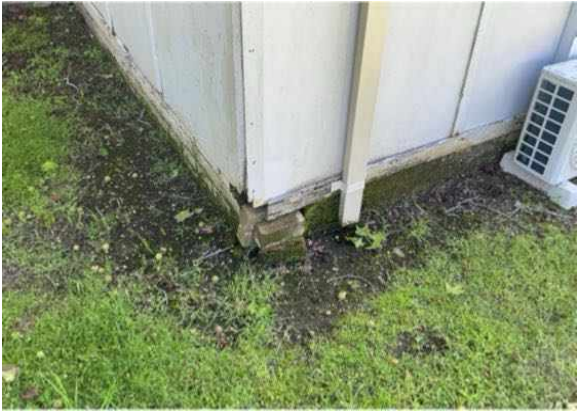
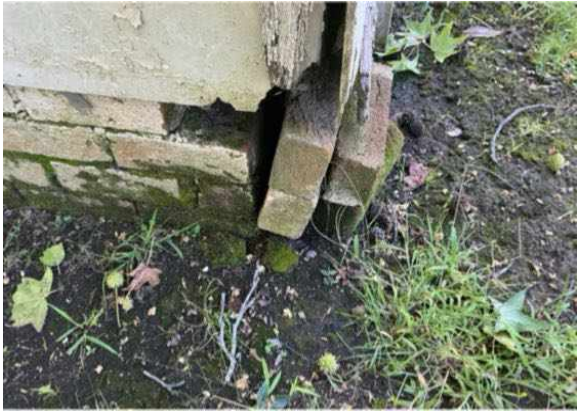
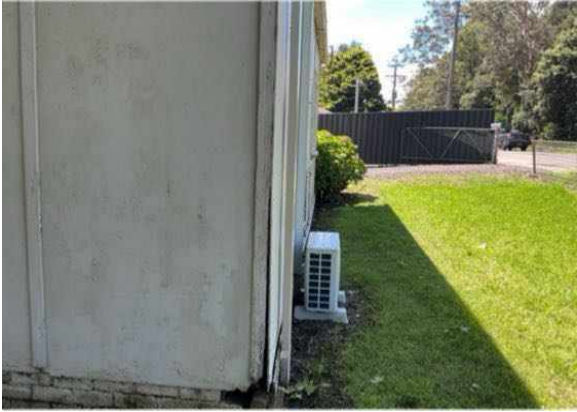
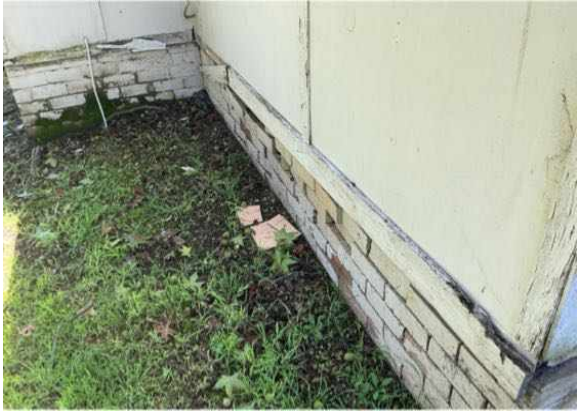
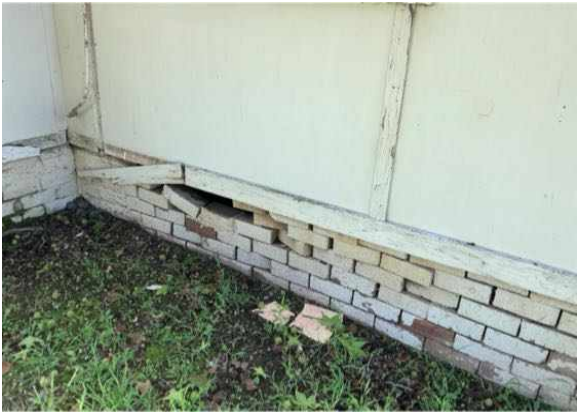
#### Finding 2.01

Building:	Main Building
Location:	Exterior walls
Finding:	Main Building Major Structural Deterioration Observed
Information:	During the inspection, the main building on the property was found to be in poor condition. Evidence of structural deterioration, termite damage, water damage, unstable floor and bowing walls were observed. Based on the visible condition of the building elements, significant repair works and major renovation are likely to be required.

During the inspection, the main building on the property was found to be in poor condition. Evidence of structural deterioration, termite damage, water damage, unstable floor and bowing walls were observed. Based on the visible condition of the building elements, significant repair works and major renovation are likely to be required.

Both the exterior and interior of the building appear to have experienced prolonged lack of maintenance, which has contributed to accelerated deterioration of various building components.

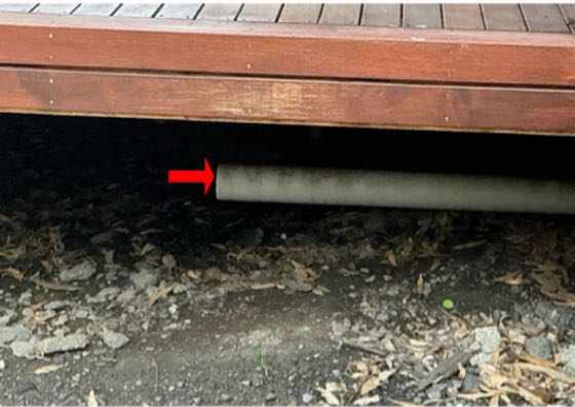
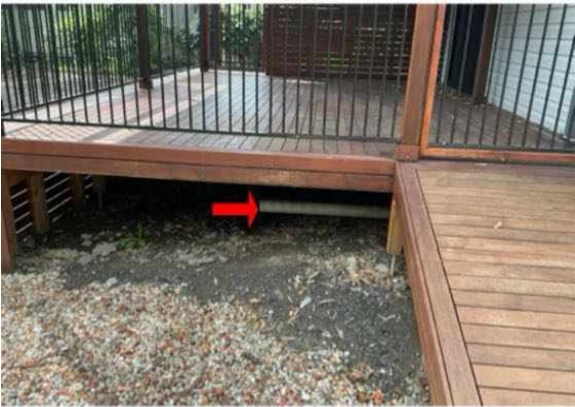
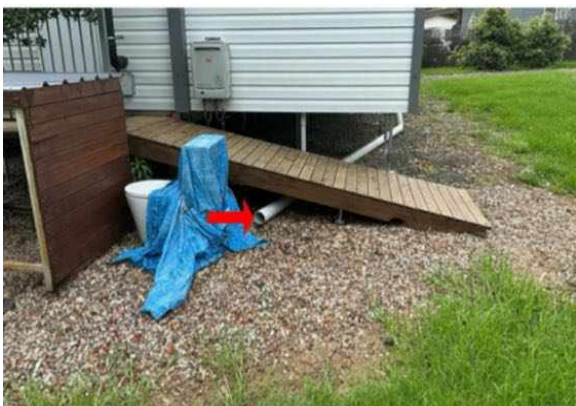
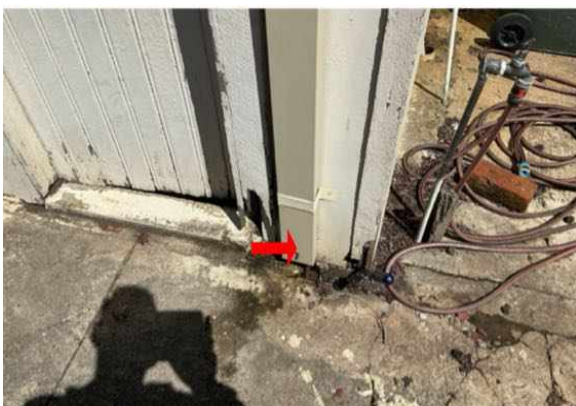
Information: During the inspection, disconnected downpipes were observed. This is a condition commonly seen in older homes and can reduce the effectiveness of the stormwater drainage system. If not addressed, water may accumulate around the building perimeter, which over time can contribute to deterioration and create moisture conditions that are attractive to termites.

To improve drainage and help protect the property, it is recommended that a qualified roof plumber to reconnect or repair the affected downpipes as required. Ensuring that water is directed away from the exterior walls and foundations will help reduce long-term moisture concerns and support the overall durability of the building.

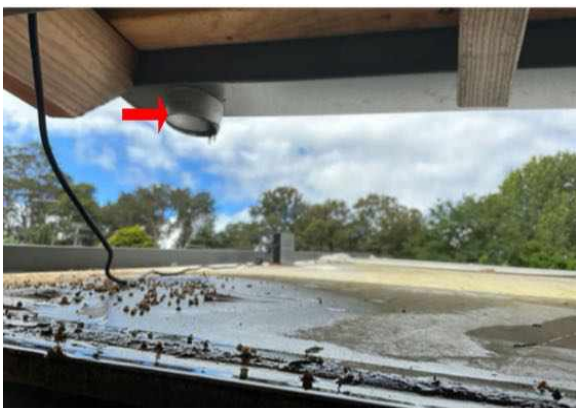
### Finding 3.03

Building:	Main Building
Location:	All Areas
Finding:	Veranda Roof Inadequate Downpipe Spreader
Information:

During the inspection, it was observed that the veranda roof drainage system has an inadequate downpipe spreader. Downpipe spreaders assist in directing rainwater evenly onto the lower roof surface and help prevent concentrated water flow.

An inadequate spreader may cause excessive water concentration in one area, increasing the risk of overflow, premature wear of roofing materials, or water ingress over time. It is recommended that a qualified roof plumber assess the installation and upgrade or extend the spreader as required to ensure effective rainwater distribution.

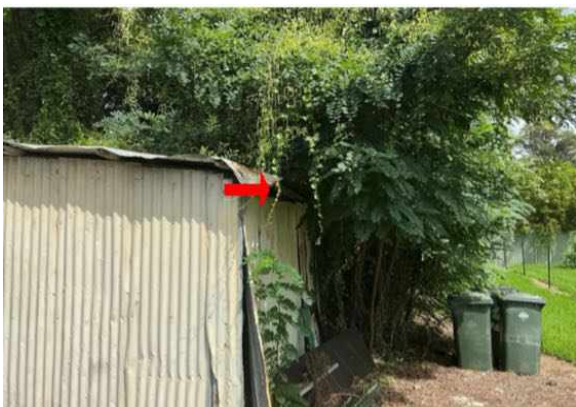
### Finding 3.04

Building: Main Building  
 Location: Exterior walls  
 Finding: Shed Missing Gutters  
 Information:

During the inspection, it was observed that the shed roof does not have gutters installed. The absence of gutters may allow rainwater to discharge directly around the base of the structure.

Over time, uncontrolled water runoff may contribute to soil erosion, moisture accumulation, or deterioration of surrounding building elements. Installation of appropriate gutters and downpipes is recommended to improve stormwater management around the shed.

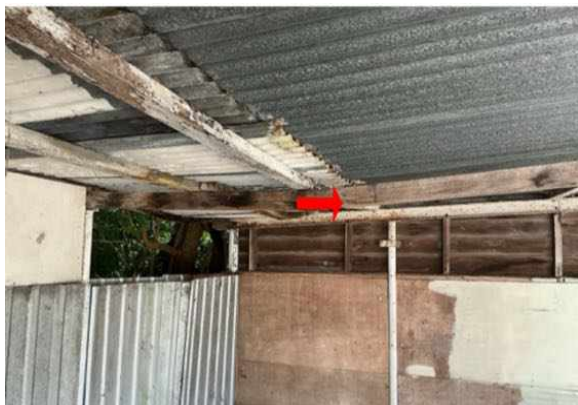
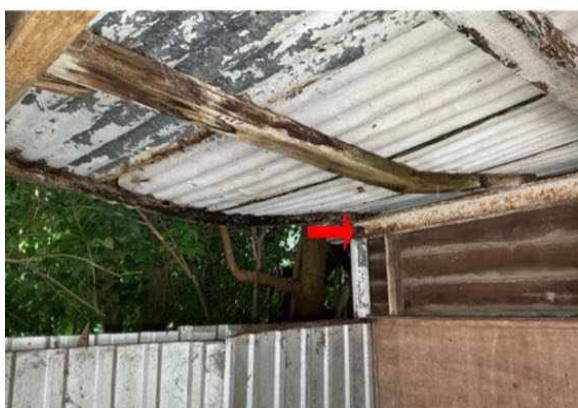
### Finding 3.05

Building: Main Building  
 Location: Exterior walls  
 Finding: Rear Carport Structural Deterioration and Termite Damage  
 Information:

During the inspection, the carport located at the rear of the main building was found to be in poor condition. Evidence of structural deterioration and termite damage was observed in the supporting timber elements.

Due to the extent of the deterioration, the structure may be considered unsafe for normal use. It is recommended that the carport be assessed by a qualified builder or structural professional to determine the extent of the damage. Major repairs or possible replacement of the affected structural members may be required to restore safety and structural integrity.

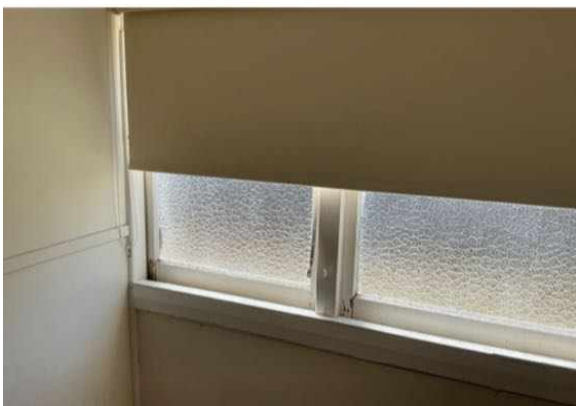
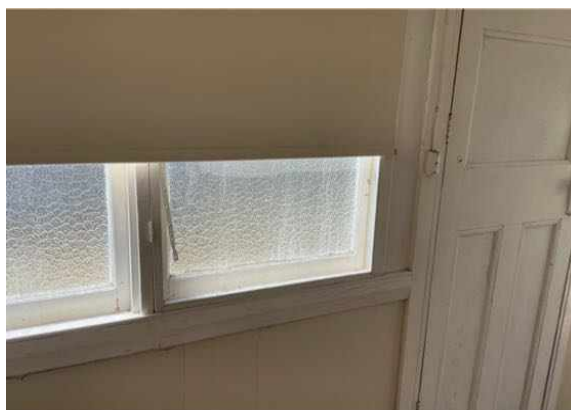
### Finding 3.06

Building: Main Building  
 Location: Exterior walls  
 Finding: Timber Windows Difficult to Open  
 Information:

During the inspection, the timber windows were found to be difficult or impossible to open. This condition may be due to swelling of the timber from moisture exposure, paint build-up, age-related movement, or deterioration of window hardware.

It is recommended that a qualified carpenter assess the affected windows and carry out the necessary adjustments, repairs, or maintenance to restore normal operation. Regular maintenance of timber windows will help ensure continued functionality and longevity.

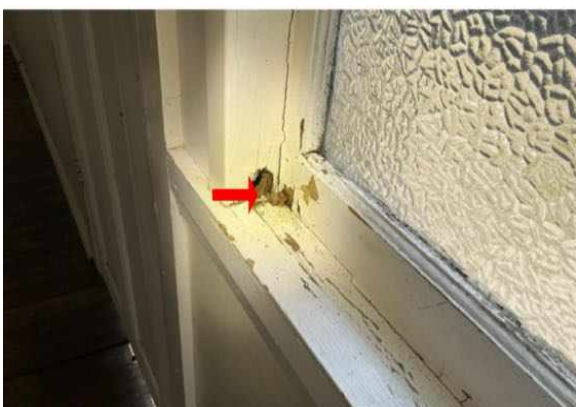
### Finding 3.07

Building:	Main Building
Location:	All Areas
Finding:	Wood Rot (Window Frames)
Information:	Wood rot was found affecting the timber window frames. This type of damage is typically caused by prolonged exposure to moisture, which allows fungi to deteriorate the wood. To address this issue, it is important to first eliminate any sources of moisture intrusion. Once the source of moisture is controlled, the affected window frames should either be repaired or replaced, depending on the extent of the damage. Engaging a professional carpenter or a window specialist is recommended to ensure that the repairs or replacement are properly conducted to restore the functionality and aesthetic appeal of the windows.

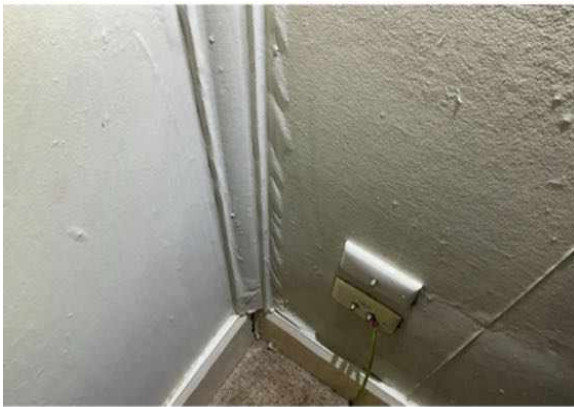
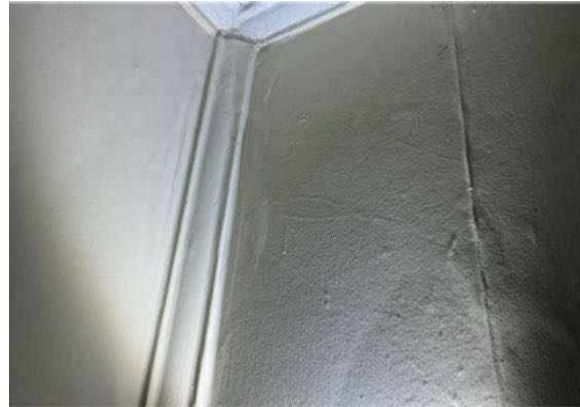
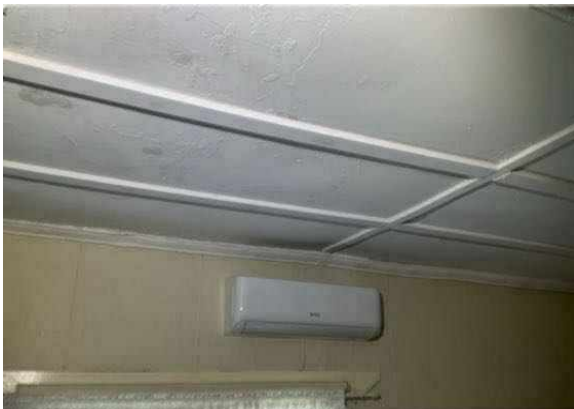
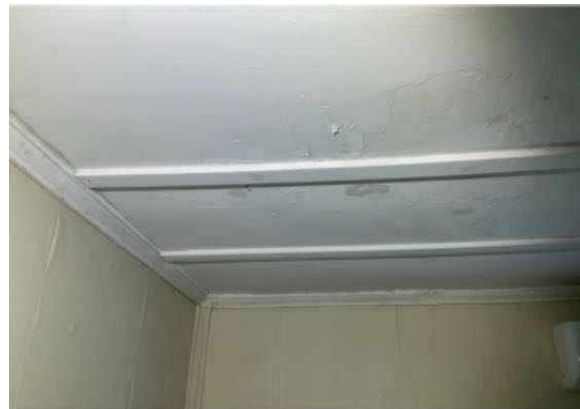
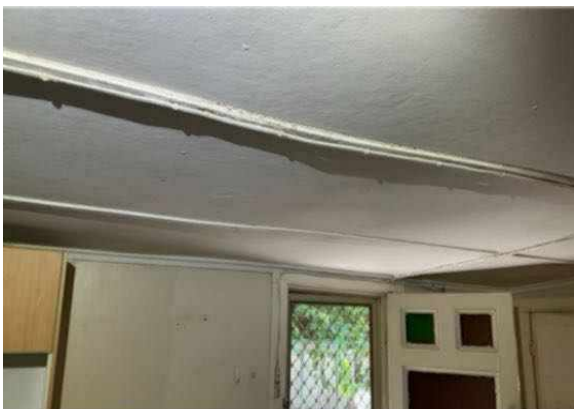
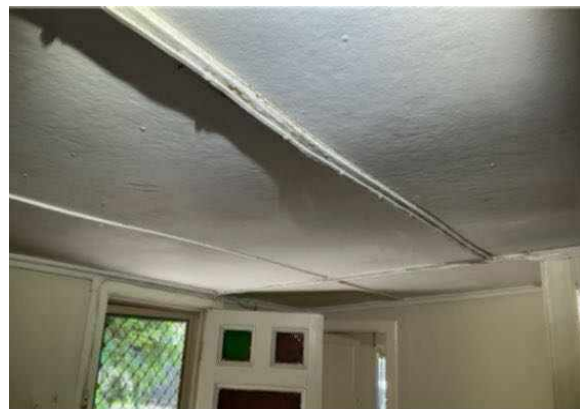
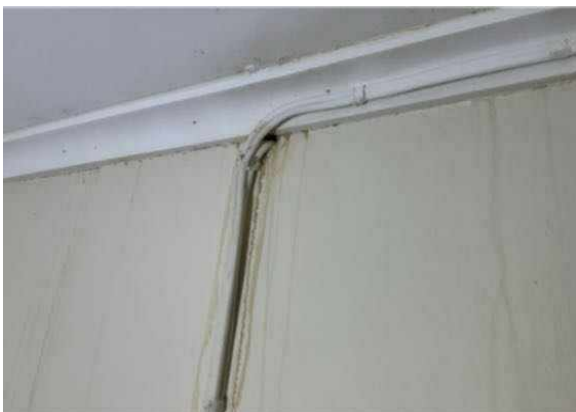
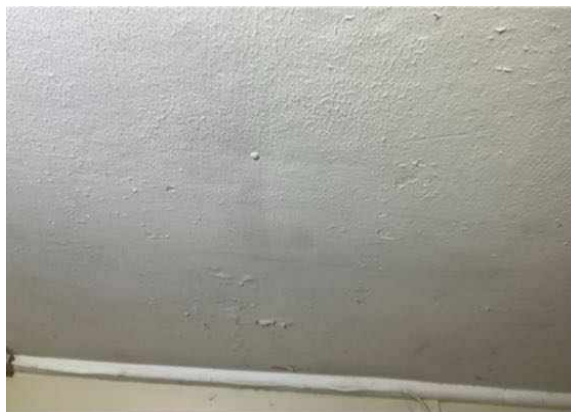
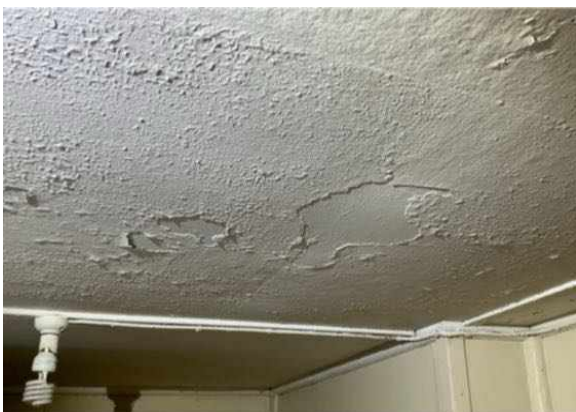
### Finding 3.08

Building:	Main Building
Location:	Exterior walls
Finding:	Ceiling Water Damage, Sagging and Peeling Paint
Information:	During the inspection, sections of the ceiling were observed to have water damage, sagging, and peeling paint. These conditions are typically associated with past or ongoing moisture exposure. External observation suggests that the roof drainage in

this area may be inadequate, which can contribute to water accumulation and potential leakage during periods of heavy rainfall.

Prolonged moisture exposure can weaken ceiling linings and affect their structural integrity over time. It is recommended that the roof drainage system be assessed and improved where necessary by a qualified roof plumber. Following rectification of the moisture source, repairs to the affected ceiling lining and finishes should be undertaken by a qualified tradesperson.

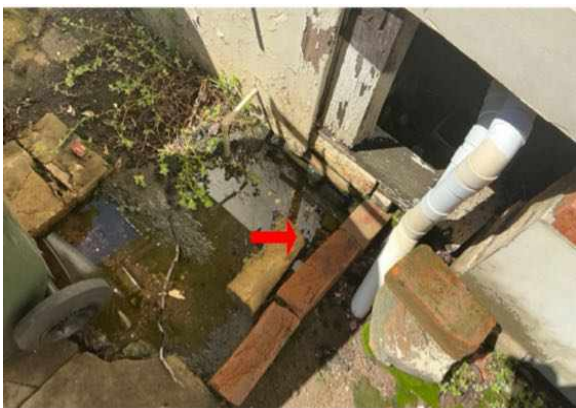
### Finding 3.09

Finding: Deteriorated Gutters

Information: It was observed that some sections of the gutters have deteriorated and are in need of repair. Leaking gutters can lead to excessive moisture around the base of the property, which may cause damage to surrounding building materials and create conditions that attract termites.

To resolve this, we recommend hiring a qualified roofing plumber to repair the gutters and ensure proper drainage. Additionally, regular gutter maintenance is advised to maintain the overall health of the roof plumbing system and reduce the risk of moisture-related issues in the future.

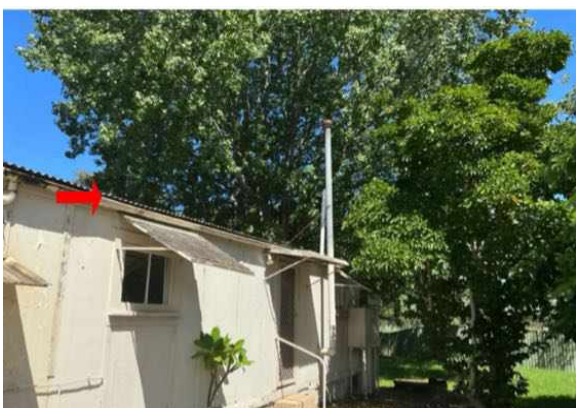
### Finding 3.10

Building:	Main Building
Location:	Exterior walls
Finding:	Gutters (Insufficient Downpipes)
Information:	During the inspection, gutters were found to have an insufficient number of downpipes, reducing the overall drainage efficiency of the roof system. This can lead to water pooling and overflow during heavy rainfall, increasing the risk of water ingress, damage to eaves and ceilings, and moisture accumulation around the building perimeter. These conditions also create an environment conducive to termite and timber pest activity.

This issue is common in properties of similar age and condition and, if left unaddressed, may result in moisture-related deterioration of building elements. To prevent further damage and ensure effective stormwater management, it is recommended to engage a qualified roof plumber to assess the current guttering system and install additional downpipes as required. Doing so will help maintain the structural integrity of the property and reduce long-term maintenance concerns.

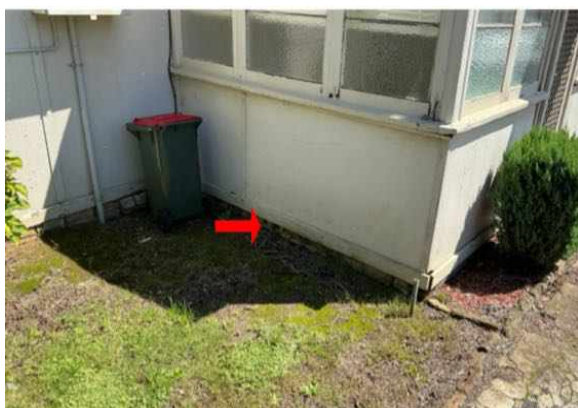
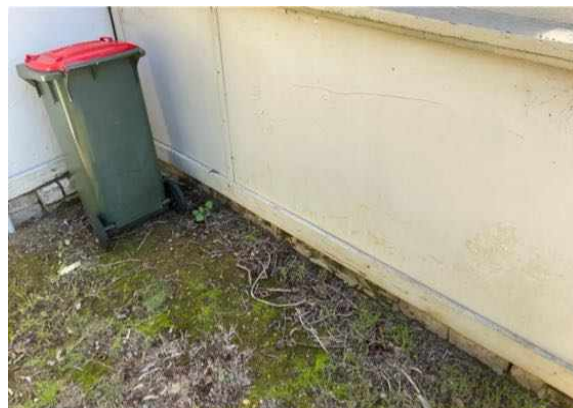
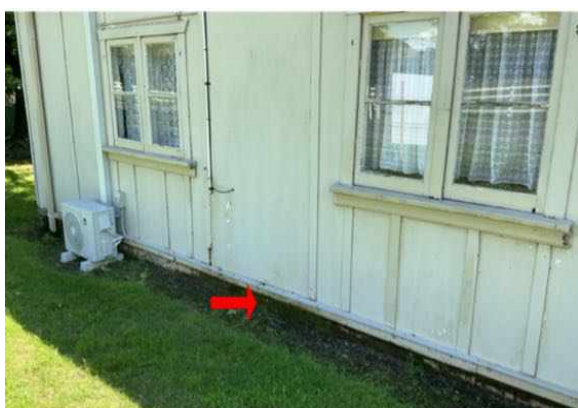
### Finding 3.11

**Finding:** Rising Damp / Poor Drainage / Inadequate Subfloor Ventilation

**Information:** During the inspection, damp or wet conditions were noted, likely resulting from inadequate site drainage, insufficient subfloor ventilation allowing moisture ingress, and rising damp characterized by moisture traveling upwards through porous building materials such as brick, sandstone, or mortar via capillary action. This issue commonly occurs in older buildings, particularly those constructed before modern Damp Proof Course (DPC) standards.

Maintaining dry conditions is essential to prevent secondary building defects. If left unresolved, persistent moisture can cause significant problems, including fungal decay, wood rot, and conditions conducive to termite and timber pest infestations.

A qualified builder should be engaged to thoroughly assess the affected areas and implement remedial measures, which may involve enhancing site drainage, improving subfloor ventilation, and installing or repairing a Damp Proof Course or moisture barriers. Prompt attention will ensure the property's long-term protection and structural integrity.

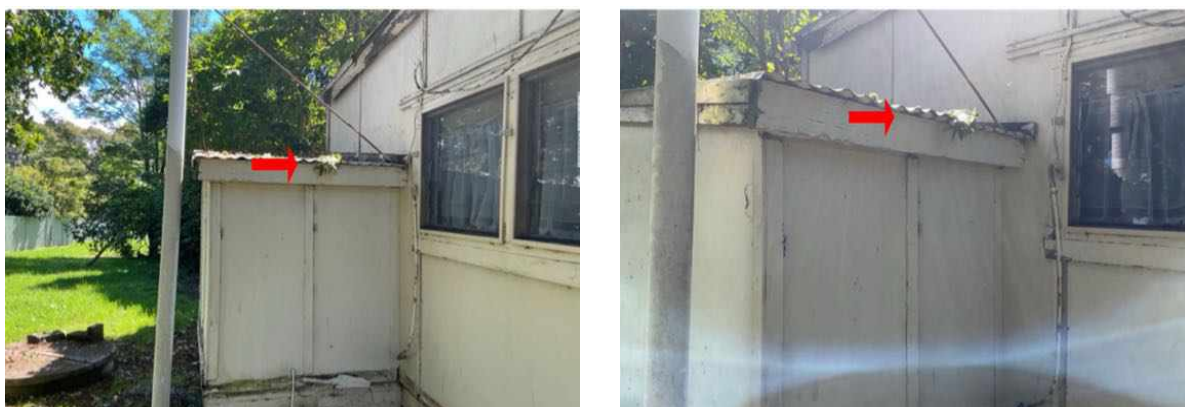
### Finding 3.12

**Finding:** Roof Plumbing Missing

Information: During the inspection, it was observed that the outdoor toilet roof is not adequately drained via gutters and downpipes. As a result, stormwater discharges directly onto the base perimeter of the building during periods of rainfall. This condition increases the risk of dampness, moisture-related damage, and creates an environment conducive to termite activity.

To mitigate these risks, it is recommended to engage a qualified roof plumber to install appropriate guttering and downpipes to ensure effective drainage. This rectification will assist in preventing water accumulation and reduce the likelihood of structural deterioration.

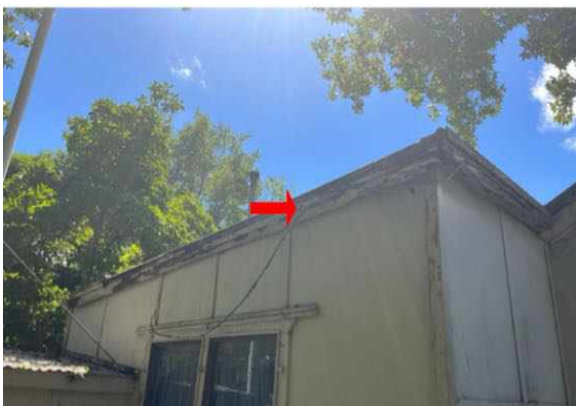
### Finding 3.13

Finding: Fascias Wood Rot

Information: The fascias have been affected by wood rot, likely due to prolonged exposure to rain and stormy weather conditions. This issue is often the result of insufficient maintenance or ongoing roof plumbing issues, which have allowed excess moisture to accumulate. Moisture build-up creates ideal conditions for wood rot and can attract termites, which are drawn to damp, decaying wood.

It is important to address both the underlying cause of moisture accumulation (such as roof plumbing issues) and the wood rot itself. A licensed roof plumber should inspect the roof for any ongoing leaks or drainage issues and make the necessary repairs. Additionally, replacing or treating the affected fascias will be required to prevent further deterioration and minimize the risk of termite infestations.

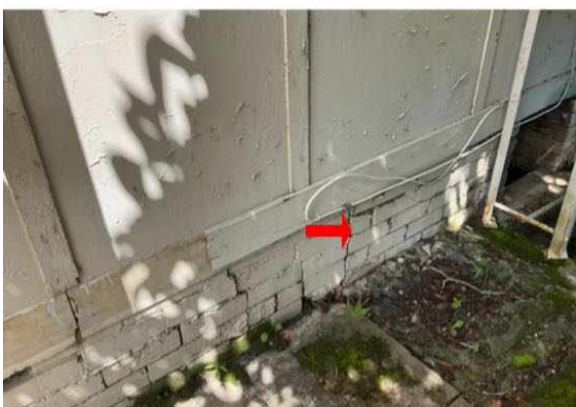
### Finding 3.14

Building:	Main Building
Location:	Exterior walls
Finding:	Step Cracking Observed
Information:	Step cracking was observed in the brickwork, which often indicates foundation movement or settling due to various factors, such as environmental wear, nearby trees or drainage issues causing soil erosion over prolonged period of time. It is recommended to monitor and record these cracks over several months, or up to a year (consult a qualified expert for guidance), to assess any progression before proceeding with repairs. This observation period will provide essential data for a structural engineer to accurately determine the cause and recommend appropriate remedial actions to prevent further deterioration.

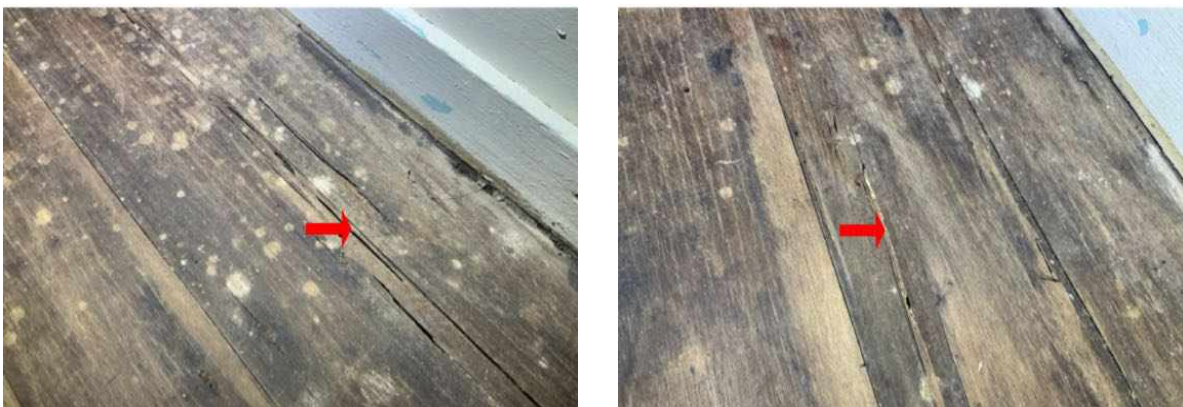
Building:	Main Building
Location:	Exterior walls
Finding:	Previous Termite Damage Observed (Structural Internal Damage)
Information:

During the inspection, evidence of previous termite damage was observed in several areas of the property, including internal floor bearers and joists, structural wall elements within the main building, and timber components in the shed and carport located at the rear of the property. Given the extent and distribution of the observed damage, a further invasive inspection is considered essential to properly assess the full impact on the structural integrity of the building.

In addition, the laundry door was observed to be binding and jamming during operation, and sections of the internal flooring near the affected areas appear uneven and out of level. These conditions may be associated with structural movement or deterioration resulting from previous termite damage.

As this inspection was limited to visible and accessible areas only, concealed sections of the structure could not be fully assessed. A detailed special-purpose inspection by a qualified builder or structural professional is strongly recommended to determine the full extent of the damage and identify any structural repairs that may be required.

Given the history of termite activity, it is recommended that quotations be obtained from a qualified builder prior to purchase to determine the scope and cost of the necessary rectification works. Ongoing termite management is also strongly advised, including regular timber pest inspections and consideration of installing a compliant post-construction termite management system to help reduce the risk of future termite

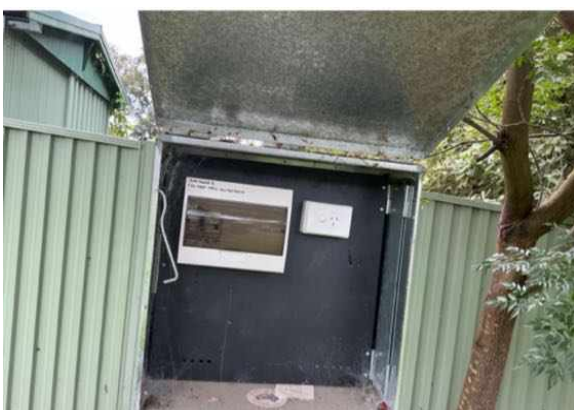
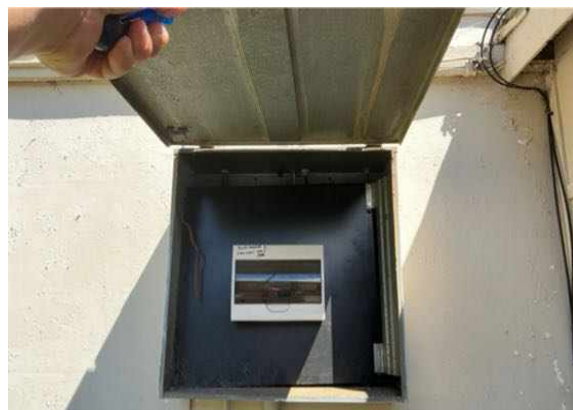
### Finding 6.01

Building:	Main Building
Location:	Meter Box
Finding:	Termite Management (No Evidence of a Chemical Installation)
Information:	During the inspection, it was noted that no termite management system had been installed, and there was no evidence of preventative works. Applying a post-construction chemical termite barrier is essential for all properties, as these barriers are highly effective in preventing termite attacks on timber building elements. A durable notice should also be prominently displayed in the meter box to ensure awareness of the termite barriers in place. It is important for the client to seek further professional advice on implementing a termite management system. Failure to address this leaves the property vulnerable to potential termite infestations.

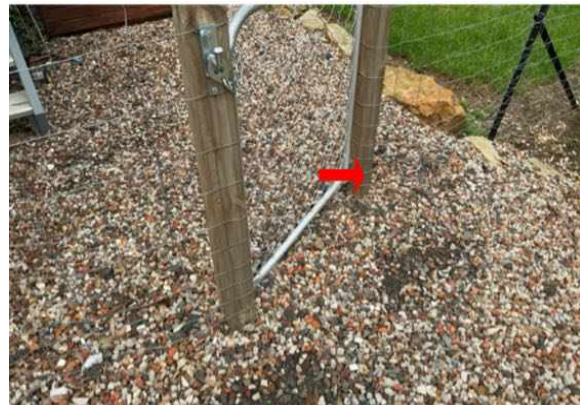
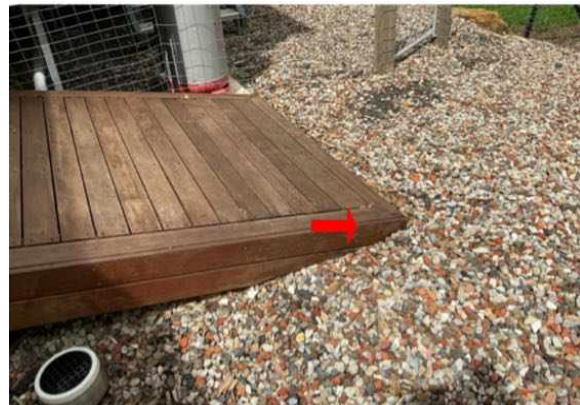
### Finding 6.02

Building:	Main Building
Location:	All Areas
Finding:	In Contact With The Ground

**Information:** During the inspection, wood and timber materials were observed in direct contact with the ground. This condition is highly conducive to timber pest activity, particularly termites, as it provides an ideal environment for infestation and timber decay due to elevated moisture levels, concealment, and direct access to cellulose material. Untreated or inadequately protected timber in ground contact significantly increases the risk of concealed termite entry and potential structural damage.

To reduce the risk of infestation, all ground-contacting timber should be promptly removed. It is recommended to engage a qualified pest control to assess the subfloor and implement appropriate termite management system, in accordance with AS 3660.2. Regular timber pest inspections, ideally every 90 days, are advised until all conducive conditions have been fully addressed.

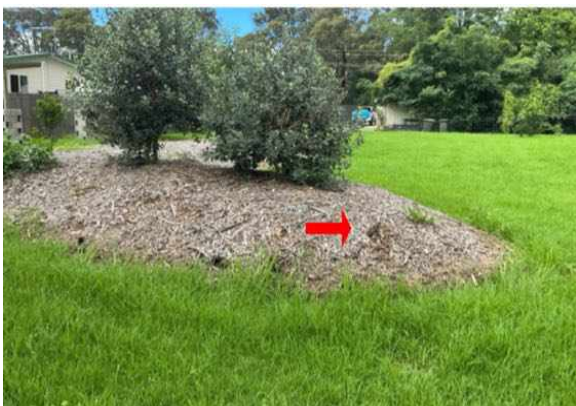
### Finding 6.04

Building:	Main Building
Location:	All Areas
Finding:	Wood-chip Garden Mulch (Conductive Condition to Termite Activity)
Information:	During the inspection, woodchip mulch was observed in the garden beds surrounding the property. While commonly used for landscaping, woodchip and other timber-based mulches are considered highly conducive to termite activity, as they provide both a food source and retain moisture, creating an ideal environment for termite nesting and concealed ingress into the structure.

In accordance with AS 3660.2 (Termite Management in and Around Existing Buildings), it is recommended to remove or replace wood chip mulch located close to the structure with a non-cellulose alternative, such as pebbles, crushed rock, or other inorganic materials. Doing so will significantly reduce the risk of attracting termites and improve long-term protection of the building.

Additionally, regular timber pest inspections are advised, ideally every 30 days, particularly where timber-based landscaping materials remain in place. These inspections will help monitor for early signs of termite activity and ensure ongoing compliance with termite management best practices.

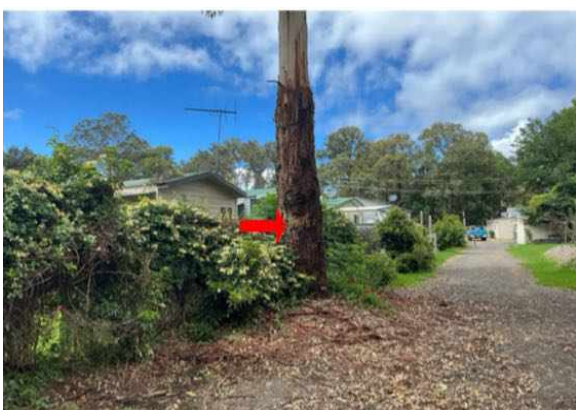
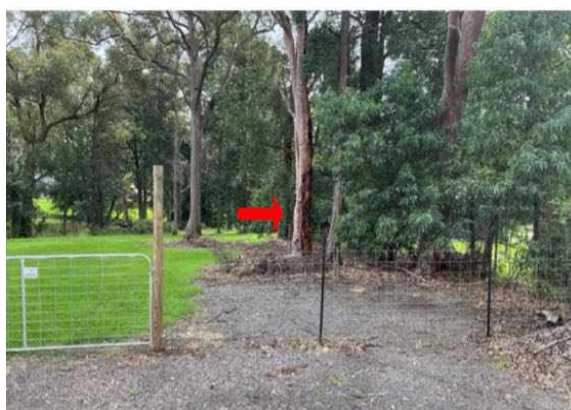
### Finding 6.05

Building:	Main Building
Location:	All Areas
Finding:	Trees / Tree Stumps
Information:	Trees and tree stumps located close to the building can provide ideal nesting conditions for termites. If left untreated, they may act as a direct pathway for termite access to the structure, increasing the risk of infestation.

To reduce this risk, it is recommended that any nearby stumps or high-risk trees be removed or professionally treated by a qualified pest control technician. Implementing these preventative measures, together with regular timber pest inspections, will assist in protecting the property and maintaining its long-term structural integrity.

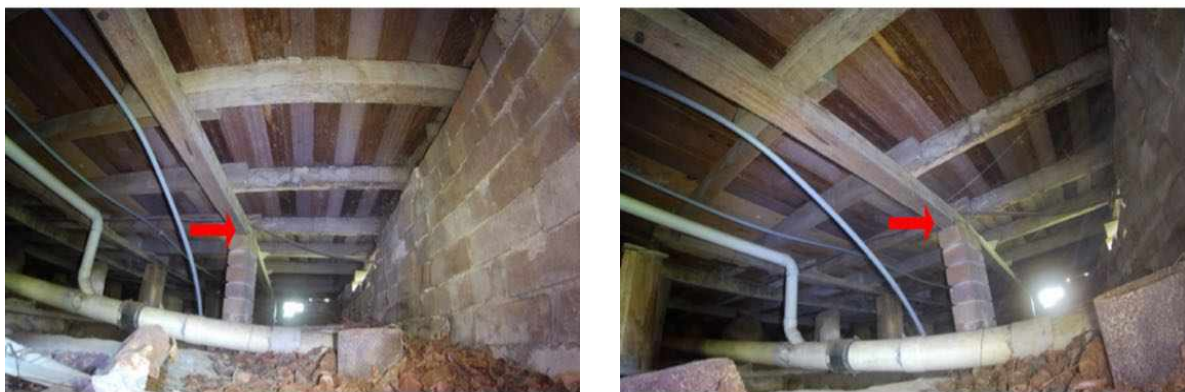
### Finding 6.06

Building:	Main Building
Location:	Ant Caps (Missing)
Finding:	Ant Caps (Missing)
Information:	During the inspection, it was observed that the ant caps were not missing in section of the subfloor structure. Typically, ant caps are placed at the junctions between the tops of piers or brickwork to facilitate the easy detection of termite or pest ingress. Their presence is crucial for monitoring and preventing termite migration from the piers to

the bearers.

Considering their absence, it is highly recommended to conduct regular monitoring of these areas to promptly identify any signs of termite or other timber pest activity. This proactive approach is essential for maintaining the structural integrity and preventing potential infestations. Furthermore, installing ant caps is advised to enhance the protection against termite entry and aid in the early detection of any pest issues.

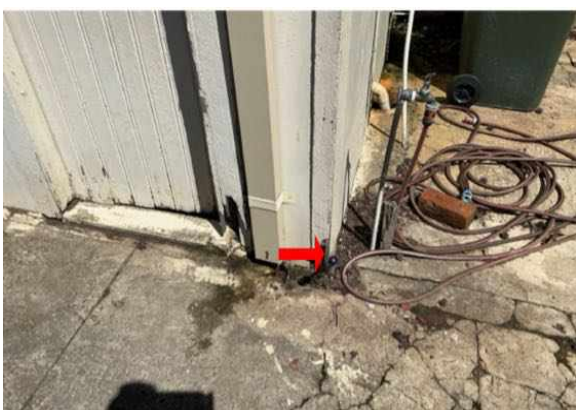
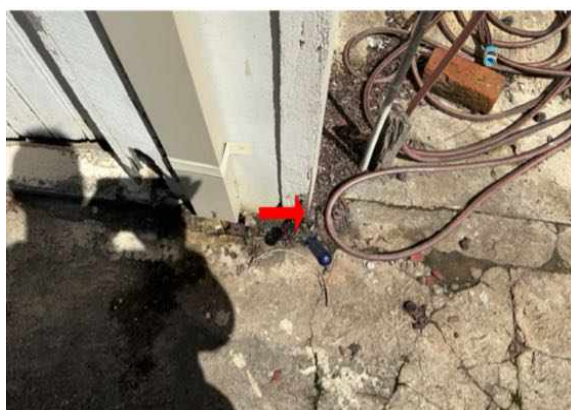
### Finding 7.01

Building:	Main Building
Location:	All Areas
Finding:	Wood Rot / Fungal Decay
Information:	Wood rot was found in the exterior timbers, a condition commonly caused by prolonged moisture exposure. This accelerates the decay process and creates an environment conducive to termite activity and fungal growth. To prevent further deterioration and reduce the risk of termite infestations, it is essential to replace the affected timber with treated or moisture-resistant alternatives. It is recommended to engage a qualified carpenter or landscaper to undertake the necessary replacements and ensure the long-term durability of the building materials.

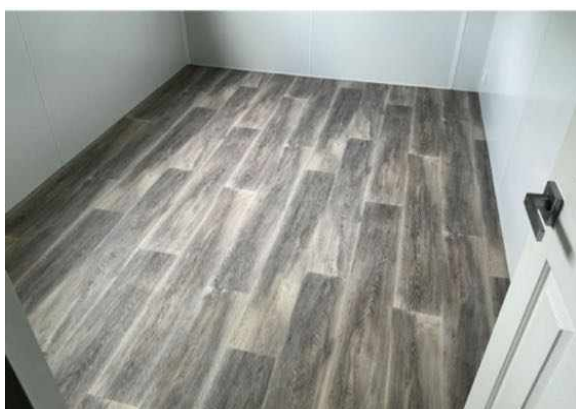
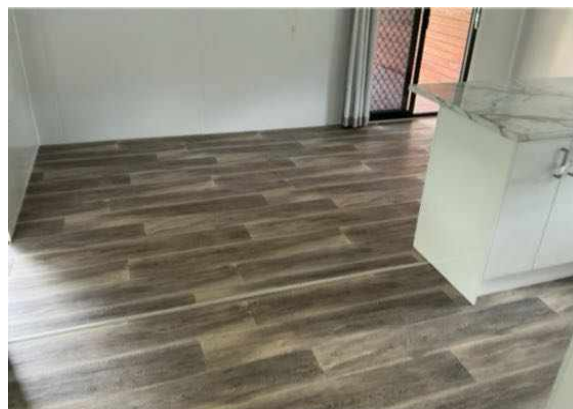
Building:	Out Building
Location:	Portable Structure
Finding:	Floor Squeaking
Information:	During the inspection, a the flooring produced a noticeable squeaking sound when walked across. This is commonly caused by friction between timber members or movement around nails or fasteners that have loosened over time. While typically not considered a structural concern, persistent squeaking can be a nuisance and may indicate minor movement or inadequate fastening.
