# Building and Timber Pest Inspection Report

Inspection Date: Thu, 15 Jan 2026

Property Address: 12A Tower Pl, Rutherglen VIC 3685,  
Australia

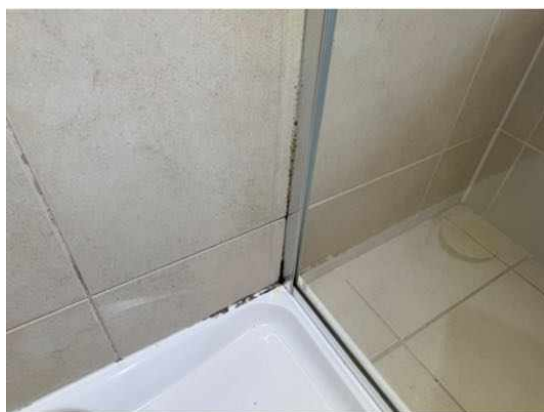
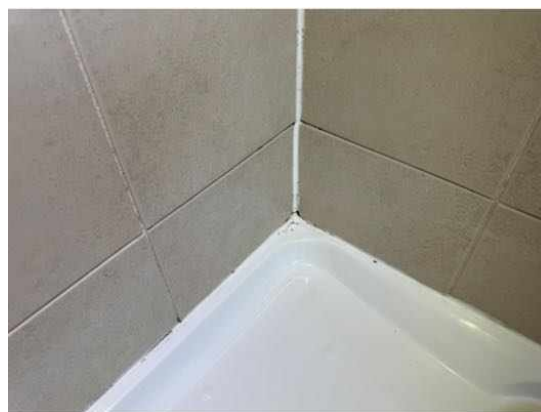
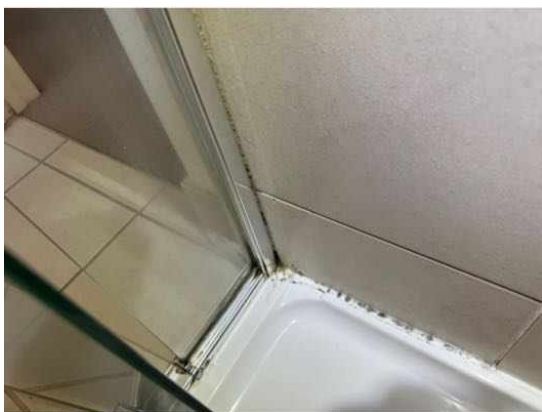
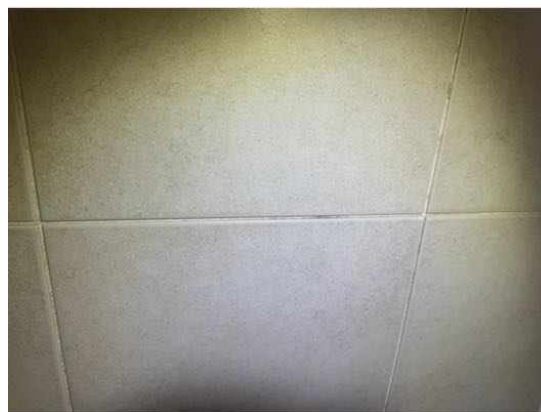
#### Finding 3.01

Building: Main Building  
Location: Tiled Areas  
Finding: Sealant and grouting - deteriorated/missing & mould growth  
Information: It appears areas of the sealant and grout were weathered / deteriorated, a common defect in houses of a similar age. Light mould growth was also evident to areas of the shower. Sealant and grouting in areas that come into regular contact with water should be maintained.

Recommend engaging a tiling contractor to provide maintenance works. Mould growth should be cleaned / removed by a cleaning contractor promptly.

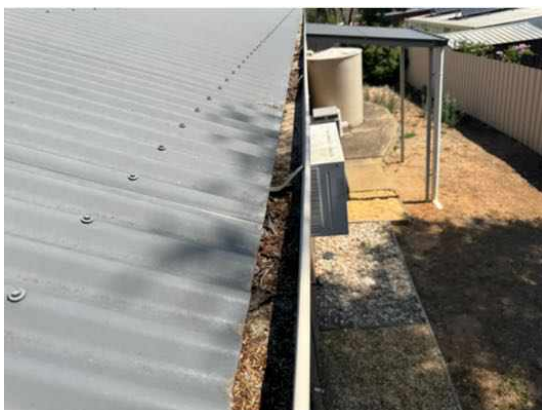
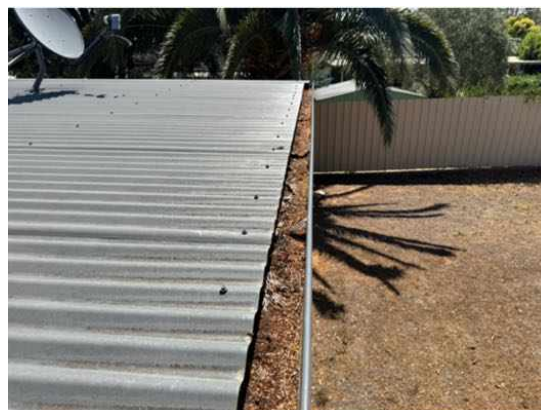
### Finding 3.02

Building:	Main Building
Location:	Guttering
Finding:	Debris in Gutters
Information:	Some debris was present in the gutters. Accumulation of debris can lead to blockages and accumulated water overflows, if neglected.

Recommend engaging a general handyman to remove debris from the gutters to prevent blockages.

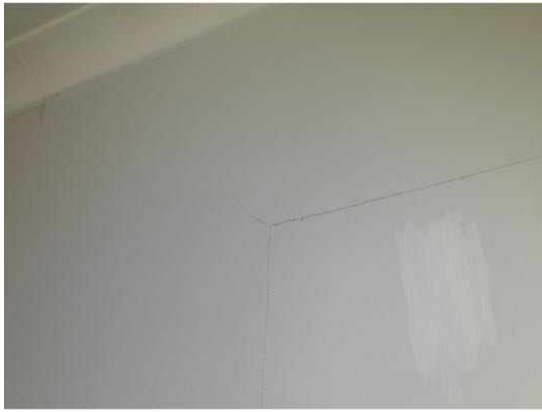
### Finding 3.03

Building:	Main Building
Location:	All Internal Areas
Finding:	Plaster - Minor Cracking
Information:	Minor cracking was identified to some areas throughout the building. Cracking of this type is common in buildings of a similar age. Although this is mostly a visual defect, it is advised that the client monitor these areas.

Should cracking widen, lengthen, or become more numerous, the client should consult with their building inspector to provide further advice.

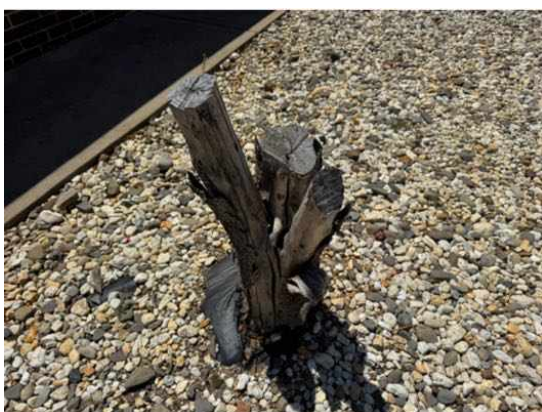
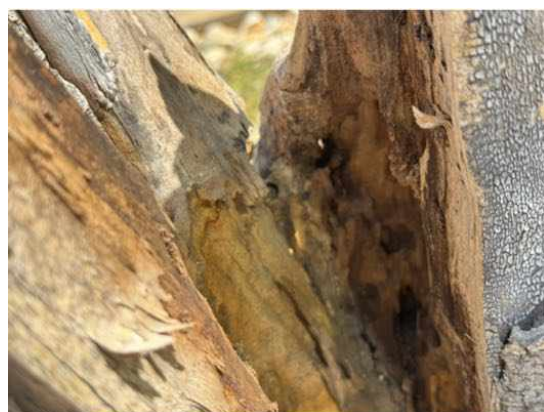
### Finding 5.01

Building: Main Building  
Location: Tree Stump  
Finding: Evidence of termite workings & damage  
Information: Although no live termite activity was identified at the time of inspection, termite damage & workings were identified at, but not limited to, the front tree stump.

The client should engage a licensed pest controller in the short term, to provide further advice regarding installation of a termite treatment.

12 monthly ongoing termite inspections, conducted by a qualified termite inspector, are also recommended

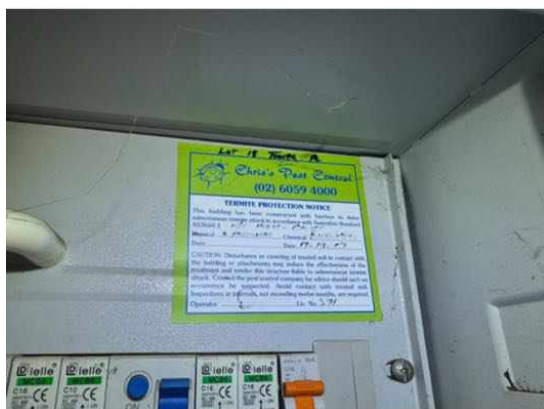
## Finding 6.01

Building:	Main Building
Location:	Switchboard
Finding:	Expired Termite Treatment
Information:	A durable notice has been installed in the meter box, indicating that a previous termite management system has been installed.

The sticker indicates that the year of installation was 2007, meaning the chemical barrier has now expired.

Such barriers are highly effective in preventing termite attack on the building and therefore should be installed. The client should engage a licensed pest controller to provide further advice regarding application of a termite treatment.

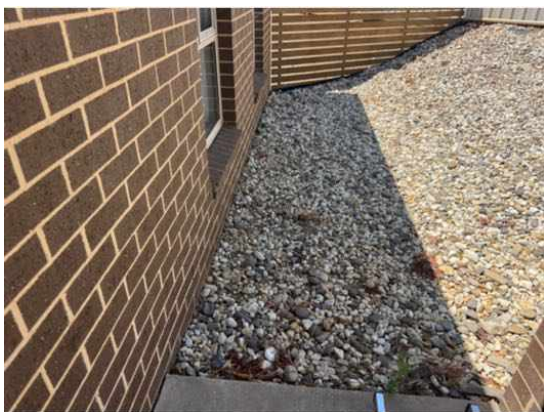
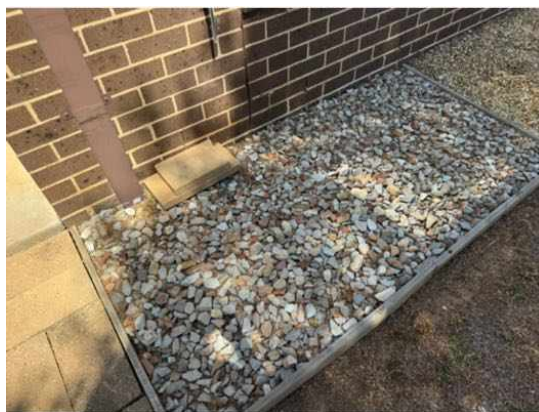
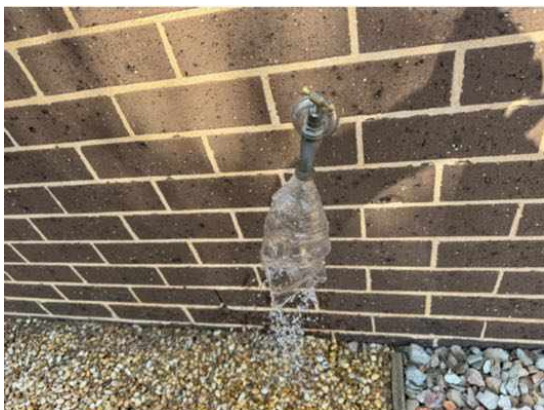
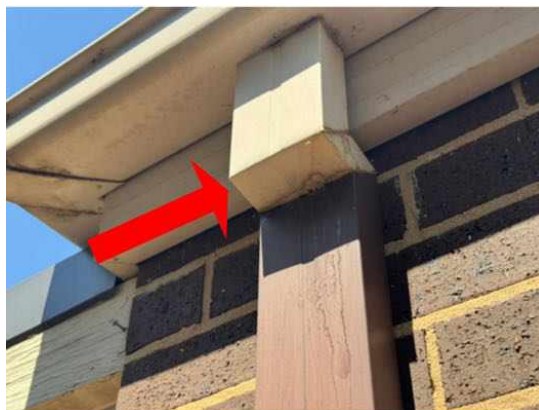
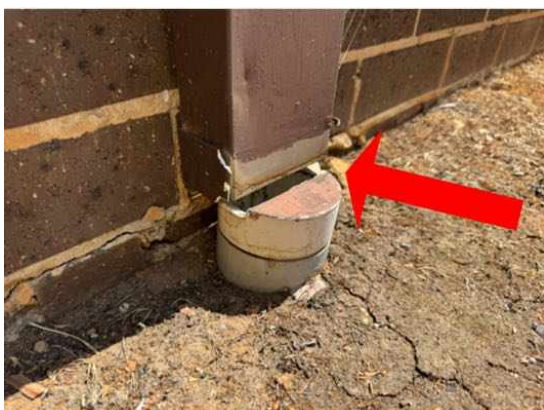
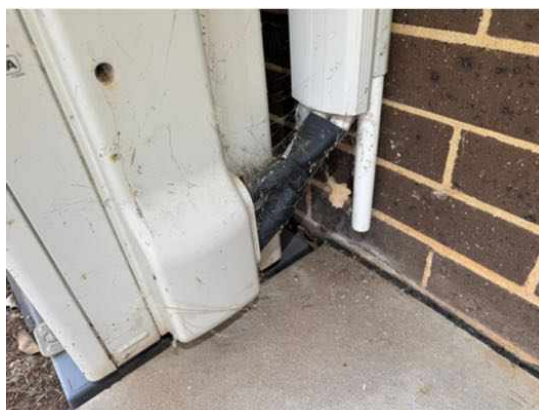
## Finding 6.02

Building:	Main Building
Location:	All external areas, Roof Plumbing
Finding:	Potential Water pooling - against property
Information:	Potential areas of water pooling around the perimeter of the property were identified. Some areas of minor damage were identified to the roof plumbing.

Where insufficient drainage of taps, roof plumbing, & aircon overflows, and garden beds against the house are present, water pooling is likely to occur, and can create areas conducive to timber pests.

Recommend consulting with a licensed plumber and/or landscaping contractor to provide further advice & maintenance works.

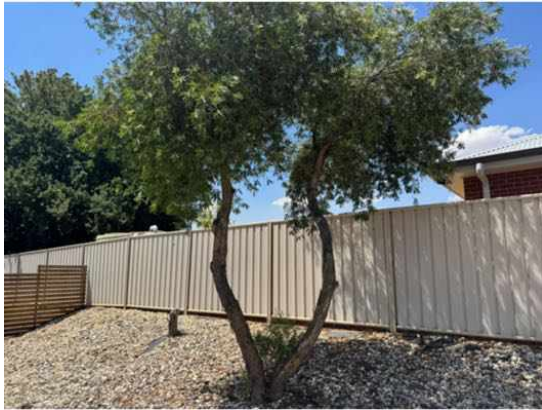
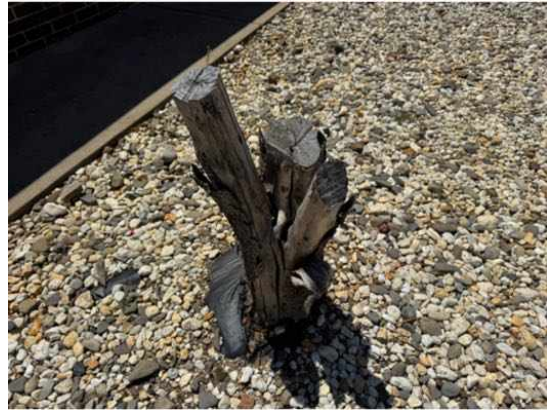
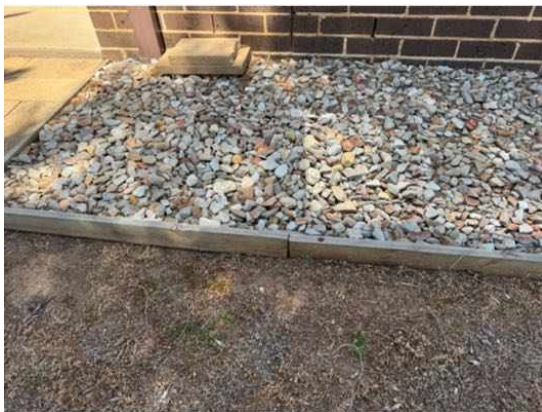
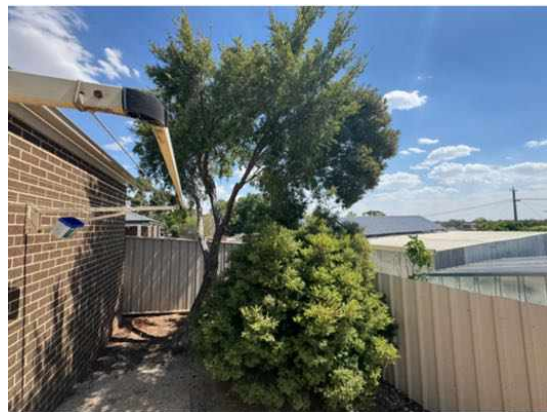
**Finding 6.03**

Building: Main Building  
 Location: All External Areas  
 Finding: Timber in direct ground contact & trees - conducive to termites  
 Information: Where timber materials are in direct contact with the ground and consequently moisture, they become conducive to termite activity. The landscaping timber's, and trees & stumps surrounding the building create an environment conducive to termite infestation.

Where feasible, any timbers in direct contact with the ground should be removed and any trees in close proximity to the building should be removed or test drilled (inspected) at least annually to reduce the risk of termite infestation & detect any early

signs of termite activity.

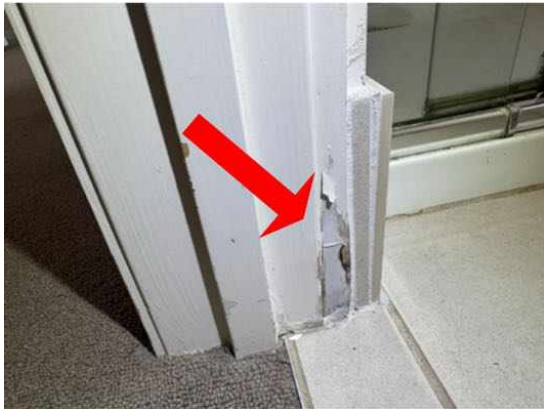
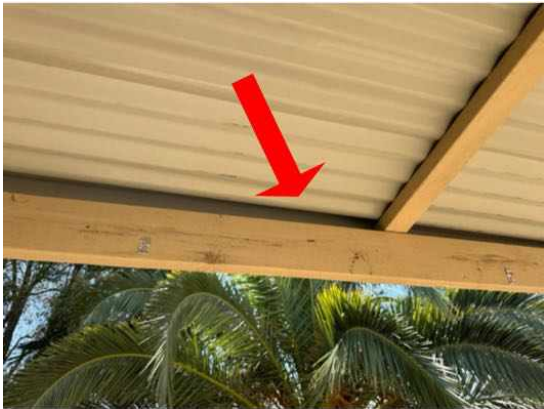
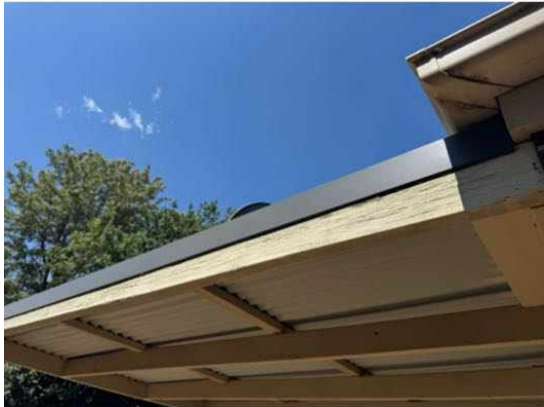
### Finding 7.01

Building:	Main Building
Location:	Patio Framing, Architrave
Finding:	Fungal decay & weathering
Information:	Areas of fungal decay (wood rot) & general weathering were identified at but not limited to the base of the bathroom architrave, and to areas of the patio framing. Recommend engaging a licensed painter to provide maintenance works where necessary, to prolong the life of the materials.

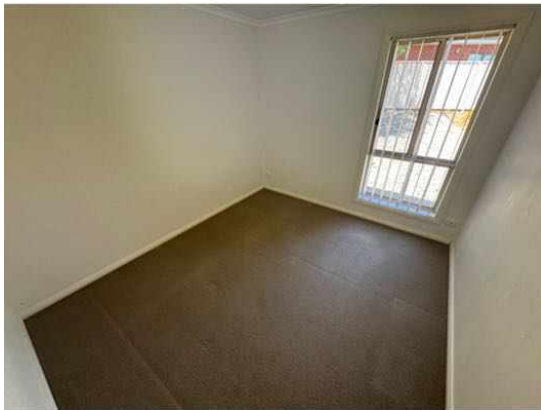
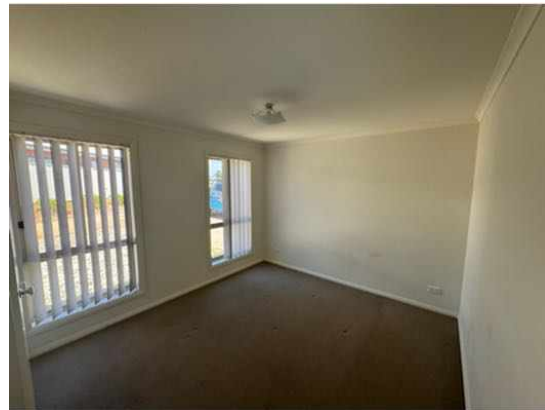
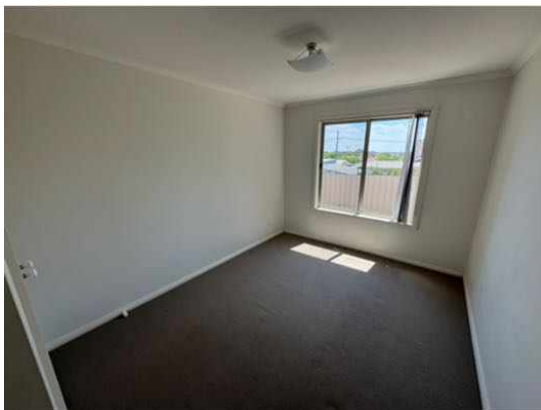
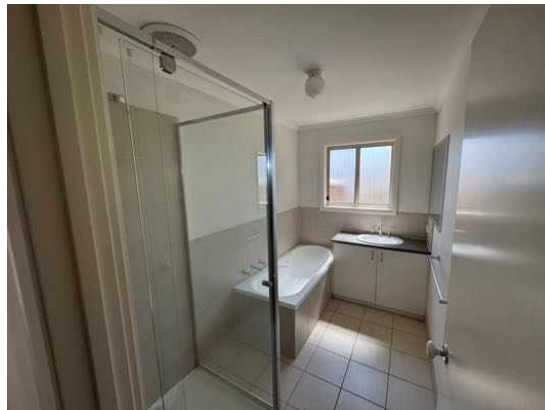
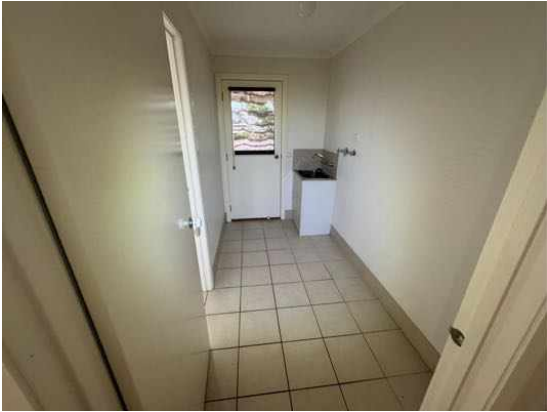
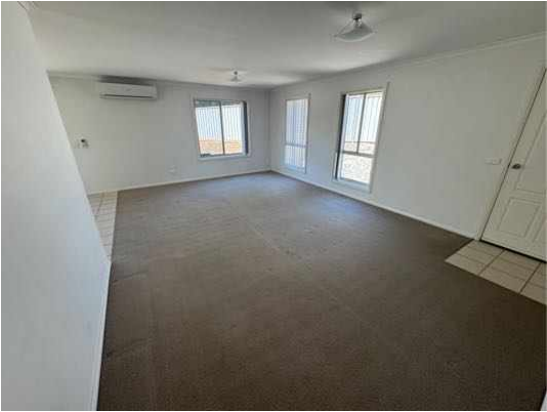
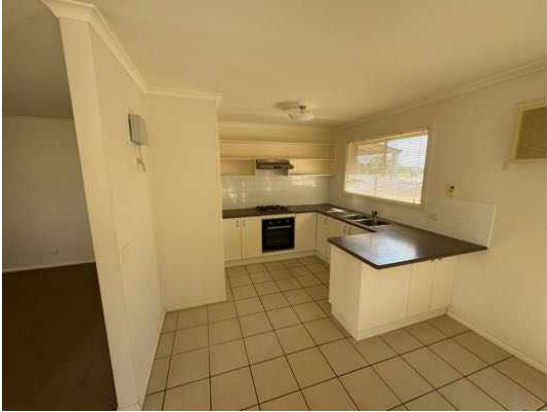
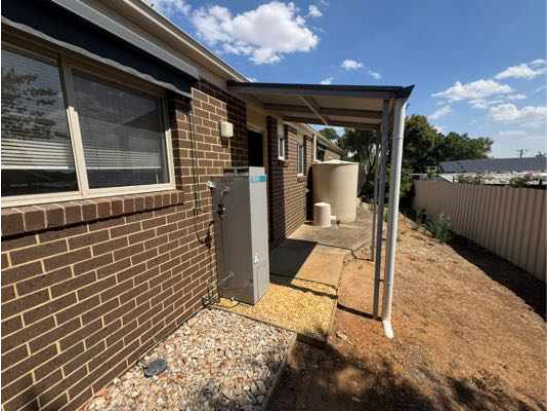
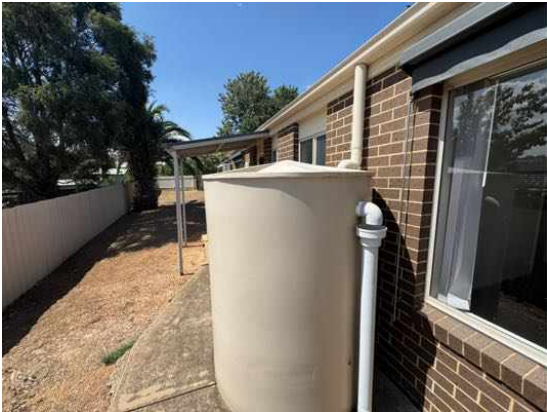
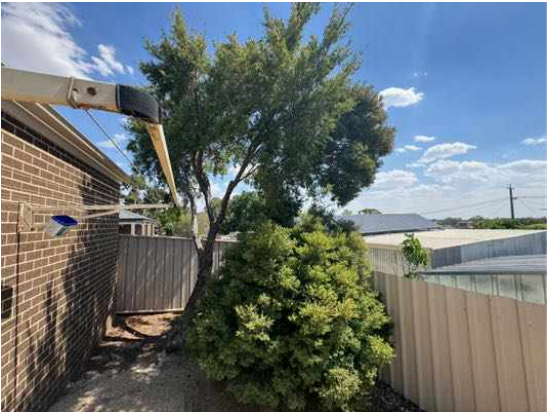
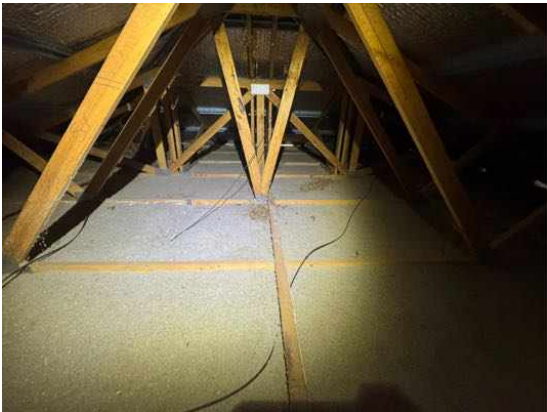
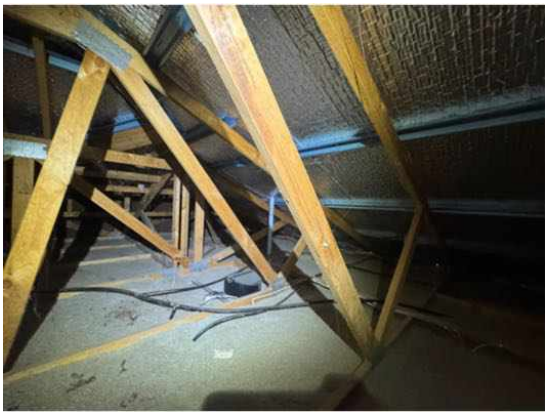
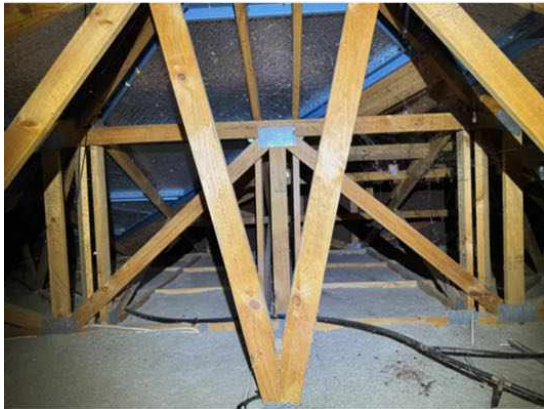
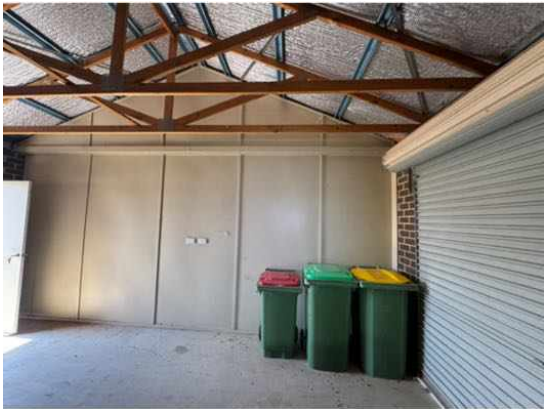
Building: Main Building  
Location: All Areas  
Finding: Additional Photos - Obstructions and Limitations  
Information: These photographs are an indication of the obstructions and limitations which impeded full inspection of the property at the time of inspection. These obstructions can hide an array of defects and should be removed to allow full inspection to be carried out. A re-inspection is recommended once the areas are made accessible.

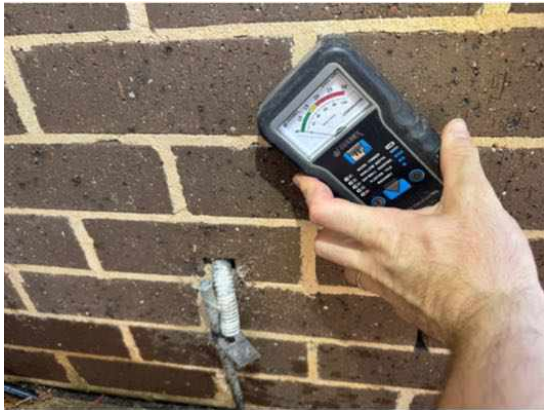
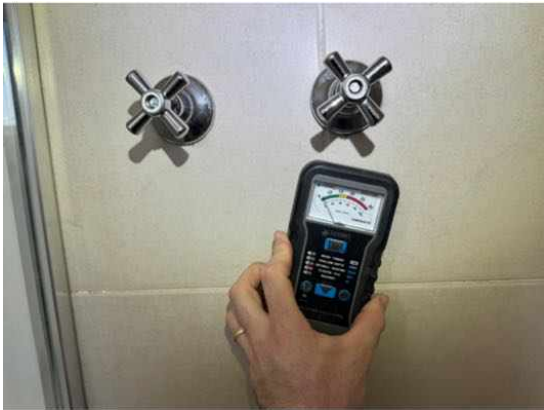
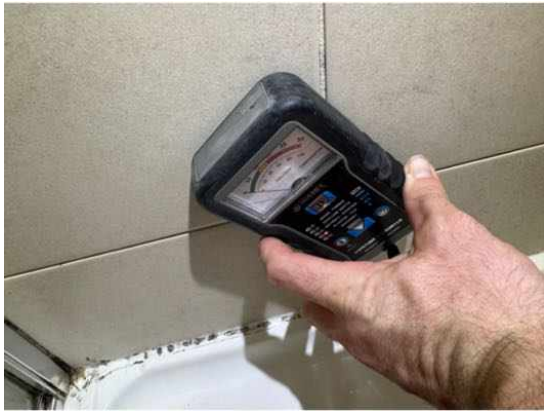
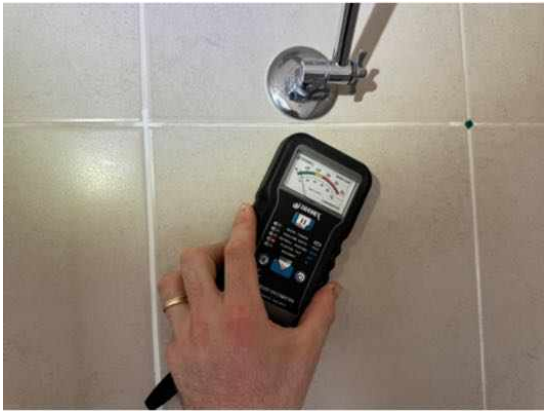
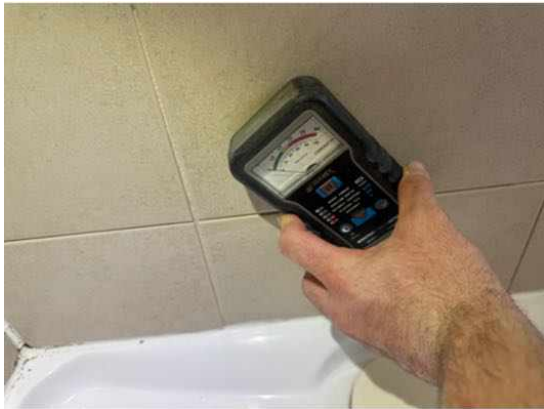
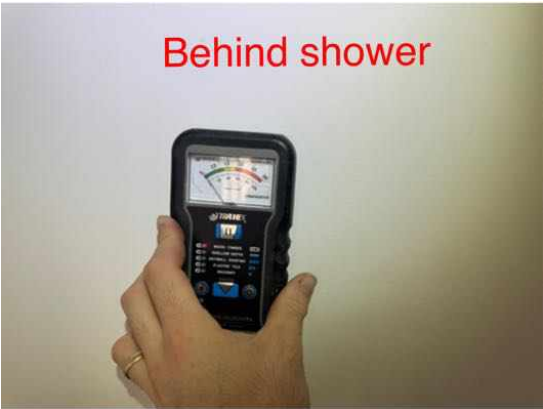
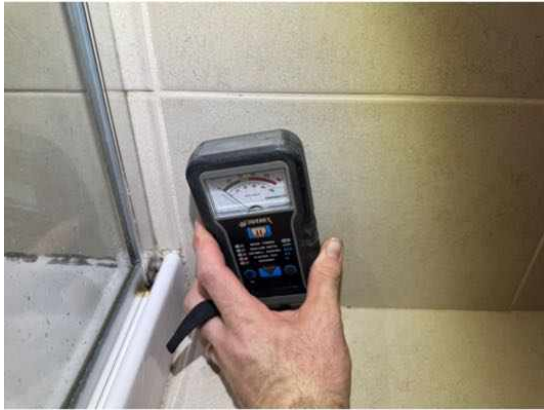
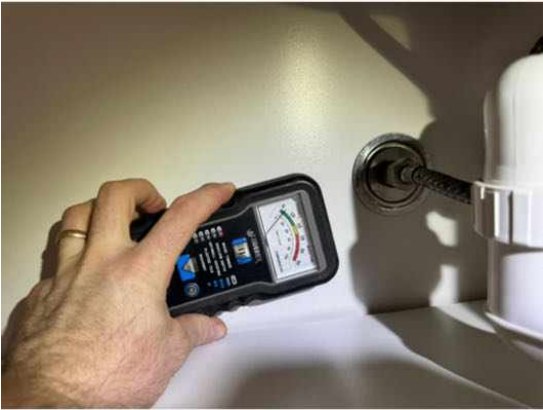
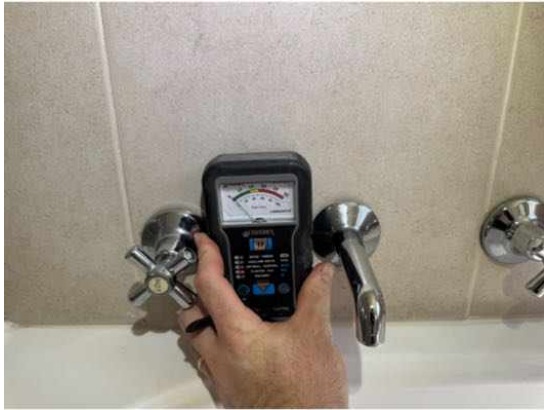
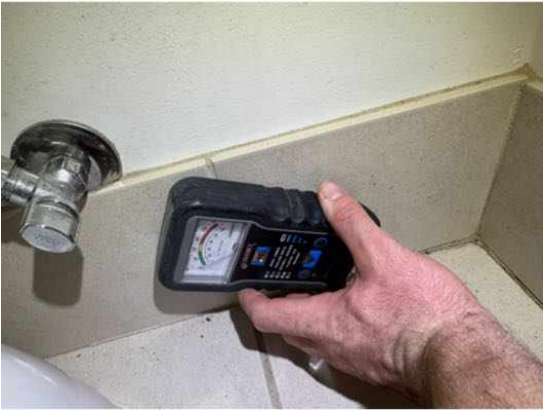
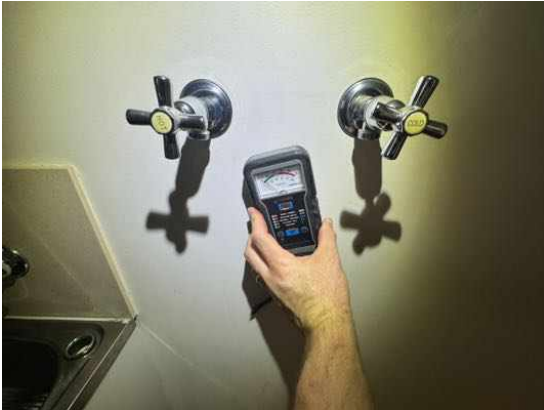
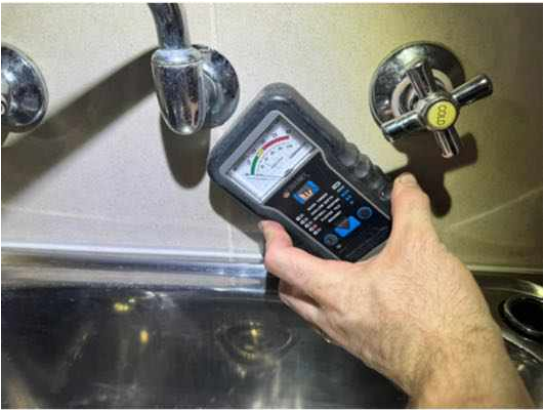
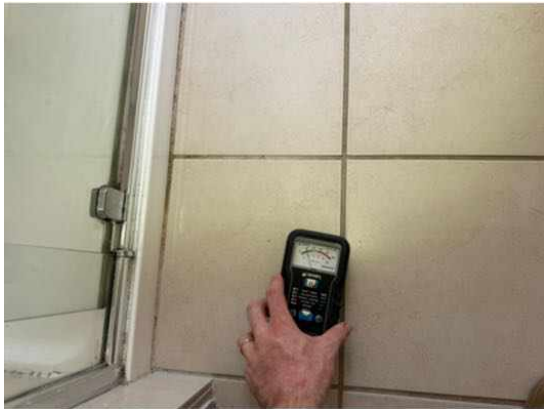
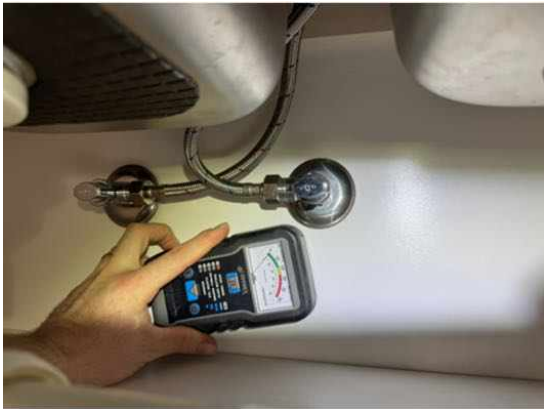
Building: Main Building  
 Location: All Areas  
 Finding: FYI Moisture Readings  
 Information: These photos are the moisture readings taken near plumbing fixtures and fittings and behind shower walls for your information.

No high moisture was evident in these areas at the time of inspection.

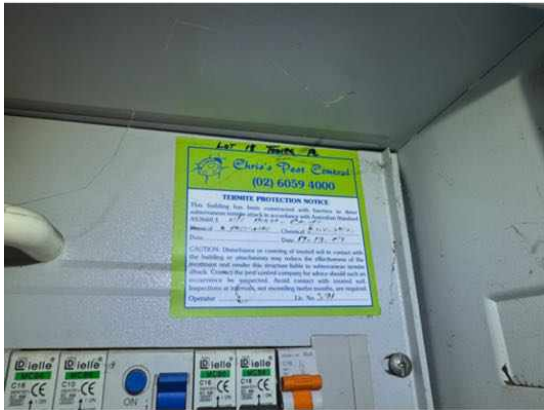
- Building: Main Building
- Location: Switchboard
- Finding: Evidence of a previous termite management system (meter box - expired)
- Information: A durable notice has been installed in the meter box, indicating that a previous termite management system has been installed.

The sticker indicates that the year of installation was 2007, meaning the chemical barrier has expired. Therefore, a termite treatment is strongly recommended. The client should engage a licensed pest controller to provide further advice regarding application of a termite treatment.
