Building and Timber Pest Inspection Report

Inspection Date: Wed, 18 Feb 2026

Property Address: 38 Ross St, Gladesville NSW 2111, Australia

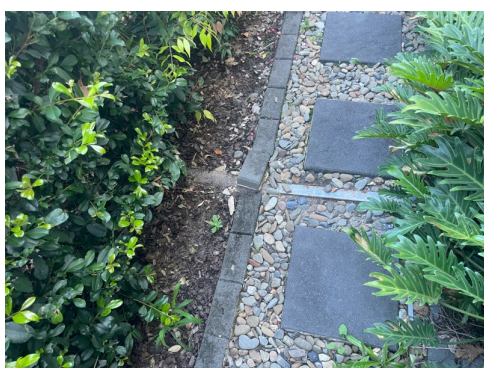
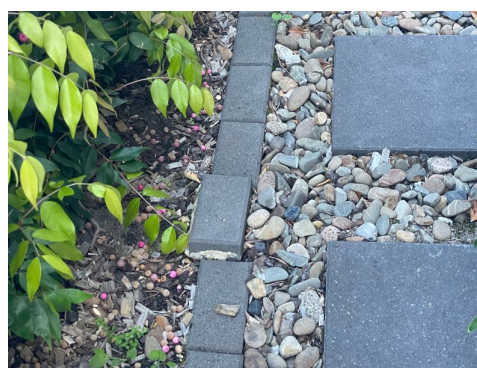
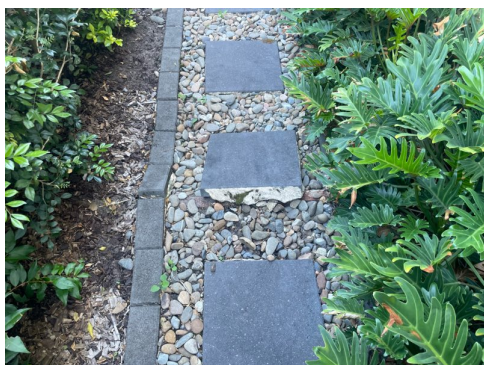
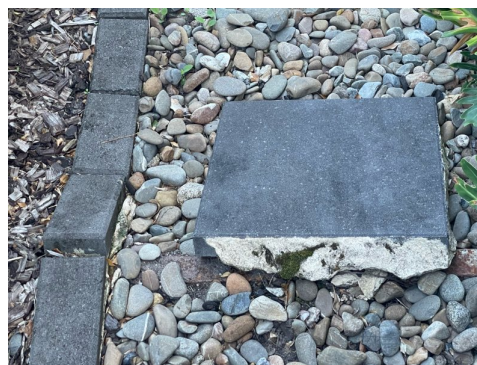
Finding: Trip Hazard Due to Travel Barrier on Ground

Information: A travel barrier (such as a raised edge, lip, or obstruction) was observed on the ground, creating a potential trip hazard. This feature, if left unaddressed, could cause individuals to trip or stumble when walking through the area.

The barrier may be the result of unfinished construction work, improper installation, or wear and tear over time. If it's an intentional feature (e.g., part of a boundary or threshold), it has not been adequately designed or installed to minimize tripping risks.

A trip hazard presents a safety risk, particularly in high-traffic areas. It could lead to personal injury or falls, which may result in liability issues for the property owner or manager.

It is strongly recommended to contact a properly qualified tradesperson as soon as possible to address this issue. The barrier should be either removed or modified to ensure the surface is level and safe for pedestrian traffic. If the barrier is necessary for design or function, it should be re-engineered to meet safety standards.

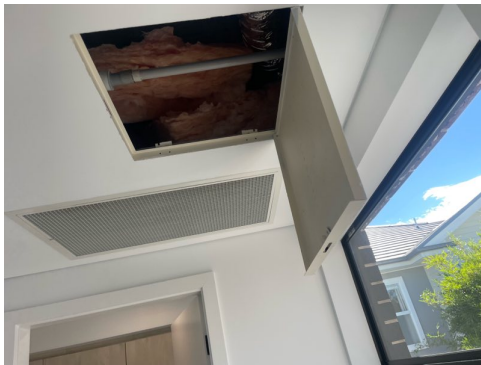
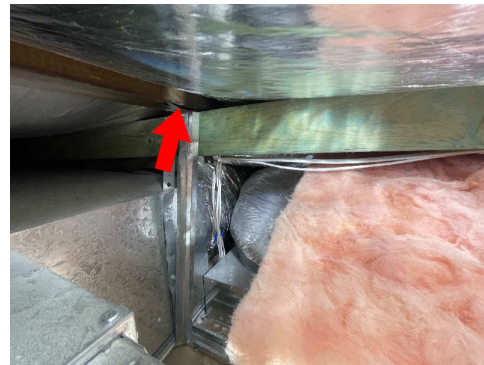
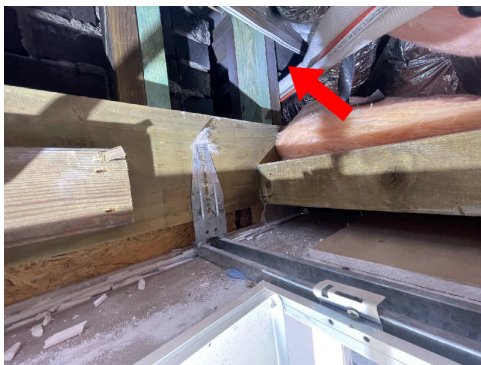
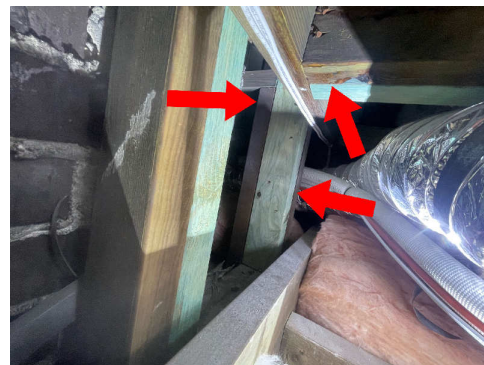
Finding 2.01

Information: During inspection of the roof cavity, sections of timber framing were observed to exhibit surface charring consistent with previous exposure to heat or fire. The affected members form part of the primary roof structure. In several locations, timber elements appear to have been replaced or locally repaired; however, the extent and structural adequacy of these remedial works could not be verified at the time of inspection.

The presence of charring may result in a reduction of the effective cross-section of timber members and consequently diminish their structural capacity. No engineering certification, building approval, or supporting documentation was provided to confirm that the rectification works comply with relevant structural requirements, including AS 1684, or that the load-bearing capacity of the affected members has been fully reinstated.

Accordingly, this condition is assessed as a major defect due to the potential structural implications, unless the vendor provides adequate documentation demonstrating that the remedial works have been properly designed, assessed, and certified by a suitably qualified structural engineer. In the absence of such evidence, further specialist assessment is warranted to confirm the adequacy and ongoing structural performance of the roof framing system.

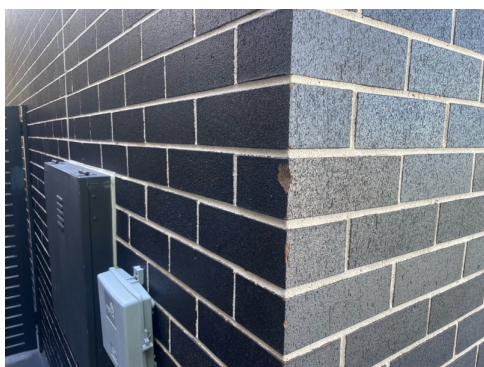
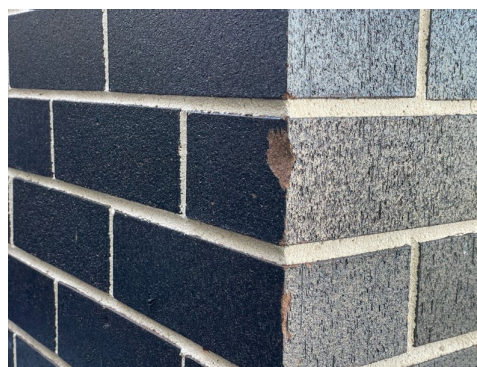
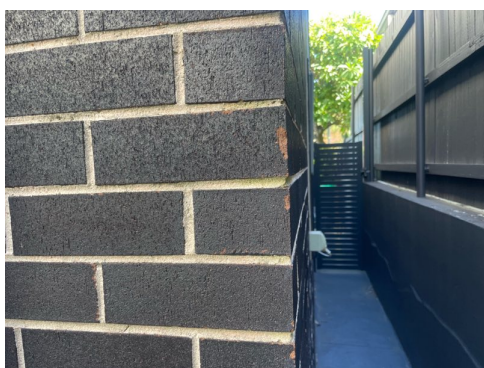
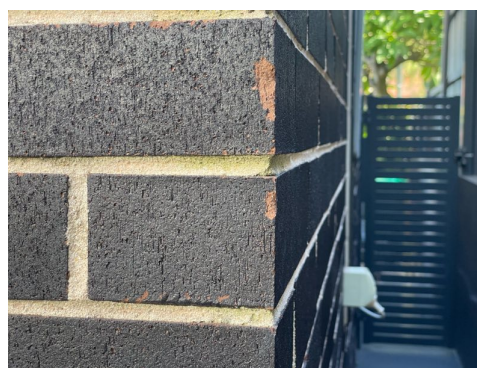
Finding 3.01

The surface of this building element appears to have chipped as a result of general wear and tear. While being an appearance defect, such damage is expected of a property of this age and condition.

Chipped surfaces rarely impede on the structure or functionality of the affected building element and generally only create a blemish on its appearance. Chipped surfaces may be left in situ at client discretion, as no repairs or replacement are necessarily required. However, the client may wish to seek quotations for the cost of refurbishment or replacement of the identified building element.

A qualified bricklayer should be appointed to repair chipped surfaces and replace building elements where major damage has occurred.

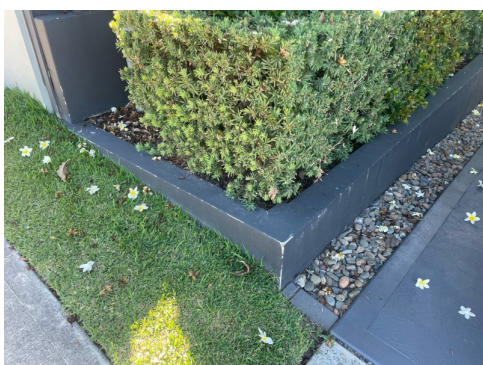
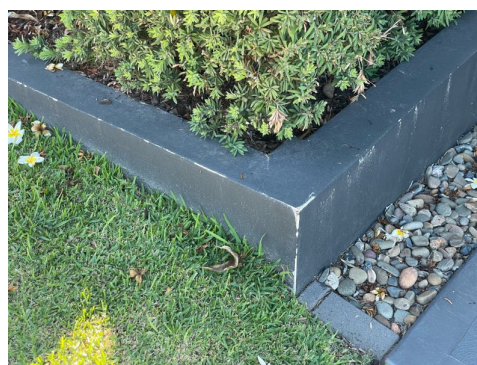
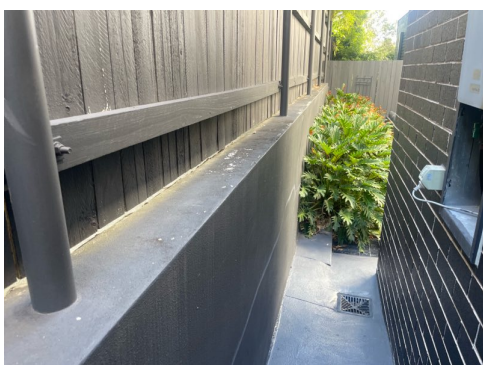
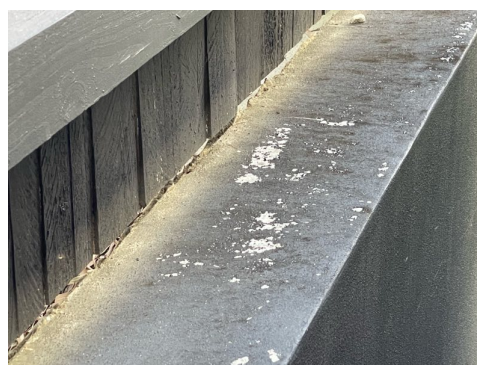
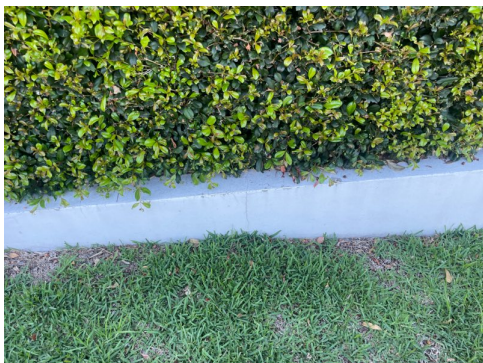
**Finding 3.02**

Finding: External painting deteriorated

Whilst incomplete or missing paint finish is generally an appearance defect, it can also lead to the development of secondary building defects over time. Incomplete areas of paint finish expose the area to moisture, potentially accelerating the deterioration of underlying building materials.

Degraded paint finishes should be sanded back, filled, leveled and painted, as applicable. Where inadequate or missing paint protection has led to the deterioration of the associated building element, repair and/or replacement of this building element may be required.

A painting contractor should be appointed as soon as possible to perform necessary works to aid the appearance of the affected area and to ensure the area is protected against further deterioration. Alternatively, the homeowner following manufacturer instructions may perform these works.

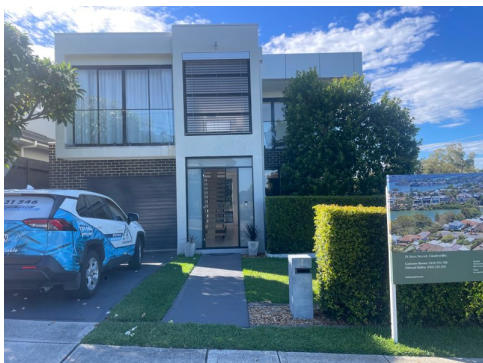
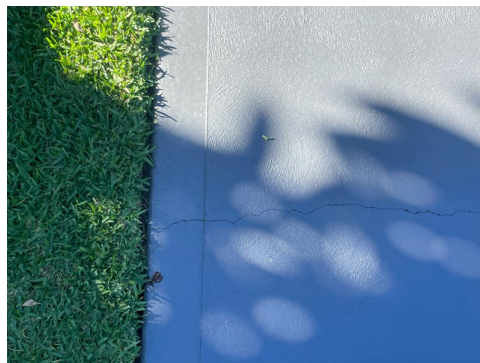
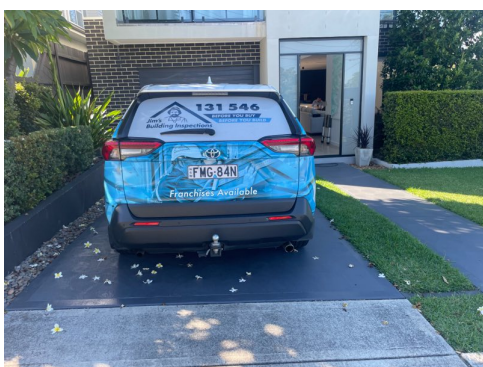
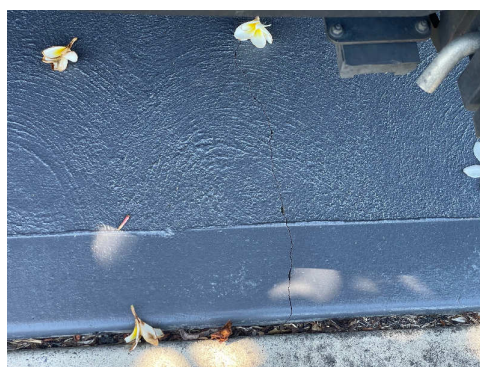
Finding 3.03

Building:	Main Building
Location:	Driveway / Footpath
Finding:	Cracking - External Concrete Paving Damage Category 1 - Fine (less than 2mm)

Information: Fine cracks were identified in external concrete paving. Although fine cracks are quite noticeable, they are often only considered to be an appearance defect, and usually do not indicate any structural damage. To be considered a Category 1 or fine crack, the crack is found to be less than 2mm in width.

Generally the cause of a hairline crack in existing concrete paving such as driveways and pathways is indicative of the expansion and contraction of the concrete. Such causes are generally due to environmental factors, such as moisture levels, weather conditions, root systems of nearby trees or the soil types on which they are laid.

Fine cracks may also be due to poor original installation of the concrete. Factors such as poor compaction of the sub surface and/or inadequate reinforcing of the slab may create cracking and other secondary defects.

Monitoring of all cracking should be conducted frequently. Always contact a building inspector should cracks widen, lengthen, or become more numerous.

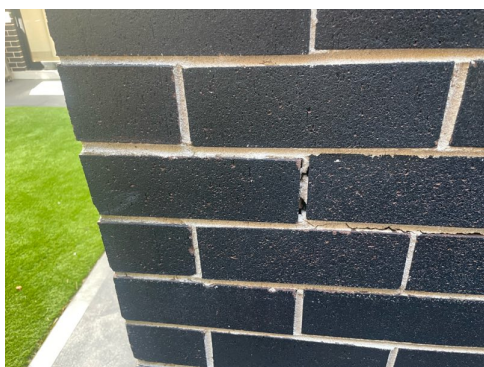
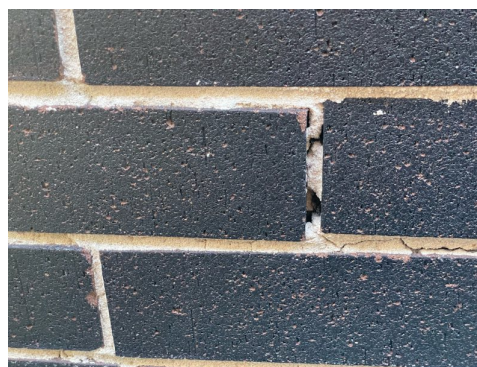
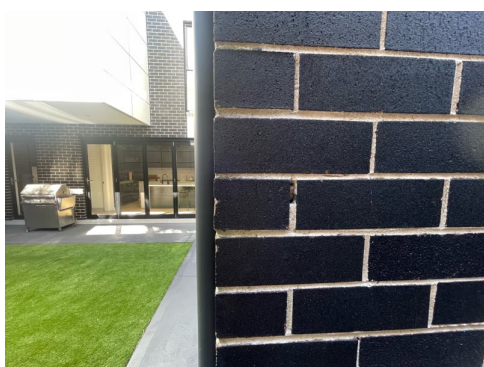
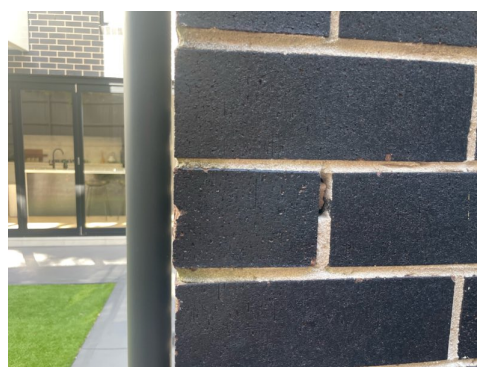
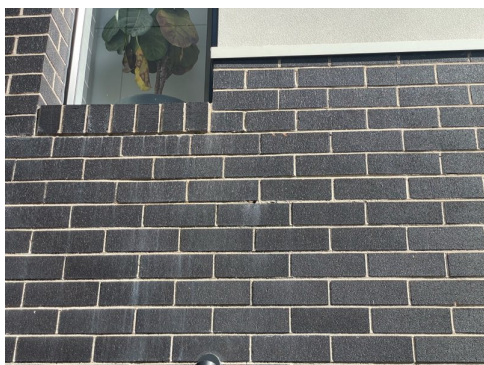
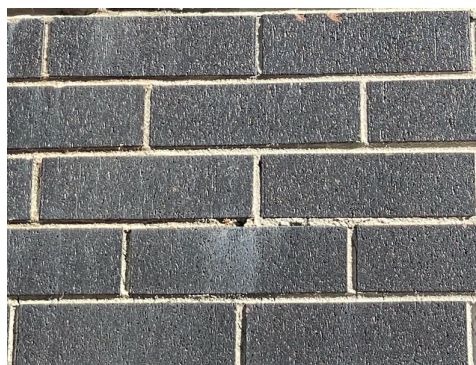
Finding 3.04

Building: Main Building
Location: Exterior walls - left side
Finding: Brickwork - Deteriorated mortar

Mortar, or 'bedding', is the material which fills joins and intersections between bricks in masonry walls and structures. Sections of mortar in this brickwork were identified as having deteriorated, which is generally expected for a property of this age and condition.

Mortar may deteriorate as a result of age of building materials, minor movement of bricks, or frequent exposure to weathering. Mortar should be replaced to ensure that bricks remain in their intended location and to prevent gaps, which would allow water or moisture ingress and secondary damage as a result.

Mortar deterioration can be addressed by a bricklayer where areas of deterioration are localised and easily accessible. Alternatively, appointment of a registered builder is advised, to repoint large areas of decaying mortar. Where secondary structural defects have become evident, consultation with a structural engineer may be required.

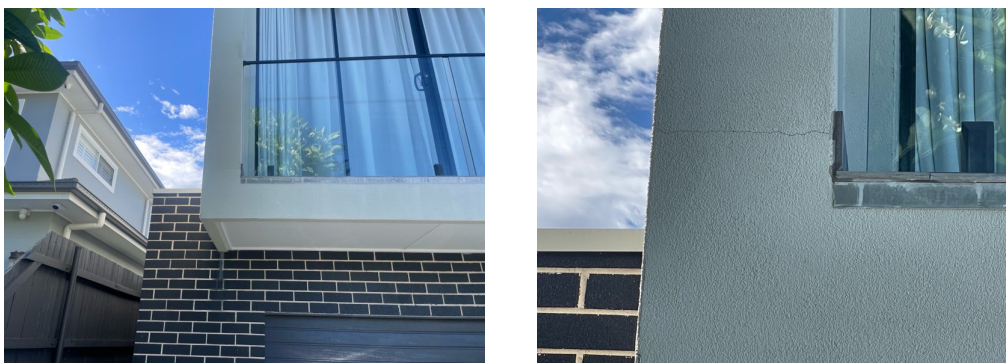
Finding 3.05

Finding: Fine Crack in External Render

Information: A fine crack has developed in the external render. The crack may be superficial but could potentially allow moisture ingress over time, which might lead to further damage to the render and underlying wall structure.

The crack does not appear to be affecting the structural integrity of the building, but it could allow water penetration, which may cause deterioration of the render or the wall behind it if left unaddressed.

It is recommended that a qualified plasterer or render contractor assess and repair the crack. The crack should be cleaned, sealed, and re-rendered as required to restore the wall's weatherproofing. This repair should be completed prior to handover to ensure the external walls remain fully protected against water damage.

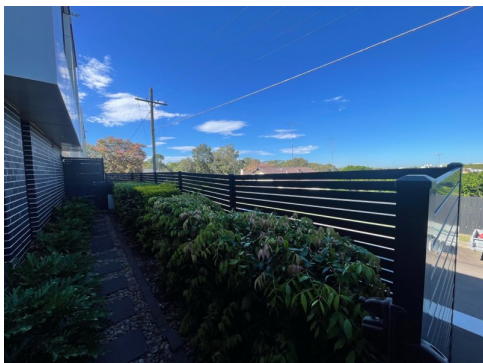
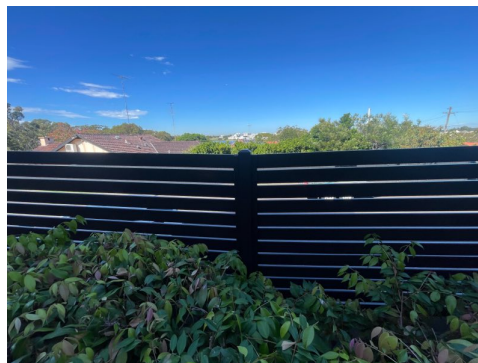
Finding 3.06

Information: During inspection, a perimeter fence post was observed to be misaligned and out of plumb along the boundary fence line. The affected post deviates from vertical alignment when compared with adjacent posts, resulting in a minor irregularity in the overall fence line.

The condition appears consistent with minor installation inaccuracy or slight footing settlement following construction. There is no evidence of structural failure or immediate safety concern; however, the misalignment detracts from the visual uniformity of the fence and does not reflect a reasonable standard of finish.

This matter is considered a minor defect associated with substandard workmanship. Monitoring is recommended, and rectification may be undertaken by the responsible contractor to restore vertical alignment and maintain consistency with adjoining fence posts.

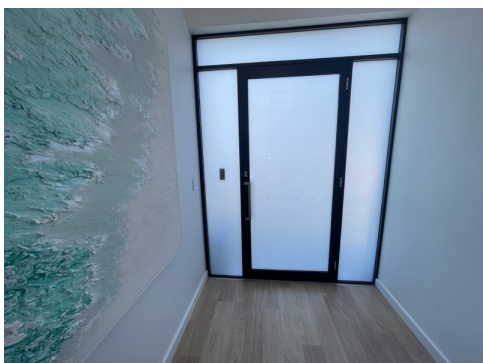
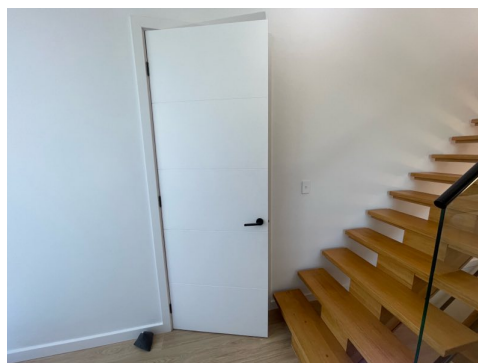
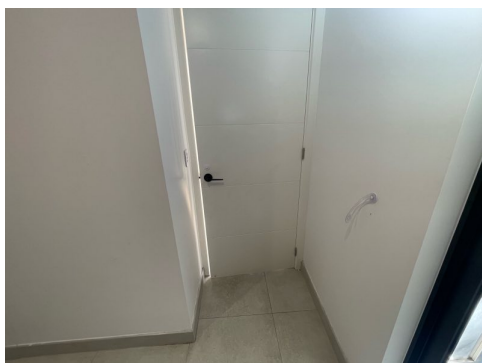
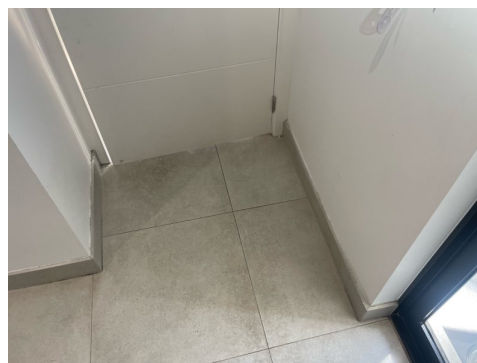
Finding 3.07

Finding: Door - Missing Stopper

Information: During inspection, it was noted that one internal door does not have a door stopper installed. Without a stopper, the door handle is at risk of striking the adjoining wall or architrave, which may lead to surface damage over time.

This is a minor but important fitting that protects both the door and surrounding finishes.

It is recommended that a suitable door stopper be installed to this door to prevent impact damage and ensure proper functionality.

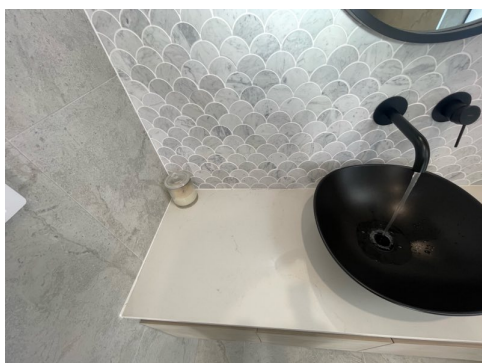
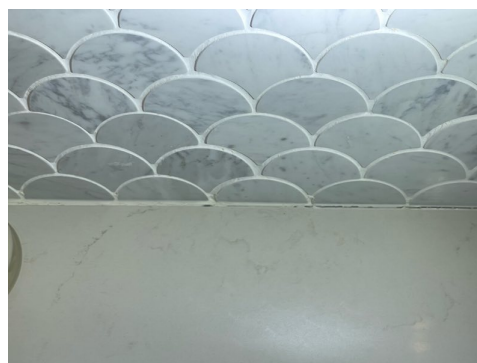
Finding 3.08

Finding: Cabinetry – Missing or Deteriorated Corner Sealant

Information: The cabinetry was observed to have missing or deteriorated sealant at the internal corners. In some areas, the sealant had not been applied, while in others it had broken down and no longer provided an effective seal.

Incomplete or deteriorated sealant can allow water, moisture, or debris to penetrate behind cabinetry panels, which may lead to swelling, staining, or damage to the cabinetry materials over time. It also detracts from the overall finish and appearance of the installation.

This matter is considered a maintenance defect. It is recommended that the affected cabinetry corners be re-sealed by a suitably qualified tradesperson to restore protection and appearance.

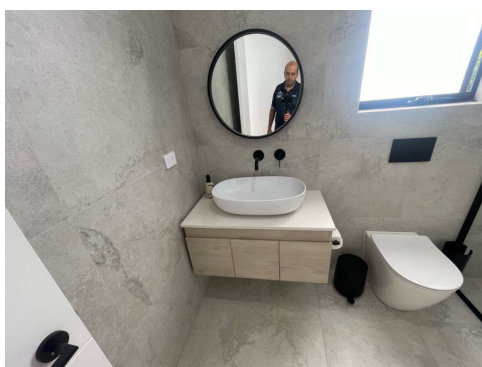
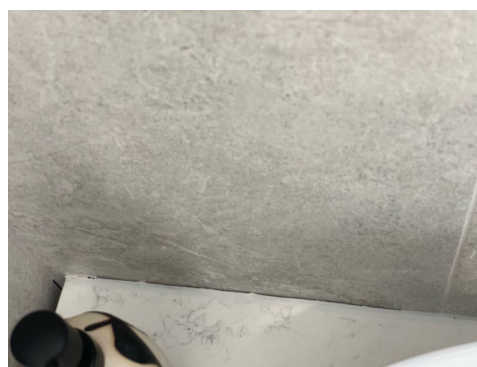
Finding 3.09

Finding: Cabinetry – Missing or Deteriorated Corner Sealant

Information: The cabinetry was observed to have missing or deteriorated sealant at the internal corners. In some areas, the sealant had not been applied, while in others it had broken down and no longer provided an effective seal.

Incomplete or deteriorated sealant can allow water, moisture, or debris to penetrate behind cabinetry panels, which may lead to swelling, staining, or damage to the cabinetry materials over time. It also detracts from the overall finish and appearance of the installation.

This matter is considered a maintenance defect. It is recommended that the affected cabinetry corners be re-sealed by a suitably qualified tradesperson to restore protection and appearance.

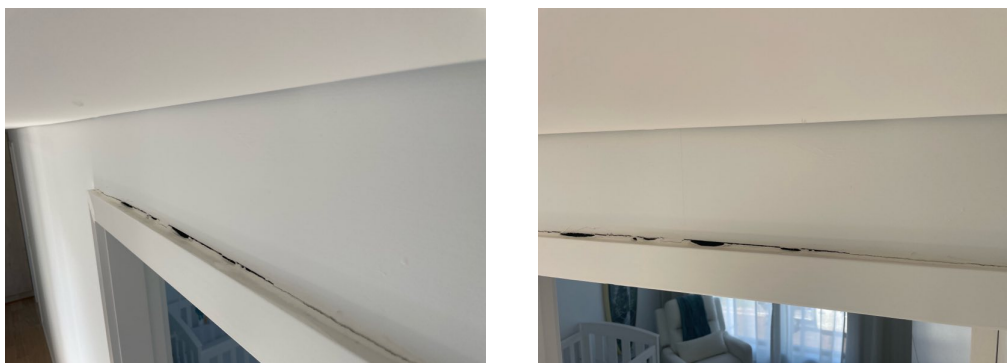
Finding 3.11

Such gaps may arise from a range of factors including minor framing movement, differential settlement, inadequate fixing of the door frame, shrinkage of surrounding materials, or workmanship deficiencies during installation. Where gaps occur at the head or base of door frames, they may also be associated with uneven flooring, hinge sagging, or minor foundation movement. While foundation movement is relatively common in residential construction and does not necessarily indicate structural failure, any visible separation at door openings warrants attention to prevent water ingress, air leakage, and potential long-term deterioration.

It is recommended that a suitably qualified carpenter assess the installation and undertake remedial works as required to restore proper alignment and ensure the junction between the door frame and wall cladding is adequately sealed and finished to a reasonable standard.

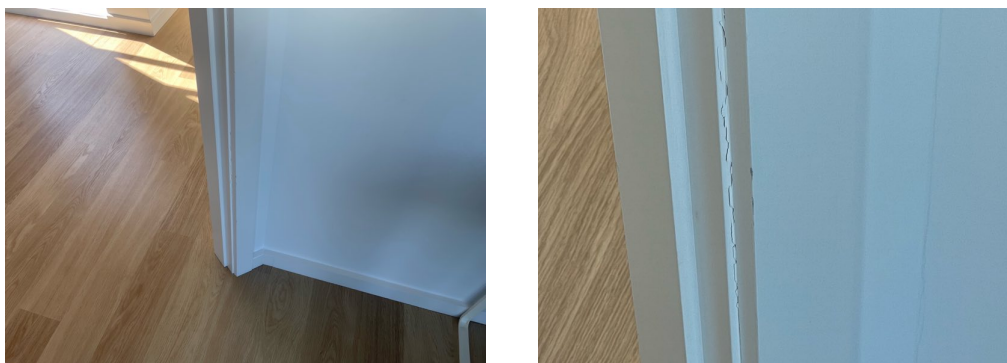
Finding 3.12

Finding: Paint – Superficial Cracking on Surface

Information: During inspection, superficial cracking was observed to the painted surface finish. The cracking is fine and limited to the paint layer, presenting as minor hairline or crazing patterns to the affected wall surface.

The condition appears consistent with normal paint shrinkage during curing, minor substrate movement, or application over inadequately prepared surfaces. There was no evidence at the time of inspection to indicate structural cracking within the underlying wall substrate.

This matter is considered a minor defect relating to surface finish only. While not structurally significant or urgent, the cracking detracts from the overall presentation and finish quality. Rectification may involve surface preparation and repainting by a suitably qualified trade where required.

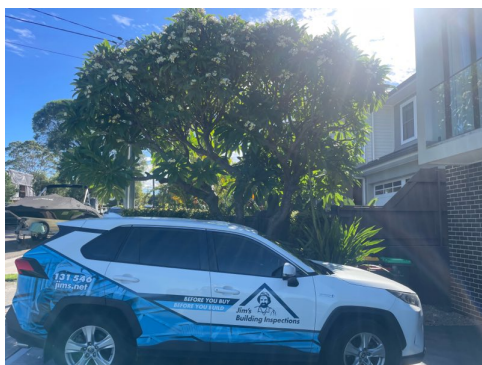
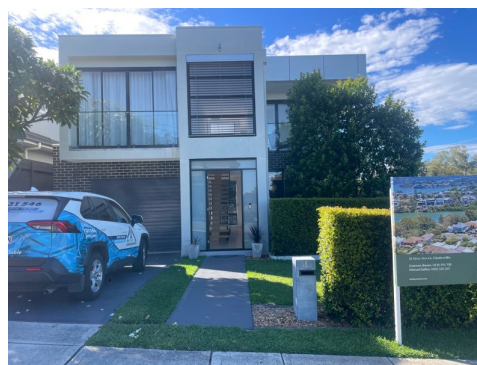
Finding: Large trees/stumps within 30m of house

Information: There are a number of large trees/stumps within 30m of the house which may contain natural termite activity. It is important to monitor these areas to ensure no natural activity is allowed to progress into the main house. Regular inspections are recommended. Consider test drilling any large trees. A pest controller can be contacted to carry out such testing at the owners discretion.

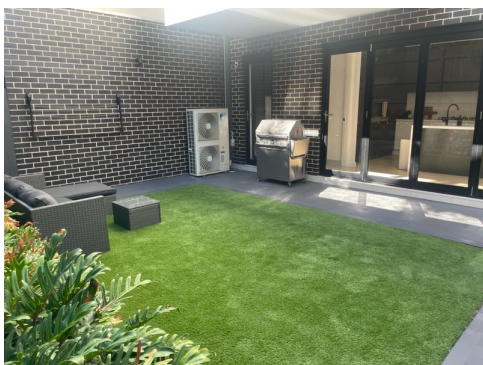
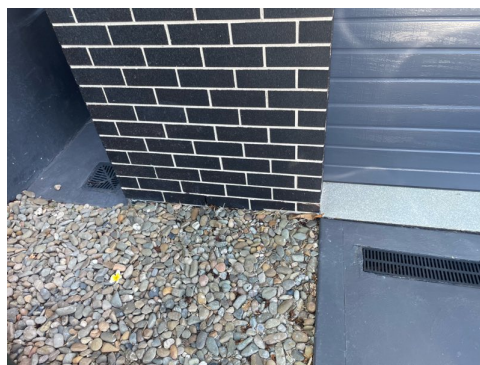
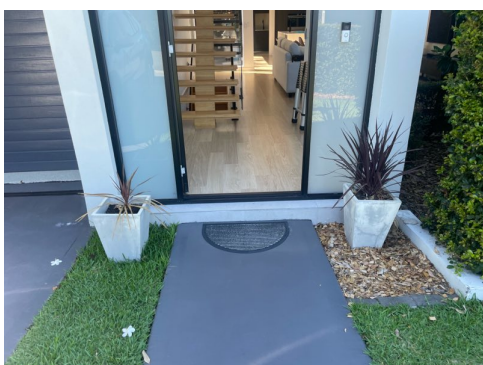
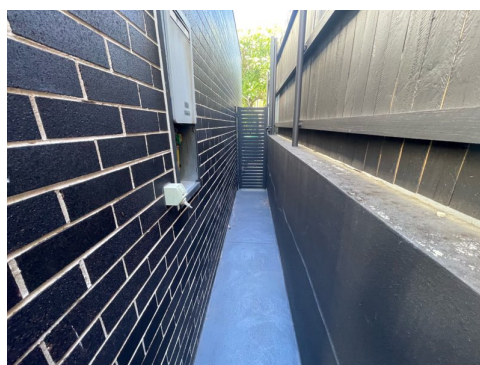
Finding 6.03

Building:	Main Building
Location:	All Areas - Slab Edge
Finding:	Slab Edge - Exposure

If the slab edge is not properly exposed there is a high risk of termite attack. Sometimes, in order to determine the type of slab, a suitably qualified person such as an architect or builder may be required to consult the construction plans.

Where the slab edge cannot be properly inspected, it is highly recommended that termite or timber pest inspections be carried out every 6-12 months to aid protection of the property against infestation.

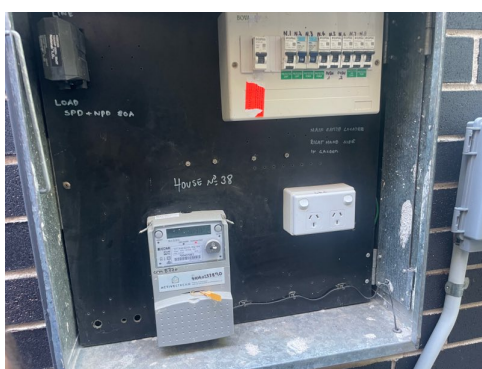
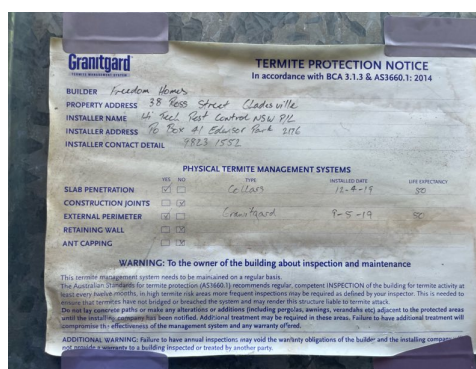
The following items were noted as -Evidence of a previous termite management program

It is recommended that the client confirms whether annual termite inspections have been carried out since installation and obtains copies of any inspection records, warranties and treatment certificates. Where inspection records are incomplete, absent or indicate that inspections have not occurred as recommended, further advice from a licensed termite management specialist is recommended.

If the existing system is assessed as compromised, incomplete or out of warranty, a new termite management plan for the property may be required. This may include installation of a new chemical soil treatment or barrier system in accordance with current Australian Standards and manufacturer requirements, followed by ongoing inspections at least annually, or more frequently in high-risk conditions.
