Building Inspection Report

Inspection Date: Thu, 5 Mar 2026

Property Address: 206/5 Dunlop Ave, Ropes Crossing NSW
2760, Australia

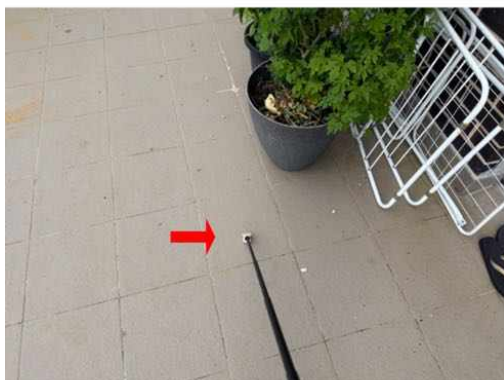
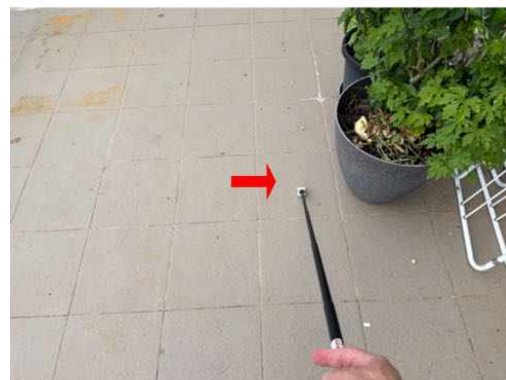
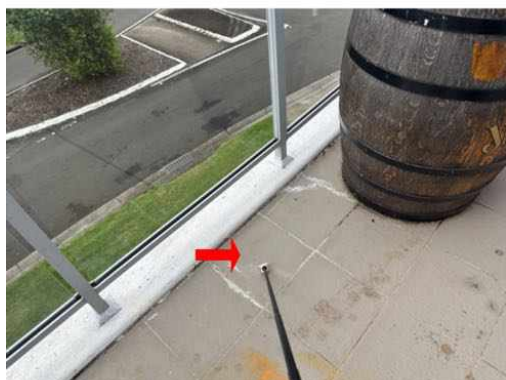
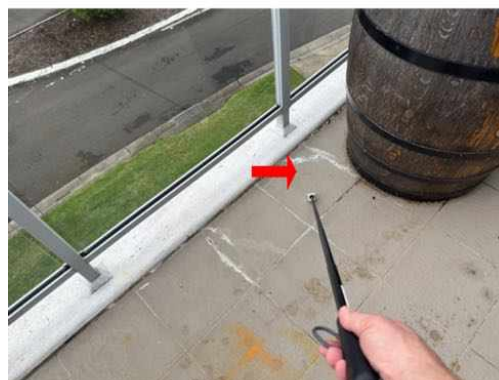
Defects 2.01

Building: Main Building
 Location: Verandah > Rear Right
 Finding: Tiles - Drummy
 Information: Drummy tiled areas were identified at the time of inspection. The term 'drummy' refers to tiles that have become detached from their fixing, despite otherwise being in relatively good condition. Such defects are generally caused by physical or moisture damage to the area. Drummy tiled areas may also be a direct result of poor workmanship during the construction process.

Tiled areas may swell and shrink with changes in air humidity if the area has sustained moisture damage. Any exposure to moisture is capable of causing tiled areas to become drummy and/or cracked over a prolonged period of time. Drummy tiled areas generally require removal and replacement of affected tiles, with adequate sealant and grouting.

Specialist trades are available for these types of services. A registered builder may be required to undertake works if damage is extensive or if secondary building defects have resulted. Otherwise, it is advised that a tiling contractor be appointed to perform works as necessary. Immediate action is recommended to ensure that no further damage is sustained in the affected area.

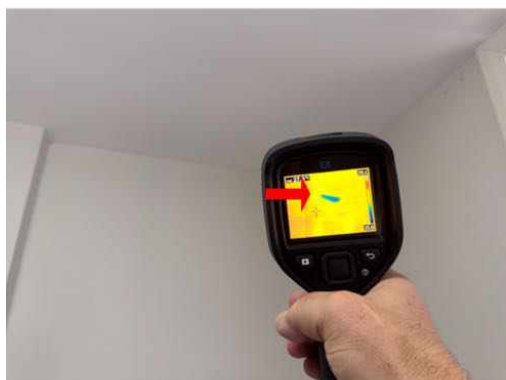
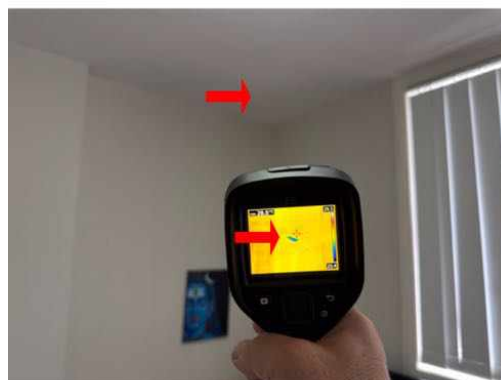
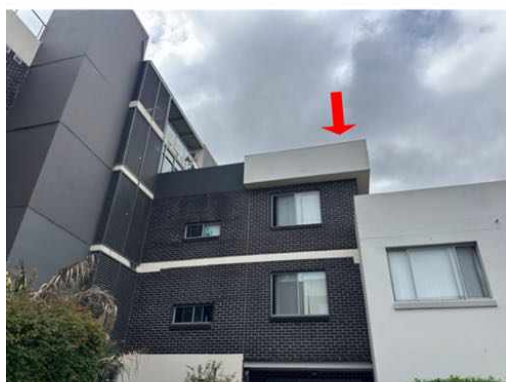
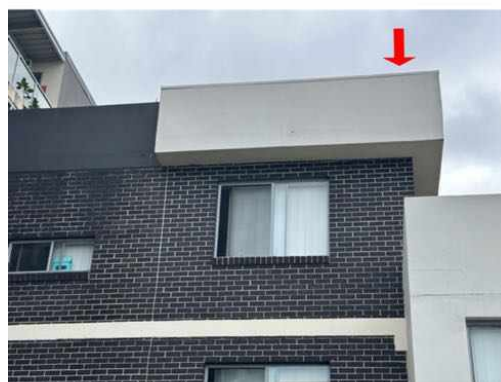
Defects 2.02

Building:	Main Building
Location:	Bedroom 2 > Front Right
Finding:	Thermal imaging: Damp Detected Ceiling.
Information:	Damp is evident to sections of the ceiling. This defect is suspected to have been caused by moisture permeating or leaching through the roof structure in this area. There appears to be a breach in the water proofing to areas of the roof structure above this area.

Damp (or structural damp) refers to the presence of unwanted moisture in the structure of a building, either as the result of intrusion from outside, or condensation from within the structure. In the ceiling area, internal water leaks, degraded materials or other sources of excessive moisture are generally the cause of damp.

Unmanaged damp in the ceiling is likely to facilitate the formation and development of mould and fungi growth, decaying associated building materials and compromising their structural integrity of associated elements. It is important to address damp conditions , as the World Health Organisation notes that excess moisture leads - on almost all indoor materials - to growth of microbes such as moulds, fungi and bacteria, which subsequently emit spores and other matter into the indoor air. Exposure to these contaminants is associated with a wide range of respiratory and other health-related problems. Damp conditions also create a conducive environment for termite infestation.

Consultation with a roof water proofing specialist is advised immediately to identify the cause of damp and to perform remedial works as required.

Always ensure that roof structure is in good condition to prevent any moisture issues occurring in the future.

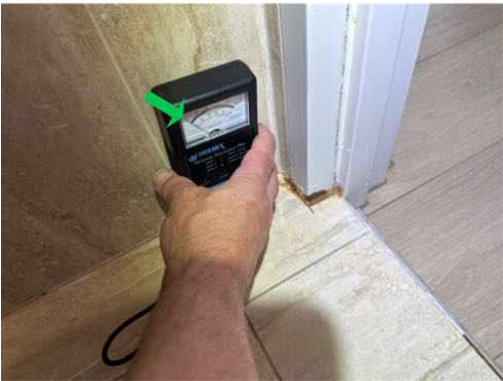
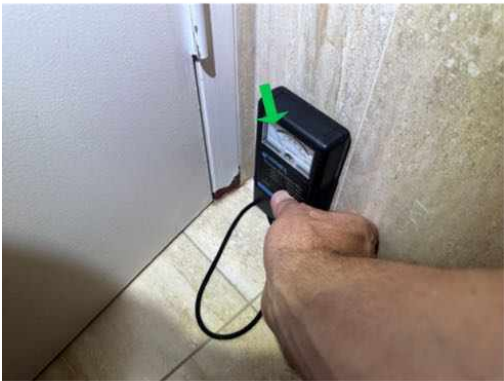
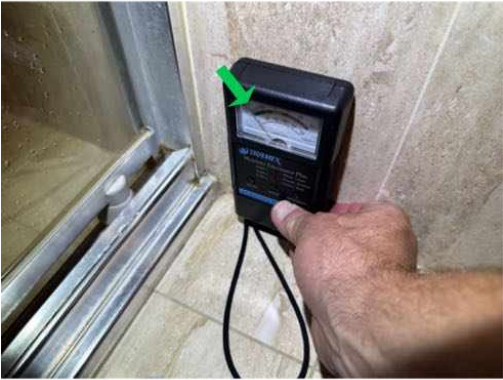
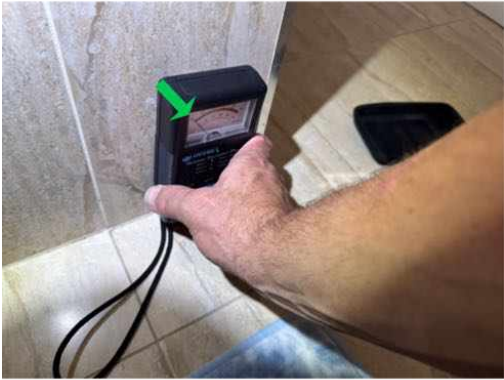
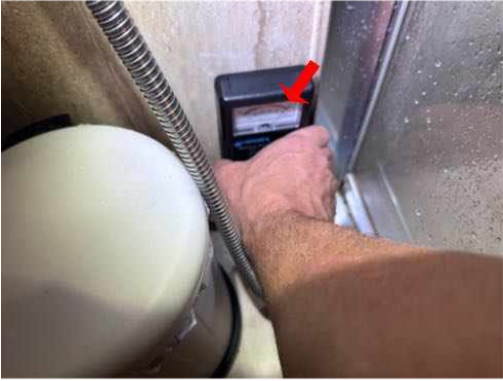
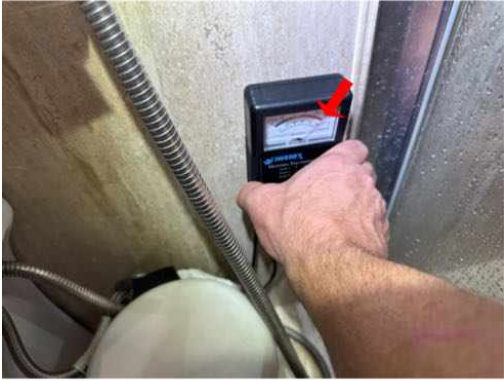
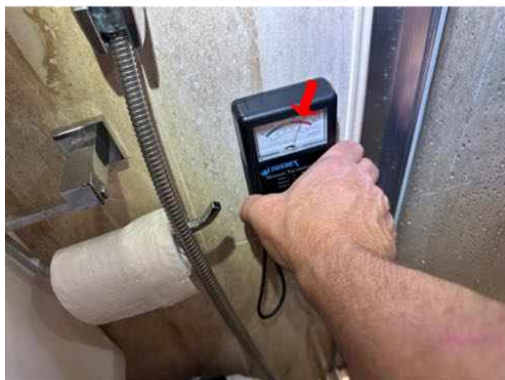
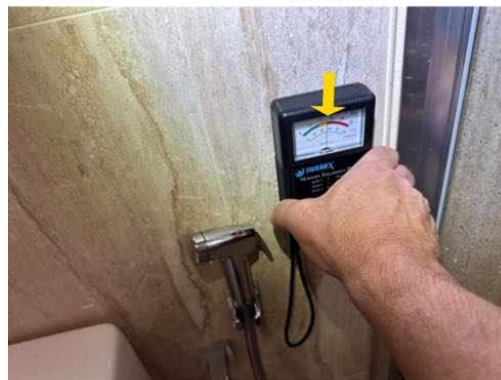
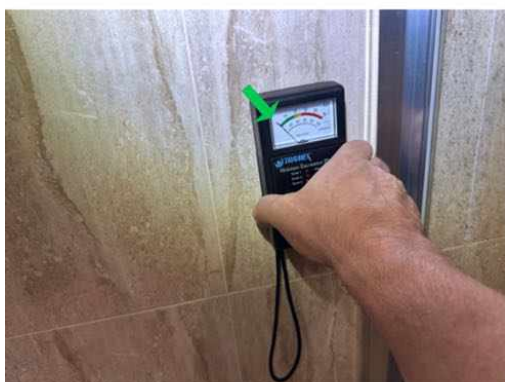
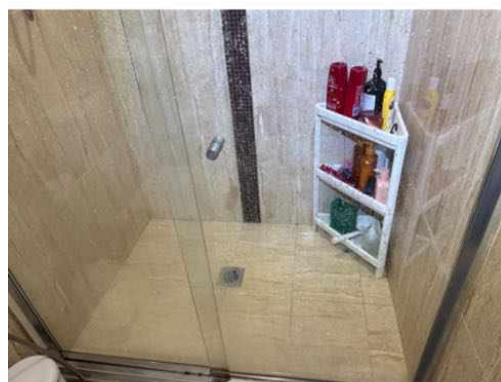
Defects 3.01

Building:	Main Building
Location:	Bedroom - Master > Centre Right
Finding:	Moisture Meter used: minor spot of Moisture Detected outside of shower recess.
Information:	Moisture meter was used during the inspection and minor spot of excessive moisture was detected to accessible walls to the exterior of the shower recess in the property at the time of inspection. The grout appeared to be in fair condition to most of the areas with minor areas requiring maintenance.

Unmanaged damp facilitates the formation and development of mould, fungi growth and wood rot, decaying associated building materials and compromising their structural integrity.

A moisture meter was used on all accessible walls during the inspection and a limited amount of excessive moisture was detected to the outside of the shower recess walls on the lower row of tiles in the property.

The first step in addressing moisture is to diagnose the cause. The identified cause should be addressed first prior to repairing the appearance and other defects which have resulted from the moisture penetration. If the original cause is not resolved, further cases of moisture penetration are likely to ensue, resulting in secondary defects.

Consultation with a qualified tiller is advised immediately to identify the cause of

moisture penetration and perform remedial works as required. Where excessive mould growth is present, further inspection by a specialist environmental health inspector should also be considered.

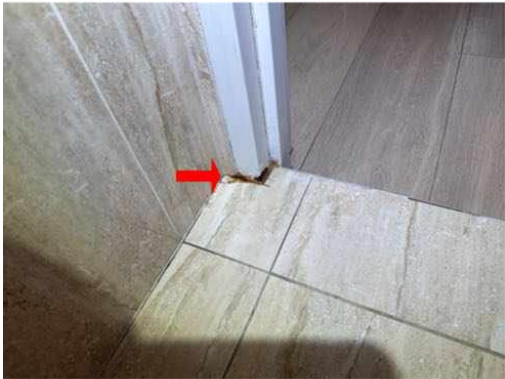
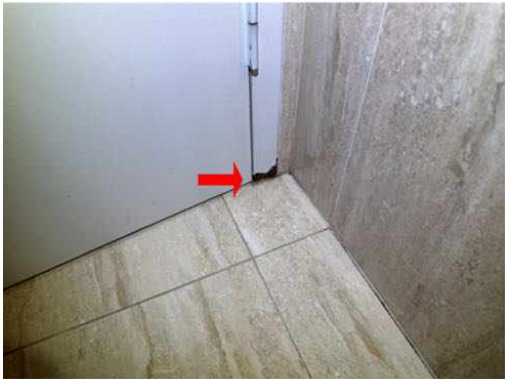
Defects 3.02

Building:	Main Building
Location:	Ensuite - Master > Rear Right
Finding:	Building element - Rusted or corroded
Information:	This building element shows evidence of rusting and corrosion, which is likely to have developed as a result of excessive exposure to moisture and or inadequate coatings.

As surface rust provides no protection to the underlying iron, the deteriorating condition is likely to worsen if not addressed in the short-term future.

Where possible, the use of galvanized (treated) metals or aluminium coated metals aid in rust prevention, as does regular general maintenance. Rust formation can be controlled with coatings, such as paint, that isolate the iron from the environment.

Rusting and corrosion should be managed by ideally removing or limiting the affected surface from exposure to moisture. A registered builder may be appointed to replace any building elements that have been severely affected by rust or water damage.

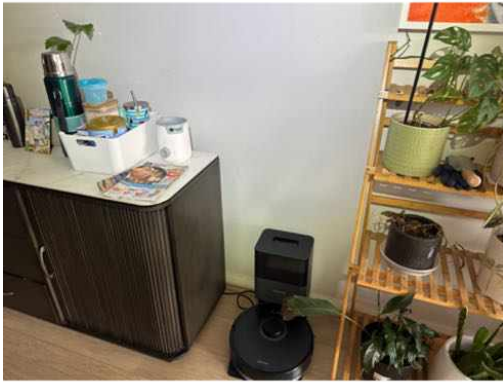
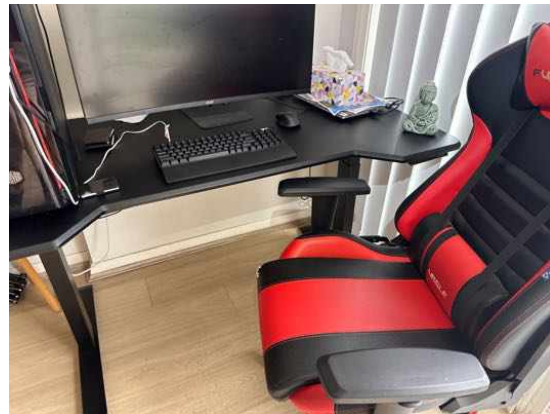
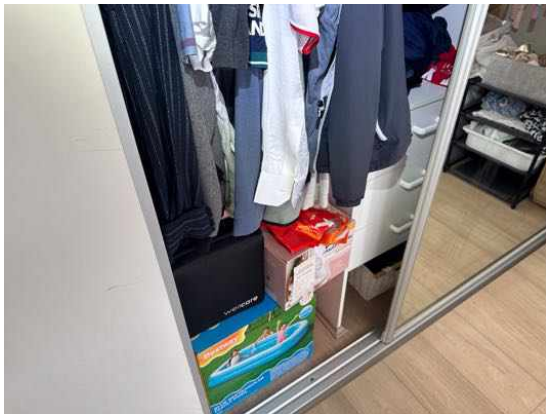
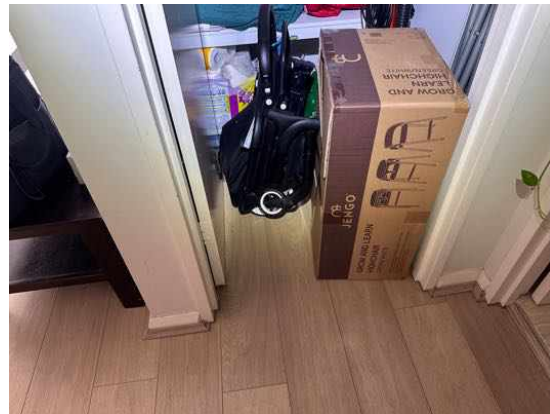
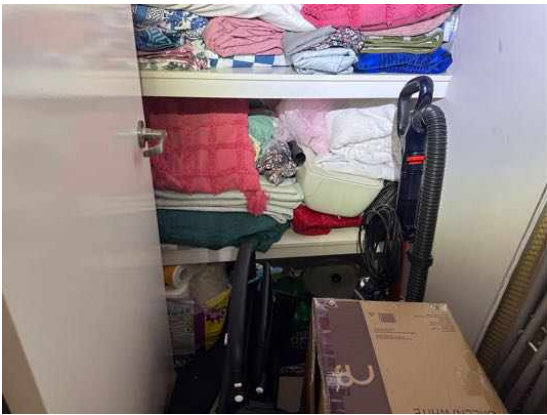
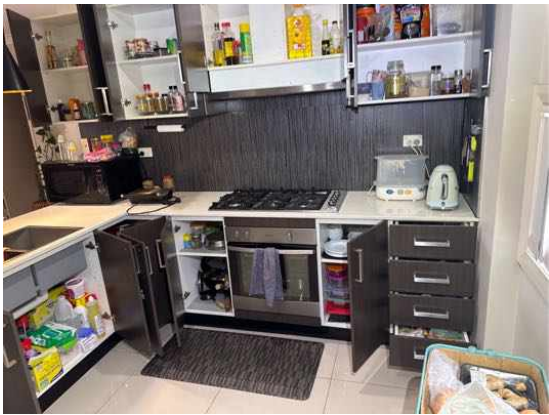
Building: Main Building
Location: All Areas > All Areas
Finding: Additional Photos - Obstructions and Limitations
Information: These photographs are an indication of the obstructions and limitations which impeded full inspection of the property at the time of inspection. These obstructions can hide an array of defects and should be removed to allow full inspection to be carried out. A re-inspection is recommended once the areas are made accessible.

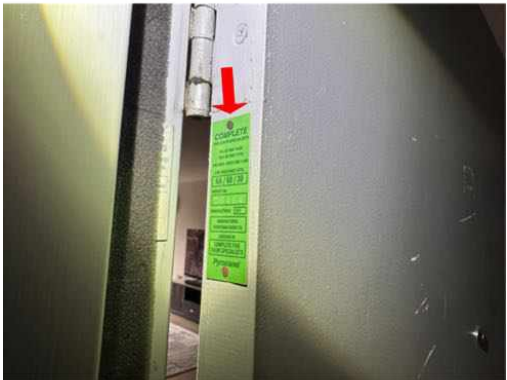
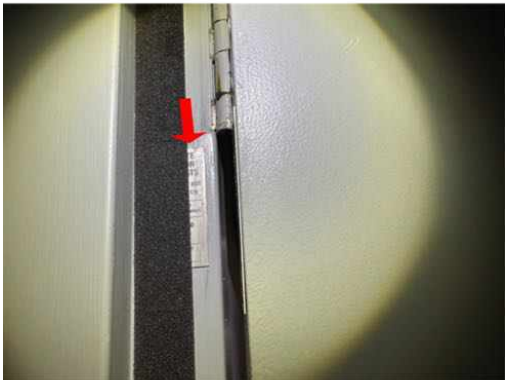
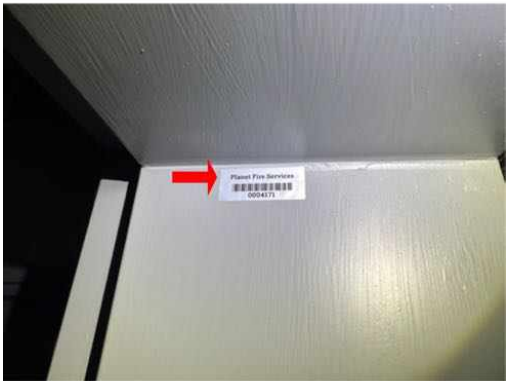
Building: Main Building
 Location: Entry > Front
 Finding: Fire Rated Door:
 Information: At the time of inspection the front door appeared to be compliant with test durable labelings in place.

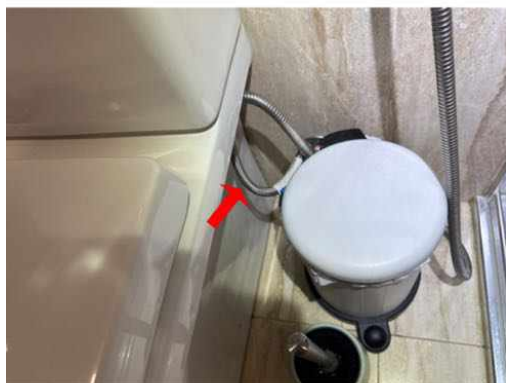
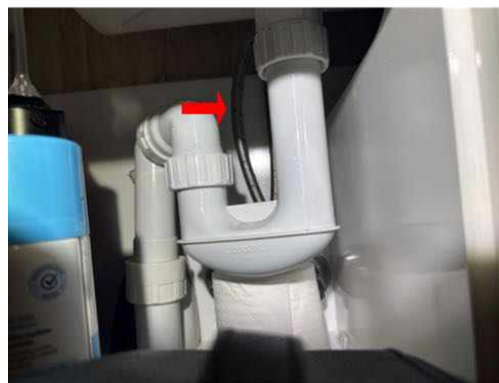
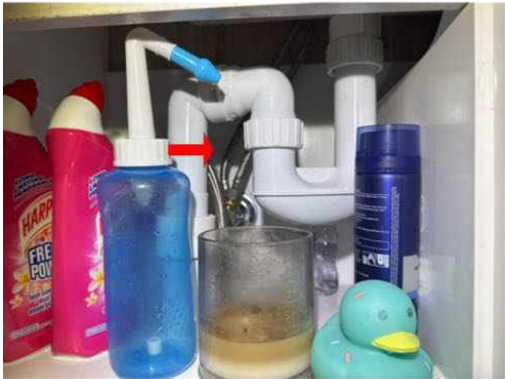
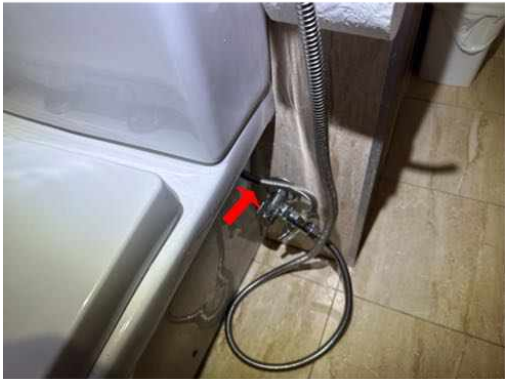
Finding: Pipe: Flexible Braided pipes.

Information: Braided Stainless Steel Flexi connector hose are popular in modern home fit outs because they can be bent into shape. They started to be installed in the early two thousands and their use is now extremely widespread in contemporary construction and renovations.

The pipes, manufactured by a wide range of companies, appear to have a limited life span. A decade after a house is built, the risk that a pipe will burst, flooding a home increases significantly, according to IAG.

It is recommended that the Flexi pipes to be replaced at the owners discretion to avoid an “escape water incident” which may lead to water damage to other building elements in the home.

This work can be undertaken by a licensed plumber, general handy person at the owners discretion.

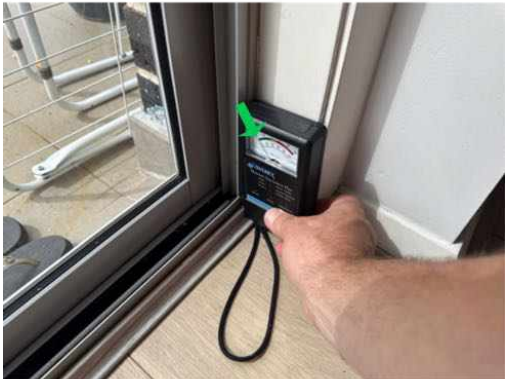
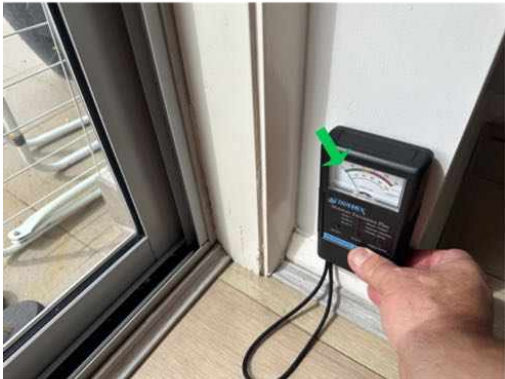
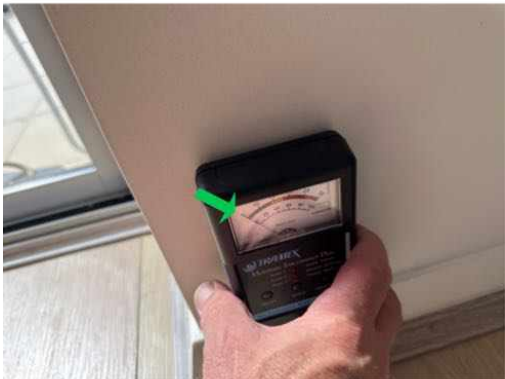
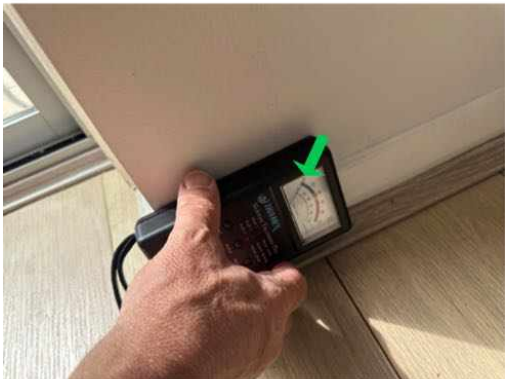
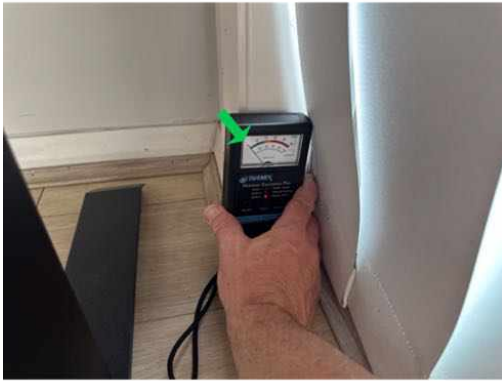
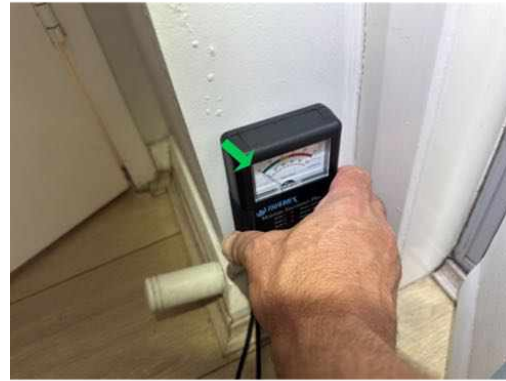
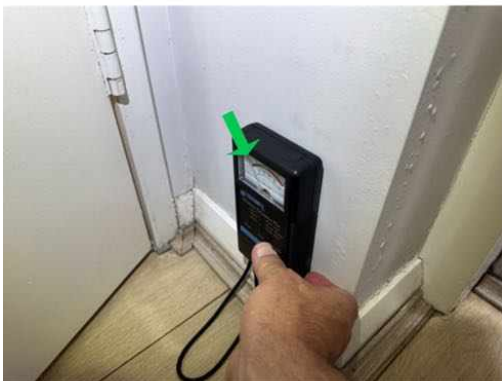
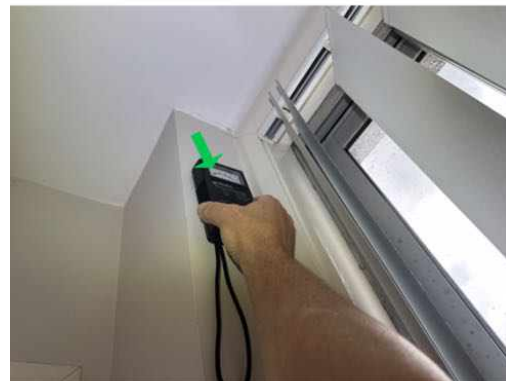
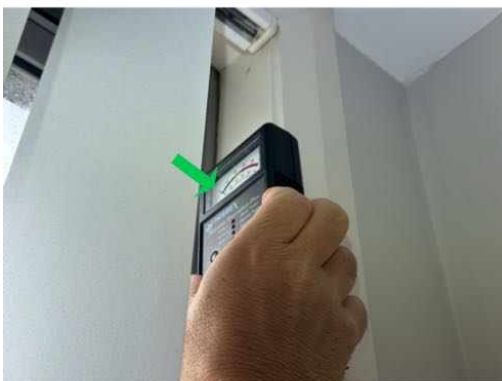
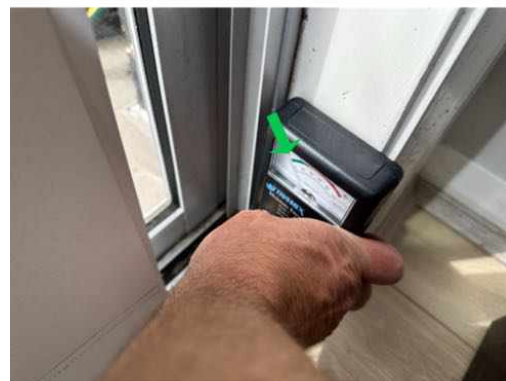
Building: Main Building
Location: All Areas > All Areas
Finding: Moisture Meter used: No Moisture Detected.
Information: Moisture meter was used during the inspection and no excessive moisture was detected to accessible walls inside the property at the time of inspection.

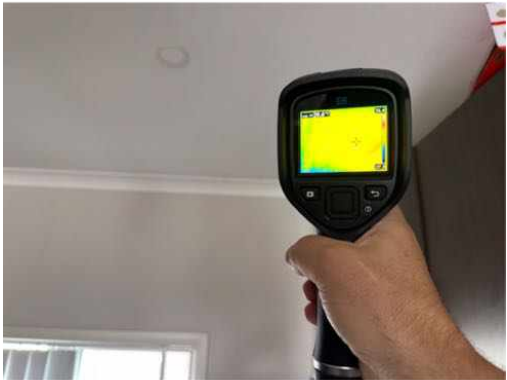
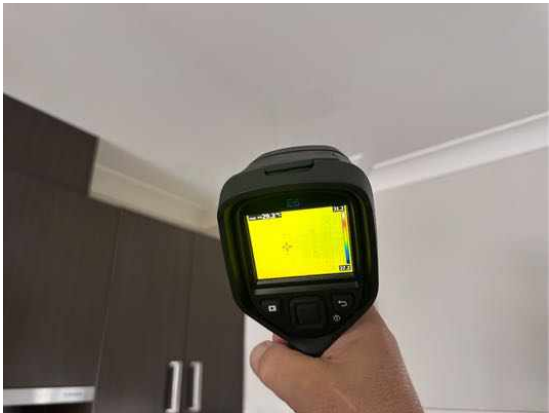
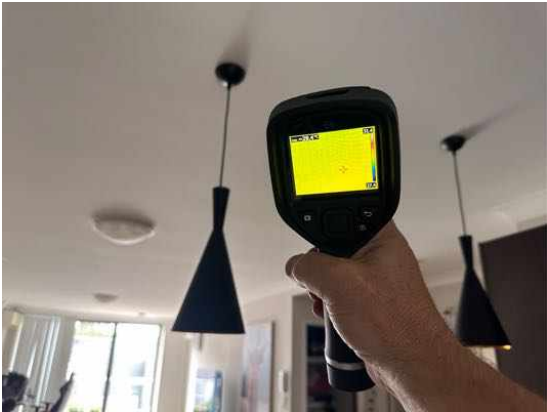
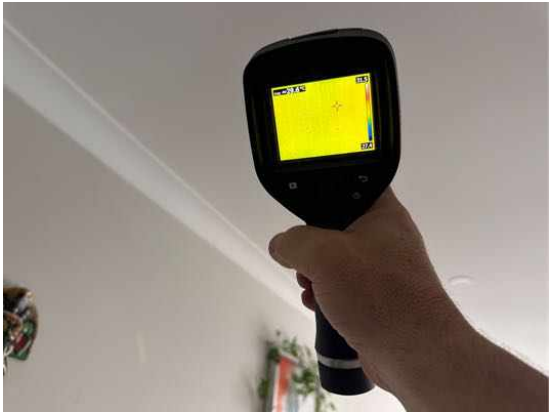
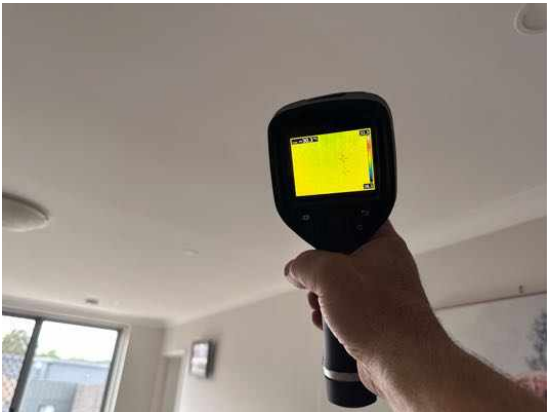
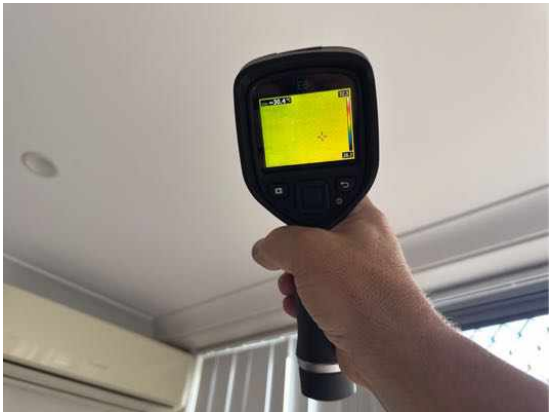
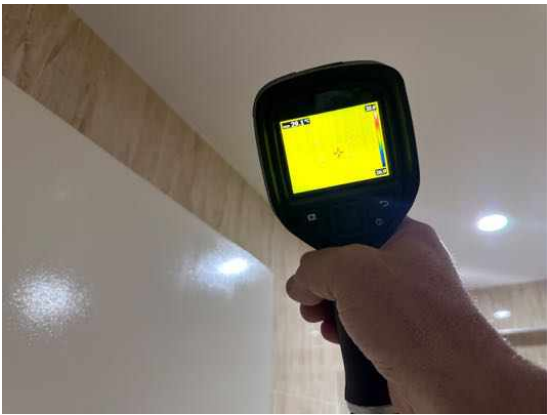
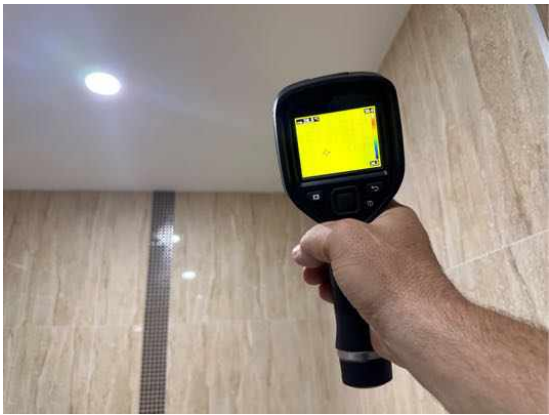
Building: Main Building
Location: All Areas > All Areas
Finding: Thermal imaging: No excessive moisture presentation.
Information: At the time of inspection there appeared to be no excessive moisture presentation in this area.

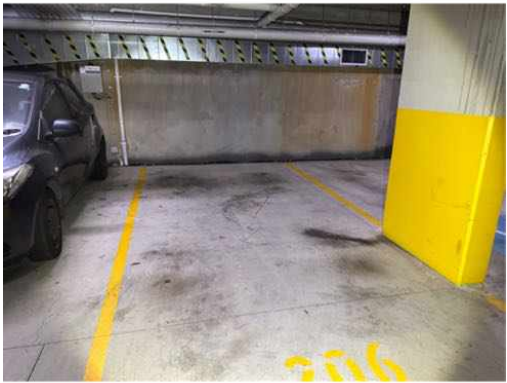
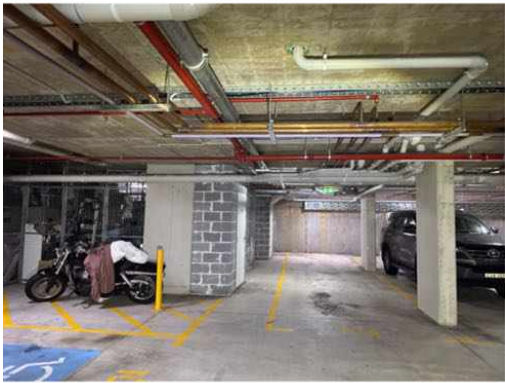
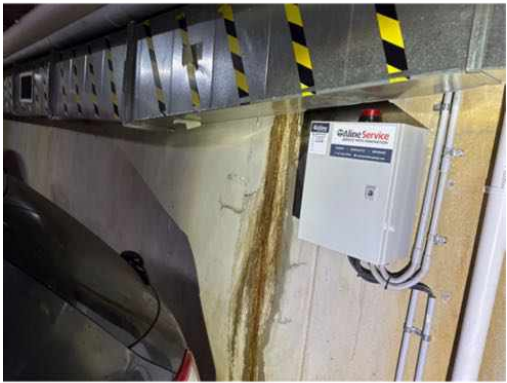
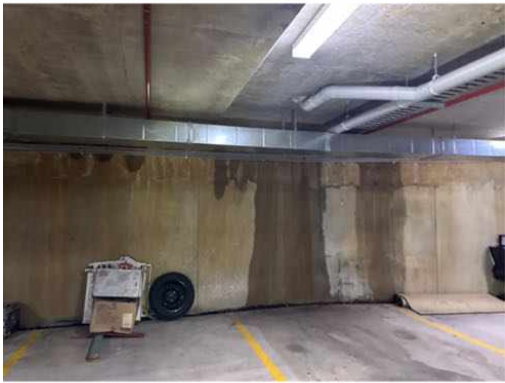
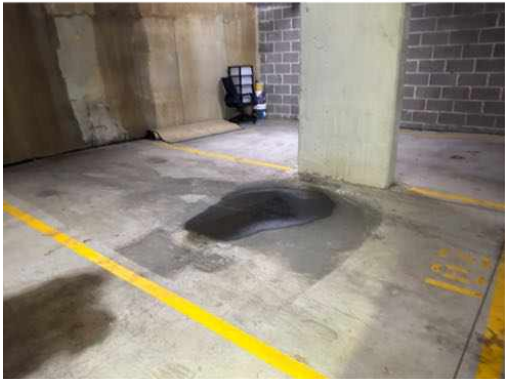
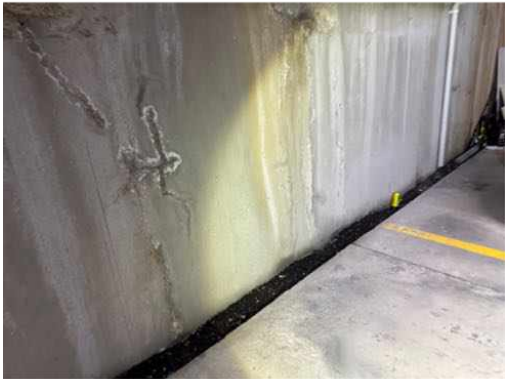
Building: Main Building
Location: Basement > All Areas
Finding: Basement Car Park:
Information: At the time of inspection the basement car park appeared to be in a fair condition with areas that have some water penetration to sections.
