# Building and Timber Pest Inspection Report

Inspection Date: Wed, 18 Feb 2026

Property Address: 6/56 Old Bathurst Rd, Blaxland NSW 2774,  
Australia

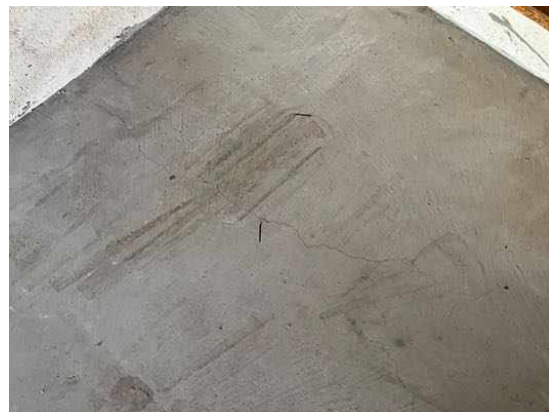
Building: Main Building  
 Location: Garage  
 Finding: Crack in concrete slab - Category 0  
 Information: A crack coded as Category 0 was identified in the slab. A Category 0 crack is described as a hairline crack, representing insignificant movement of slab from level.

The approximate width of the crack to be considered Category 0 is 0.3mm, or change in offset of less than 8mm when a 3m straight edge is placed over the defect.

No rectification is required at this time. However, all cracking should be monitored over a 12 month period to identify any further damage in the area.

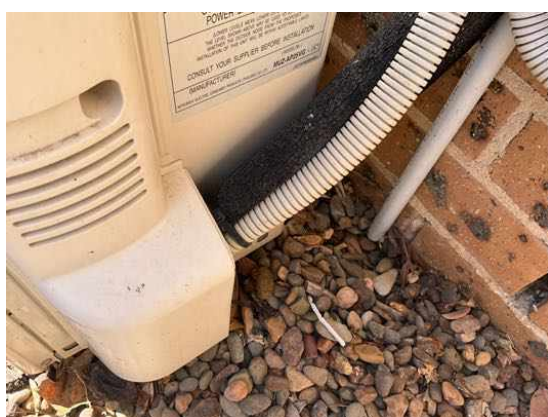
#### Finding 3.02

Building: Main Building  
 Location: All Areas  
 Finding: Air conditioner - Disconnected overflow  
 Information: The Air Conditioner (A/C) overflow was found to be disconnected from storm water drainage and is creating excessive moisture in the surrounding area.

Such leaking creates an environment which is conducive to an array of defects, including water damage to associated building elements and the attraction of termite or timber pest infestation.

It is highly recommended that a licensed plumber be appointed to connect the A/C overflow in order to prevent such an environment from being created. These minor works should be carried out as soon as possible.

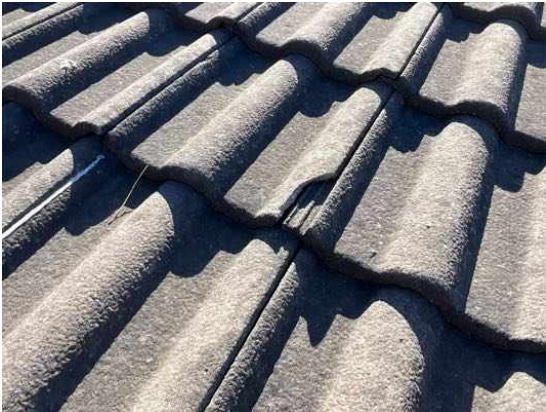
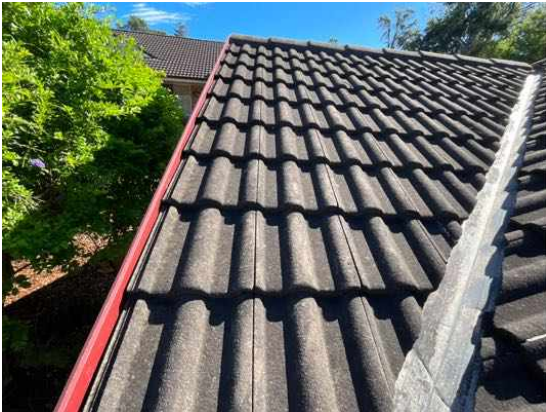
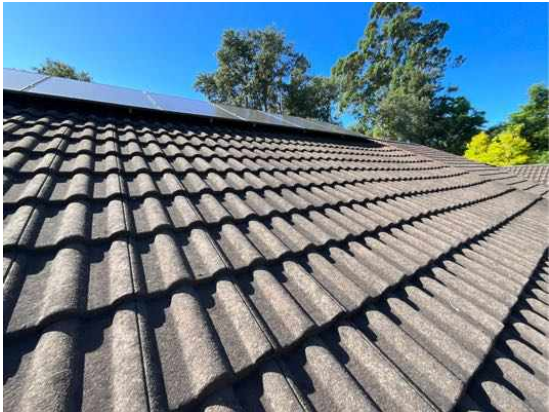
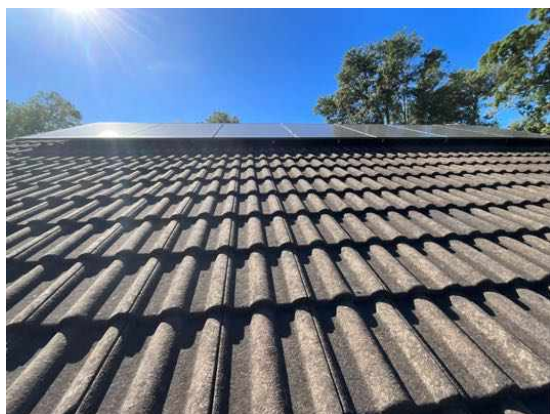
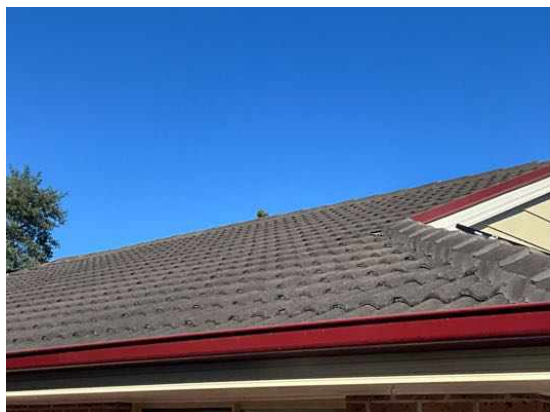
Building:	Main Building
Location:	All Areas
Finding:	Roof Weathered
Information:	Inspection of the roof revealed widespread weathering to the tiled roof surface. The tiles show loss of surface finish, colour fading, and age-related deterioration typical of older roof coverings. Although no significant cracking was noted, weathering can lead

to increased porosity, reduced water-shedding capability, and a higher risk of future cracking or displacement during adverse weather conditions.

A licensed roofer should be engaged to undertake a closer inspection, carry out routine maintenance, and replace any tiles that may be compromised. Ongoing monitoring is recommended due to the age and condition of the roof covering.

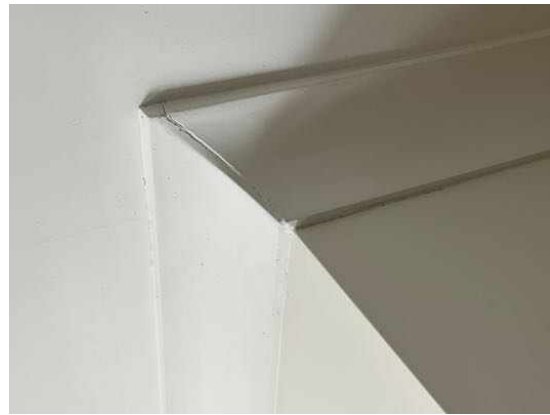
### Finding 3.05

Building:	Main Building
Location:	All Areas
Finding:	Cornice - Cracking [Fine]
Information:	Fine cracking observed in the cornice, indicating potential structural issues or settling concerns.

Fine cracks in the cornice may lead to aesthetic deterioration and, if left unaddressed, could contribute to more significant structural problems over time.

Engaging the services of a skilled plasterer or home renovation specialist is recommended to assess and repair the fine cracking in the cornice, ensuring proper restoration and preventing further issues.

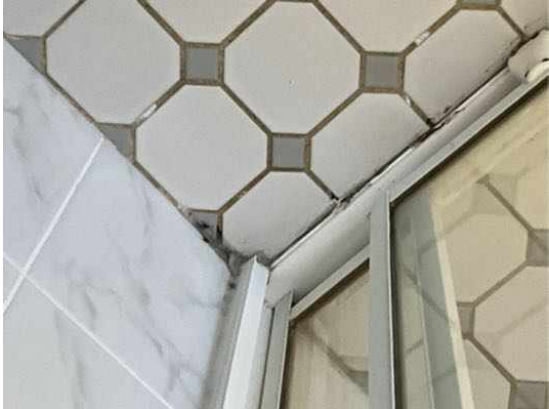
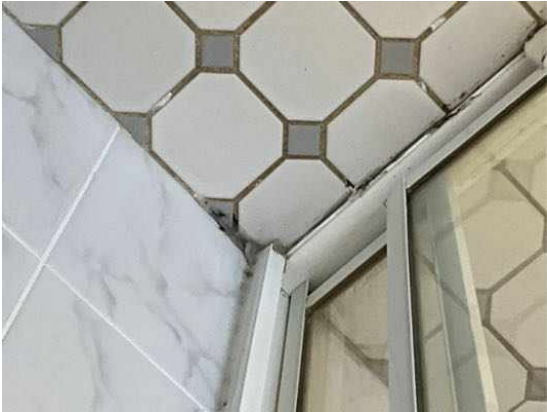
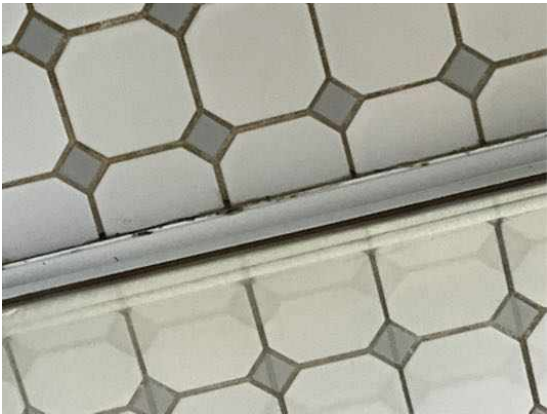
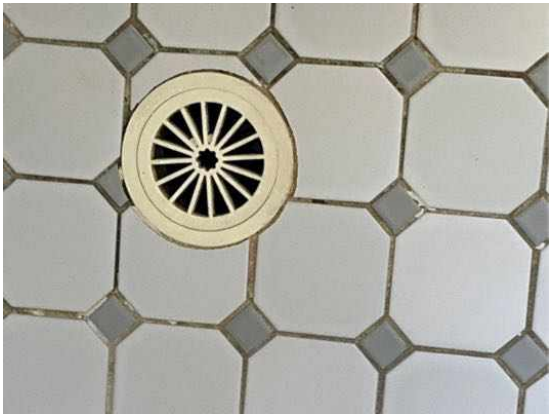
Building:	Main Building
Location:	Bathroom
Finding:	Sealant and grouting - Missing or damaged
Information:	It was noted on inspection that sealant or grout is degraded to the tiled shower alcove and or other areas of the bathroom.

Different materials and floor areas move at different rates, generally causing cracking to grout or sealant at this point. A flexible sealant is required to allow for expected expansion and contraction, while keeping the joint water tight and protective of all associated building materials.

There appears to be excessive mould to the sealant and grout which will likely require scraping out and replacement.

Flexible and mould resistant materials should be applied to affected areas to prevent any subsequent water damage that is likely to occur. Regular maintenance and

A sealant specialist or tiling contractor should be appointed to complete these works as soon as possible

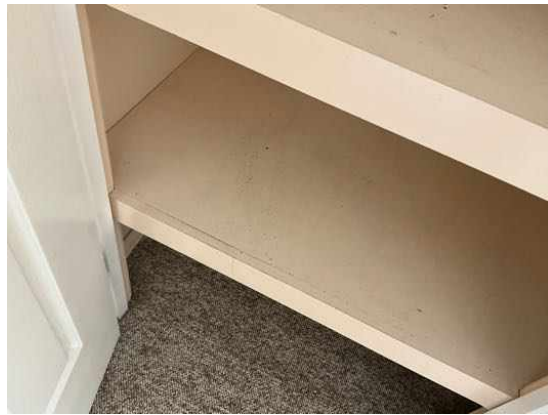
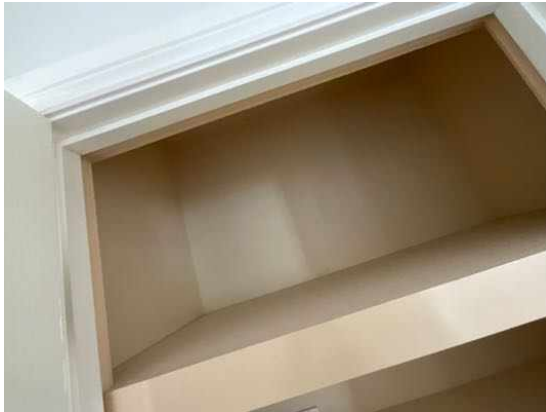
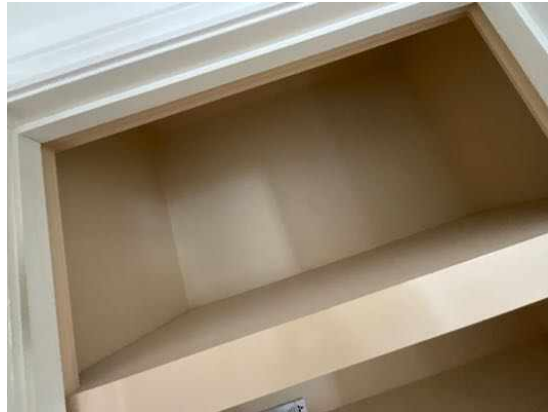
**Finding 3.08**

Finding: Cabinetry noticeable signs of aging and wear and tear  
Information: “The cabinetry within the property is exhibiting noticeable signs of aging and wear and tear, manifesting as surface scratches, faded finishes, and worn edges. This degradation not only compromises the aesthetic quality of the cabinetry but also raises concerns about long-term durability and functionality.”

- Engage a professional cabinetry specialist or carpenter to assess the extent of wear and recommend refinishing or refacing options.
- This may involve repairing scratches, applying new finishes, or replacing worn-out components to restore the cabinetry’s appearance.

- In cases of severe wear, consider upgrading specific components or replacing the cabinetry to ensure long-term durability and aesthetic satisfaction.

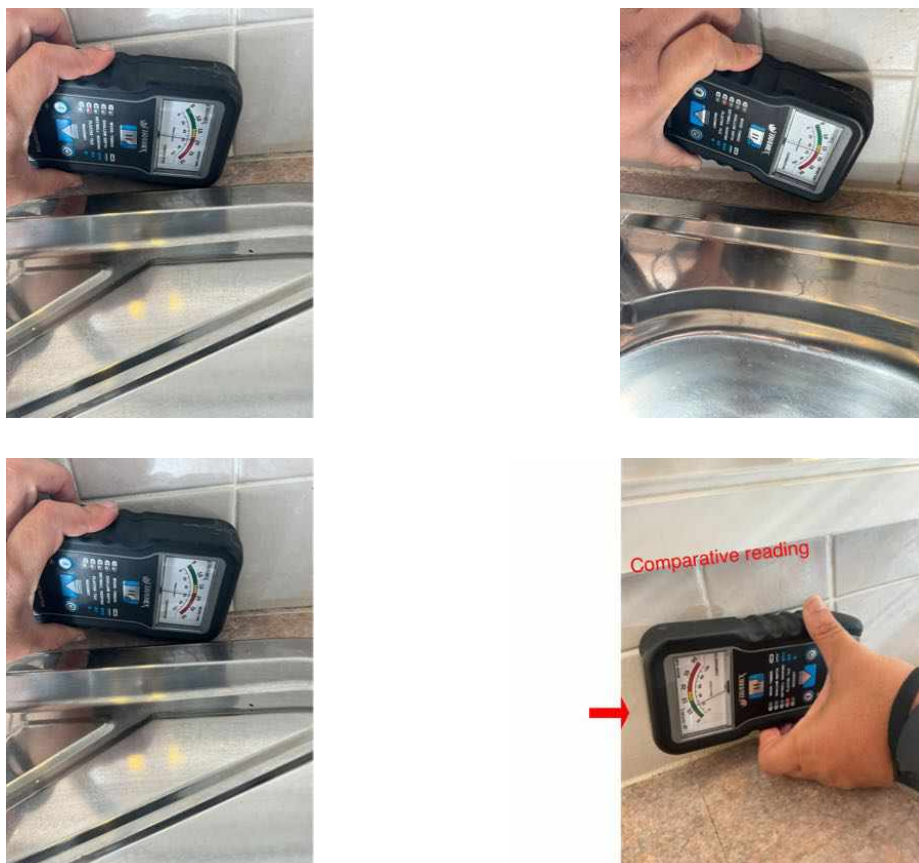
Building:	Main Building
Location:	Kitchen
Finding:	Evidence of excessive moisture was present at the time of inspection
Information:	Excessive moisture is present behind the bathroom tiles, indicating a potential water leakage issue within the wall.

The prolonged presence of moisture can lead to mold growth, deteriorate the structure, and create an environment conducive to health hazards. Additionally, it may compromise the adhesive holding the tiles, leading to their detachment.

A licensed plumber or a qualified contractor specializing in water damage remediation should investigate the source of the moisture, fix any leaks, and address the damage. Additionally, replacing affected tiles and ensuring proper waterproofing are crucial to preventing future issues.

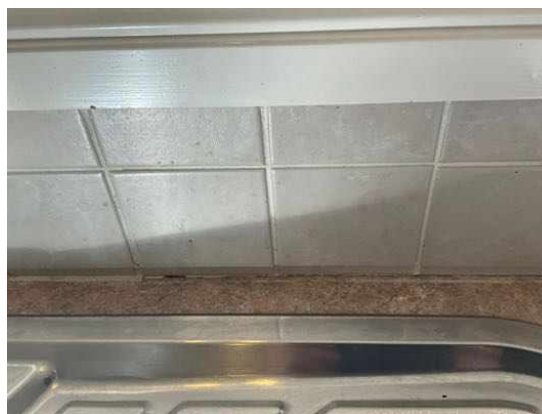
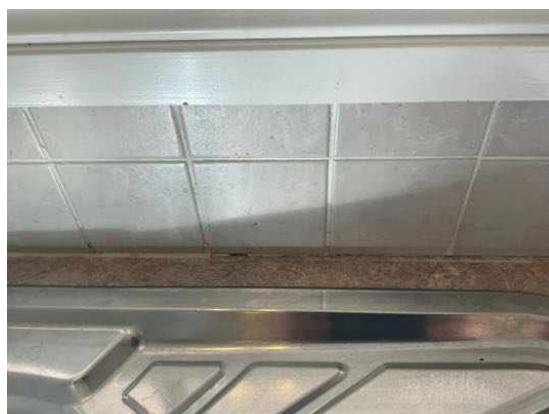
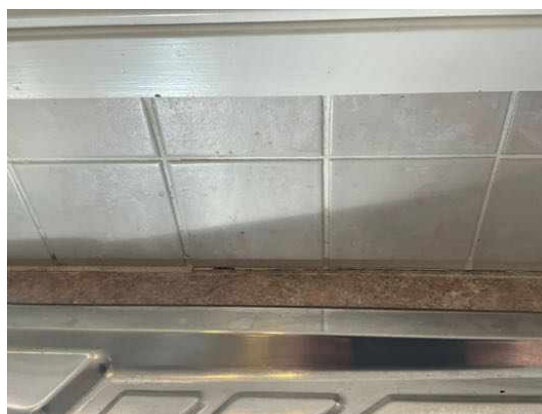
### Finding 3.12

Building:	Main Building
Location:	Kitchen
Finding:	Grouting - Missing or damaged
Information:	It was noted on inspection that sealant or grout is Missing or damaged. A flexible sealant is required to allow for expected expansion and contraction, while keeping the joint water tight and protective of all associated building materials.

Flexible and mould resistant materials should be applied to affected areas to prevent any subsequent water damage that is likely to occur. Regular maintenance and replacement of damage or missing or damaged sealant and grout is highly recommended , as this is a regular wear and tear defect.

A sealant specialist or tiling contractor should be appointed to complete these works as soon as possible

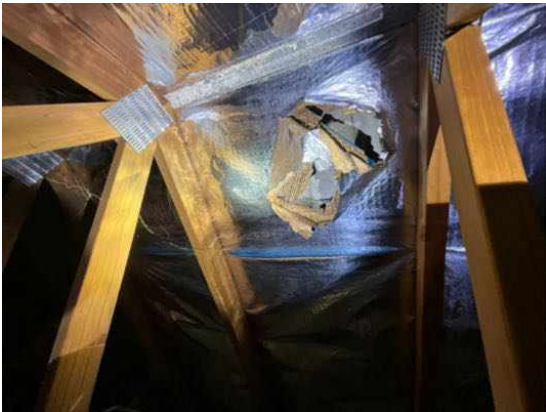
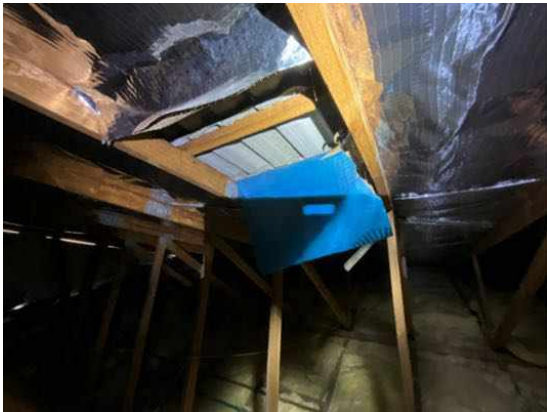
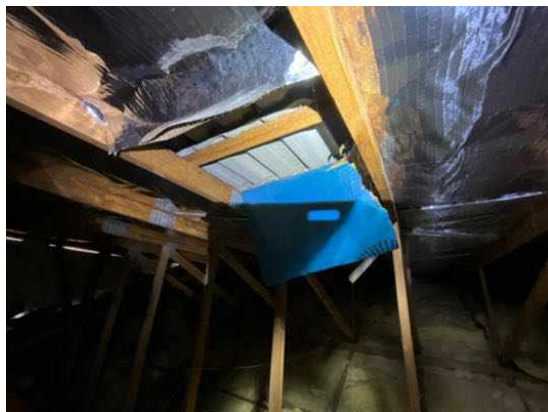
### Finding 3.14

Building:	Main Building
Location:	Roof Void
Finding:	Sarking - Damaged
Information:	Sarking, a laminated aluminium foil applied to the interior of the roof covering, assists in insulating the property and acting as a vapour-barrier to the roof void and, subsequently, to the household.

Where sarking is damaged, both insulation and moisture protection of the property are inhibited. This creates a loss of energy and thus negatively impacts the energy efficiency of the property, allowing potential for moisture ingress from condensation or leaking roof tiles.

It is important to repair any holes or damaged sections of sarking to ensure that the building material is fully functional. A registered builder or qualified carpenter should be consulted to provide further advice on this defect and to perform rectification works at client discretion.

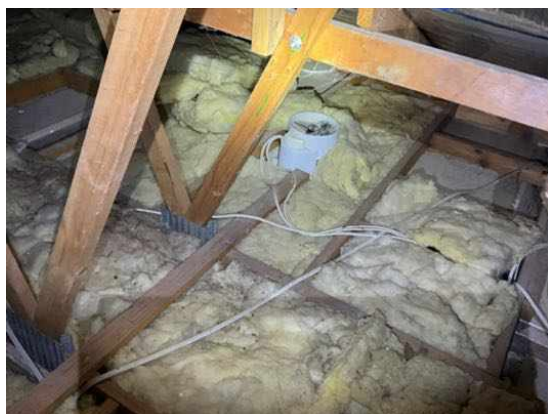
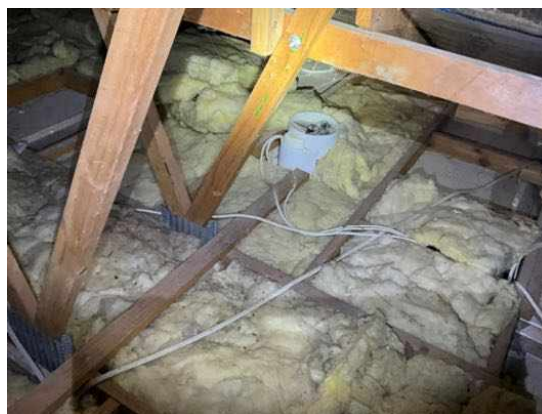
### Finding 3.15

Building:	Main Building
Location:	Roof Void
Finding:	Exhaust fan not vented out
Information:	The exhaust fan located within the roof void is not appropriately ducted to the external atmosphere and is currently discharging moist air directly into the roof space. This is considered a defect under AS 4349.1, as it does not meet the minimum standard of residential building performance expected under normal residential building practices.

This condition may lead to excessive condensation within the roof void, increasing the risk of mould growth, deterioration of insulation, timber decay, and overall reduced durability of building elements. It may also result in poor indoor air quality, potentially affecting occupant health.

It is recommended that the exhaust fan be modified by a licensed HVAC contractor or qualified builder, ensuring it is properly ducted to discharge externally in accordance with manufacturer specifications, the National Construction Code (NCC), and applicable Australian Standards.

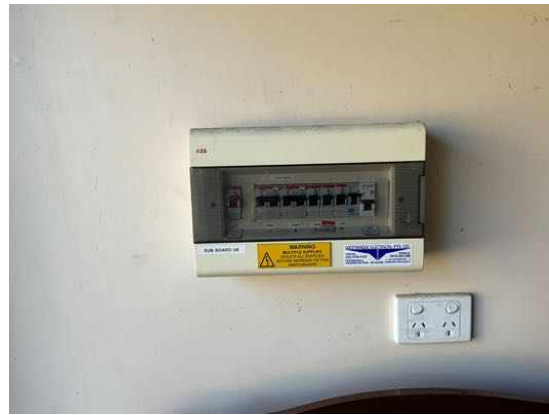
Building: Main Building  
 Location: Garage  
 Finding: No Evidence of Termite Management System - Durable notice / Legible Sticker  
 Information: The application of a pre & post-construction chemical termite barrier is highly recommended for all properties. Such barriers are highly effective in preventing termite attack on any timber building elements throughout the property.

A durable notice was not placed in the switchboard unit to indicate current termite barriers is legible at the time of inspection.

Client must seek further information from the vendor or real estate agent if the conditions of termite management systems were maintained.

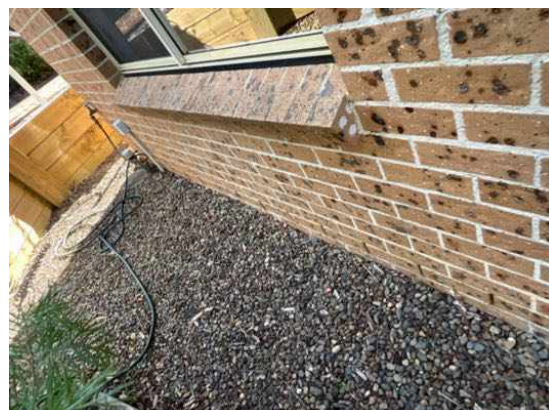
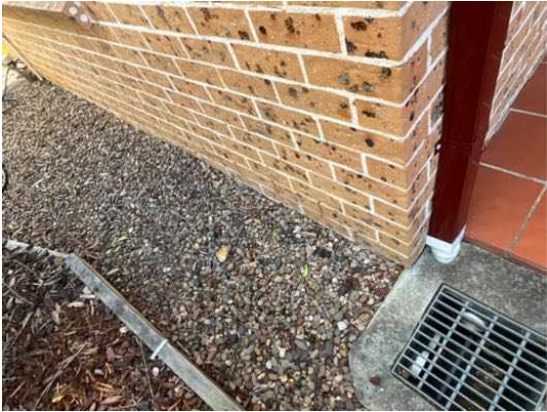
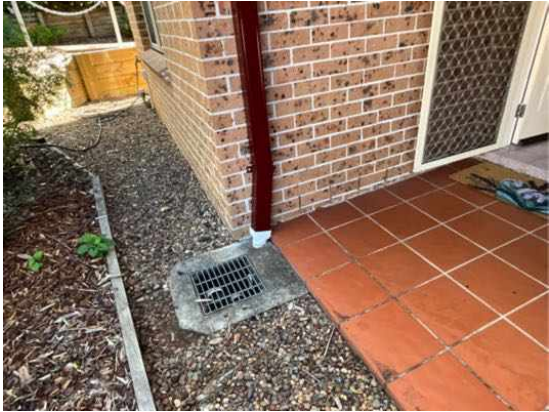
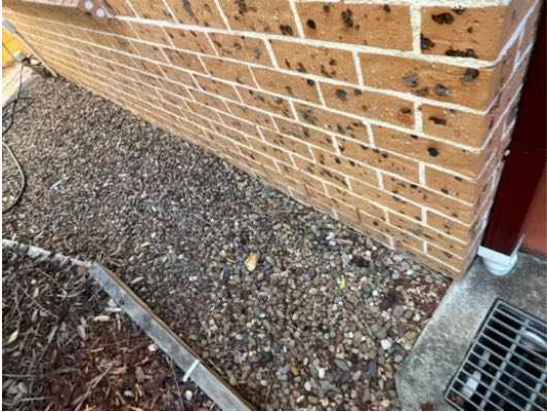
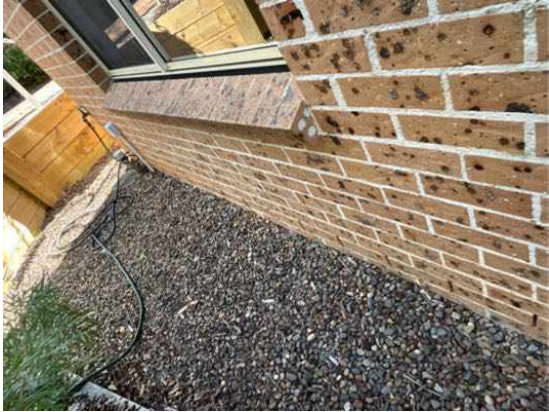
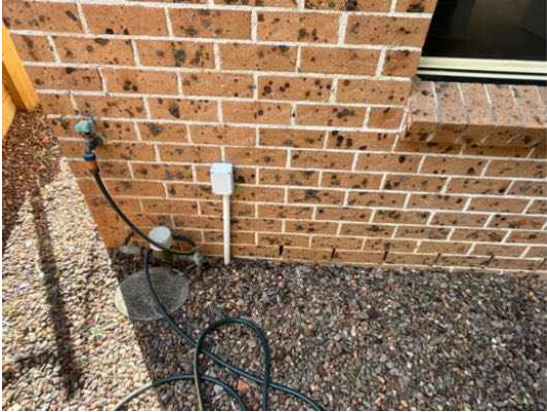
### Finding 6.02

If the slab edge is not properly exposed there is a high risk of termite attack. Sometimes, in order to determine the type of slab, a suitably qualified person such as an architect or builder may be required to consult the construction plans.

Where the slab edge cannot be properly inspected, it is highly recommended that termite or timber pest inspections be carried out every 6-12 months to aid protection of the property against infestation.

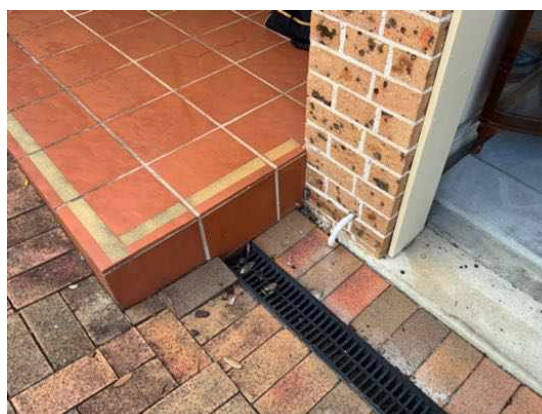
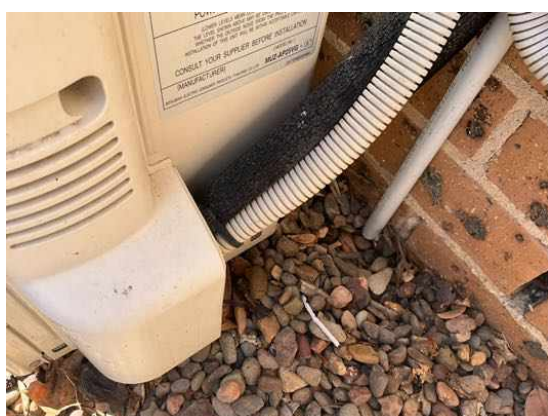
Finding 6.03

Building:	Main Building
Location:	Front Elevation
Finding:	Excessive moisture - Conducive to Timber pest
Information:	Excessive moisture can attract termites and produce conditions that promote fungal growth and wood decay.

Excessive moisture is generally caused by deteriorated inadequate or missing roof drainage leaking plumbing pipes or fixtures poorly plumbed HWS overflows or condenser units and poor site drainage.

Prior to any remedial works being performed a qualified plumber should be appointed to further inspect the property and to identify the cause of the excessive moisture. Works to remove affected building elements may then be necessary and should be performed by an appropriate tradesperson.

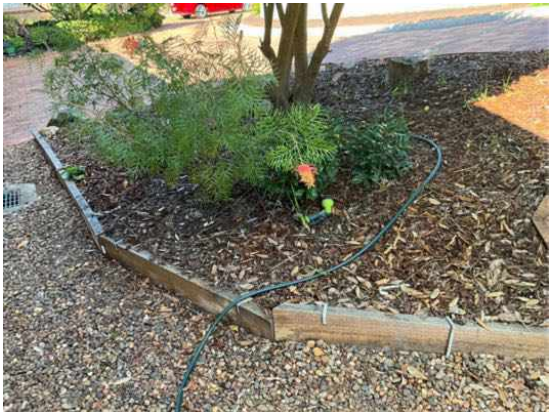
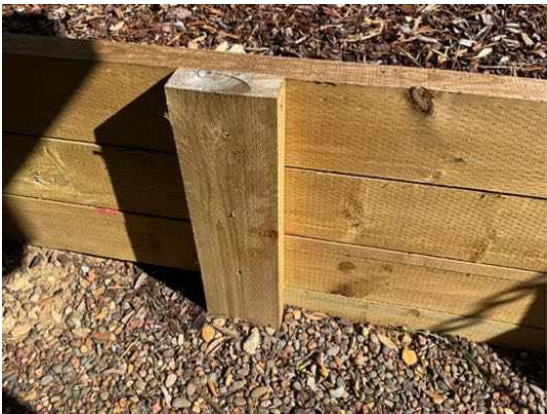
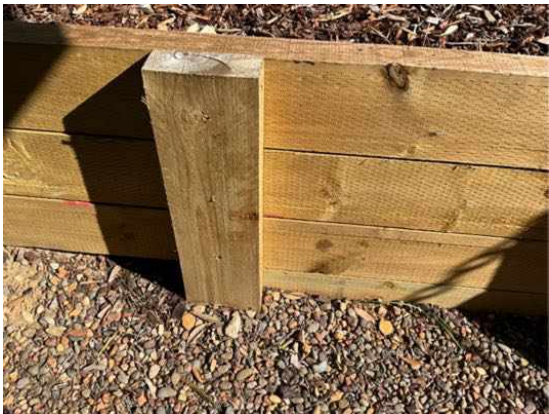
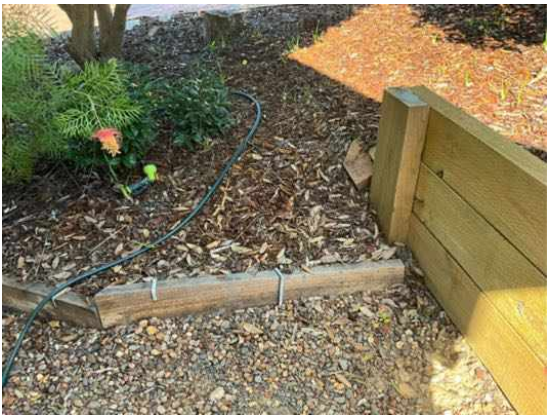
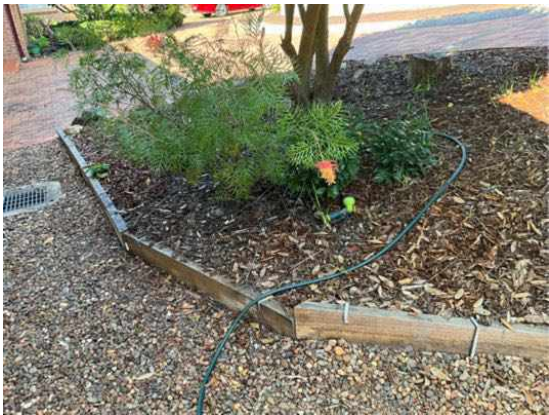
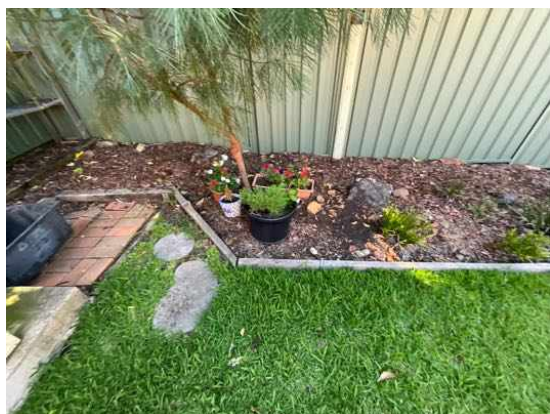
#### Finding 6.04

Finding: Timber on ground / conducive conditions to termite damage  
Information: Timber on the ground is indeed conducive to termite damage. Termites are known to thrive in moist environments, and wood in contact with soil or moisture is more susceptible to infestation.

To prevent this, it's important to keep timber elevated and away from direct ground contact. Regular inspections and proper termite control measures are also essential to protect your wooden structures from termite damage.

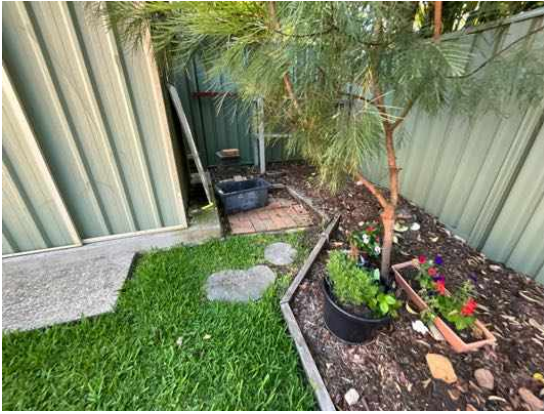
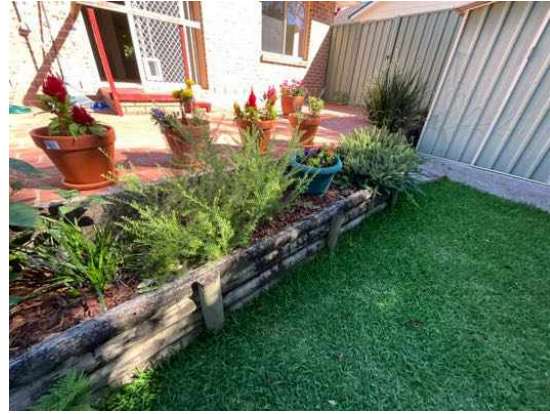
### Finding 6.05

Building:	Main Building
Location:	All Areas
Finding:	Dense vegetation around a property can increase the risk of termite infestation
Information:	The presence of dense vegetation around a property can increase the risk of termite infestation, as it provides a conducive environment for them. To address this, consider maintaining a clear space between the vegetation and your home. If you suspect a termite issue, it's advisable to consult with a licensed pest control professional for inspection and treatment.
