**BEFORE YOU BUY
BEFORE YOU BUILD**

Building and Timber Pest Inspection Report

Inspection Date: Mon, 2 Feb 2026

Property Address: 27 Royalden Cl, Boronia VIC 3155, Australia

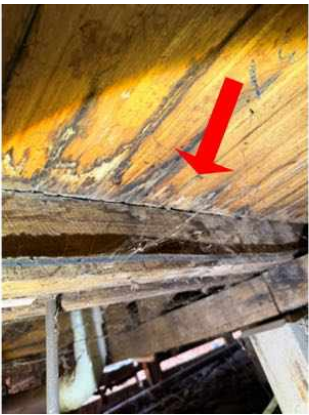
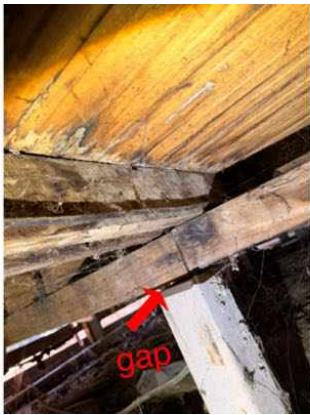
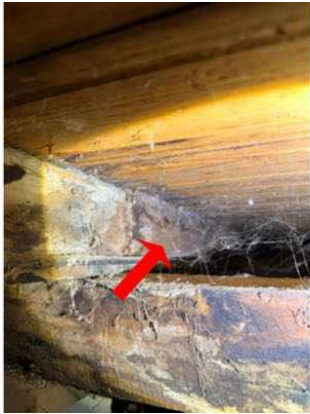
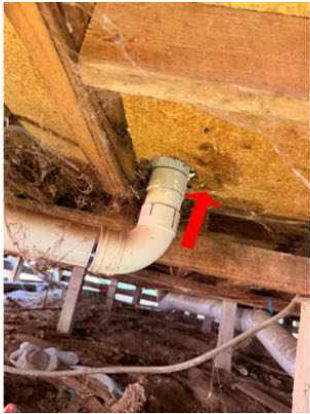
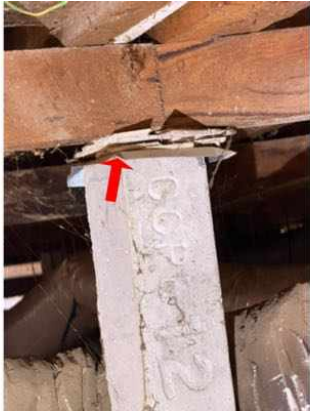
A standard laser level was set up at approximately 125 mm above the floor, as shown in the photo. Based on the readings taken, the floor level variation across the room is approximately 30 mm from the lowest point to the highest point, with the most pronounced deviation noted near the laundry doorway. This equates to roughly 30 mm per metre of floor deviation, which is indicative of significant subfloor settlement.

In addition, within the subfloor area, extensive water damage was observed (refer photos). Evidence of prior re-stumping works was also noted, including an abandoned timber stump left within the subfloor. A visible gap was observed between the stump and the floor joist, indicating the stump is not providing correct load support. Non-compliant packing/shimming was also observed at some supports.

Based on the above, these conditions are assessed as a major structural defect and should be investigated and rectified by a suitably qualified structural engineer and licensed building practitioner as a priority.

For further information or investigation, contact a licensed builder for cost estimation and a structural engineer to assess the extent of settlement and the condition of the stumps.

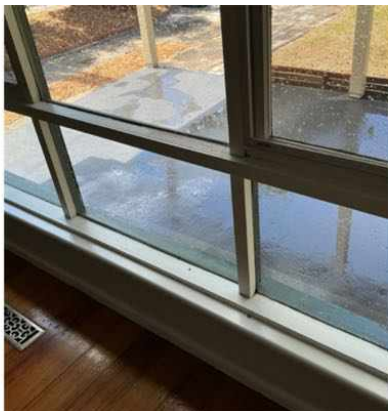
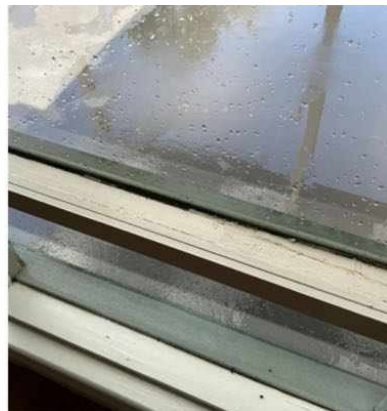
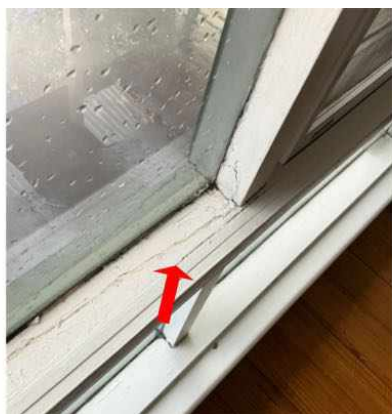
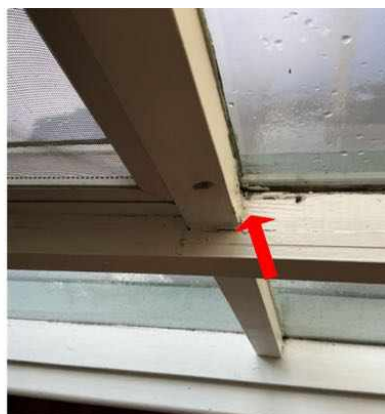
Building:	Main Building
Location:	Living Room
Finding:	Previous window repair
Information:	Evidence of prior repair works was observed to the window frame/sill, with cracked paint and localised deterioration consistent with timber decay. These defects are commonly associated with ongoing or past moisture ingress.

If moisture ingress is continuing, timber decay may progress and lead to reduced window performance, further water penetration, and potential damage to adjacent linings/finishes.

Have a qualified carpenter/builder (and plumber if required) investigate the moisture source (e.g., failed seals, flashing, sill junctions, external drainage) and complete repairs/replacement of affected timber and resealing as needed.

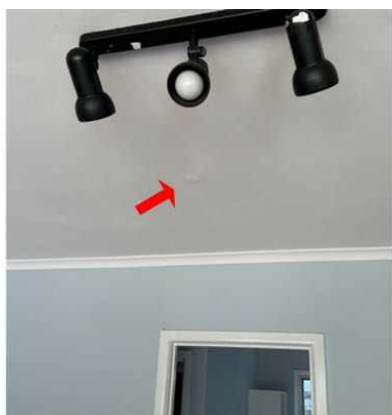
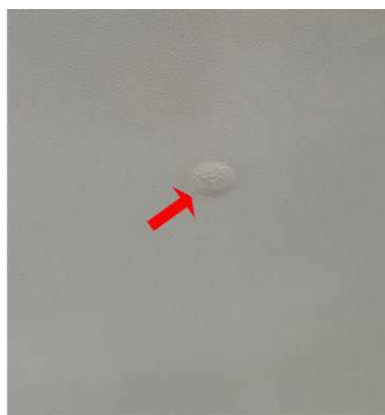
Finding 3.03

Building:	Main Building
Location:	Living Room
Finding:	Ceiling plaster
Information:	A small localised surface imperfection was observed to the ceiling finish, consistent with minor paint/plaster blemish or previous patch repair.

While currently minor, this type of defect can indicate past movement/repair or localised moisture impact and may worsen or reappear over time.

Monitor for any change. If staining, softening, or further bubbling develops, engage a qualified contractor to investigate the source (e.g., roof/water services above) and complete patching and repainting.

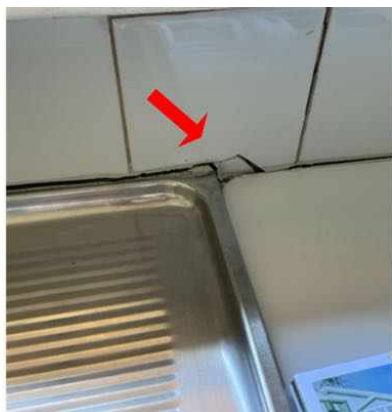
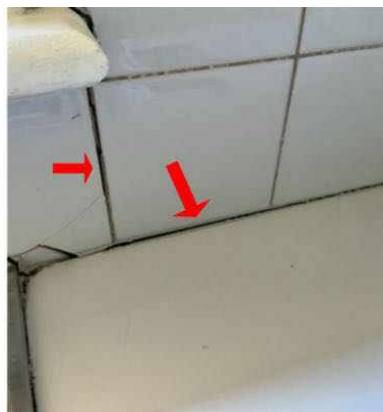
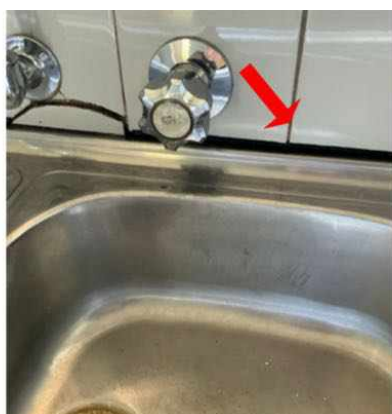
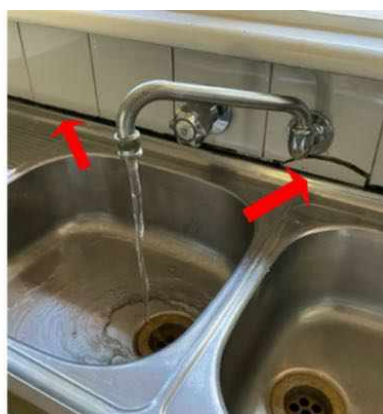
Finding 3.04

Building:	Main Building
Location:	Kitchen
Finding:	Tile cracks and missing sealant
Information:	Cracked/damaged tiles were observed to the splashback area adjacent to the sink, and the sealant at the wall junction (tile-to-bench/splashback junction) was missing/failed with visible gaps.

These defects can allow water to penetrate behind the tiles and into the wall/benchtop junction, increasing the risk of moisture damage to wall linings/cabinetry, mould growth, and further tile debonding.

Engage a suitably qualified tiler to replace/repair damaged tiles and reinstate a continuous sanitary-grade silicone sealant to the junctions after confirming the substrate is dry and sound.

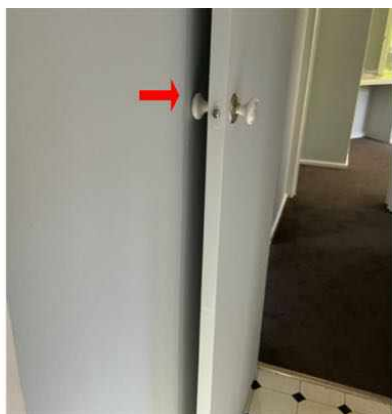
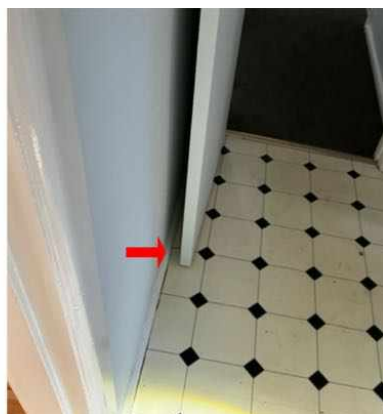
Finding 3.05

Building:	Main Building
Location:	Kitchen
Finding:	Door stop - Missing
Information:	The door stop is missing or is inadequate to stop the door handle from damaging the wall. Although some building elements may seem irrelevant or unnecessary, all building elements play a key role in the operation and function of the overall structure and its performance.

Re-installation or replacement of the door stop is advised as soon as possible to prevent any subsequent damage to the door or associated structures. A general handyman may be appointed to perform these works at client discretion.

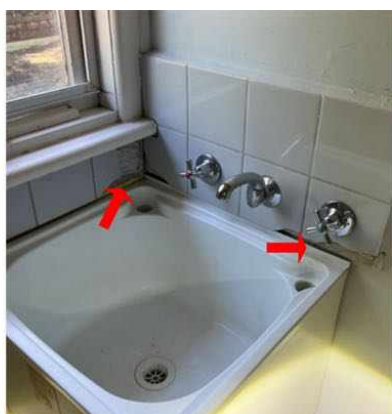
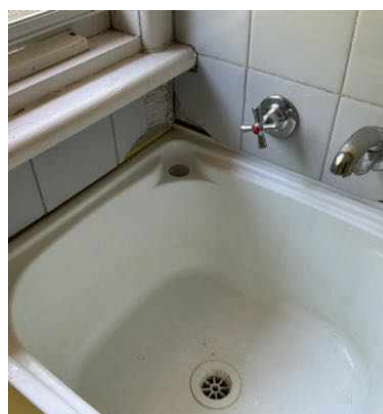
Finding 3.06

Building: Main Building
 Location: Laundry
 Finding: Tile cracks and missing sealant
 Information: Cracked/damaged tiles were observed to the laundry splashback area, and the sealant/finishing at the wall junctions (including around the laundry tub and tap penetrations) was missing/failed with visible gaps.

These defects can allow water to penetrate behind the tiles and into the wall/tub junction, increasing the risk of moisture damage to wall linings/cabinetry, mould growth, and further tile debonding.

Engage a suitably qualified tiler to repair/replace damaged tiles and reinstate a continuous sanitary-grade silicone sealant to all relevant junctions/penetrations after confirming the substrate is dry and sound.

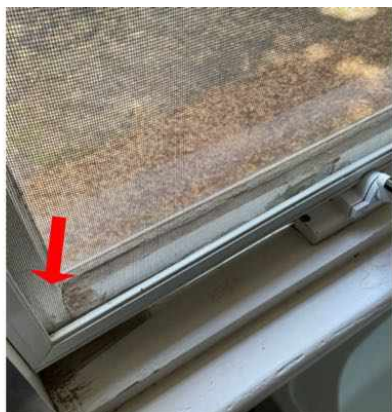
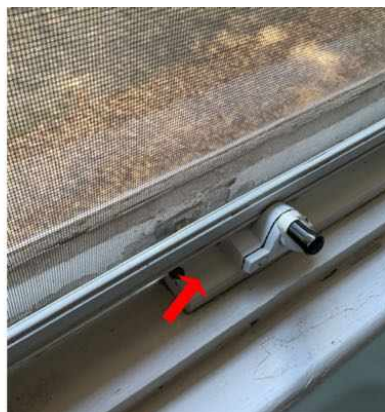
Finding 3.07

Building: Main Building
 Location: Laundry
 Finding: Window - Stiff to operate
 Information: The window in this area was jammed and difficult to operate at the time of the

inspection. Windows provide ventilation to the adjoining area and should be at a fully operational level to ensure user comfort. Restricted function of the window may also pose as a potential safety hazard if required for emergency egress from the building.

Generally, factors such as general age of the building element and a lack of maintenance are the usual causes for this type of defect.

Replacement of window hardware or frame may be required, as well as minor repairs and cleaning. A registered builder or general handy person will be required to repair the window.

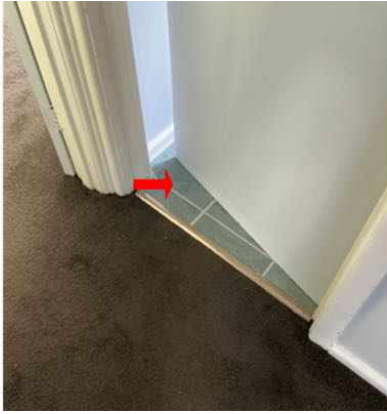
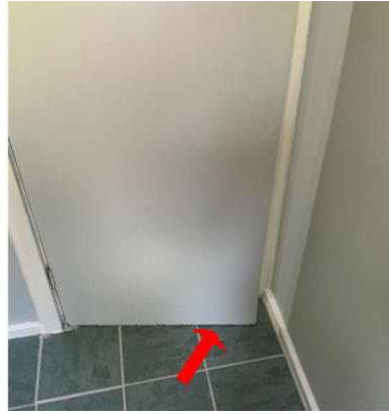
Finding 3.08

Building:	Main Building
Location:	Bathroom
Finding:	Door - Binding/jamming
Information:	Binding and/or jamming of this door is evident during standard operation. This defect inhibits the functionality of the affected door as well as creating potential for secondary defects to associated building elements, such as damage to the floor covering.

A door that binds to flooring or to the associated door frame may have several causes, ranging from minor defects, such as poor installation of the door or deteriorated hinges, through to major structural issues, such as damage to subfloor structures.

For minor causes, a qualified carpenter or general handyperson should be appointed to perform minor rectification works at client discretion.

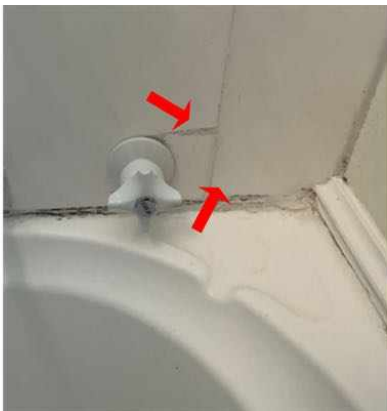
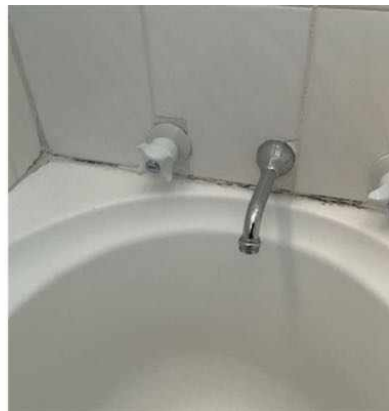
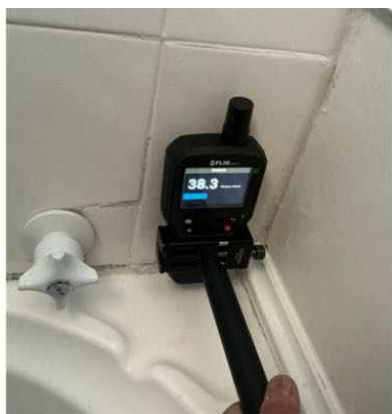
Finding 3.09

Building: Main Building
 Location: Bathroom
 Finding: Slightly Elevated Moisture Reading and cracked tiles
 Information: Cracked/damaged tiles were observed to the laundry splashback area, and the sealant/finishing at the wall junctions (including around the laundry tub and tap penetrations) was missing/failed with visible gaps.

These defects can allow water to penetrate behind the tiles and into the wall/tub junction, increasing the risk of moisture damage to wall linings/cabinetry, mould growth, and further tile debonding.

Engage a suitably qualified tiler to repair/replace damaged tiles and reinstate a continuous sanitary-grade silicone sealant to all relevant junctions/penetrations after confirming the substrate is dry and sound.

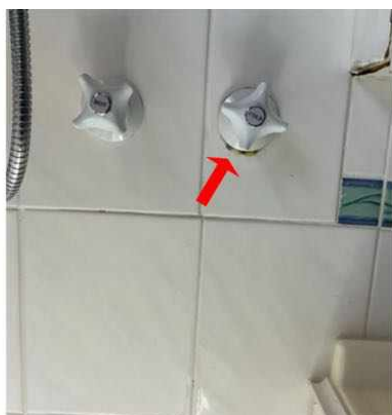
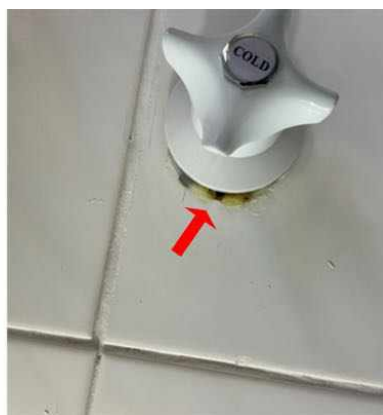
Finding 3.10

Building:	Main Building
Location:	Bathroom
Finding:	Visible hole- tap
Information:	A visible hole was observed in the bathroom at the tap penetration point. This opening allows water to enter the substrate, and prolonged exposure may lead to material deterioration, and mould growth.

Engage qualified handyman or damp proof specialist properly seal the opening, and ensure the area is watertight to prevent further moisture ingress and damage.

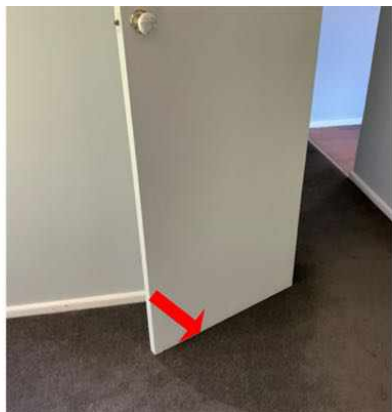
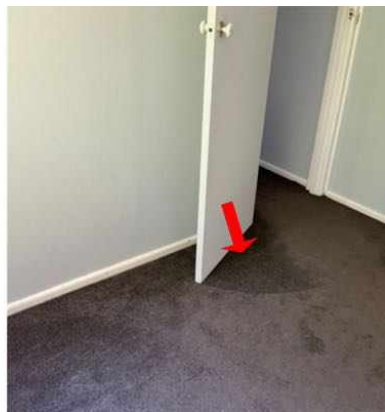
Finding 3.11

Building:	Main Building
Location:	Bedroom
Finding:	Door - Binding/jamming
Information:	Binding and/or jamming of this door is evident during standard operation. This defect inhibits the functionality of the affected door as well as creating potential for secondary defects to associated building elements, such as damage to the floor covering.

A door that binds to flooring or to the associated door frame may have several causes, ranging from minor defects, such as poor installation of the door or

deteriorated hinges, through to major structural issues, such as damage to subfloor structures.

For minor causes, a qualified carpenter or general handyperson should be appointed to perform minor rectification works at client discretion.

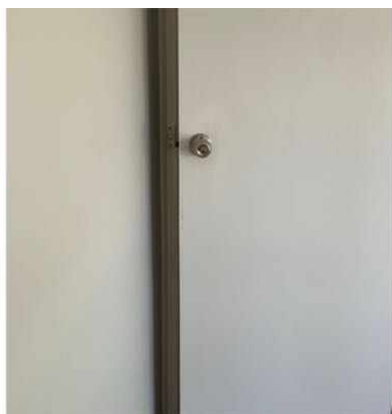
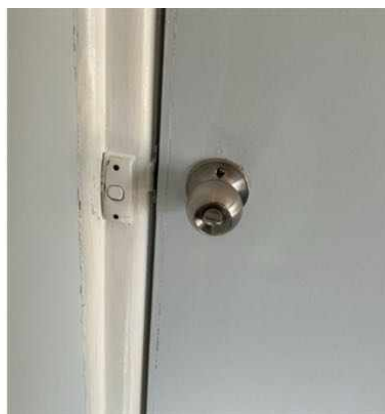
Finding 3.12

Building:	Main Building
Location:	Bedroom - Master
Finding:	Door handle - Not latching
Information:	It was noted that the door in this area was not latching during operation at the time of inspection. Whilst detracting from the functionality of this building element, this minor defect may also be a security risk, and may therefore have serious implications if left unattended.

It is suspected that this defect has occurred due to minor issues with the associated hinges. Such damage is identified as general wear and tear, which is expected for building elements of this age.

A qualified carpenter or general handyperson may be appointed to perform rectification works as necessary, at client discretion. If left unattended, further functional impairment is likely to occur.

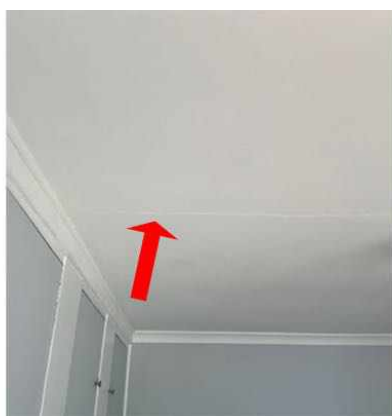
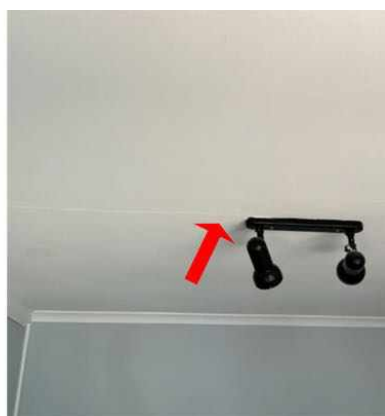
Finding 3.13

Building:	Main Building
Location:	Bedroom - Master
Finding:	Ceiling plaster crack
Information:	Ceiling plaster cracks are a common occurrence in homes. It's important to monitor them over time, as they can affect both the appearance and structural integrity of the property. If the cracks worsen, it's advisable to consult structural engineer. They can assess the situation and recommend appropriate repairs based on the specific conditions of your home.

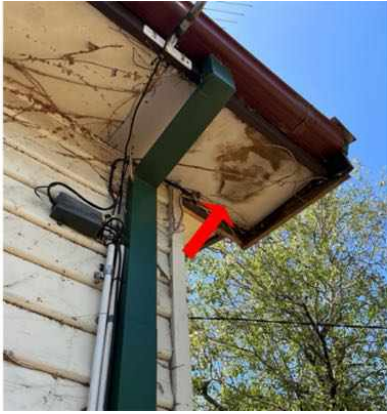
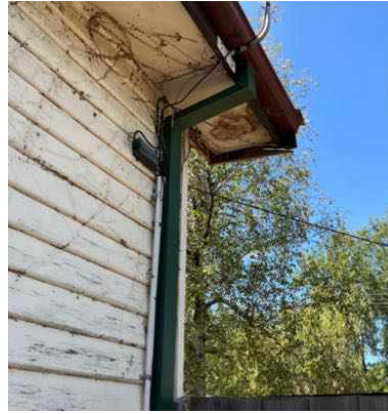
Finding 3.14

Building:	Main Building
Location:	Eaves
Finding:	Eaves - Water stained
Information:	Water staining to the eaves in this area was evident at the time of inspection. Water staining indicates that surfaces have been exposed to excessive moisture over time. Minerals and other elements in the water can leave discolouration, which may progress to corrosion and material deterioration if left unmanaged.

While mostly an appearance defect, water staining can sometimes indicate more serious issues, such as roof or gutter leaks, which may be currently concealed by external cladding or roof coverings.

It is recommended to monitor the area over time, and if no further deterioration is observed, the surface may be repainted.

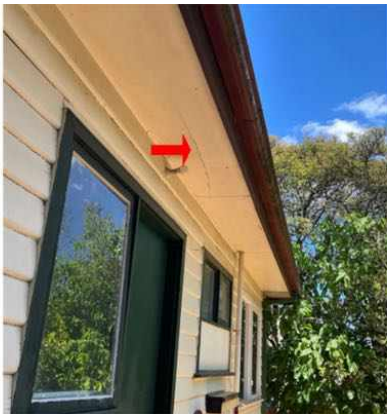
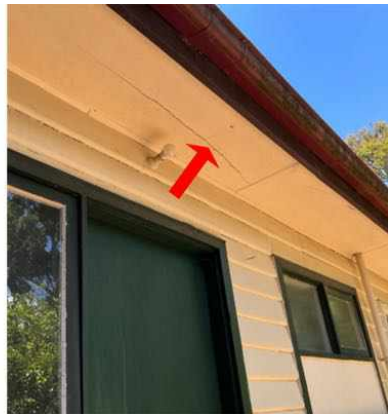
Finding 3.15

Building:	Main Building
Location:	Eaves
Finding:	Cracked eave board
Information:	Cracking was observed to the eaves/soffit lining during inspection (circled), consistent with ageing and/or minor movement to the lining at sheet joints.

Open cracks may worsen over time, leading to further lining deterioration and increased maintenance requirements.

Have a suitably qualified contractor assess the eaves lining, repair/replace affected sections as required, and seal and repaint to maintain weather protection (including checking adjacent guttering/roof drainage for any leak sources).

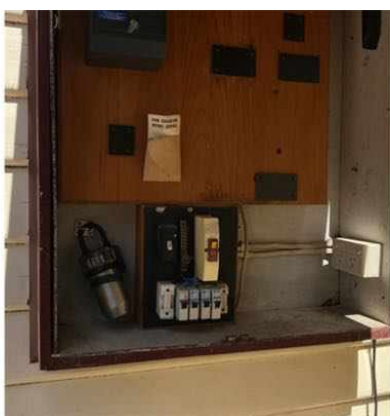
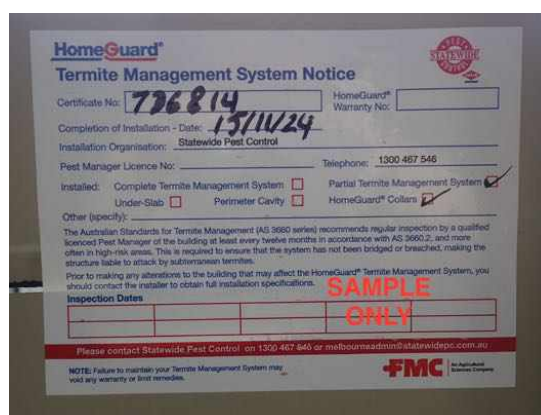
Building:	Main Building
Location:	Electrical switchboard
Finding:	Termite Management System - no evidence of a chemical installation
Information:	The application of a post-construction chemical termite barrier is highly recommended for all properties, particularly if live termite activity has been found on the site previously. Such barriers are highly effective in preventing termite attack on any timber building elements throughout the property.

A durable notice should be placed in the switchboard unit to indicate current termite barriers. At the time of inspection, it appeared as though no termite management system has been installed, with no evidence to suggest preventative works taking place.

The client may consider gaining further advice from a pest controller as to the costs and procedures involved with this application. It is recommended that obtaining such advice be a short-term priority.

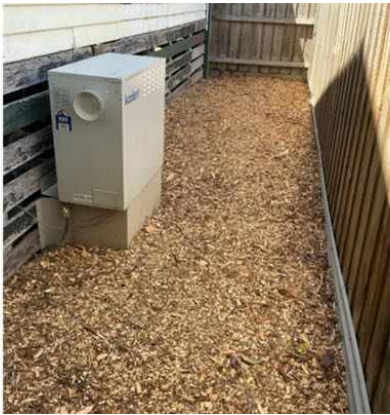
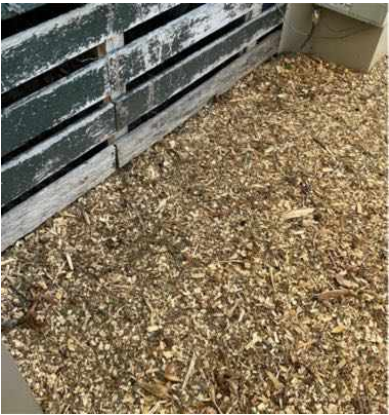
Finding 6.02

Building:	Main Building
Location:	All Areas
Finding:	Stored timbers - subfloor space or external area
Information:	The storing of timbers in the subfloor space or around the external property (including bark mulch) increases the risk of termite activity being present. As they are likely to come into contact with weather conditions or excessive moisture wood rot is likely to develop on timbers that are not treated.

It is highly recommended that any stored timbers be immediately removed from areas in which they may attract any termite / timber pest attack. Minimisation of risk / prevention of termite attack is far more adequate than dealing with the presence of

termite activity.

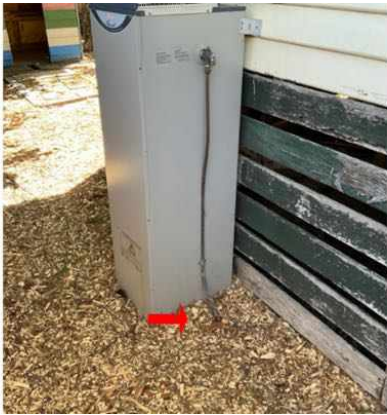
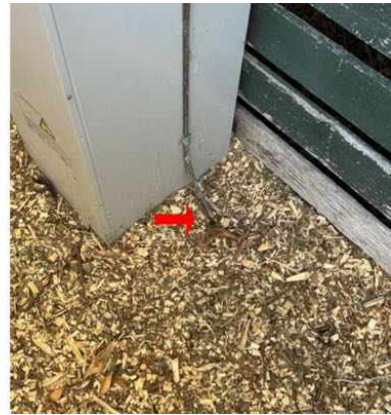
Finding 6.03

Building: Main Building
Location: Hot water/aircon unit(s)
Finding: The air conditioning overflow pipe is not properly connected and discharges directly into the soil adjacent to the building.
Information: This creates a conducive condition for termite activity by providing a constant moisture source near the structure. It may also lead to soil erosion, mould growth, or damage to nearby building materials.

The overflow should be redirected to an appropriate discharge point—such as a stormwater connection or designated drainage area—away from the building foundation, in accordance with plumbing and termite management standards.

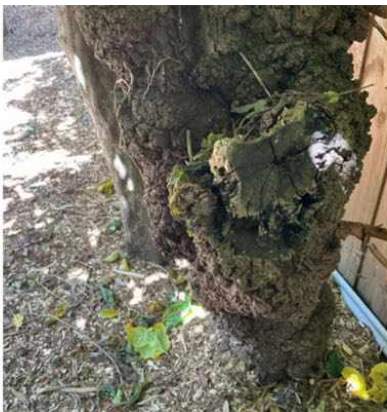
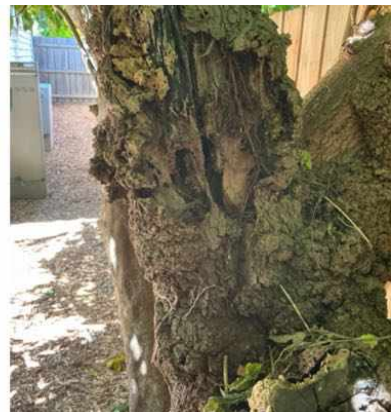
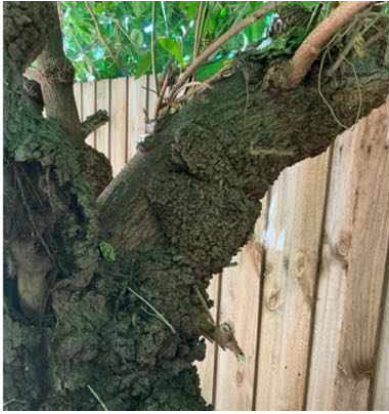
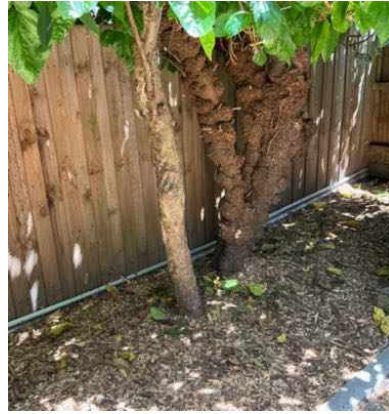
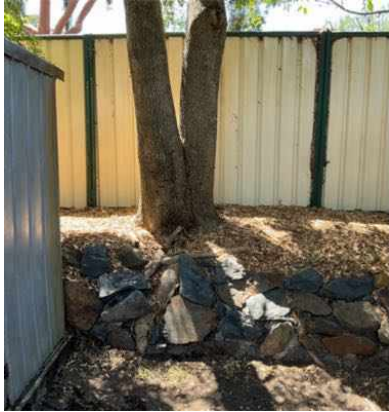
Finding 6.04

Building: Yard
 Location: Yard
 Finding: Large trees/stumps within 30m of house
 Information: There are a number of large trees/stumps within 30m of the house which may contain natural termite activity. It is important to monitor these areas to ensure no natural activity is allowed to progress into the main house.

Regular inspections are recommended. Consider test drilling any large trees.

A pest controller can be contacted to carry out such testing at the owners discretion.

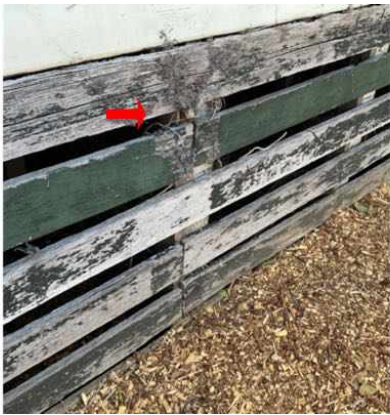
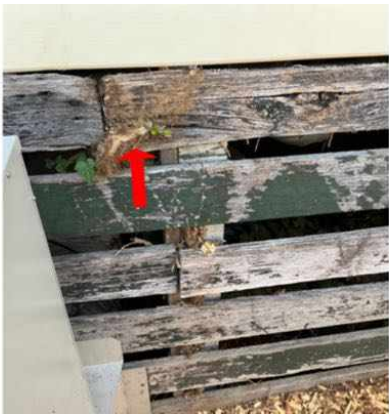
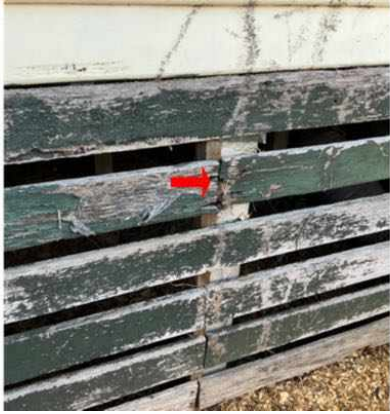
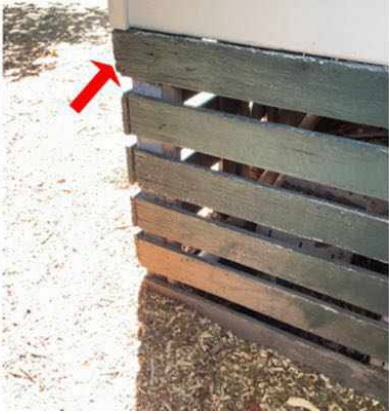
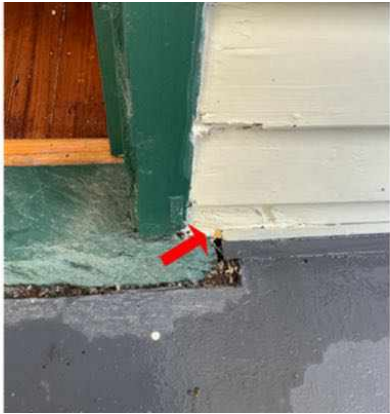
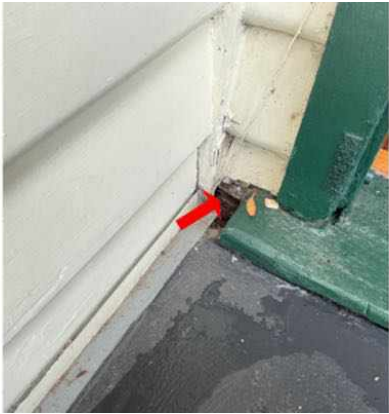
Finding 7.01

Building:	Yard
Location:	Yard
Finding:	Wood rot-external timbers
Information:	Wood rot which is technically known as Fungal Decay occurs when timbers and other cellulose building materials are exposed to damp conditions on an ongoing basis. This could be the result of exposure to weathering in the long term or the pooling of water or absorbed moisture from other abutting building materials. It is advisable to remove these affected timbers to prevent any chance of attack in the future.

Wood decay is more susceptible to termite attack and these timbers should be replaced to limit termite attack.
