# Building and Timber Pest Inspection Report

Inspection Date: Tue, 24 Mar 2026

Property Address: 2/9 Hart Dr, Constitution Hill NSW 2145,  
Australia

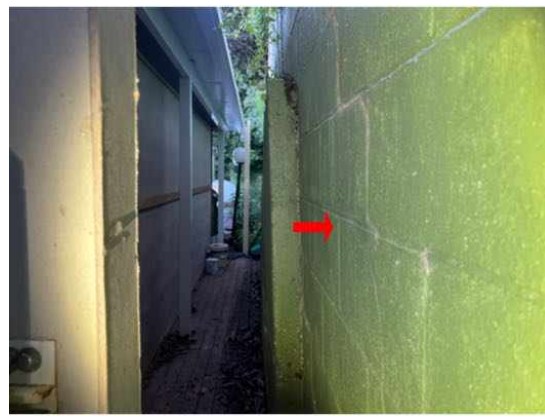
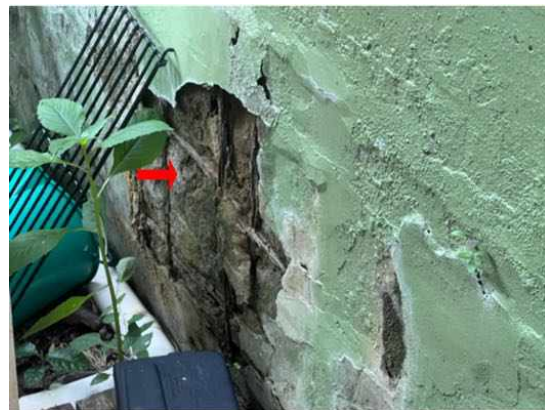
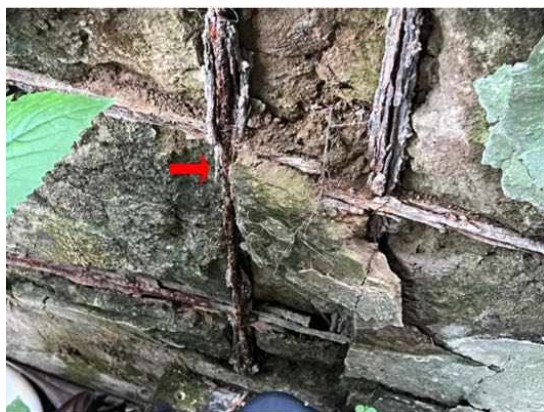
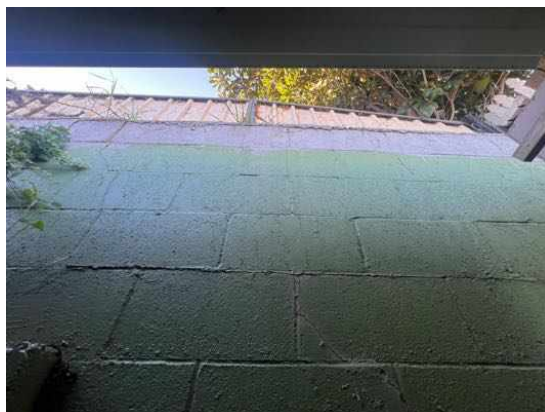
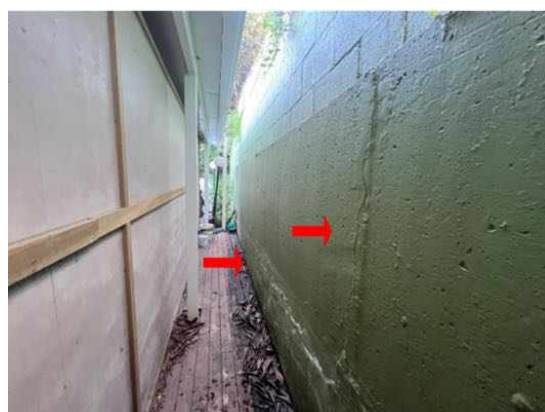
Building:	Main Building
Location:	All External Areas
Finding:	Retaining wall - Defective - Cracking , spalling concrete , damp and possible lean requires further investigation
Information:	The retaining wall in this area was found to be defective at the time of inspection. Generally, defective retaining walls are caused by poor original design or material use.

However, deteriorated retaining walls may also be a result of substandard construction, poor site drainage or unmanaged stormwater flows.

If left unmanaged, the retaining wall may become a safety hazard if it continues to destabilise. Where retaining walls further rot and decay, an environment is created that is conducive to termite and pest infestation.

Significant repair and replacement should be expected. Where retaining walls are considered structural walls, a structural engineer / surveyor should be consulted regarding required remedial works. Otherwise, a landscaper or retaining wall installer may be appointed to repair or replace the wall, at the discretion of the client.

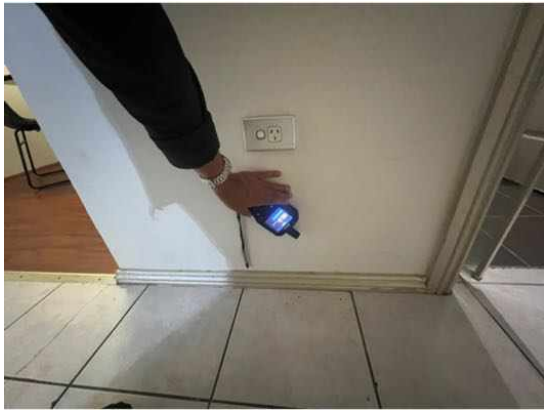
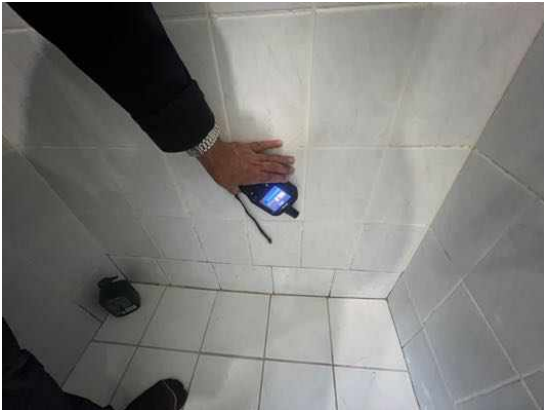
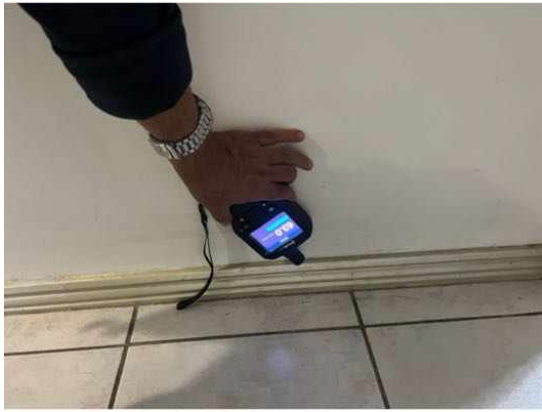
Building:	Main Building
Location:	Bathroom, Ensuite
Finding:	Elevated Moisture Bathroom & Back of shower - Further investigation recommended (Possible waterproofing)
Information:	Elevated moisture levels were detected to tiled surfaces in bathroom/shower areas. This may be due to porous or missing grout, cracked tiles or recent use, however the

possibility of waterproofing membrane failure or plumbing leaks cannot be excluded. Persistent moisture ingress can lead to concealed damage, including timber rot and mould growth. Further investigation by a licensed plumber and/or waterproofing contractor is recommended as soon as possible. The back of shower area also showed elevated moisture but no visible deterioration was evident at the time of inspection.

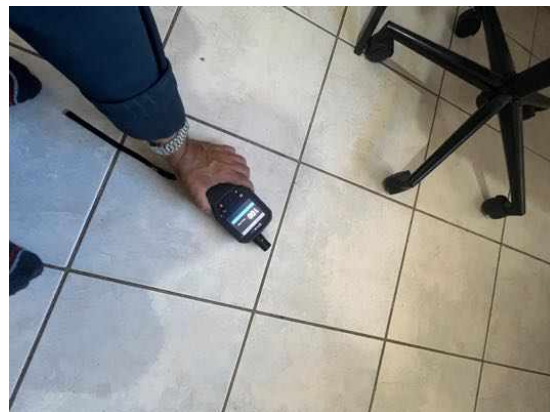
Building:	Main Building
Location:	All Internal Areas - Flooring
Finding:	Elevated Moisture – Further Investigation Recommended
Information:	Elevated moisture readings were detected in several locations in the flooring, with no visible surface issues, although no significant structural damage was evident at the time of inspection, dampness can contribute to deterioration if left unaddressed.

Moisture meters can be affected by conductive materials beneath tiled finishes, including screeds, adhesives, salts, or embedded services, which may result in high readings that do not necessarily indicate active moisture ingress. However, consistently high readings across multiple areas may also indicate the presence of retained moisture beneath the tiled surfaces.

A further investigation by a licensed plumber or waterproofing specialist is recommended to confirm the source and ensure no concealed issues are developing.

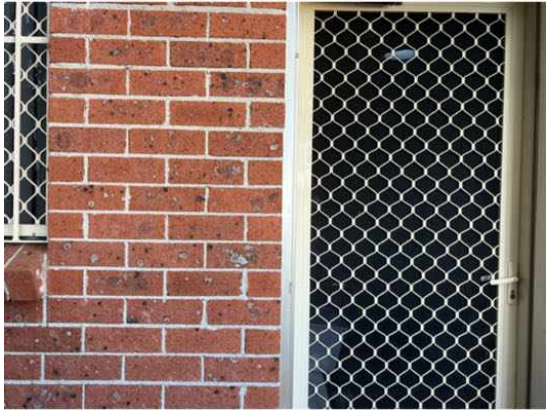
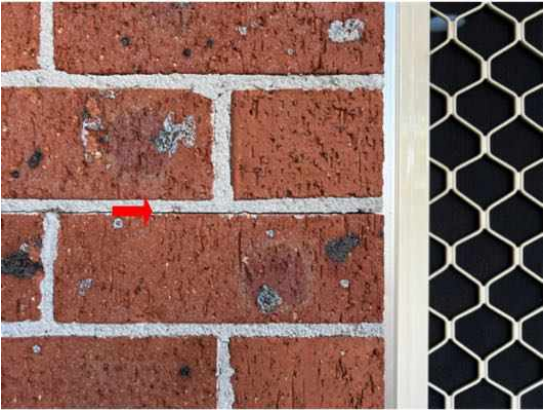
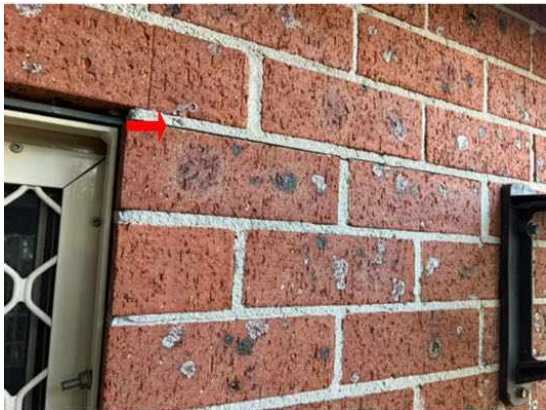
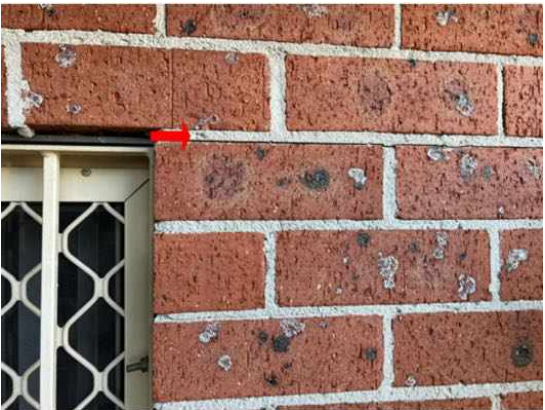
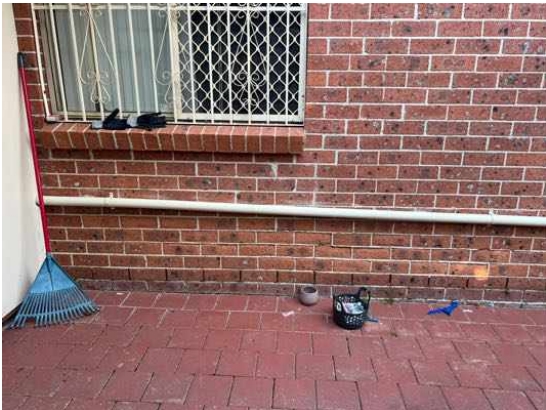
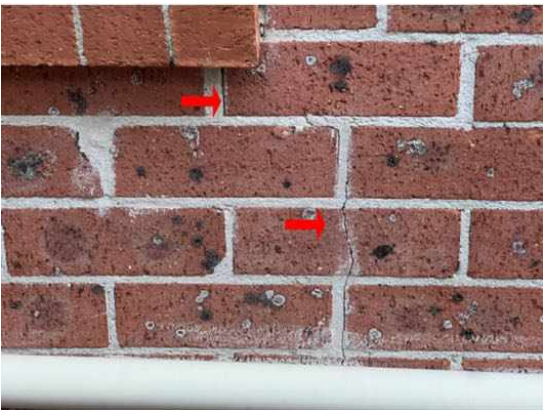
### Finding 3.03

Building:	Main Building
Location:	All External Areas
Finding:	Brickwork - Cracking noticeable to some areas
Information:	There were several cracks and or crack repairs evident to external brickwork.

Noticeable cracks are a common occurrence in external brickwork and are a likely result of age expected building movement, general expansion, and/or contraction of building materials in different weather conditions. Noticeable cracks in brickwork may develop if left unattended, with potential for necessitating major remedial works or replacement of the brickwork.

It is highly advised that a qualified bricklayer be appointed to provide necessary works to cracked brickwork to prevent any further damage. Such works should be conducted as soon as possible.

Always monitor these cracks and contact a building inspector should cracks widen, lengthen, or become more numerous.

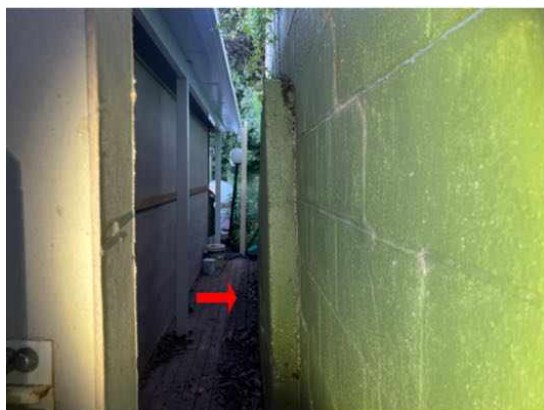
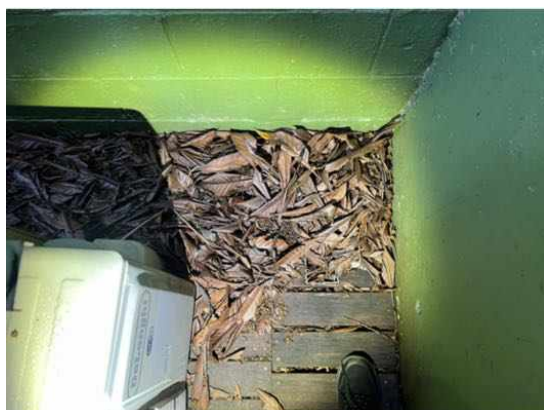
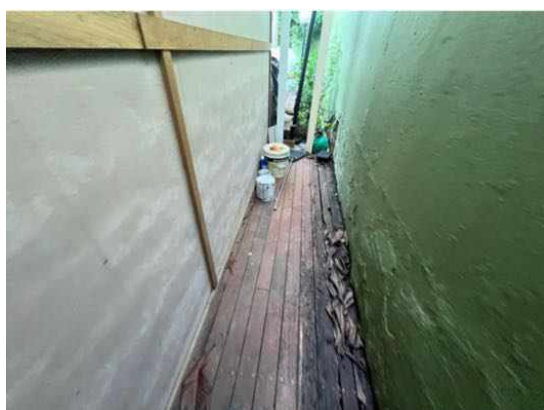
Information: Damp (or structural damp) refers to the presence of unwanted moisture in the structure of a building, either as the result of intrusion from outside, or condensation from within the structure. Generally, structural damp is caused by rain penetration, rising damp, and leaks from plumbing pipes.

Unmanaged damp facilitates the formation and development of mould, fungi growth and wood rot, decaying associated building materials and compromising their structural integrity. Damage to finishes is also likely to occur, including lifting, bubbling,

It is important that water does not lie against the base of walls; surrounding paths and ground levels should be sloped to drain water away from walls. Downpipes should not discharge stormwater onto lower walls or plinths. Stormwater should be carried away by large, regularly cleaned drains. Ground levels may need to be lowered to expose a buried DPC.

Where site drainage is inadequate, installation of an Agricultural (Aggie) Drain may be required. A qualified plumber should be appointed to further inspect the property and perform any remedial works as necessary. Water damage and secondary defects are likely to occur if left unmanaged.

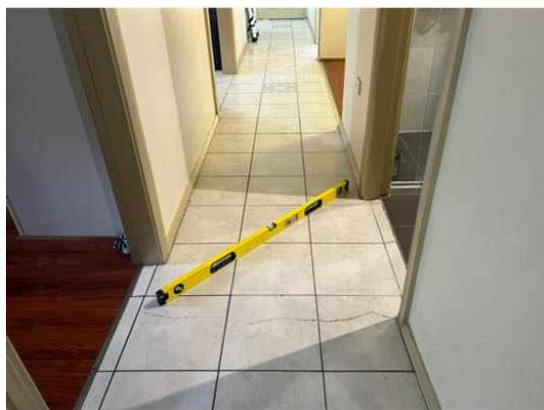
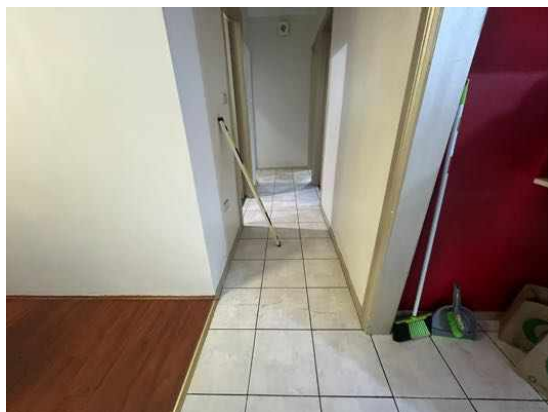
The internal flooring in this area is out of level and uneven. Uneven flooring is likely to indicate minor defects such as expected movement of the foundations of the property, but may also indicate subsidence of the associated subfloor stumps.

It is advised that the flooring be closely monitored to identify any further movement. Where flooring remains relatively unchanged for an extended period of time (i.e. several months), it is likely that this defect has been caused by expected movement of the foundations of the property.

However, where flooring is uneven further, potentially invasive inspection of the subfloor structures and stumps in this area is required. In this case, works to repair are likely to be required, and would be carried out by a registered builder

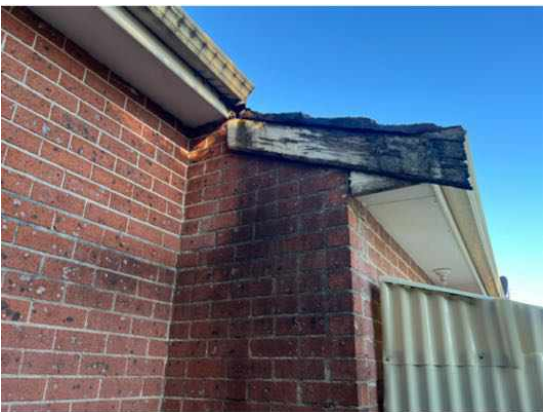
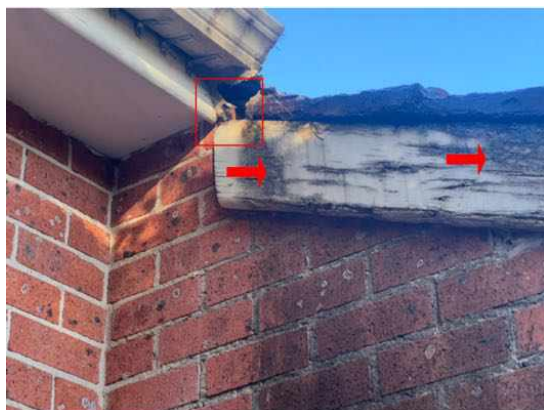
### Finding 3.09

Building:	Main Building
Location:	All External Areas
Finding:	Fascias - Wood rot
Information:	Wood rot was found to be affecting fascias and barges in this area, evidenced by the presence of mould on the surface in some areas. Wood rot, also known as Fungal Decay, occurs when timbers and other cellulose building materials are exposed to damp conditions on an ongoing basis.

A qualified plumber may be appointed to assess the cause of excessive moisture and

to provide advice on any remedial works as required. A qualified carpenter or registered builder may also be required to replace affected building materials.

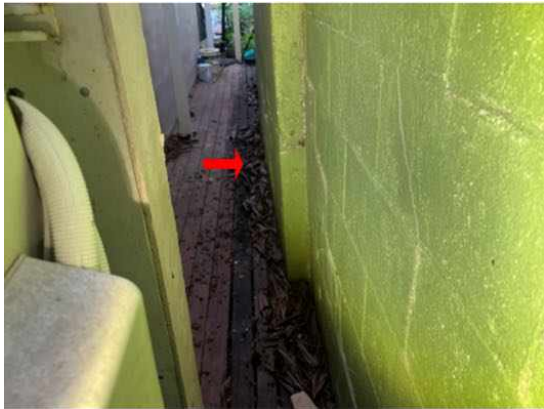
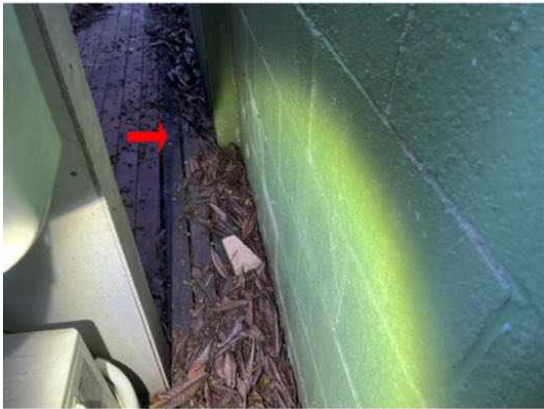
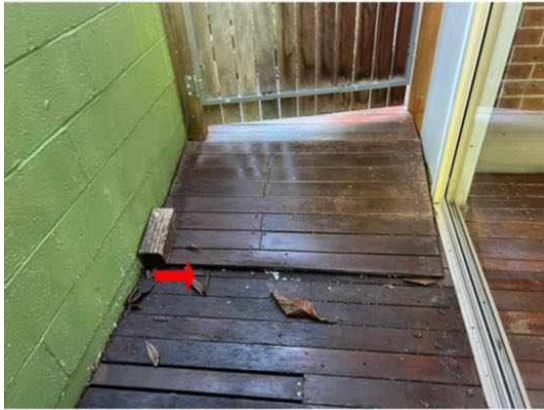
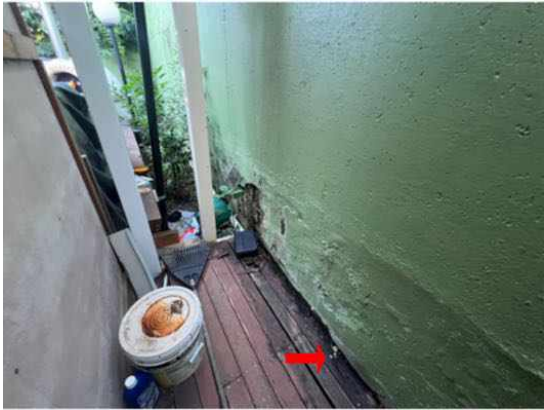
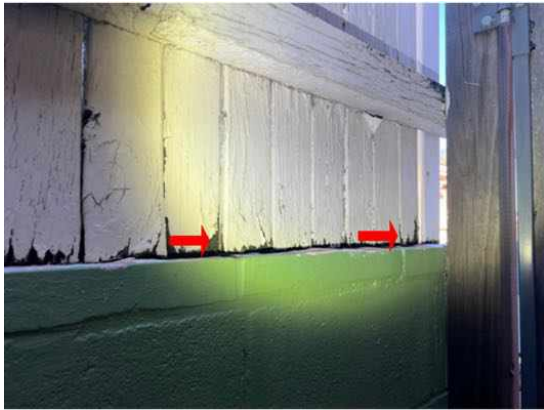
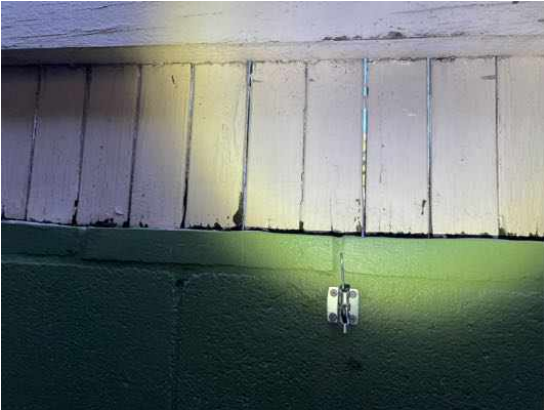
### Finding 3.10

Building:	Main Building
Location:	All Internal Areas
Finding:	Wood rot to some areas
Information:	This building element shows evidence of wood rot. Wood rot, also known as Fungal Decay, occurs when timbers and other cellulose building materials are exposed to damp conditions on an ongoing basis. This could be the result of exposure to weathering over a prolonged period of time, or the attraction of excessive moisture from other abutting building materials. Contributing factors also include poor air ventilation in the area.

A qualified plumber may be appointed to assess the cause of excessive moisture and to provide advice on any remedial works as required. A qualified carpenter or registered builder may also be required to replace affected building materials.

Even though Liver termite activity was not visible. A further invasive inspection by a licensed termite technician its also highly recommended to eliminate possibility of potential termite activity.

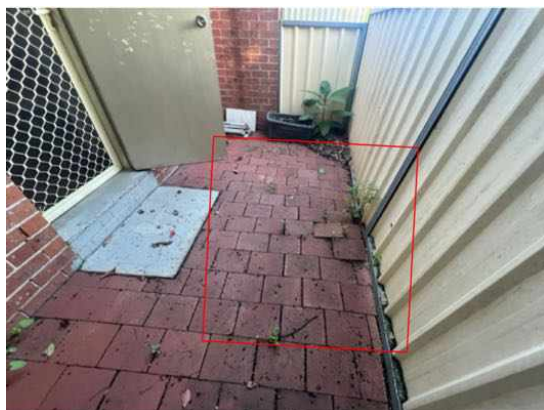
Where paving creates a trip hazard, personal injury may ensue if due caution is not taken by all persons within this area.

Re-paving of the area is required as soon as possible to remedy this situation. Further consultation with a specialist concreter is advised.

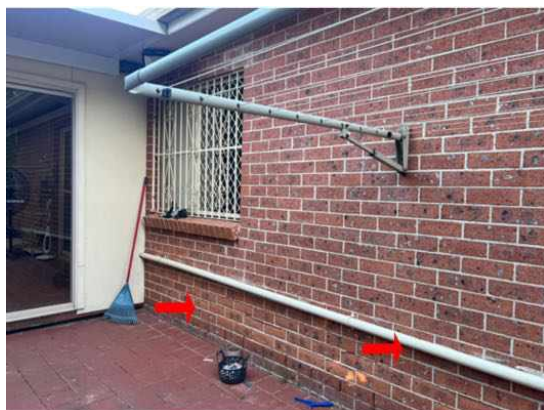
**Finding 3.14**

Building: Main Building  
Location: All External Areas  
Finding: Brick Erosion to some areas  
Information: The external brickwork exhibits signs of erosion at the base of the wall, with surface deterioration likely due to prolonged moisture exposure, or ground splashback. If left untreated, it may lead to further material loss and compromise the protective paint coating. It is recommended that affected bricks and mortar joints be assessed and remediated by a qualified bricklayer to ensure ongoing durability and to maintain the wall's weatherproofing function.

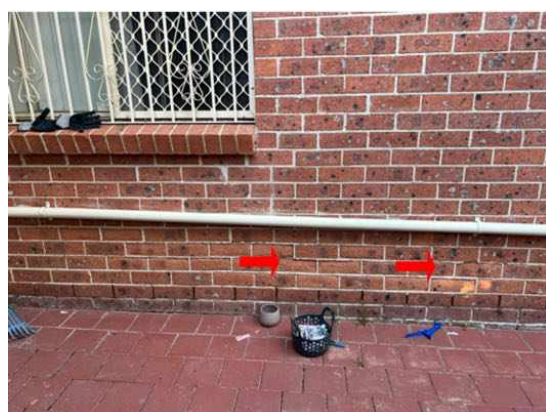
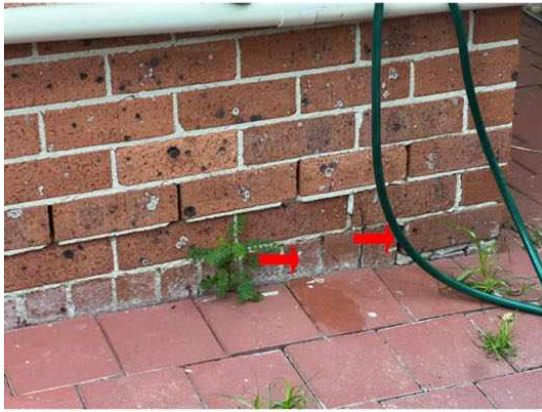
Mortar may deteriorate as a result of age of building materials, minor movement of bricks, or frequent exposure to weathering. Mortar should be replaced to ensure that bricks remain in their intended location and to prevent gaps, which would allow water or moisture ingress and secondary damage as a result.

Mortar deterioration can be addressed by a bricklayer where areas of deterioration are localised and easily accessible. Alternatively, appointment of a registered builder is advised, to repoint large areas of decaying mortar. Where secondary structural defects have become evident, consultation with a structural engineer may be required.

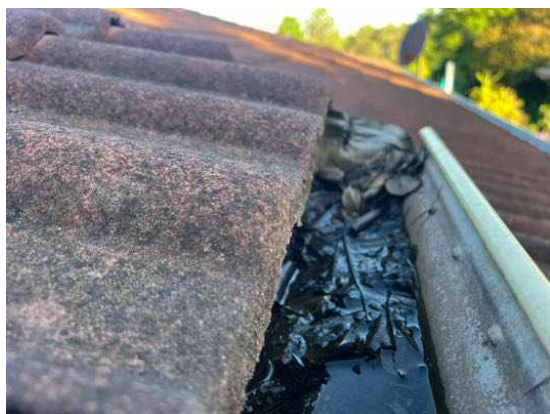
### Finding 3.20

Building:	Main Building
Location:	All External Areas
Finding:	Gutters - Blocked to some areas
Information:	Roof plumbing structures, such as guttering and downpipes, should be free of all debris to prevent blockages. Blockages of the guttering and downpipes will lead to pooling and accumulated water overflows, which is likely to subsequently flood eaves and exterior walls.

Consult a Licensed Plumber for further specific advice on remedial works that may be required. In the interim, it is highly advised that blocked gutters be removed by the homeowner or a general handyperson as a matter of urgency.

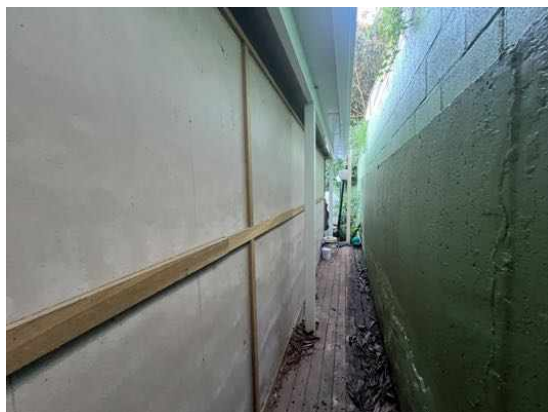
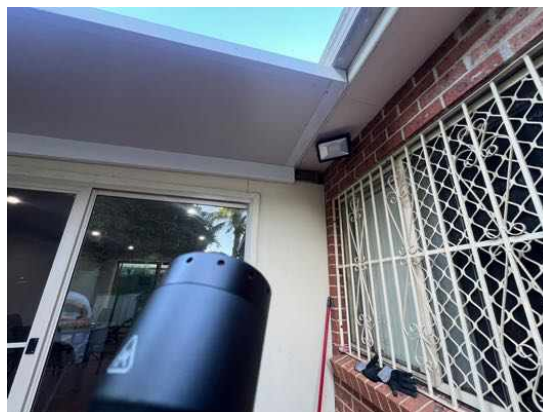
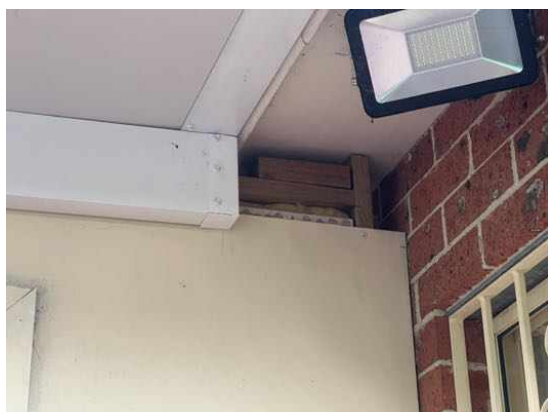
Building:	Main Building
Location:	All External Areas - Garage , Right exterior
Finding:	Installation - substandard or incomplete
Information:	The installation of this building element appears to have been completed to a substandard level of workmanship or is incomplete. Generally substandard repairs or installation are related to poor workmanship, the use of inappropriate materials, or a failure to complete installation to a suitable standard.

Where installation is substandard and/or incomplete, the client should contact the responsible trade to undertake rectification. Unfinished and substandard building works are likely to degrade more quickly and may create potential for secondary defects to associated building elements.

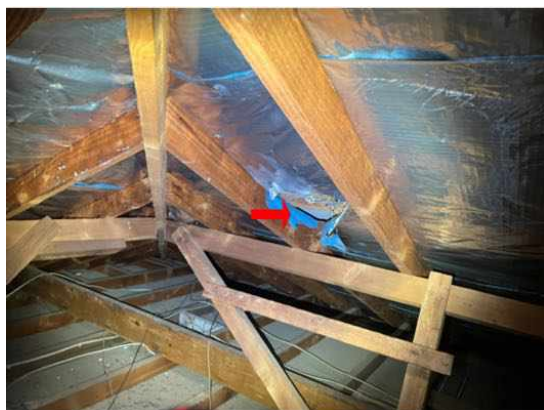
### Finding 3.33

Building:	Main Building
Location:	Roof Void
Finding:	Sarking - Damaged
Information:	Sarking, a laminated aluminium foil applied to the interior of the roof covering, assists in insulating the property and acting as a vapour-barrier to the roof void and, subsequently, to the household.

It is important to repair any holes or damaged sections of sarking to ensure that the building material is fully functional. A registered builder or qualified carpenter should be consulted to provide further advice on this defect and to perform rectification works at client discretion.

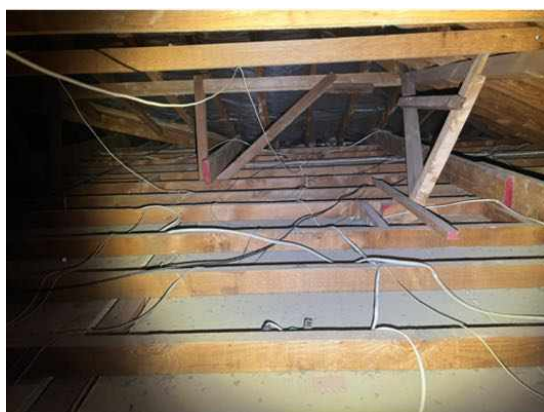
### Finding 3.34

Building:	Main Building
Location:	Roof Void
Finding:	Insulation - Missing & loose cables
Information:	Upon inspection of the roof void it was noted that insulation is not present.

Unsecured cables were also found in the roof void at the time of inspection , they should be secured by a licensed electrician to ensure safety and they don't cause a trip hazard during inspections.

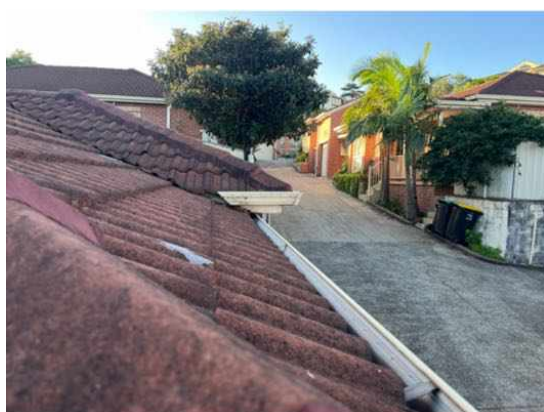
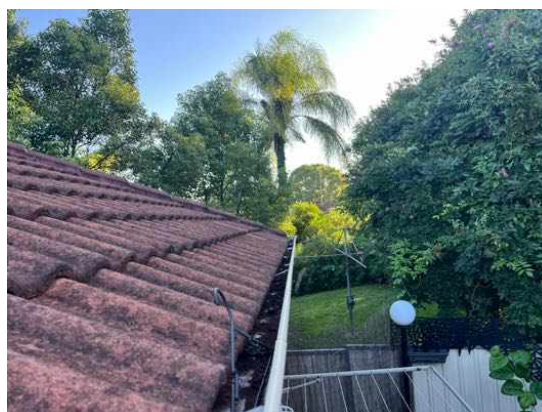
## Finding 6.02

Building:	Main Building
Location:	All External Areas
Finding:	Trees within 50m
Information:	Trees within 50m of the property can be conducive to termite activity. It is recommended an invasive inspection of all trees with 50m to the property be carried out by a qualified pest control expert.

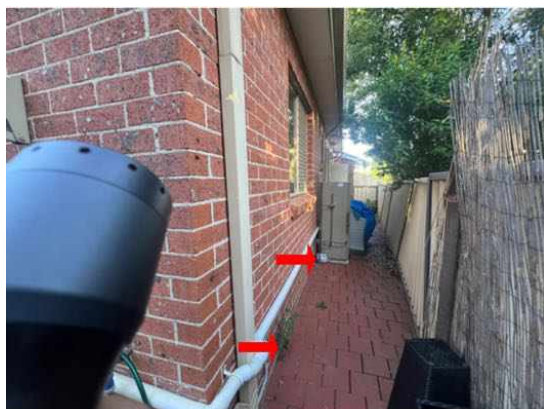
## Finding 6.03

Building:	Main Building
Location:	All External Areas
Finding:	Slab Edge - Exposure
Information:	An inspection zone of at least 75mm in relation to the exposed slab edge, between the bottom brick and the perimeter pavement, is required. This inspection zone should be maintained in order to force termites into the open where they can be detected more readily during regular inspections. The slab edge should not be concealed by anything that may prevent inspection of the area, including render, landscaping, soil, turf, paving, concrete cladding or other structures.

Where the slab edge cannot be properly inspected, it is highly recommended that termite or timber pest inspections be carried out every 6-12 months to aid protection of the property against infestation.

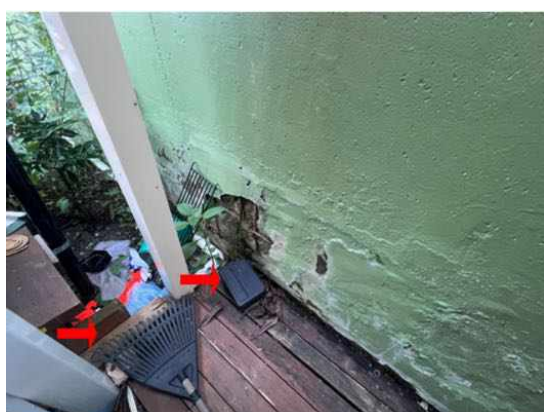
### Finding 6.04

Building: Main Building  
 Location: All External Areas  
 Finding: In ground contact - Timber  
 Information: Any timbers in direct ground contact provide opportunity for concealed termite entry and are likely to be subject to premature rot and decay as the soil retains moisture or damp conditions against the timbers.

Remove untreated timber that is in direct contact with external grounds. Consider replacement with more durable materials i.e. treated timber or non timber elements. Frequent pest inspections are advised to readily identify any termite activity in these areas.

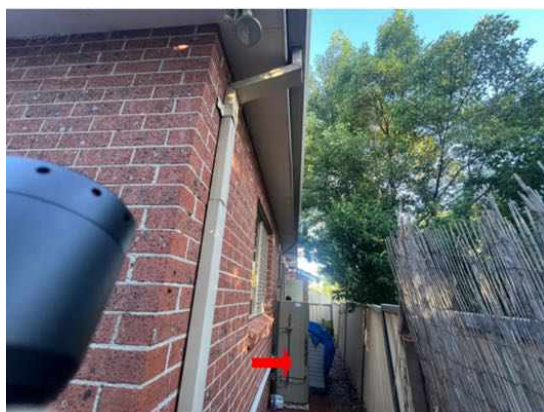
### Finding 6.05

Building: Main Building  
 Location: All External Areas  
 Finding: HWS Overflow - Not Connected

It is highly recommended that a licensed plumber be appointed to connect the HWS overflow in order to prevent such an environment from being created. These minor works should be carried out as soon as possible.
