Building Inspection Report

Inspection Date: Mon, 30 Mar 2026

Property Address: 303/48 Blenheim St Balaclava, VIC, 3183

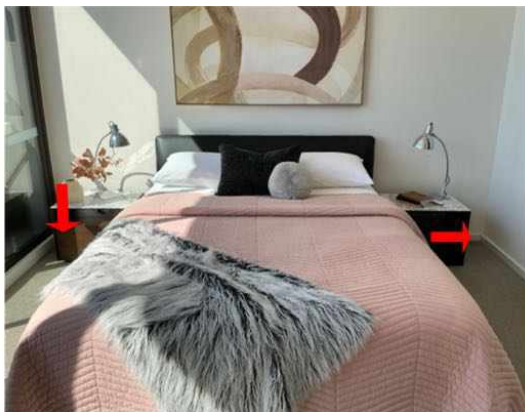
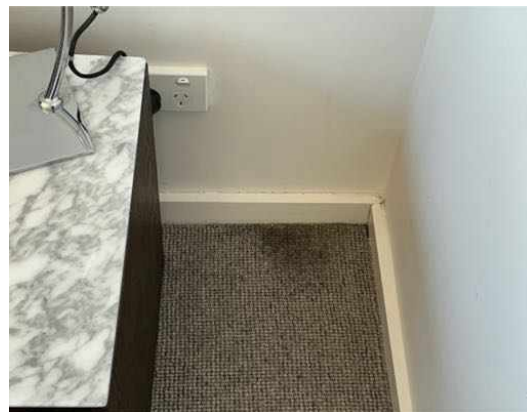
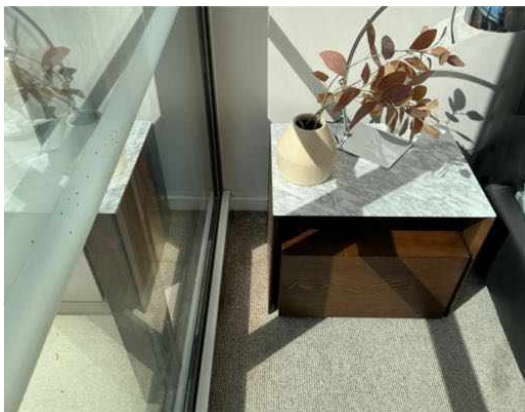
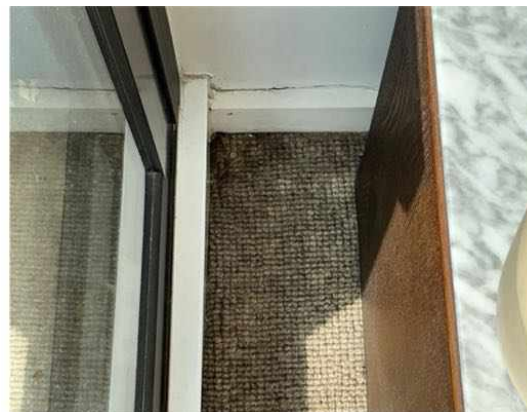
Defects 2.01

Building: Main Building
Location: Bedroom - Master
Finding: Evidence of excessive moisture was present at the time of inspection
Information: Excessive moisture can attract fungal growth and decay. Excessive moisture is generally caused by deteriorated, inadequate or missing roof drainage, leaking plumbing pipes or fixtures, and poor site drainage. It is highly recommended that all plumbing and drainage fixtures and fittings be maintained regularly in order to prevent excessive moisture being present in the external / internal property.

Excess moisture was found to the carpet and skirting of the master bedroom and cabinets in the en-suite area.

This is considered a major defect as without rectification associated building elements will continue to degrade.

A registered builder and qualified plumber should be engaged immediately to investigate further and rectify this moisture problem.

Further invasive inspection will be required by the appropriate trades in order to determine the cause of the excess moisture and rectify the issue.

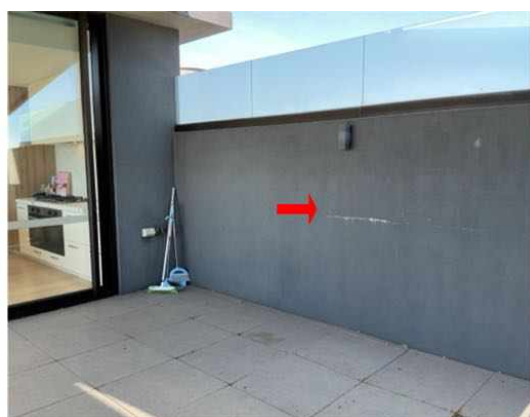
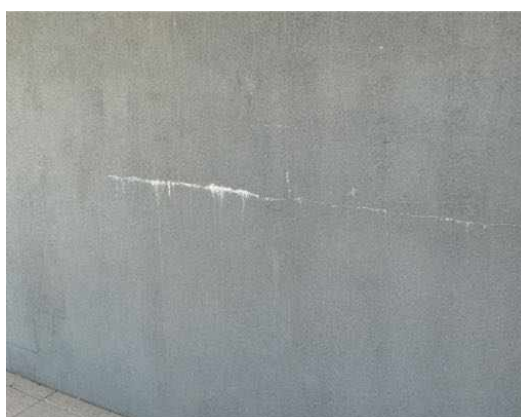
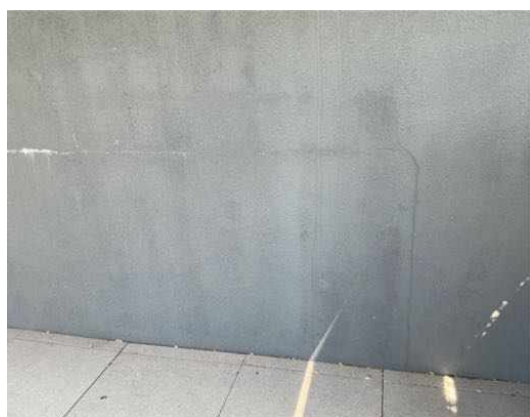
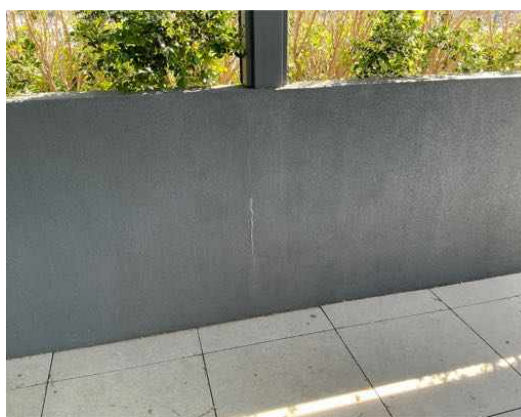
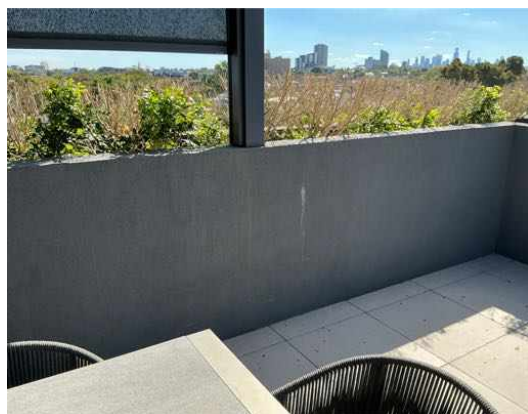
Defects 3.01

Building: Main Building
Location: Balcony
Finding: Cracks to render - Category 1
Information: It has been observed that cracking to rendered surfaces has occurred. The degree of damage falls within Category 1, described as fine cracks that do not need repair and which are less than 1.0mm in width limit.

Damage of this category is not considered a defect for rectification. Always contact your building inspector should cracks widen, lengthen, or become more numerous.

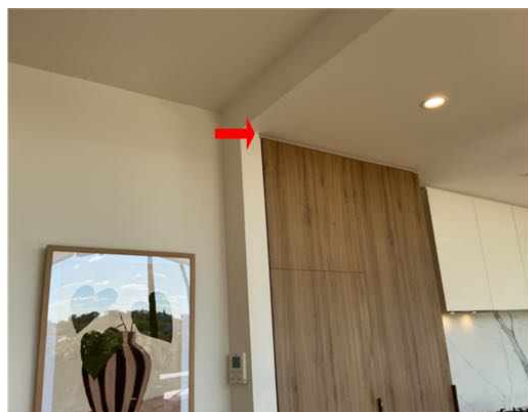
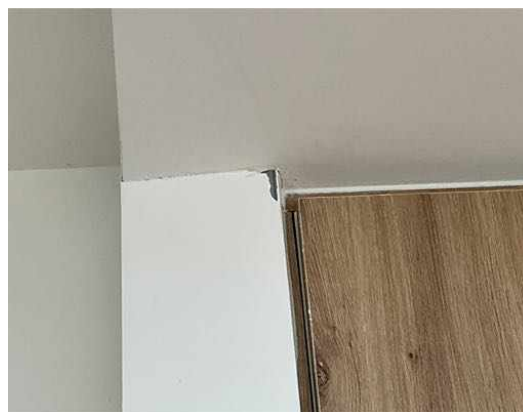
Defects 3.02

Building:	Main Building
Location:	Kitchen
Finding:	Surface - Chipped
Information:	The surface of this building element appears to have chipped as a result of general wear and tear. While being an appearance defect, such damage is expected of a property of this age and condition.

Chipped surfaces rarely impede on the structure or functionality of the affected building element and generally only create a blemish on its appearance. Chipped surfaces may be left in situ at client discretion, as no repairs or replacement are necessarily required. However, the client may wish to seek quotations for the cost of refurbishment or replacement of the identified building element.

A qualified carpenter or cabinet maker should be appointed to repair chipped surfaces and replace building elements where major damage has occurred.

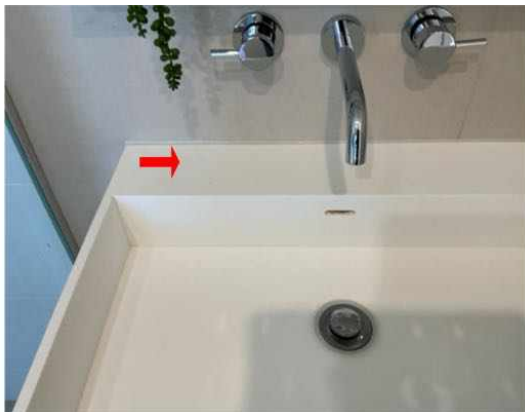
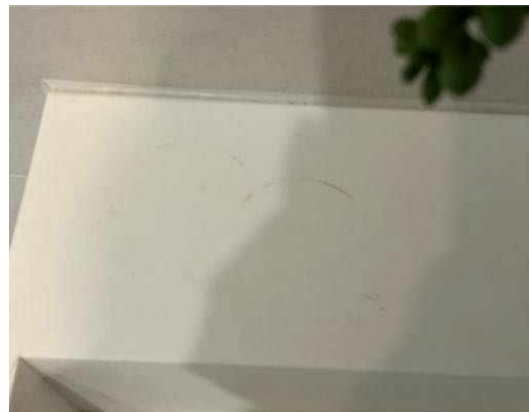
Defects 3.03

Building:	Main Building
Location:	Bathroom
Finding:	Surface - Marked

Information: Although detracting from the overall appearance, marked or stained surfaces do not indicate any operational or structural damage. This degree of surface damage is consistent with general wear and tear and is expected of a property of this age and condition.

Marked surfaces may be left as is at client discretion, as no repairs or replacement are necessarily required for this appearance defect. However, the client may wish to seek quotations for the cost to refurbish or replace the identified building element.

A painting or cleaning contractor may be appointed to rectify marked surfaces at the discretion of the client.

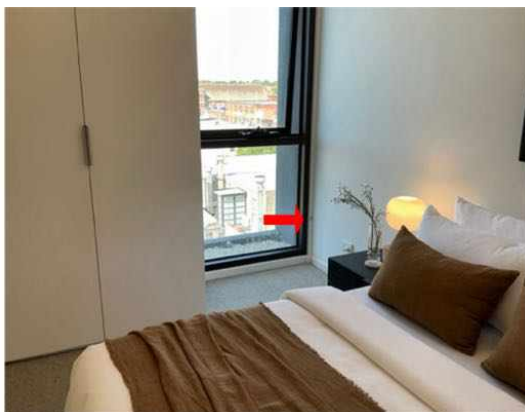
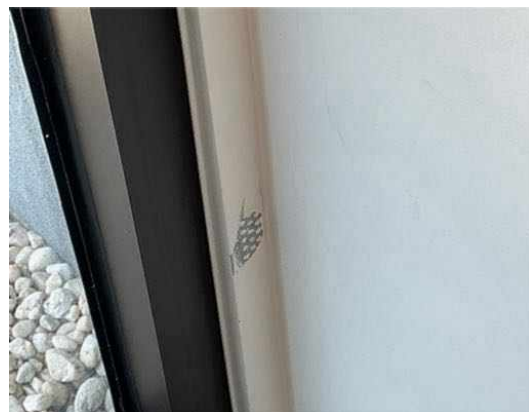
Defects 3.04

Building: Main Building

Location: Bedroom

Finding: Building element - Damaged

Information: Evidence of damage was identified to the wall in this bedroom, a plasterer and painter will be able to repair this minor damage.

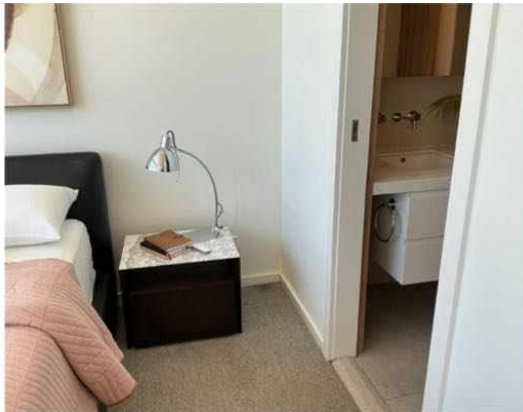
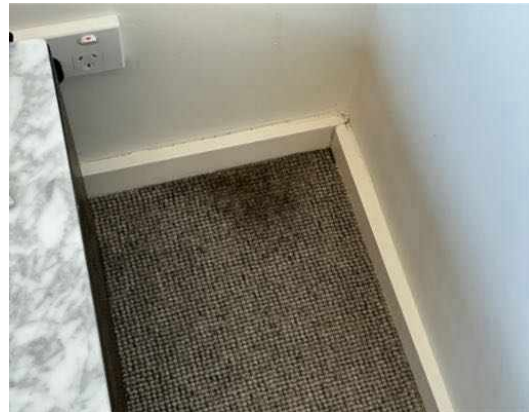
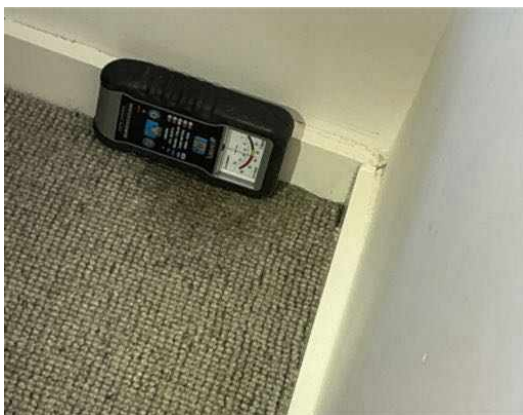
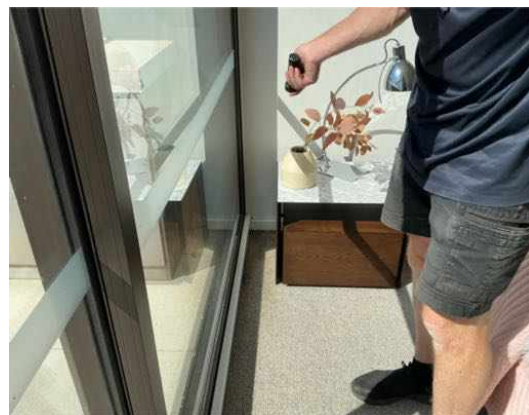
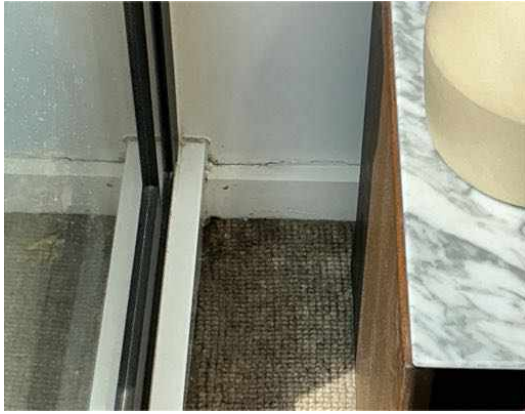
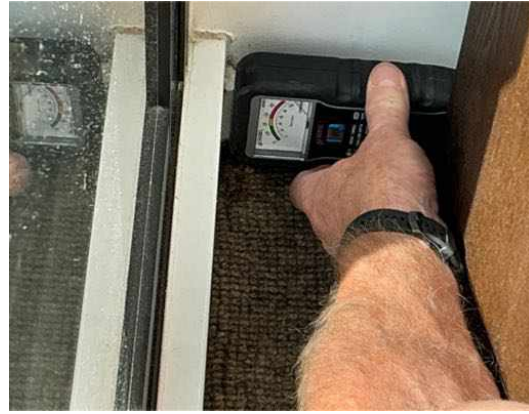
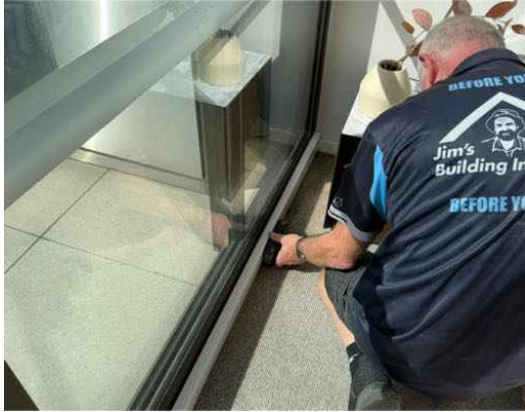
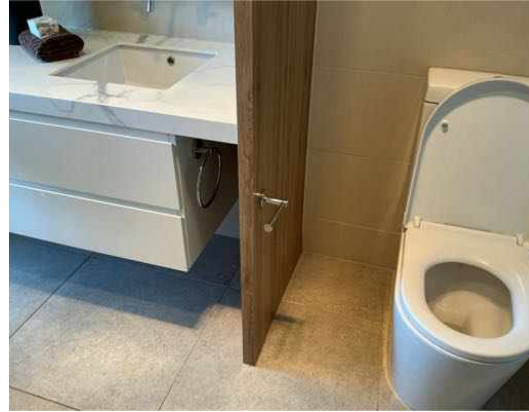
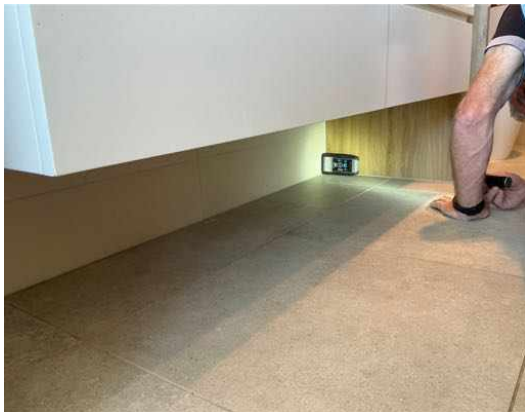
Defects 3.05

Building: Main Building

Location: Bedroom - Master
Finding: Building element - Swollen
Information: Swollen building elements generally indicate that the building materials have been affected by excessive moisture over a prolonged period of time, and have swollen as a result. The formation and development of mould/fungi or mildew is also a likely consequence of excessive moisture, which may pose major respiratory issues for occupants, particularly the elderly, the very young and those with existing illnesses and could be potential health safety hazards. In these cases an appropriately qualified inspector/tester should also be contacted for advice and/or technical assistance.

The structural integrity of swollen building elements can not be guaranteed, and further damage is likely to develop if left unmanaged. Excessive moisture is likely to lead to the development of secondary damage to any associated building elements, which may necessitate major reparation works if prolonged.

Rectification of the cause of the water leak should be addressed prior to any remedial works to the swollen building elements. A licensed plumber should be appointed immediately to identify the cause of the leak and provide advice on remedial works as necessary. Repair and/or replacement of swollen building elements should be conducted as a matter of urgency by a registered builder or qualified carpenter.

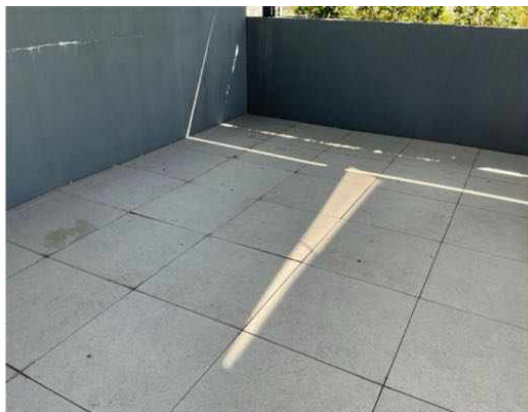
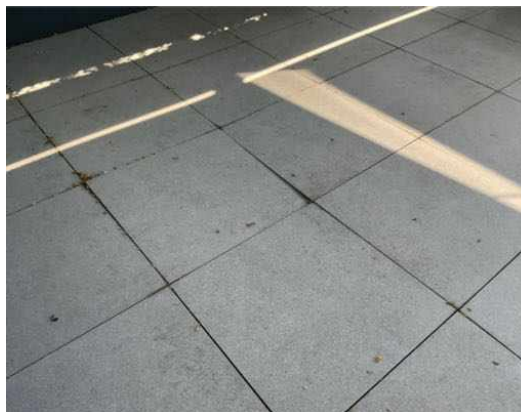
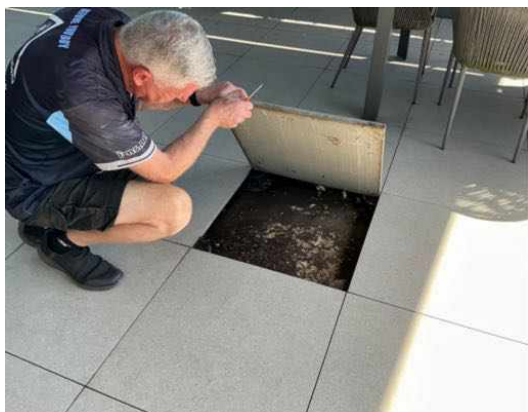
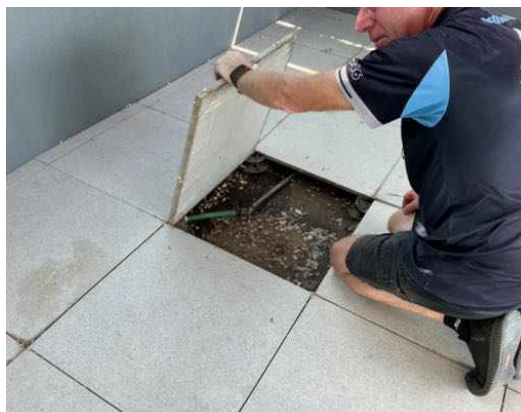
Defects 3.06

Building:	Main Building
Location:	Balcony
Finding:	Maintenance required
Information:	The balcony tiling was found to be on a pod system. Several pavers are not level and require readjustment, a tiling contractor should be engaged in order to adjust pavers to the correct height and clean underneath.

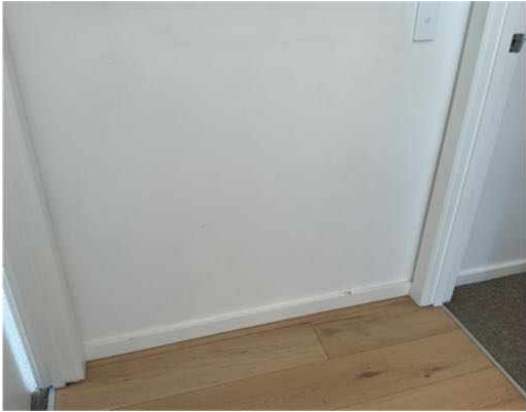
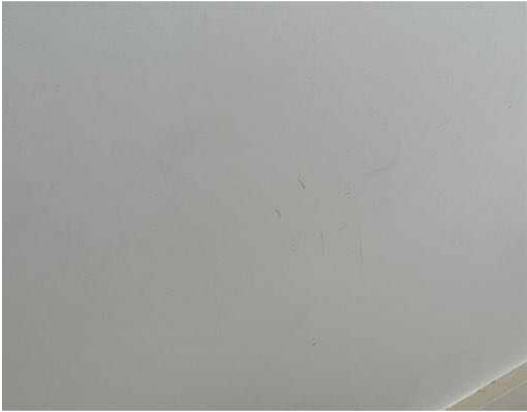
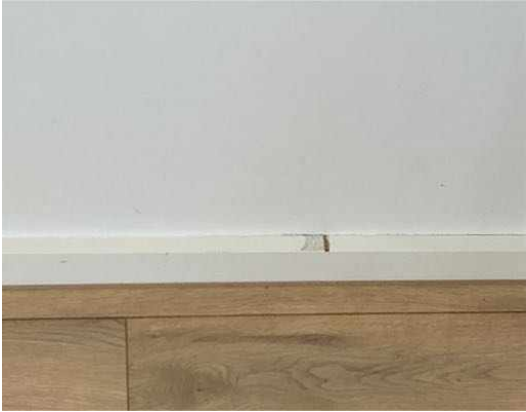
Defects 3.07

Building:	Main Building
Location:	All Areas
Finding:	Walls - Scuffed
Information:	Superficial scuff marks were noted to the internal walls in this area at the time of inspection. Marked and scuffed surfaces, while detracting from the overall appearance of the affected building element, do not indicate any operational or structural damage. This degree of surface damage is consistent with general wear and tear.

Marked surfaces may be left at client discretion, as no repair/replacement is necessarily required. Marked surfaces are unlikely to result in the development of secondary damage; however, the client may wish to seek quotations for the cost to refurbish or replace the affected wall linings.

A general handyman or cleaning contractor may be appointed to rectify marked or scuffed surfaces at the client's discretion.

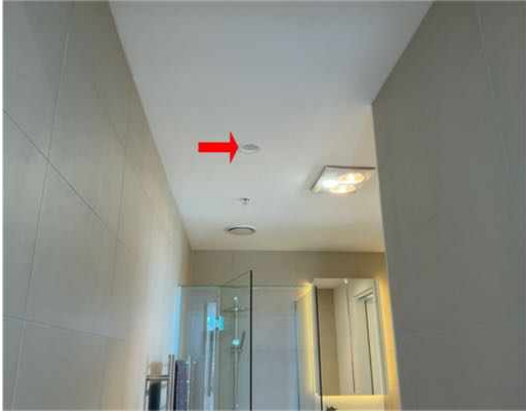
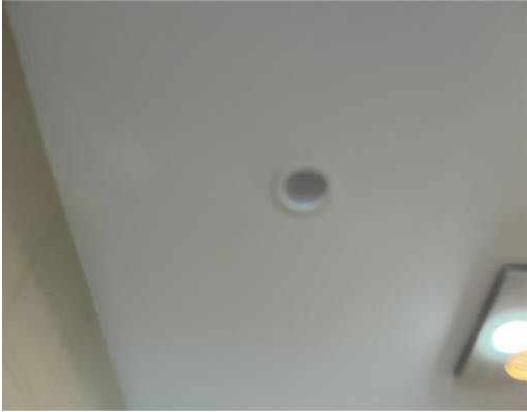
Defects 3.08

Building: Main Building
Location: Bathroom
Finding: Light not working
Information: This light was not operating at the time of inspection
