Building and Timber Pest Inspection Report

Inspection Date: Mon, 30 Mar 2026

Property Address: 10 Shirley St, Padstow NSW 2211, Australia

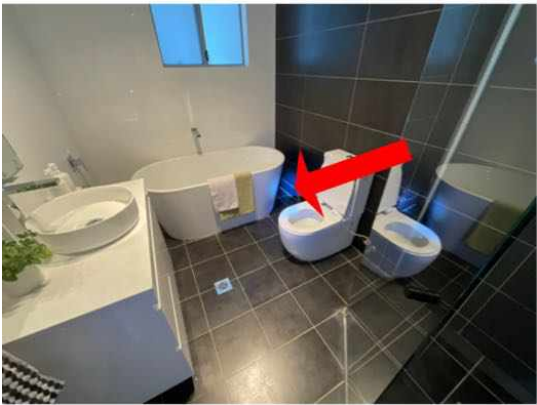
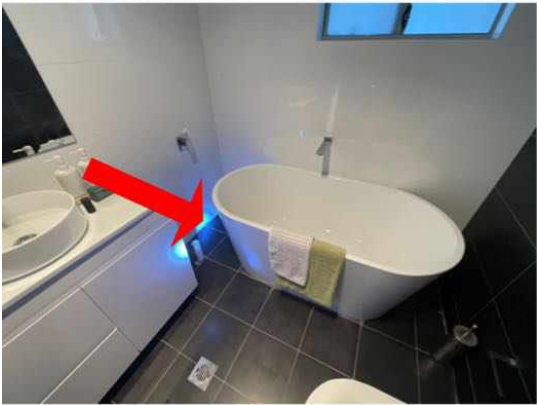
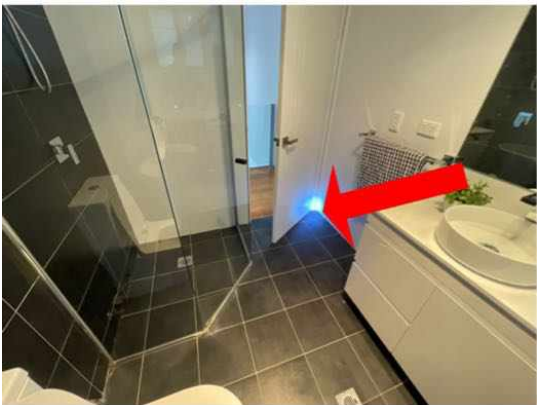
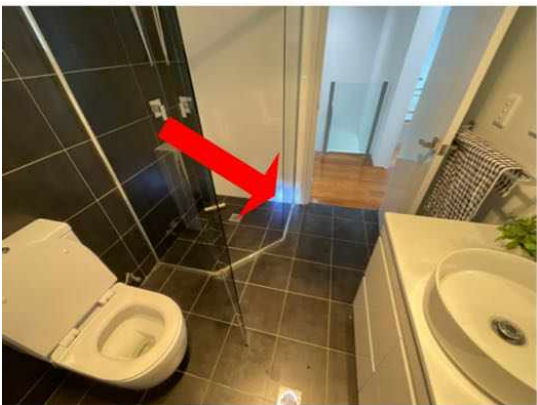
Building: Main Building
 Location: Bathroom
 Finding: Bathroom – Water Ingress / Waterproofing Failure (Major Defect)
 Information: Evidence of water ingress observed to bathroom floor and wall junctions, including:

- Deteriorated / missing sealant at perimeter junctions (wall-to-floor and shower screen)
- Water staining and residue build-up indicating prolonged moisture exposure
- Gaps at door threshold and tile edges allowing water migration to adjacent flooring

Condition indicates failure of waterproofing system and inadequate sealing to wet area.

- NCC 2022 – F1P1 (Wet areas): Must prevent water penetration causing damage
- AS 3740 – Waterproofing of wet areas: Requires continuous membrane and proper sealing at junctions and penetrations

Recommendation

- Engage licensed waterproofer / tiler to assess
- Likely require:
 - Removal of affected tiles
 - Reinstallation of compliant waterproof membrane
 - Resealing of all junctions and penetrations
 - Inspect adjoining areas for concealed moisture damage

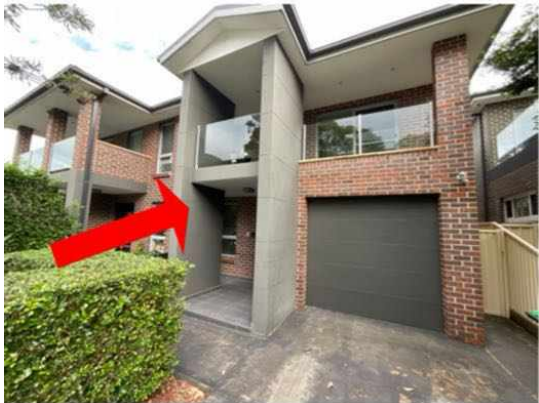
| Information: | Sections of paint in this area was found to have bubbled and deteriorated. Paint bubbling is generally an indication of excessive moisture in the area, that is currently hidden by the painted surface. |

The presence of excessive moisture can have major implications on associated building elements if left unattended. While only seemingly minor at this stage, the damage cannot be determined due to the paint obstructing any further inspection of the damage.

It is highly advised that the affected paint be cleaned to allow a further, more invasive inspection by a licensed plumber. Failure to act on this defect may necessitate major works in the future.

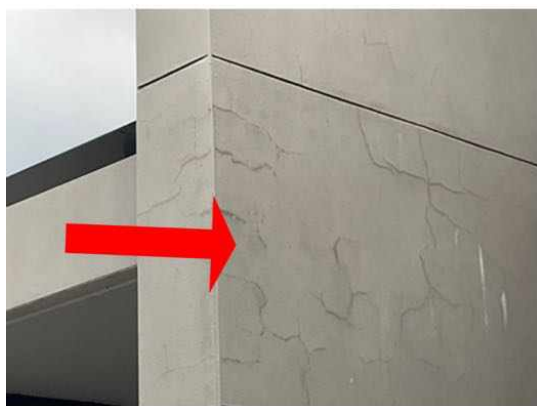
Finding 3.02

Building: Main Building
 Location: Exterior walls
 Finding: Cracks to external render - Category 1
 Information: It has been observed that cracking to internal rendered surfaces has occurred. The degree of damage falls within Category 1, described as fine cracks that do not need repair and which are less than 1.0mm in width limit.

Damage of this category is not considered a defect for rectification. Always contact your building inspector should cracks widen, lengthen, or become more numerous.

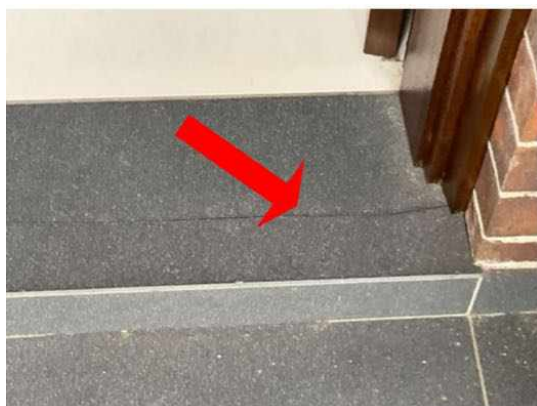
Finding 3.03

| Finding: | Tiles - Cracked or damaged |
| Information: | Cracking was evident to the tiling in this area at the time of inspection. While the cracking appears to be minor, this area is frequently exposed to water, allowing potential for water penetration into adjoining sections of walls or flooring. |

If left unmanaged, water penetration to these areas may lead to subsequent water damage, which is likely necessitate repair work to affected building elements.

A tiling contractor should be appointed to ensure that no further water damage occurs. The re-application of silicone and grouting throughout remaining tile work is also advised, to further protect the area against water penetration.

Where water penetration has led to water damage, appointment of a relevant tradesperson may be required to repair damaged building elements.

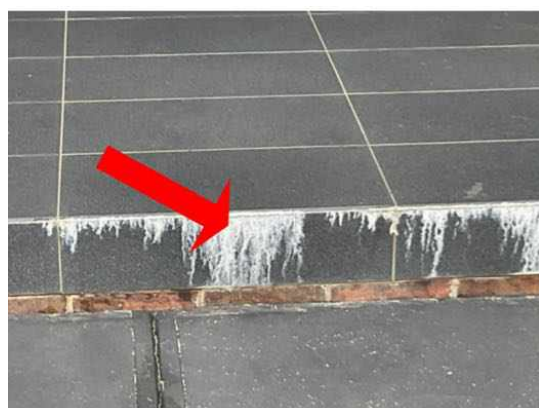
Building: Main Building
 Location: Alfresco
 Finding: Alfresco – Tiling & Wall (Evidence of Moisture Ingress)
 Information: Evidence of moisture-related deterioration was observed to the Alfresco area. Tile adhesive is lifting through grout joints, tiles show signs of debonding, and cracking is visible to the adjoining concrete wall. Water staining and efflorescence were noted to the base of the external brick wall.

The conditions observed are consistent with possible waterproofing failure and/or inadequate drainage to the balcony. Ongoing moisture ingress may result in further deterioration of tiling, substrate damage, and structural cracking over time.

An invasive inspection by a qualified waterproofing specialist is recommended to:

- Lift tiles as required
- Assess condition of waterproof membrane and substrate
- Check falls toward drainage point
- Rectify waterproofing and drainage defects as necessary

Monitoring is recommended to determine whether moisture intrusion is active.

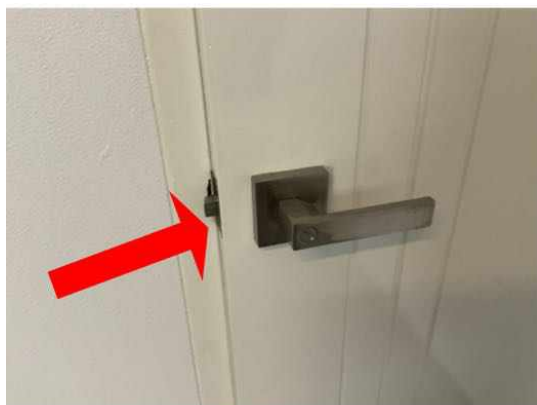
Information: Binding and/or jamming of this door is evident during standard operation. This defect inhibits the functionality of the affected door as well as creating potential for secondary defects to associated building elements, such as damage to the floor covering.

A door that binds to flooring or to the associated door frame may have several causes, ranging from minor defects, such as poor installation of the door or deteriorated hinges, through to major structural issues, such as damage to subfloor structures.

Where door binding/jamming appears to indicate major structural issues, a registered builder specialising in re-stumping should be appointed to provide an estimate on the cost of rectification.

For minor causes, a qualified carpenter or general handyman should be appointed to perform minor rectification works at client discretion.

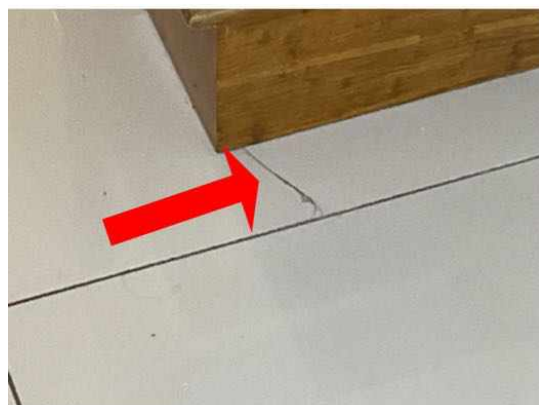
Finding 3.10

Building: Main Building
 Location: All Internal Areas
 Finding: Cracked floor tiles
 Information: Cracking in the floor tiles was evident in this area at the time of inspection. It is suspected that this cracking has occurred as a result of minor settlement or shrinkage

Cracked tiles throughout the household detract from the overall appearance of the affected areas however it is unlikely to create or lead to any secondary defects.

While not considered a matter of urgency, replacement of cracked floor tiles is recommended at the clients discretion. A tiling contractor may be appointed to perform these works. Where cracks become more numerous, contact a licensed building inspector for further investigation.

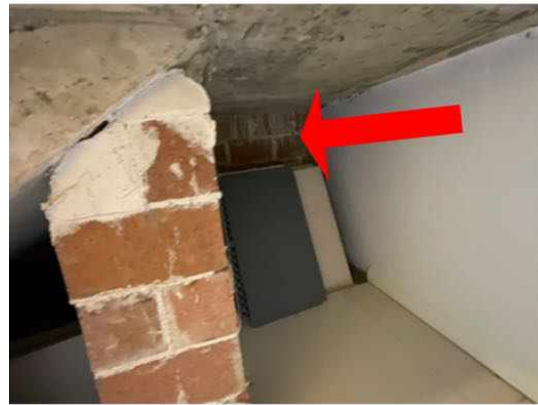
Sub standard and incomplete work are determined by identifying a failure to achieve the minimum requirement set out in the mandated Australian Standard as outlined in the Building Code of Australia and referenced by the Manufacturers Guideline.

Where a building element is installed in such a way that it fails to achieve the required minimum standard or level of finish at the time of the inspection, the builder needs to rectify the defect as soon as possible and complete works to the required standard prior to continuing with the stage of construction.

All known defects need to be rectified by builder

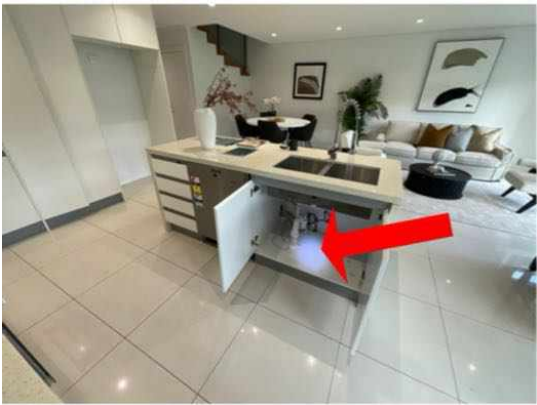
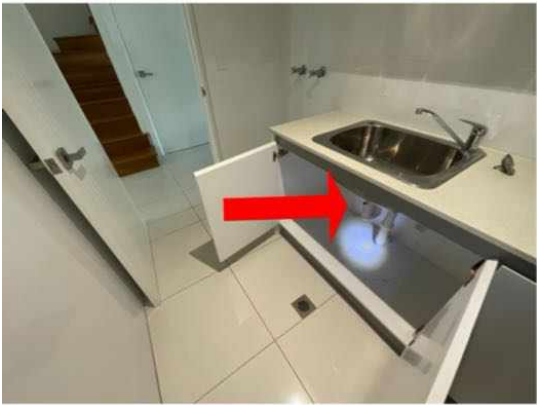
Finding 3.12

Building: Main Building
 Location: Kitchen / Laundry
 Finding: Water leak - Internal
 Information: A water leak was found in this area at the time of inspection. Internal water leaks can be detrimental to surrounding building elements; their potential causes include damage to plumbing fittings and fixtures, through to water damage and deterioration of associated building elements.

Rust, corrosion, decay and water damage are potential outcomes where a minor water leak is left unattended. More serious defects may also result, such as electrical hazards, or water damage to structural building elements.

In extreme cases, structural damage may develop due to a prolonged water leak. It is highly advised that internal water leaks be addressed by a licensed plumber as a matter of relative urgency.

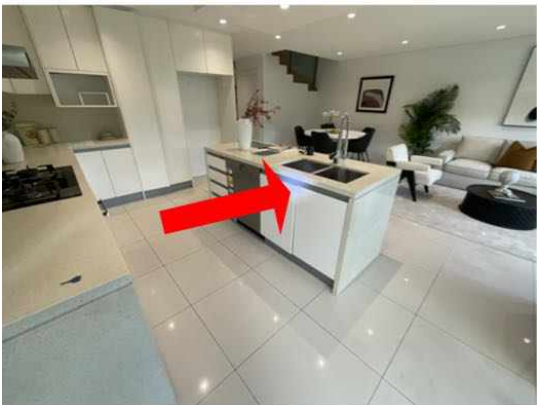
Finding 3.13

Building: Main Building
Location: Kitchen
Finding: Cabinet doors - misaligned
Information: It is observed that some of the cabinet doors are not aligned and / or have inconsistent gaps between the doors.

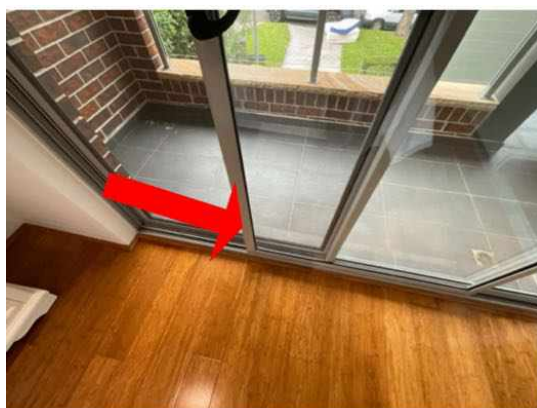
Finding 3.14

Building: Main Building
Location: Balcony

Finding: Sliding Door - Stiff to slide
 Information: The door in this area was jammed and difficult to slide along the associated tracks at the time of the inspection. Restricted function of the affected door may pose as a potential safety hazard if required for emergency egress from the building.

Generally, factors such as general age of the building element and a lack of maintenance are the usual causes for this type of defect.

Replacement of door hardware or tracks may be required, as well as minor repairs and cleaning. A registered builder or general handy person will be required to repair the affected doors.

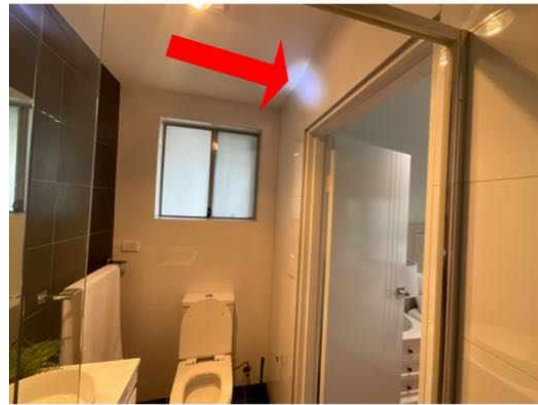
Finding 3.15

Building: Main Building
 Location: Bathroom / Ensuite
 Finding: Tiles - Cracked or damaged
 Information: Cracking was evident to the tiling in this area at the time of inspection. While the cracking appears to be minor, this area is frequently exposed to water, allowing potential for water penetration into adjoining sections of walls or flooring.

If left unmanaged, water penetration to these areas may lead to subsequent water damage, which is likely necessitate repair work to affected building elements.

A tiling contractor should be appointed to ensure that no further water damage occurs. The re-application of silicone and grouting throughout remaining tile work is also advised, to further protect the area against water penetration.

Where water penetration has led to water damage, appointment of a relevant tradesperson may be required to repair damaged building elements.

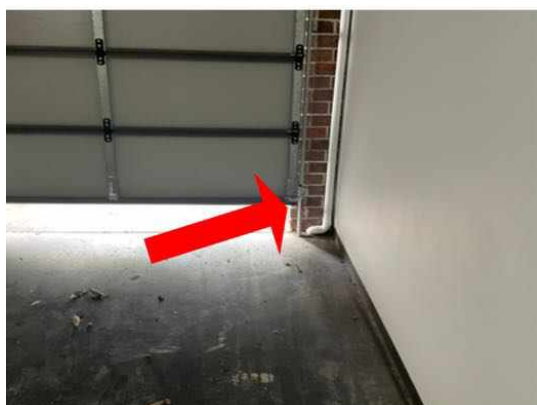
Building: Main Building
 Location: Garage
 Finding: Garage Door - not working properly
 Information: At the time of the inspection, Garage roller doors can fail when the building materials have aged with some concerns as below:

Spring Tension: If the springs responsible for counterbalancing the weight of the door are too loose or too tight, it can affect the door's operation. Adjusting the spring tension to the manufacturer's specifications can help resolve this issue.

Repair of the two garage doors would improve the condition of the garage but certainly not an urgent item

A qualified roller door installer or supplier should be engaged to check out the operation and overall condition of the doors to determine if repair is an option otherwise replacement may need to be considered.

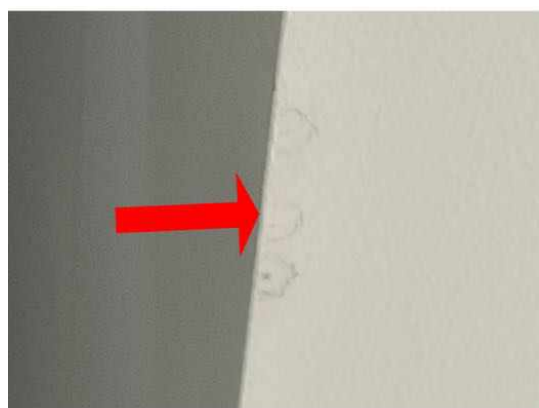
Finding 3.19

Building: Main Building
 Location: Stairs - Internal
 Finding: Ceiling - Water stained
 Information: Water staining to ceiling linings in this area was evident at the time of inspection. Water staining indicates that surfaces have been exposed to excessive moisture over time. The minerals and other elements in the water lead to staining, which may graduate to corrosion and deterioration if left unmanaged.

While mostly an appearance defect, water staining can be indicative of more serious

defects, which may be currently concealed by interior ceilings.

Where water staining is active, a licensed plumber must be consulted to identify the cause of the staining and to provide advice on any reparation works that may be required. Replacement of any damaged structures is advised.

Conversely, where water staining is old and inactive, affected building materials may be repaired or replaced at client discretion.

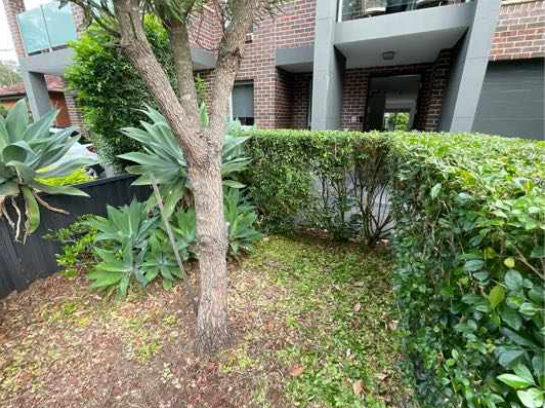
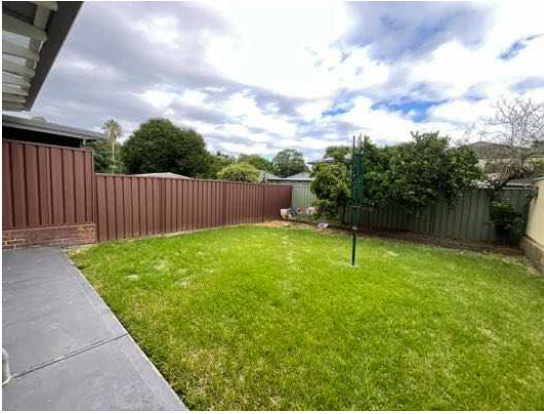
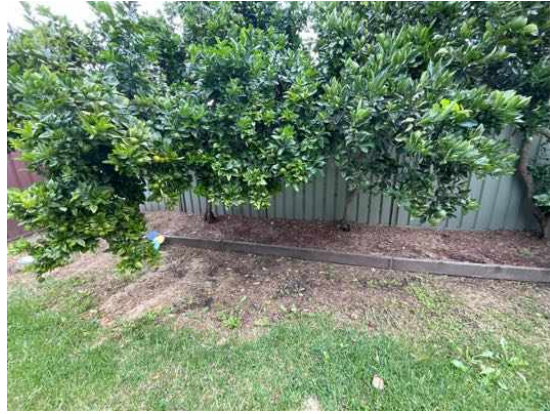
Finding 6.01

Building: Main Building
 Location: All Areas
 Finding: Garden Beds - Conditions Conducive to Termites
 Information: Garden beds were found to be evident in the garden area. These garden beds can include untreated timber, and with a combination of moisture from watering hosing can make conditions conducive to termite activity and termite ingress.
