Building and Timber Pest Inspection Report

Inspection Date: Mon, 2 Feb 2026

Property Address: 5/108 Princess St, Werrington NSW 2747,
Australia

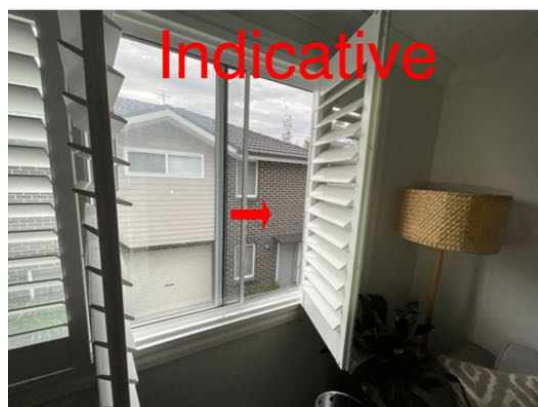
Finding 1.01

Building:	Main Building
Location:	Upstairs Windows
Finding:	Window restrictions - Missing
Information:	Window restrictors were found to be missing.

The National Construction Code (NCC) requirements apply to all openable bedroom windows in residential buildings, including hotels, motels and for all windows in early childhood centres.

Windows need to be locked at 12.5cm when the devices are engaged. The safety devices must be robust and child proof. The alternative is security screens such as bars or grills on the windows so long as they have gaps no bigger than 12.5cm. Flyscreens do not comply unless they are the reinforced security type and capable of resisting the very strong outward pressure which would prevent a child falling through. The laws apply to openable windows in a building within 1700mm of the internal floor and if the internal floor is more than 2m above the ground floor outside.

Windows upstairs lack appropriate child locks, creating a safety hazard. Window restrictors must be installed on these Windows immediately for added safety.

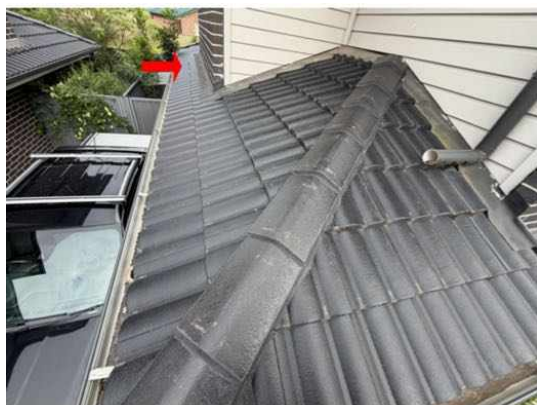
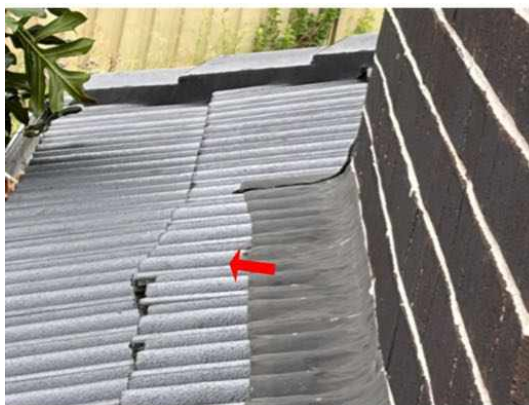
Finding 3.01

Building:	Main Building
Location:	Roof Exterior

Finding: Roof tiles - Slippage
Information: Upon inspection of the exterior roof covering, it was noted that numerous tiles have slipped from their original fixing. Tiles may slip over time due to a number of minor causes, including breakage of tiles, failings in the adjoining battens, or fixings that may have failed.

Roof tiles that have moved from their original position are very likely to allow water penetration into the roof void, exposing roofing structures to excessive moisture. This creates an environment that is conducive to water damage and accelerated deterioration of all associated building elements.

Replacement of loose or missing roofing tiles is recommended immediately to prevent the development of any secondary defects. A roofing restoration specialist should be appointed to complete such works as necessary.

- Replace slipped roof tiles

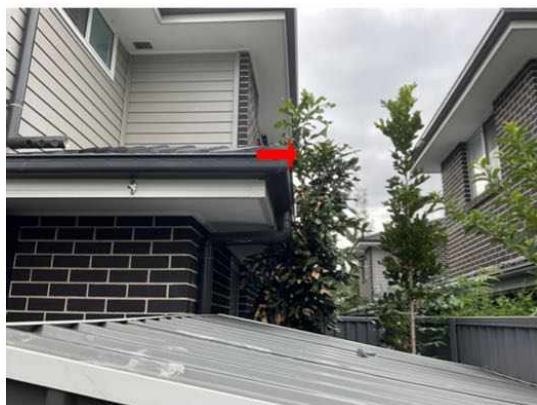
Finding 3.02

Building: Main Building
Location: Roof Exterior
Finding: Trees - Overhanging and filling gutters
Information: Overhanging trees often result in excessive amounts of leaf debris accumulating in gutters.

Gutters are a critical part of the building's management of storm water and rain. It is therefore important that they be kept clear to prevent secondary damage to associated building elements, including exterior and interior walls, ceiling linings and any adjoining building elements. Where gutters are blocked, pooling of rainwater is likely to occur, fast-tracking rust and corrosion of the roof plumbing elements.

It is highly advised that all overhanging tree branches be removed as soon as possible to prevent any further damage. Repair and/or replacement of sections of damaged guttering may also be required where the extent of the damage necessitates.

Such works should be performed by the homeowner; however, appointment of a landscape contractor or an arborist may be required. Consultation with a licensed roof

plumber is required where guttering has been damaged.

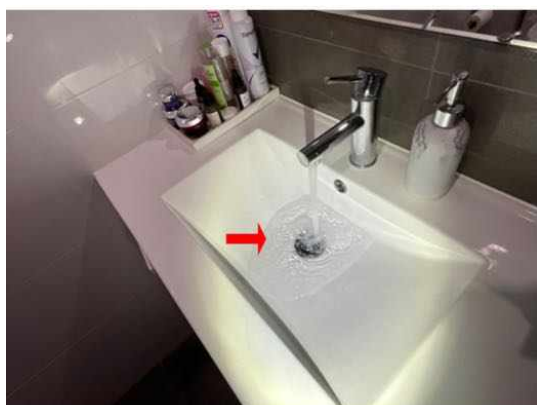
Finding 3.03

Building: Main Building
 Location: Ensuite
 Finding: Sink/basin - slow draining
 Information:

The sink/basin drain appeared to be partially blocked at the time of inspection. Blockages here are usually caused by hair and other debris. If left unmanaged, a lack of general maintenance may lead to the development of more significant defects, such as water damage to surrounding building materials.

A licensed plumber should be appointed to remove the blockage at the client's discretion.

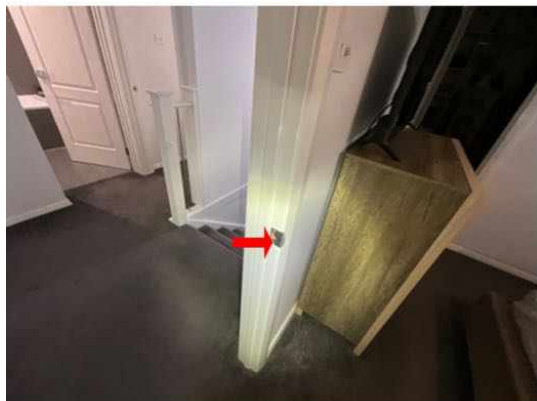
Finding 3.04

Building: Main Building
 Location: Bedroom - Master
 Finding: Door - Striker plate misaligned
 Information: The striker plate to this door appears to have become misaligned and has consequently resulted in the door's operation being compromised.

This is a common defect and is expected in a property of this age, whether being due to substandard installation or general deterioration of the door hardware.

Readjustment of the striker plate is recommended at client discretion. Works such as these can be completed by a general handyman or qualified carpenter.

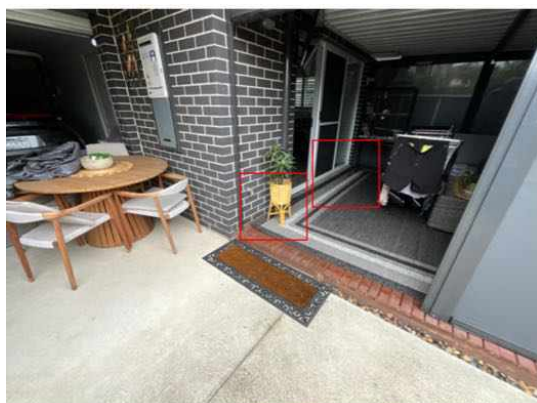
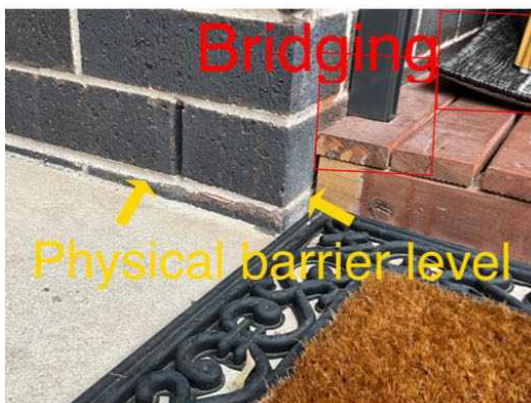
Finding 6.01

Building:	Main Building
Location:	Deck
Finding:	Bridging of termite barrier
Information:	Bridging of termite barriers occurs when termites bridge (usually by building a mud tunnel) a termite barrier or inspection zone or where termites have a passage allowing them to bridge the barrier.

Generally this takes the form of finished ground levels external paving or concrete being retrospectively installed above the damp course level the adjacent internal floor level or weep and ventilation holes.

Where bridging has occurred full inspection is prevented and termites may enter a property in a concealed or undetectable manner.

- Remove any bridging to the termite physical barrier
- Regular inspections every 12 months

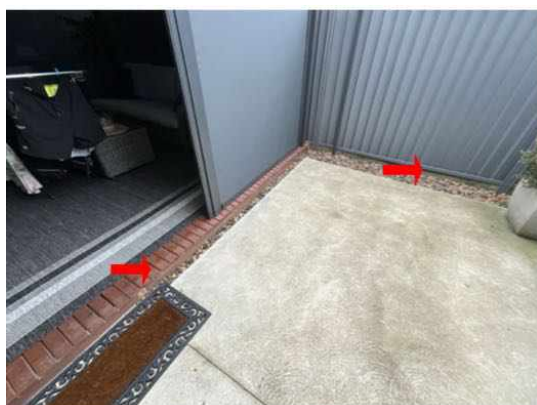
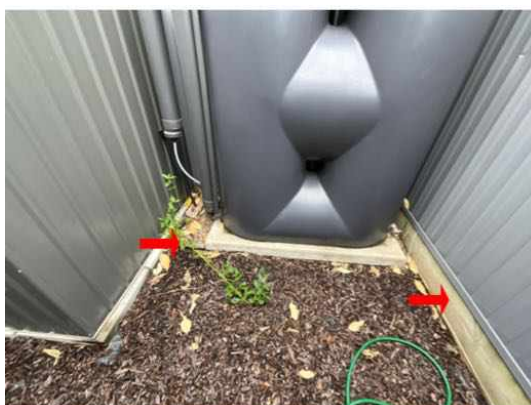
Finding 6.02

Building: Main Building
 Location: Fencing & Landscaping
 Finding: Building materials in direct ground contact - conducive to termites
 Information: Where timber elements are in direct contact with the ground and consequently moisture or dampness they become conducive to termite activity. Whether timber is used as a building element part of a fencing structure or stored as an unused item they can provide an environment that is attractive to termite infestation.

When met with excessive moisture timber begins to decay and develop wood rot. Any timbers that are in direct contact with external grounds especially if left untreated or non-durable also provide ingress for subterranean termites into that particular element.

The removal of any such materials that may be conducive to termite activity should be removed as soon as possible to minimise the risk of termite attack.

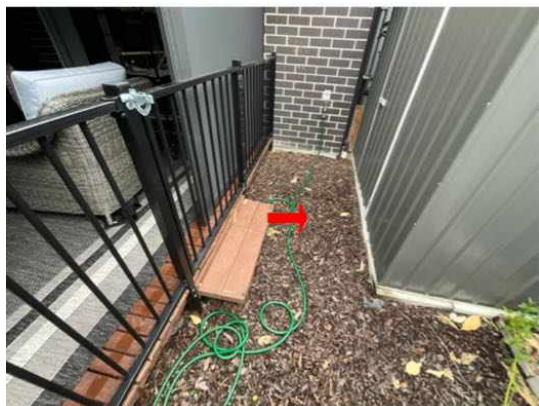
Finding 6.03

Building: Main Building
 Location: Garden beds
 Finding: Garden Beds
 Information: Garden beds were found to be evident in the garden area. These garden beds can

include untreated timber, and with a combination of moisture from watering hosing can make conditions conducive to termite activity and termite ingress.

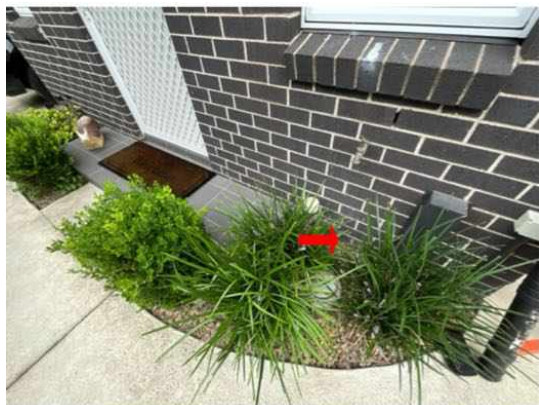
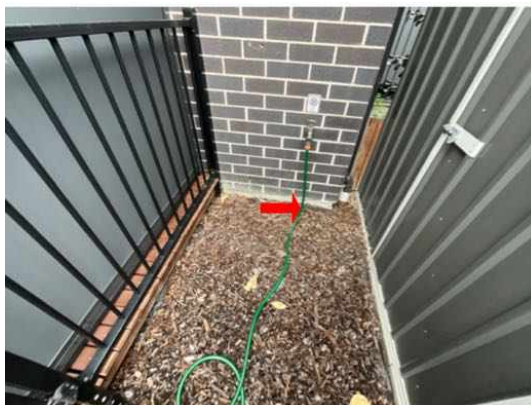
Finding 6.04

Building: Main Building
 Location: External tap
 Finding: Tap - No drain
 Information: The external tap in this area was noted to have no drain at the time of inspection.

This keeps the surrounding surfaces damp while using the tap, which becomes conducive to termite activity.

A licensed plumber must be appointed to ensure an appropriate drain is installed.

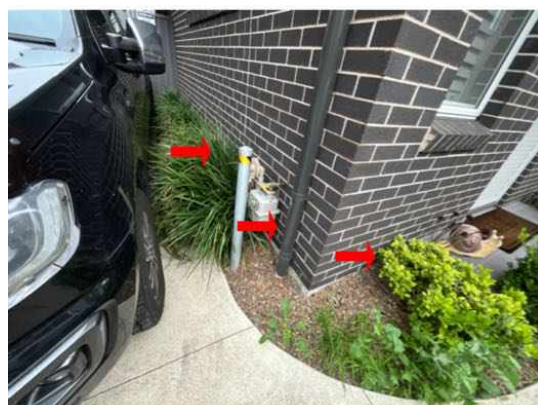
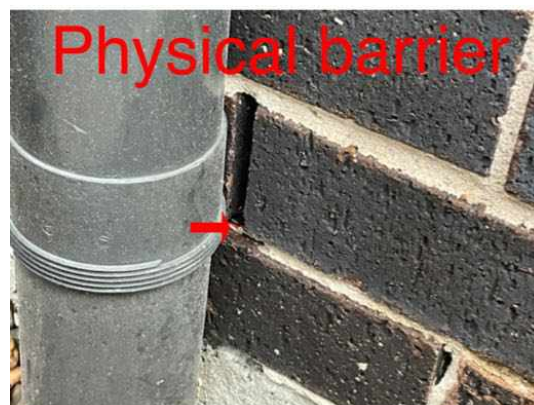
Building: Main Building
Location: Meterbox
Finding: Termite Management System - no evidence of installation
Information: The application of a post-construction chemical termite barrier is highly recommended for all properties, particularly if live termite activity has been found on the site previously. Such barriers are highly effective in preventing termite attack on any timber building elements throughout the property.

A durable notice should be placed in the switchboard unit to indicate current termite barriers. At the time of inspection, it appeared as though no termite management system has been installed, with no evidence to suggest preventative works taking place.

The client may consider gaining further advice from a pest controller as to the costs and procedures involved with this application. It is recommended that obtaining such advice be a short-term priority.
