Building Inspection Report

Inspection Date: Wed, 18 Feb 2026

Property Address: 8 Aruma Ct, Burwood East VIC 3151,
Australia

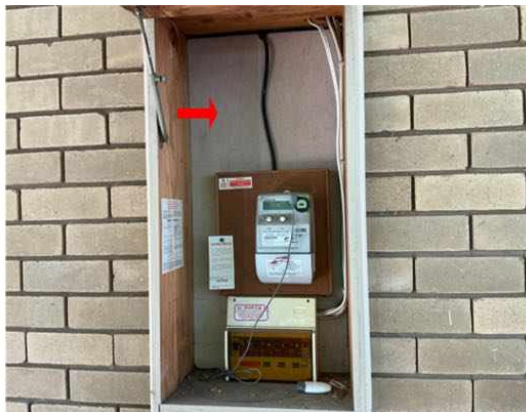
Defects 1.01

Building:	Main Building
Location:	Electrical Switchboard
Finding:	Asbestos - Suspected ACM Identified on Site
Information:	Reporting on Asbestos is outside the Scope of this Report. This suspected defect is highlighted as a caution only. We suspect, based on our experience in the building industry, that there is a higher risk of the identified building element containing asbestos.

As Asbestos Reporting is outside the scope of this report, we advise that you consider a separate Asbestos Inspection and Condition Audit, which can include the taking of samples for definitive confirmation of the presence of Asbestos.

In the interim, the client is advised to act with caution, especially when considering any damage to building materials general wear and tear renovations extensions demolition and general maintenance activities due to the suspected presence of Asbestos.

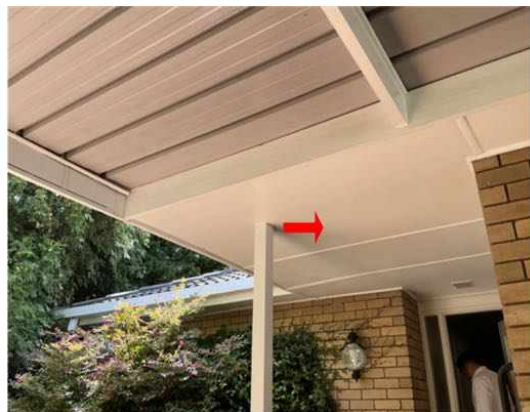
Defects 1.02

Building:	Main Building
Location:	Eaves
Finding:	Asbestos - Suspected ACM Identified on Site
Information:	Reporting on Asbestos is outside the Scope of this Report. This suspected defect is highlighted as a caution only. We suspect, based on our experience in the building industry, that there is a higher risk of the identified building element containing asbestos.

As Asbestos Reporting is outside the scope of this report, we advise that you consider a separate Asbestos Inspection and Condition Audit, which can include the taking of

samples for definitive confirmation of the presence of Asbestos.

In the interim, the client is advised to act with caution, especially when considering any damage to building materials general wear and tear renovations extensions demolition and general maintenance activities due to the suspected presence of Asbestos.

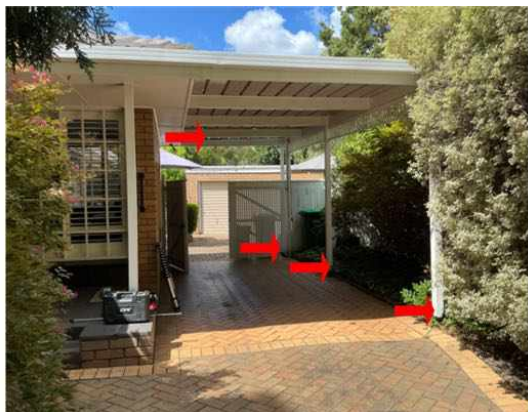
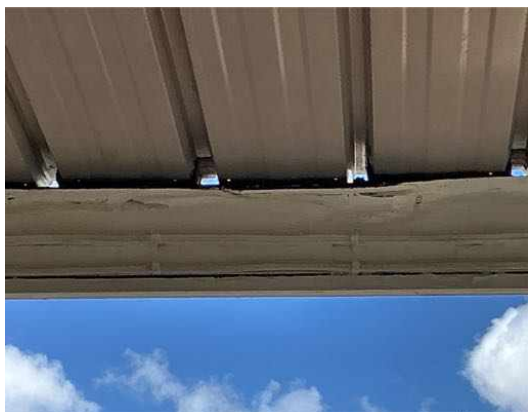
Defects 1.03

Finding: Wood rot

Information: This building element shows evidence of wood rot and may be structurally unsafe. Wood rot, also known as Fungal Decay, occurs when timbers and other cellulose building materials are exposed to damp conditions on an ongoing basis. This could be the result of exposure to weathering over a prolonged period of time, or the attraction of excessive moisture from other abutting building materials. Contributing factors also include poor air ventilation in the area.

Wood rot is often associated with general damp problems and is evidenced by a 'musty' smell or mould and mildew occurring on surfaces. If left unmanaged, damp conditions can lead to further health problems and the decay of timbers will continue.

Early intervention and regular maintenance, particularly of exterior timbers, will prolong the useful life of these building elements. Prior to any works being performed, the cause of the moisture that has created the visible wood rot should be identified and addressed in a suitable manner. Replacement of affected timbers may then be a necessary step in protecting surrounding building elements from such deterioration.

A qualified plumber may be appointed to assess the cause of excessive moisture and to provide advice on any remedial works as required. A qualified carpenter or registered builder may also be required to replace affected building materials.

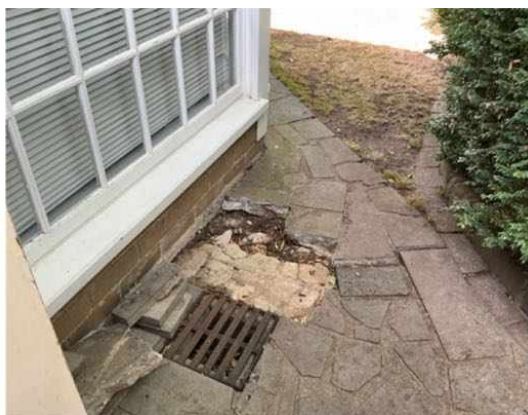
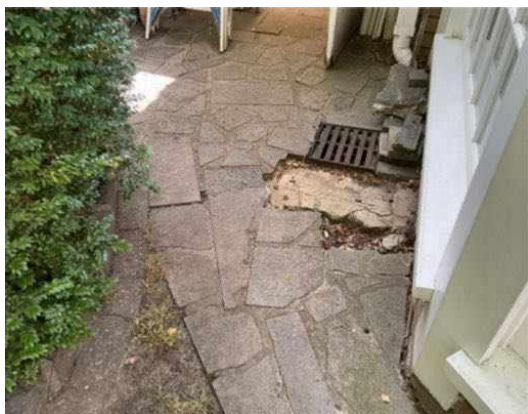
Defects 1.04

Building:	Building 2
Location:	Bungalow
Finding:	Cracking - External Concrete Paving Damage Category 4 - Gaps in Slab (4mm - 10mm +)
Information:	Gaps in the slab were identified in external concrete paving. Gaps in the slab are significant and are likely to lead to the development of safety hazards and secondary defects if left unmanaged, such as the creation of a trip hazard.

General age and expected deterioration of the paved areas is a common cause of this type of cracking. However, expansion and contraction of the slab may also have occurred due to environmental factors. Such factors include variable moisture and weather conditions, the presence of trees and their roots having a settling or lifting affect on the soil, or the effect of load bearing, e.g. heavy vehicles over a sustained period of time.

Cracking to this degree may also be due to poor original installation of the concrete. Factors such as poor compaction of the sub surface and/or inadequate reinforcing of the slab may create cracking and other secondary defects. Gaps in the concrete paving may also have a more significant structural cause, such as subsidence of soils.

Where gaps in the concrete paving are adjacent to structural elements of the building, the advice of a Structural Engineer is advisable before undertaking repairs. Significant

repair and likely replacement of the concrete paving is probable.

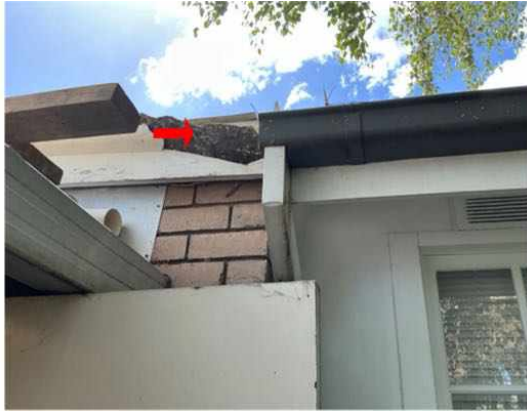
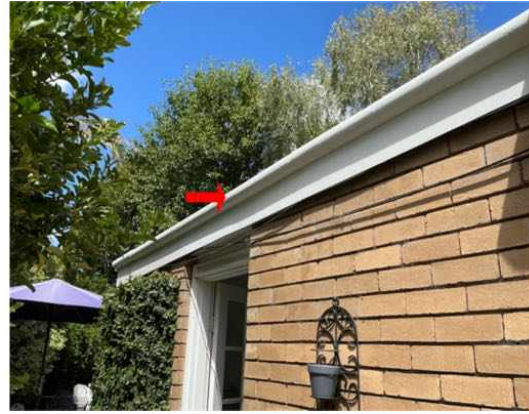
Defects 1.05

Building:	Building 2
Location:	Bungalow roof
Finding:	Asbestos - Suspected ACM Identified on Site
Information:	Reporting on Asbestos is outside the Scope of this Report. This suspected defect is highlighted as a caution only. We suspect, based on our experience in the building industry, that there is a higher risk of the identified building element containing asbestos.

As Asbestos Reporting is outside the scope of this report, we advise that you consider a separate Asbestos Inspection and Condition Audit, which can include the taking of samples for definitive confirmation of the presence of Asbestos.

In the interim, the client is advised to act with caution, especially when considering any damage to building materials general wear and tear renovations extensions demolition and general maintenance activities due to the suspected presence of Asbestos.

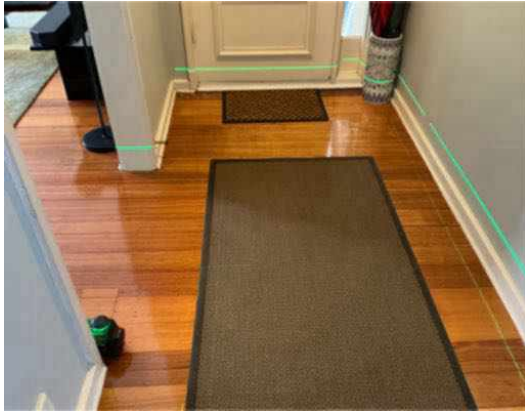
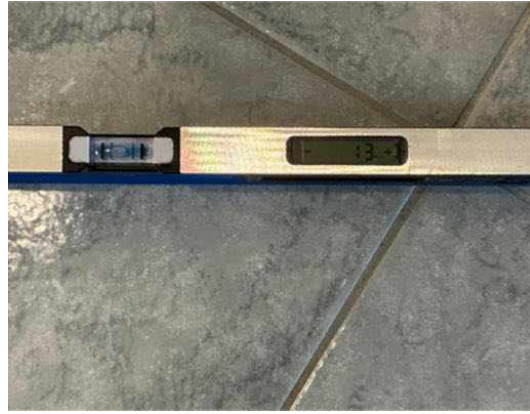
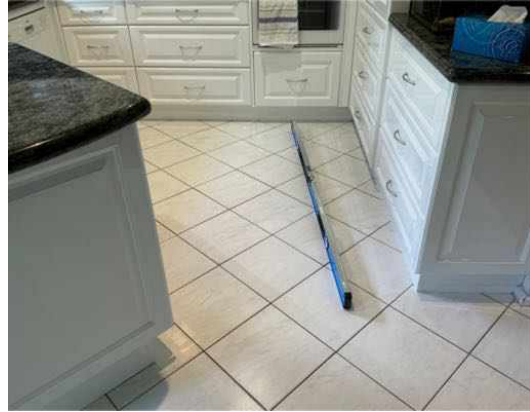
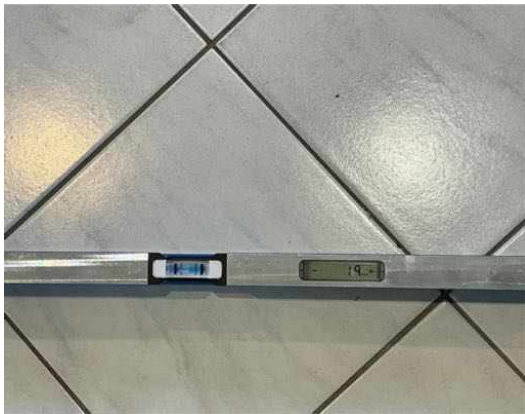
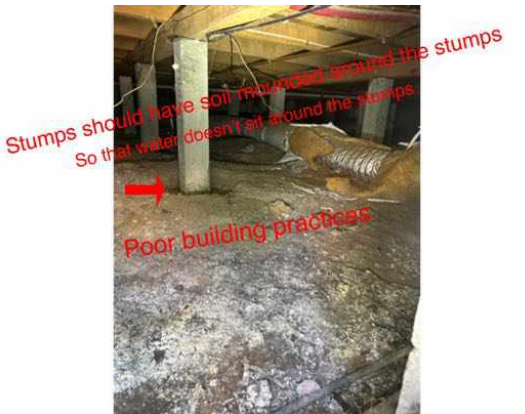
Defects 2.01

Building:	Main Building
Location:	All Areas
Finding:	Flooring - Uneven
Information:	The internal flooring in this area is out of level and uneven. Uneven flooring is likely to indicate minor defects such as expected movement of the foundations of the property, but may also indicate subsidence of the associated subfloor stumps.

It is advised that the flooring be closely monitored to identify any further movement. Where flooring remains relatively unchanged for an extended period of time (i.e. several months), it is likely that this defect has been caused by expected movement of the

foundations of the property.

However, where flooring is uneven further, potentially invasive inspection of the subfloor structures and stumps in this area is required. In this case, works to repair are likely to be required, and would be carried out by a registered builder specialising in re-stumping.

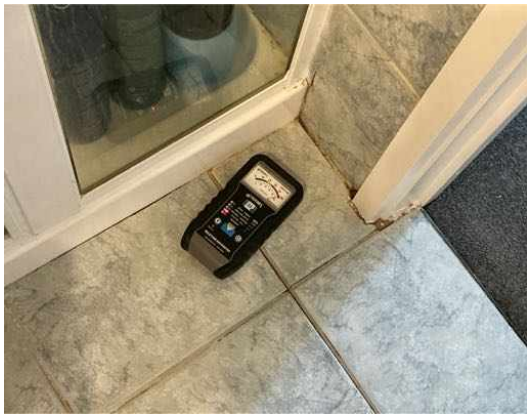
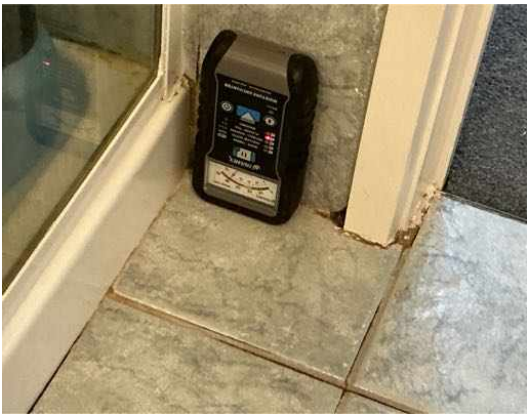
Defects 2.02

Building: Main Building
Location: Bathroom
Finding: Shower base - Leaking
Information: Leaking was evident to the shower base at the time of inspection. It is suspected that the leaking has occurred as a result of minor impact damage to the shower base or general ageing of the building elements.

Leaking from the shower base, where left unattended, is likely to lead to water damage to adjoining flooring and walls. Such damage can lead to water damage and necessitate extensive remedial works being required. Active water leaks may also create an environment that is susceptible to the formation and development of mould.

Appointment of a tiling contractor is required to repair or replace the shower base. Such works should be performed as soon as possible to ensure that no further damage occurs.

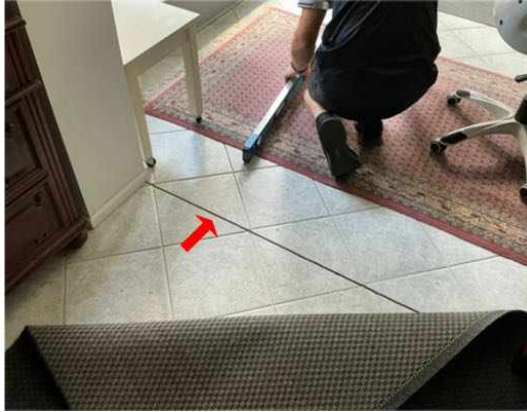
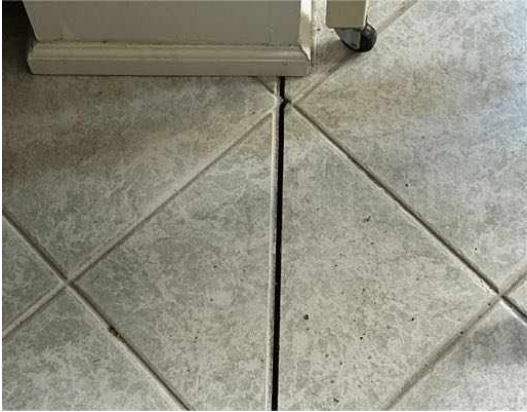
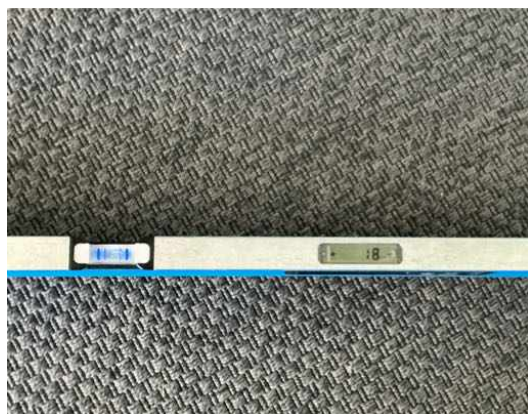
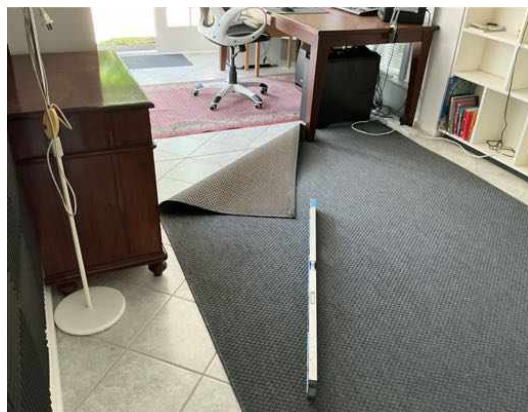
Defects 2.03

Building: Building 2
Location: Bungalow
Finding: Crack in concrete slab - Category 4
Information: A crack coded as Category 4 was identified in the slab. A Category 4 crack is described as a crack that appears as a gap in the slab, with disturbing curvature or change in level affecting the slab.

The approximate width of the crack or gap is 4mm-10mm or a change in offset of greater than 25mm when a 3m straight edge is placed over the defect.

Category 4 cracking to slabs exceeds allowable Standards and Tolerances, and are therefore considered as major defects that require rectification.

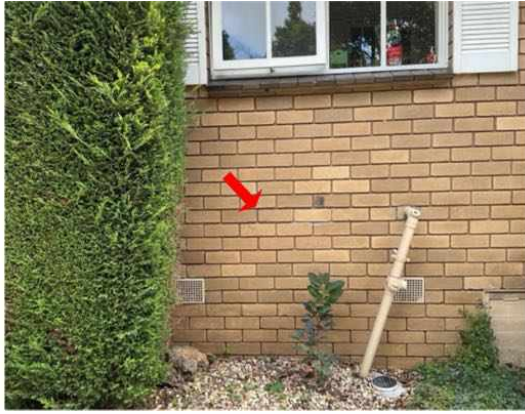
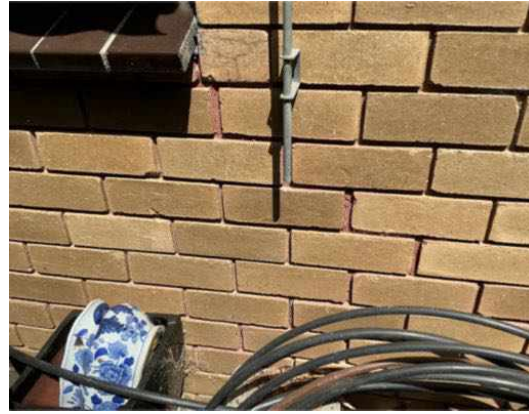
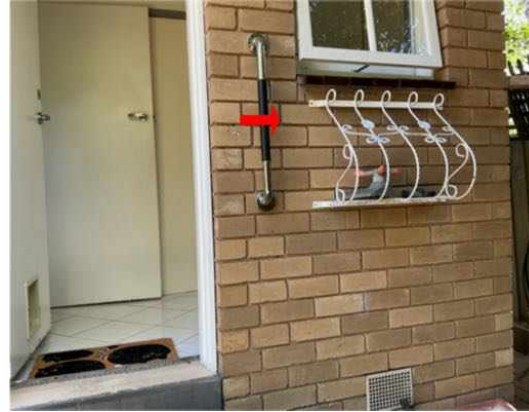
Defects 3.01

Building:	Main Building
Location:	Rear Elevation
Finding:	Brickwork - Step cracking
Information:	Step cracking was identified to the brickwork in this area at the time of inspection. Step cracking, which is similar to other forms of cracking, has a variety of possible causes. However, the most common is the subsidence of adjacent footings.

Step cracking is a relatively common defect, and is most likely to occur adjacent to windows, doors and other openings. Mortar failure in the gaps between affected bricks indicates the stresses and tensions affecting the wall.

Where step cracking is extensive or severe, the client is advised to consult a structural engineer. Minor step cracking can be used as a warning sign to address factors causing stress to the wall, which can include the effect of surrounding trees, water leaks, soil erosion, or even the presence of reactive soils in the surrounding area.

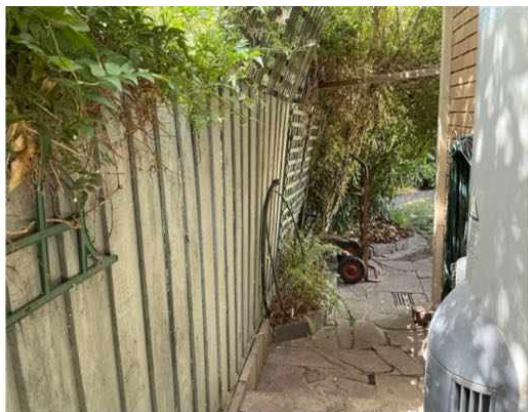
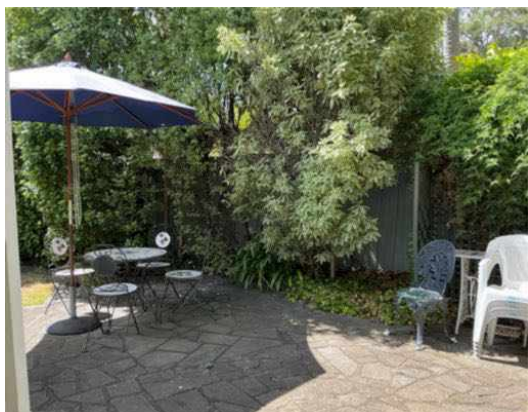
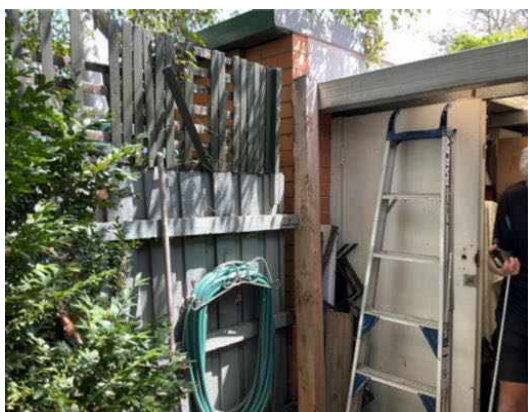
Defects 3.02

Building:	Main Building
Location:	Fencing
Finding:	Fencing - Deteriorated
Information:	It was noted at the time of inspection that sections of the fencing throughout the property have deteriorated. Typically fencing deteriorates due to age and or wear, rot and or rust which is generally expected for a structure of this age, due to prolonged exposure to weather conditions. Sometimes inadequate installation or maintenance can be to blame.

If left unattended, it is likely that further damage will occur. It is suspected that repair of several elements of the fencing may be required however replacement may be a consideration of the client also.

A licensed fencing contractor should be appointed to provide further advice and perform rectification works as necessary.

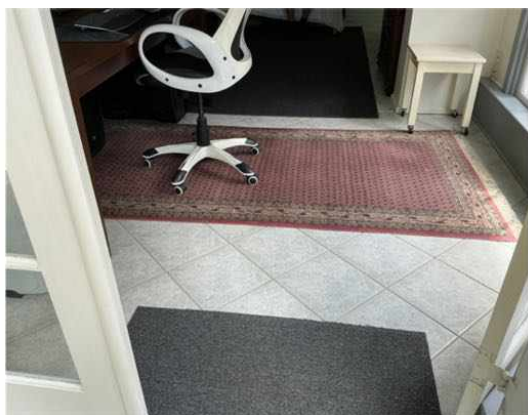
Defects 3.03

Building:	Building 2
Location:	Bungalow
Finding:	Tiles - Drummy
Information:	Drummy tiled areas were identified at the time of inspection. The term 'drummy' refers to tiles that have become detached from their fixing, despite otherwise being in relatively good condition. Such defects are generally caused by physical or moisture damage to the area. Drummy tiled areas may also be a direct result of poor workmanship during the construction process.

Tiled areas may swell and shrink with changes in air humidity if the area has sustained moisture damage. Any exposure to moisture is capable of causing tiled areas to

become drummy and/or cracked over a prolonged period of time. Drummy tiled areas generally require removal and replacement of affected tiles, with adequate sealant and grouting.

Specialist trades are available for these types of services. A registered builder may be required to undertake works if damage is extensive or if secondary building defects have resulted. Otherwise, it is advised that a tiling contractor be appointed to perform works as necessary. Immediate action is recommended to ensure that no further damage is sustained in the affected area.

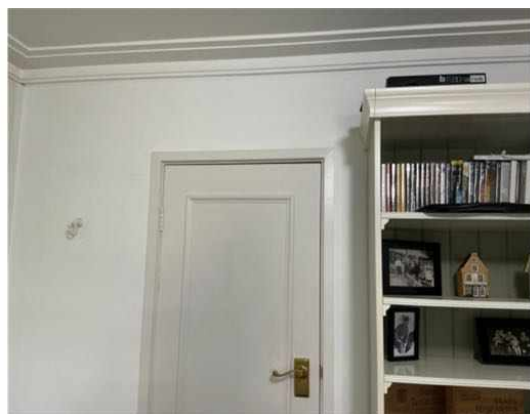
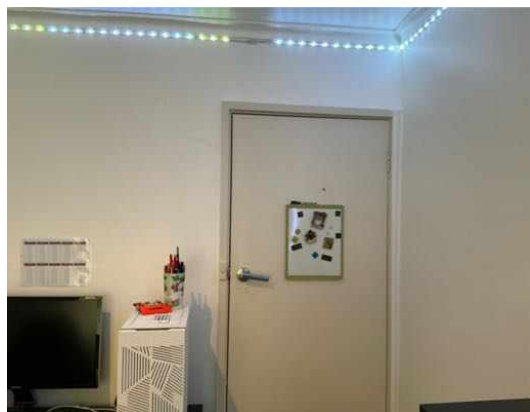
Defects 3.04

Building:	Main Building
Location:	All Areas
Finding:	Door - Gap
Information:	A significant gap was identified between the door and door frame in this area. Where large gaps to the head or foot of door frames appear, it may indicate a variety of defects, ranging from uneven framework, sagging hinges or uneven flooring.

A gap to the head of the door may also indicate movement of the foundation of the property, which is a common occurrence and does not indicate structural damage.

A qualified carpenter should be appointed to perform remedial works to restore the door to a fully operational level.

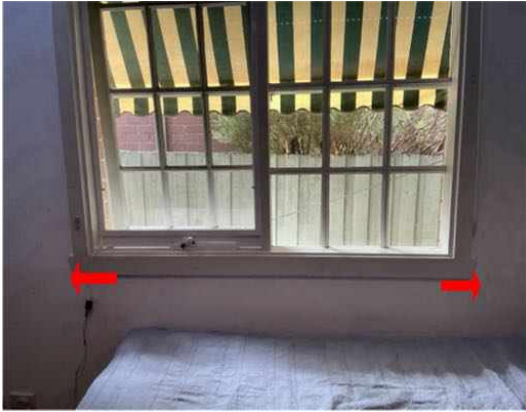
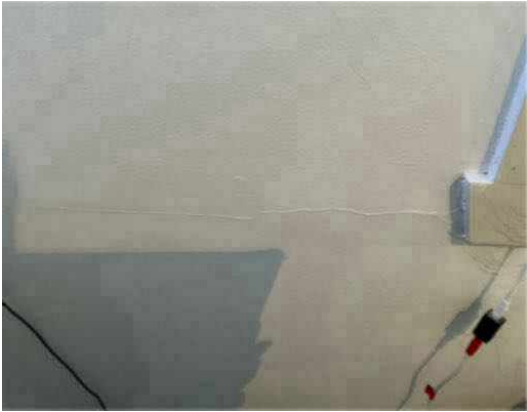
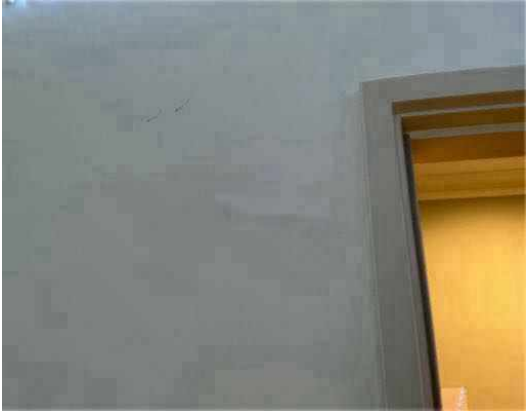
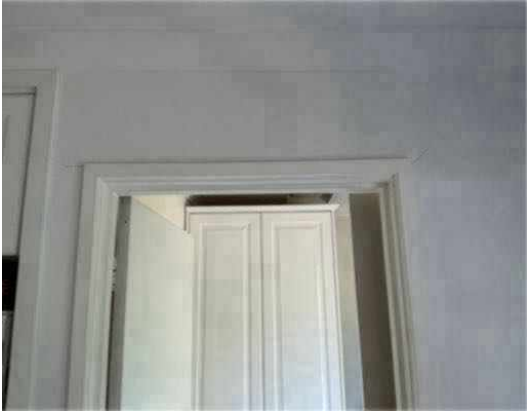
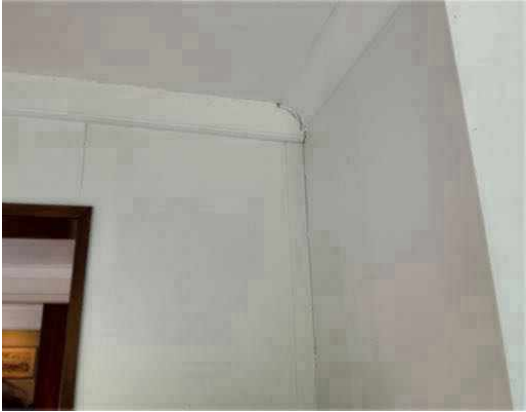
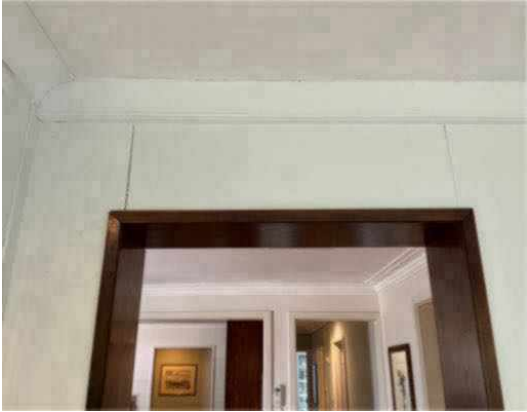
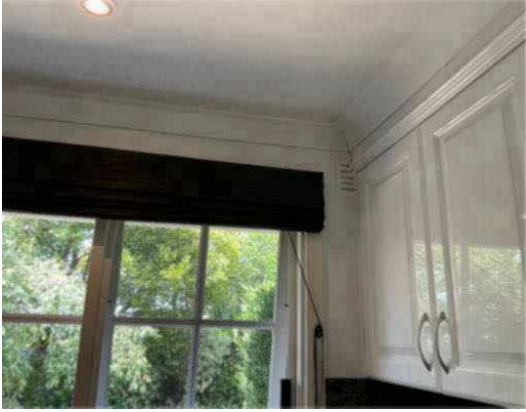
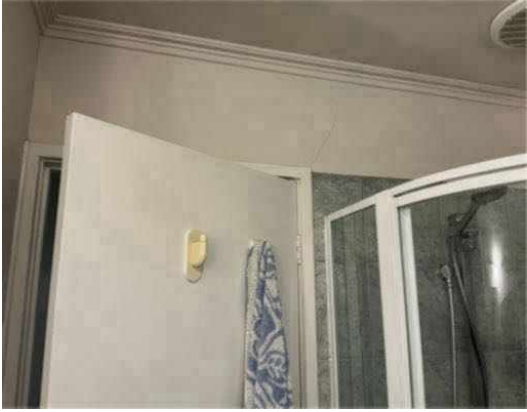
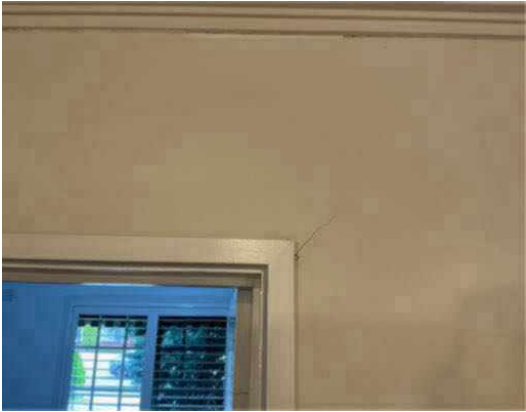
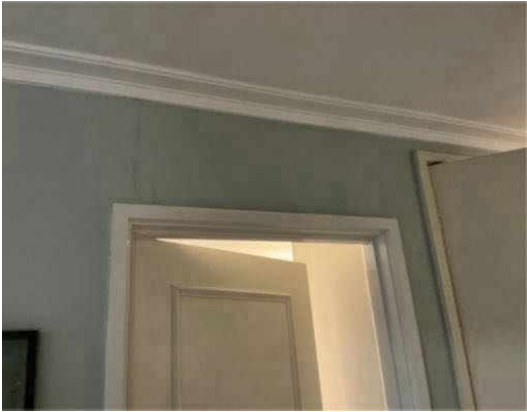
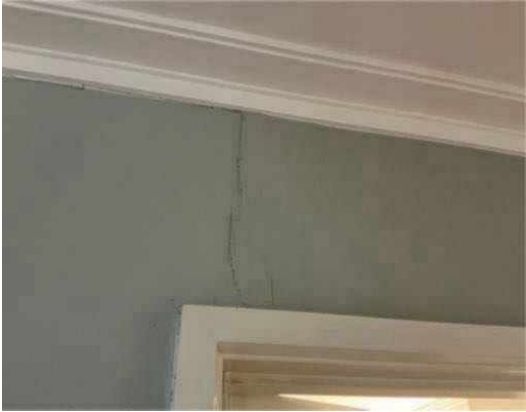
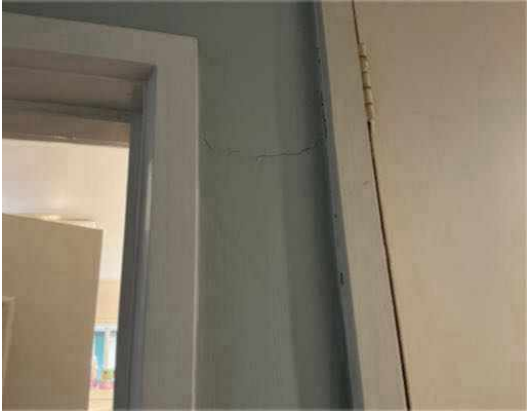
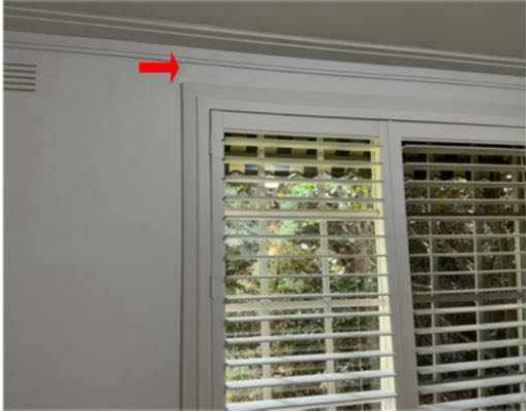
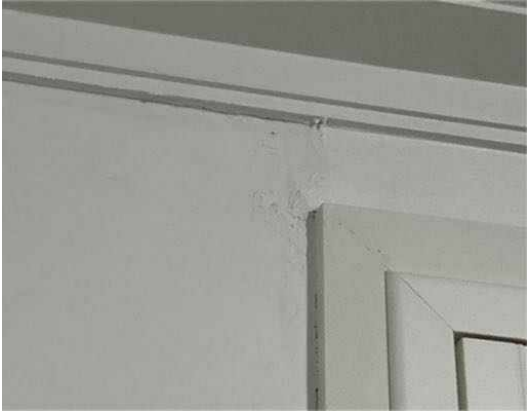
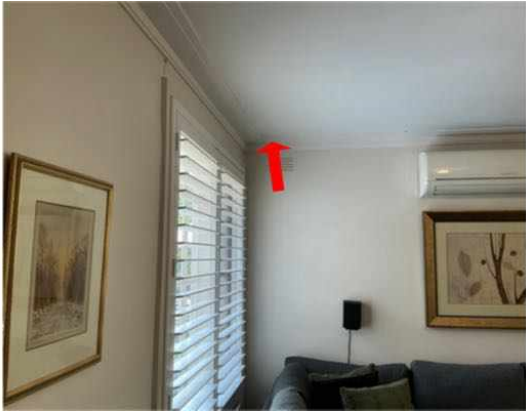
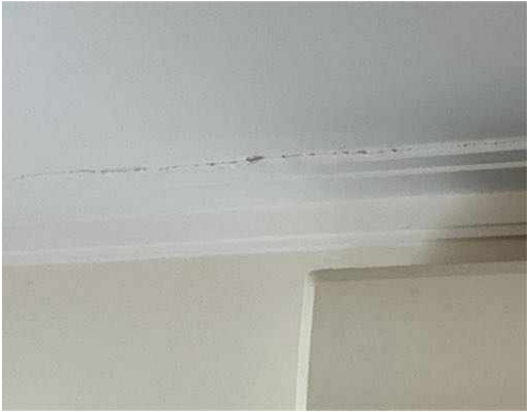
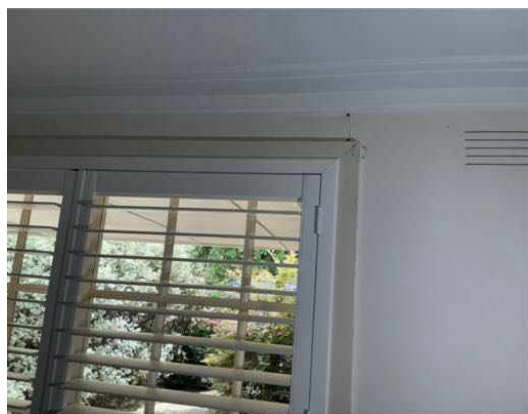
Defects 3.05

Building:	Main Building
Location:	All Areas
Finding:	Cracking - Damage Category 2 - Noticeable (up to 5mm)
Information:	Noticeable cracks are a common occurrence as a result of many primary defects. Such causes may include age, general wear and tear, expected building movement, general expansion/contraction of building materials in different weather conditions, and/or minor failings in the installation or application of building materials.

Noticeable cracks may result in minor sticking or jamming of associated doors and windows, which require easement. However, noticeable cracks are easily filled and repaired. A plasterer can be consulted to install an expansion joint at this point to allow for this movement during different weather conditions.

Monitoring of all cracking should be conducted frequently. Always contact a building inspector should cracks widen, lengthen, or become more numerous. Additionally, your building inspector should also be contacted if associated building elements such as doors and windows become more difficult to operate over time.

Relevant tradespeople, such as carpenters, painters and plasterers, should be appointed to perform remedial works, as deemed necessary.

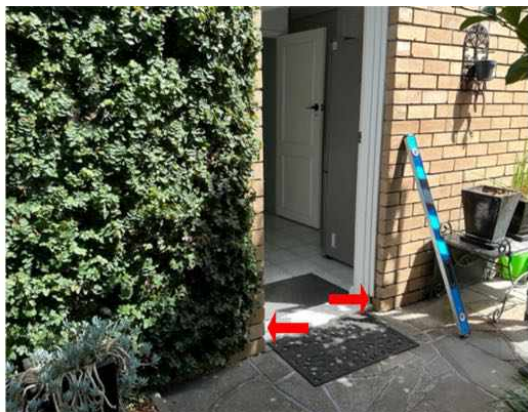
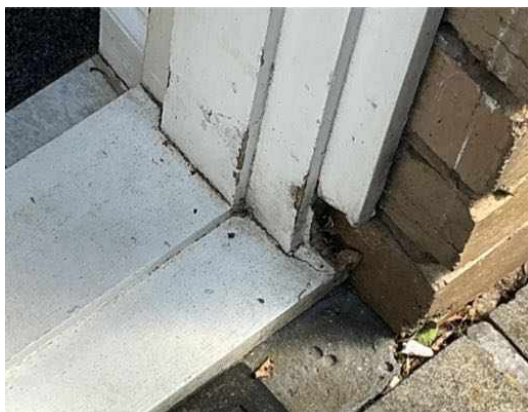
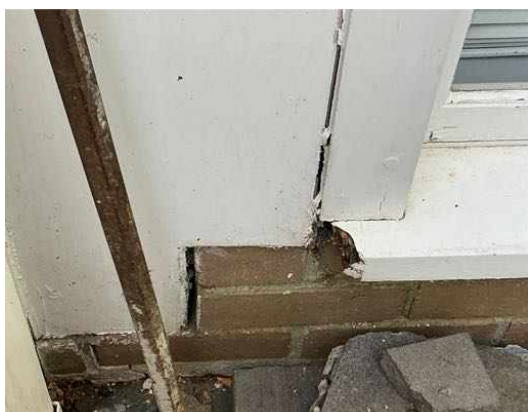
Defects 3.06

Building:	Building 2
Location:	Bungalow
Finding:	Windows and doors- Wood rot
Information:	Wood rot was found to be affecting external windows. Wood rot, also known as Fungal Decay, occurs when timbers and other cellulose building materials are exposed to damp conditions on an ongoing basis.

It is likely that this wood rot has developed as a result of frequent exposure to rain and other weather conditions. It is suspected that failure to maintain the window frames over a prolonged period has resulted in them deteriorating at an accelerated rate, increasing their susceptibility to the development of wood rot. Leaks in roof plumbing or associated pipework may have also contributed to the formation of the wood rot in this area.

Early intervention and regular maintenance will prolong the useful life of these building elements. Prior to any works being performed, any associated pipework or roof plumbing should be inspected by a licensed plumber for faults or leaks.

Repair and/or replacement of affected window frames may be a necessary step in protecting surrounding building elements from such deterioration. Remedial works should be performed by a qualified carpenter or registered builder as soon as possible to prevent any further damage.

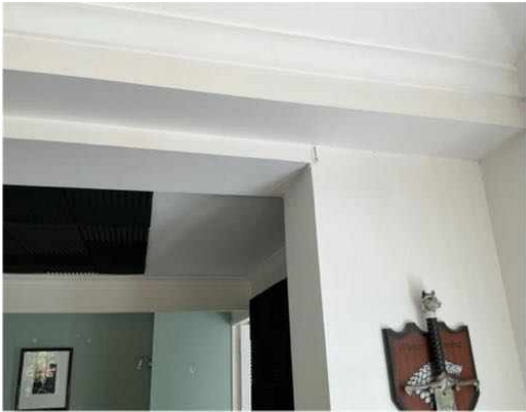
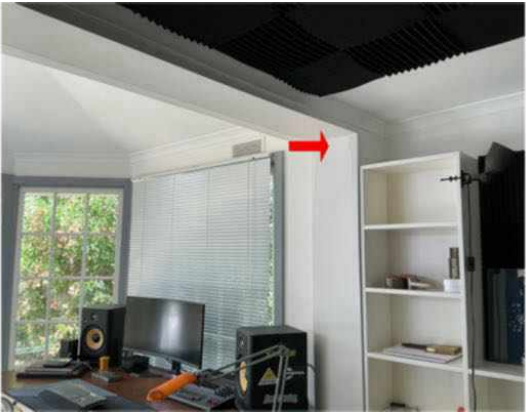
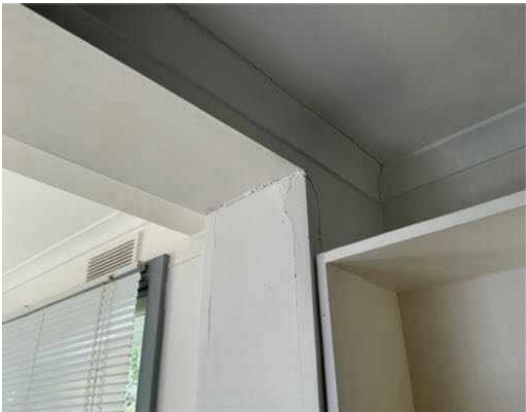
Defects 3.07

Building:	Building 2
Location:	Bungalow
Finding:	Cracking - Damage Category 3 - Repair Required (5mm-15mm or a grouping or cluster of cracks of 3mm or more)
Information:	Cracks of this type are likely to have been caused by minor, expected movement of building elements, but may also have a structural cause that is more significant. Cracking of this degree may result in doors and windows sticking or jamming, but may have more serious implications, such as fracturing service pipes. Weather tightness (the ability to resist rain and wind) is also often impaired, creating potential for the development of secondary defects.

A crack of this size may be repaired. However, these repairs may also include further works, such as easement of associated window and door frames that are jamming, as well as more extensive filling, sanding and/or repainting.

It is highly recommended to gain quotations on repair and restoration works that are required. Always contact your building inspector should cracks widen, lengthen or become more numerous.

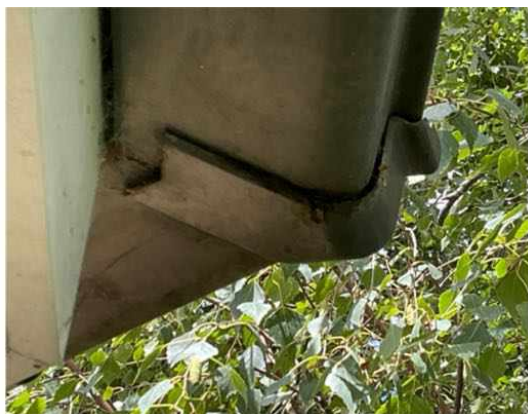
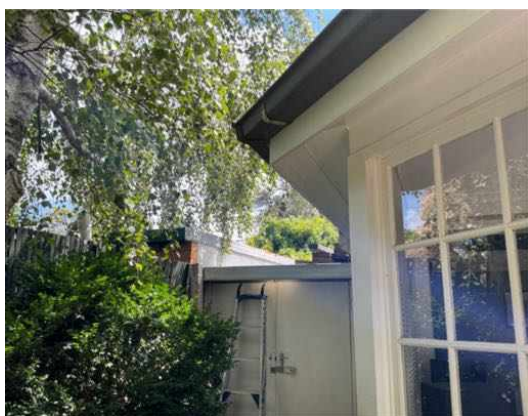
Defects 3.08

Building: Building 2
Location: Bungalow roof

Finding: Roof plumbing - Rusted or corroded
 Information: The roof plumbing has areas of rust and corrosion. It is suspected that this has been caused by blockages, resulting in pooling or standing water, that have prematurely rusted elements of the roof plumbing.

Rusted roof plumbing will generally develop holes and leaks that can affect other building elements with poor drainage of storm water. Poorly drained roof areas will also lead to damp conditions surrounding the base perimeter of the building which, if left unmanaged, can lead to a range of secondary building defects.

Repair and/or replacement of rusted roof plumbing is highly required in order to reinstate the roof drainage system to a fully operational level. To further maintain these areas, gutters should be cleaned frequently, allowing the avoidance of any partial blockages.

A licensed plumber or specialist roof restoration company should be appointed to undertake these works. It is advised that such works be completed as soon as possible to prevent any further damage and deterioration.

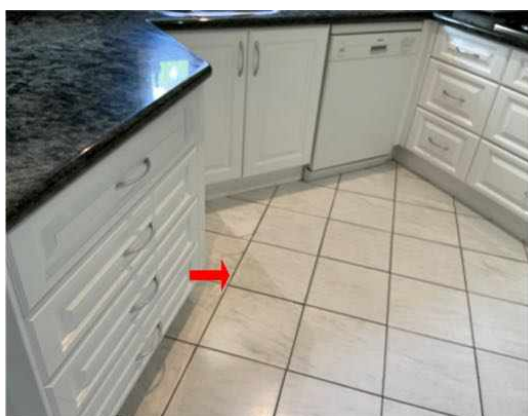
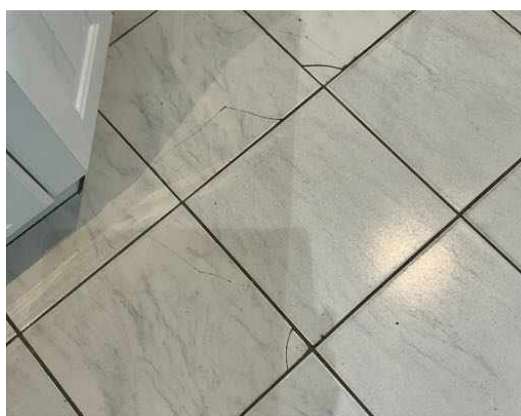
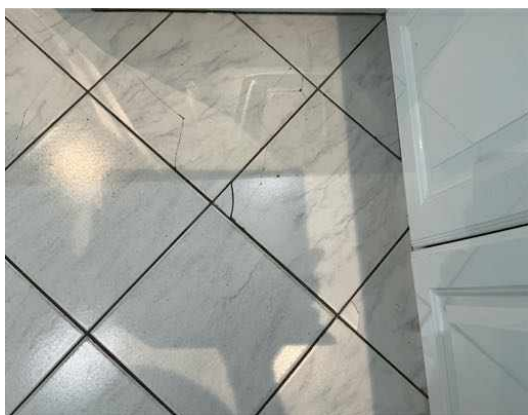
Defects 3.09

Building: Main Building
 Location: Kitchen
 Finding: Floor tiles - Cracked

Information: Cracking in the floor tiles was evident in this area at the time of inspection. It is suspected that this cracking has occurred as a result of the floor being uneven and lacking a solid or suitable foundation for the tiles to be laid on. Settlement in the floor foundations may also have caused movement and resulted in the cracking of tiles in this area.

Cracked tiles throughout the household detract from the overall appearance of the affected areas, as well as creating potential for water penetration to adjoining building elements. If left unmanaged, water damage may occur as a result of constant water penetration over a prolonged period of time.

While not considered a matter of urgency, replacement of cracked floor tiles is advised as a solution. A tiling contractor or general handyperson may be appointed to perform these works at client discretion. Where cracks become more numerous, consultation with a registered builder specialising in re-stumping may be required.

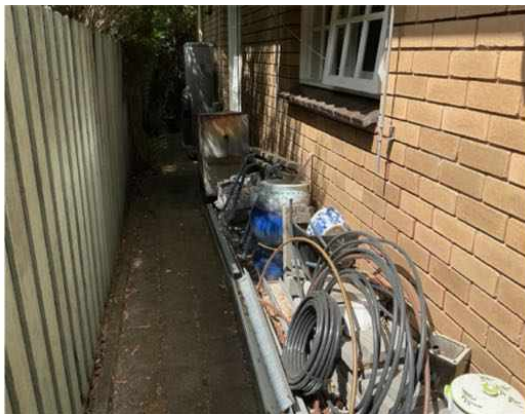
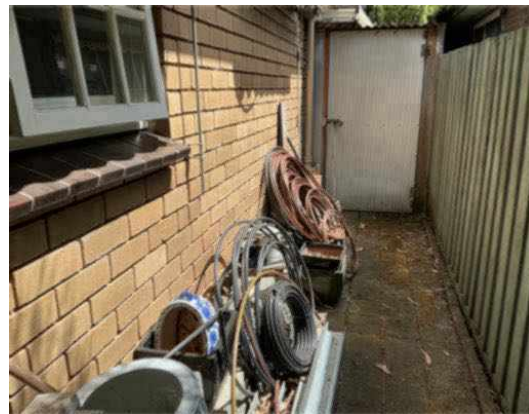
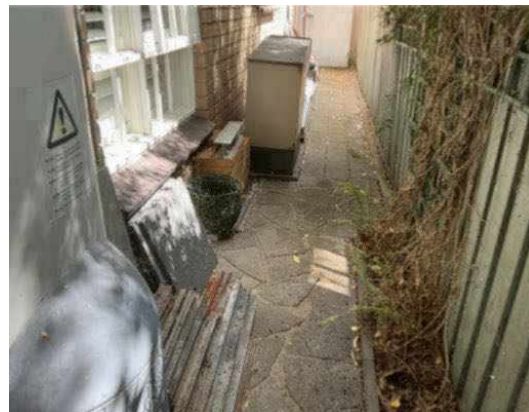
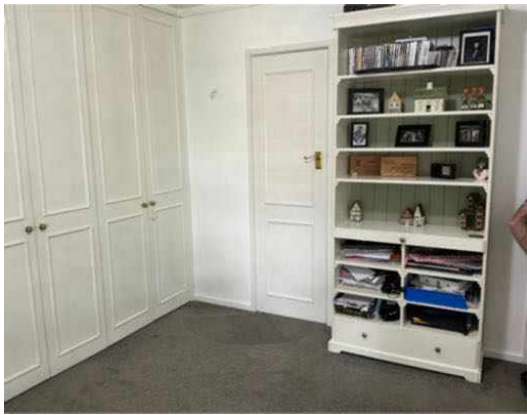
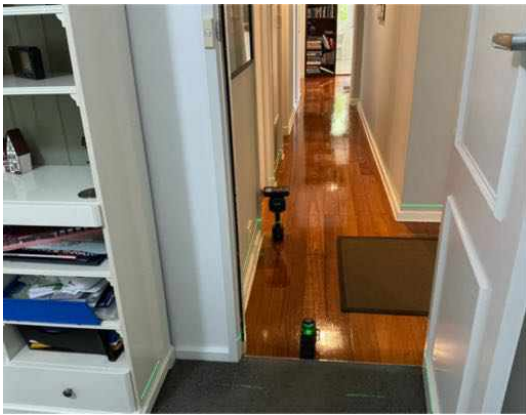
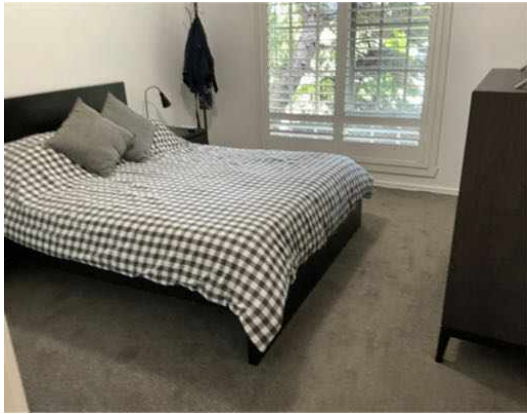
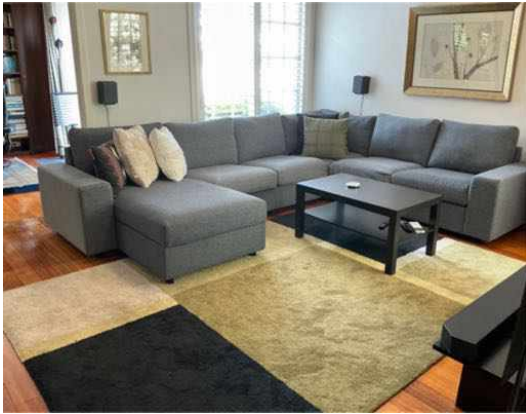
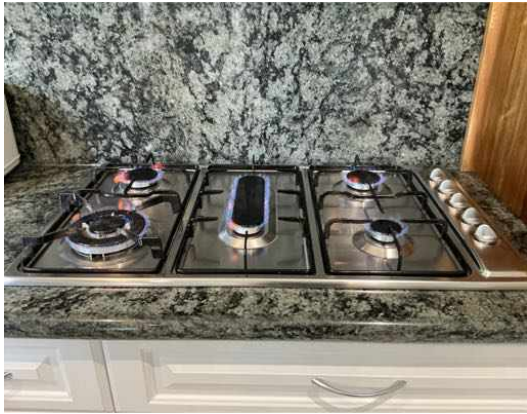
Noted Item

Building: Main Building
Location: All Areas
Finding: Additional Photos and Obstructions and Limitations
Information: These are additional photographs and photographs of the obstructions and limitations inside and outside (furniture, landscaping etc) which may impede full inspection of the property at the time of inspection. These obstructions can hide an array of defects and may be removed to allow full inspection to be carried out. A re-inspection may be made if clients require once the areas are made accessible.

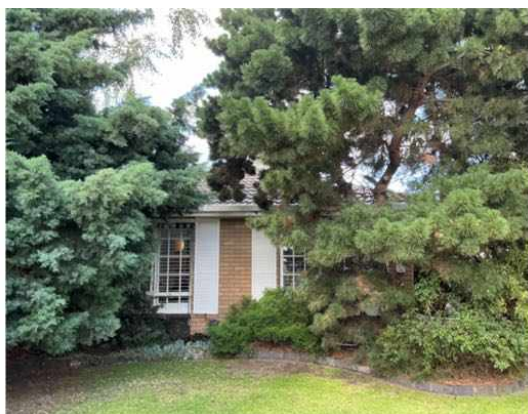
Noted Item

Building: Main Building
 Location: Roof Exterior
 Finding: Trees - Overhanging and filling gutters
 Information: Overhanging trees often result in excessive amounts of leaf debris accumulating in gutters.

Such works should be performed by the homeowner; however, appointment of a landscape contractor or an arborist may be required. Consultation with a licensed roof plumber is required where guttering has been damaged.

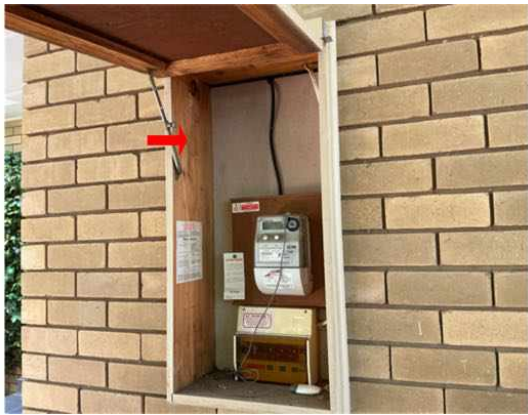
Noted Item

Building:	Main Building
Location:	Electrical Switchboard
Finding:	Termite Management System - no evidence of a chemical installation
Information:	The application of a post-construction chemical termite barrier is highly recommended for all properties, particularly if live termite activity has been found on the site previously. Such barriers are highly effective in preventing termite attack on any timber building elements throughout the property.

The client may consider gaining further advice from a pest controller as to the costs and procedures involved with this application. It is recommended that obtaining such advice be a short-term priority.

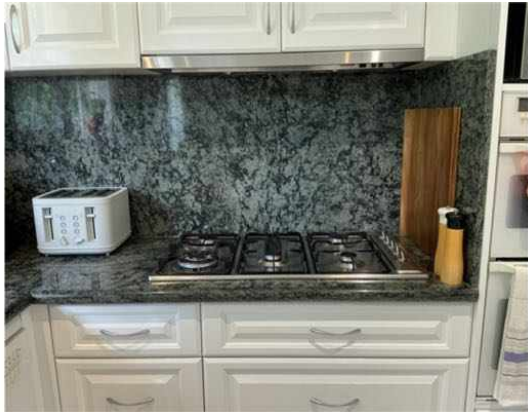
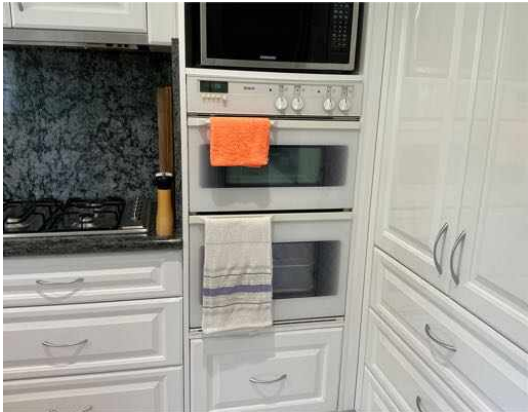
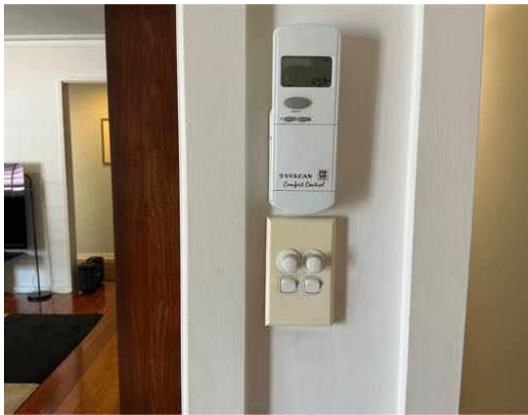
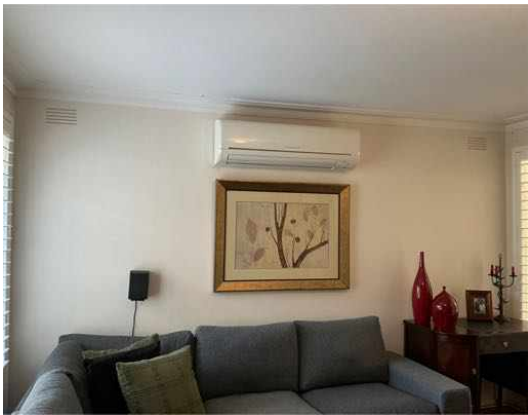
Noted Item

Building: Main Building
Location: All Areas
Finding: Warranty - Expired
Information: Where appliances are beyond their warranty period, the owner should be prepared to meet the cost of replacement or repair of the item at any time. The operation of the appliance can not be guaranteed and further inspection by an appropriately qualified tradesperson may be required.
