Building and Timber Pest Inspection Report

Inspection Date: Wed, 11 Feb 2026

Property Address: 6 Crane Ave, Green Valley NSW 2168,
Australia

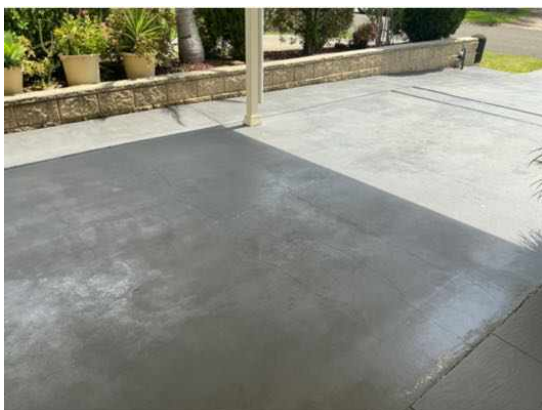
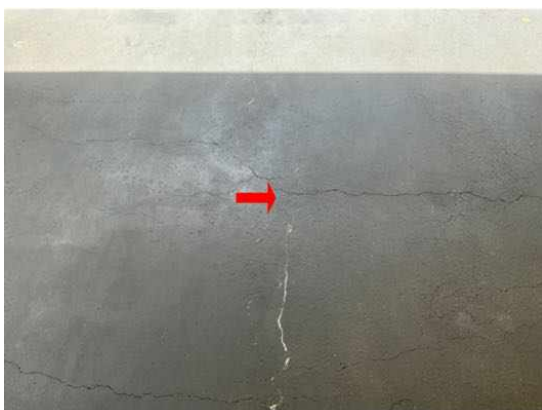
Building:	Main Building
Location:	Driveway
Finding:	Cracking - Driveway Distinct
Information:	Distinct cracks were identified in external concrete paving. Distinct cracks are generally found in older concrete paving, and may also present as a trip hazard as consequence of an uneven or curved surface.

General age and expected deterioration of the paved areas is a common cause of this type of cracking. However, expansion and contraction of the slab may also have occurred due to environmental factors. Such factors include variable moisture and weather conditions, the presence of trees and their roots having a settling or lifting affect on the soil, or the effect of load bearing, e.g. heavy vehicles over a sustained period of time.

Cracking to this degree may also be due to poor original installation of the concrete. Factors such as poor compaction of the sub surface and/or inadequate reinforcing of the slab may create cracking and other secondary defects.

Repairs are likely to be required to prevent further cracking and to reduce hazards associated with cracking, such as tripping. Monitoring of all cracking should be conducted frequently. Always contact a building inspector should cracks widen, lengthen, or become more numerous.

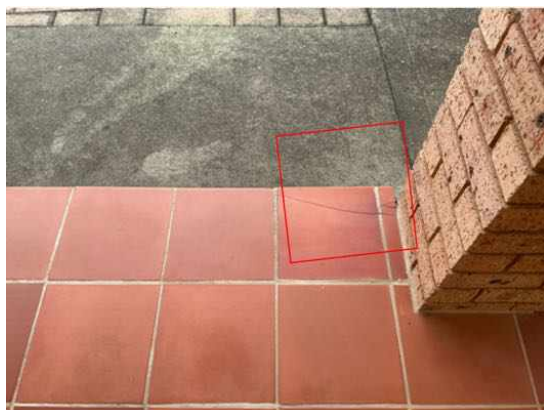
Finding 3.02

Building:	Main Building
Location:	Alfresco
Finding:	Tiles - Cracked or damaged
Information:	Cracking was evident to the tiling in this area at the time of inspection. While the cracking appears to be minor, this area is frequently exposed to water, allowing potential for water penetration into adjoining sections of of the home.

If left unmanaged, water penetration to these areas may lead to subsequent water damage, which is likely necessitate repair work to affected building elements. This can be seen in the photos.

A tiling contractor should be appointed to ensure that no further water damage occurs. The re-application of silicone and grouting throughout remaining tile work is also advised, to further protect the area against water penetration.

Where water penetration has led to water damage, appointment of a relevant tradesperson may be required to repair damaged building elements.

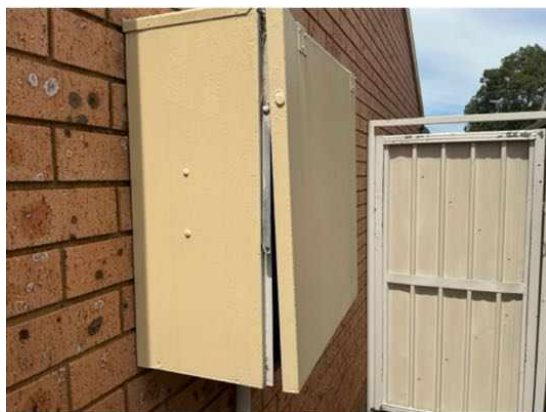
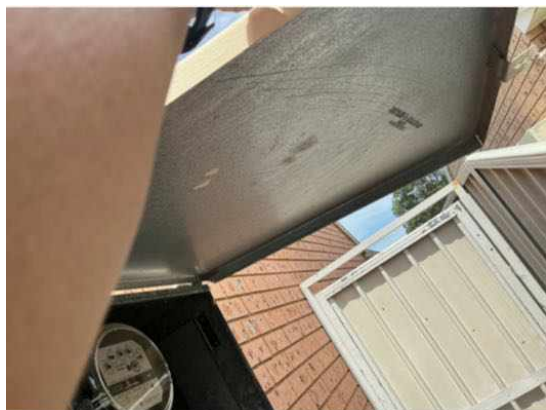
Evidence of this sticker has NOT been located in the meter box. Please see photos attached

Where a Termite Management System has not been identified you should consult a licensed pest inspector immediately to undergo further investigation in what measures would be necessary to maintain a functional pest management system. It is also recommended that a Licensed Pest Controller attend to determine the viability of the current or past treatments

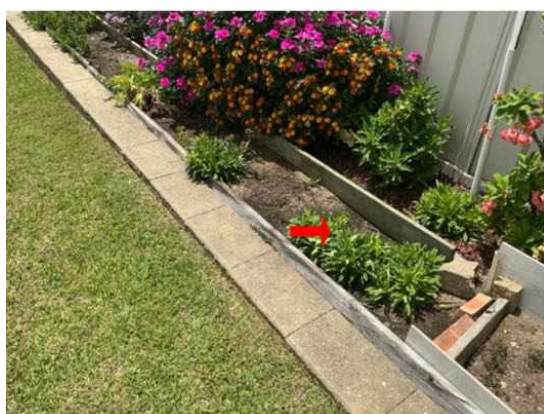
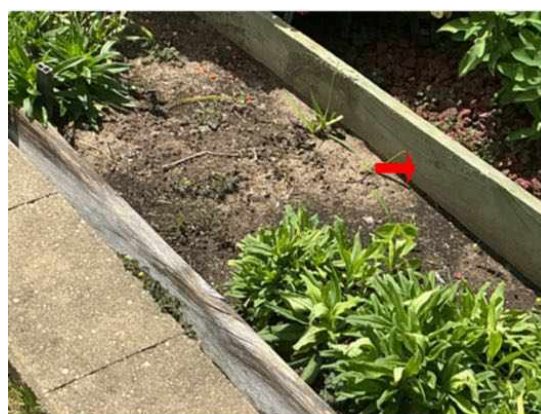
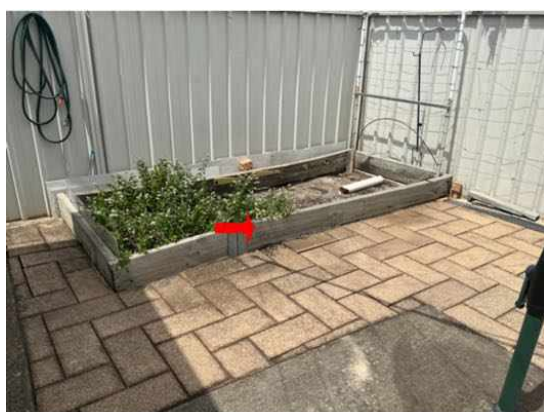
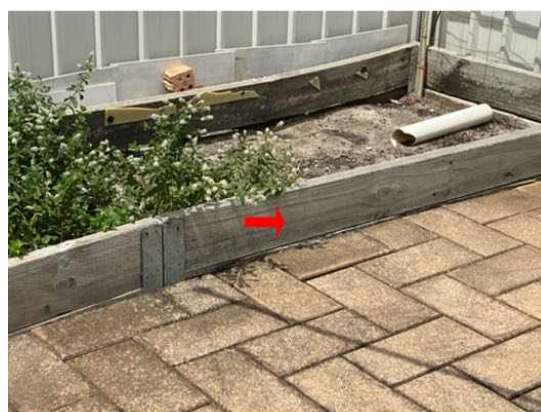
Finding 6.02

Building:	Main Building
Location:	All External Areas
Finding:	Timber Materials In Direct Ground Contact- Conducive to Termites
Information:	Timber elements that are in direct contact with the ground and exposed to moisture or damp conditions are highly conducive to termite activity. This susceptibility arises because of timber, when in contact with soil and dampness, create an environment that is particularly attractive to termites, encouraging infestation and potential structural compromise. Whether the timber is used as part of the building construction or incorporated into fencing, the presence near or on the ground can become a pathway for termites to access and damage the property.

When exposed to excessive moisture, timber begins to deteriorate developing conditions such as wood decay or rot. These compromised areas of timber are even more appealing to termites as they are easier to infest and consume. This is especially true for untreated or non-durable timber, which lacks the protective treatments that can deter or withstand termite attacks. Termites can use these weakened moisture-laden elements as a bridge into other parts of the structure, creating an entry point for potential infestations that can spread and cause extensive damage if left unchecked.

For any timber in direct contact with the external ground special attention is required. The combination of moisture untreated wood and direct ground contact not only accelerates the decay process but also provides subterranean termites with a

straightforward means of ingress into the structure this can lead to termites moving undetected into other vulnerable areas resulting in potentially significant structural issues and costly repairs.

To mitigate the risk of termite activity it is imperative that any such materials or timber elements be appropriately treated or removed as soon as possible. Timbers that are necessary for use should be made durable through appropriate treatments and maintained to ensure they do not create conditions conducive to termites. Additionally the client is advised to schedule regular termite treatments to maintain an effective barrier against infestations and ensure ongoing protection.

Regular inspections, proactive maintenance and consistent termite treatment are essential steps in minimising the risk of termite attack and protecting the structural integrity of the property. Taking these preventative measures is crucial for maintaining a termite free environment and avoiding potentially costly damage and future repairs.

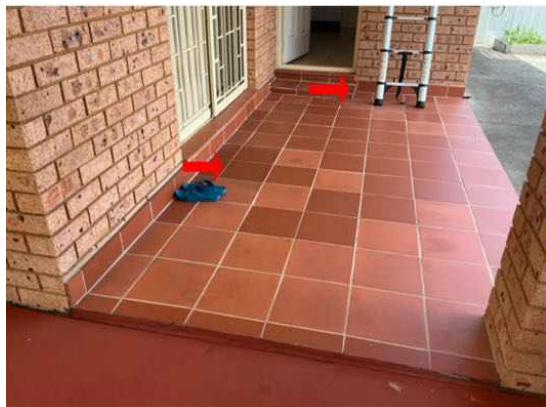
Finding 6.03

Building:	Main Building
Location:	All External Areas >
Finding:	Bridging Of Physical Barriers - Patios/Porches
Information:	Breaching is the spanning of a physical termite barrier or inspection zone so that subterranean termites are provided with an entry point over or around that barrier.

The concrete porch/patios are providing a concealed entry point at the time of the inspection. Where the location of the porch is retrospectively installed against an external wall this will provide a concealed entry point for termites.

The client should consider gaining further advice from a timber pest technician as to treatments required in this area. It is recommended that obtaining such advice be a short-term priority.

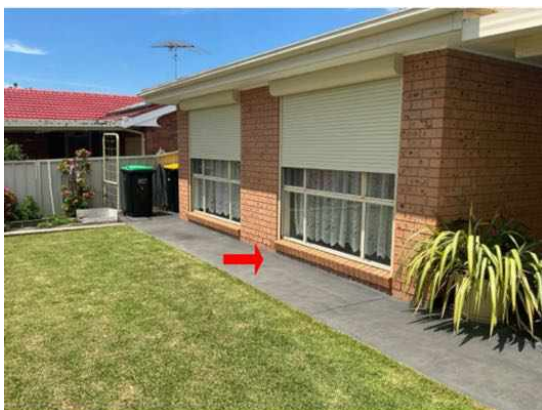
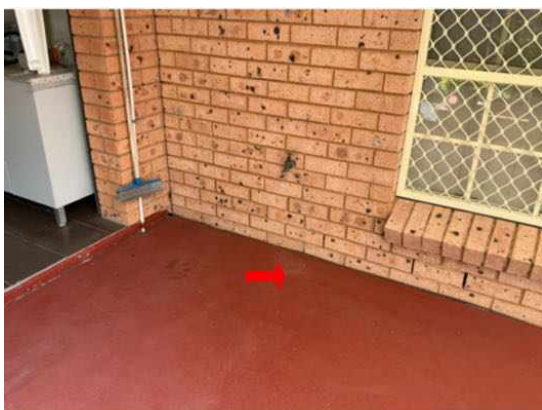
Finding 6.04

Building:	Main Building
Location:	All External Areas
Finding:	Slab Edge - Exposure
Information:	An inspection zone of at least 75mm in relation to the exposed slab edge, between the bottom brick and the perimeter pavement, is required. This inspection zone should be maintained in order to force termites into the open where they can be detected more readily during regular inspections. The slab edge should not be concealed by anything that may prevent inspection of the area, including render, landscaping, soil, turf, paving, concrete cladding or other structures.

If the slab edge is not properly exposed there is a high risk of termite attack. Sometimes, in order to determine the type of slab, a suitably qualified person such as an architect or builder may be required to consult the construction plans.

Where the slab edge cannot be properly inspected, it is highly recommended that termite or timber pest inspections be carried out every 6-12 months to aid protection of the property against infestation.

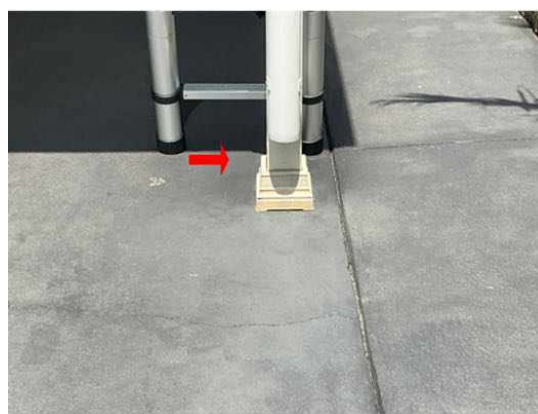
Where roof plumbing doesn't drain adequately, the area at the base perimeter can become excessively damp, potentially creating an environment that is susceptible to rust and corrosion of surrounding building elements, as well as attracting termites and other pests.

It is highly recommended that a plumber be appointed to further inspect the area and to install adequate drainage equipment where necessary.

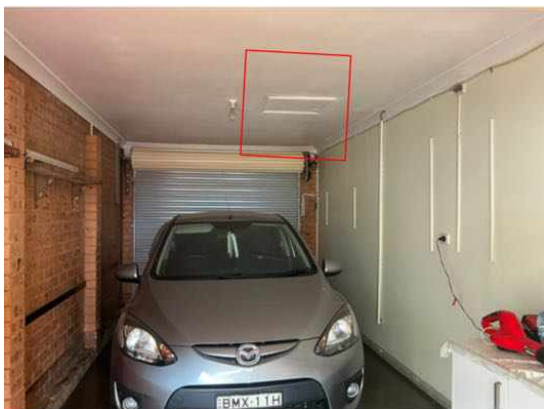
Building: Main Building
 Location: Roof Void
 Finding: Roof Void - Restricted Access
 Information: Access to the roof void was not possible at the time of inspection as the access hatch was restricted within. The restriction of access to a manhole restricts the ability to inspect the roof space, which is an essential area for assessing the condition of structural roof framing, insulation, electrical installations, and identifying any signs of water ingress, pest activity, or other defects.

Inspection of the roof void is important to detect issues such as leaks, timber damage, insulation deficiencies, and safety hazards that are not visible from within the living

areas. Without access, the overall condition of these elements remains unknown, increasing the risk of undetected damage or non-compliance with current building standards.

For a more complete assessment of the roof void area it is suggested that the restrictions be moved and access gained.

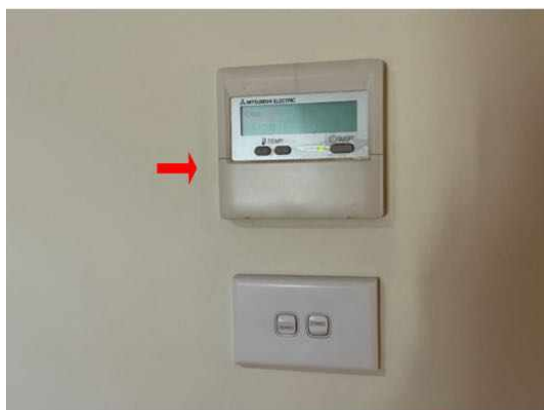
Building: Main Building
 Location: All Internal Areas
 Finding: Air Conditioner System
 Information: Inspection of Air conditioning and associated electrical equipment is not part of this inspection but it was noted that at the time of the inspection the control box showed error codes, these codes could lead to incorrect or poor performance of the associated system.

Routine inspection and servicing of the air conditioning units and condensate drainage system should be carried out by a licensed air conditioning technician.
