Building and Timber Pest Inspection Report

Inspection Date: Thu, 19 Feb 2026

Property Address: 11 Grassmere Ave, South Penrith NSW
2750, Australia

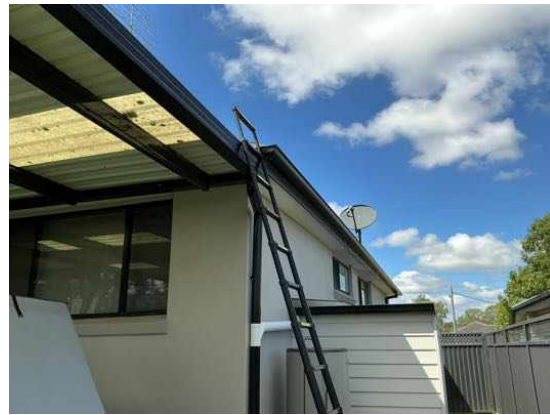
Building:	Main Building
Location:	Rear
Finding:	Debris in Gutters
Information:	Debris, including leaves and organic matter, was observed in the gutters and roof valleys at the time of inspection. This build-up can obstruct proper water flow, leading to water pooling, overflow, and potential moisture ingress into the roof structure. Prolonged moisture retention in these areas creates damp conditions that are conducive to termite activity, particularly where timber components are present nearby. It is recommended that the gutters and valleys be cleared of all debris and maintained regularly to ensure proper drainage and to reduce the risk of both water damage and termite infestation.

The client is advised to engage services of a lawn maintenance professional or a landscaper at own discretion.

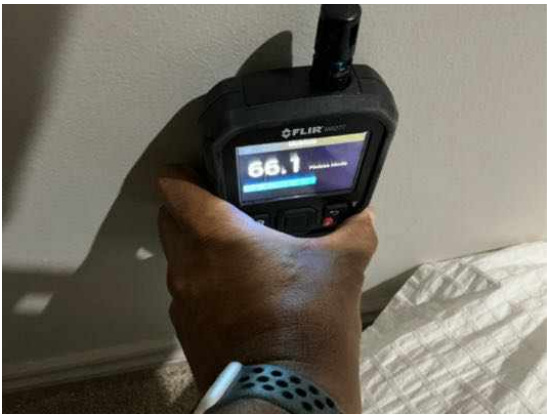
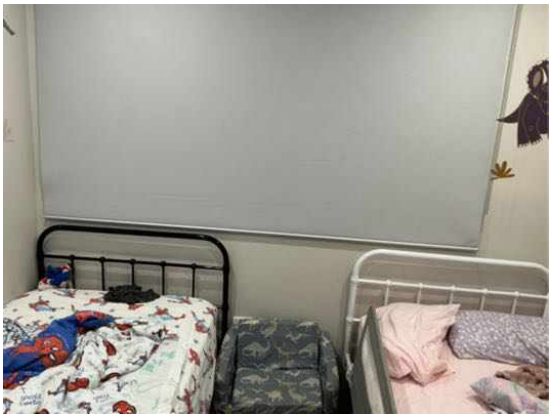
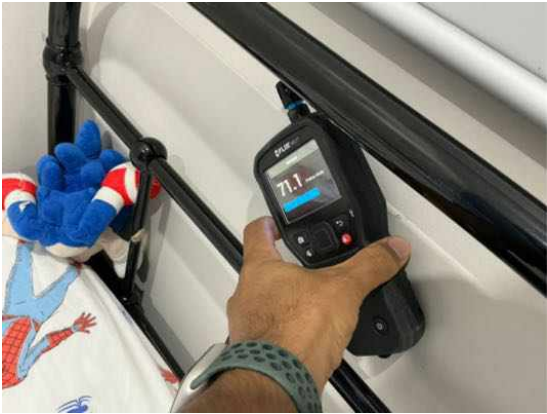
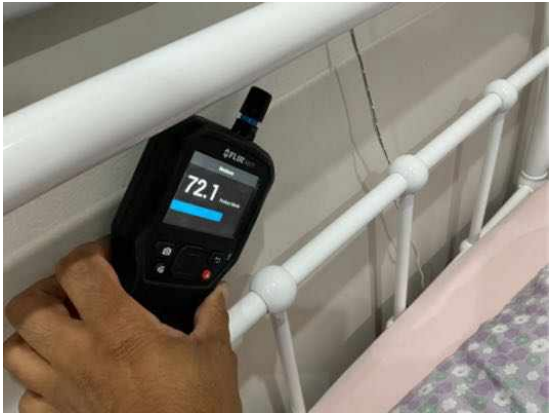
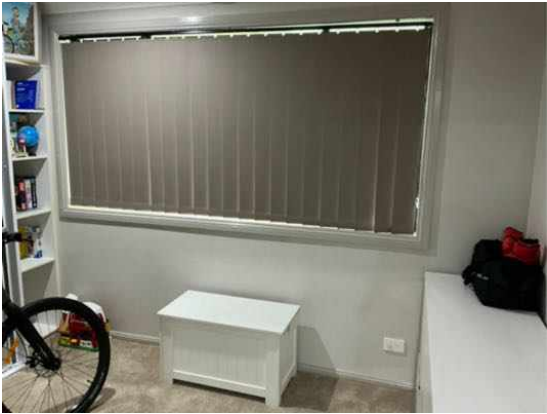
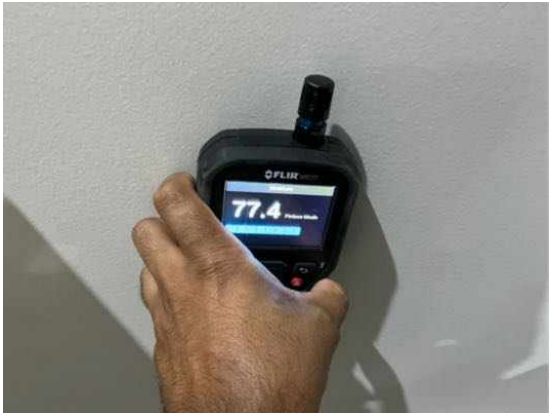
Building:	Main Building
Location:	All Bedrooms
Finding:	Rising Damp - Inadequate Subfloor Drainage
Information:	At the time of inspection, elevated moisture readings were recorded to the lower sections of internal walls, consistent with rising damp.

The moisture ingress appears consistent with rising damp originating from the subfloor area, likely influenced by inadequate site drainage and insufficient subfloor ventilation. Elevated ground moisture beneath the dwelling can allow moisture vapour to migrate upward into wall linings, resulting in dampness to internal wall surfaces. Prolonged exposure to such conditions may contribute to deterioration of wall finishes, mould growth, and potential timber decay if left unaddressed.

Installation of a mechanical subfloor ventilation system is recommended to assist in reducing subfloor humidity levels and improving airflow beneath the dwelling. A licensed electrician specialising in mechanical ventilation systems should be consulted to assess, supply, and install an appropriate system suited to the property.

In the interim, the client is advised to increase natural ventilation within the dwelling by leaving windows open for a couple of hours each day (weather permitting) to assist in reducing internal humidity levels. Ongoing monitoring of the affected wall areas is recommended following rectification works.

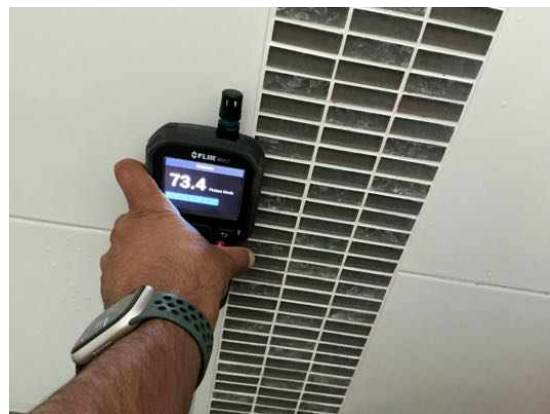
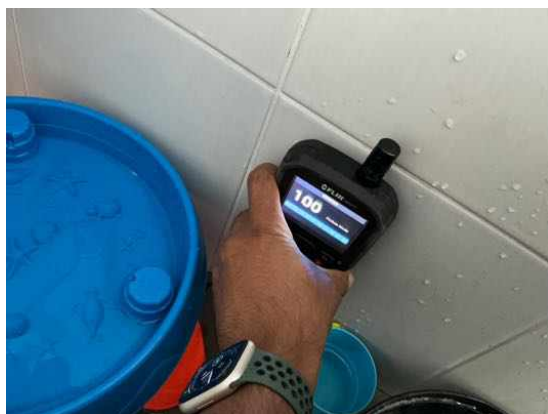
Finding 3.11

Finding: Excessive Moisture - Shower Damp

Information: At the time of inspection, excessive moisture was noted within the shower area, which is a common issue in wet areas due to the continual exposure to water. This condition is typically caused by moisture seeping through grout lines and settling behind tiles, resulting in localised high-moisture zones. Provided there is no evidence of water staining or elevated moisture readings on the opposite side of the wall, this is considered a minor defect.

However, persistently damp conditions may act as conducive conditions for termite activity, as termites are strongly attracted to moisture-rich environments. It is recommended that the client ensures regular use of the exhaust fan and maintains adequate ventilation after shower use to promote drying and reduce long-term moisture build-up, thereby also reducing the risk of attracting termites.

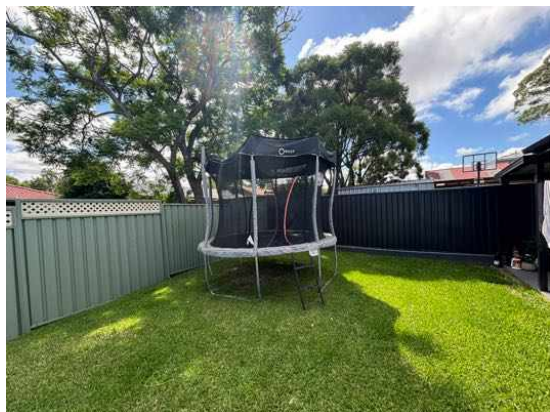
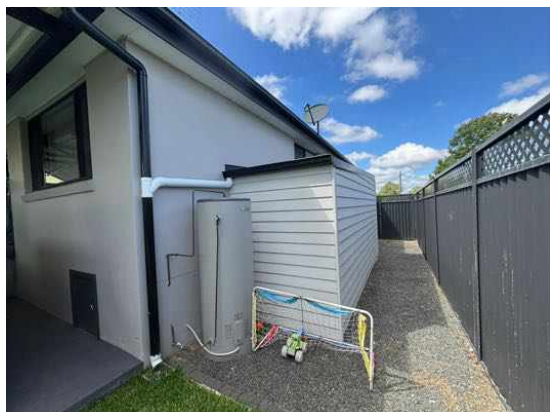
Therefore, it is strongly recommended that the obstructions be removed and a re-inspection be scheduled once the affected areas are made fully accessible. This will ensure a complete evaluation of the property's exterior and provide the client with a clear understanding of any potential issues that may have been concealed during the initial inspection.

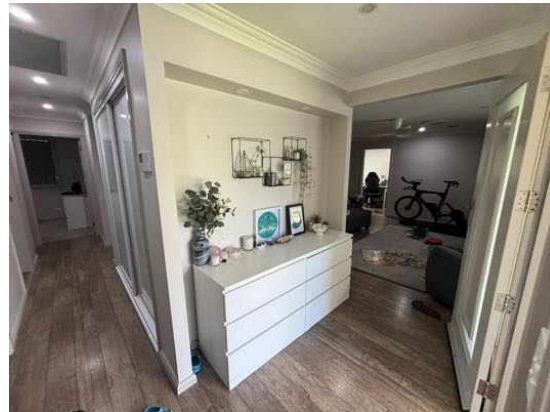
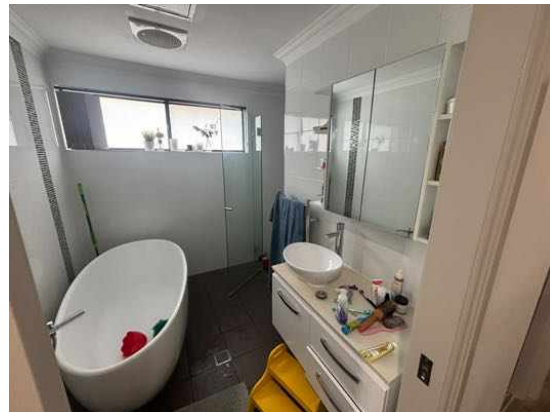
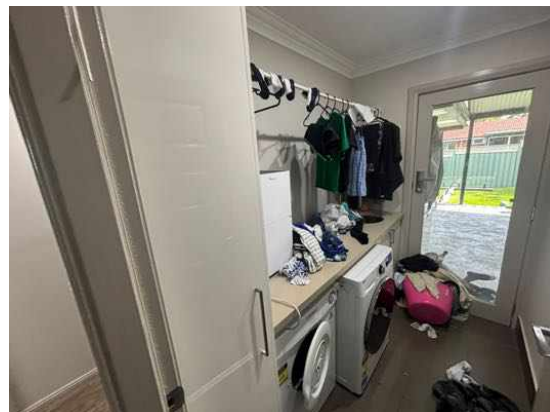
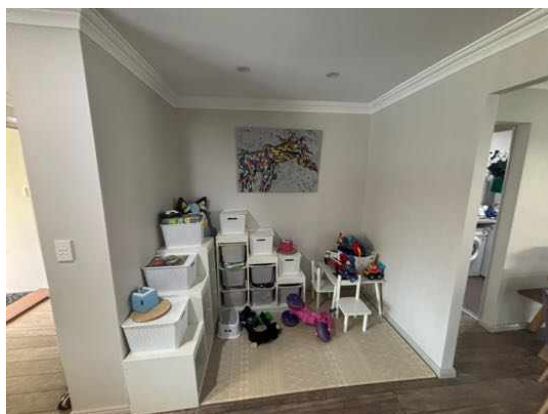
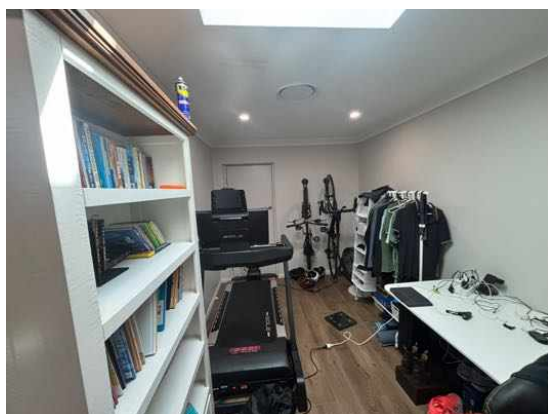
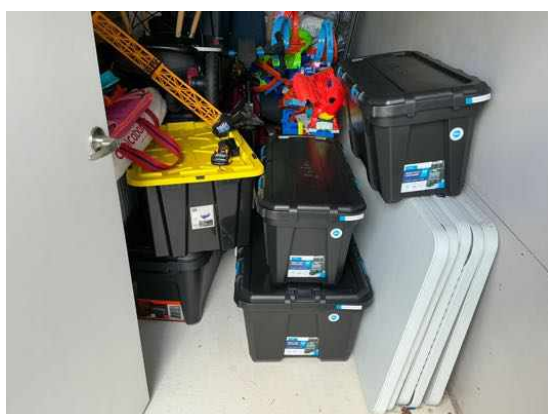
previously concealed issues can be properly identified and rectified. This follow-up inspection will provide a more accurate assessment of the property's internal condition and help the client make informed decisions about any necessary repairs or maintenance.

In summary, the limitations encountered during the inspection highlight the importance of ensuring full access to all areas of the property to accurately assess its overall condition. A re-inspection is strongly advised once these areas are made accessible.

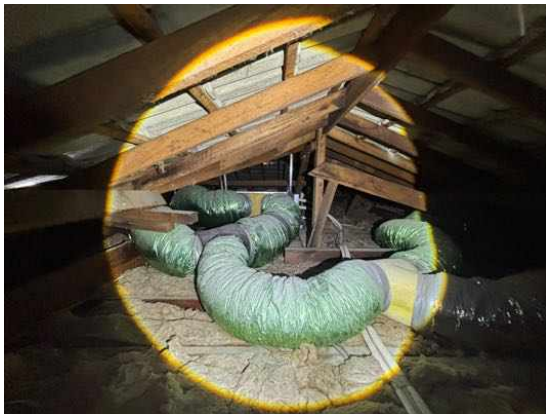
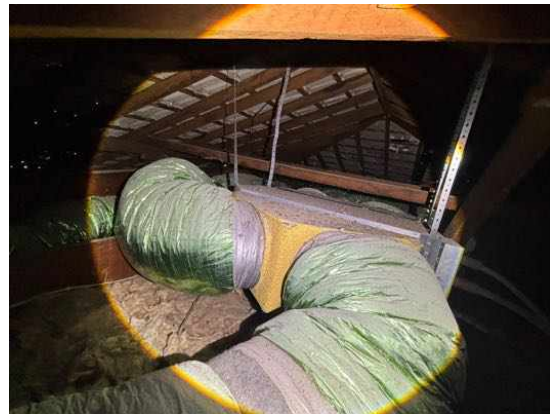
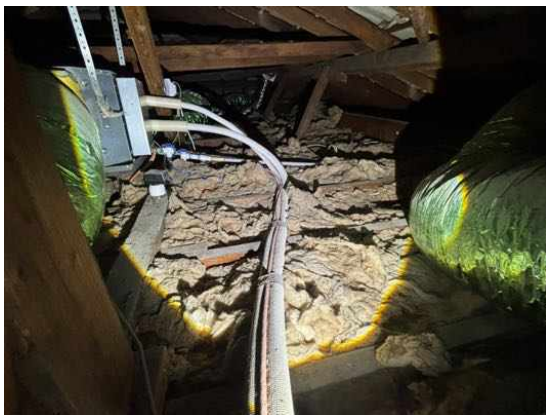
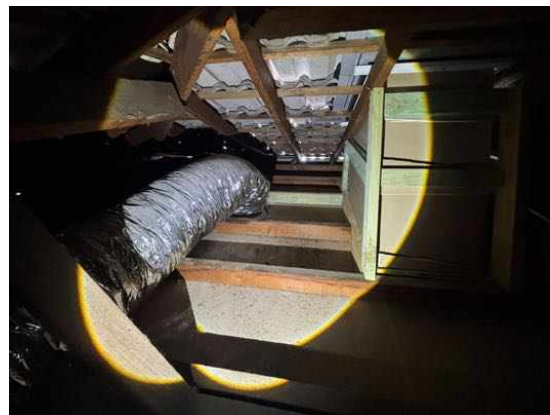
damaged framing, compromised insulation, evidence of moisture ingress, pest activity, or electrical hazards. While no major issues were observed in the visible areas, the presence of these limitations means that some defects may remain undetected.

It is recommended that these barriers be removed or repositioned to facilitate full and safe access to the roof space. Once clear, a follow-up inspection should be conducted to allow for a thorough assessment of all concealed areas. This will help ensure that the condition of the roof cavity is accurately evaluated and any hidden issues are appropriately identified and addressed.

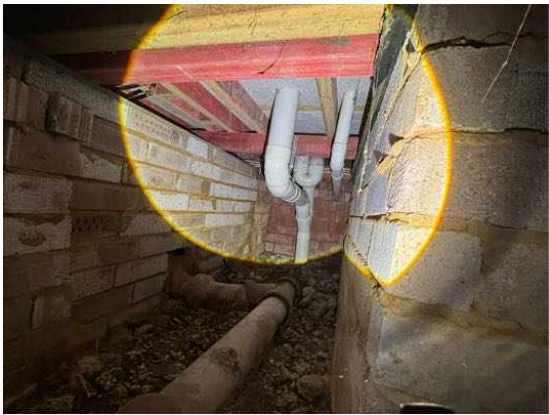
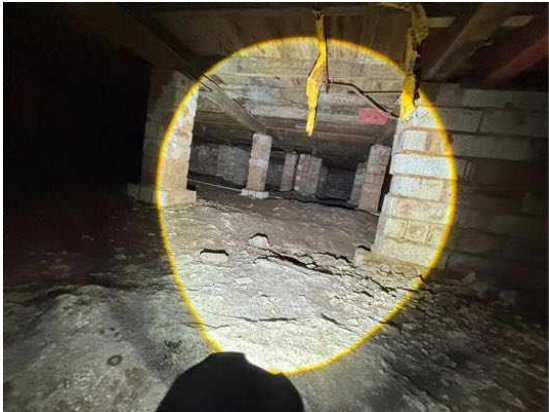
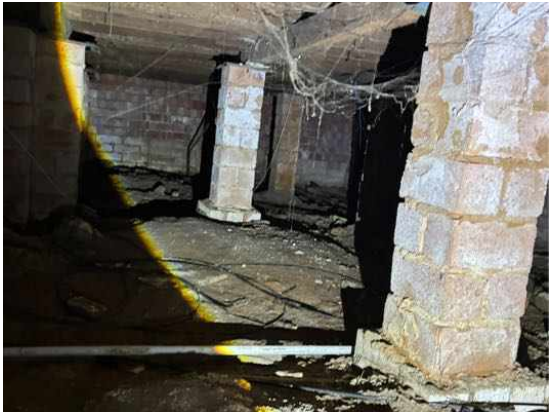
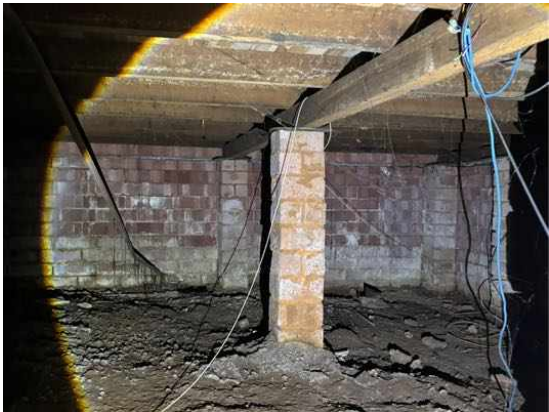
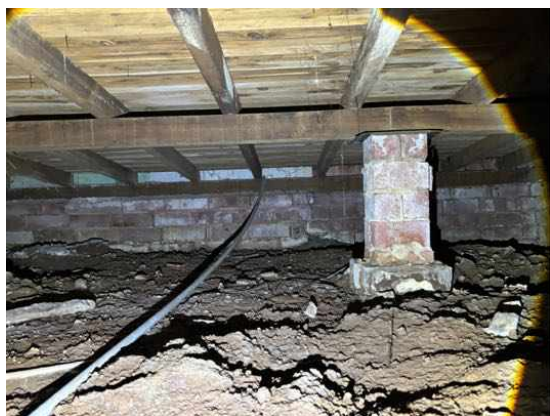
Restricted access and confined spaces can significantly hinder the ability to evaluate important elements such as floor joists, bearers, stumps, drainage, subfloor ventilation, and signs of moisture or pest activity. These obstructions may also conceal defects such as timber decay, water ingress, termite damage, inadequate support, or ventilation issues that are not immediately visible during a limited inspection.

While no major concerns were identified in the accessible areas, a full and unobstructed inspection is necessary to properly assess the overall condition of the subfloor. It is recommended that obstructions be removed and access improved where possible. Once adequate clearance is provided, a re-inspection should be arranged to ensure that any concealed defects can be identified and addressed accordingly. This will assist in providing a more comprehensive understanding of the subfloor's condition and reduce the risk of unforeseen issues.

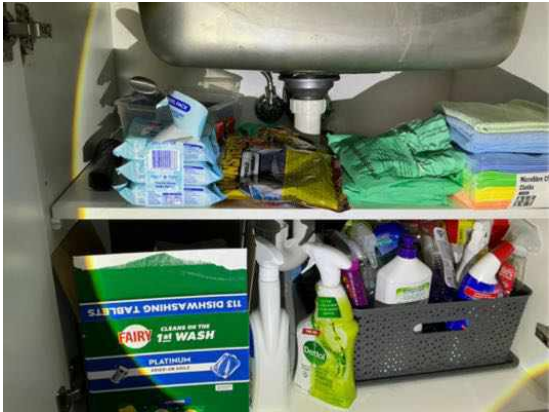
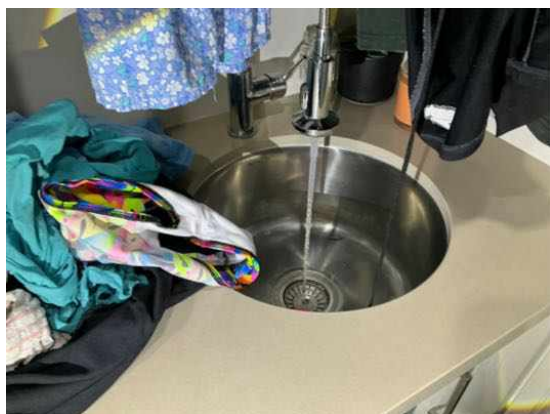
It is important to note that while a visual inspection of cupboards and cabinetry beneath sinks and vanities was undertaken, stored personal items and fixtures presented obstructions that limited full visibility of the internal areas. As per standard inspection practices, inspectors are not permitted to move or disturb personal belongings during the inspection process. Therefore, only visible and accessible sections were inspected, and concealed water damage or plumbing defects may not have been detected.

Given this, a re-inspection is recommended after all obstructions have been cleared to allow for a comprehensive assessment of these areas. Regular maintenance and monitoring of plumbing and drainage systems is also advised to ensure ongoing functionality and early detection of potential issues.
