Building and Timber Pest Inspection Report

Inspection Date: Wed, 4 Feb 2026

Property Address: 2/55 Durham St, Eaglemont VIC 3084,
Australia

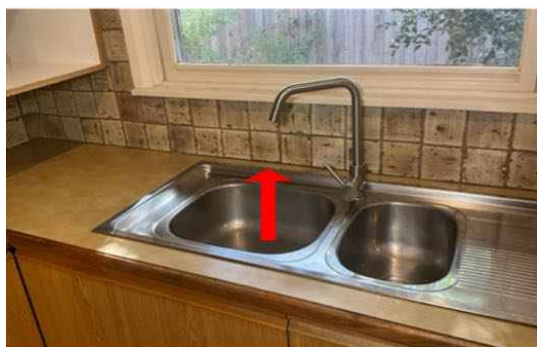
Finding: Sealant - Damaged or Missing

Information: Sealant is damaged in this area. Sealant is used to protect gaps and crevices in building materials to ensure that they are water-tight and prevent water penetration to the associated structures.

Failure to do so may lead to further deterioration of the sealant which in turn can lead to water damage to the surrounding area.

Where sealant is missing or damaged , a competent handyman may be appointed to scrape out and re-apply any silicone where necessary.

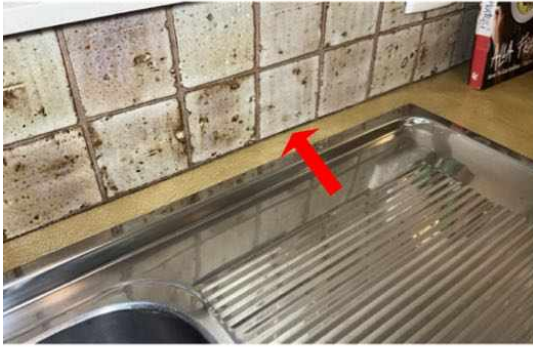
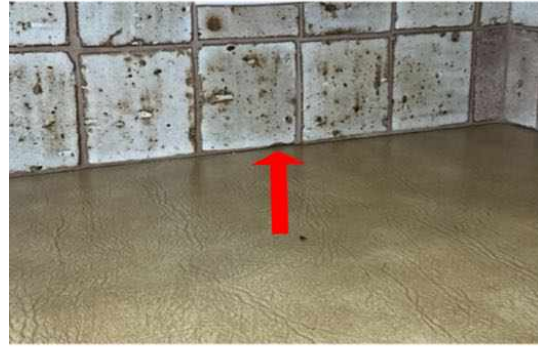
Finding 3.02

Information: At the time of inspection, the join within the bench top surface was slightly open and not sealed effectively. This has the potential to allow water ingress into the gap and cause secondary damage to the cabinets underneath.

It is highly recommended that the benchtop be sealed to prevent water ingress.

A competent handyman or kitchen benchtop specialist may be engaged to perform this task.

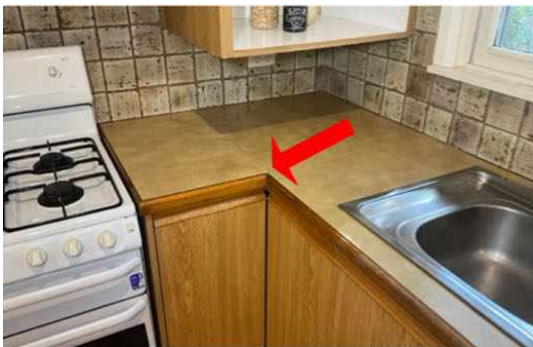
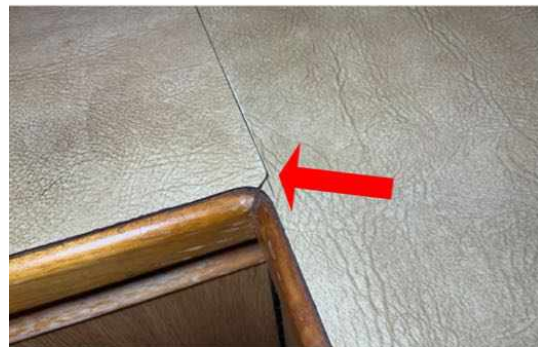
Finding 3.03

Finding: Slight damage to the kitchen cupboards

Information: Evidence of damage was identified to the kitchen cabinetry at the time of inspection .

It is suspected that this has occurred as a result of either excess moisture from internal spills or impact damage to the area.

A licenced carpenter or competent handyman should be engaged to inspect the damaged areas and repair or replace any items where necessary.

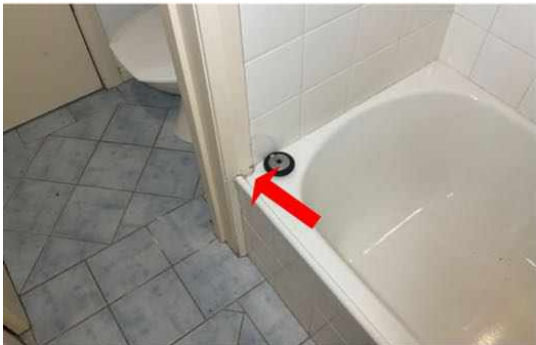
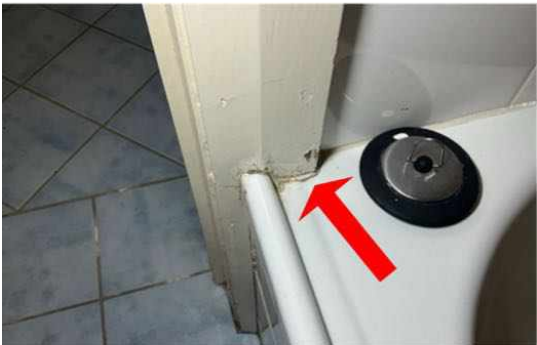
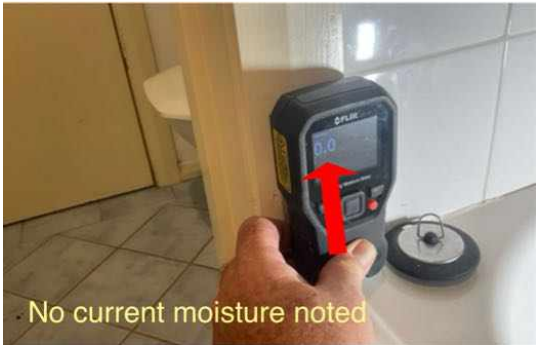
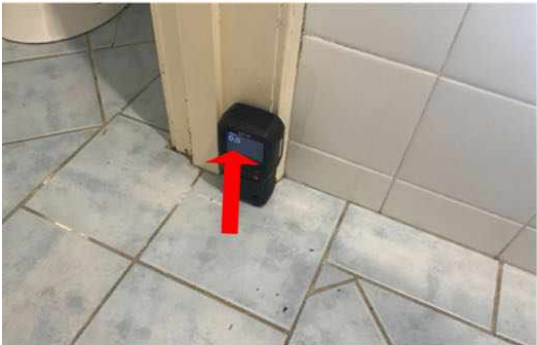
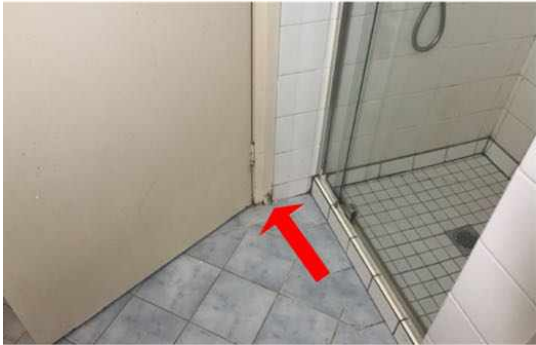
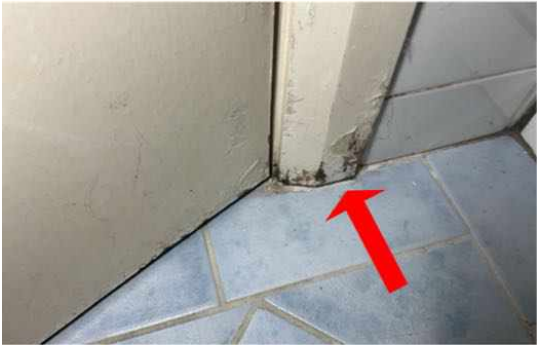
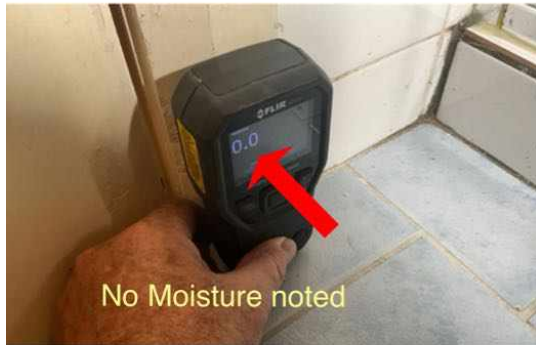
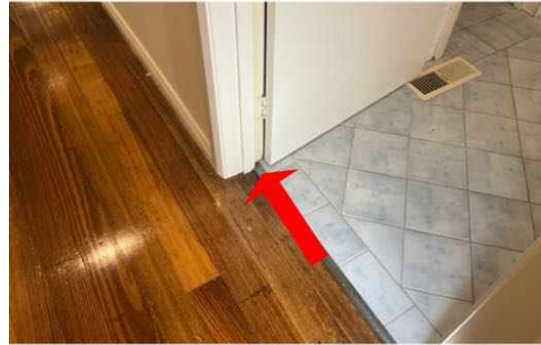
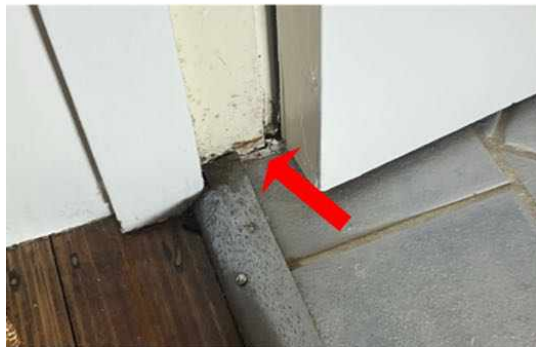
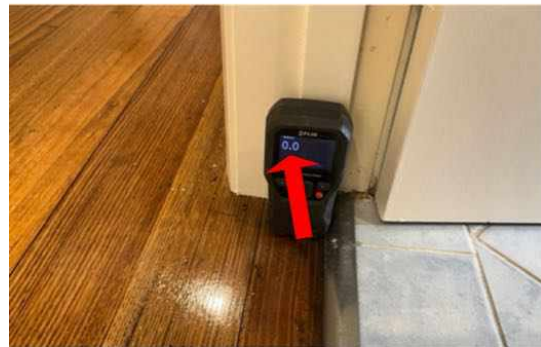
Building:
Location: Bathroom
Finding: Moisture damage to door framing
Information: Evidence of moisture damage was identified to the door framing in the bathroom.

It is suspected that this has occurred as a result of excess moisture from internal spills. No current moisture was noted to the areas when tested with a moisture meter.

A licenced carpenter or competent handyman should be engaged to inspect the moisture damaged areas and repair or replace any items where necessary.

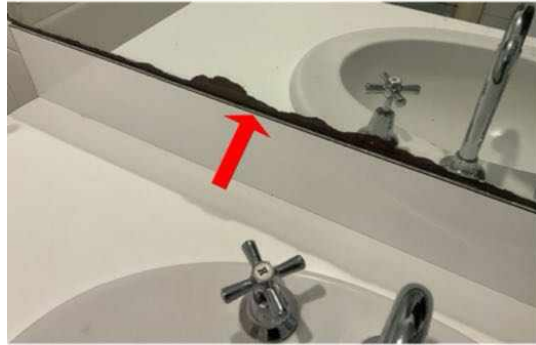
Finding 3.09

This usually happens when the reflective silver (or aluminium) backing starts to deteriorate, often from moisture, cleaning chemicals, or age.

This defect is more of a cosmetic defect.

The mirror should be monitored for any further deterioration and should that occur, the homeowner may replace the mirror at their discretion.

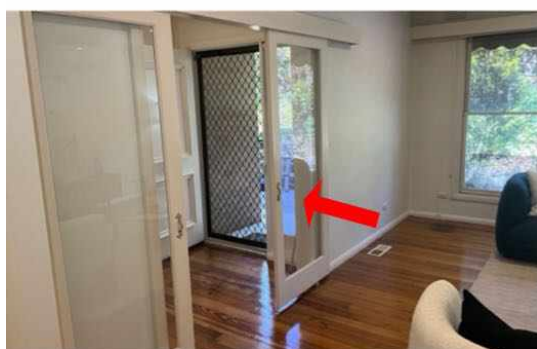
Information: The door in this area was stiff and difficult to slide along the associated tracks at the time of the inspection. The door also appeared to be slightly loose within the frame.

Restricted function of the affected door may pose as a potential safety hazard if required for emergency egress from the building.

Generally, factors such as age of the building element and a lack of maintenance are the usual causes for this type of defect.

Cleaning of the tracks may improve the operation of the door. Replacement of door hardware or tracks may be required should the cleaning not be effective.

A door specialist or competent handyman may be engaged to perform this task.

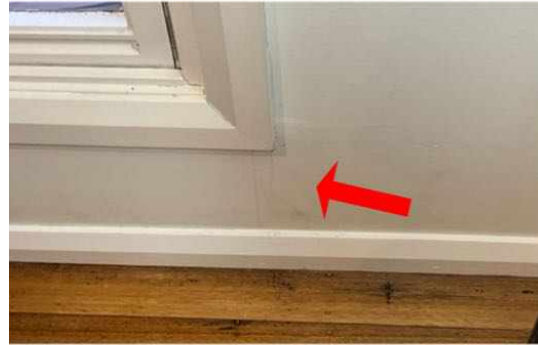
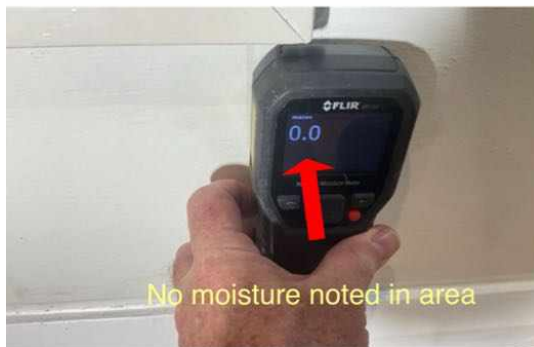
Finding 3.12

Finding: Wall stained - no current moisture noted

Information: At the time of inspection, there appeared to be some suspected moisture staining to the wall in this area. It is suspected the staining may be the result of moisture coming in around the window or window frame in this area. No current moisture was noted to the wall when tested with a moisture meter.

It is recommended that the area be monitored for any changes or increase in staining. Should this occur, consultation with a registered builder should be undertaken to determine the source of the leak and make necessary repairs.

Should no changes occur, the area may be repainted at the discretion of the homeowner.

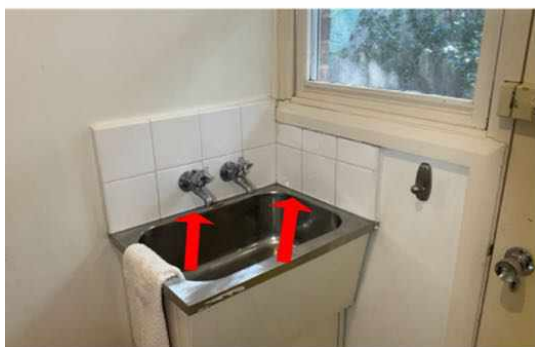
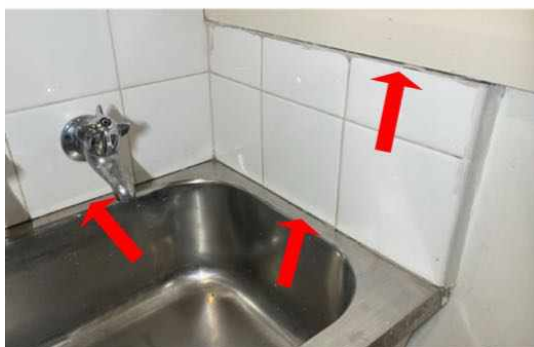
Finding: Sealant / grout - Damaged or Missing

Information: Sealant or grout is damaged in this area. Sealant and grout is used to protect gaps and crevices in building materials to ensure that they are water-tight and prevent water penetration to the associated structures.

Failure to do so may lead to further deterioration of the sealant which in turn can lead to water damage to the surrounding area.

Where sealant or grout is missing or damaged , a competent handyman may be appointed to scrape out and re-apply where necessary.

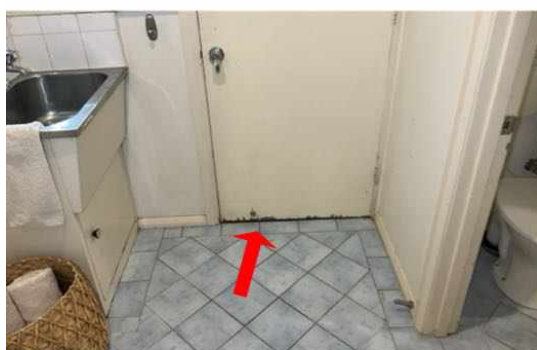
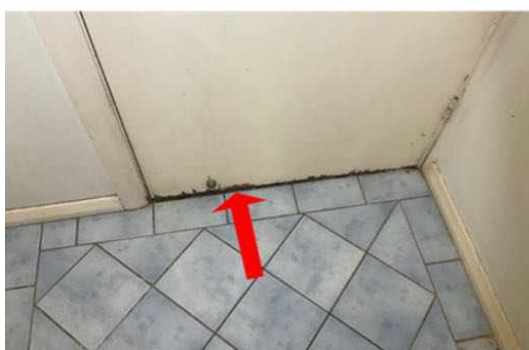
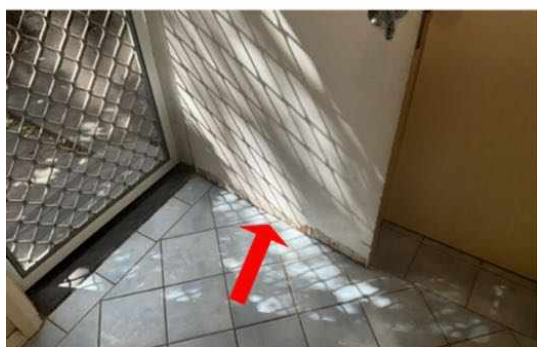
Finding 3.15

Finding: Door showing signs of damage to the base
 Information: At the time of inspection there appeared to be some moisture damage at the base of the door in this area.

Doors should be sealed on all faces including top and bottom to prevent moisture seeping into the door structure and potentially causing secondary damage.

A suitably qualified handyman or painter should be engaged to remove doors, repair any damage, paint the door including top and bottom and rehang them.

If the door cannot be repaired, a new door may be required.

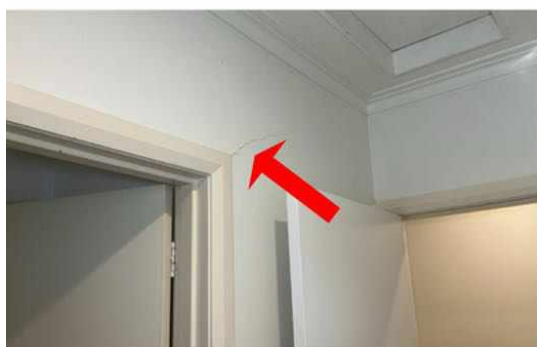
Finding 3.16

Building:
 Location: Laundry
 Finding: Cracking - Noticeable
 Information: Cracking was noted within the plasterboard wall in the laundry.

Noticeable cracks are a common occurrence as a result of many primary defects. Such causes may include age, general wear and tear, expected building movement, general expansion/contraction of building materials in different weather conditions, and/or minor failings in the installation or application of building materials.

Noticeable cracks may result in minor sticking or jamming of associated doors and windows, which require easement. However, noticeable cracks are easily filled and repaired.

Monitoring of all cracking should be conducted frequently. Always contact a building inspector should cracks widen, lengthen, or become more numerous. Additionally, your building inspector should also be contacted if associated building elements such as doors and windows become more difficult to operate over time.

Relevant tradespeople, such as carpenters, painters and plasterers, should be appointed to perform remedial works, as deemed necessary.

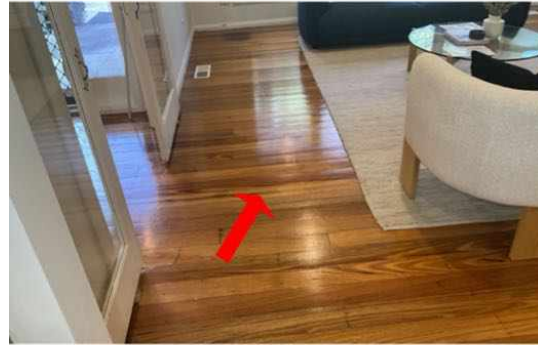
Finding 3.17

Building:	
Location:	All Areas
Finding:	Floor - creaking slightly
Information:	The internal flooring in this area was creaking slightly when walked upon at the time of inspection.

Creaking floors generally indicate that the fixings for the flooring may be coming loose slightly.

The area should be monitored for any changes or unevenness. Should this occur, consultation with a registered builder should be undertaken to determine the cause. The potential resolution may involve regluing and screwing the floor down through to replacement of subfloor support structures.

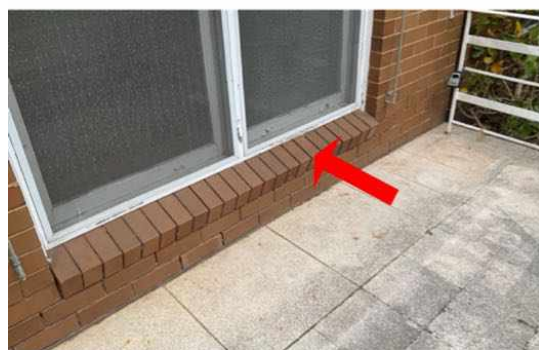
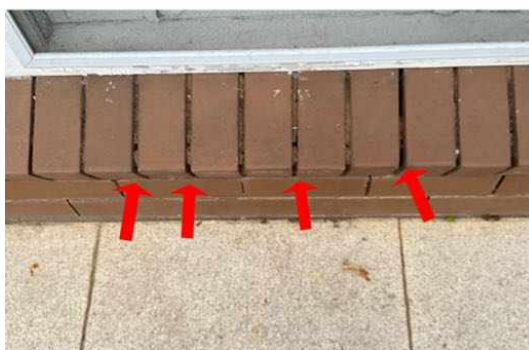
Building:	
Location:	Exterior walls - front
Finding:	Brickwork - Deteriorated mortar
Information:	Deteriorated or missing mortar was noted around brickwork in this area.

Mortar, or 'bedding', is the material which fills joints and intersections between bricks in masonry walls and structures. Sections of mortar in this brickwork were identified as having deteriorated, which is generally expected for a property of this age and condition.

Mortar may deteriorate as a result of age of building materials, minor movement of bricks, or frequent exposure to weathering. Mortar should be replaced to ensure that bricks remain in their intended location and to prevent gaps, which would allow water or moisture ingress and secondary damage as a result.

Mortar deterioration can be addressed by a bricklayer where areas of deterioration are localised and easily accessible. Alternatively, appointment of a registered builder is advised, to repoint large areas of decaying mortar. Where secondary structural defects have become evident, consultation with a structural engineer may be required.

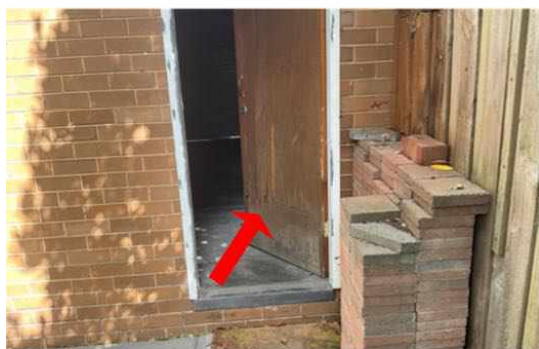
Finding 3.20

Building:	
Location:	Garage
Finding:	Door showing signs of damage to the base
Information:	At the time of inspection the rear garage door showed evidence of moisture damage. It is suspected this has occurred due to a lack of upkeep on the external door.

Doors should be sealed on all faces including top and bottom to prevent moisture seeping into the door structure and potentially causing secondary damage.

A suitably qualified handyman or painter should be engaged to remove door, repair any damage, paint the door including top and bottom and rehang them.

If the door cannot be repaired, a new door may be required.

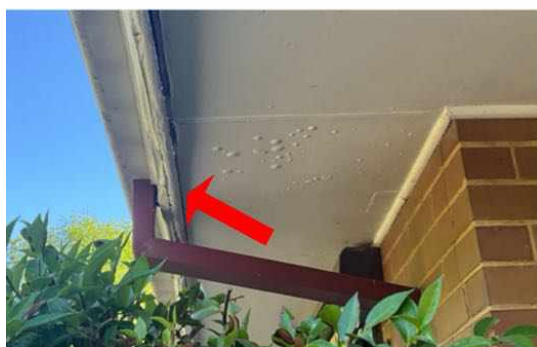
Finding 3.21

Finding: Fascia - Wood rot noted

Information: Wood rot was found to be affecting the fascia in this area. Wood rot, also known as Fungal Decay, occurs when timbers and other cellulose building materials are exposed to damp conditions on an ongoing basis.

It is advised that a roof plumber be appointed to inspect all roof plumbing and subsequently identify the cause of the wood rot. Replacement of affected fascias and barges may then be a necessary step in protecting surrounding building elements from such deterioration.

A qualified carpenter or registered builder will then be required to replace affected building materials.

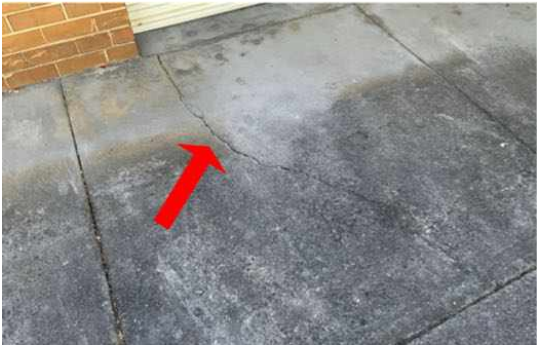
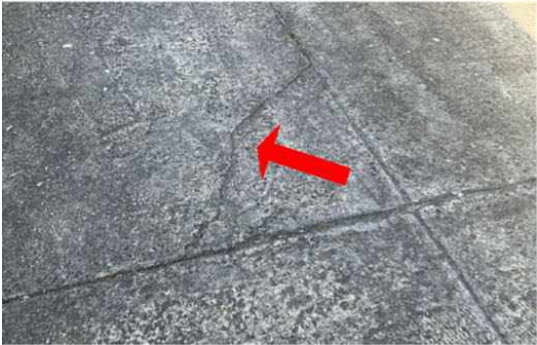
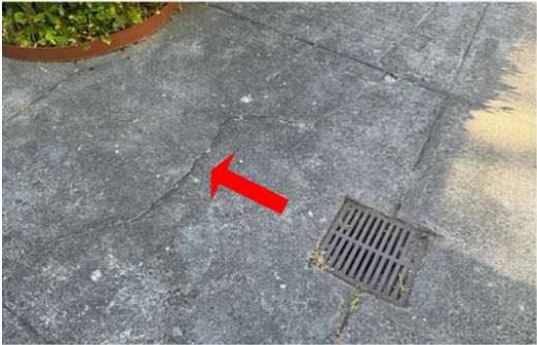
Finding 3.22

Building:	
Location:	Driveway
Finding:	Noticeable Cracking - Concrete driveway (suspected owners corporation responsibility)
Information:	Noticeable cracks were identified in the concrete driveway.

Cracking to this degree may also be due to poor original installation of the driveway. Factors such as poor compaction of the sub surface and/or inadequate reinforcing of the slab may create cracking and other secondary defects. Noticeable cracks may also be due to subsidence of soils.

The area should be monitored for any changes that may occur and potentially cause tripping hazards. Should this occur, repair and likely replacement of the concrete section may be necessary.

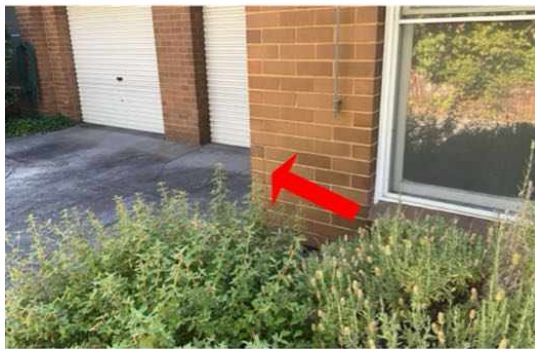
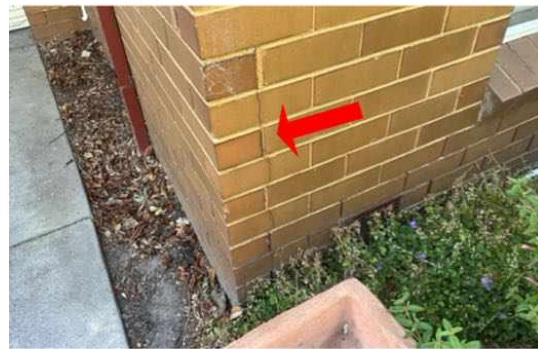
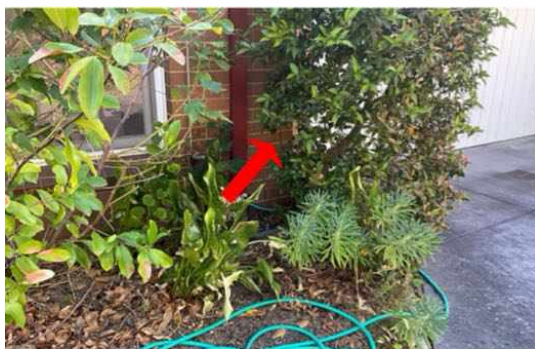
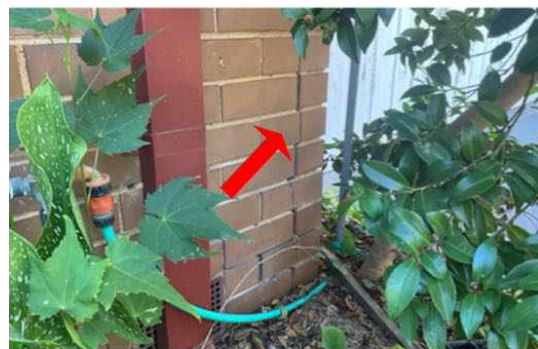
Finding 3.23

Building:
Location: Exterior walls - front
Finding: Brickwork - noticeable cracking
Information: Noticeable cracking to the brickwork at the front of the property was observed at the time of inspection.

It is highly advised that monitoring of these cracks be carried out to ensure no further cracking occurs in the area. Should no further movement occur, the brickwork may be patched by a competent bricklayer.

Always contact a building inspector should cracks widen, lengthen, or become more numerous.

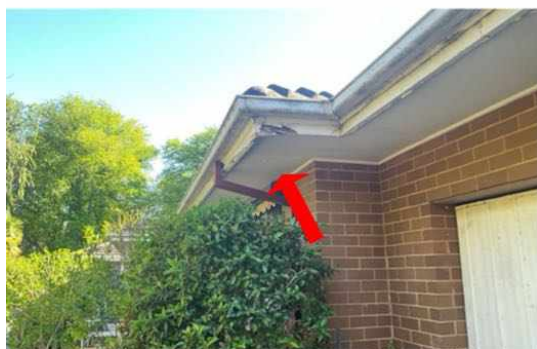
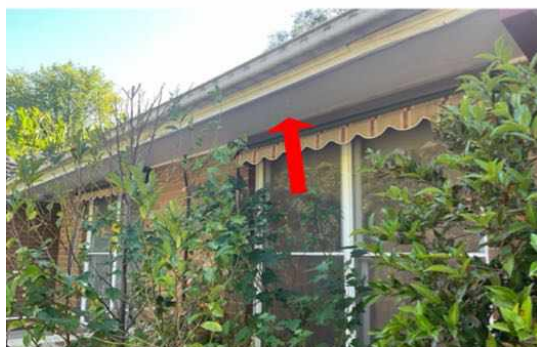
Finding 3.24

Please note: given the age of the property there is a high chance that the eave sheets may contain asbestos material. It is recommended that prior to any works being carried out on the eaves, an asbestos inspection and sampling be carried out to determine whether this is the case. Your Jim's building consultant can help you with this.

Please note: As the eaves form part of the exterior structure of the building, this defect may be covered by the owners corporation. Your own enquiries should be made to determine whether this is the case.

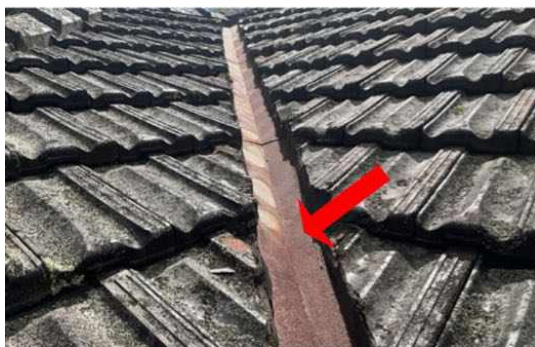
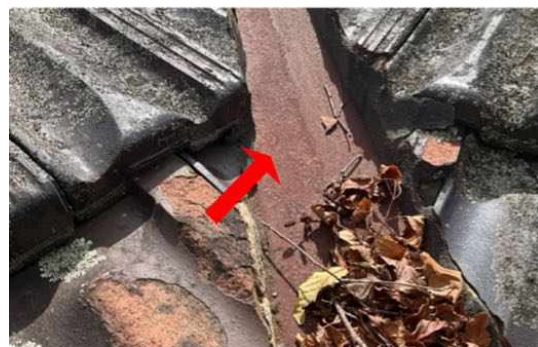
If left unmanaged, this can lead to holes developing and potential water ingress to the internal roofing structures - leading to secondary damage of building elements. Accelerated deterioration of the valley channels and any associated building elements is also likely to occur.

A roofing contractor should be appointed to assess the damage and to perform remedial works as necessary. Works may include replacement of severely affected areas or minor works such as the application of rust-retardant surface protectors.

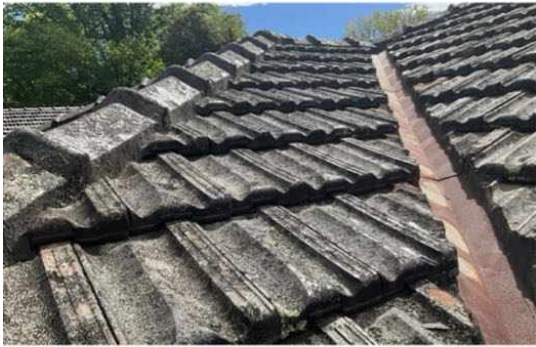
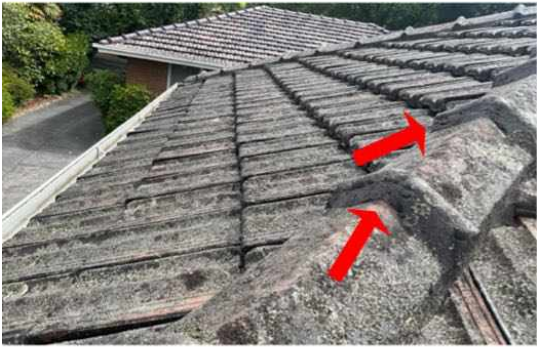
Finding 3.28

Repairs to the roof is required.

Consultation with a roofing contractor is advised to gain advice on remedial works that will be required . Where left unmanaged, damage can lead to a number of secondary defects, including water leaks and weather exposure to internal roofing structures.

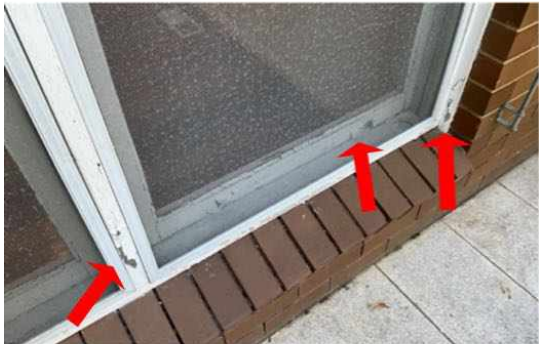
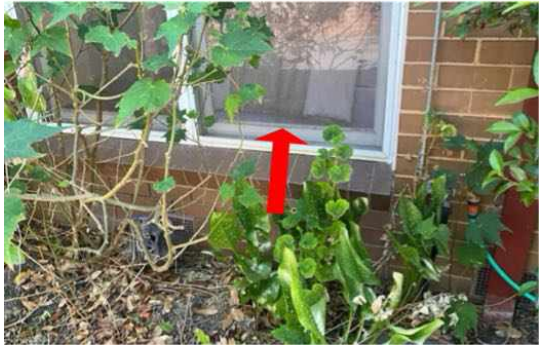
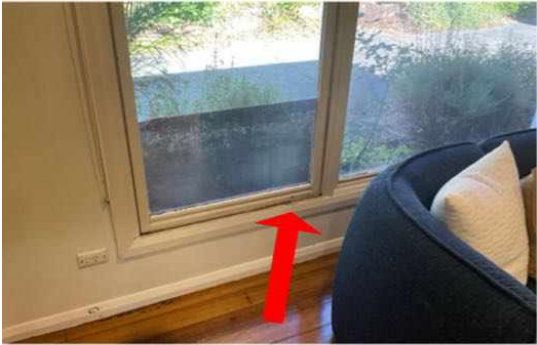
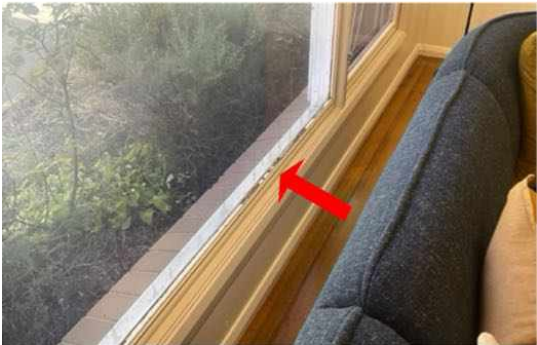
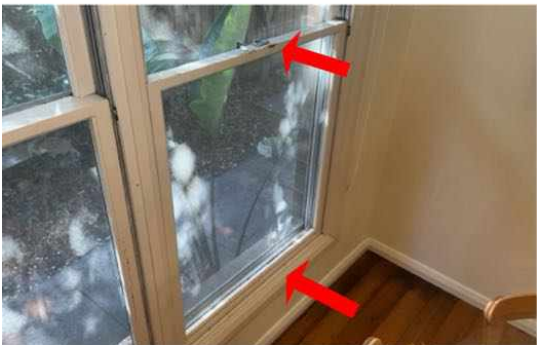
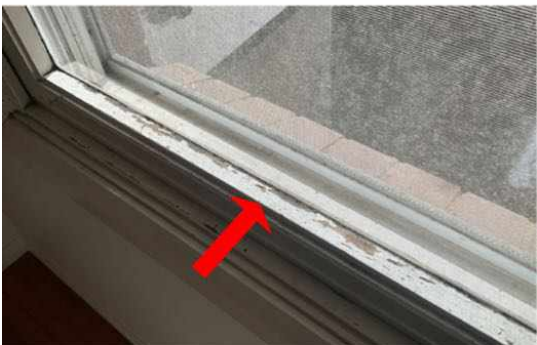
Finding 3.30

Timbers that are frequently exposed to harsh weather conditions require adequate protection in order to maintain their condition. Where timbers have not been painted or treated adequately, general deterioration is likely to occur at an accelerated rate.

If left unattended, replacement of these timbers is likely to be necessary in the short-term future. Adequate treatment of these timbers is required as soon as possible by a painting contractor or general handyman.

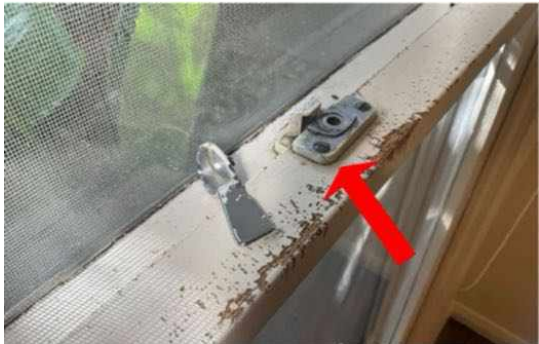
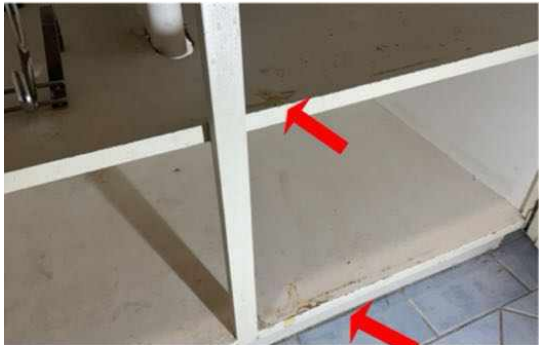
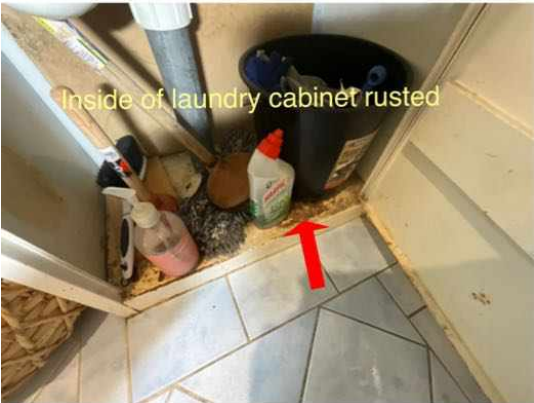
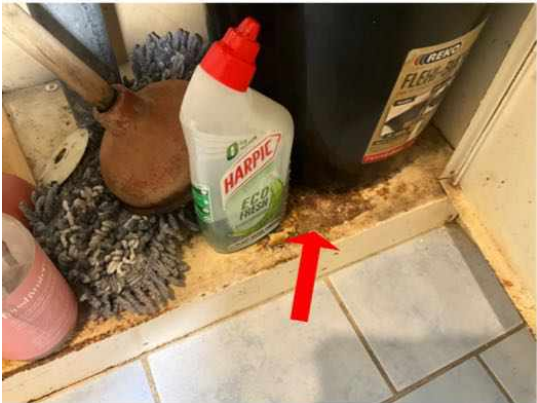
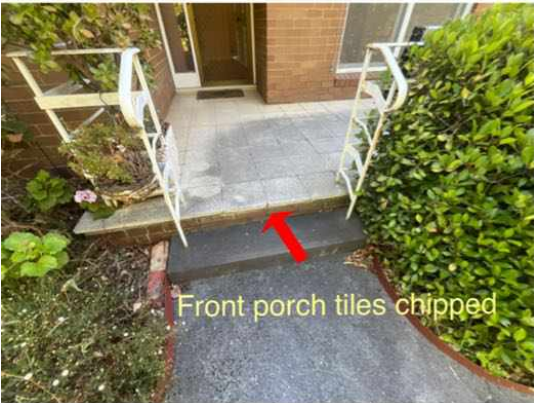
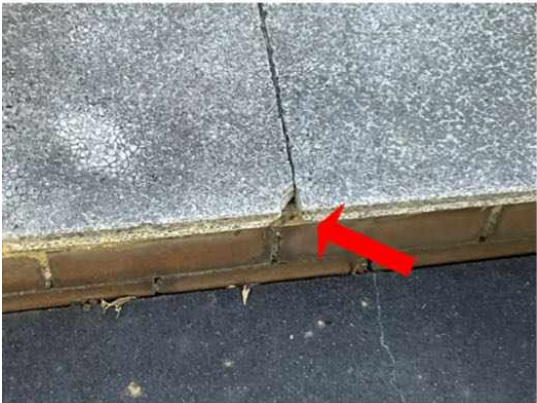
Finding 3.31

Building:
Location: All Areas
Finding: Additional Photos - minor defects
Information: Additional photos are provided for your general reference. Arrows have been included where necessary to highlight areas of importance.

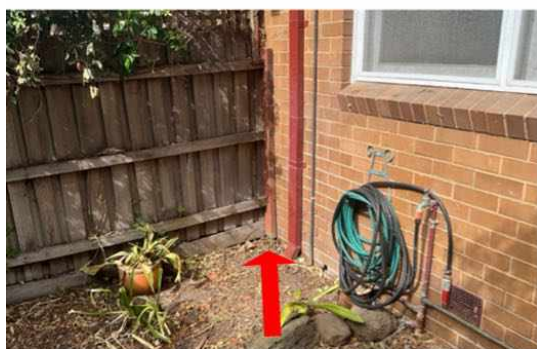
When met with excessive moisture, timber begins to decay and develop wood rot. Any timbers that are in direct contact with external grounds especially if left untreated or non-durable also provide ingress for subterranean termites into that particular element.

Where possible, the removal of any such materials that may be conducive to termite activity should be carried out as soon as possible to minimise the risk of termite attack. Where not possible or practical, regular monitoring of timber elements is recommended. Replacement of any damaged materials should be carried out where necessary.

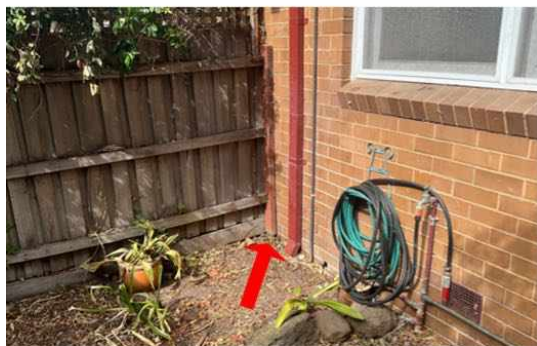
Generally fungal decay develops on timber elements that are in use in an external environment which are exposed to rain penetration.

Decaying timbers can create an environment conducive to timber pest attack. It is recommended that the decaying timbers be repaired / replaced to lessen the risk of timber pests.

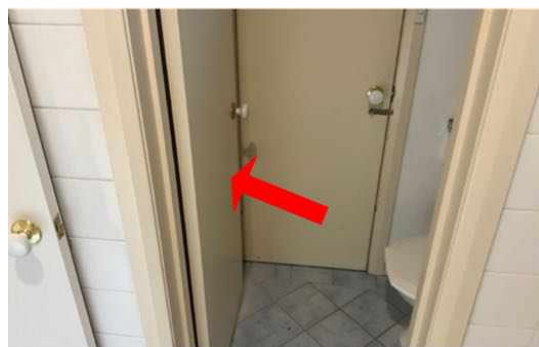
Building:
 Location: All Areas
 Finding: Additional Photos for your information - toilet and bathroom door hit each other
 Information: At the time of inspection, it was noted that the toilet and the bathroom door hit each other when they were both opened.

This item is more of a design feature issue and is listed for your information only.
