Building and Timber Pest Inspection Report

Inspection Date: Tue, 3 Feb 2026

Property Address: 80 Hamilton Ave, Earlwood NSW 2206,
Australia

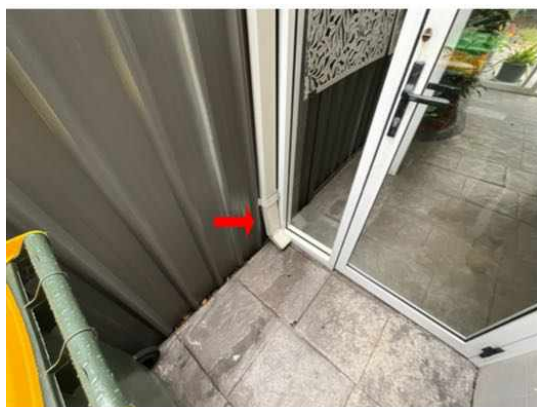
Finding 3.01

Building:	Main Building
Location:	Exterior walls
Finding:	Stormwater drain - Not connected
Information:	The roof plumbing is not adequately connected to stormwater drainage on the site. This disconnection negatively impacts the functional capacity of the roof plumbing. Where roof plumbing doesn't drain adequately, the area at the base perimeter can become excessively damp, potentially creating an environment that is susceptible to rust and corrosion of surrounding building elements, as well as attracting termites and other pests. It is highly recommended that a plumber be appointed to further inspect the area and to install adequate drainage equipment where necessary.

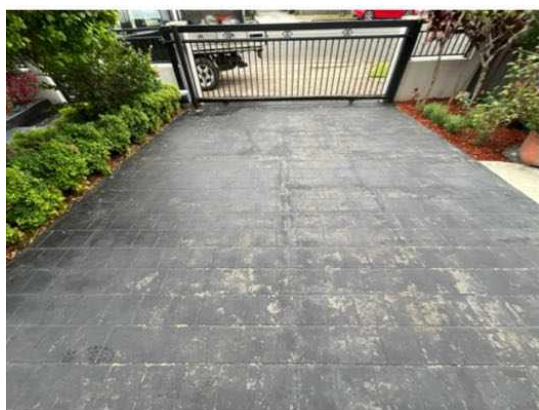
Finding 3.02

Building:	Yard
Location:	Pathway
Finding:	Cracking - External Concrete Paving Damage Category 1 - Fine (less than 2mm)
Information:	Fine cracks were identified in external concrete paving. Although fine cracks are quite noticeable, they are often only considered to be an appearance defect, and usually do not indicate any structural damage. To be considered a Category 1 or fine crack, the

crack is found to be less than 2mm in width.

Generally the cause of a hairline crack in existing concrete paving such as driveways and pathways is indicative of the expansion and contraction of the concrete. Such causes are generally due to environmental factors, such as moisture levels, weather conditions, root systems of nearby trees or the soil types on which they are laid.

Fine cracks may also be due to poor original installation of the concrete. Factors such as poor compaction of the sub surface and/or inadequate reinforcing of the slab may create cracking and other secondary defects.

Monitoring of all cracking should be conducted frequently. Always contact a building inspector should cracks widen, lengthen, or become more numerous.

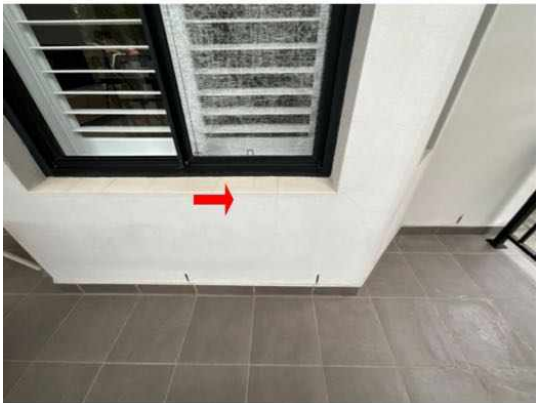
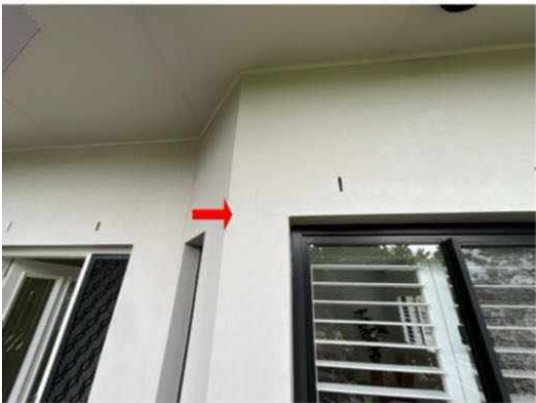
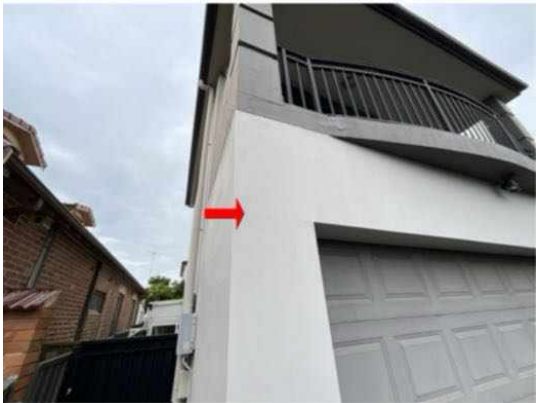
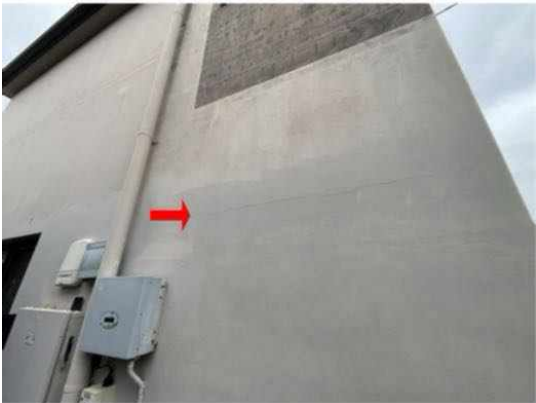
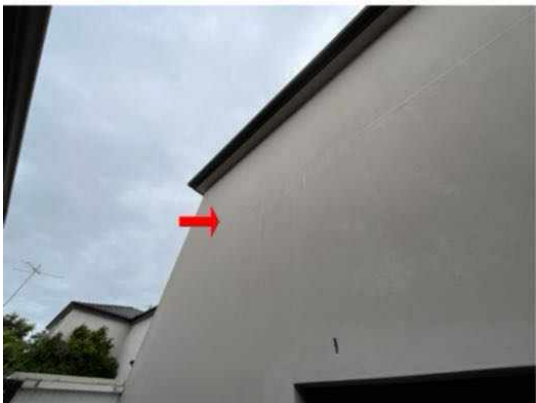
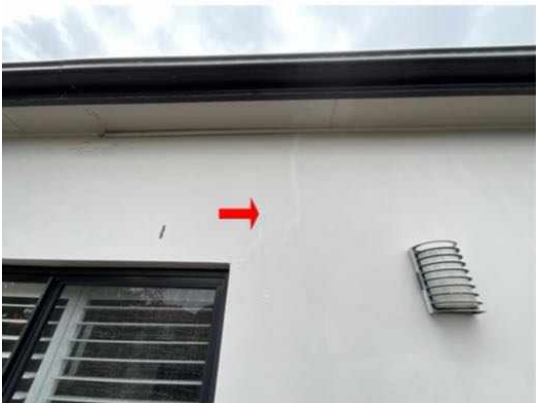
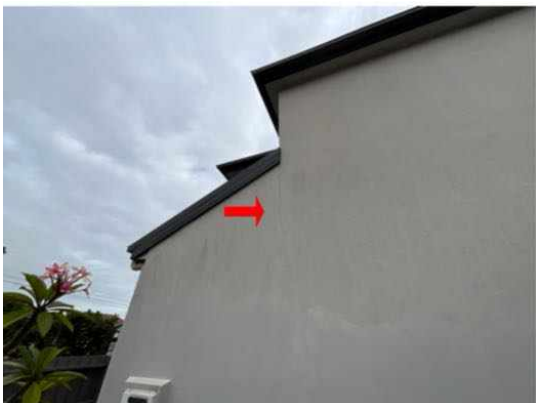
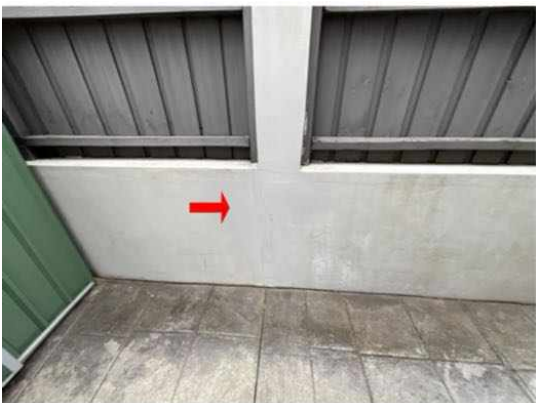
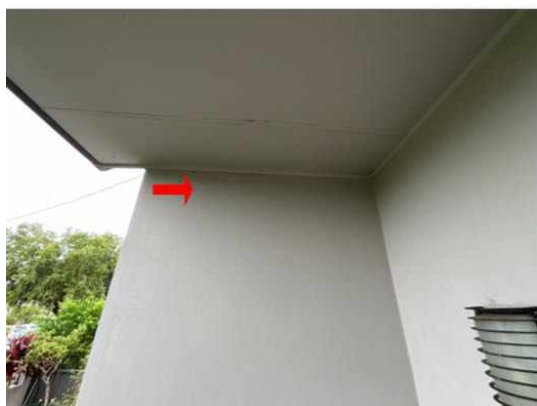
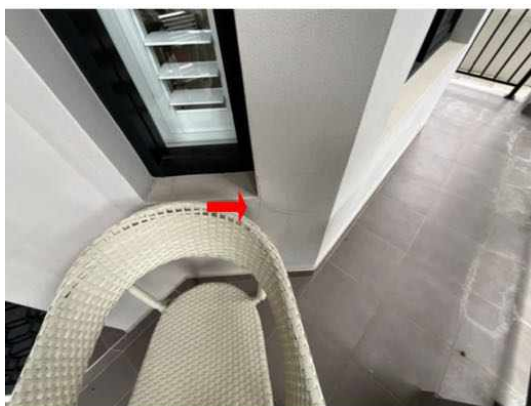
Finding 3.03

Building:	Main Building
Location:	Exterior walls
Finding:	Cracking - Damage Category 2 - Noticeable (up to 5mm)
Information:	Noticeable cracks are a common occurrence as a result of many primary defects. Such causes may include age, general wear and tear, expected building movement, general expansion/contraction of building materials in different weather conditions, and/or minor failings in the installation or application of building materials.

I recommend monitoring and if further cracking is evident appoint a bricklayer to see what works are required.

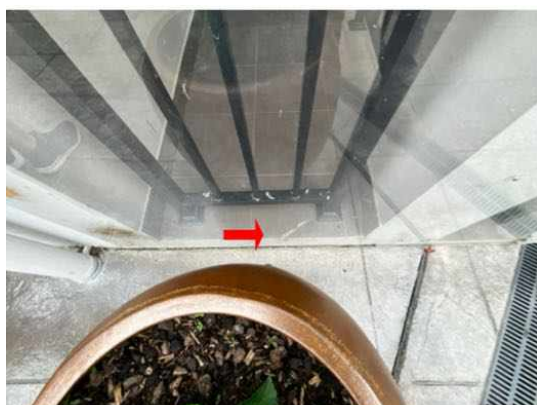
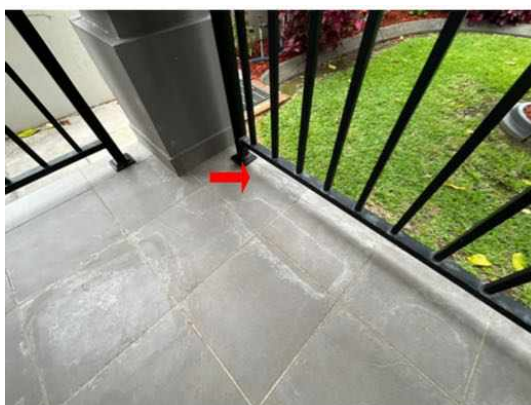
Finding 3.04

Building:	Main Building
Location:	External Tiled Areas
Finding:	Tile - Cracked or damaged
Information:	Cracking was evident to the tiling in this area at the time of inspection.

I recommend appointing a tiling contractor to see what necessary works are required to replace any damaged tiles.

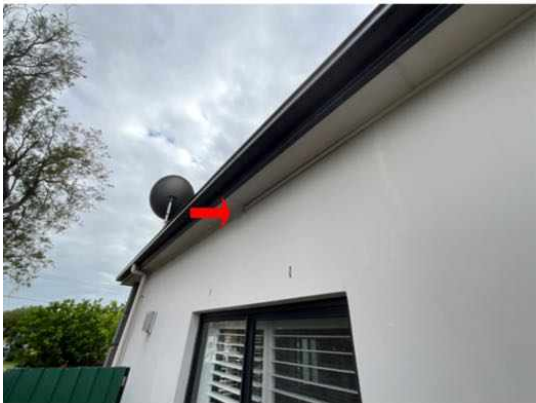
Finding 3.05

Building:	Main Building
Location:	Eaves
Finding:	Nails - Popping
Information:	Popped nails were identified at the time of inspection. Nails and screws are held by the friction between them and the surface that they are applied to. Over time, the nails and screws can back out, which is often a result of general ageing and deterioration of the building structure.

Re-fastening of popped nails will help to maintain the stability of these, and associated, building elements. Such minor works will also help to improve the appearance of the affected area and secure the linings. These works should be performed by a qualified

carpenter at client discretion.

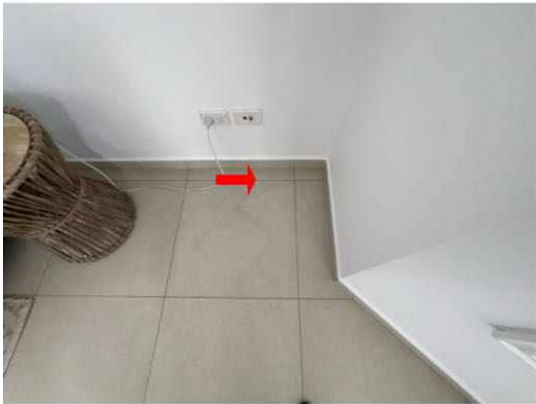
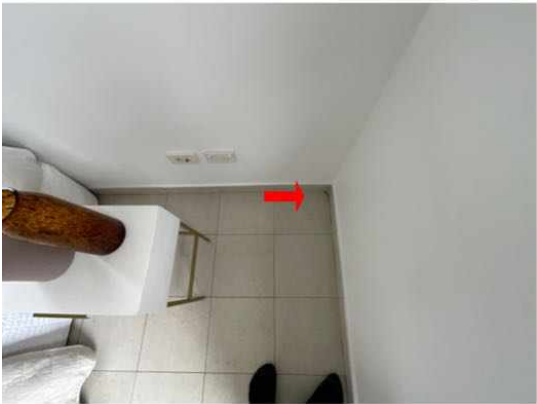
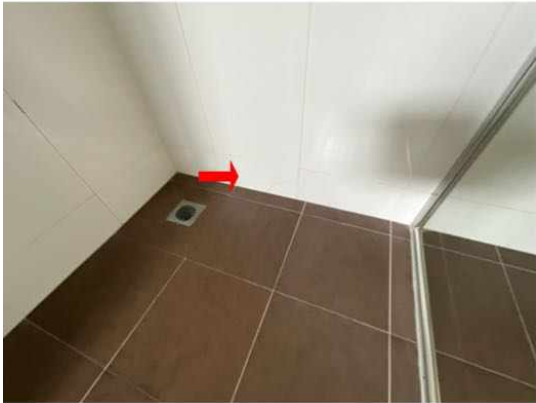
Finding 3.06

Building: Main Building
Location: Internal Areas
Finding: Tile - Cracked or damaged
Information: Cracking was evident to the tiling in this area at the time of inspection.

I recommend appointing a tiling contractor to see what necessary works are required to replace any damaged tiles.

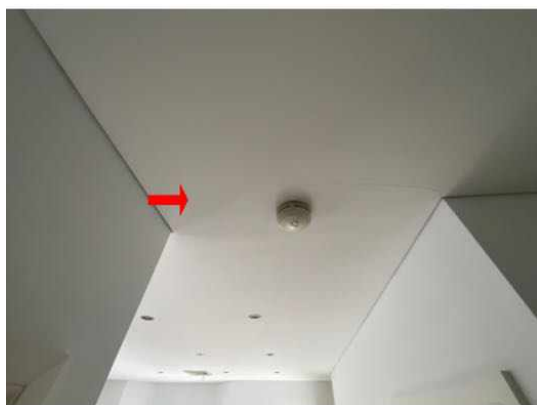
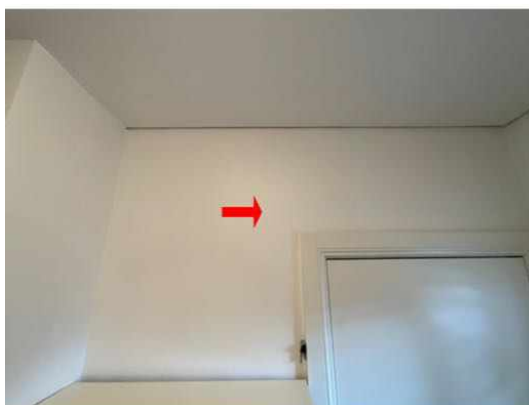
Finding 3.07

Building:	Main Building
Location:	Internal Areas
Finding:	Cracking - Damage Category 1 - Fine (up to 1mm)
Information:	Although fine cracks are quite noticeable, they are often only considered to be an appearance defect, and usually do not indicate any structural damage. Generally, the cause of a fine crack is indicative of a separation between building materials and finishes (e.g. paint, plaster, etc.) along joins.

Cracking of this nature can generally be repaired with minor sanding, filling and/or repainting. Such works should be performed by a qualified painter or a general handyman.

Monitoring of all cracking should be conducted frequently. Always contact a building inspector should cracks widen, lengthen, or become more numerous.

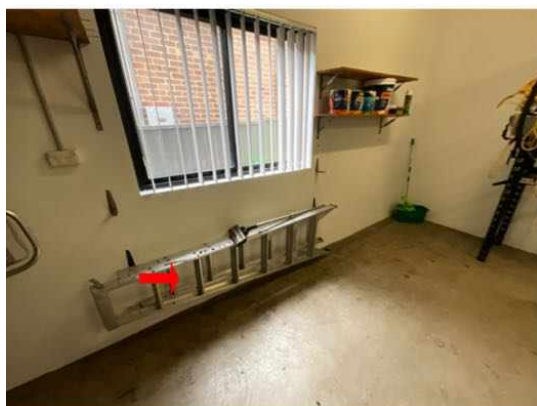
Finding 3.08

Building:	Main Building
Location:	Garage
Finding:	Painted surface - Bubbling
Information:	Sections of paint in this area was found to have bubbled and deteriorated. Paint bubbling is generally an indication of excessive moisture in the area past or present.

Although there was no moisture detected in the wall I would recommend monitoring this area.

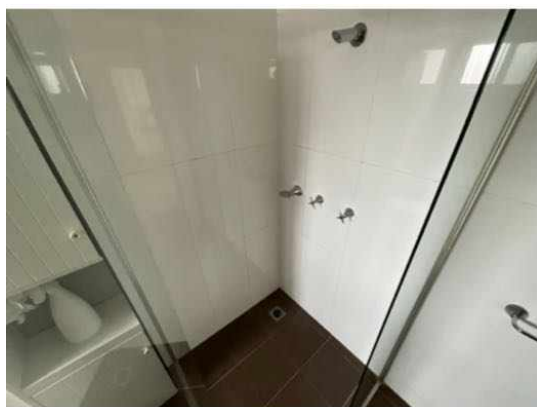
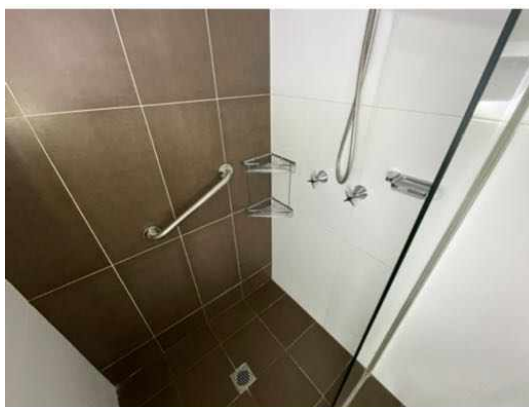
Finding 3.09

Building:	Main Building
Location:	Bathroom & Ensuite
Finding:	Grout - Missing
Information:	Grout is missing in this area. Grout is used to protect gaps and crevices in building materials to ensure that they are water-tight and prevent water penetration to the associated structures.

Where grout is missing, a tiling contractor should be appointed immediately to apply grout and re-apply any silicone where necessary. Failure to do so is likely to lead to water damage to the surrounding area.

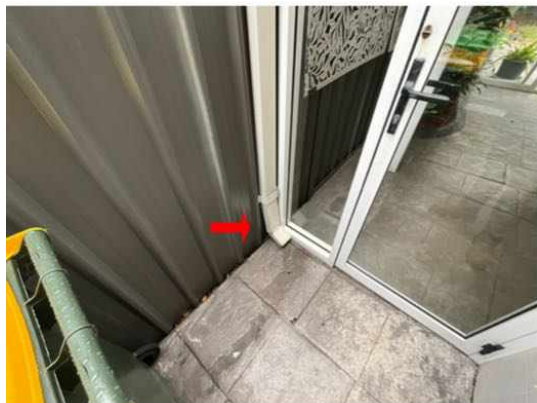
Finding 6.01

Building:	Main Building
Location:	Exterior walls
Finding:	Excessive moisture - identified
Information:	Excessive moisture can attract termites and produce conditions that promote fungal growth and wood decay. Prior to any remedial works being performed a qualified plumber should be appointed to further inspect the property and to identify the cause of the excessive moisture.

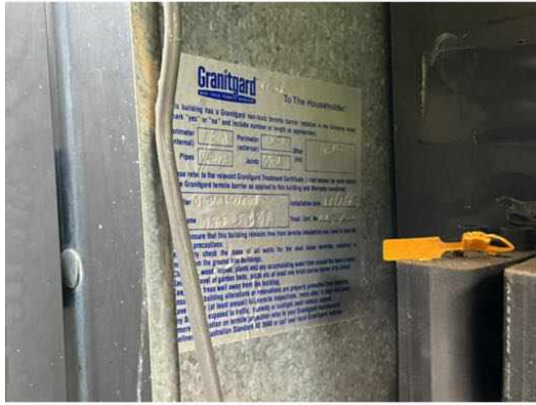
Noted Item

Building:	Main Building
Location:	All Areas
Finding:	Evidence of a previous termite management system was identified
Information:	There are a number of factors which indicate the presence of a previously installed or applied termite barrier. The most common are a durable notice (to the inside of your meter box) observable physical barriers installed to building perimeter and in ground reticulation systems.

Where a Termite Management System has been identified you should refer to the type of barrier date of installation warranty conditions and any documentation provided by a builder or past owner. Consult the company who installed the barrier to confirm whether the system is still under warranty.

Most chemical termite management systems expire and require replenishment and all physical systems are primarily designed to prevent concealed entry.
