Building and Timber Pest Inspection Report

Inspection Date: Mon, 19 Jan 2026

Property Address: 1051 Invergordon Rd, Invergordon VIC
3636, Australia

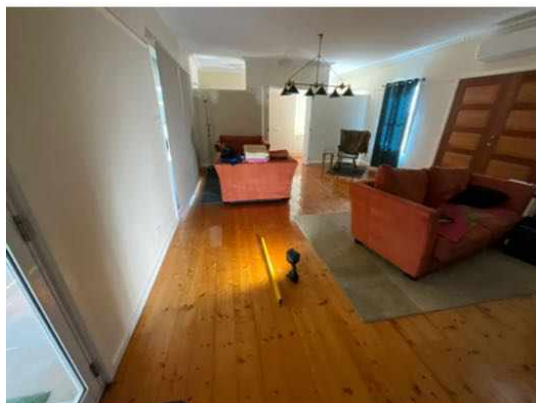
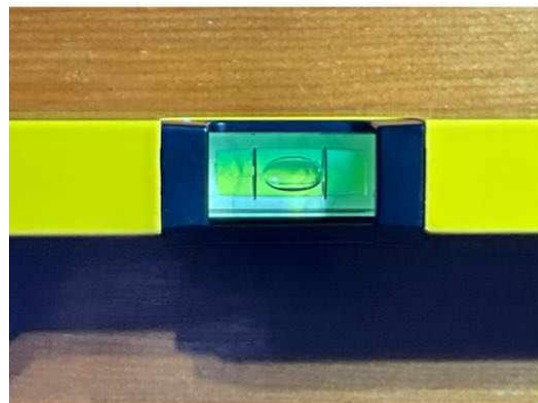
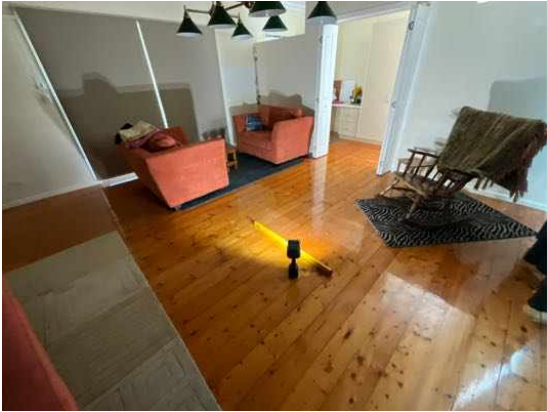
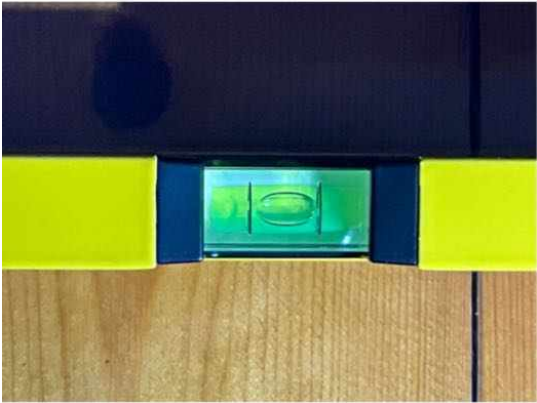
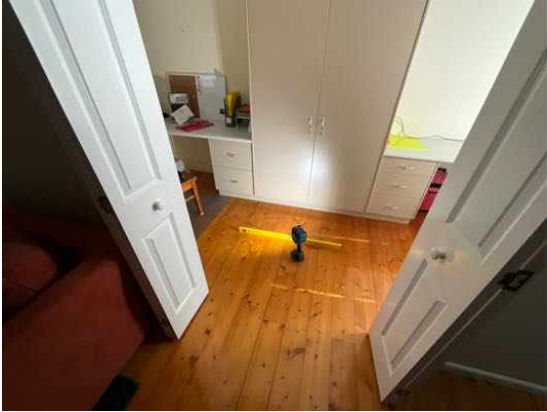
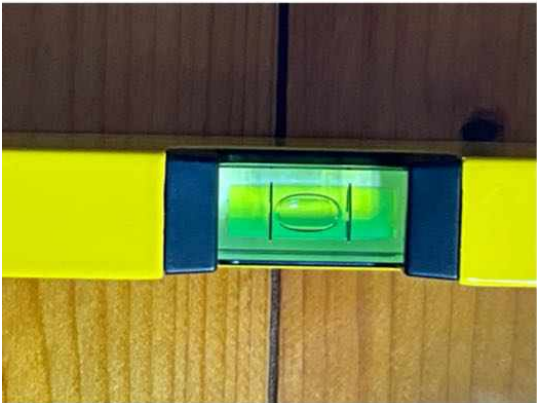
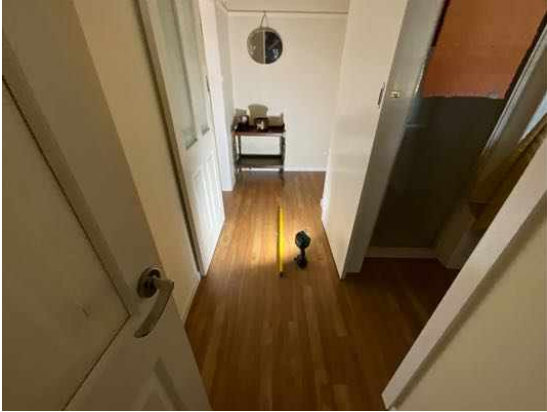
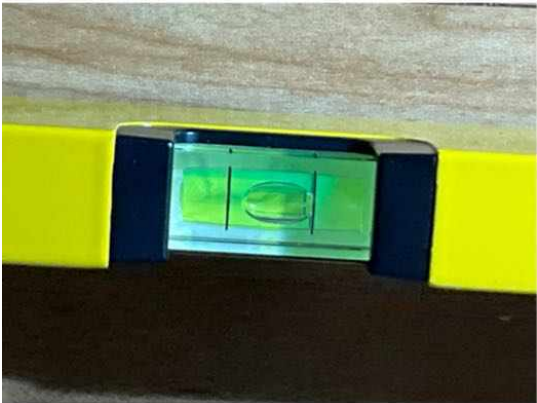
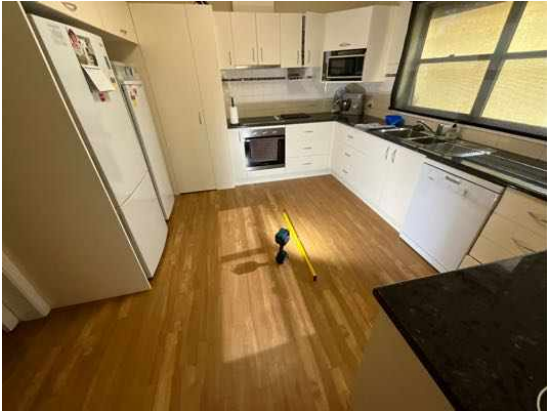
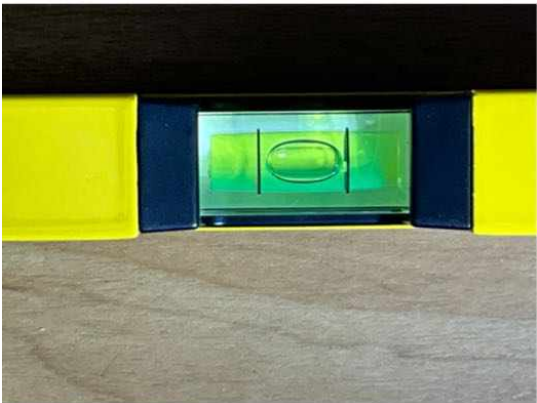
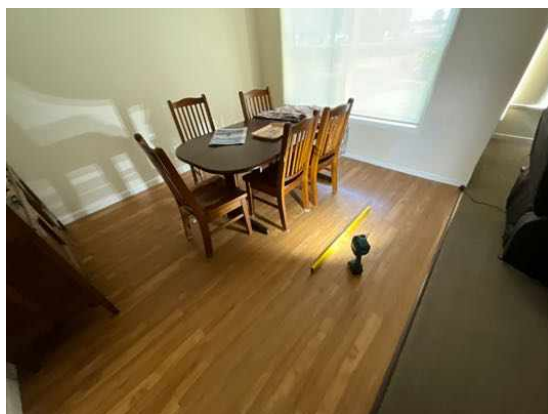
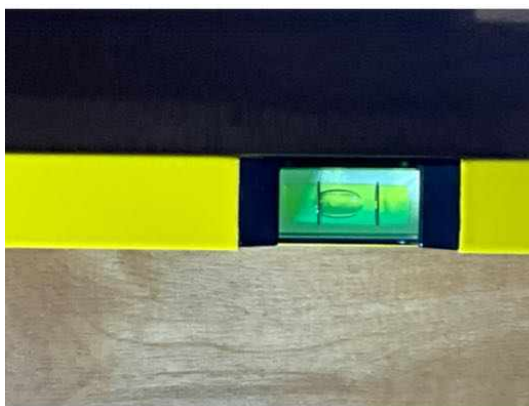
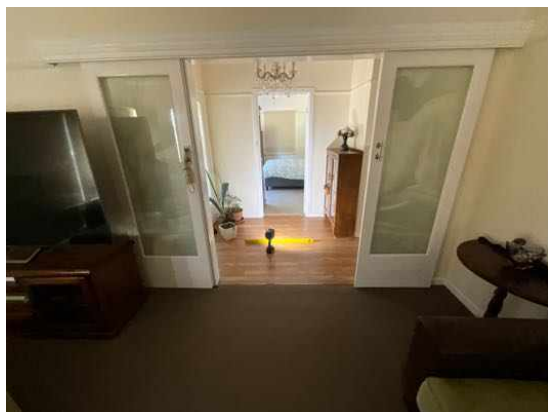
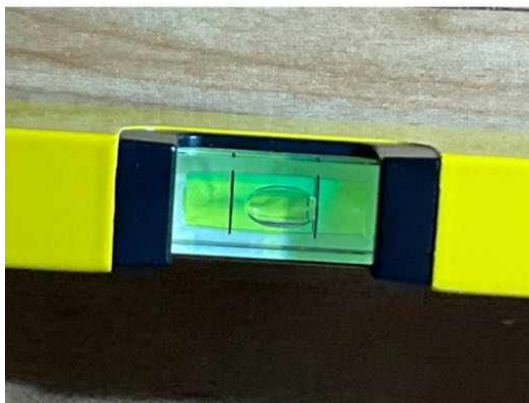
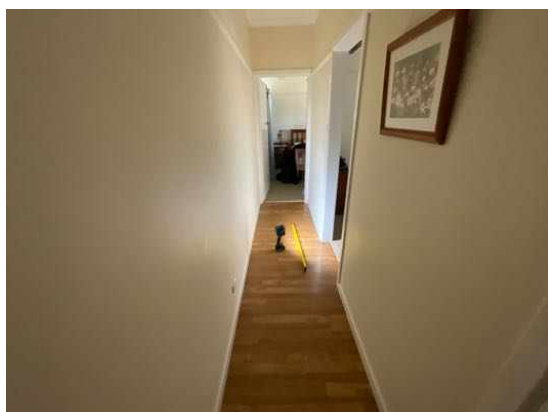
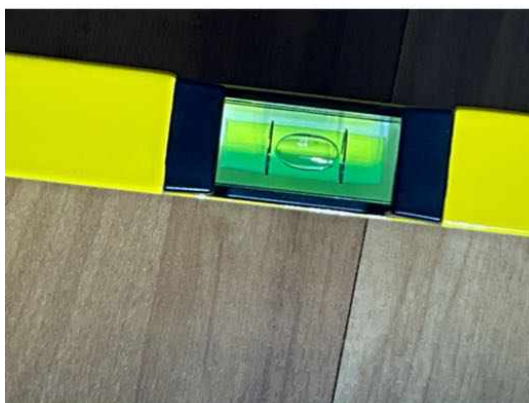
Finding 3.01

Building: Building 1
Location: All Internal Areas
Finding: Flooring - Uneven
Information: The internal flooring in this area is out of level and uneven. Uneven flooring is likely to indicate minor defects such as expected movement of the foundations of the property, but may also indicate subsidence of the associated subfloor stumps.

It is advised that the flooring be closely monitored to identify any further movement. Where flooring remains relatively unchanged for an extended period of time (i.e. several months), it is likely that this defect has been caused by expected movement of the foundations of the property.

However, where flooring is uneven further, potentially invasive inspection of the subfloor structures and stumps in this area is required. In this case, works to repair are likely to be required, and would be carried out by a registered builder specialising in re-stumping.

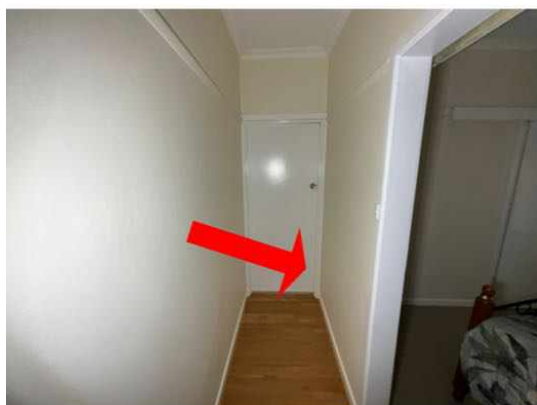
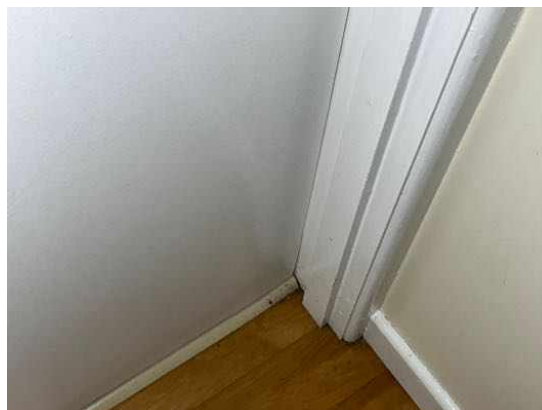
Finding 3.02

Building: Building 1
 Location: Bedroom 3
 Finding: Door- Binding
 Information: Binding and/or jamming of this door is evident during standard operation. This defect inhibits the functionality of the affected door as well as creating potential for secondary defects to associated building elements, such as damage to the floor covering.

A door that binds to flooring or to the associated door frame may have several causes, ranging from minor defects, such as poor installation of the door or deteriorated hinges, through to major structural issues, such as damage to subfloor structures.

A qualified carpenter or general handyperson should be appointed to perform minor rectification works at client discretion.

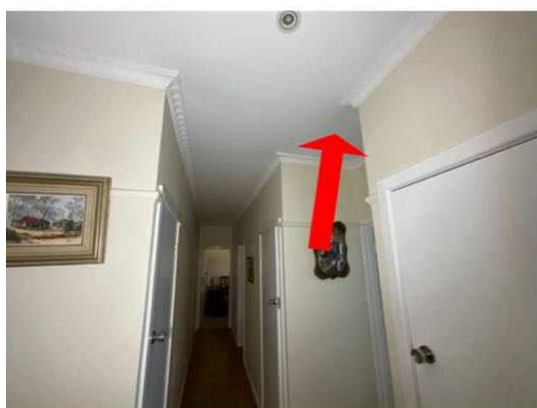
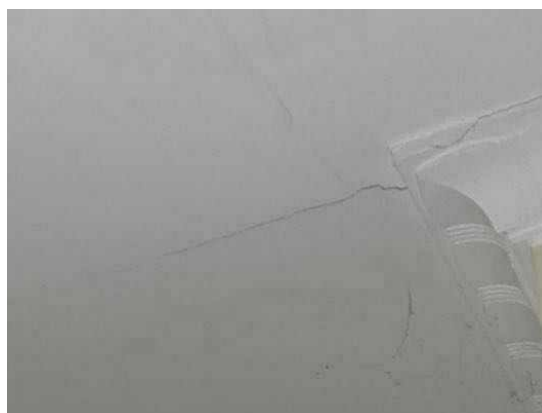
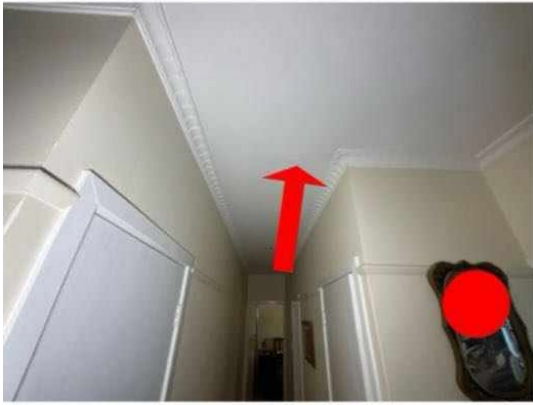
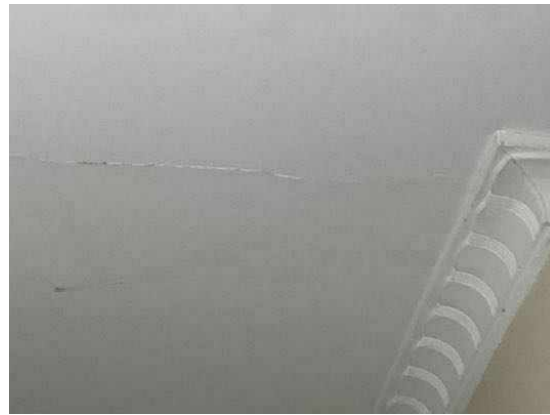
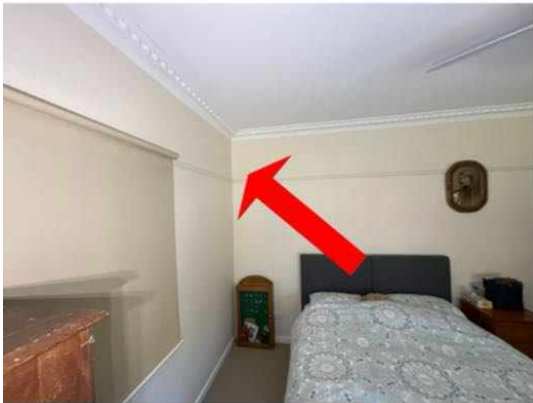
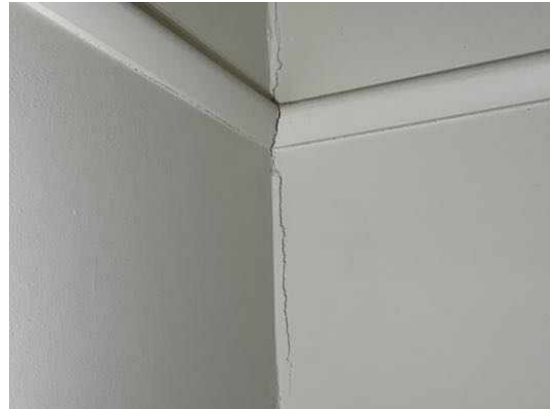
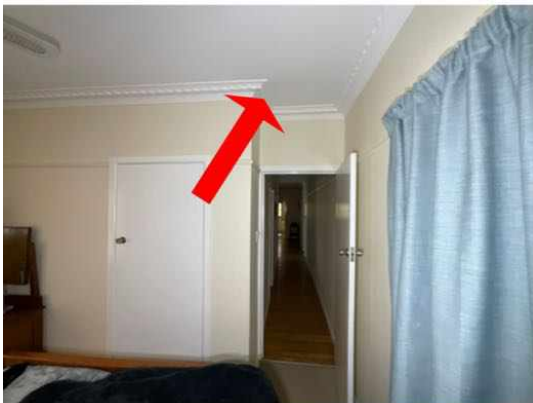
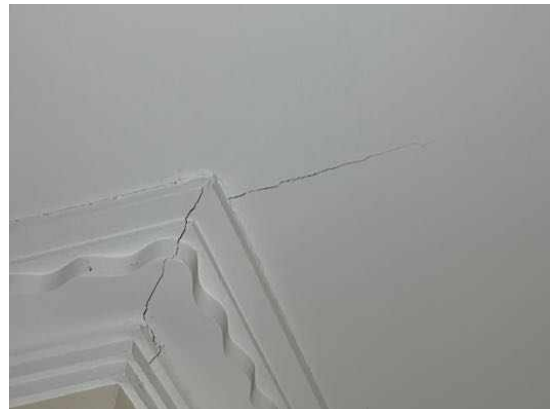
Finding 3.03

Building:	Building 1
Location:	Hallway, bed 1,3
Finding:	Cracking - Damage Category 1 - Fine (up to 1mm)
Information:	Although fine cracks are quite noticeable, they are often only considered to be an appearance defect, and usually do not indicate any structural damage. Generally, the cause of a fine crack is indicative of a separation between building materials and finishes (e.g. paint, plaster, etc.) along joints.

Cracking of this nature can generally be repaired with minor sanding, filling and/or repainting. Such works should be performed by a qualified painter or a general handyman.

Monitoring of all cracking should be conducted frequently. Always contact a building inspector should cracks widen, lengthen, or become more numerous.

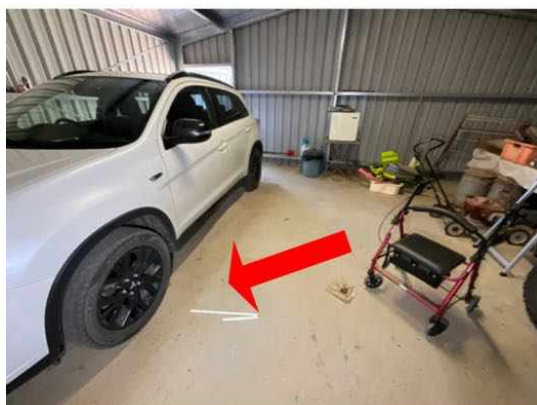
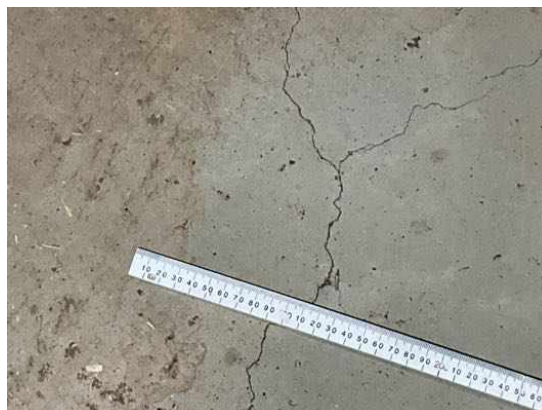
Finding 3.04

Building: Building 1
 Location: Garage
 Finding: Crack in concrete slab - Category 1
 Information: A crack coded as Category 1 was identified in the slab. A Category 1 crack is described as a fine but noticeable crack, with the slab at an otherwise reasonable level.

To be considered Category 1, the approximate width of the crack is less than 1.0mm, or a less than 10mm change in offset when a 3m straight edge is placed over the defect.

Category 1 cracks should be monitored for a period of 12 months. At the end of the monitoring period, identified cracks that are rated greater than Category 2 are considered defects, and require rectification.

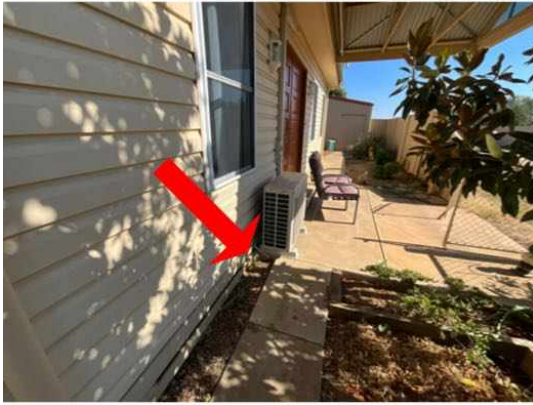
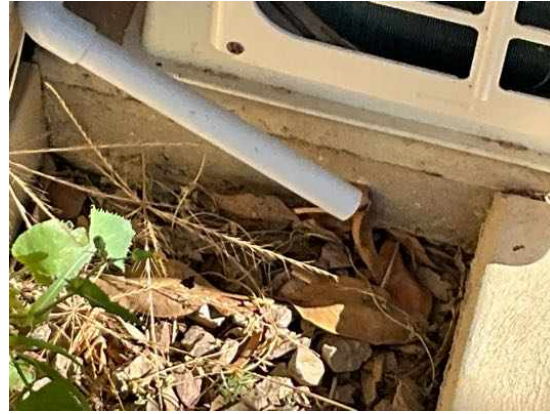
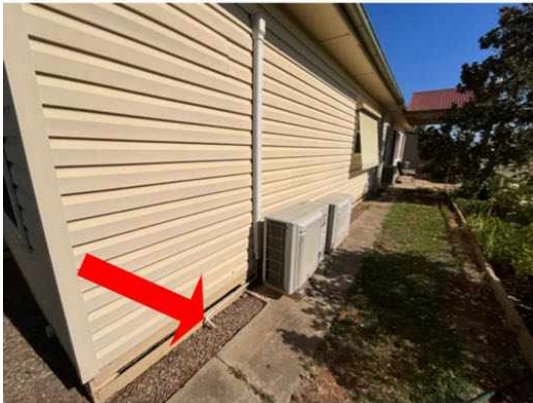
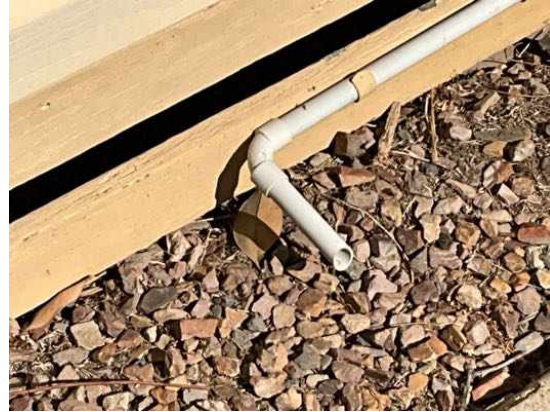
Finding 6.01

Building: Building 1
 Location: Yard - Side
 Finding: Air conditioner - Disconnected overflow
 Information: The Air Conditioner (A/C) overflow was found to be disconnected from storm water drainage and is creating excessive moisture in the surrounding area.

Such leaking creates an environment which is conducive to an array of defects, including water damage to associated building elements and the attraction of termite or timber pest infestation.

It is highly recommended that a licensed plumber be appointed to connect the A/C overflow in order to prevent such an environment from being created. These minor works should be carried out as soon as possible.

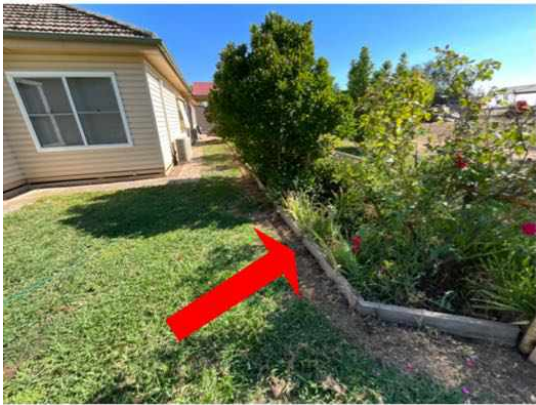
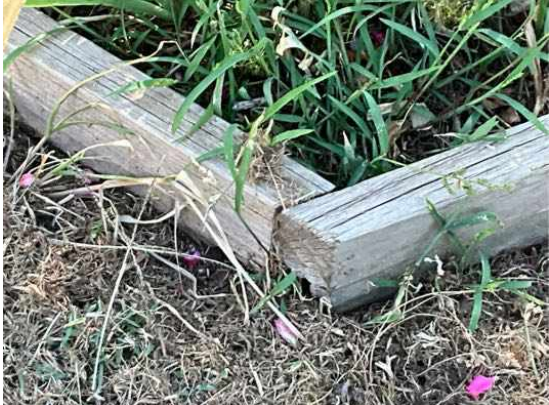
Finding 6.02

Building:	Building 1
Location:	Yard - Front
Finding:	Untreated or non-durable timbers in a hazardous environment
Information:	To reduce the risk of timber pest attack it is essential that timber used in a hazardous environment (e.g. in direct contact with the ground or frequently exposed to damp conditions) is of sufficient durability and/or is adequately preservative treated.

Untreated timbers in direct contact with the ground are likely to develop severe wood rot and/or fungal decay if left unattended creating attraction for subterranean termites to infest the timbers from surrounding areas.

If untreated or non-durable timbers are found to be in a hazardous environment it is highly advised that replacement of these building elements be performed as soon as possible to aid the protection of the property against termite / timber pest attack.

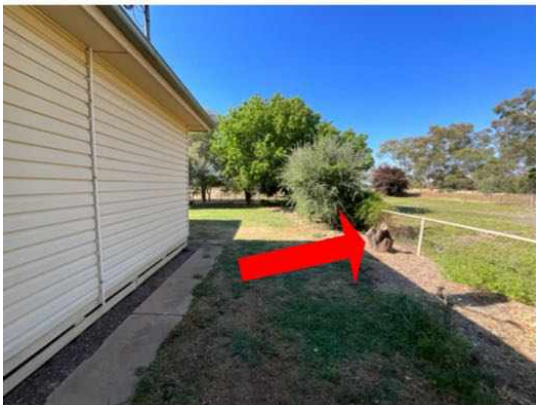
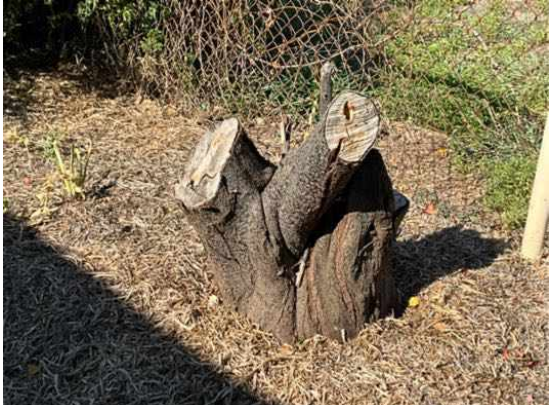
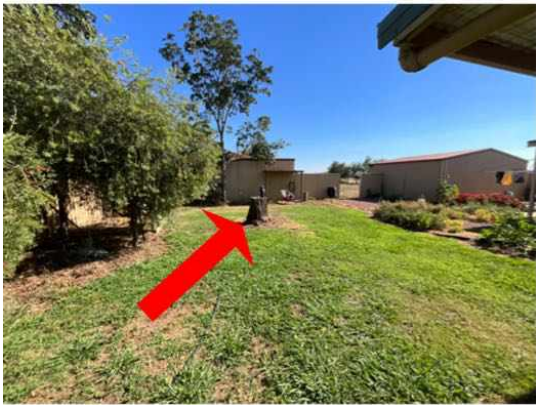
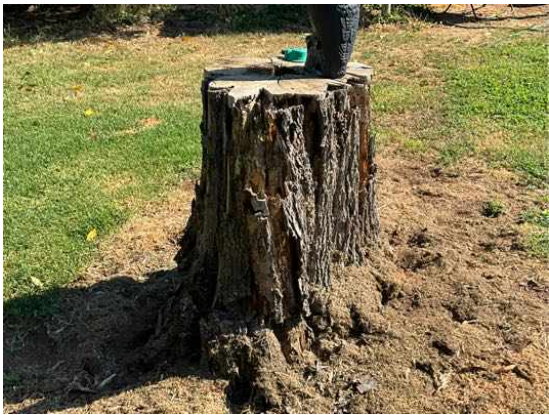
Finding 6.03

Building: Building 1
Location: Yard - Side, back
Finding: Tree Stump in Ground
Information: Any tree stumps in the yard not removed during the tree removal process provides the opportunity for Termite infestation and is likely to be subject to decay from damp conditions against the stump.

All tree stumps should be removed by professional tree removal services where possible. Meanwhile regular inspections are advised to identify any termite activity in the areas identified.

Services for tree stump removal should be contacted as soon as possible to reduce the risk of timber pest attack.

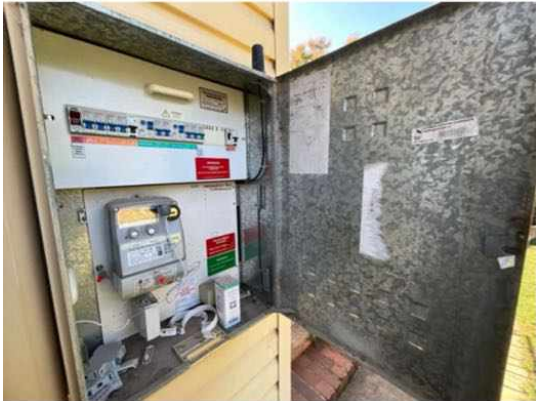
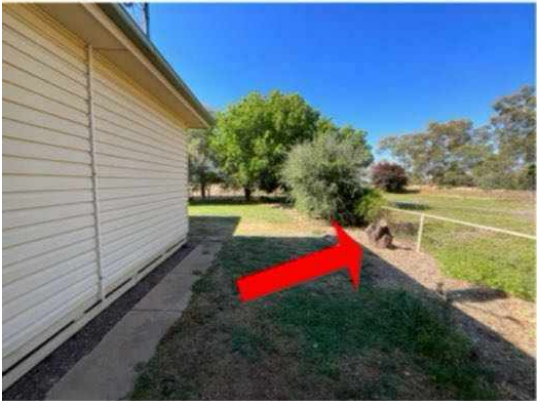
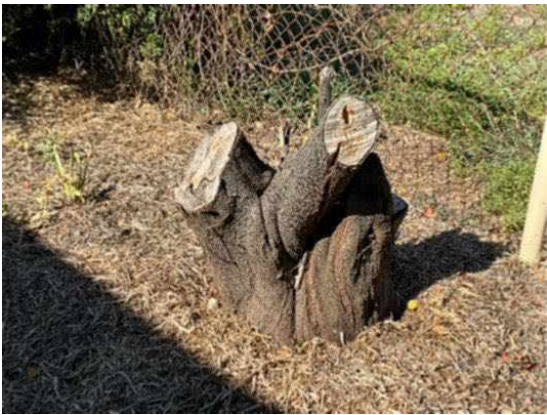
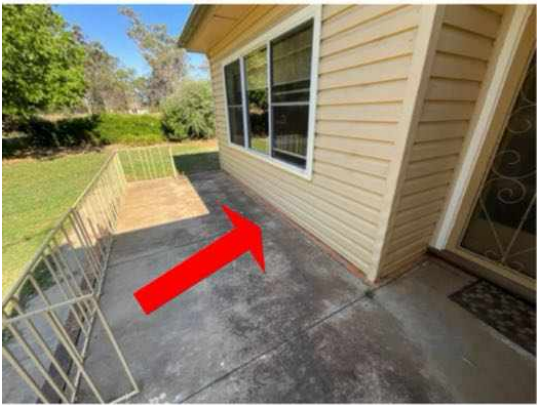
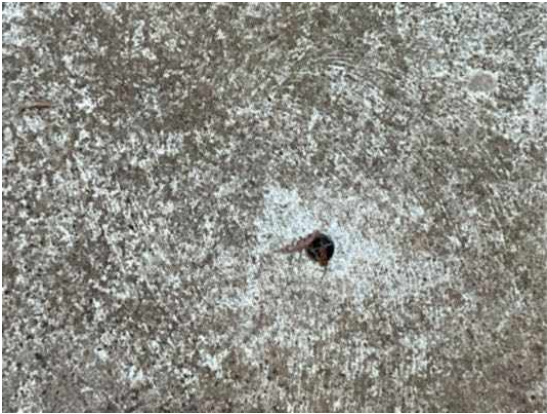
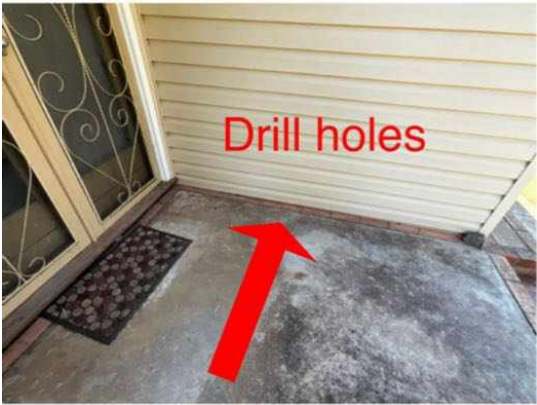
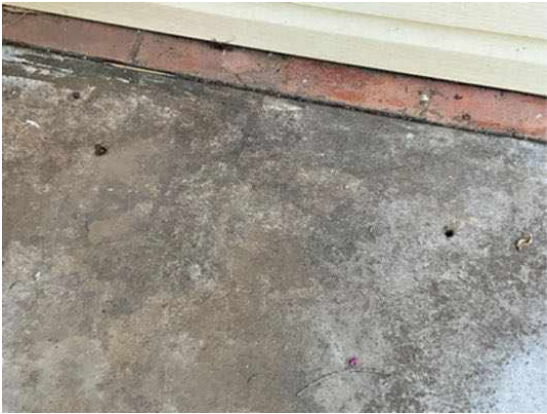
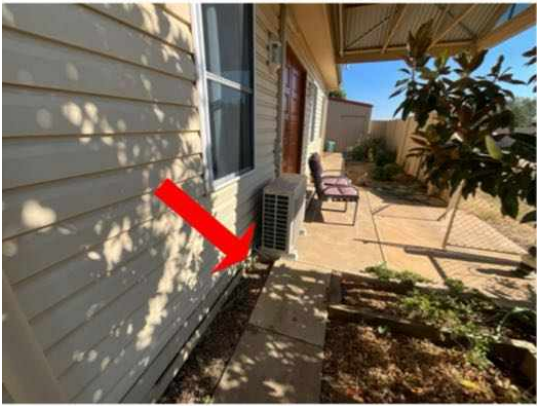
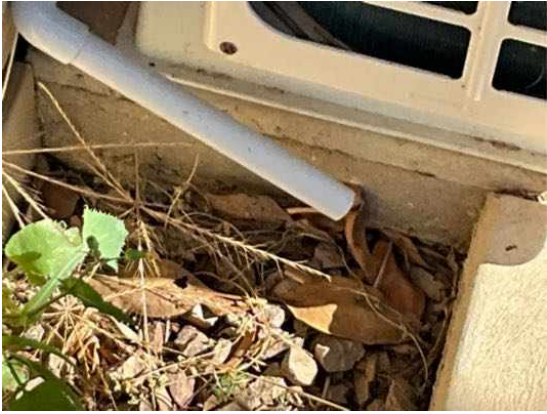
Finding 6.04

Building: Building 1
Location: All External Areas
Finding: Termite Management System- evidence of a chemical installation
Information: The application of a post-construction chemical termite barrier is highly recommended for all properties, particularly if live termite activity has been found on the site previously. Such barriers are highly effective in preventing termite attack on any timber building elements throughout the property.

A durable notice has been placed in the switchboard unit to indicate current termite barriers. At the time of inspection, it appeared as though a termite management system has been installed. The recency of any treatment cannot be determined.

The client may consider gaining further advice from a pest controller as to the costs and procedures involved with this application. It is recommended that obtaining such advice be a short-term priority.

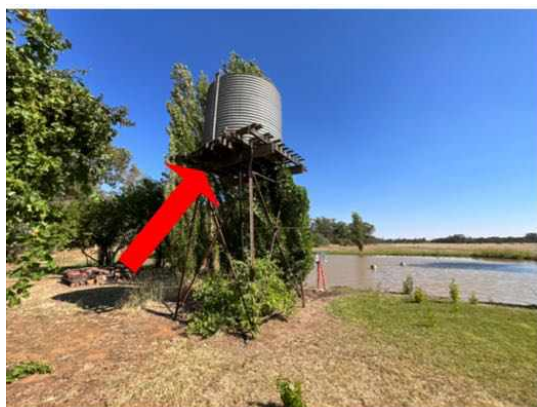
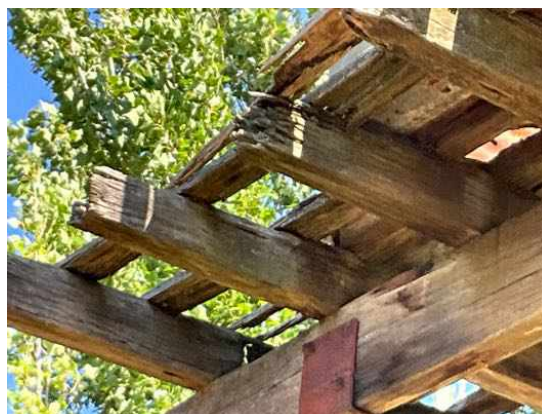
Finding 7.01

Building:	Building 1
Location:	Yard - Back
Finding:	Fungal decay - present (widespread)
Information:	Fungal decay is also known as wood decay or wood rot generally refers to the deterioration of timber elements when in contact with excessive levels of moisture for a prolonged period of time.

The development of fungal decay is accelerated by temperatures in the range of 5degreeC to 40degreeC as well as the presence of oxygen. Generally fungal decay develops on timber elements that are in use in an external environment which are exposed to rain penetration.

In this case, fungal decay appears to have become widespread and is likely to have affected any adjoining timber elements/structures. The widespread development of fungal decay is likely to have heavily impacted the structural integrity and tensile strength of the affected timber elements and the associated structure.

Timbers affected by widespread fungal decay should be replaced immediately. The cause of the moisture that has led to the development of such decay should also be identified and dealt with in an appropriate manner.

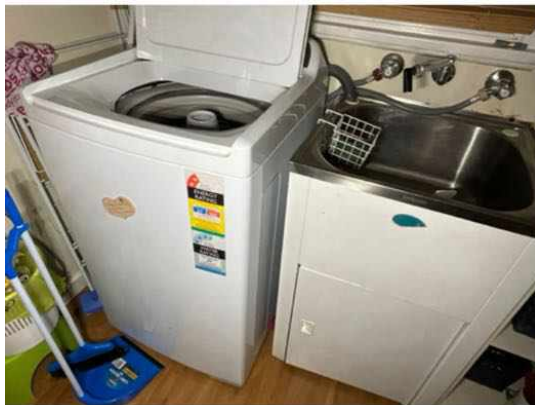
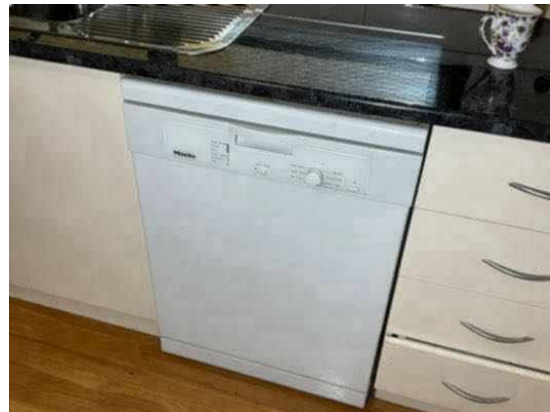
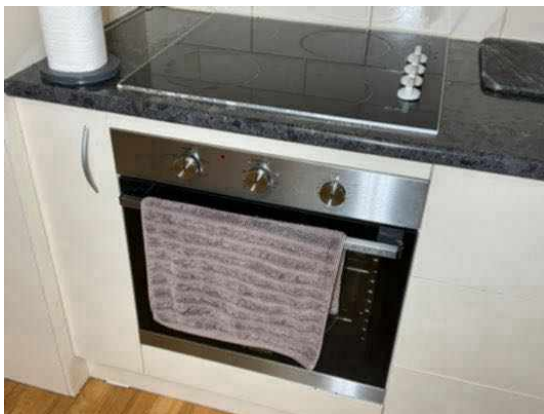
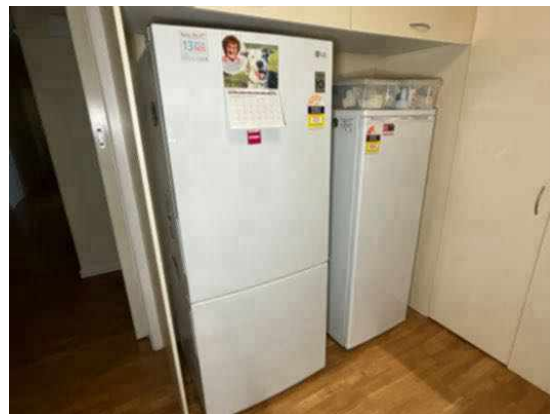
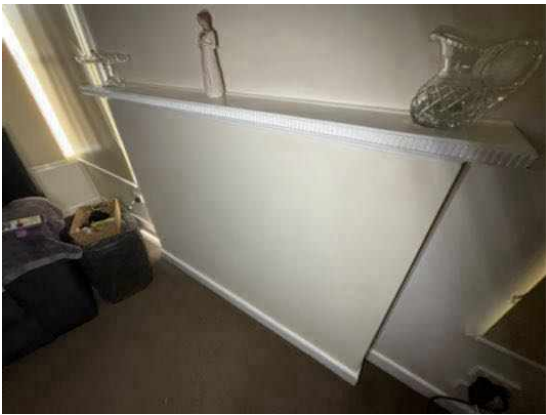
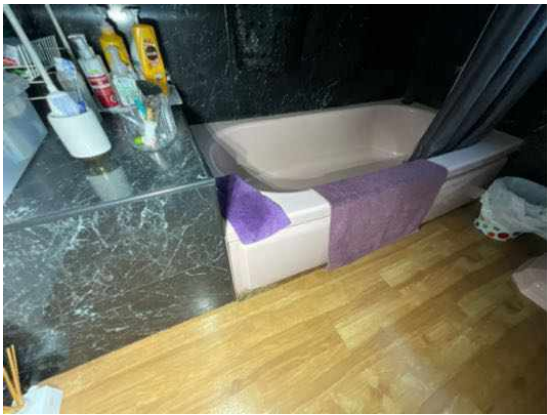
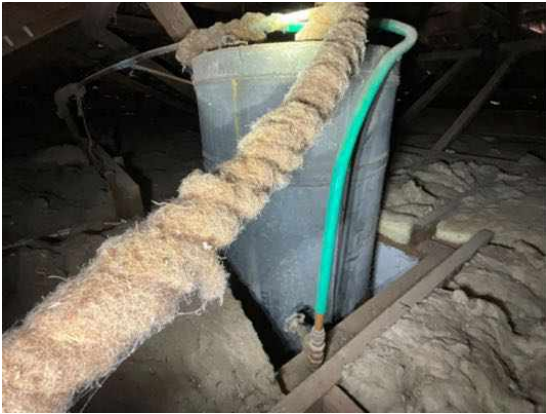
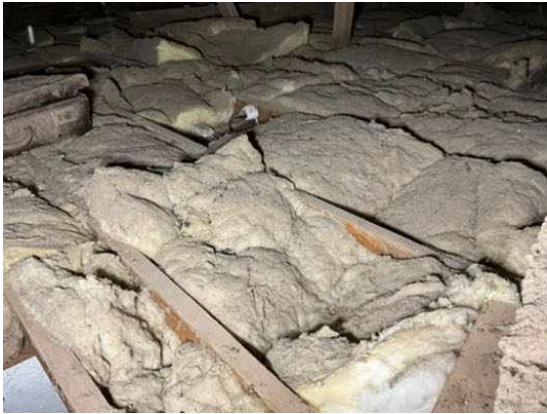
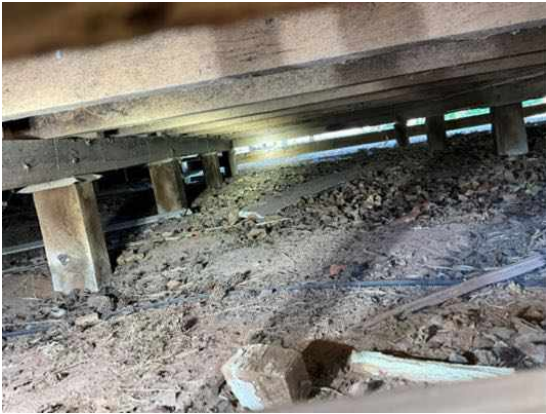
Noted Item

Building: Building 1
Location: All Areas
Finding: Additional Photos - Obstructions and Limitations
Information: These photographs are an indication of the obstructions and limitations which impeded full inspection of the property at the time of inspection. These obstructions can hide an array of defects and should be removed to allow full inspection to be carried out. A re-inspection is recommended once the areas are made accessible.
