Building and Timber Pest Inspection Report

Inspection Date: Sat, 31 Jan 2026

Property Address: 11/9-11 Troy Street, Emu Plains NSW 2750

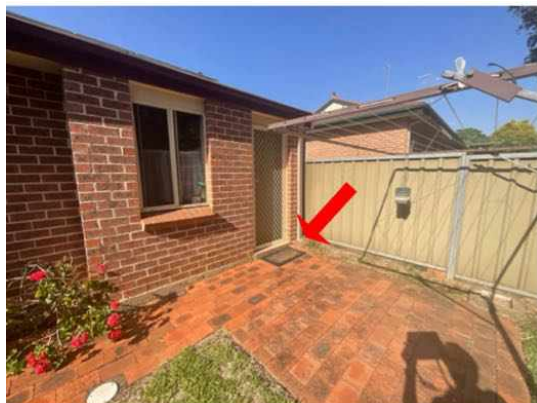
Building: Main Building
Location: Exterior walls - rear/left
Finding: Downpipe - Damaged connection
Information:

- The roof plumbing (downpipe connection) in this location has been damaged and is not fully sealed.

- Poorly sealed downpipes can result in:
 - Water pooling around the base of the building
 - Excessively damp conditions at the foundation or subfloor level
 - Increased risk of foundation movement, moisture ingress, or wood rot
- Water runoff may also be diverted to a neighbouring property, which is non-compliant with building codes and may create legal or council-related issues.

- Rectification is strongly advised.
- A licensed plumber should be appointed to:
 - Inspect the area thoroughly
 - Assess the condition of the stormwater system
 - Repair, replace or properly connect all downpipes to ensure compliant and effective drainage

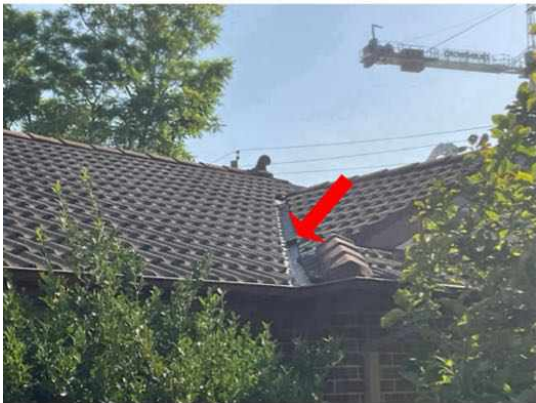
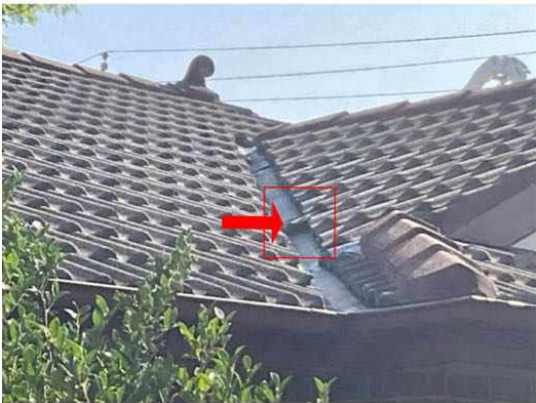
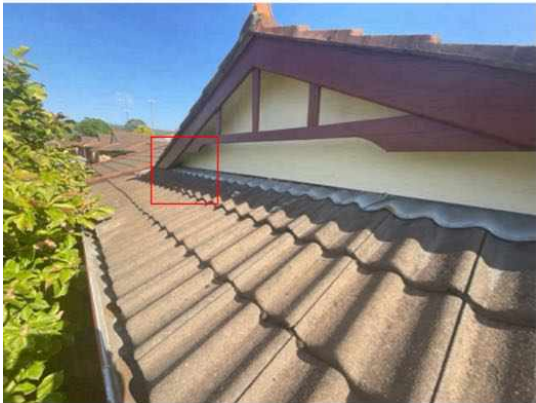
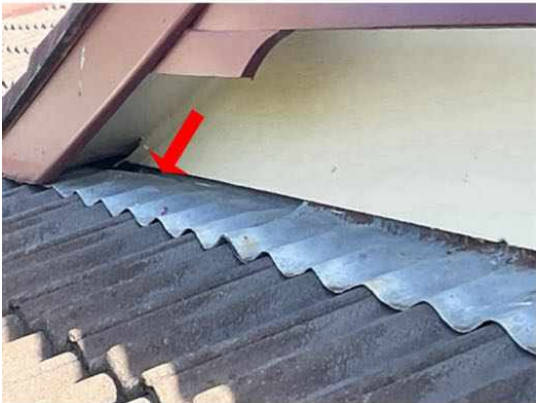
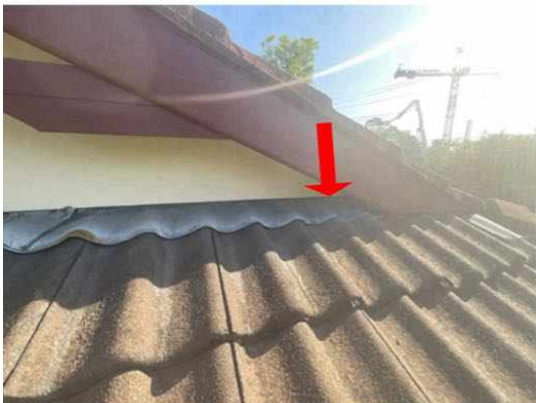
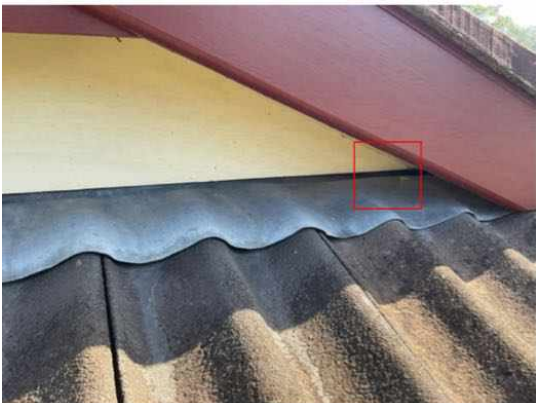
Finding 3.02

At the time of inspection, the tiled roof covering appeared to be in a generally sound condition. No cracked or broken tiles were observed in accessible areas. Some tiles were noted to be uneven in isolated locations, particularly adjacent to flashings. These conditions are considered consistent with age, weather exposure, and minor movement over time. While not currently presenting as a failure, uneven tile alignment may increase the risk of water ingress if left unmanaged.

The ridge and hip cappings were observed to be generally intact. Minor deterioration of mortar bedding and pointing was noted in isolated areas. This level of deterioration is common for roofs of this age and does not currently constitute a major defect. However, periodic maintenance, including re-pointing, is recommended to maintain weatherproofing and prevent future water penetration.

Lead roof flashings were observed to be in average condition overall. Localised sagging and cracking were noted. Sagging flashings may provide inadequate fall for effective water run-off, and cracked flashings can allow moisture entry, particularly if deterioration progresses. Maintenance or re-sealing by a licensed roofing contractor is recommended to reduce the risk of future water ingress.

Roof valleys and drainage channels were generally clear and appeared functional at the time of inspection. Some tiles within the valley areas were noted to have become loose and will require reinstatement to ensure proper water flow. Regular cleaning and maintenance of valleys is recommended to prevent debris build-up, blockages, and potential water overflow beneath roof tiles.

The tiled roof covering was observed to be in generally sound condition at the time of inspection, with no active leaks identified in accessible areas. Minor maintenance is recommended to ridge cappings, flashings, and valley tiles to ensure continued weather resistance. Due to access limitations associated with roof pitch and non-trafficable framing, the inspection was restricted to safely accessible areas only. Improved access, including the installation of an additional manhole, would allow for a more thorough inspection in the future.

Regular roof maintenance, including cleaning of valleys and gutters and periodic re-pointing of ridge tiles, is recommended to preserve the roof's performance and extend its overall service life.

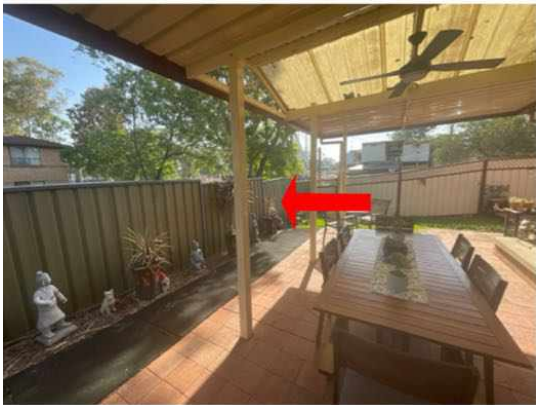
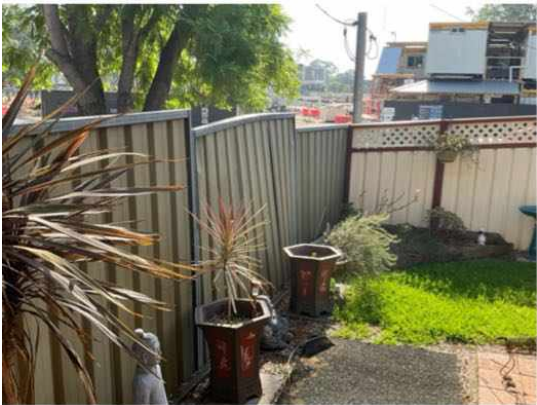
Finding 3.03

At the time of inspection, sections of the boundary fencing were observed to be leaning. This condition is typically caused by natural deterioration due to age, prolonged exposure to weather, or potentially inadequate original installation or maintenance.

While currently considered a minor defect, continued movement or further degradation may result in instability, reduced privacy, or boundary disputes.

Rectification is at the discretion of the client. A licensed fencing contractor or qualified handyman should be engaged to assess the extent of deterioration and carry out repairs or replacement as required.

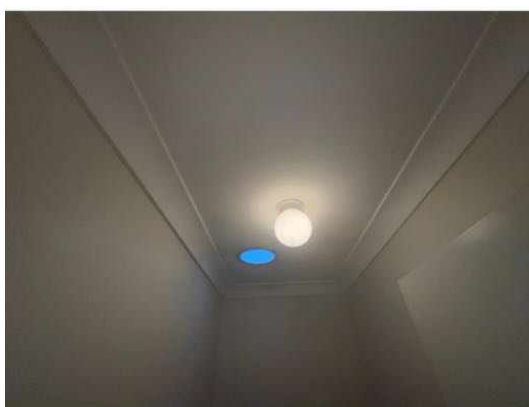
Finding 3.04

Building:	Main Building
Location:	Toilet (WC)
Finding:	Defect – Inadequate Ventilation (No Exhaust Fan Installed)
Information:	Observation:

At the time of inspection, it was noted that no exhaust fan or alternative form of mechanical ventilation had been installed in this area.

This can result in deterioration of building elements and may pose health risks over time if left unaddressed.

- An electrician and/or ventilation specialist should be engaged immediately to:
- Assess the area
- Install a compliant exhaust fan or alternative ventilation system
- Rectification is recommended prior to occupancy to ensure compliance and reduce the risk of long-term moisture-related issues.

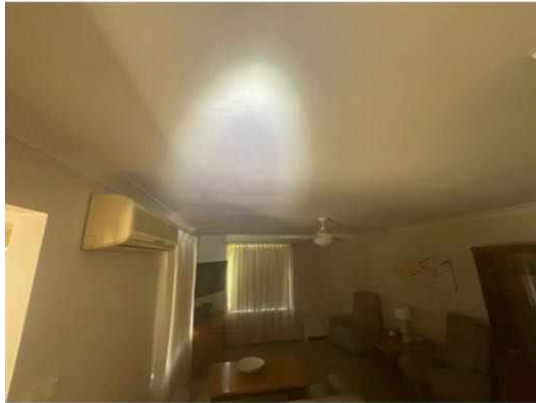
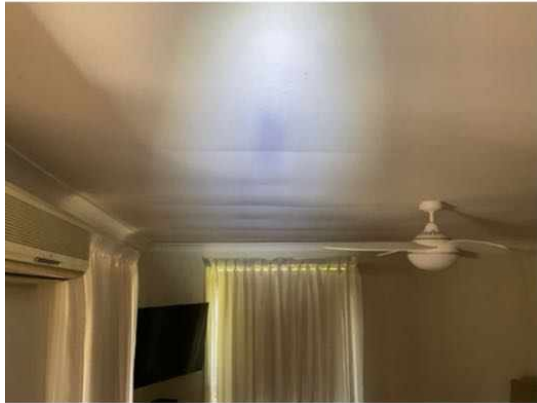
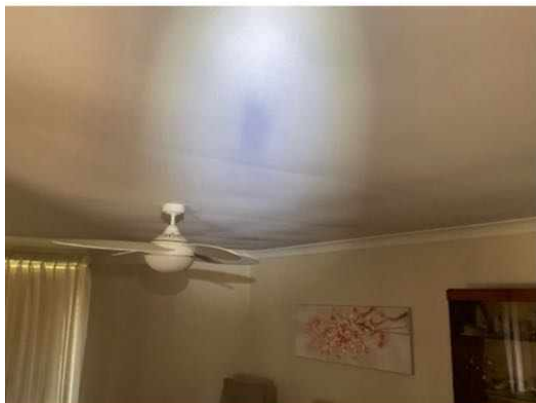
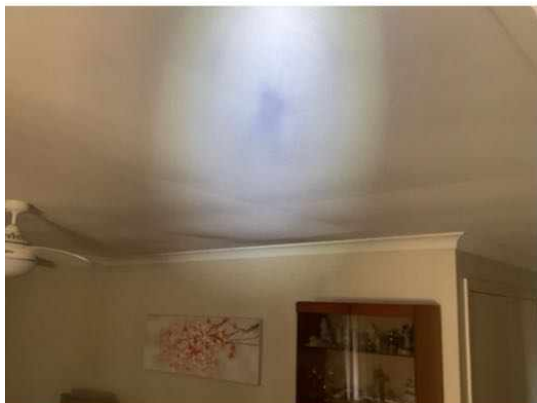
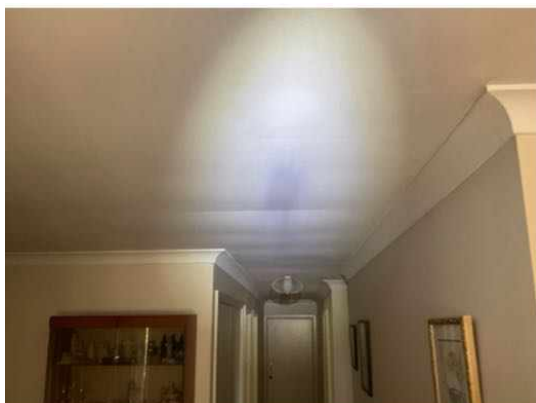
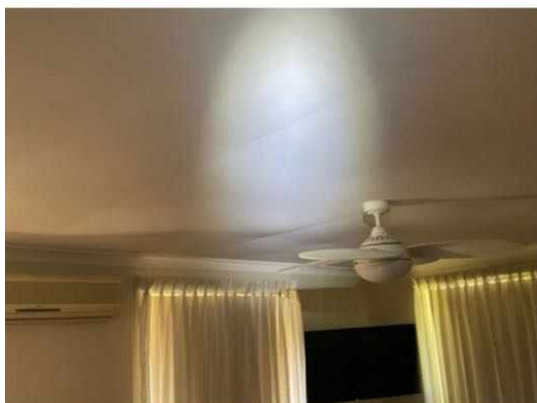
Finding 3.05

Building:	Main Building
Location:	All Areas
Finding:	Ceiling Linings – Uneven or Sagging Surfaces.
Information:	Observation:

Uneven sagging ceiling linings were observed in various areas throughout the property. At the time of inspection, the condition appeared to be minor and cosmetic in nature, however, the ceiling lining in particular near the garage panel lift door and living room needs attention.

This is a common occurrence in homes of similar age and construction, often caused by the gradual deterioration or loosening of original fixings, such as nails, screws, or adhesives used to secure ceiling sheets.

- Re-gluing or re-adhering the ceiling sheeting

- Re-securing sheets using appropriate modern fixings
- These works can be carried out by a qualified plasterer or painter,
- Ongoing monitoring is advised to detect any worsening of the condition or further movement over time.

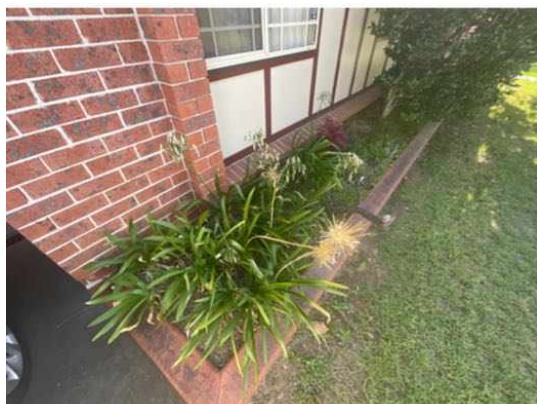
Garden beds were observed directly against the perimeter of the building. This condition can result in water pooling or retention during rainfall or from regular watering/hosing, which may lead to moisture ingress beneath the structure.

- Persistent moisture buildup around the base of the building creates an environment that is conducive to termite activity and timber decay.
- Plants and vegetation close to or in contact with external walls can provide shade and cover, further increasing the likelihood of termite infestation.
- Garden beds are also concealing weep holes, slab edges, or termite barriers, reducing visibility during inspections and allowing for undetected termite entry.

It is strongly recommended that garden beds be removed or relocated away from the

building perimeter. Maintaining a clear inspection zone around the structure helps reduce moisture retention and improves visibility during regular pest inspections. This preventative measure significantly lowers the risk of termite ingress and related structural damage.

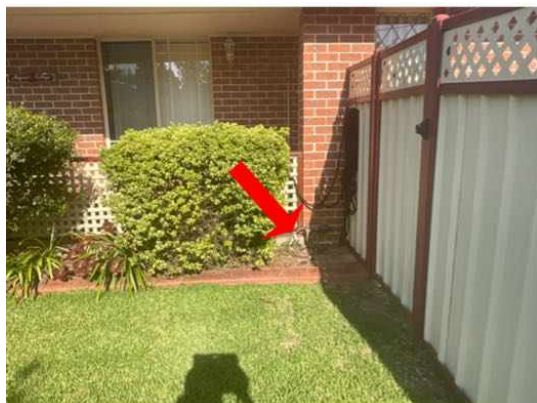
Finding 6.02

Building:	Main Building
Location:	All External Areas
Finding:	Overflow Management – Risk of Termite Activity..
Information:	Observation: Water Pooling from HWS and Air Conditioning Overflows

Water discharge from the Hot Water System (HWS) pressure relief valve and air conditioning unit overflows was observed discharging close to the base of the structure, contributing to water pooling around the building perimeter.

Persistent moisture near the foundation or subfloor area significantly increases the likelihood of termite activity. Termites are highly attracted to damp environments, and stagnant water near structural elements provides ideal conditions for foraging and infestation.

It is highly recommended that all overflows from the HWS and air conditioning units be

redirected away from the building, preferably via fixed drainage or extension piping, to prevent water accumulation near the structure.

These minor corrective works should be undertaken promptly to minimise the risk of both termite ingress and potential structural damage due to ongoing moisture exposure.
