# Building and Timber Pest Inspection Report

Inspection Date: Sat, 7 Feb 2026

Property Address: 376 Abell Rd, Melonba NSW 2765, Australia

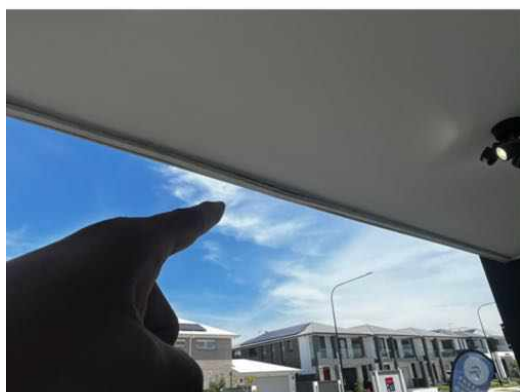
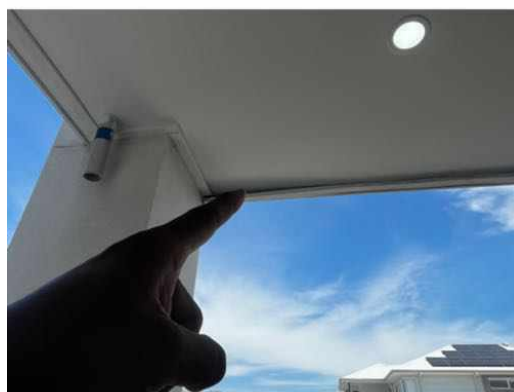
Building:	Main Building
Location:	Front Balcony
Finding:	Balcony - Floor / Render Cracking - Damage in Exterior Render - Noticeable

Information: Upon Inspection The gradients of the Balcony floor levels are checked and found to be ok with a fall towards the floor trap.

There were Render Cracks noticed , Noticeable cracks are a result of many primary defects. Such causes may include age, general wear and tear, expected building movement, general expansion/contraction of building materials in different weather conditions, and/or minor failings in the installation or application of building materials.

The most important cause for the crack of render could be the moisture being trapped between the render and the wall. It could be also be due to poor application and also the sub standard matériels being used.

Extreme heat and cold weather could have also impacted the settlement of applied render. It can also be the cause of Base coat being expanded more than the Top coat being applied.

Relevant tradespeople, Licensed Renderer , Licensed Builder should be consulted before arriving at a decision to take action as they can further do an invasive inspection and remedy the situation.

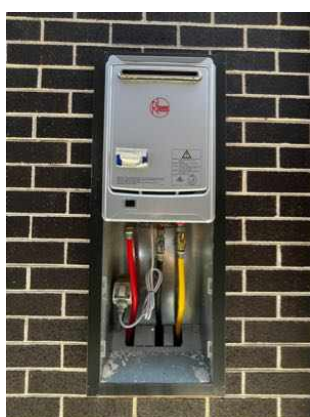
Information: The HWS appeared to be in good condition at the time of inspection.

The Hot water unit was missing the lid cover at the time of inspection.

It is advised that the cover may be replaced to prevent any safety hazard.

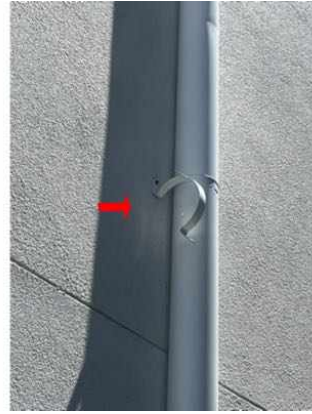
Building:	Main Building
Location:	Front RHS
Finding:	Down Pipes clamp not connected.
Information:	The Roof plumbing is not adequately connected to stormwater drainage on the site as the clamp holding the down pipe is loose and has to be fixed in order to any building element coming loose of the building and creating any further defects.

Where roof plumbing doesn't drain adequately, the area at the base perimeter can become excessively damp, potentially creating an environment that is susceptible to rust and corrosion of surroundings building elements, as well as attracting termites and other pests.

It is highly recommended that a plumber be appointed to further inspect the area and to install adequate drainage equipment where necessary.

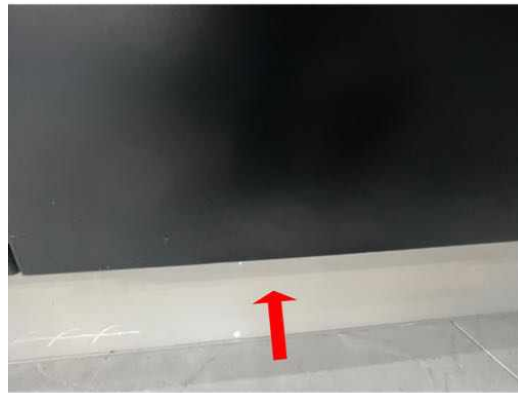
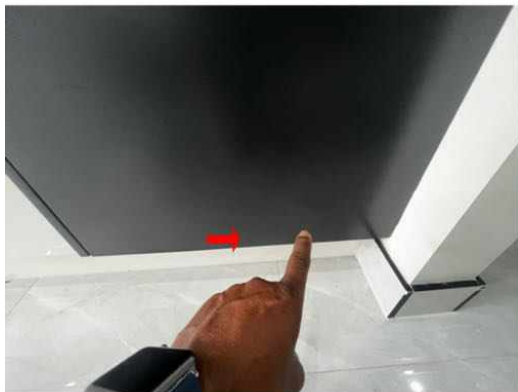
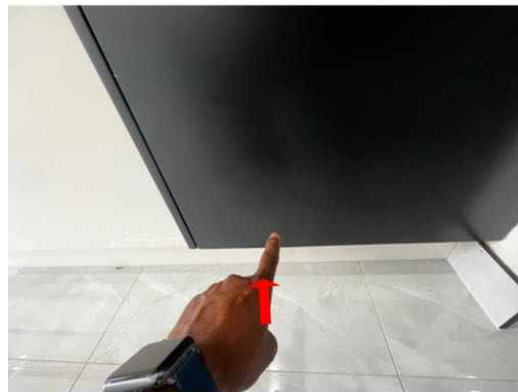
Information: Though comments on Kitchen joinery is not part of the report, Still we would like to bring to your note few photos where the Joinery has been damaged due to Wear and tear/ daily Usage or low quality of materials used in the product.

The Buyer may consider renovation costs involved by requesting quotes from Joinery manufacturers etc if relevant.

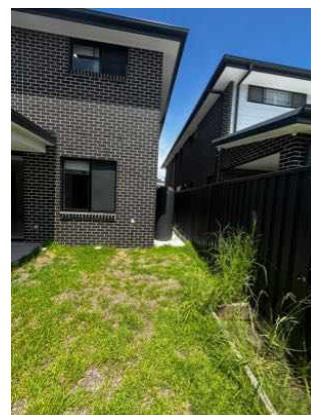
Building: Main Building  
Location: All Areas  
Finding: Additional Photos - Obstructions and Limitations  
Information: These photographs are an indication of the obstructions and limitations which impeded full inspection of the property at the time of inspection. These obstructions can hide an array of defects and should be removed to allow full inspection to be carried out. A re-inspection is recommended once the areas are made accessible.

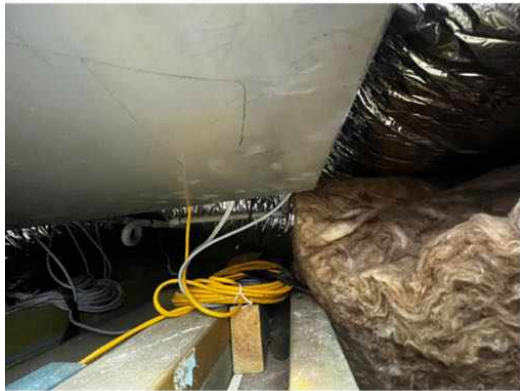
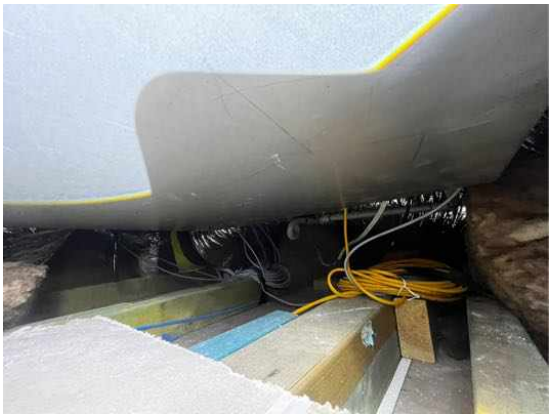
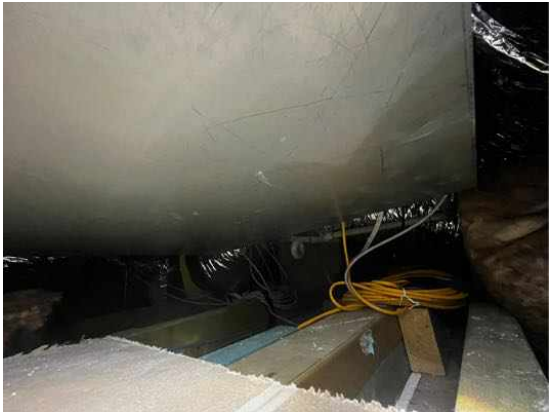
Building:	Main Building
Location:	Roof Void
Finding:	Obstructions and Limitations - Roof space
Information:	Upon Inspection of the Roof void below mentioned photos have been attached as to the point been reachable to inspect the roof upon safe condition.

These photographs are an indication of the obstructions and limitations which impeded inspection of the Roof Space/Void at the time of inspection such as Stored items, Ducting, Aircon ducting, Skylight tubes, Electrical wires , insulation and cross beams, rafters, low clearance as of the pitch in the roof. These obstructions can hide an array of defects and should be removed to allow full inspection to be carried out.
