# Building and Timber Pest Inspection Report

Inspection Date: Thu, 26 Mar 2026

Property Address: 2/72 Page Ave, North Nowra NSW 2541, Australia

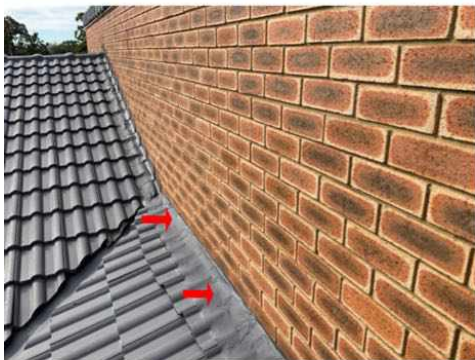
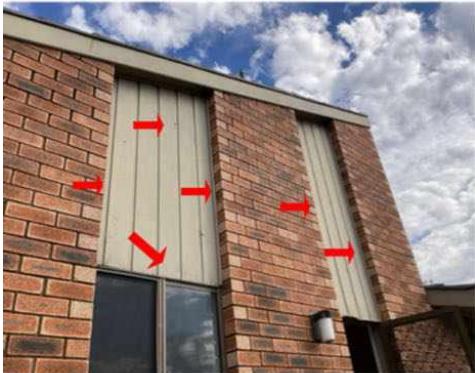
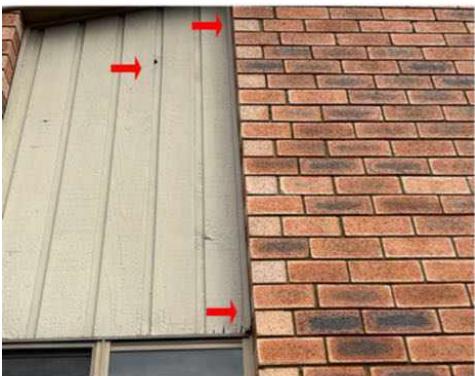
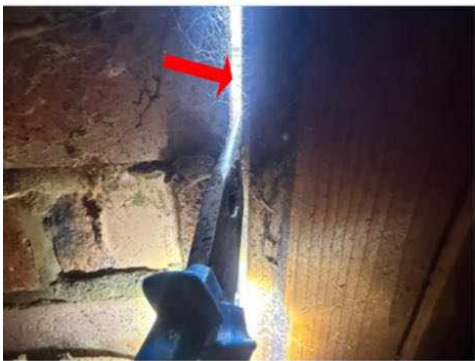
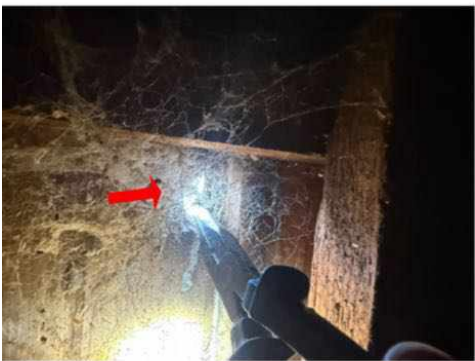
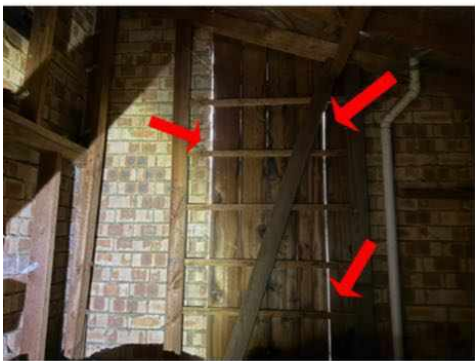
Building: Building 1  
Location: Roof Exterior/ Roof Void  
Finding: Flashing cracked and large gaps in cladding found  
Information: Cracks were evident to the pictured roof flashing and gaps in the timber cladding were found at the time of inspection.

Regardless of the location, if left unmanaged, even minor leaks can lead to serious damage of associated building elements, potentially resulting in the need for replacement of building materials. Damage to ceilings and wood rot has already occurred as these defects have largely been left unmanaged.

A roofing contractor should be engaged to replace this damaged flashing and cladding as soon as possible (see also wood rot and sealant damaged defects).

Replacing the timber cladding with colorbond will be relatively maintenance free for many years.

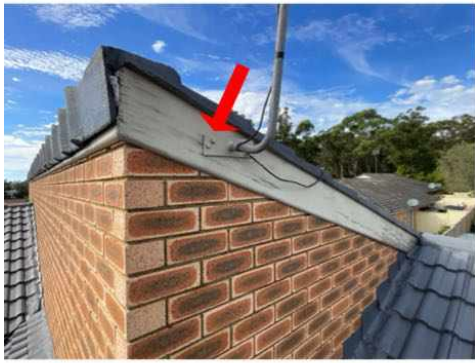
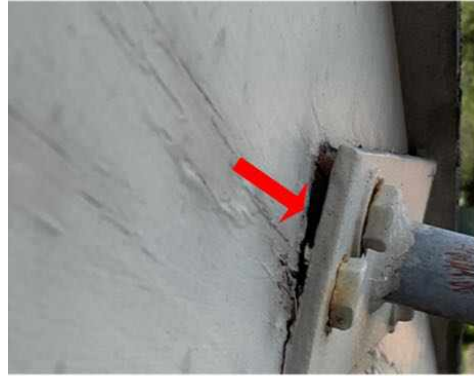
**Finding 2.02**

Building: Building 1  
 Location: Pictured areas  
 Finding: Aerial - Loose  
 Information: The aerial attached to this area is loose and requires removal and timber barge replacement before it falls and breaks tiles.

It is attached to rotting timber. If left unmanaged, the aerial will fall and cause other secondary defects.

A carpenter should be appointed immediately to perform these rectification works, replacing this timber.

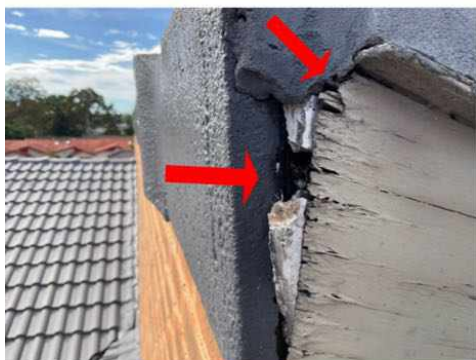
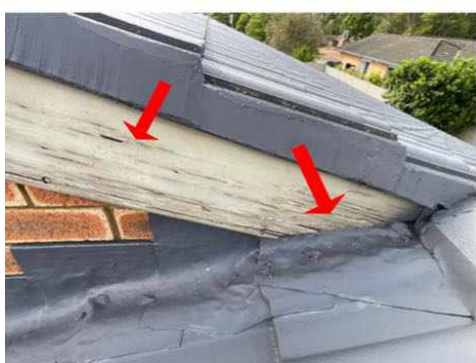
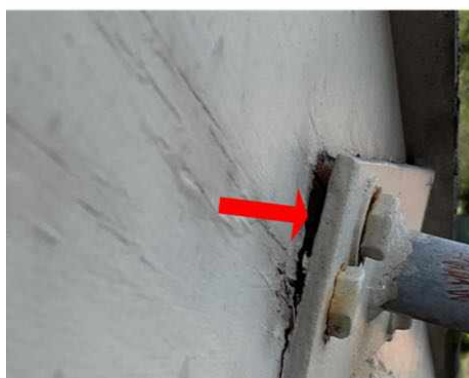
### Finding 3.01

Building:	Building 1
Location:	Roof Exterior
Finding:	Roofing areas - Weathered
Information:	Upon inspection of the exterior roofing, the majority of the roof areas were considered to be in a fair condition. While weathering of these pictured areas is consistent with the age of the property, maintenance works are required.

Re-sealing and replacing small areas of gaps, damage, wood rot and rust must be considered as an interim solution by the client to help preserve and extend the life span of these roofing areas. Where left unmanaged, deteriorating roofing materials are likely to lead to a number of secondary defects, including minor water leaks and weather exposure to internal roofing structures.

Remedial works are likely to increase the longevity of the exterior roofing structure.

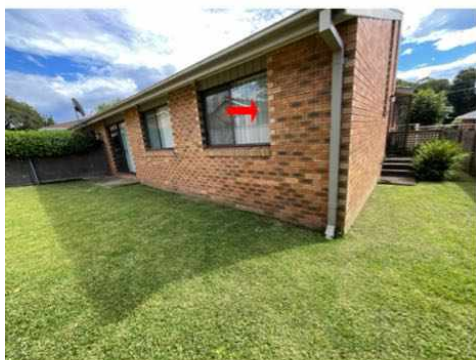
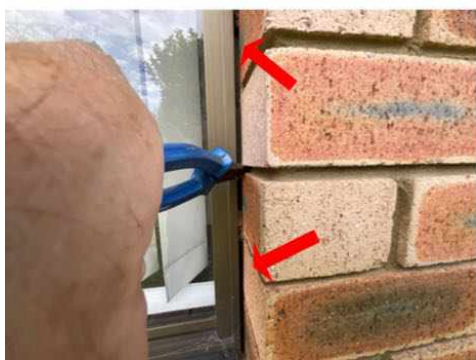
### Finding 3.02

Building:	Building 1
Location:	Rear window
Finding:	Sealant (external) - Missing.
Information:	It was noted on inspection that areas of external sealant was missing to small areas of the external rear window.

Flexible sealants should be applied to these affected areas to prevent any subsequent water damage that is likely to occur.

A sealant specialist or skilled handy person should be appointed to complete these works as soon as possible

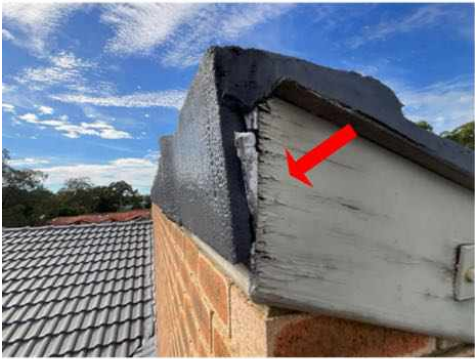
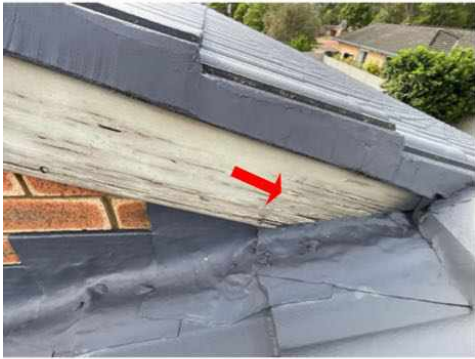
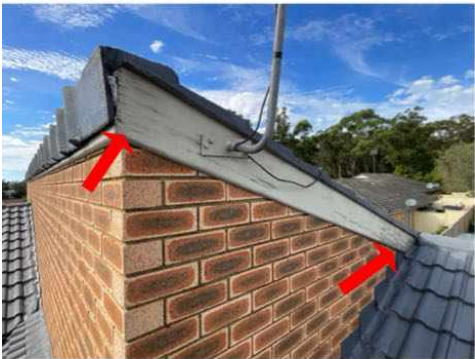
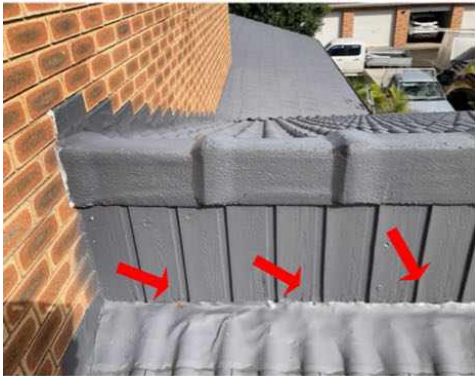
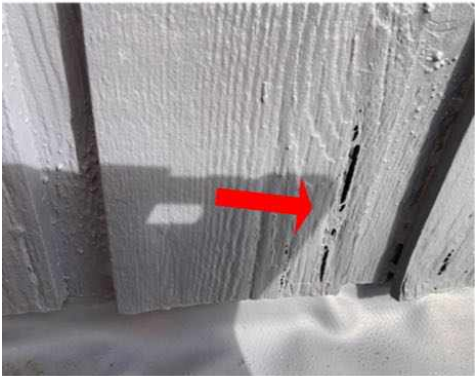
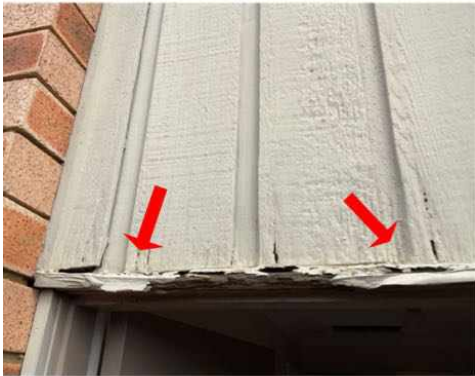
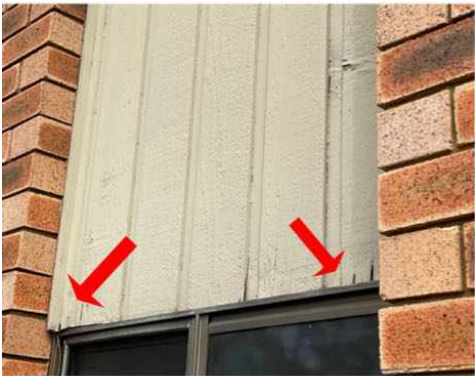
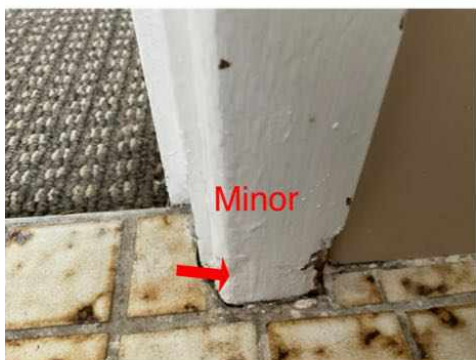
### Finding 3.03

Building:	Building 1
Location:	Pictured areas
Finding:	Wood rot
Information:	The building shows evidence of wood rot to roof barges, roof cladding and the bathroom door frame. Wood rot, also known as Fungal Decay, occurs when timbers and other cellulose building materials are exposed to damp conditions on an ongoing basis. This could be the result of exposure to weathering over a prolonged period of time, or the attraction of excessive moisture from other abutting building materials.

Early intervention and regular maintenance, particularly of exterior timbers, will prolong the useful life of these building elements. Replacement of affected roof timbers is a necessary step in protecting surrounding building elements from such deterioration.

A qualified carpenter or registered builder may also be required to replace affected building materials.

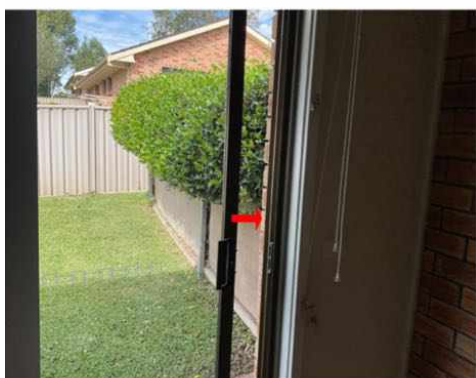
### Finding 3.04

Building:	Building 1
Location:	Pictured areas
Finding:	Building elements - Damaged
Information:	Evidence of minor damaged areas was identified at the time of the inspection. These include -

1. The loungeroom sliding door frame and south east bedroom sliding window frame (holding the glass) are slightly loose and require additional fixings to the wall and sliding window frames respectively.

2. The laundry tap shows a consistent slow leak into the tub when on, requiring a minor plumbing repair.

A carpenter and plumber would be the trade responsible for rectification of these areas when convenient.

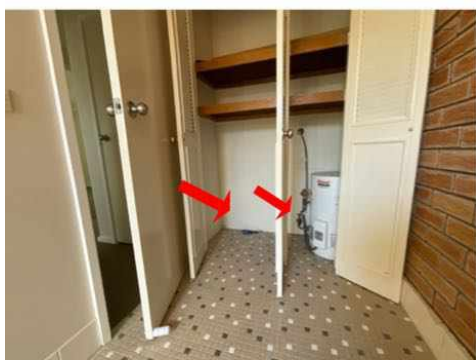
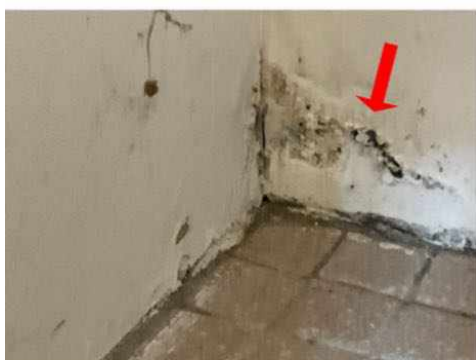
### Finding 3.05

Building:	Building 1
Location:	Laundry cupboard
Finding:	Evidence of excessive moisture and mould was present at the time of inspection
Information:	Excessive moisture and mould was found in the laundry cupboard. A medium

moisture reading of 47.9 was recorded. All nearby areas and all other rooms had zero readings out of 24 readings taken. This moisture can attract termites and produce conditions that promote termite attack fungal growth and wood decay.

Excessive moisture is generally caused by deteriorated, inadequate or missing drainage, leaking plumbing pipes or fixtures poorly plumbed HWS overflows or condenser units and poor site drainage.

It is highly recommended that all plumbing and drainage fixtures and fittings be maintained regularly in order to prevent excessive moisture being present in the internal property. This wall needs to be opened to find the source.

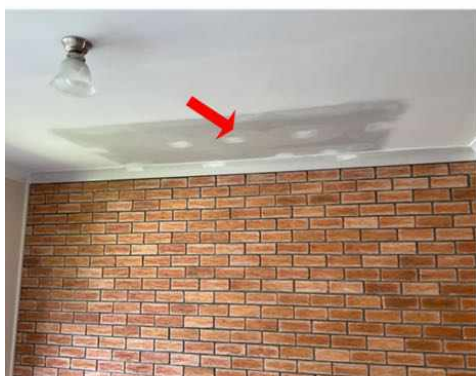
Building: Building 1  
 Location: Lounge Room  
 Finding: Unfinished construction  
 Information: The construction of this structure appears to be incomplete. The safety of the structure can therefore not be ensured and the creation of secondary defects to surrounding building elements may be likely.

A Registered Builder should be appointed immediately to complete this construction process.

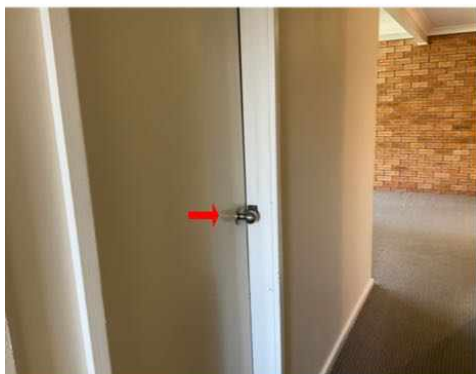
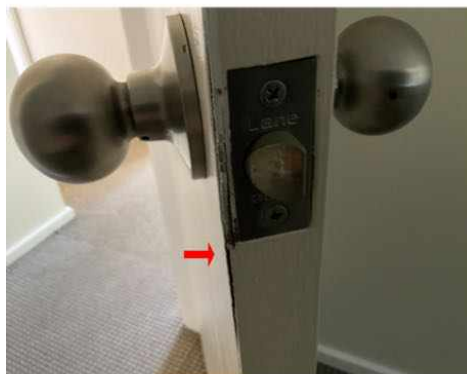
### Finding 3.08

Building: Building 1  
 Location: Pictured door  
 Finding: Door - Binding/jamming  
 Information: Binding and/or jamming of this door is evident during standard operation. This defect inhibits the functionality of the affected door and the door is starting to

A door that binds to flooring or to the associated door frame may have several causes, ranging from minor defects, such as poor installation of the door or deteriorated hinges, through to major structural issues, such as damage to subfloor structures.

For this minor cause, a qualified carpenter or general handyperson should be appointed to perform minor rectification works at client discretion.

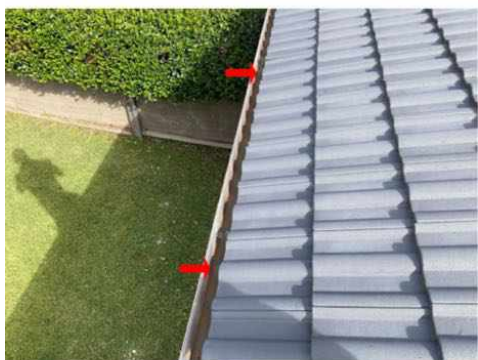
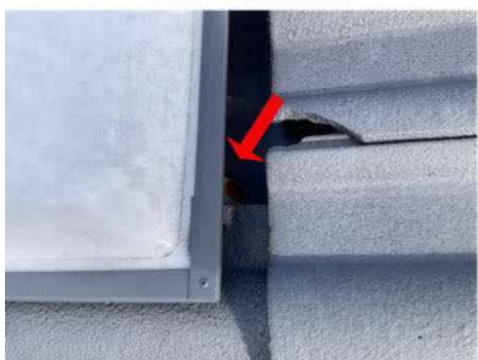
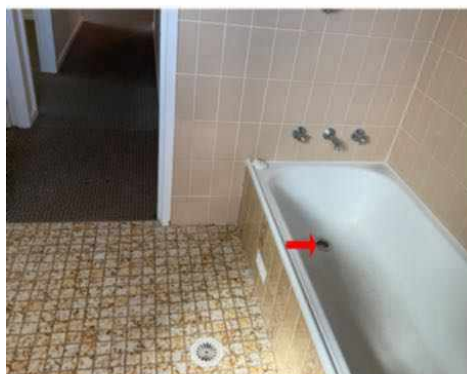
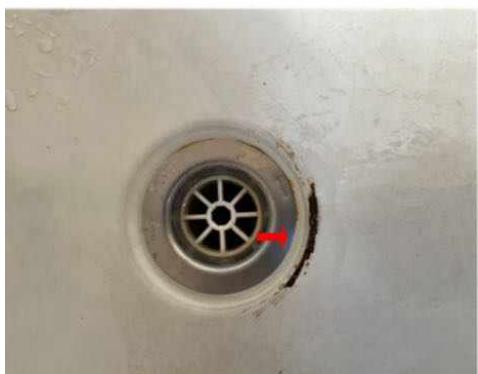
### Finding 3.09

Building:	Building 1
Location:	Roof Exterior & bath
Finding:	Roof areas and bath with minor rusted
Information:	These areas shows evidence of minor rusting and corrosion, which is likely to have developed as a result of excessive exposure to moisture and or inadequate coatings.

As surface rust provides no protection to the underlying iron, the deteriorating condition is likely to worsen if not addressed in the short-term future.

Where possible, the use of galvanized (treated) metals or aluminium coated metals aid in rust prevention, as does regular general maintenance. Rust formation can be controlled with coatings, such as paint, that isolate the iron from the environment.

Rusting and corrosion should be managed by ideally removing or limiting the affected surface from exposure to moisture. A registered builder may be appointed to replace any building elements that have been severely affected by rust or water damage.

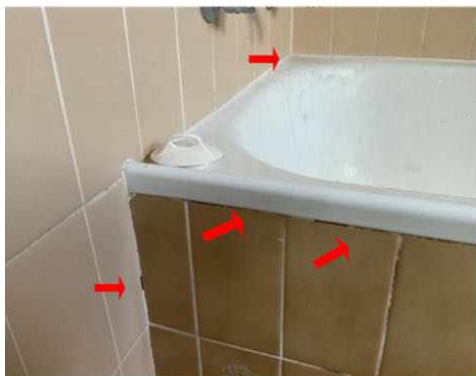
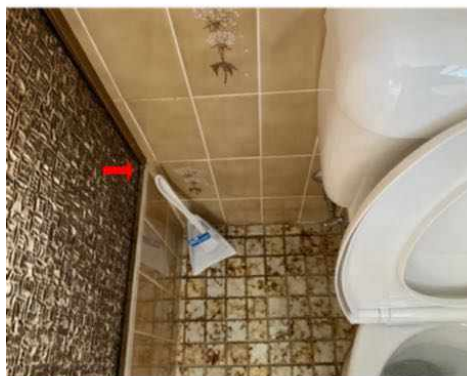
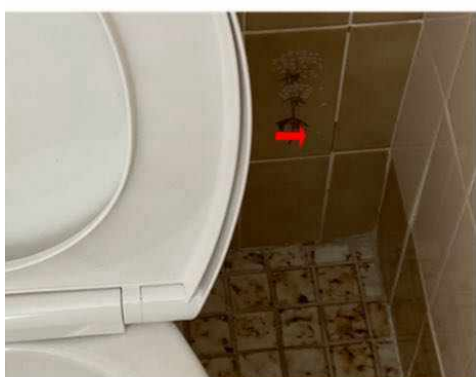
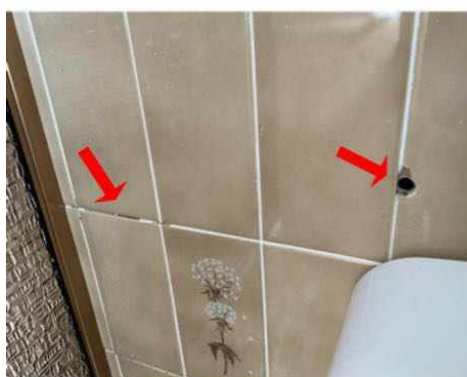
### Finding 3.10

Building:	Building 1
Location:	Bathroom
Finding:	Sealant and grouting - Missing or damaged
Information:	It was noted on inspection that sealant or grout is degraded to these pictured wet areas.

Different materials and floor areas move at different rates, generally causing cracking to grout or sealant at this point. A flexible sealant is required to allow for expected expansion and contraction, while keeping the joint water tight and protective of all associated building materials.

Flexible and mould resistant materials should be applied to affected areas to prevent any subsequent water damage that is likely to occur. Regular maintenance and replacement of damage or missing or damaged sealant and grout is highly recommended to the wet areas, as this is a regular wear and tear defect. Sealant and grouting in areas that come into regular contact with water should be maintained for the long term care of your property.

A sealant specialist or tiling contractor should be appointed to complete these works as soon as possible

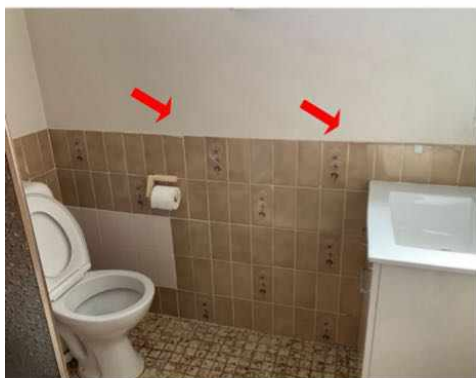
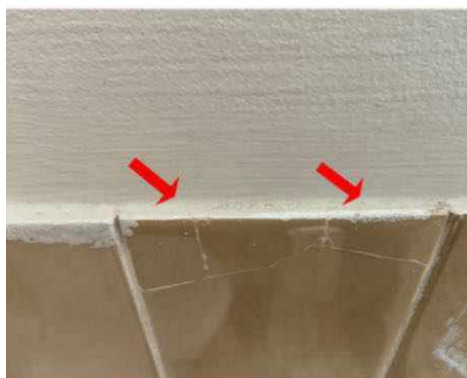
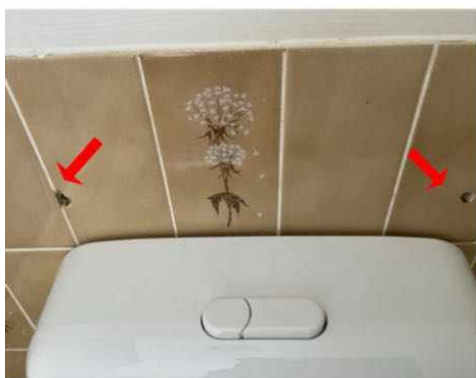
### Finding 3.11

Building:	Building 1
Location:	Bathroom, laundry
Finding:	Tiles cracked
Information:	Cracked tiles were evident in these pictured areas at the time of inspection. It is suspected that this cracking has occurred as a result of minor settlement or impact damage.

Cracked tiles throughout the household detract from the overall appearance of the affected areas. In wet areas of kitchens and bathrooms, it can lead to water damage of adjoining walls and floors.

Replacement of cracked tiles is recommended as soon as possible. A tiling contractor

may be appointed to perform these works. Where cracks become more numerous, contact a licensed building inspector for further investigation.

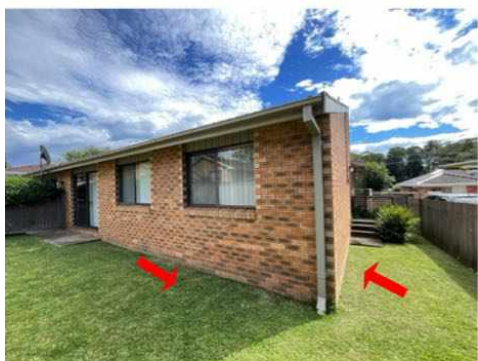
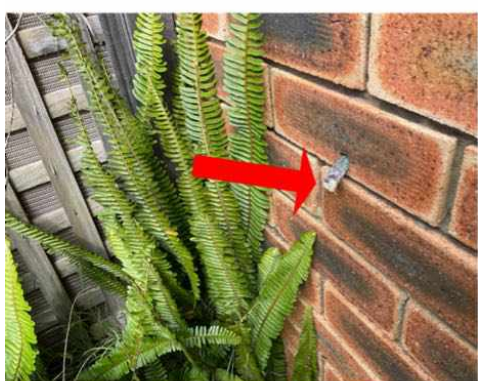
### Finding 3.12

Building:	Building 1
Location:	Walls
Finding:	Site drainage - Inadequate
Information:	The site drainage in this area was found to be inadequate at the time of inspection, creating potential for subsequent water damage to associated building elements.

No rear drainage is evident. One rear downpipe boot has cracked. The hot water system overflow run against the house walls.

Where site drainage is inadequate, installation of an Agricultural (Aggie) Drain may be required. A qualified plumber should be appointed to further inspect the property and perform any remedial works as necessary. Secondary defects are likely to occur if left

unmanaged.

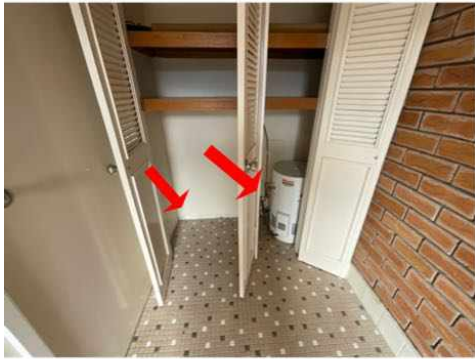
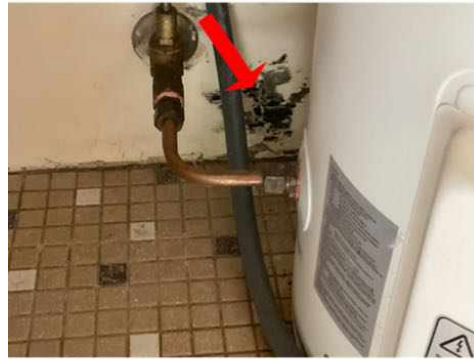
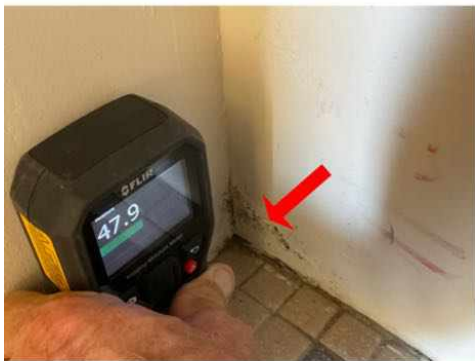
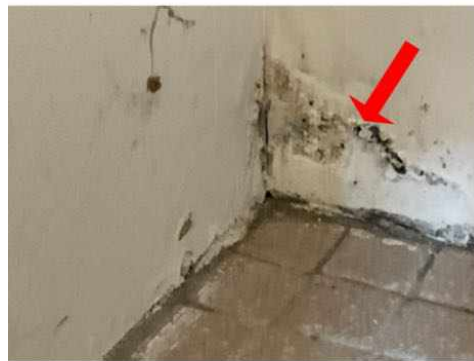
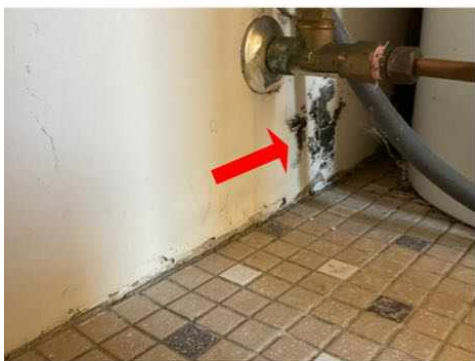
Building:	Building 1
Location:	Laundry cupboard
Finding:	Mould - Present
Information:	Where evidence of mould growth was noted, there may be environmental, biological or health issues associated with the report. A specialist inspection by a suitably qualified environmental health inspector is warranted, where mould is extensive or where any queries regarding air quality spores or other related issues apply.

This mould appears to be from a water leak inside the wall. Any mould found during the inspection should be cleaned immediately by a cleaning contractor or the homeowner as applicable.

Generally, the client is advised to ensure that the general environment is free of moisture and humidity to aid in the prevention of mould formation and development.

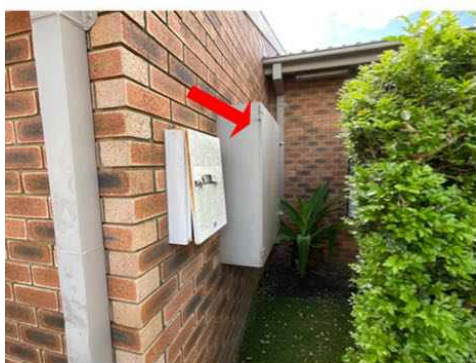
### Finding 6.02

Building:	Building 1
Location:	Meter Box
Finding:	Termite Management System - no evidence of a chemical installation

Information: The application of a post-construction chemical termite barrier is highly recommended for all properties. Such barriers are highly effective in preventing termite attack on any timber building elements throughout the property.

A durable notice should be placed in the switchboard unit to indicate current termite barriers. At the time of inspection, no durable notice was evident and it appeared as though no chemical termite management system has been installed, with no evidence to suggest preventative works taking place since the property was built.

The client may consider gaining further advice from a pest controller as to the costs and procedures involved with a 'chemical' application. It is recommended that obtaining such advice be a short-term priority.

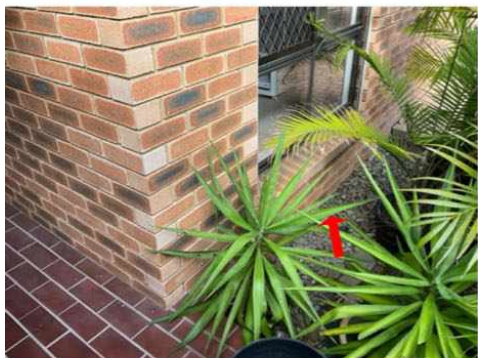
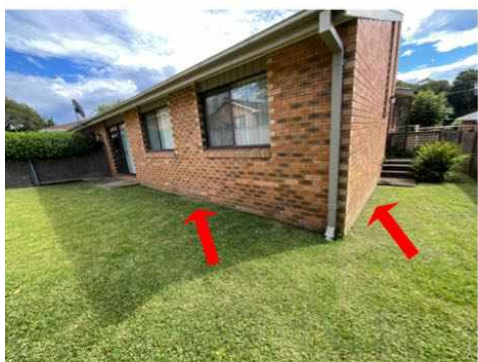
### Finding 6.03

Building: Building 1  
 Location: Exterior walls  
 Finding: Slab Edge - Exposure  
 Information: An inspection zone of at least 75mm in relation to the exposed slab edge, between the bottom brick and the perimeter pavement, is required. This inspection zone should be maintained in order to force termites into the open where they can be detected more readily during regular inspections. The slab edge should not be concealed by anything that may prevent inspection of the area, including render, landscaping, soil, turf, paving, concrete cladding or other structures.

If the slab edge is not properly exposed there is a high risk of termite attack. Sometimes, in order to determine the type of slab, a suitably qualified person such as an architect or builder may be required to consult the construction plans.

Where the slab edge cannot be properly inspected, it is highly recommended that termite or timber pest inspections be carried out every 6-12 months to aid protection of the property against infestation.

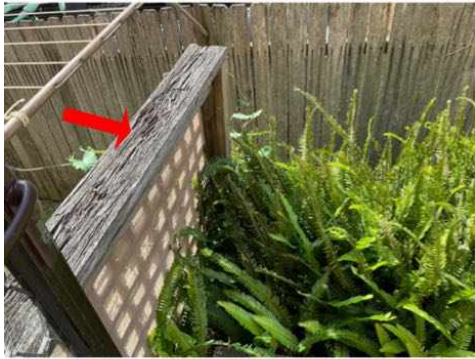
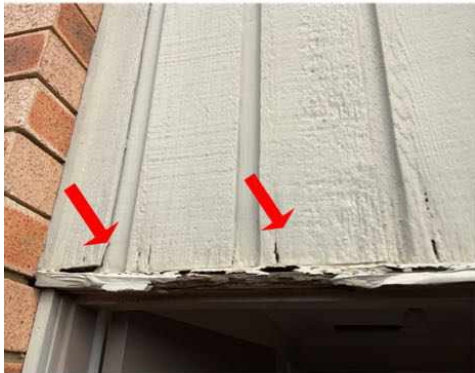
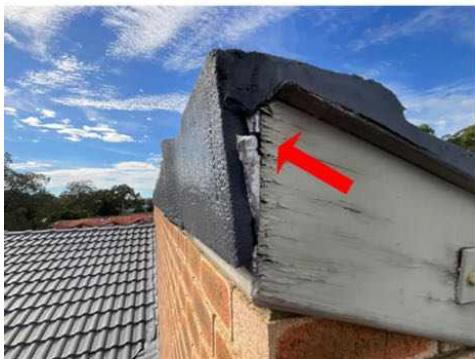
### Finding 7.01

Building:	Building 1
Location:	Verandah
Finding:	Fungal decay - present (localised)
Information:	Fungal decay also known as wood decay or wood rot generally refers to the deterioration of timber elements when in contact with excessive levels of moisture for a prolonged period of time.

The development of fungal decay is accelerated by temperatures from 5degreeC to 40degreeC as well as the presence of oxygen. Generally fungal decay develops on timber elements that are in use in an external environment which are exposed to rain penetration.

In this case, the affected timber element is in a decaying state and will need replacement by a carpenter or licensed builder.
