Building and Timber Pest Inspection Report

Inspection Date: Tue, 17 Mar 2026

Property Address: 2 Bradford Ave, Prospect Vale TAS 7250,
Australia

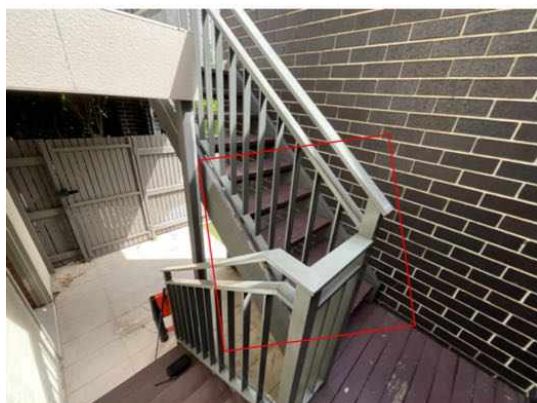
Building:	Main Building
Location:	Staircase
Finding:	Loose handrail — Fall from heights
Information:	The handrail was lacking appropriate support and fixing to the adjacent wall or floor at the time of inspection.

The handrail was further loose and moving upon minimal force applied with hand.

These handrails pose a risk and persons coming in contact may fall from heights if these handrails fail, thus causing sever injury.

The handrails were found to be loose, requiring urgent repairs by a licensed builder.

A licensed builder must be appointed as soon as possible to rectify any non-compliance.

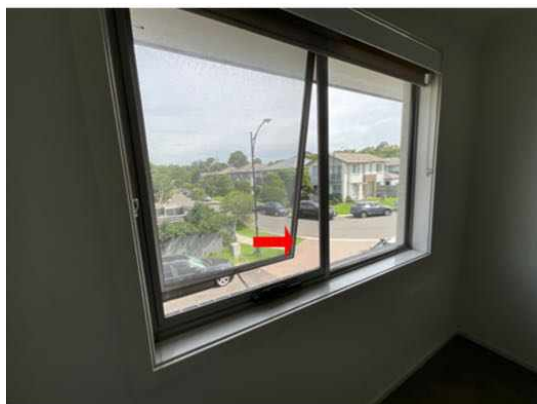
Finding 1.02

Building:	Main Building
Location:	Bedroom - Master
Finding:	Window restrictions - Missing
Information:	Window restrictors were found to be missing.

Windows need to be locked at 12.5cm when the devices are engaged. The safety devices must be robust and child proof. The alternative is security screens such as bars or grills on the windows so long as they have gaps no bigger than 12.5cm.

Flyscreens do not comply unless they are the reinforced security type and capable of resisting the very strong outward pressure which would prevent a child falling through. The laws apply to openable windows in a building within 1700mm of the internal floor and if the internal floor is more than 2m above the ground floor outside.

Master bedroom window lacks appropriate child lock, creating a safety hazard. Window restrictor must be installed immediately for added safety.

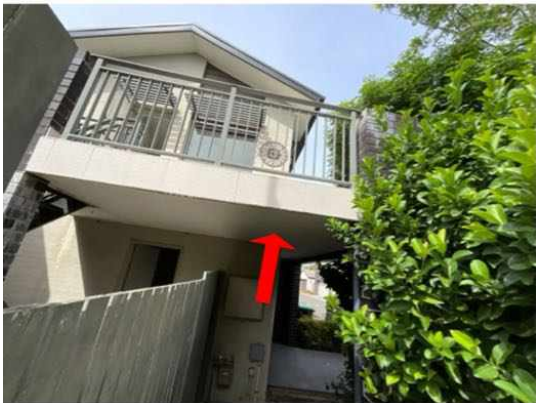
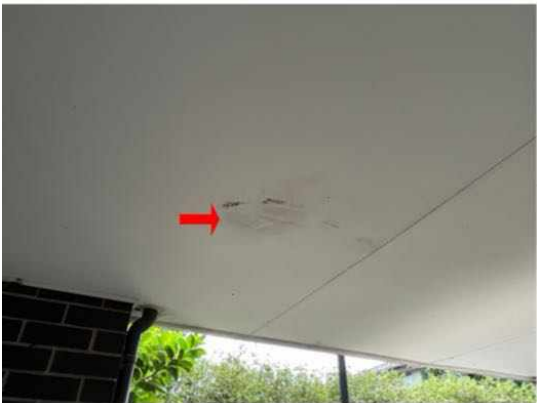
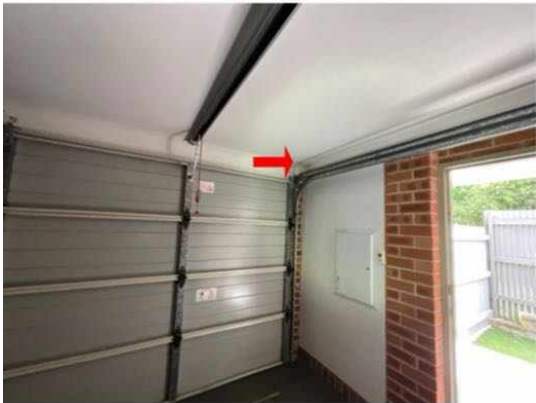
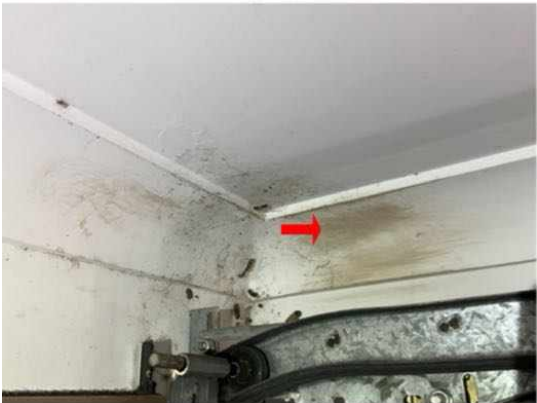
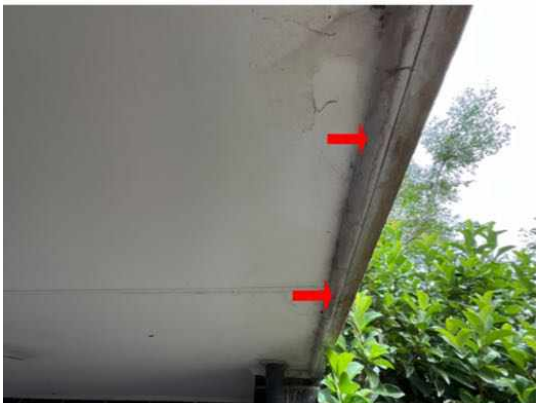
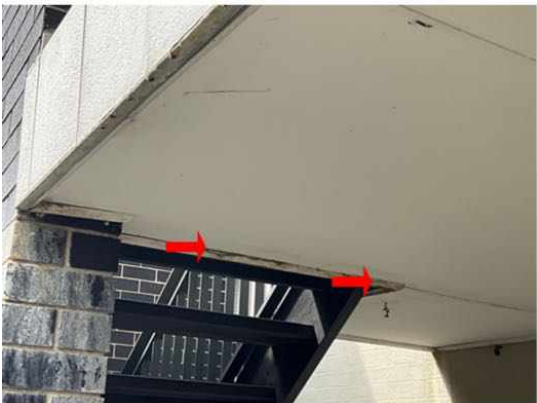
Finding 2.01

Building:	Main Building
Location:	Balcony
Finding:	Waterproofing damage - Suspected
Information:	Excessive moisture was detected in these areas at the time of inspection. Internal water leaks can be detrimental to surrounding building elements. The potential cause in this area is damage to the balcony waterproofing membrane.

Attracting termites, corrosion, mould, decay and water damage are potential outcomes where a minor water leak is left unattended. More serious defects may also result, such as electrical hazards, or water damage to structural building elements.

In extreme cases, structural damage may develop due to a prolonged water leak. It is highly advised that a licensed plumber be appointed immediately for a further invasive inspection and also to complete a flood test procedure. Once confirmed, a licensed builder must be appointed for rectifications. Major works should be expected.

The balcony appears to be leaking due to waterproofing failure. A licensed plumber must be appointed urgently for a further invasive inspection and flood test procedure. Once water leak is confirmed, a licensed builder must be appointed for rectifications. Major works should be expected.

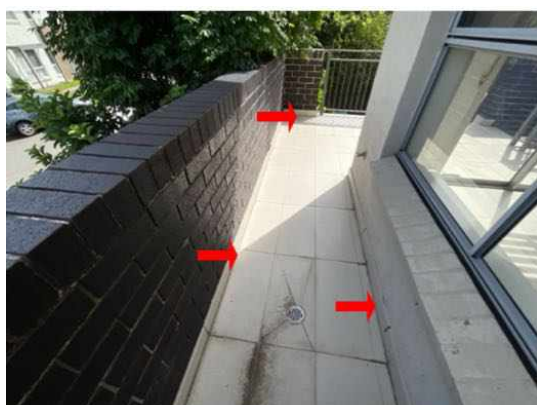
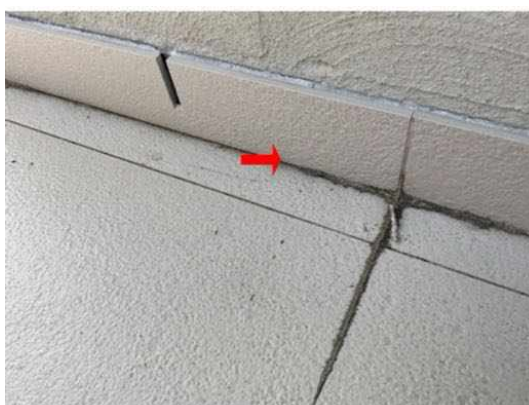
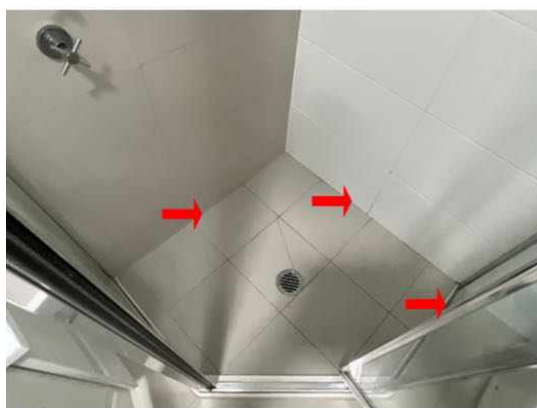
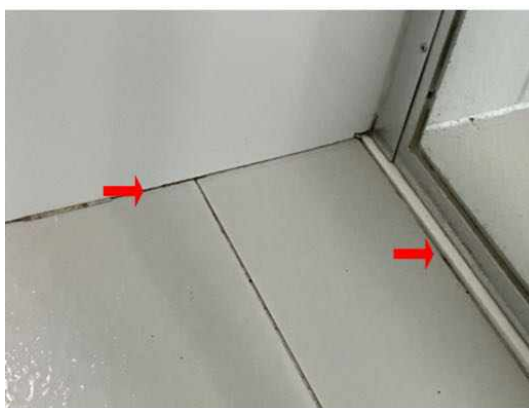
Finding 3.01

Building: Main Building
Location: All Wet Areas
Finding: Sealant and grouting - Missing or damaged
Information:

It was noted on inspection that sealant or grout is degraded to this area.

Different materials and floor areas move at different rates, generally causing cracking to grout or sealant at this point. A flexible sealant is required to allow for expected

Flexible and mould resistant materials should be applied to affected areas to prevent any subsequent water damage that is likely to occur. Regular maintenance and replacement of damage or missing or damaged sealant and grout is highly recommended to the wet areas, as this is a regular wear and tear defect. Sealant and grouting in areas that come into regular contact with water should be maintained for the long term care of your property.

A sealant specialist should be appointed to complete these works as soon as possible.

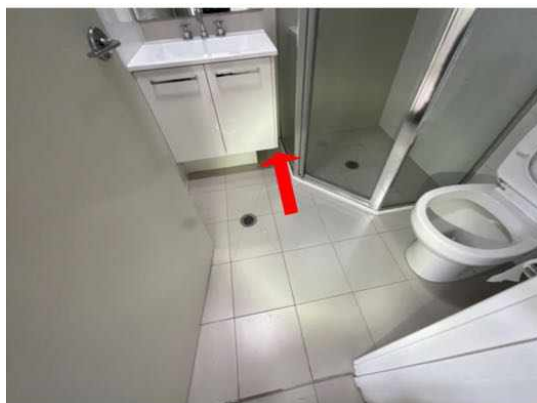
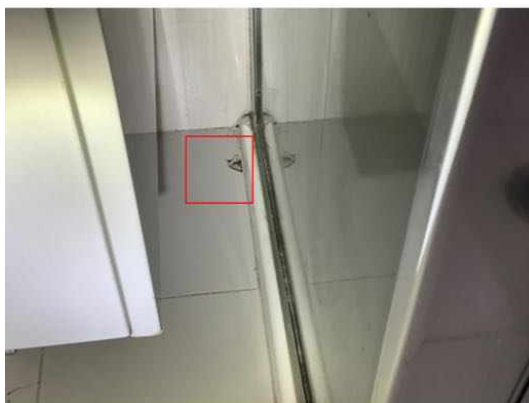
Finding 3.02

Building:	Main Building
Location:	Bathroom
Finding:	Wet area tiles - Cracked or damaged
Information:	Cracking was evident to the tiling in this area at the time of inspection. While the cracking appears to be minor, this area is frequently exposed to water, allowing potential for water penetration into adjoining sections of walls or flooring.

damage, which is likely necessitate repair work to affected building elements.

A bathroom specialist should be appointed to determine the integrity of the bathroom waterproofing membrane. If the membrane was found to be intact then relatively minor works to replace the cracked tiles should be carried out to ensure no further damage occurs. The re-application of silicone and grouting throughout remaining tile work is also advised, to further protect the area against water penetration.

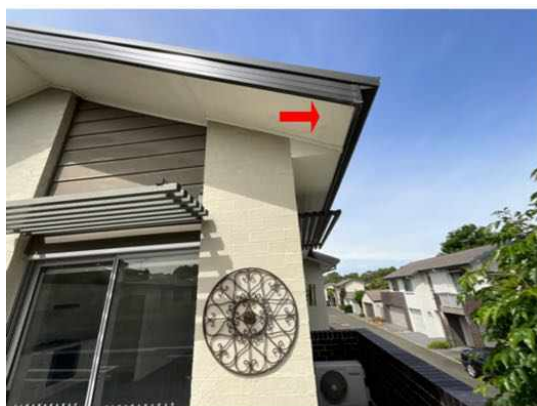
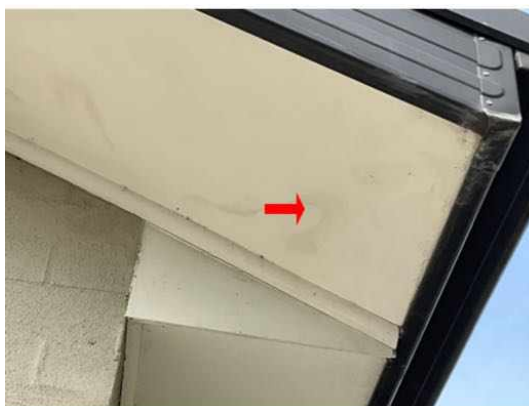
Finding 3.03

Building:	Main Building
Location:	Eaves
Finding:	Eaves - Water staining
Information:	Water staining to eaves linings in this area was evident at the time of inspection. Water staining indicates that surfaces have been exposed to excessive moisture over time. The minerals and other elements in the water lead to staining, which may graduate to corrosion and deterioration if left unmanaged. While mostly an appearance defect, water staining can be indicative of more serious defects, which may be currently concealed by the lining. A possible cause could be overflow of stormwater from the gutters due to gutters being blocked.

The client is advised to ensure the gutters are free of any obstruction at all times. Where water staining is active, a licensed roof plumber must be consulted to identify the cause of the staining and to provide advice on any reparation works that may be required. Replacement of any damaged structures is advised.

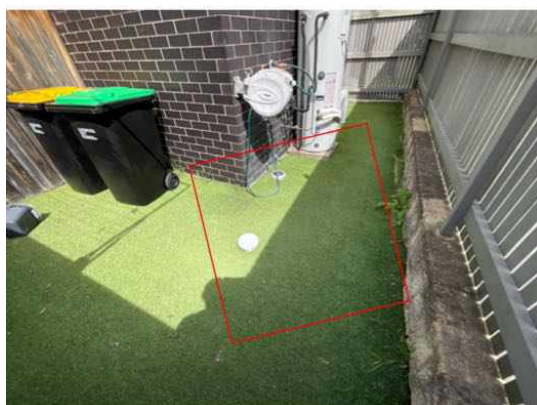
Finding 3.04

Finding: Site drainage— Inadequate

Information: The site drainage in this area was found to be inadequate at the time of inspection, creating potential for subsequent water damage to associated building elements. This is additionally conducive to termite activity.

It is important that water does not lie against the base of walls; surrounding paths and ground levels should be sloped to drain water away from walls. Downpipes should not discharge stormwater onto lower walls or plinths. Stormwater should be carried away by large, regularly cleaned drains. Ground levels may need to be lowered to expose a buried DPC.

Where site drainage is inadequate, installation of an Agricultural (Aggie) Drain may be required. A licensed plumber should be appointed to further inspect the property and perform any remedial works as necessary. Water damage and secondary defects are likely to occur if left unmanaged.

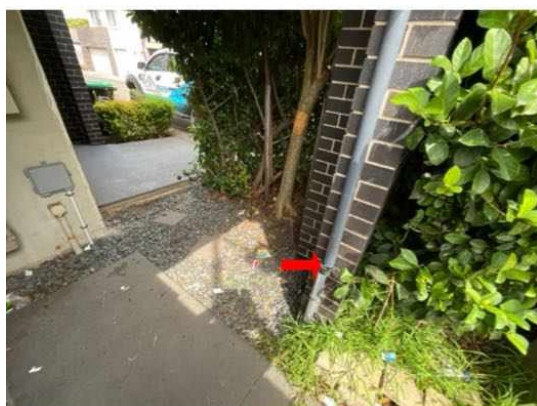
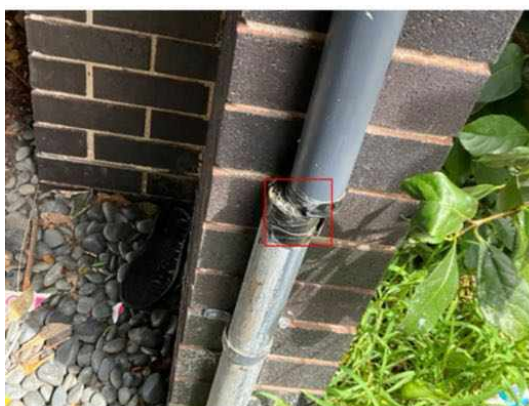
Finding 3.05

Finding: Stormwater drain - Not connected/ Damaged
 Information: The roof plumbing is not adequately connected to stormwater drainage on the site. This disconnection negatively impacts the functional capacity of the roof plumbing.

Where roof plumbing doesn't drain adequately, the area at the base perimeter can become excessively damp, potentially creating an environment that is susceptible to rust and corrosion of surrounding building elements, as well as attracting termites and other pests.

It is highly recommended that a plumber be appointed to further inspect the area and to install adequate drainage equipment where necessary.

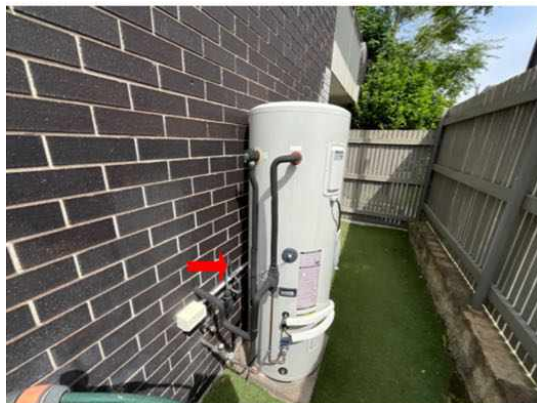
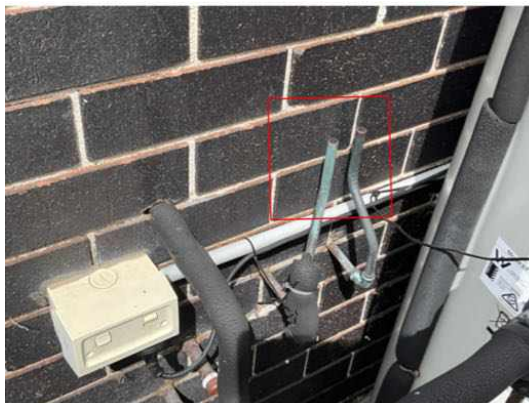
Finding 3.06

Building: Main Building
 Location: Hot water unit
 Finding: Incomplete or substandard works
 Information: The works to this area appear to be incomplete or have been completed to a substandard level.

Works that have not been completed to a satisfactory level create potential for the development of building defects and may impede on the safety and integrity of the overall structure.

It is highly recommended that the relevant trades be appointed to complete these works and ensure the safety of the area and the longevity of all associated building elements.

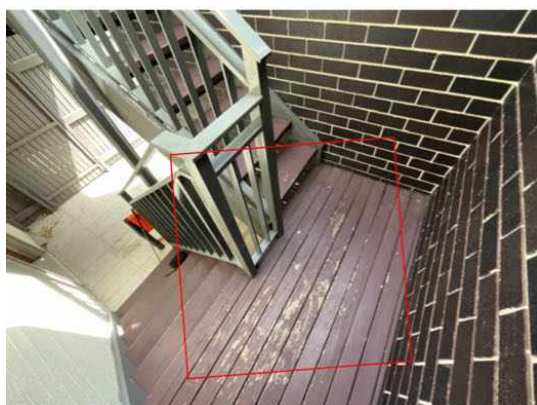
Finding 3.07

Building:	Main Building
Location:	Stairs
Finding:	Timber - exposed to weather
Information:	External timbers that are frequently exposed to harsh weather conditions require adequate protection in order to maintain their condition. Where timbers have not been painted or treated adequately, general deterioration is likely to occur at an accelerated rate.

If left unattended, replacement of these timbers is likely to be necessary in the short-term future. Adequate treatment of these timbers is required as soon as possible by a painting contractor or general handyman.

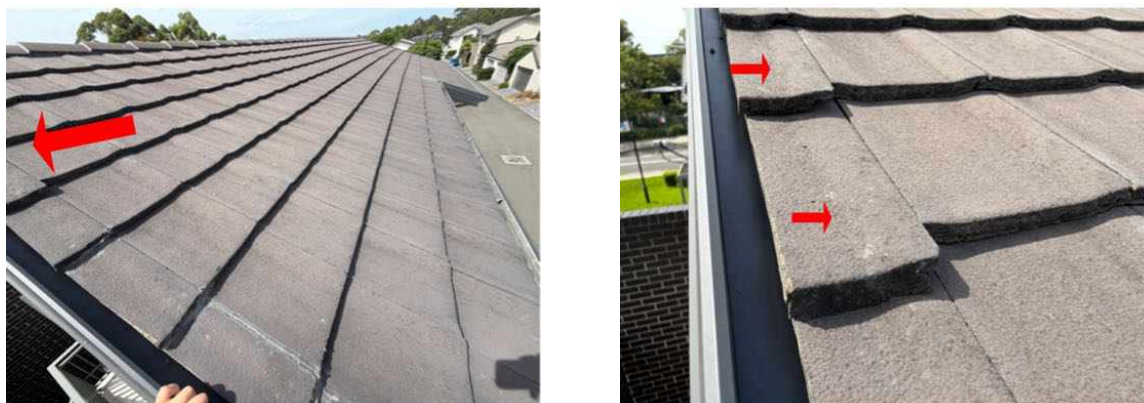
Finding 3.08

Building:	Main Building
Location:	Roof Exterior
Finding:	Roof tiles - Slippage
Information:	Upon inspection of the exterior roof covering, it was noted that numerous tiles have slipped from their original fixing. Tiles may slip over time due to a number of minor causes, including breakage of tiles, failings in the adjoining battens, or fixings that may have failed.

Roof tiles that have moved from their original position are very likely to allow water penetration into the roof void, exposing roofing structures to excessive moisture. This creates an environment that is conducive to water damage and accelerated deterioration of all associated building elements.

Replacement of loose or missing roofing tiles is recommended immediately to prevent the development of any secondary defects. A roofing restoration specialist should be appointed to complete such works as necessary.

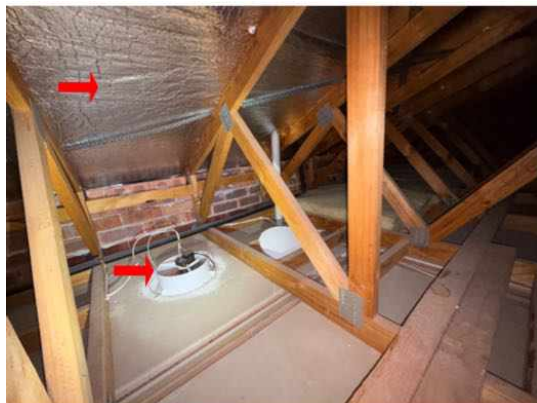
Finding 3.09

Building:	Main Building
Location:	Roof Void
Finding:	Roof void ventilation
Information:	Exhaust fans have not been connected to the outside through ducts. In further inspection, there was also no whirlybird installed to the roof surface for ventilation purposes.

As the roof is fully sarked the vents are recommended to be ducted to the eave or a whirlybird be installed.

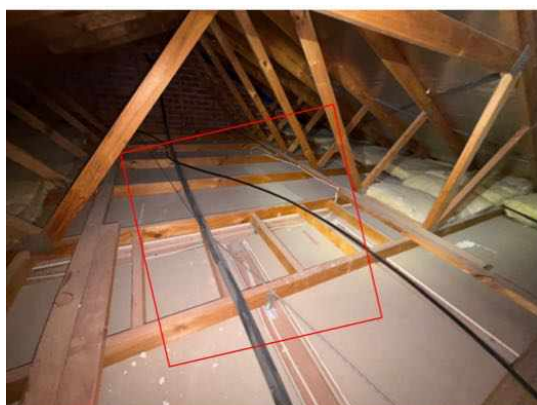
Finding 3.10

Building:	Main Building
Location:	Roof Void
Finding:	Insulation - Missing
Information:	Upon inspection of the roof void it was noted that insulation is not present.

Insufficient insulation will result in a comparatively higher cost to heat and cool a property as there is a lack of Insulation (or uneven coverage of insulation) which works as a barrier to heat transfer. This helps to keep out unwanted heat in summer and preserves warmth inside your home in winter. It can also help soundproof your home from unwanted airborne noise transfer.

Where insulation is absent, the area does not meet current Australian Standards. Installation of adequate insulation is required and should be conducted as soon as possible.

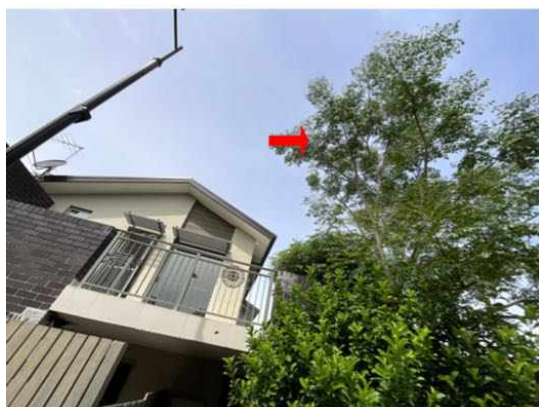
Finding 3.11

Building:	Main Building
Location:	Roof Exterior
Finding:	Trees - Overhanging and filling gutters

Gutters are a critical part of the building's management of storm water and rain. It is therefore important that they be kept clear to prevent secondary damage to associated building elements, including exterior and interior walls, ceiling linings and any adjoining building elements. Where gutters are blocked, pooling of rainwater is likely to occur, fast-tracking rust and corrosion of the roof plumbing elements.

It is highly advised that all overhanging tree branches be removed as soon as possible to prevent any further damage. Repair and/or replacement of sections of damaged guttering may also be required where the extent of the damage necessitates.

Such works should be performed by the homeowner; however, appointment of a landscape contractor or an arborist may be required. Consultation with a licensed roof plumber is required where guttering has been damaged.

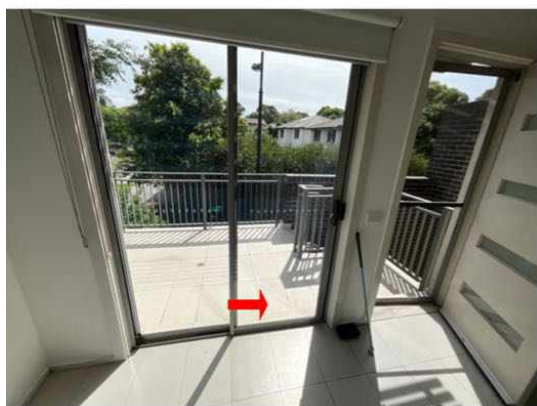
Finding 3.12

Building: Main Building
 Location: Balcony
 Finding: Door - Stiff to slide
 Information:

The door in this area was jammed and difficult to slide along the associated tracks at the time of the inspection. Restricted function of the affected door may pose as a potential safety hazard if required for emergency egress from the building.

Generally, factors such as general age of the building element and a lack of maintenance are the usual causes for this type of defect.

Replacement of door hardware or tracks may be required, as well as minor repairs and cleaning. A registered builder will be required to repair the affected doors.

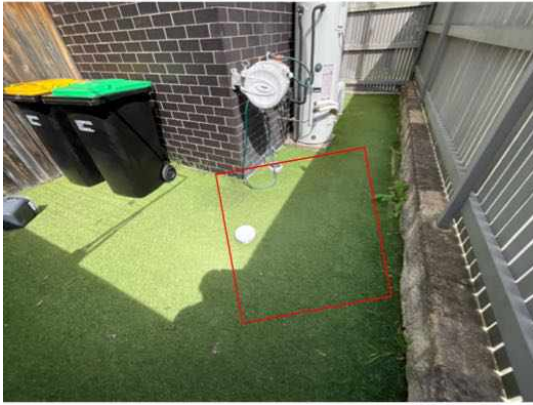
Building:	Main Building
Location:	Yard
Finding:	Site drainage— Inadequate
Information:	The site drainage in this area was found to be inadequate at the time of inspection, creating potential for subsequent water damage to associated building elements. This is additionally conducive to termite activity.

Where site drainage is inadequate, installation of an Agricultural (Aggie) Drain may be required. A licensed plumber should be appointed to further inspect the property and perform any remedial works as necessary. Water damage and secondary defects are likely to occur if left unmanaged.

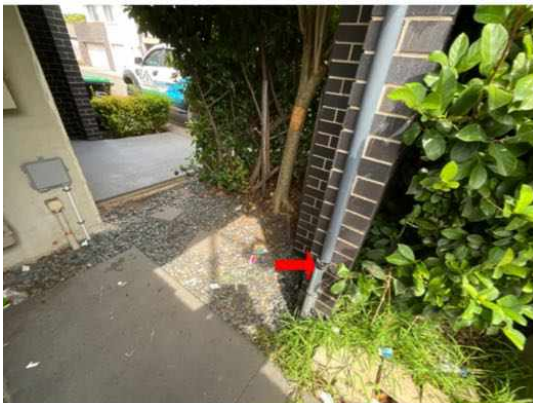
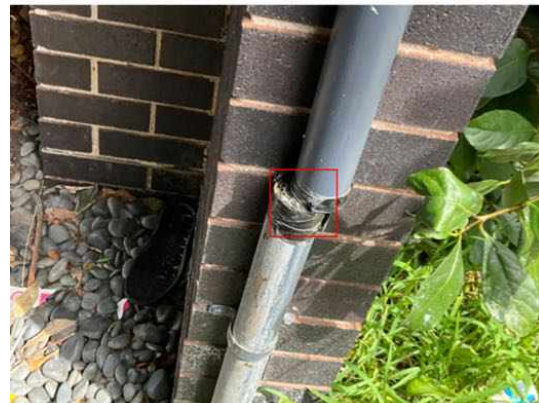
Finding 6.02

Building:	Main Building
Location:	Front Elevation
Finding:	Stormwater drain - Not connected/ Damaged
Information:	The roof plumbing is not adequately connected to stormwater drainage on the site. This disconnection negatively impacts the functional capacity of the roof plumbing.

Where roof plumbing doesn't drain adequately, the area at the base perimeter can become excessively damp, potentially creating an environment that is susceptible to rust and corrosion of surrounding building elements, as well as attracting termites and other pests.

It is highly recommended that a plumber be appointed to further inspect the area and to install adequate drainage equipment where necessary.

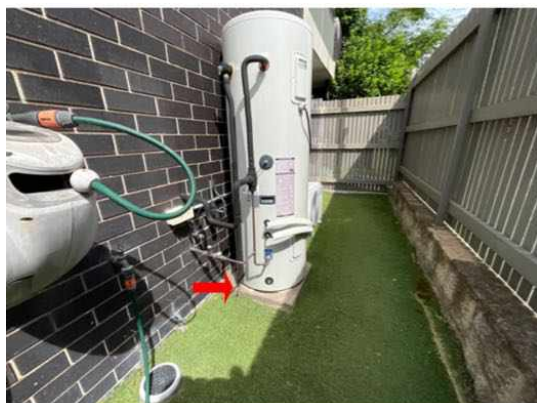
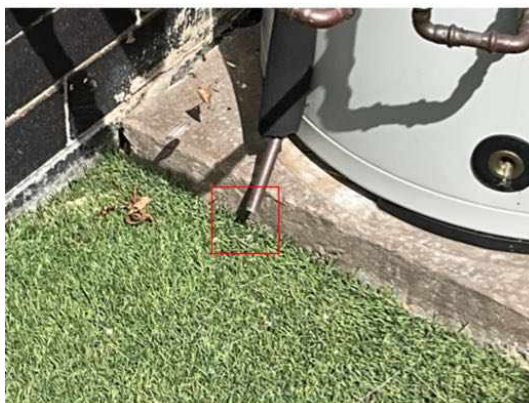
Finding 6.03

Building:	Main Building
Location:	Yard - Side
Finding:	Overflow - Not plumbed for drainage
Information:	The overflow is not plumbed or connected to suitable drainage, which can result in the surrounding area becoming excessively damp.

These damp conditions can lead to secondary defects such as rot, rust or corrosion of associated building elements, the formation of fungal decay, or even the creation of potential slip hazards. When coupled with poor site drainage, pooling of water may also attract termite activity to this area.

It is highly recommended that a licensed plumber be appointed to install adequate drainage to the overflow. These works will ensure that the area remains dry and free of any secondary defects.

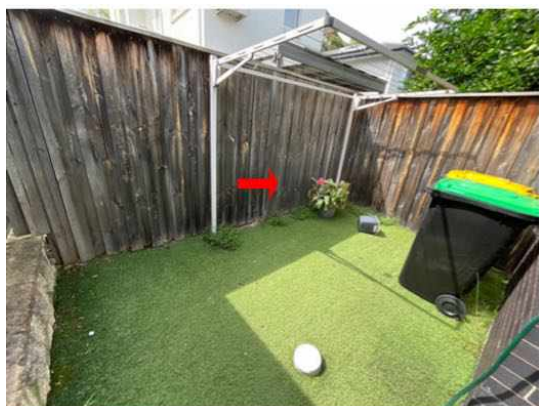
Finding 6.04

Building:	Main Building
Location:	Fencing & Landscaping
Finding:	Building materials in direct ground contact - conducive to termites
Information:	Where timber elements are in direct contact with the ground and consequently moisture or dampness they become conducive to termite activity. Whether timber is used as a building element part of a fencing structure or stored as an unused item they can provide an environment that is attractive to termite infestation.

When met with excessive moisture timber begins to decay and develop wood rot. Any timbers that are in direct contact with external grounds especially if left untreated or non-durable also provide ingress for subterranean termites into that particular element.

The removal of any such materials that may be conducive to termite activity should be removed as soon as possible to minimise the risk of termite attack.

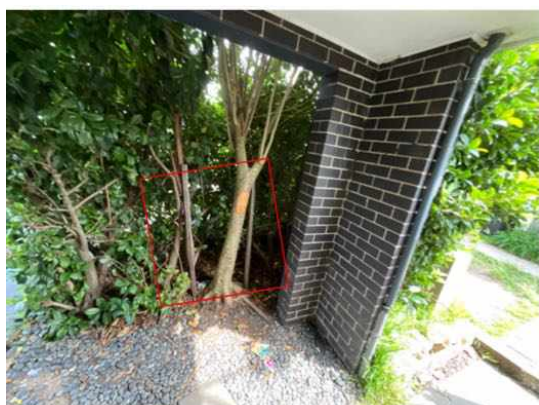
Finding 6.05

Building:	Main Building
Location:	Vegetation
Finding:	Vegetation - Abutting property
Information:	Vegetation against external wall may have an invasive root system. If there are weak points in the brick work or concrete slab, it is possible for the roots to gain entry into these areas. Once the roots have gained entry, it is possible for termites to gain concealed entry via these roots. It is recommended to remove the vegetation and root system where possible.
