Building and Timber Pest Inspection Report

Inspection Date: Wed, 11 Feb 2026

Property Address: 510 Milro Ave, East Albury NSW 2640,
Australia

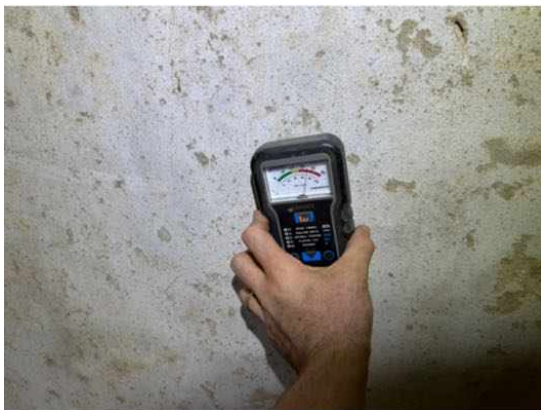
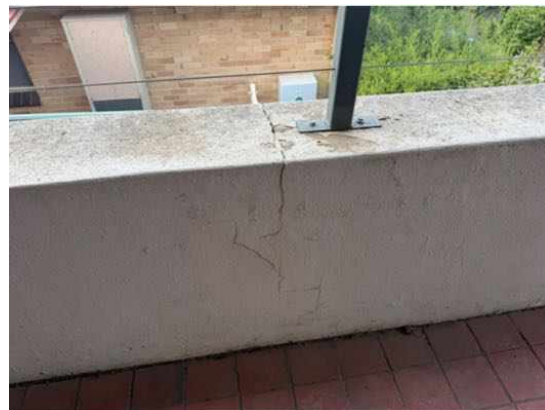
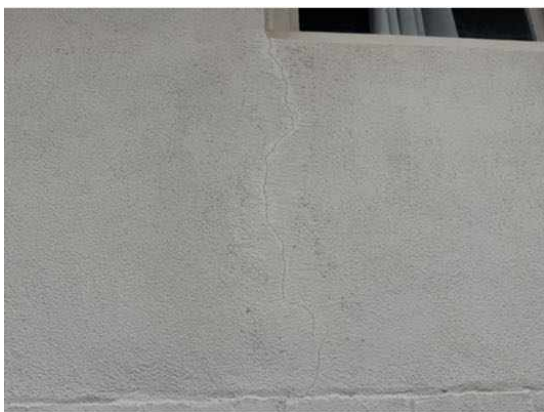
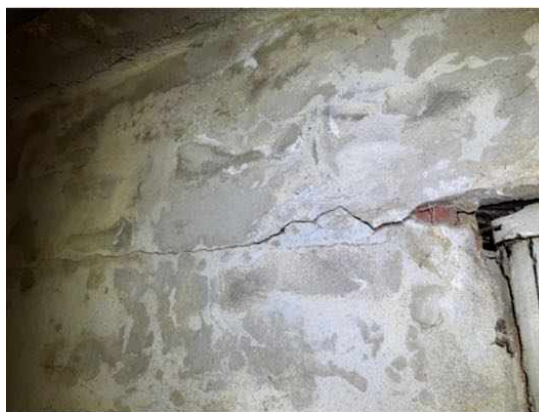
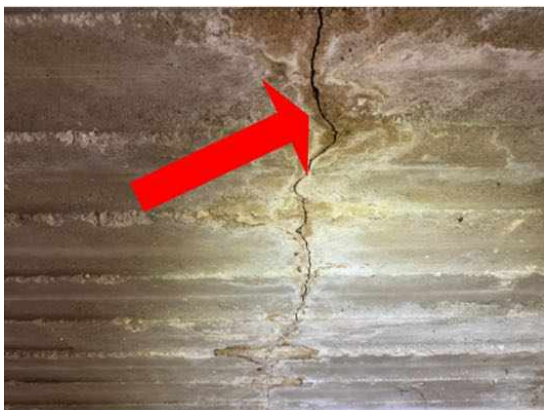
Building: Main Building
Location: Balcony Slab, Brickwork
Finding: Brickwork & Balcony Slab - Cracking & Rising Damp
Information: Cracking was identified to some areas of the brickwork and the balcony slab at the time of inspection. Cracking, has a variety of possible causes. However, the most common is general movement of adjacent footings. Rising damp (moisture in the brickwork) was also identified to the garage walls.

Step cracking is a relatively common defect, and is most likely to occur adjacent to windows, doors and other openings.

The client should monitor the cracking. Should the cracking lengthen, widen or become more numerous, a structural engineer should be engaged promptly, to provide further advice. Should the rising damp develop, a damp-proofing specialist should be engaged to provide further advice.

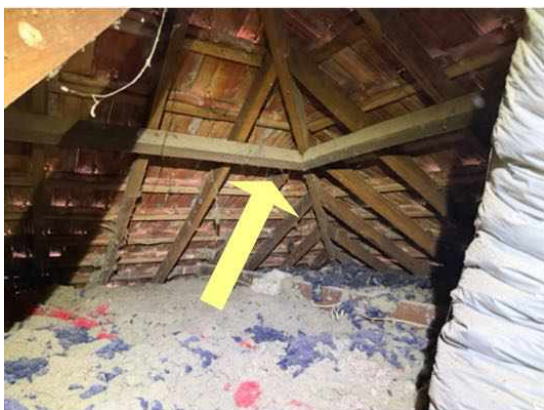
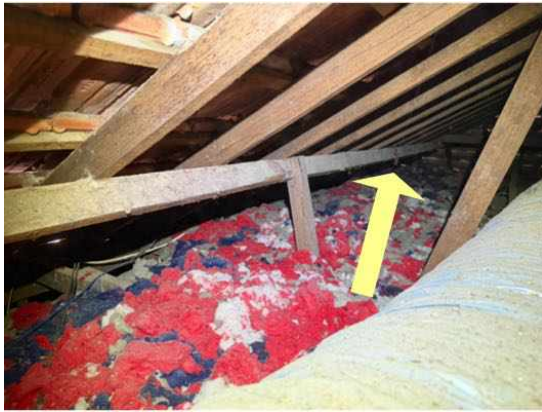
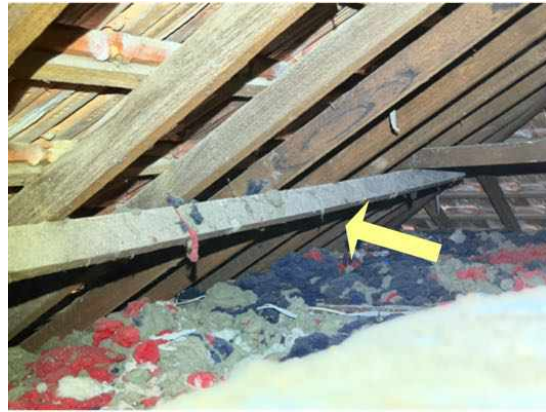
Finding 3.02

Building: Main Building
Location: Roof Void
Finding: Roof Framing - Additional Fixings / Support Recommended
Information: It appears some areas of the under-purlins in the roof void, are slightly sagging and require additional fixings and/or support. Although it appears this has been present for an extended period of time, additional fixings / support are recommended to avoid further potential movement and sagging.

Recommend engaging a registered builder in the short term, to provide further advice & remedial works where necessary.

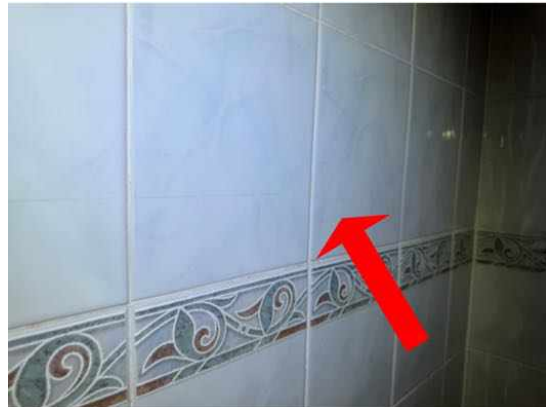
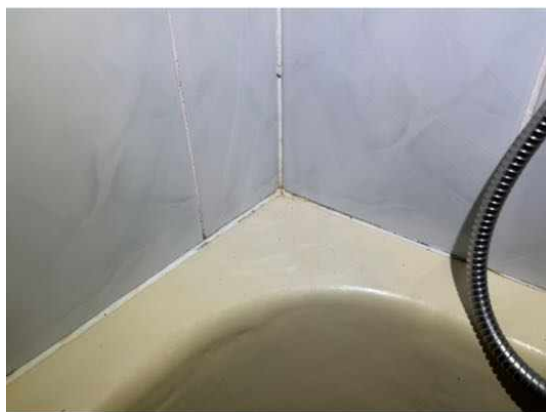
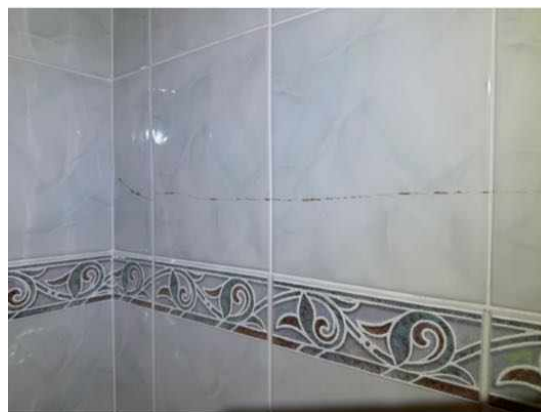
Finding 3.03

Finding: Sealant / grouting - deteriorated or missing & Cracked Tiles

Information: It appears that the sealant and grout has deteriorated in some tiled areas, a common defect in buildings of a similar age. Areas of cracked tiles were also noted, which can allow for moisture ingress behind the tiles, if neglected.

Sealant and grouting in areas that come into regular contact with water should be maintained for the long term care of your property.

Recommend engaging a licensed tiling contractor in the short term, to provide maintenance works where necessary.

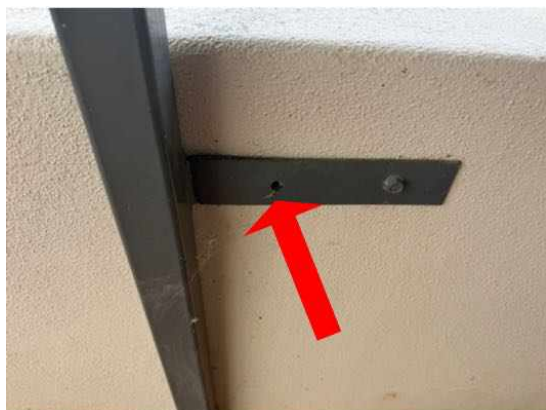
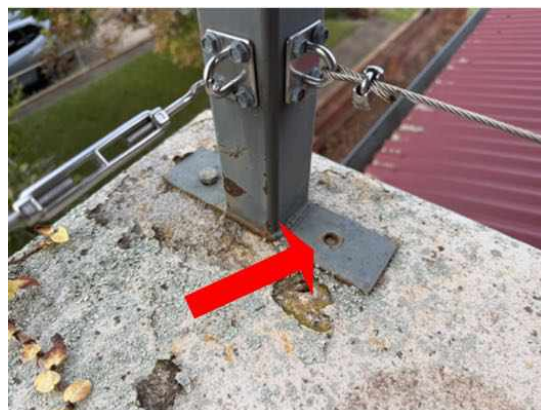
Finding 3.04

| Finding: | Balcony Posts - Additional fixings advised |
| Information: | It appears insufficient fixings were present at but not limited to the balcony posts. Recommend engaging a licensed carpenter, in the short term, to install additional fixings where necessary. |

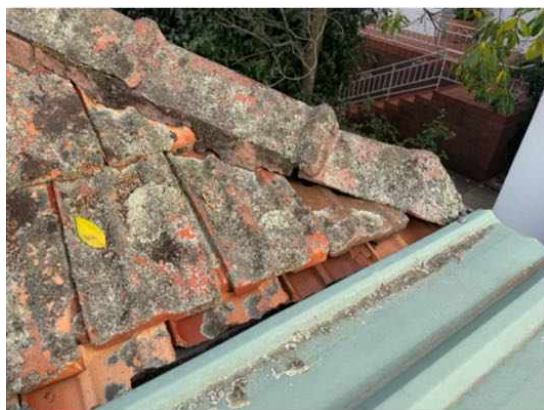
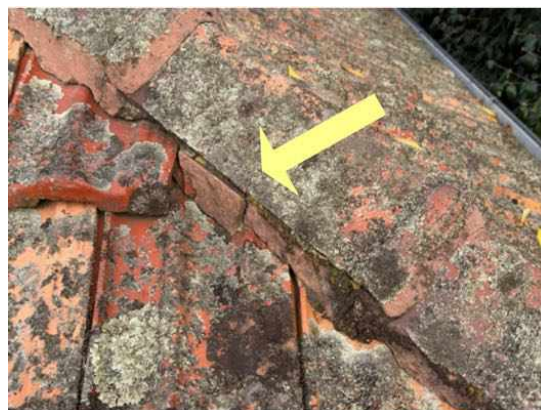
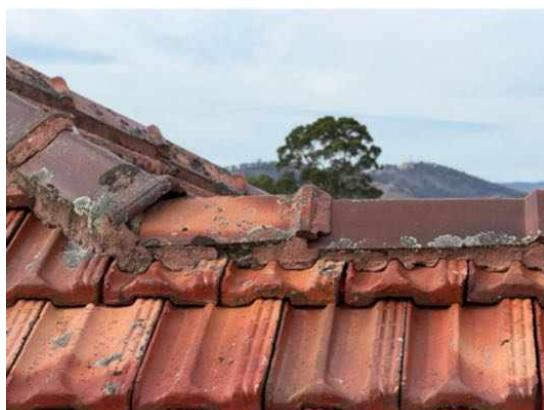
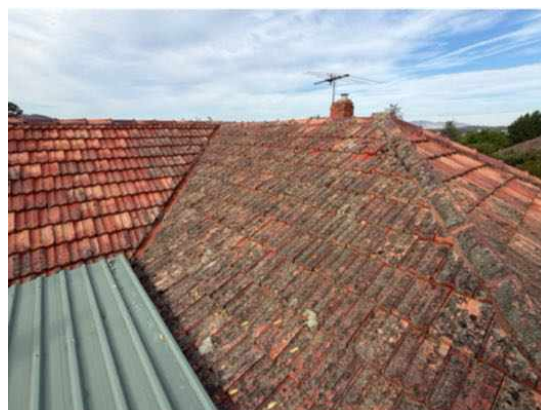
Finding 3.05

| Finding: | Roof Exterior - Weathered, Cracking |
| Information: | <p>The roof exterior was found to be in a weathered condition at the time of inspection evidenced by lichen growth, and cracking in the tile pointing. While weathering of the tiles is consistent with the age of the property, maintenance works are advised.</p> <p>Where left unmanaged, weathered roof tiles are likely to lead to secondary defects, including water leaks. Recommend consulting with a licensed roofing contractor in the short term, to provide further advice on maintenance works required.</p> |

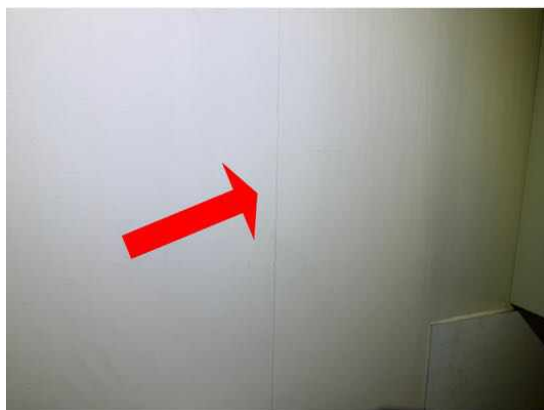
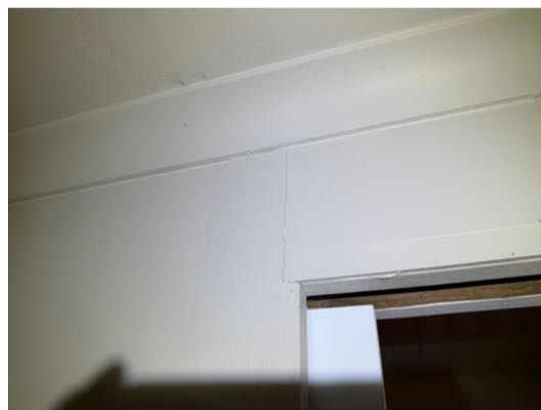
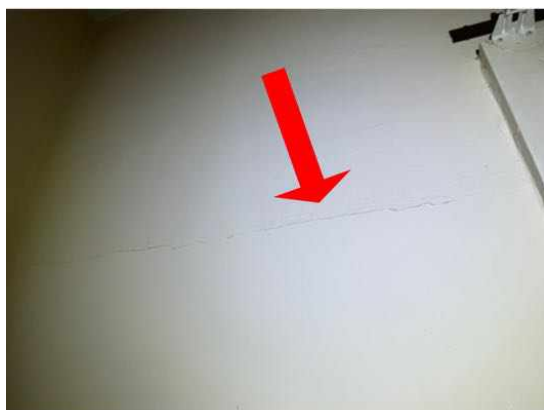
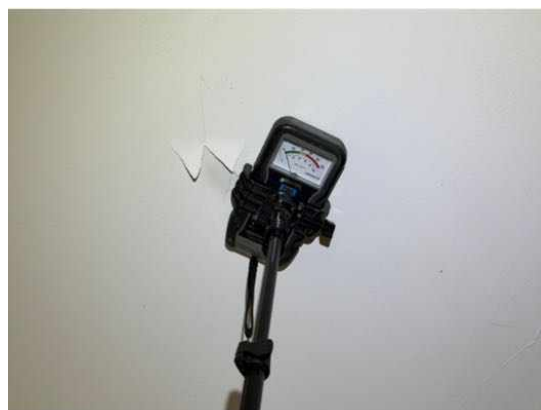
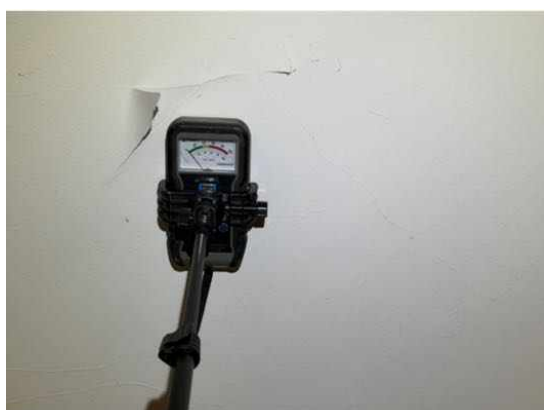
Finding 3.06

| Finding: | Plaster - Cracking & Peeling |
| Information: | There appears to be minor cracking in some areas of the ceiling and wall linings throughout the building. Cracking of this type is common in buildings of a similar age. Some areas of the paintwork were also found to be peeling, no high moisture was evident in these areas. |

Although this is mostly a visual defect, it is advised that the client monitor these areas. Should cracking widen, lengthen, or become more numerous, the client should consult with a structural engineer for further evaluation.

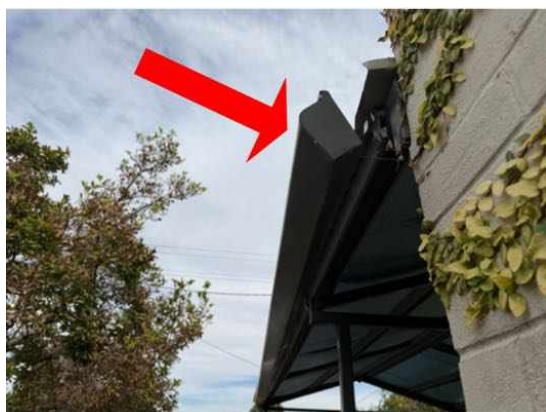
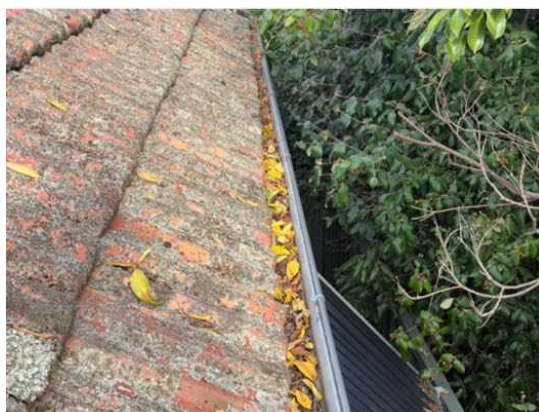
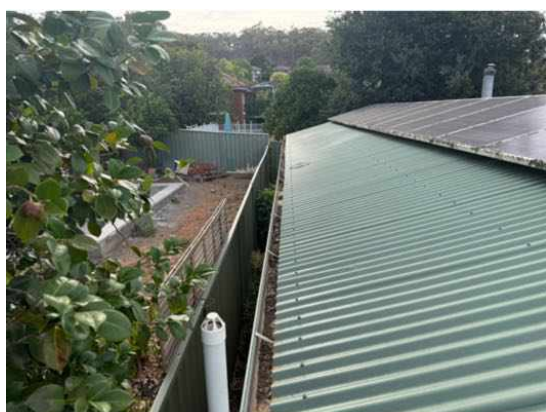
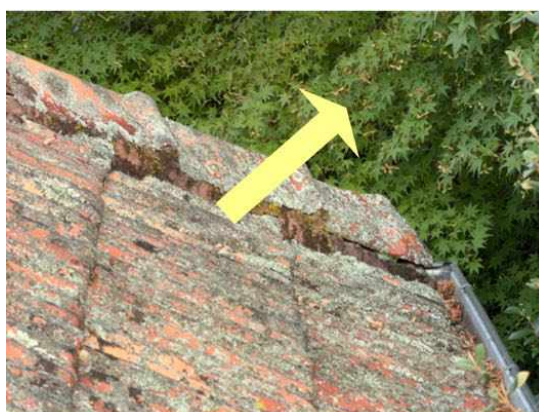
Finding 3.07

| Information: | It appears that there is debris present in the guttering. Overhanging vegetation was also noted in areas of the guttering, and the carport gutter was found to be sagging. All roof plumbing should be free of all debris to prevent blockages, accumulated water overflows and/or flooding of the eaves. |

The client or a general handyman should be contacted to remove all debris from the guttering and cut back any overhanging vegetation, to prevent secondary building defects from occurring. A licensed roof plumber should be engaged to re-connect the

carport gutter to the clips.

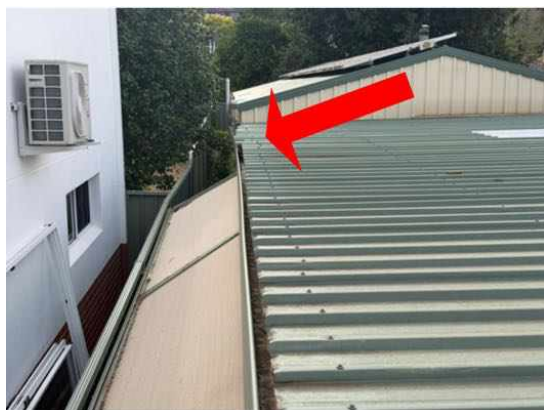
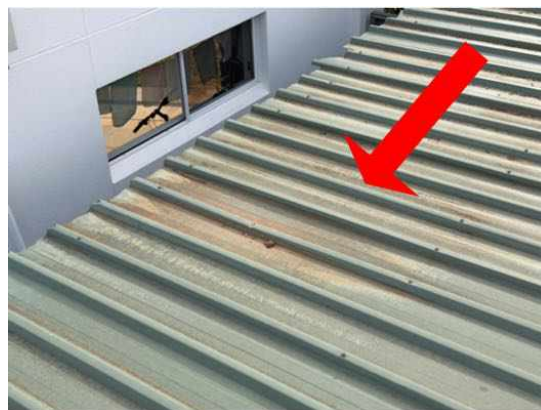
Finding 3.08

| Information: | It appears that the roof sheeting of the undercover area was overhanging the gutters, which can allow for stormwater runoff and water pooling at the base. It appears some areas of the roof sheeting were sagging, allowing water to pool on the roof. |

Recommend consulting with a licensed roofing contractor to provide further advice & remedial works where necessary.

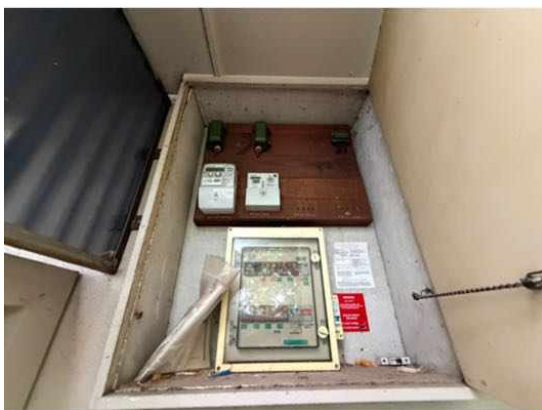
| Information: | The application of a termite barrier is strongly recommended, as it appears no termite management system has been installed, with no evidence or durable notice to suggest works taking place. Generally, a durable notice is placed in the meter box to indicate current termite barriers. |

Such barriers are highly effective in preventing termite attack on the building and therefore should be installed.

Recommend seeking further advice from a licensed pest controller.

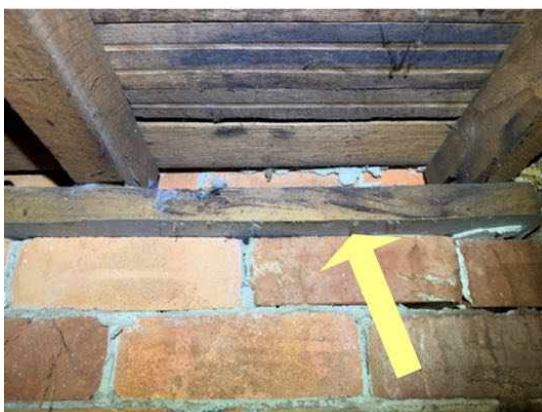
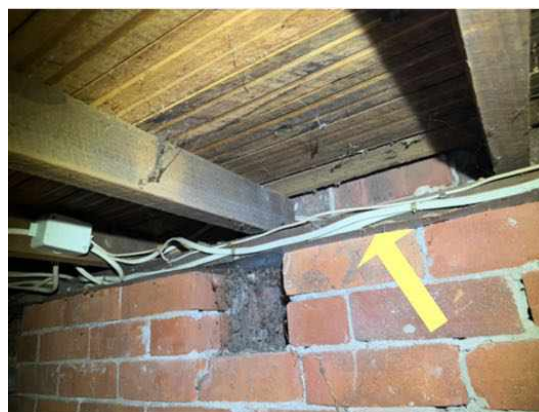
Finding 6.02

| Finding: | Ant caps - Inadequate |
| Information: | It was found that several ant caps that have been installed are inadequate. Ant caps are designed to easily identify termite or pest ingress from stumps to the adjoining bearers. |

Where ant caps are inadequate, this poses as an obstruction to the inspection and frequent monitoring of these areas should be carried out in order to identify any early signs of termite workings. Recommend engaging a licensed carpenter to install adequate ant caps to the subfloor.

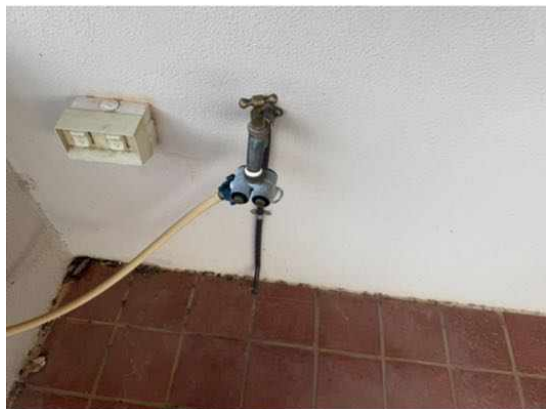
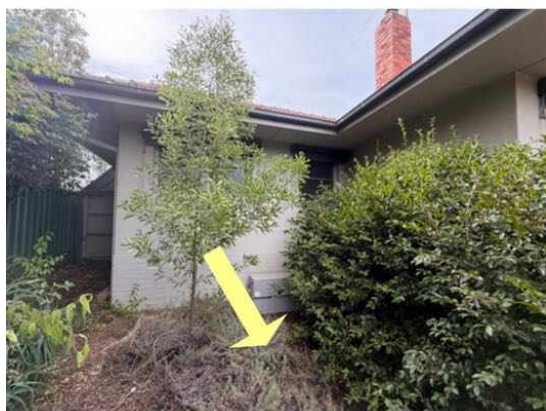
Finding 6.03

beds against the house are present, water pooling is likely to occur, and can create areas conducive to timber pests and potential damage to the subfloor structure overtime, if neglected.

Recommend consulting with a licensed plumber in the short term to further assess and provide remedial advice.

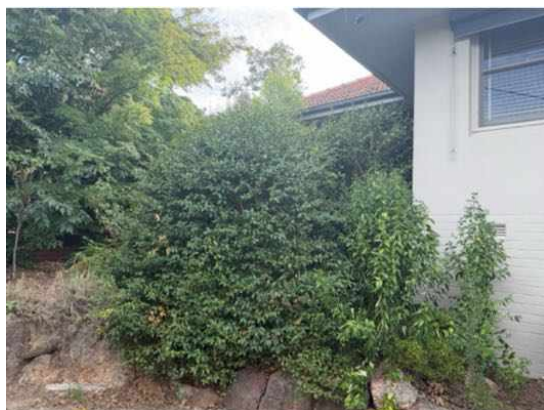
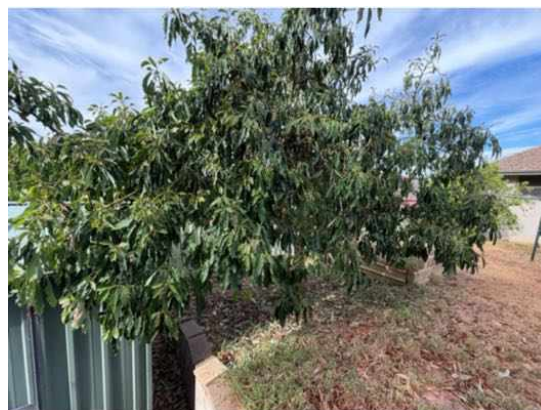
Finding 6.04

| Information: | Where timber materials are in direct contact with the ground and consequently moisture, they become conducive to termite activity. The landscaping timbers and trees surrounding the building create an environment conducive to termite activity. |

Where feasible, any timbers in direct contact with the ground should be removed and any trees in close proximity to the building should be removed or test drilled (inspected) at least annually to reduce the risk of termite infestation & detect any early signs of termite activity.

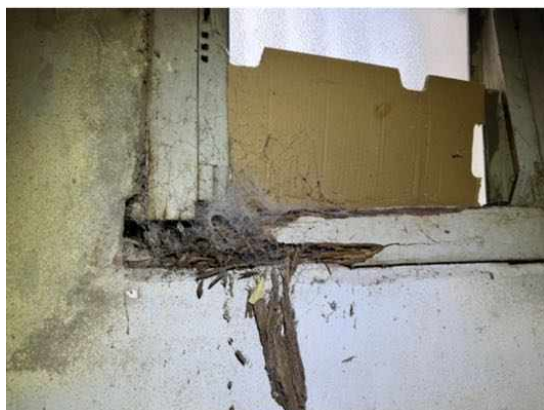
Finding 7.01

| Finding: | Fungal decay & weathering |
| Information: | Areas of fungal decay (wood rot) were identified at but not limited to the garage window frame. The client can engage a licensed carpenter at their discretion to replace affected materials. |

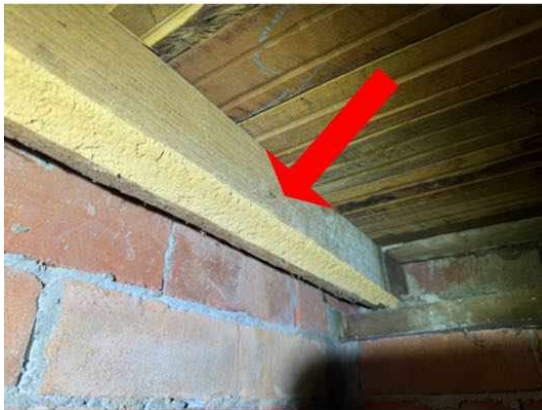
Finding 8.01

| Finding: | Evidence of wood borer damage identified (powder-post) |
| Information: | Evidence of previous Lyctus Borer (powder-post beetle) damage was identified to the side of a bearer in the sub-floor. Wood borer damage is generally considered |

superficial damage to the affected timber. As no live wood borer activity was identified treatment is not required.

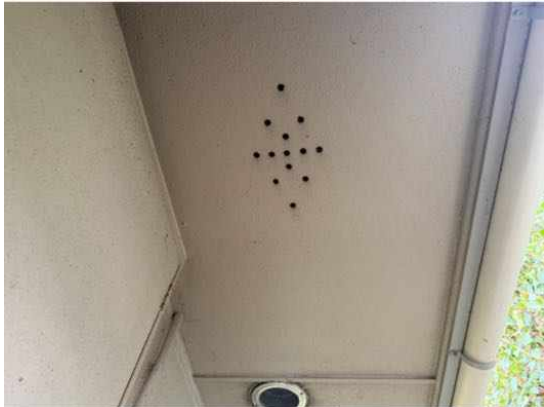
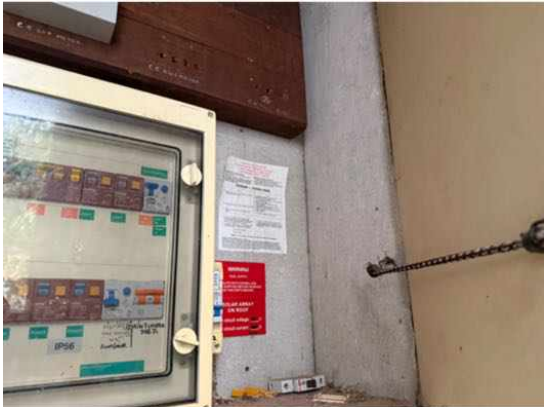
Building: Main Building
 Location: Eaves, Bathroom, Toilet, Laundry, Switchboard
 Finding: Asbestos - Suspected ACM Identified on Site
 Information: This suspected defect is highlighted as a caution only as reporting on asbestos is outside the scope of this report. It is suspected that the materials including but not limited to the eave sheets, switchboard, bathroom, toilet & laundry wall linings may be ACM (Asbestos containing materials)

It is advised that the client consider a separate Asbestos Inspection and Condition Audit, which can include the taking of samples for definitive confirmation of the presence of Asbestos, carried out by a licensed Asbestos Inspector.

In the interim, no works should be conducted to these areas without further specialist advice.

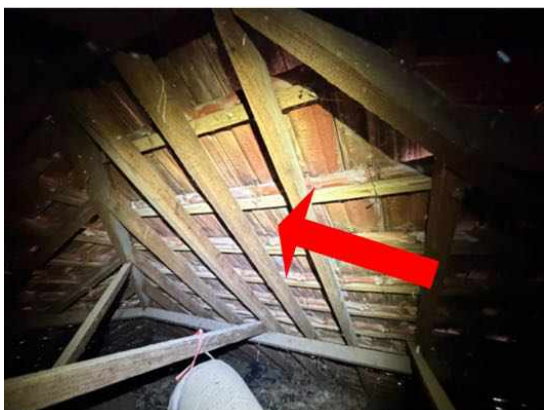
Building: Main Building
Location: Roof Void
Finding: Sarking - Not Present
Information: It is noted for your information that sarking has not been installed on the roof. Sarking is a laminated aluminium foil applied to the interior of the roof covering, assists in insulating the property and acting as a vapour-barrier to the roof void.

The client can consult with a licensed roofing contractor at their discretion, to provide further advice.

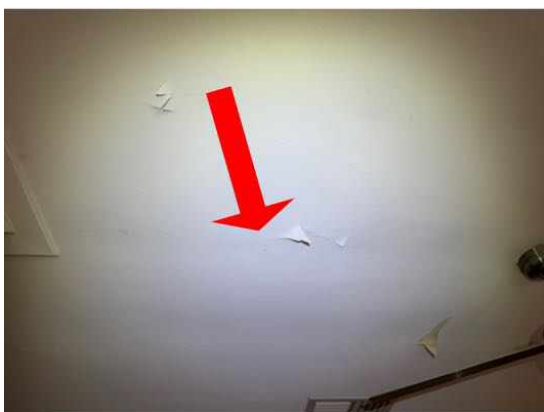
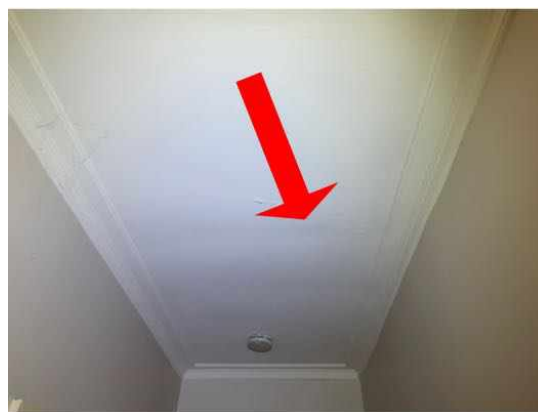
| Finding: | Ceiling - Minor Sagging |
| Information: | Sections of the ceiling at but not limited to the hallway & lounge room appear to be slightly sagging at the time of inspection. Causes of ceiling sagging include fixings (e.g. nails or glue) that have become loose and require re-fixing. Recommend the client to monitor the sagging and engage a licensed plasterer to provide maintenance works, should the sagging develop. |

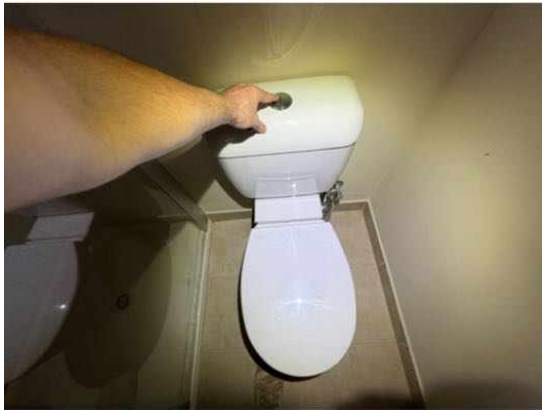
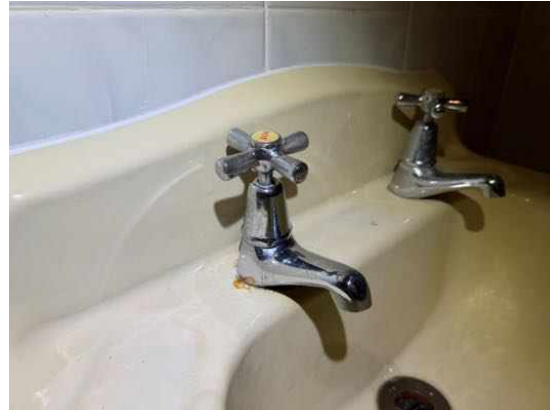
| Finding: | Maintenance Items - Shed Toilet Not Operating & Loose Tap |
| Information: | It appears that the outside toilet was not operating/flushing at the time of inspection, and a bathroom tap was found to be loose. |

Recommend engaging a licensed plumber to provide further advice and maintenance

works where necessary

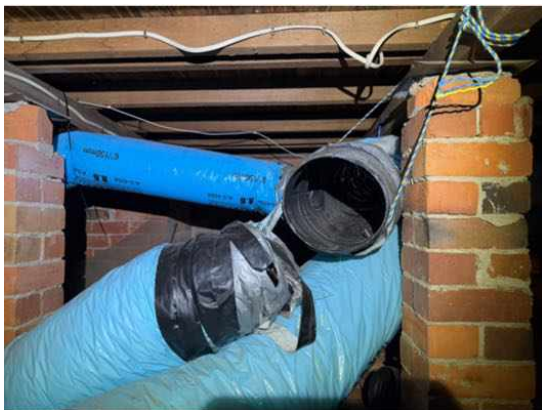
Building: Main Building
Location: Subfloor
Finding: Ducting - disconnected
Information: Areas of the ducting in the subfloor appeared to be disconnected. This defect inhibits the functionality of the affected system. Consultation with a licensed electrician is advised at clients discretion, to reconnect the ductwork.
